THE MODEL T FORD

ITS REPAIR, SERVICE, & RESTORATION

Clincher Rim Inspection for Tire Care

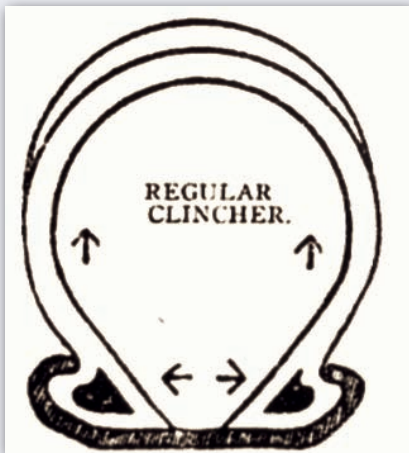
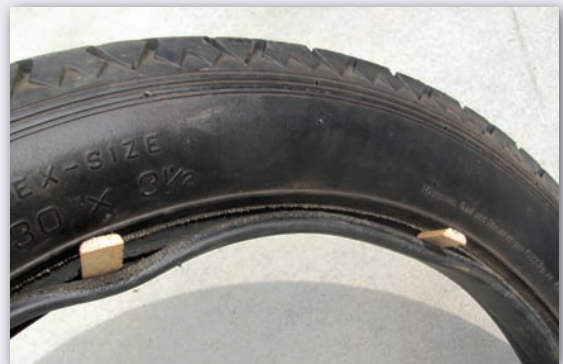
Rims with damage caused by curb hits where the rim is bent or folded will, over time, cause the tire to bulge at the bent clincher rim edge, which will shorten the life of the tire considerably.

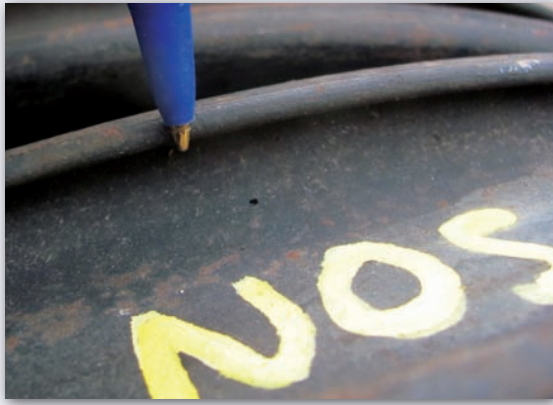
In the following picture, this new clincher tire was mounted on a rim with sharp, narrowed clincher edges - due to heavy rust - which rotted away the thickness of the curved metal rim. That thinned edge then cut into the tire casing and ruined a new tire in less than 100 miles.

To help avoid tire troubles, be sure to carefully inspect the inner edges of the clincher rims to be sure that the thickness is there for good use. Early non-demountable clincher wheels had edge thickness of 1/8" or .125" (3.17 mm), with a 1/16" smooth radius on that edge. Later rims have more thickness, as shown in the following photo of a new old stock (NOS) rim. New reproduction clincher rims* are made of quality steel, 10 gauge, or .134" (3.4 mm) edge thickness. Note ball point pen tip, for reference.

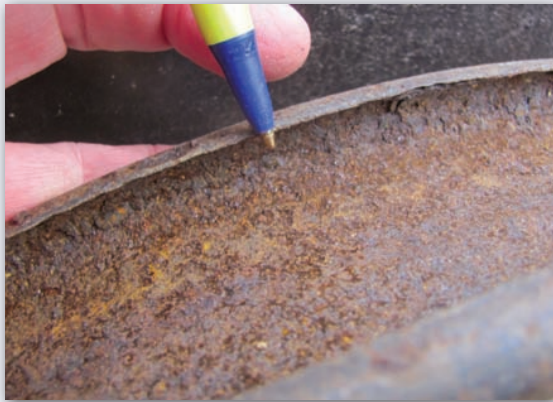
Now compare the previous photo with the photo below, which shows a rusted-away clincher rim. It's the same ball point pen tip, but notice that this rim thickness is considerably below the 1/8" minimum and has rusted to a sharp thin edge. Rims like this will eventually cause tire trouble.

Use care in the inspection of clincher rims on which you may choose to mount tires. The rim should, of course, be round and without rim bends or damage. Especially check the clincher edges to be sure of the minimum 1/8" thickness needed, and for thin or sharp edges from excessive rust. Replace rims that exhibit thin rim edges, damage, and abusive wear.

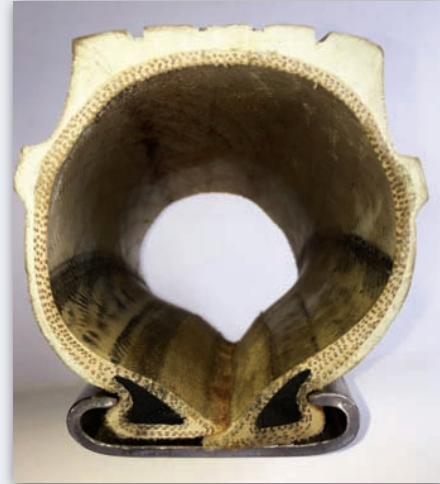
RIM TROUBLES
That Lower Tire Mileage

Rim Cutting Bead broken down from running on flat tire. New rim required.

Irregular Contours Caused by curb bumping or running on flat tires. In some cases can be repaired, usually new rims are advisable.

Rusty Rims Rims regardless of how good they are eventually wear out. When rims accumulate heavy cakes of rust injury to sidewall and bead of tire will result. Do not apply tires to rims in this condition.

All Out of Round and Faulty Alignment These faults cause uneven tire wear and result in lower mileage. New rims are necessary.
