# Inspection Report

**Property Address:**  
22 Easy Lane  
Richville SC

**DuBose Home Inspection, Inc.**

<b>Date:</b> 3/4/2013	<b>Time:</b> 09:00 AM	<b>Report ID:</b> IC04S
<b>Property:</b> 22 Easy Lane Richville SC	<b>Customer:</b> Suzie Sample	<b>Real Estate Professional:</b>

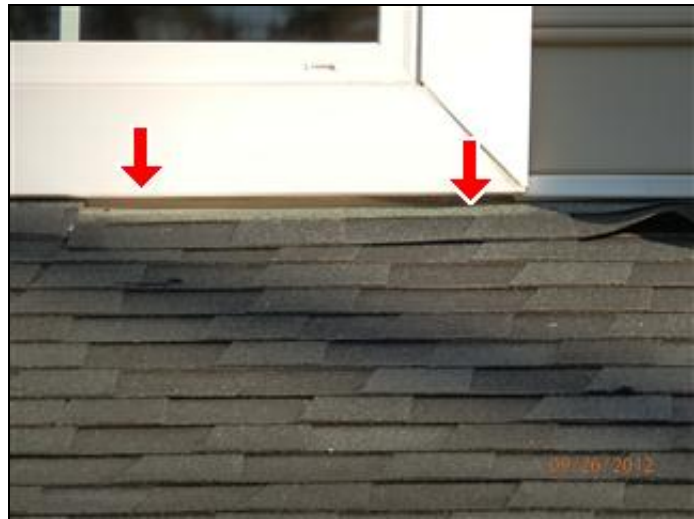
1.0 Picture 1

(2) There is one loose shingle on the front of the house. Recommend licensed contractor evaluate and make necessary repairs.

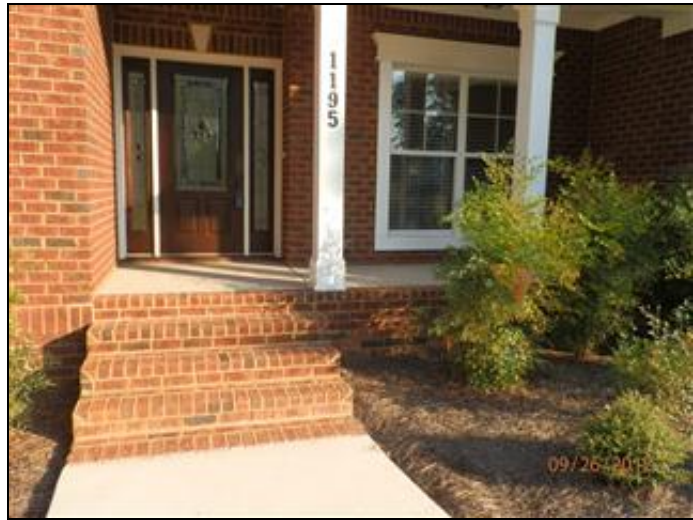
2.6 Picture 1

At the time of construction, handrails and/or guardrails may not have been required. For safety concerns I recommend you consider adding handrails and/or guardrails.

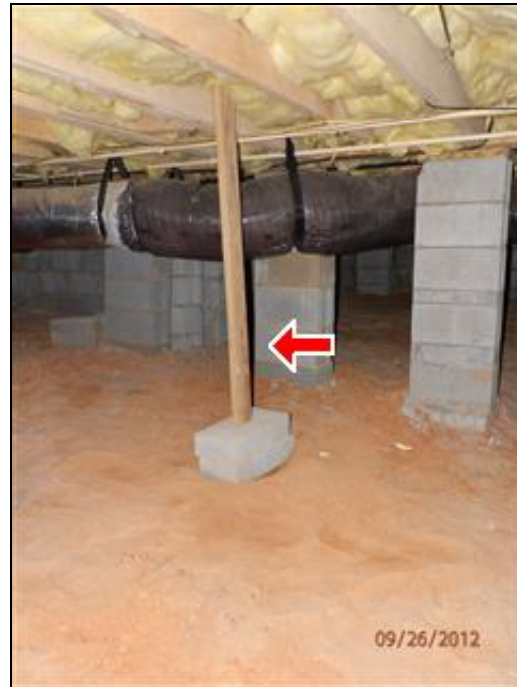
4.5 Picture 1

Additional supports have been added in the crawlspace. They appear to be functioning as intended, but these added supports should be considered temporary supports. This means they may need periodic maintenance because they lack proper footings which could cause some settlement. You may want a licensed contractor evaluate.

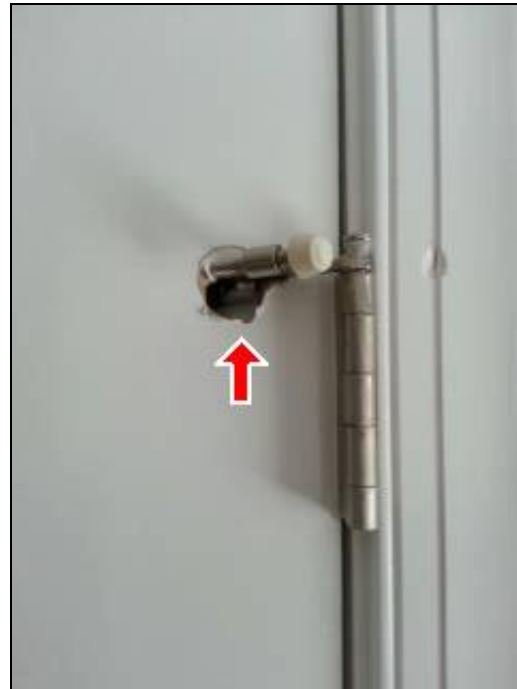
6.4.A Picture 1

One of the bonus room doors is damaged because the door stop penetrated the door. Recommend licensed contractor evaluate and make necessary repairs.

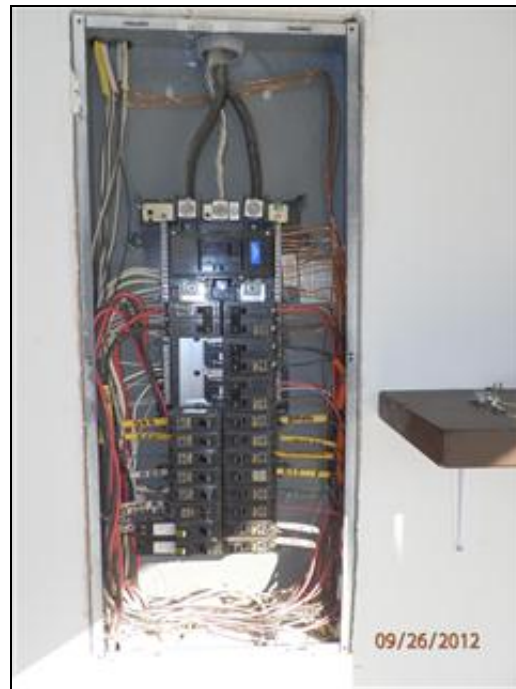
9.6 Picture 1 Breaker Panel

The main panel is located in the Garage.

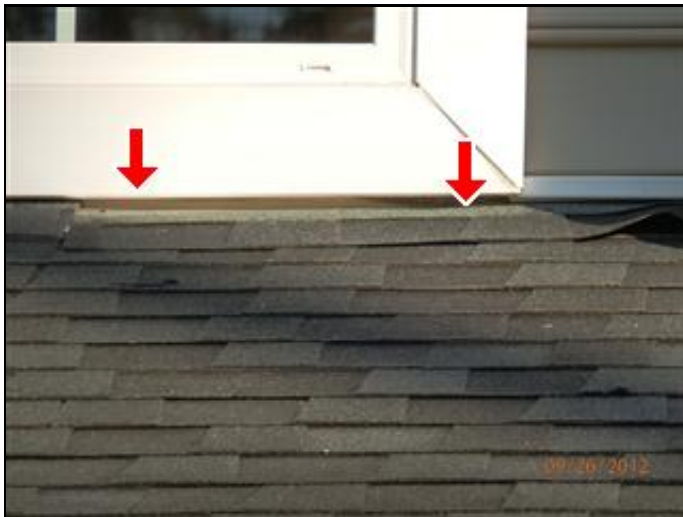
1.0 Picture 1

(2) There is one loose shingle on the front of the house. Recommend licensed contractor evaluate and make necessary repairs.

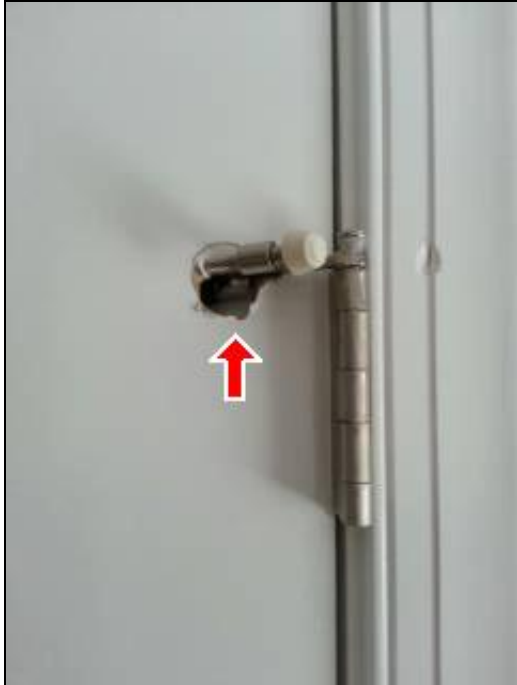
6.4.A Picture 1

One of the bonus room doors is damaged because the door stop penetrated the door. Recommend licensed contractor evaluate and make necessary repairs.
