CONCRETE

FLOOR

EPOXY

Back to the Grind on Coffee Facility Floor

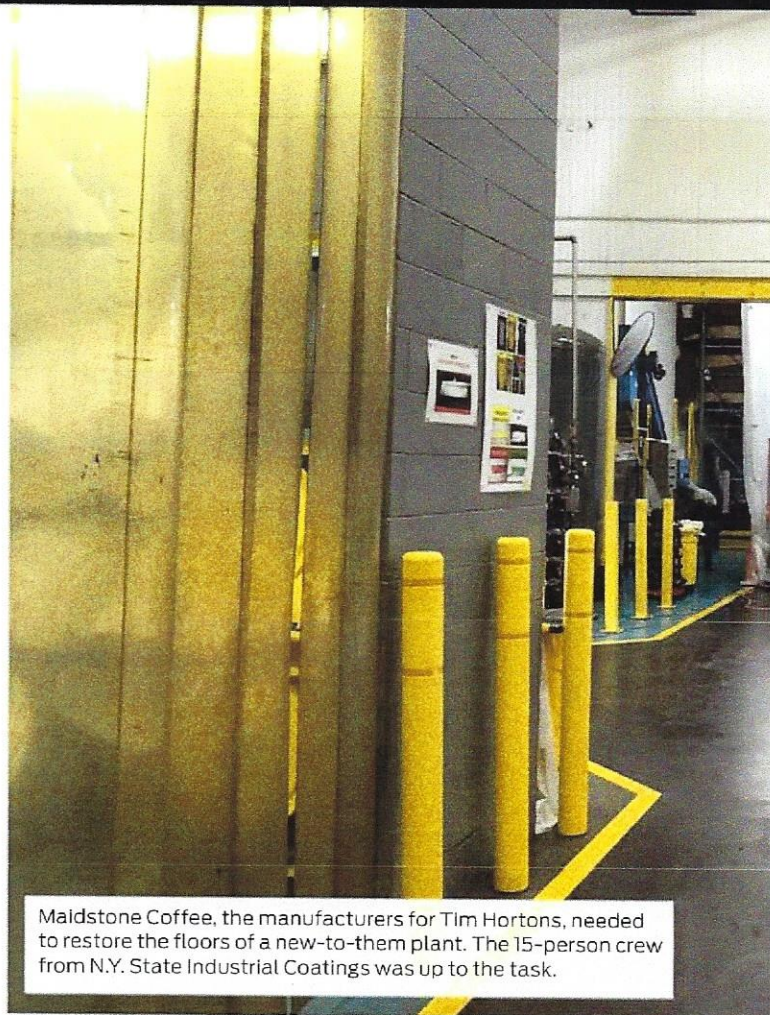
Maidstone Coffee, the manufacturers for Tim Hortons, needed to restore the floors of a new-to-them plant. The 15-person crew from N.Y. State Industrial Coatings was up to the task.

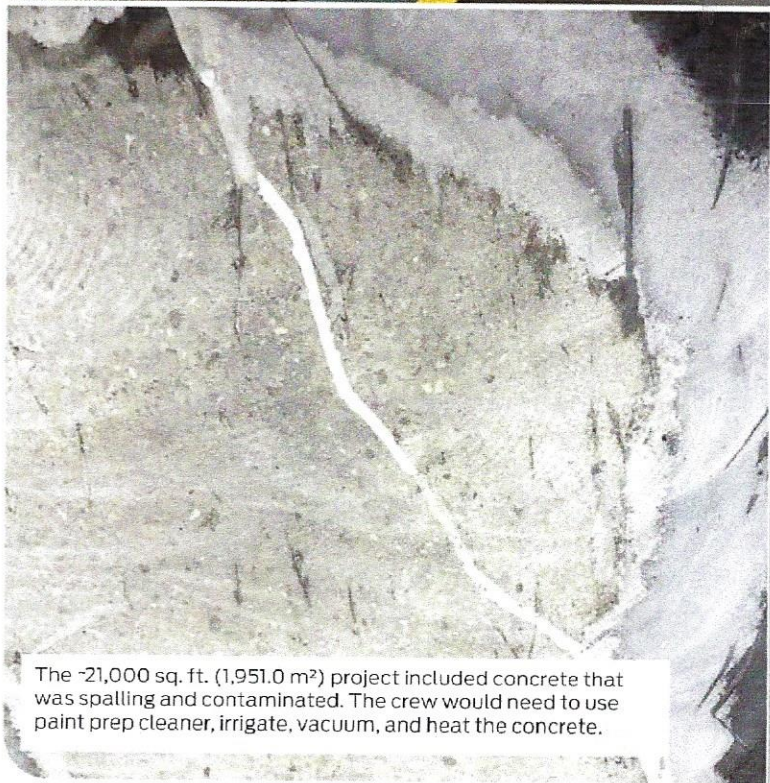
The ~21,000 sq. ft. (1,951.0 m²) project included concrete that was spalling and contaminated. The crew would need to use paint prep cleaner, irrigate, vacuum, and heat the concrete.

Next they got to the surface prep. Over the course of about 2¹/₂ weeks, the N.Y. State crew covered all its bases, prepping the concrete for the coatings. The first step was to use AEROGREEN 4110 Paint Prep Cleaner, which is manufactured by Hi-Lite Solutions and distributed by Sherwin-Williams. The crew buffed that onto the floor using Mercury Floor Machines equipment then irrigated using a Mi-T-M 4,000 psi (27.6 MPa) power washer. As much water as possible was removed using Ruwak vacuums, and any remaining moisture was removed by heating the concrete.

The plan was to achieve an International Concrete Repair Institute (ICRI) Concrete Surface Profile (CSP) 3, but the condition of the concrete threw the crew for a loop. "It was discovered after shot blasting and scarifying the cleaned surface that oil-laden contaminants were wicking up through the slab. In addition, profiling the surface exposed several areas of deteriorated concrete that produced an extremely spalled substrate," he continued. They had to re-clean those areas with the 4110 Paint

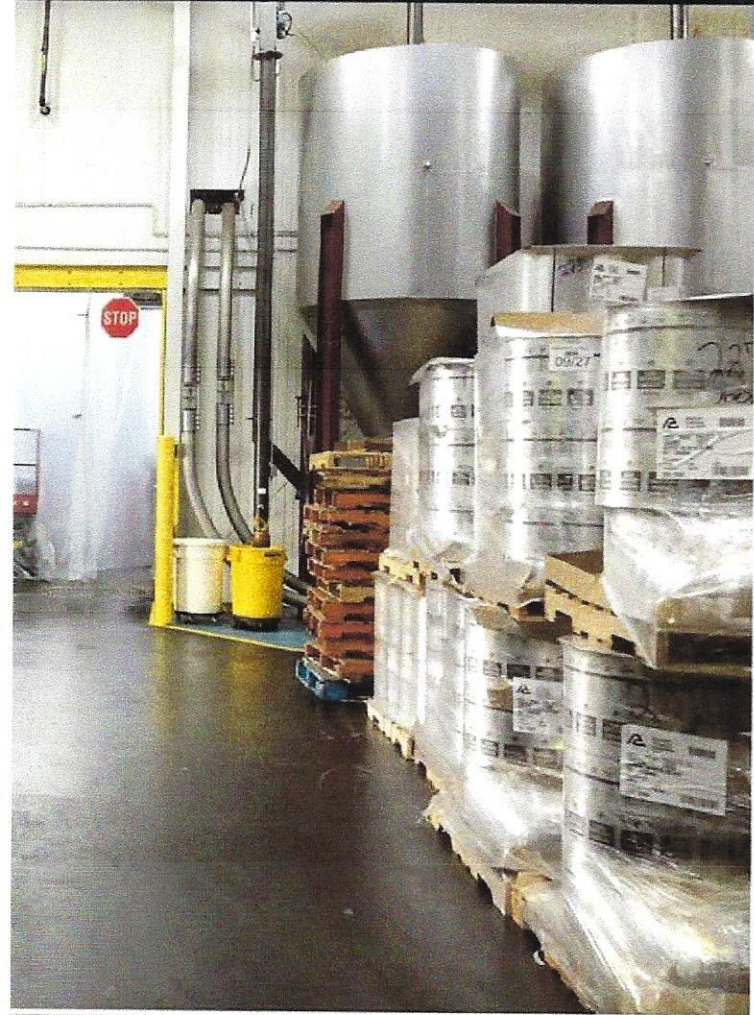
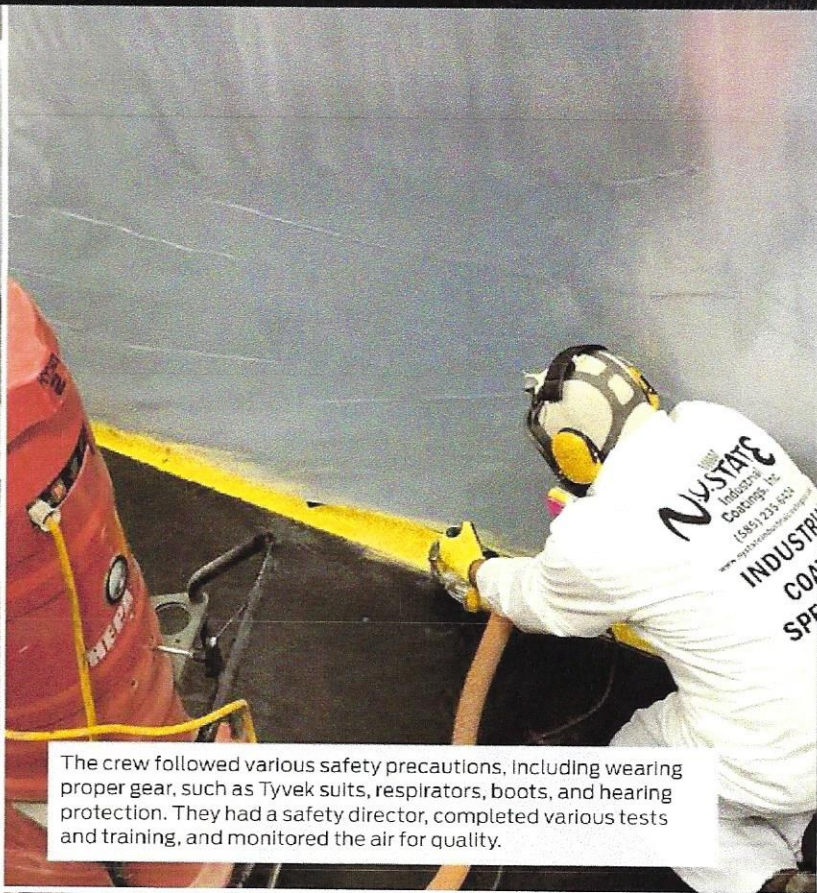
The crew followed various safety precautions, including wearing proper gear, such as Tyvek suits, respirators, boots, and hearing protection. They had a safety director, completed various tests and training, and monitored the air for quality.

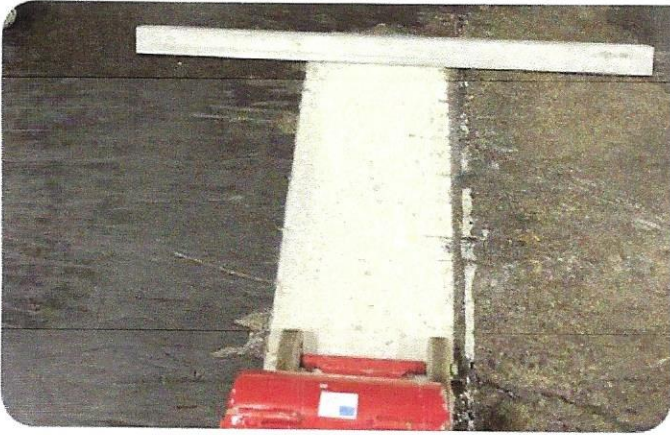
To prep the concrete for the coating, the crew scarified and shot-blasted with equipment from Metabo and BlastPro. They were aiming to achieve an International Concrete Repair Institute (ICRI) Concrete Surface Profile (CSP) of 3.

They followed that by testing the floor for moisture using calcium chloride tests. That helped ensure that the water they added when cleaning didn't remain, and it also accounted for moisture coming from under the slab. At that point, finally, the crew could scarify and shot blast using equipment from Metabo and BlastPro, respectively, "to get to a solid base," DeFranco explained.

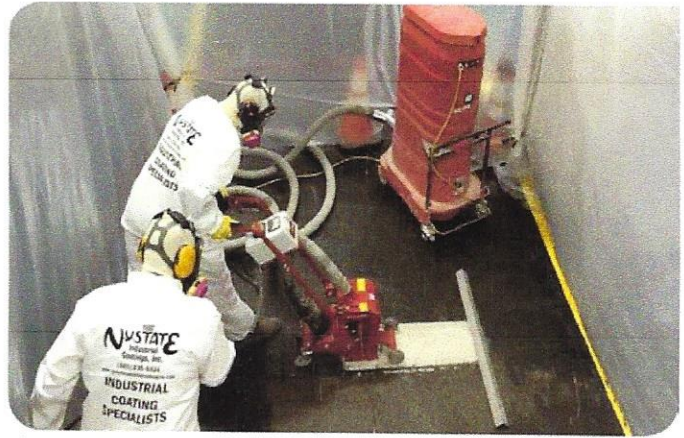
The project was completed while the facility was still on line, so not only did the crew have to create a containment but they also had to put up plastic to protect the client's equipment.

In between the two installations, Maidstone Coffee moved its roasting and packaging equipment into the space. To keep the processing of the beans free of contaminants, the crew hung 6-mil (152.4 microns) plastic barriers. "We had zip walls with decontamination areas so we could come out of the area, disrobe, and then come back into their production area clean," DeFranco said. It was "very similar to an asbestos decontamination area."

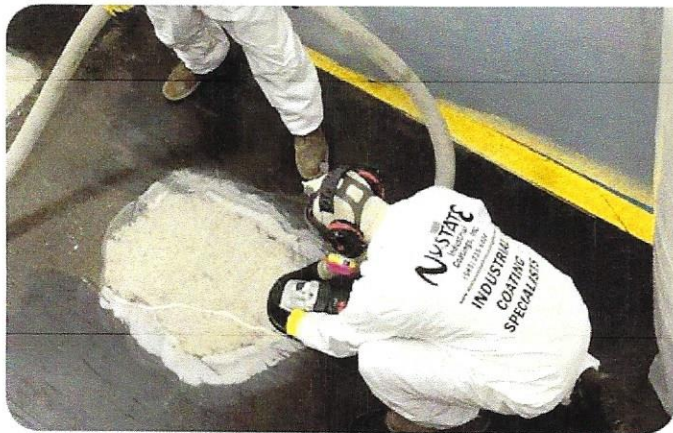
The project took place very soon after Occupational Safety and Health Administration's (OSHA's) new silica standards went into place. Prep equipment had dust shrouds and high-efficiency particulate air (HEPA) filters.

Each N.Y. State employee also received a lung scan, respiratory function test, full physical, and respirator fit tests as well as OSHA silica certification training. And even though the equipment was furnished with dust shrouds and high-efficiency particulate air (HEPA) filters per OSHA's new silica laws, the crew doubled up with air scrubbers to ensure that the Maidstone environment wasn't contaminated. Those were portable HEPA filtration units by Advanced Containment Systems, Inc.

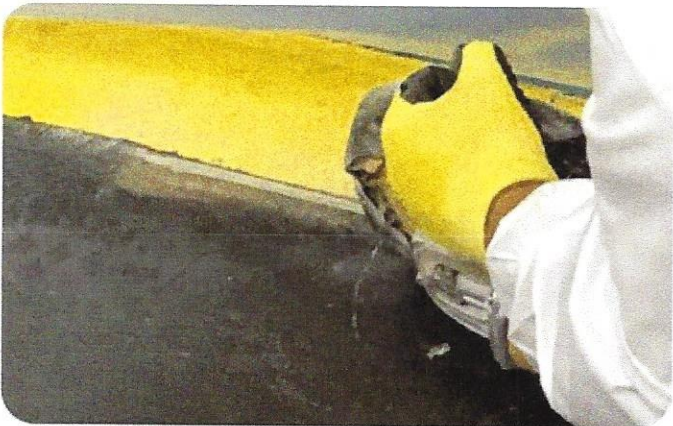
Some areas had to be re-cleaned and -blasted because oil was still wicking up. According to Jeff DeFranco, N.Y. State Industrial Coatings president and CEO, they had "to get to a solid base."

Prep Cleaner to remove the extra oil and used a more aggressive shot blasting to hit a CSP of 5-9.

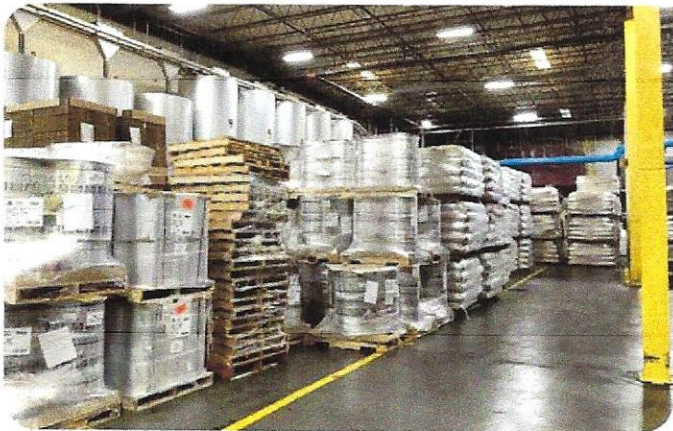
The coating system had to be U.S. Department of Agriculture (USDA) compliant and have zero volatile organic compounds (VOCs). That included a primer on spalled areas, followed by a full primer to the entire floor.

The Milamar system included International Coatings (ICO) Primer LV, applied using rollers and brushes. That and the ICO Quik Patch Resurfacer were applied at varying thicknesses, depending on the integrity of the concrete, to bring it back to flush, especially in spalled areas. The resurfacer was hand- and power-troweled. That was followed by a full prime coat at 200-250 square feet per gallon (4.9-6.1 m²/L) and then a coat of ICO Floor 51/Guard 51, which was squeegeed and backrolled to an average of 1/4-inch (0.6 cm) thick. The crew broadcast aggregate into the slurry coat for slip resistance. The final layer was ICO Floor Coating/Guard Coating, and it was applied again with squeegee and rollers — regular and spike — at an average of 20 mils (508.0 microns).

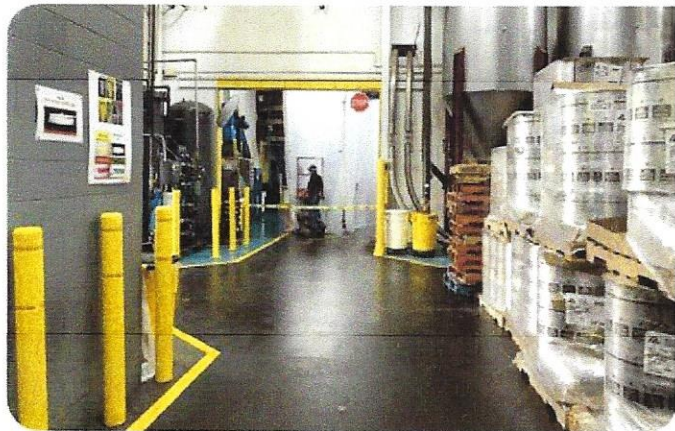
The crew finished with ICO Floor 51/Guard 51 with broadcast aggregate and a layer of ICO Floor Coating/Guard Coating. And with that, the crew was able to call it a day and grab a cup o' joe.
