# Designing Scour-Resistent Bridge Structures for Extreme Events

## Roger L. Simpson, Ph.D., P.E.<sup>1</sup> and Gwibo Byun, Ph.D.

**ICSE-10 Proceedings - Track K - Scour & Erosion**

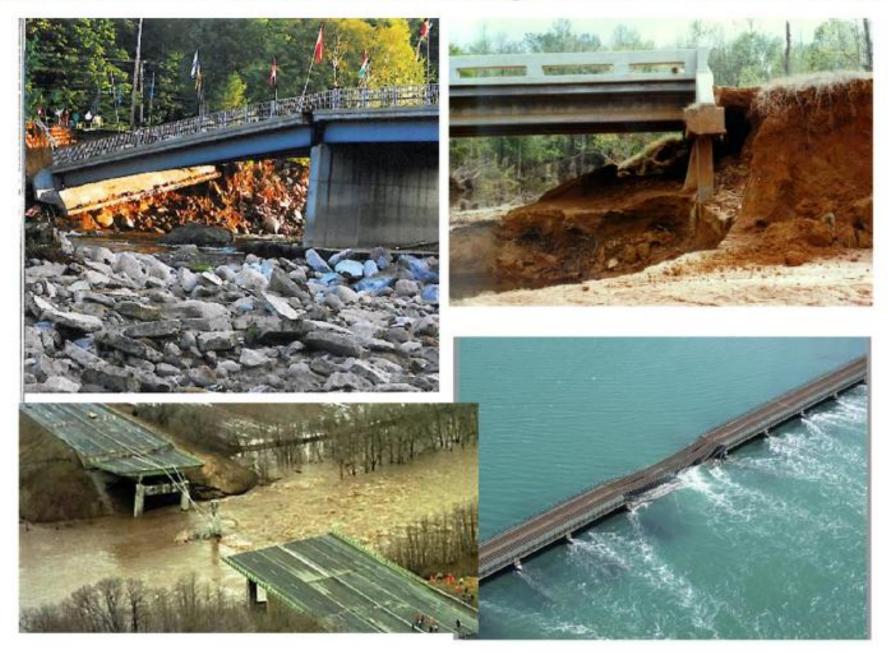
#### Failure of the Schoharie Creek Bridge, NY State Thruway, April 5, 1987

## **Causes of the Schoharie Creek Bridge Failure**

A number of design and maintenance deficiencies Flood velocity was higher than anticipated in the original design

Inadequate "riprap" rock protection

Inadequate inspection and maintenance.

## Other Aggravating Factors in the Schoharie Creek Bridge Failure

- Debris accelerated the downward scouring flow.
- Berms increased the floodwater speed under the bridge.
- A high hydraulic gradient formed between upstream and downstream in the spring.
- Insufficient design of the bridge structure for scour conditions:
   > The superstructure bearings allowed for the uplift and slide of the superstructure from the piers;
   >Simple spans without any redundancy were utilized;
   > The lightly reinforced concrete piers
  - had limited ductility;

>> Deficient plinth reinforcement resulted in sudden cracking of the plinth instead of a hinging failure.

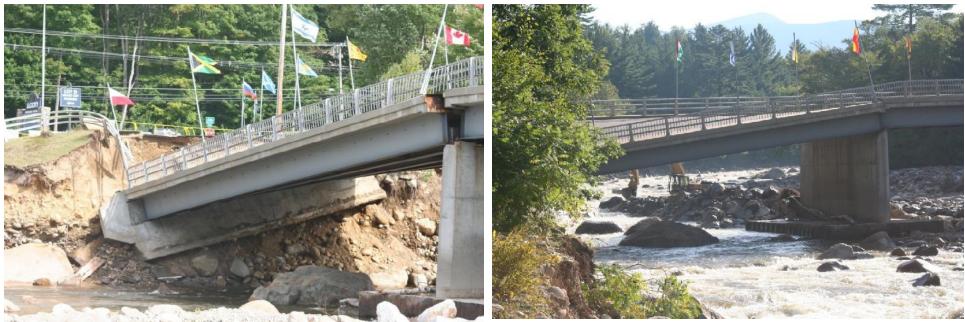
## **The Loon Mountain Bridge Abutment Failure**

In August 2011 high water due to Tropical Storm Irene washed out an abutment of the Loon Mountain, New Hampshire Bridge.

This bridge abutment was on the outer bank in a bend in the river, so swirling flow brought high velocity water into the outer river bank, causing quick erosion and loss of soil and rock under the concrete part of the abutment.

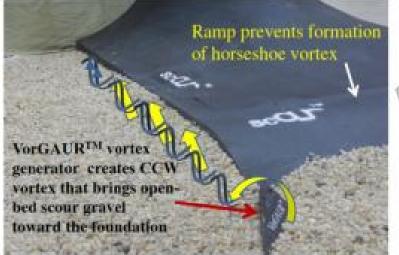
Example stainless steel scAUR<sup>TM</sup> retrofit (black) for a 45° wingwall abutment. Note SS vortex generators.

Ramp and VorGAUR<sup>TM</sup> vortex generator bring open-bed scour material toward a pier

Pre-fabricated interlocking modules permit quick and exact assembly and preserve the scAUR<sup>TM</sup> shape

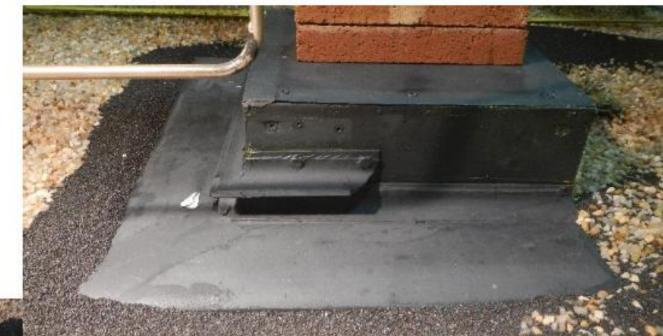
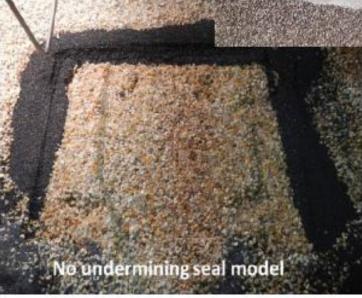
AUR Flume Tests Case 43: Seal model with C-shaped extended ramp on the front and both sides

RESULTS AFTER ONE HOUR TEST RUN

Note that the streamlined ramps and fairings have prevented scour near and under the seal and downstream.
