**United States v. Brace et al., 17-cv-06, W.D. Pa.**  
**Expert Report: Ecological Functions and Connections**  
**of Wetlands and Waters at the Marsh Site,**  
**Waterford, Erie County, Pennsylvania**

Prepared for:  
U.S. Department of Justice

Prepared by:  
Robert P. Brooks, Ph.D.  
Brooks Consulting  
61 Aloha St.  
Port Matilda, PA 16870  
rpbrooks2@gmail.com, 814-880-7607

18 December 2017

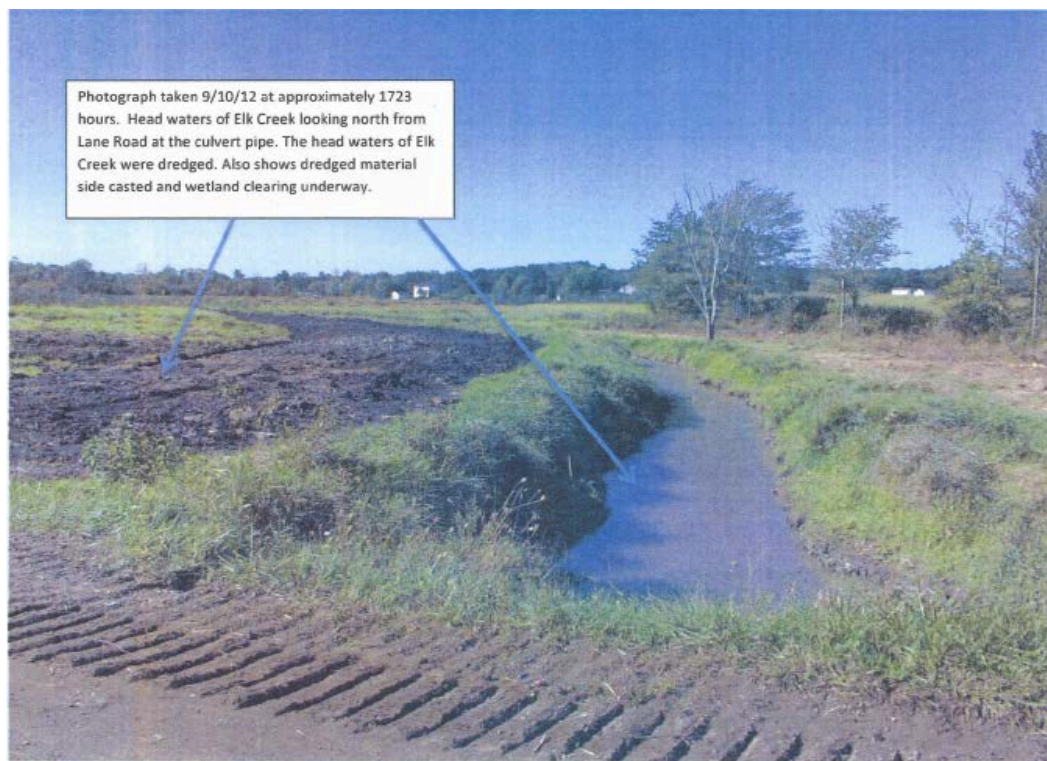
Figure 14. September 2012 photograph from Marsh Site inspection by Smolko; Elk Creek from Lane Road looking downstream (north) showing disturbed soils and side-casting from dredging Elk Creek.

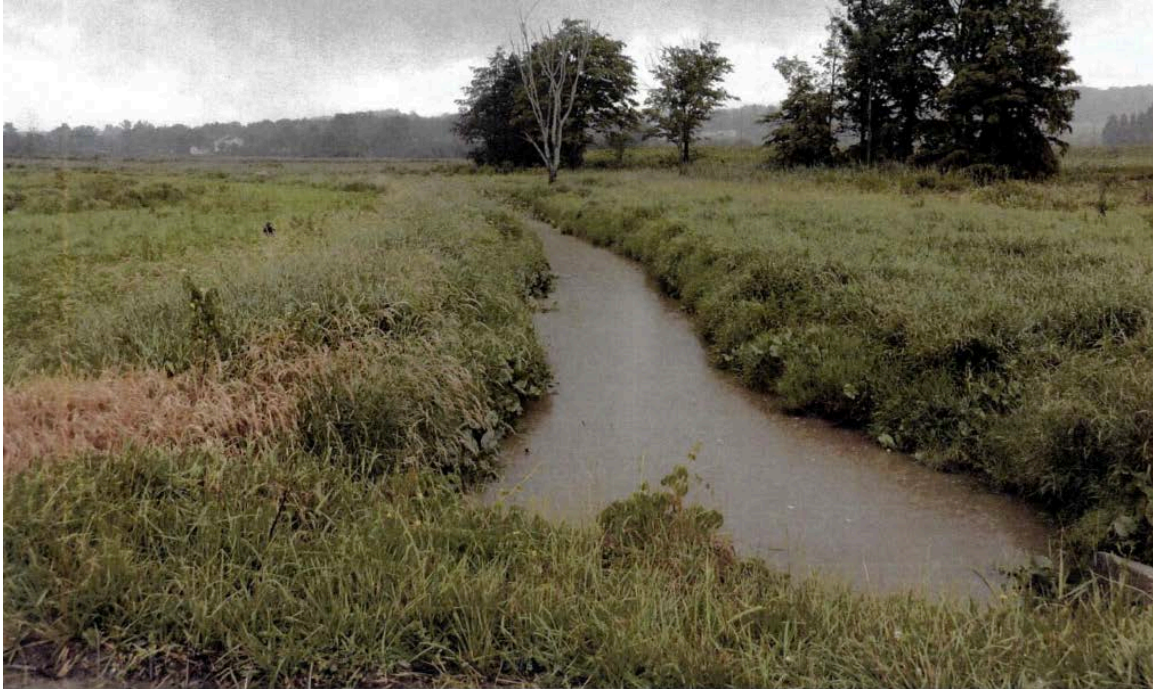
Figure 15. June 2013 photograph from Marsh Site inspection by EPA; Elk Creek from Lane Road looking downstream (north) showing recovering herbaceous vegetation after soil disturbance in 2012, and channelized reach of Elk Creek.

During the June 2013 inspection, new growth of hydrophytic vegetation was observed in portions of the site previously disturbed (Figures 15, Lane Road bridge). Based on the wetland delineation data sheets from three samples points, all located on the Marsh Site, hydrophytic plants were dominant, and soils showed hydric characteristics (i.e., chroma of 1 or 2, gleyed matrix, mottles). Surface hydrology was observed, so evidence of all three wetland parameters was present, indicating the presence of wetlands on the Marsh Site. Their Sample Point #1 was located near my Sample Point #6. Their other two points were located in the middle area of the Marsh Site. Heavy rains made obtaining additional soil samples difficult, and obscured some of the natural surface hydrology. A site inspection report from the same visit prepared by Scott Dudzic of the Pennsylvania Department of Environmental Protection (PADEP) dated 27 June 2013 described similar findings.

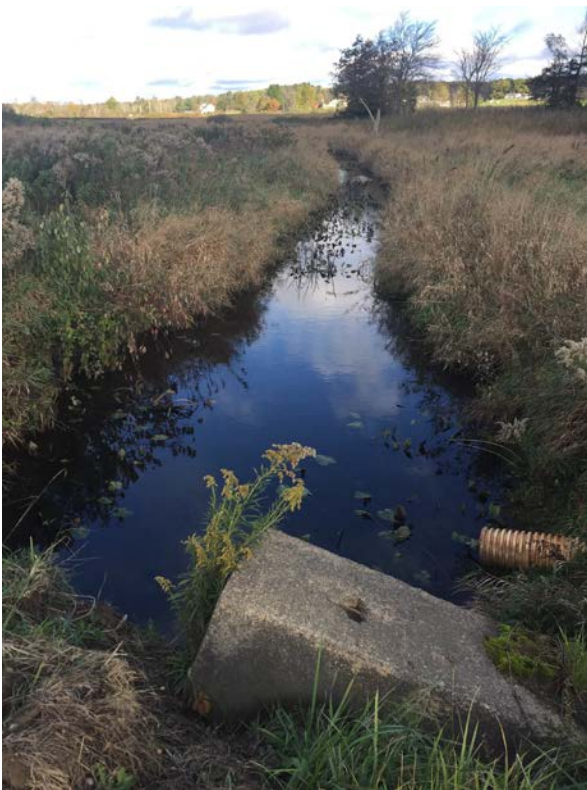
Figure 16. October 2017 photograph from Marsh Site inspection by Brooks; Elk Creek from Lane Road looking downstream (north) showing recovering herbaceous vegetation after soil disturbance in 2012, and channelized reach of Elk Creek.

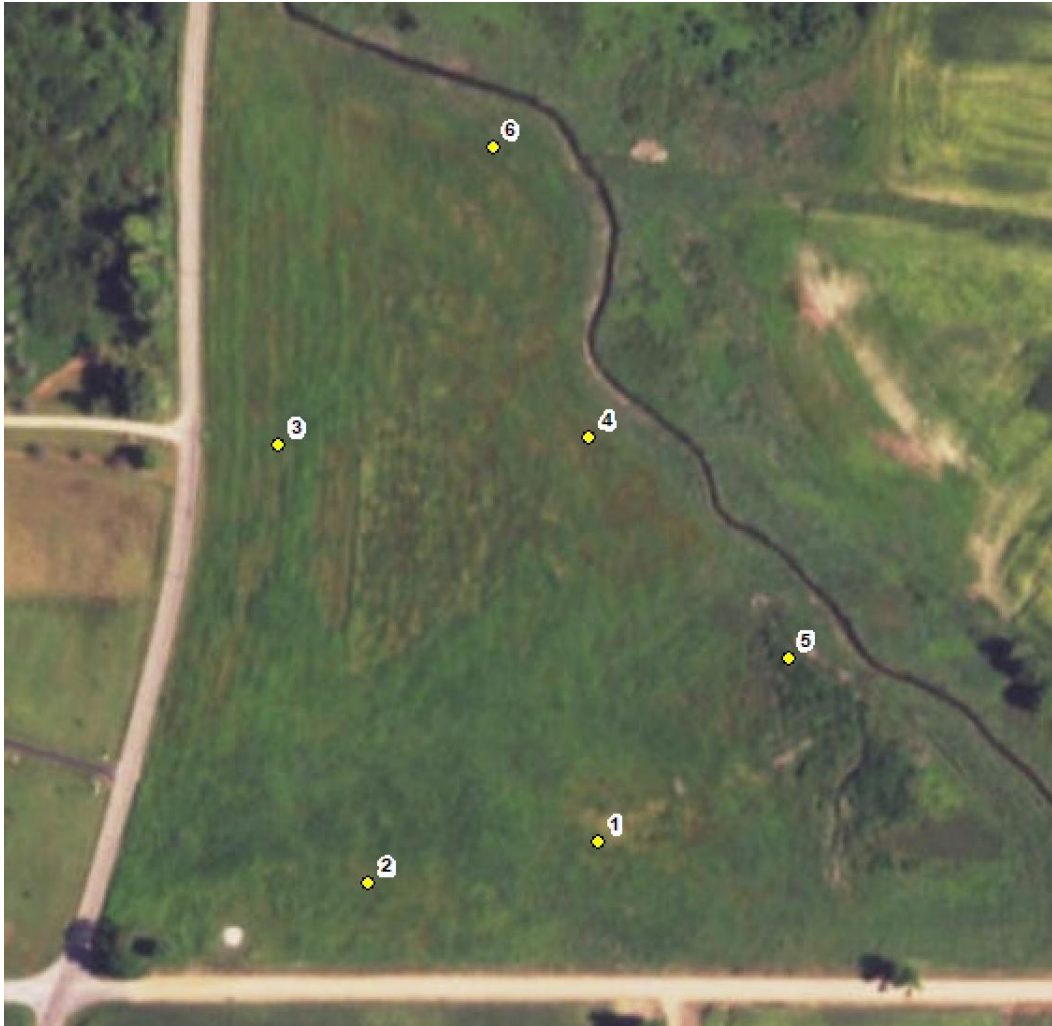
Figure 17. Approximate locations of six Sample Points for wetland identification protocol superimposed on a 2015 image of the Marsh Site from ESRI (Brooks Oct 2017).

On 16 October 2017, I chose and sampled the ecological characteristics of six points on the Marsh Site (Figures 2 & 17). The objective was to collect sufficient data to reach an independent opinion about the occurrence of wetlands on the Marsh Site and their connectivity to Elk Creek at the current time (October 2017), which is defined as *post-disturbance* (after the major land and water alterations by Brace in 2012). I also was tasked to consider the extent and condition of wetlands on the Marsh Site before the 2012 alterations; defined as *pre-disturbance*.

Sample Point #1 (Figure 17) – Located at (approx. lat-long: 41.9793548, -80.0456344), which is at the visual intersection of the gas well tank on Lane Road to the south, and the end of the tree row along the east side of Elk Creek downstream of the culvert on Lane Road. I chose this point because it was located upslope of the patch of alder shrubs in the southeast corner of the Marsh Site. The alder patch, later sampled as Sample Point #5, appeared to be quite wet, so I wanted to know the conditions upslope.

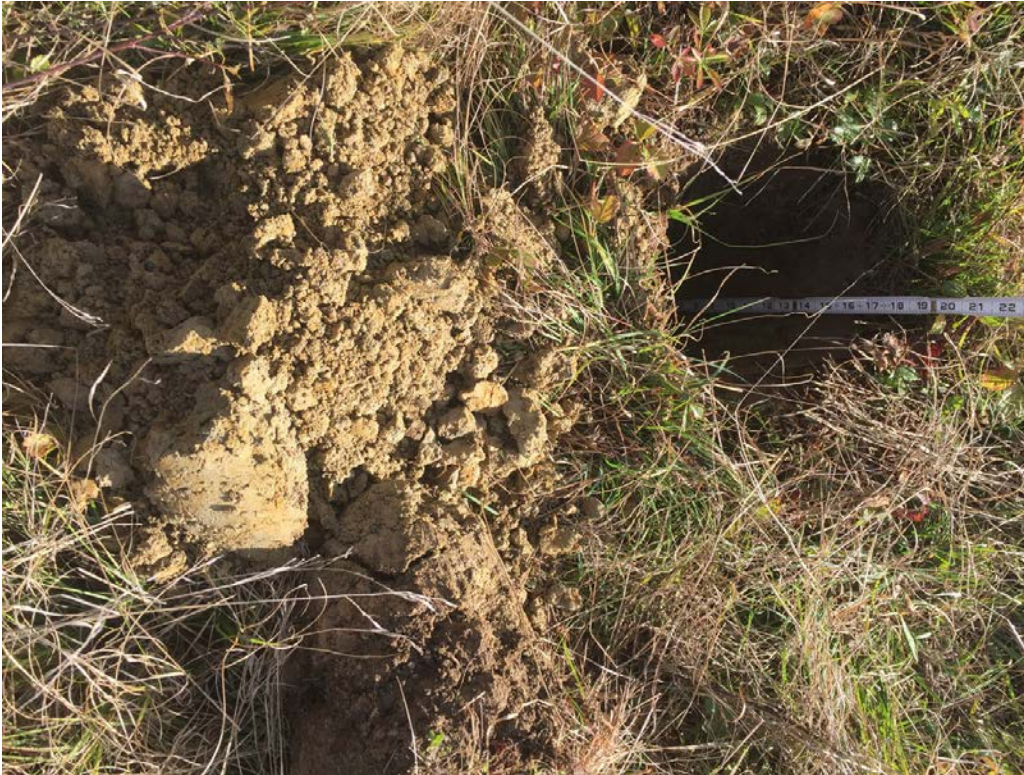
Figure 19. Marsh Site Sample #1 soil pit with profile (see text for description).

increasing to about 30% from 5-18 inches, with color of 7.5YR6/8. Soil texture from 0-5 inches was smooth, and an extended ribbon of 2.0 inches, indicating this is a silty clay loam. From 5-18 inches the soil had slight grit, and after moistening, a ribbon extended to 1.5 inches, indicating a texture of clay loam. Based on later laboratory analysis, the organic matter content from a sample taken at a depth of about 8-12 inches was quite low at 0.9% (Table 3). In summary, the soil at Sample Point #1 showed hydric characteristics (i.e., low matrix chroma, the presence of redoximorphic features; Figures 19 & 20).

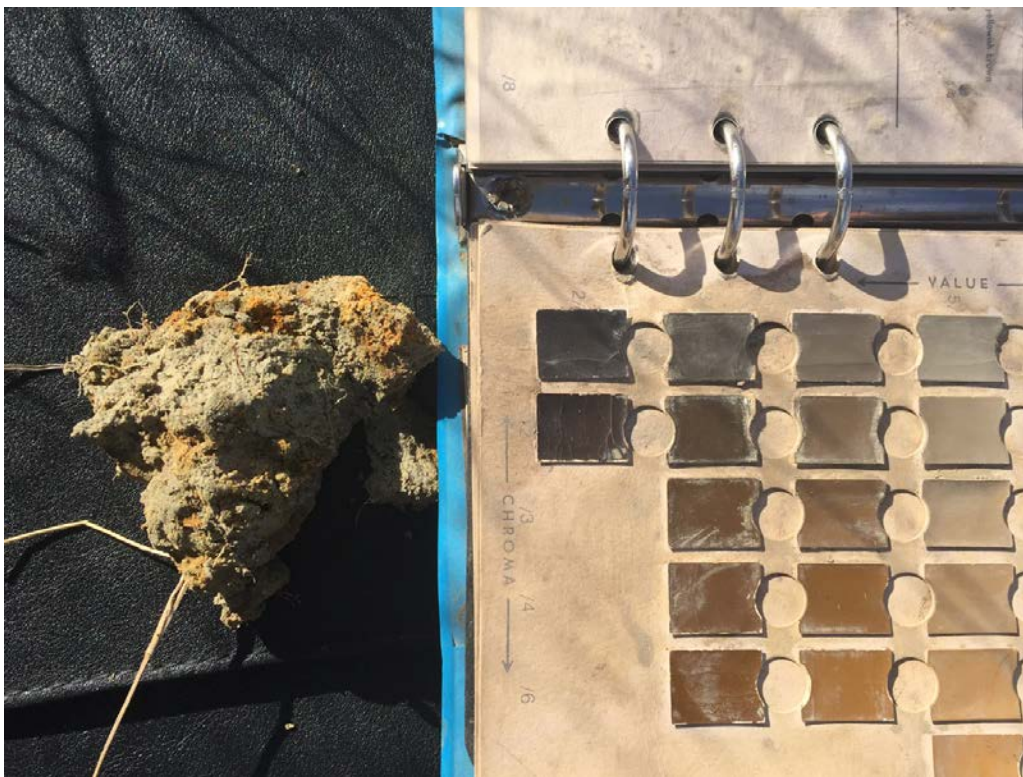
Figure 20. Munsell soil colors for Sample #1 showing hydric matrix, brighter mottles and oxidized rhizospheres (see text for discussion).

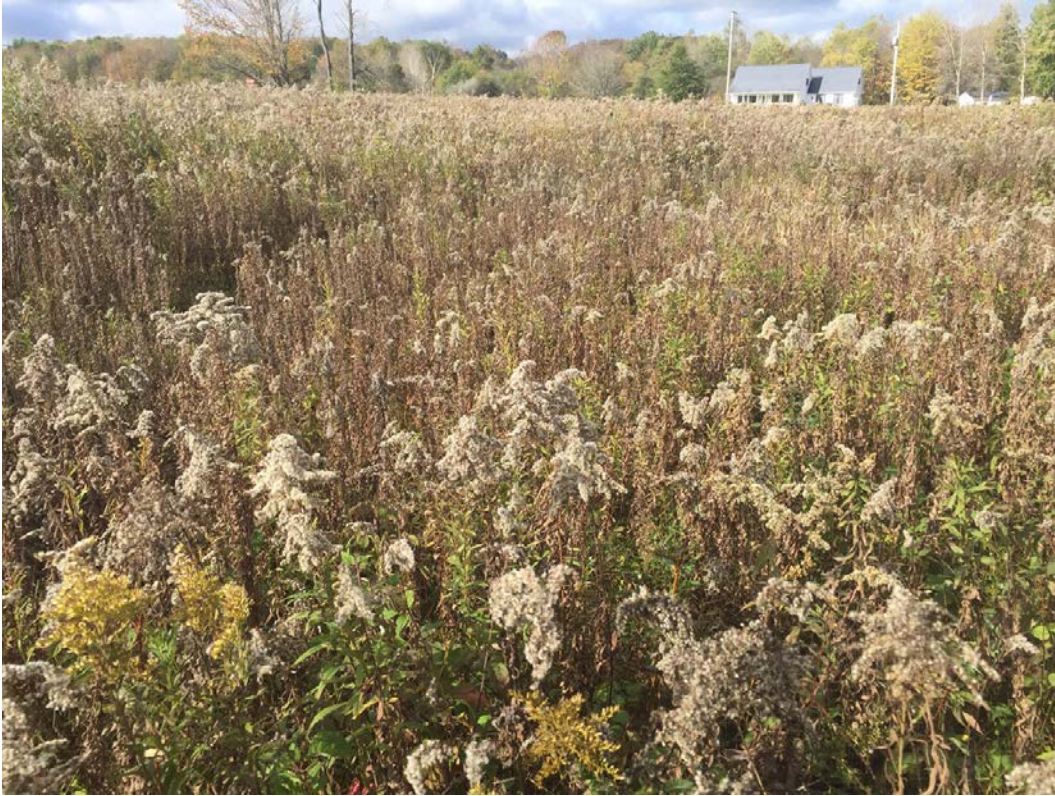
Figure 23. Marsh Site Sample#2 vegetation (looking west) (see text for description).

The vegetation in the vicinity of Sample Point #2 consisted of a combination of herbaceous and shrub species (Figure 23). The Dominance Test was positive for hydrophytic vegetation at 67% wetland species. There were no definitive hydrologic indicators at this point. Since normal circumstances do not exist at Sample Point #2, due to site alterations of hydrology and vegetation, the presence of all three wetlands indicators is not necessary to determine if the site is a wetland where a plausible explanation for the unconfirmed indicator is found. There was not sufficient detail available for the layout of the tile drainage and ditch network to estimate quantitative impacts on the Marsh Site, nor are there any known hydrologic measuring devices on site. The presence of a histosol (highly organic hydric soil), however, is a strong indicator that hydric conditions are present, especially when a viable hydrophytic plant community is present. Based on observations and the presence of a histosol, which develops over extensive time periods when conditions are sufficiently wet, there is active hydrology on this portion of the Marsh Site. Therefore, in my opinion wetlands are present at Sample Point #2 at the present time, despite efforts to alter the hydrology and vegetation in 2012.

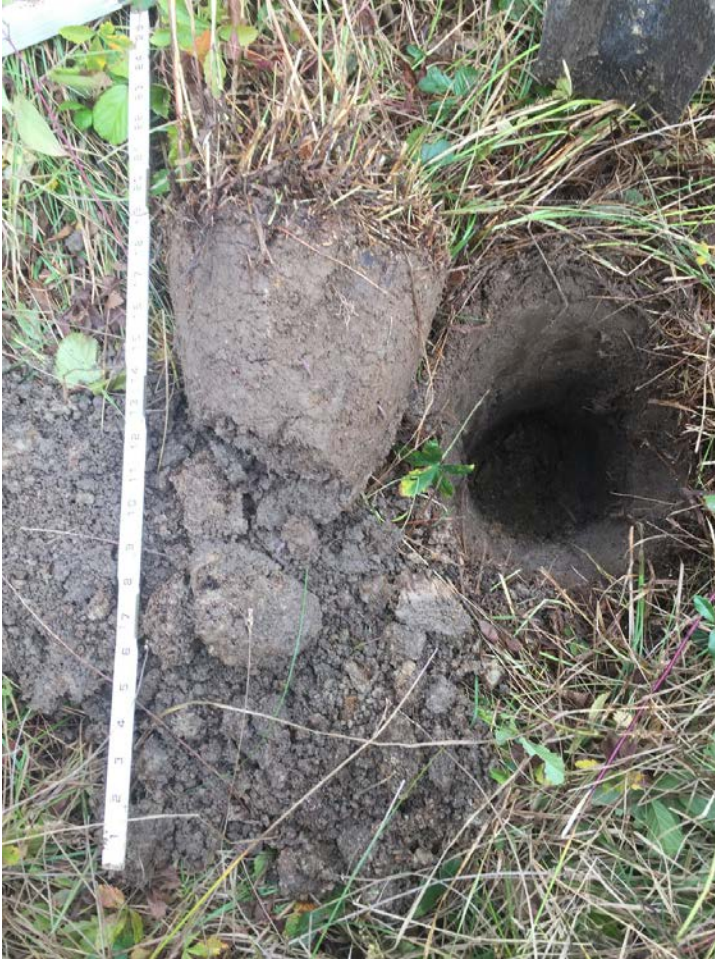
Figure 24. Marsh Site Sample #3 soil pit and profile, (see text for description).

Sample Point #3 – Located at (41.9806992, -80.0470911) in a level area about 200 feet off Sharp Road. According to the Erie County Soil Survey, this point is located near the transition between Canandaigua mucky silt loam, which is listed as a strongly hydric soil in this county, and Red Hook silt loam (along Sharp Road), which is listed as a non-hydric soil (Figures 17 & 18). The soil pit suggested this is a transition area, with 5YR5/1 matrix from 0-10 inches, and mottles occupying 10% with a color of 75YR5/6. Oxidized rhizospheres were observed (and photographed, Figure 25) in the upper 9-10 inches. The soil texture was not gritty, and produced a ribbon of 1.5 inches, indicating this is a silty clay loam. From 10-18 inches the matrix color was a mixture of 10YR6/2 and 10YR4/4, with small areas (2%) of mottles of 5YR4/4 presenting redoximorphic features (Figure 24 & 25).

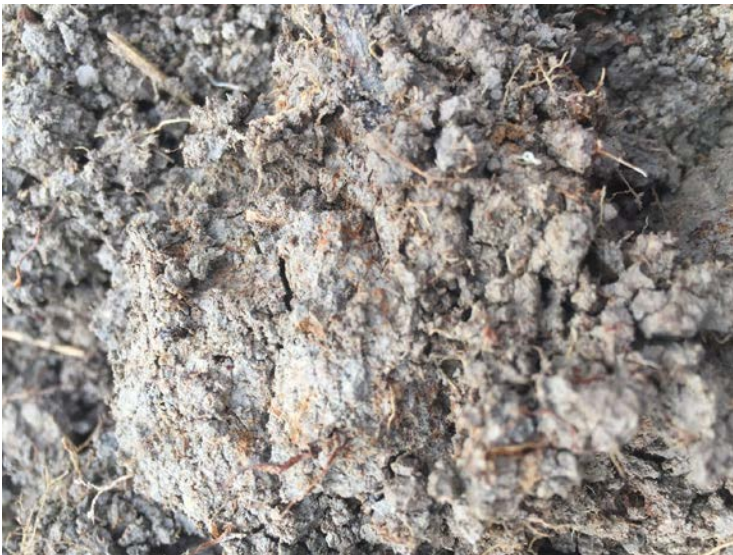
Figure 25. Marsh Site Sample #3 oxidized rhizospheres, 9-10 inches depth (see text for description).

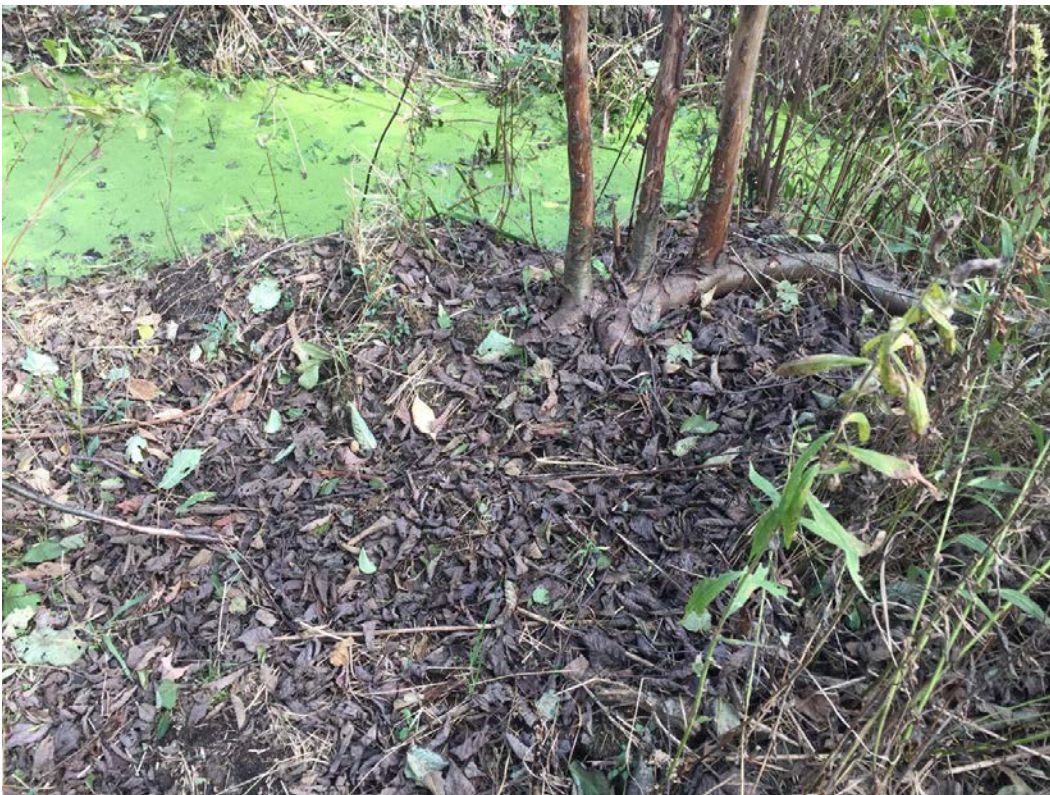
Figure 31. Marsh Site Sample #5 next to auxiliary duckweed-covered ditch flowing into Elk Creek.

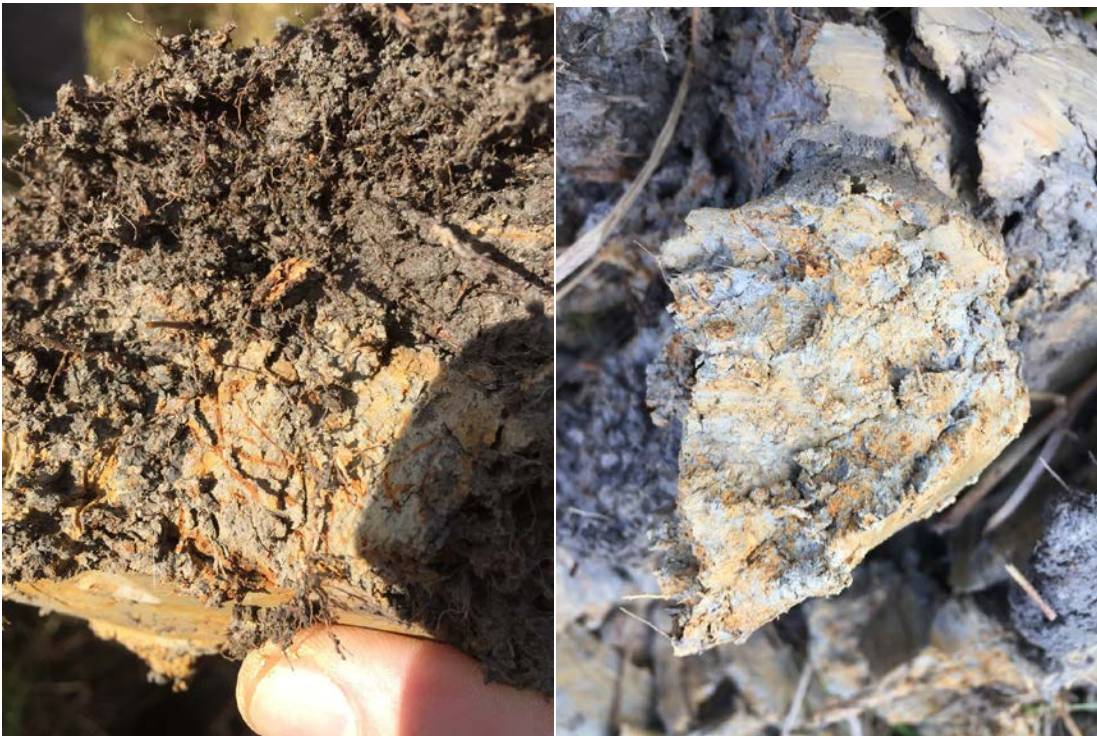
Figure 35. Marsh Site Sample #6 hydric soils: left – oxidized rhizospheres near surface; right – gleyed soil with mottles in lower portion of soil pit.

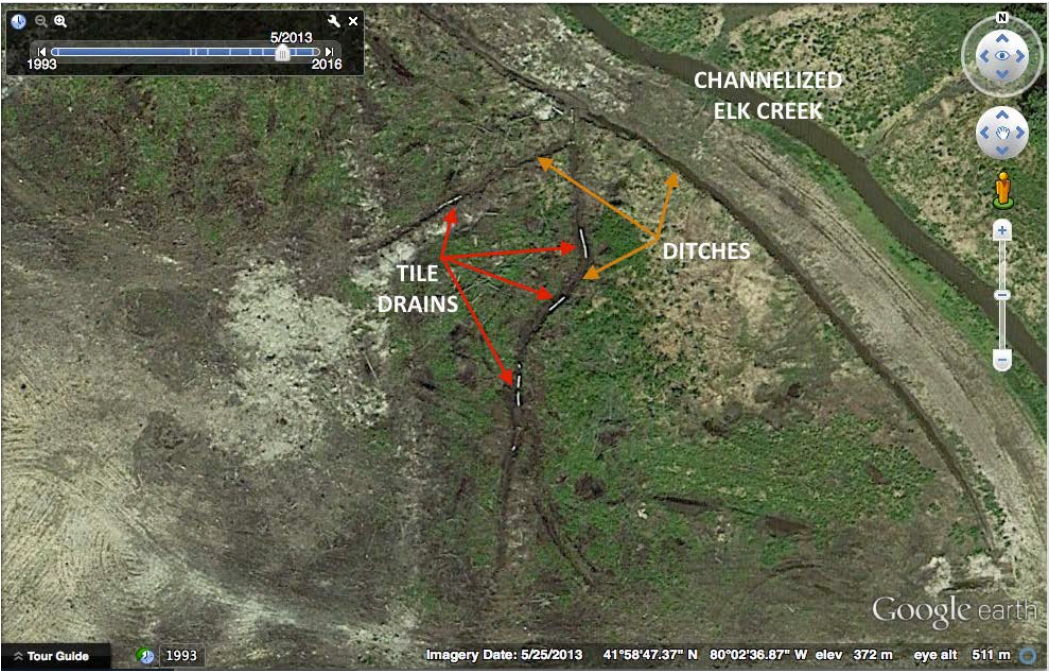
Figure 47 (close-up Figure 11). May 2013 aerial photograph of the Marsh Site (natural color, Google Earth) showing extensive disturbance of vegetation throughout site to bare soil, scattered logs and branches on the ground, plus labeled hydrologic alterations of tile drains (red arrows) and ditches (orange arrows) causing changes to wetlands in the floodplain of Elk Creek (near Sample Point #5).

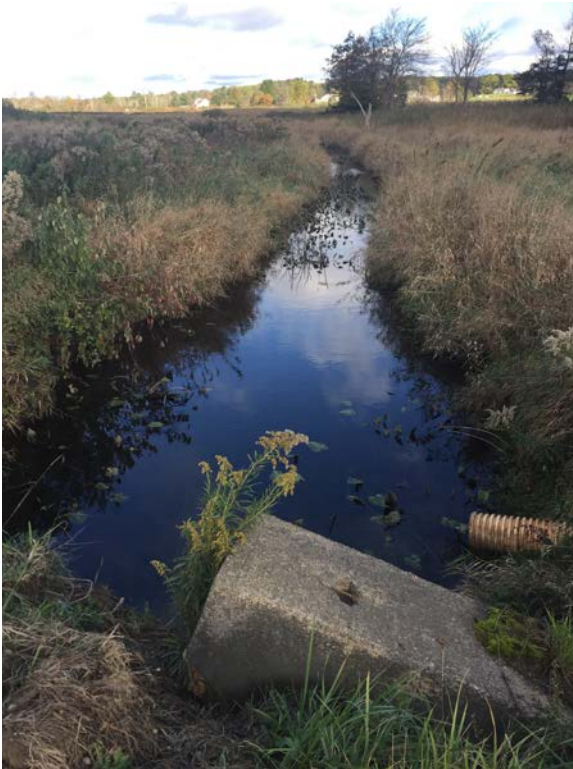
Figure 49. October 2017 photograph from Marsh Site inspection by Brooks; Elk Creek from Lane Road looking downstream (north) showing recovering herbaceous vegetation after soil disturbance in 2012, and channelized reach of Elk Creek.

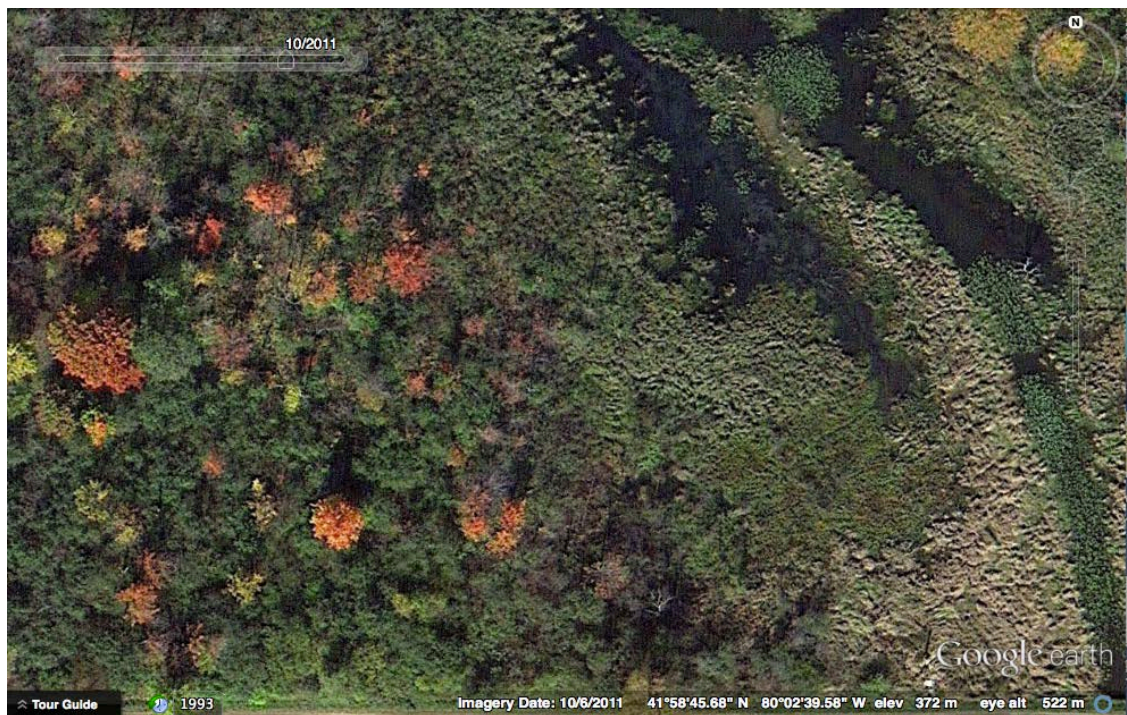
**Figure 68.** Conceptually, wetland and stream restoration of the Marsh Site should be designed and constructed to reach vegetation communities and hydrologic regimes comparable to the pre-disturbance condition of the site (2011 aerial photograph – close-up of southeast corner of the Marsh Site (Google Earth)).

Figure 68. Conceptually, wetland and stream restoration of the Marsh Site should be designed and constructed to reach vegetation communities and hydrologic regimes comparable to the pre-disturbance condition of the site (2011 aerial photograph – close-up of southeast corner of the Marsh Site (Google Earth)). [see 11.0 Restoration Plan]
