Uniform Mitigation Verification Inspection Form

Inspection Date: Jun 1, 2024		
Owner Information		
Owner Name: LONGWOOD CONDO ASSOCIATION		Contact Person: LONGWOOD CONDO ASSOCIATION
Address: 11811 AVE OF PGA BUILDING #2		Home Phone:
City: PALM BEACH GARDENS	Zip: 33418	Work Phone:
County: PALM BEACH		Cell Phone:
Insurance Company:		Policy #:
Year of Home: 1970	# of Stories: 2	Email:

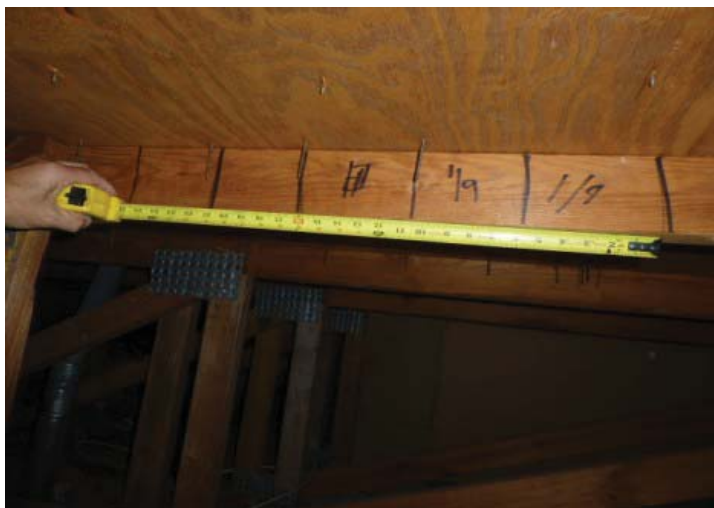
#3 ROOF DECK ATTACHMENT
6" X 6" NAIL SPACING

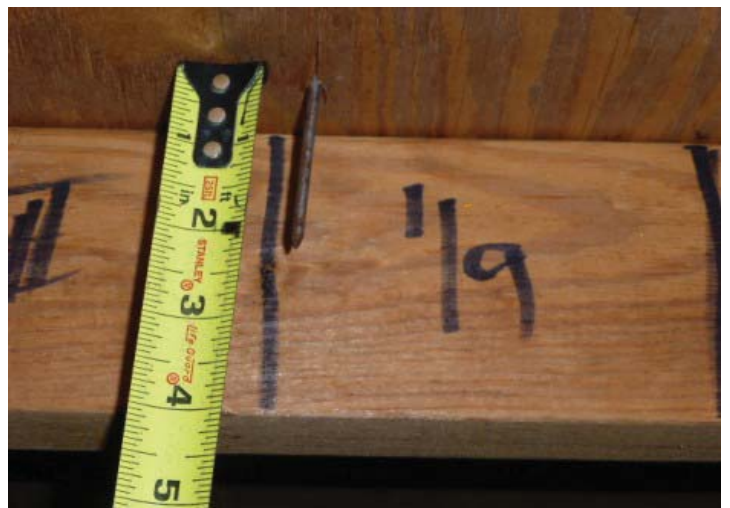
- ☒ C. Plywood/OSB roof sheathing with a minimum thickness of 7/16" inch attached to the roof truss/rafter (spaced a maximum of 24" inches o.c.) by 8d common nails spaced a maximum of 6" inches in the field. -OR- Dimensional lumber/Tongue & Groove decking with a minimum of 2 nails per board (or 1 nail per board if each board is equal to or less than 6 inches in width). -OR- Any system of screws, nails, adhesives, other deck fastening system or truss/rafter spacing that is shown to have an equivalent

or greater resistance than 8d common nails spaced a maximum of 6 inches in the field or has a mean uplift resistance of at least 182 psf.

#3 ROOF DECK ATTACHMENT
8d NAILS

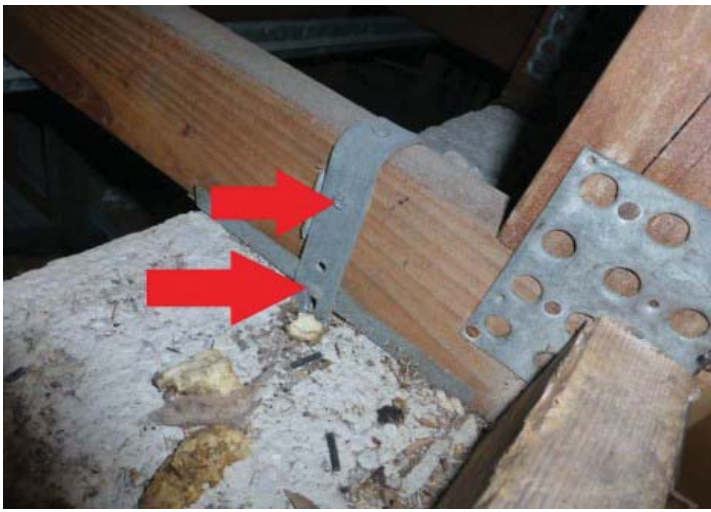
- ☒ C. Single Wraps
 - Metal connectors consisting of a single strap that wraps over the top of the truss/rafter and is secured with a minimum of 2 nails on the front side and a minimum of 1 nail on the opposing side.

#4 ROOF TO WALL ATTACHMENT
FACE SIDE

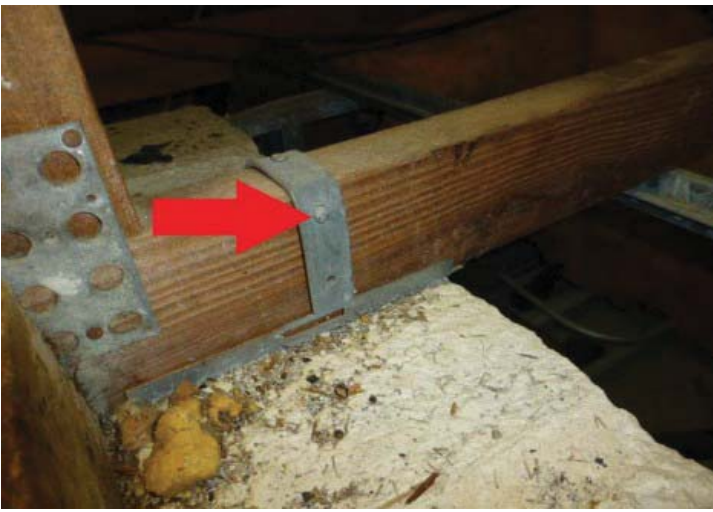
#4 ROOF TO WALL ATTACHMENT
OPPOSITE SIDE

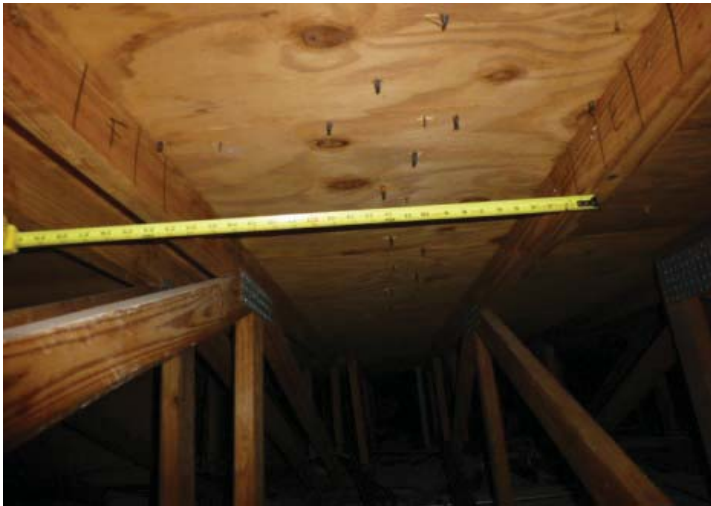
TRUSS/RAFTER SPACING

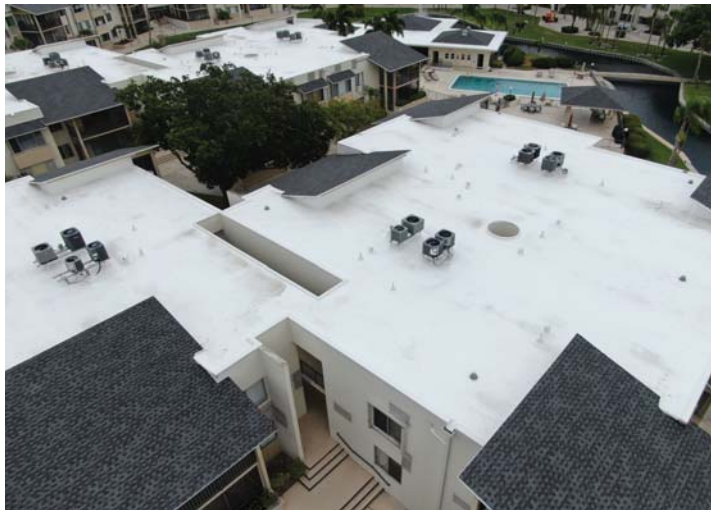
2.1 Roof Covering Type:	Permit Application Date	FBC or MDC Product Approval #	Year of Original Installation or Replacement	No Information Provided for Compliance
<input checked="" type="checkbox"/> 1. Asphalt/Fiberglass Shingle	04/09/2024		2024	<input type="checkbox"/> PERMIT BELOW
<input type="checkbox"/> 2. Concrete/Clay Tile	____/____/____			<input type="checkbox"/>
<input type="checkbox"/> 3. Metal	____/____/____			<input type="checkbox"/> ON PAGE 7
<input type="checkbox"/> 4. Built Up	____/____/____			<input type="checkbox"/>
<input type="checkbox"/> 5. Membrane	____/____/____			<input type="checkbox"/>
<input checked="" type="checkbox"/> 6. Other FLAT ROLLED	04/09/2024		2024	<input type="checkbox"/> PERMIT BELOW

- ☒ A. All roof coverings listed above meet the FBC with a FBC or Miami-Dade Product Approval listing current at time of installation OR have a roofing permit application date on or after 3/1/02 OR the roof is original and built in 2004 or later.

ROOF COVERING

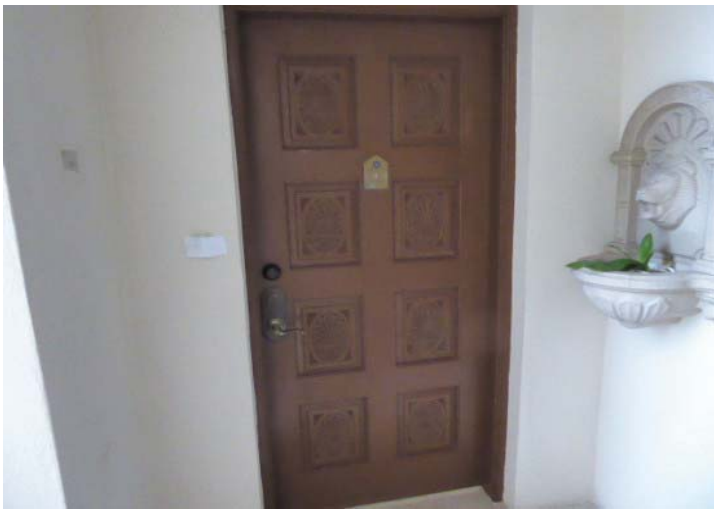
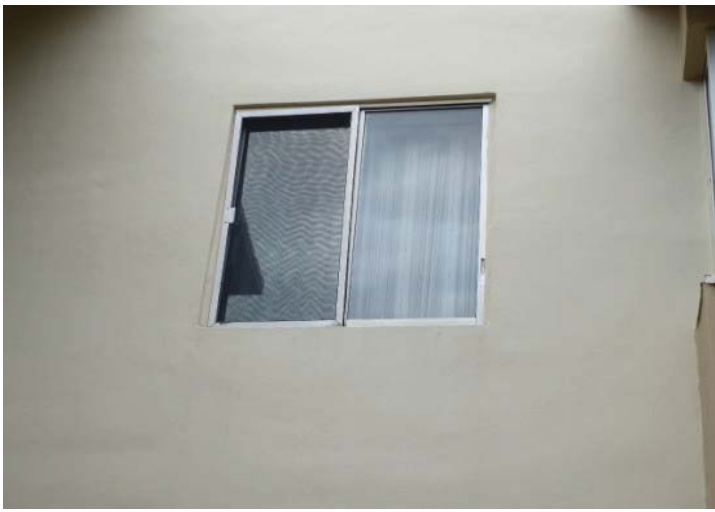
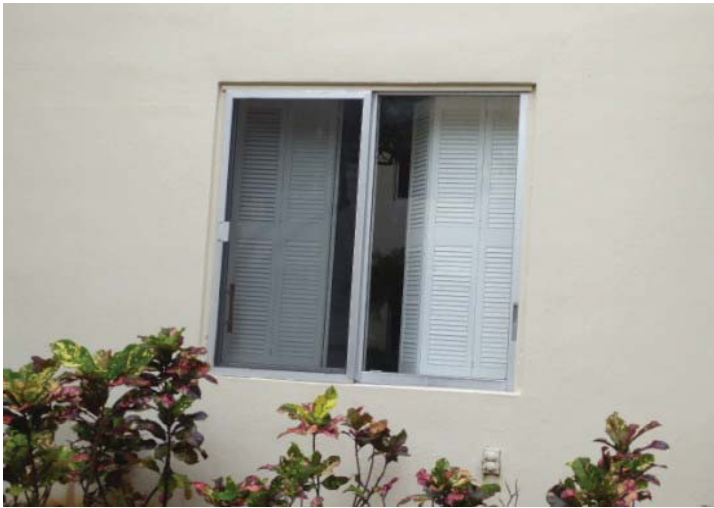
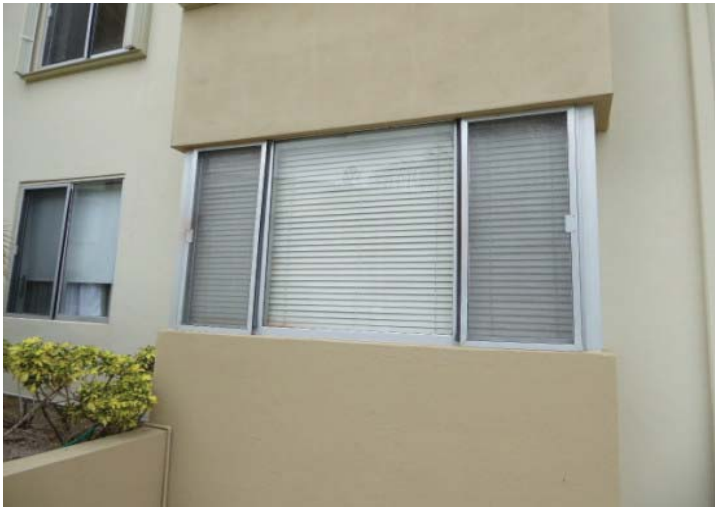
N	Opening Protection products that appear to be A or B but are not verified						
	Other protective coverings that cannot be identified as A, B, or C						
X	No Windborne Debris Protection	X				X

#9 OPENING PROTECTION
