CONDON GRADE SCHOOL 220 S. EAST STREET, CONDON, OREGON PHASE I ENVIRONMENTAL SITE ASSESSMENT

Prepared for CITY OF CONDON April 28, 2021 Project No. 2053.01.01

Prepared by Maul Foster & Alongi, Inc. 3140 NE Broadway Street, Portland, OR 97232

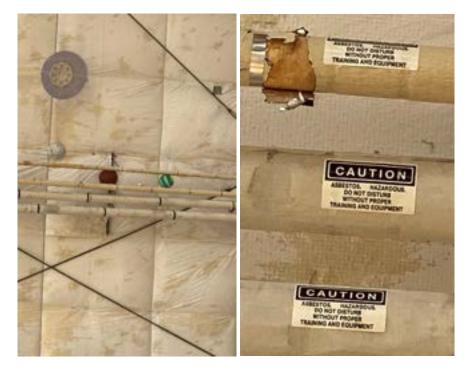
Photo No. 7.

Photographs show asbestos-containing heating pipes on the ceiling of the play shed. Pipes and pipe wraps appear to have been damaged from recreational activities.

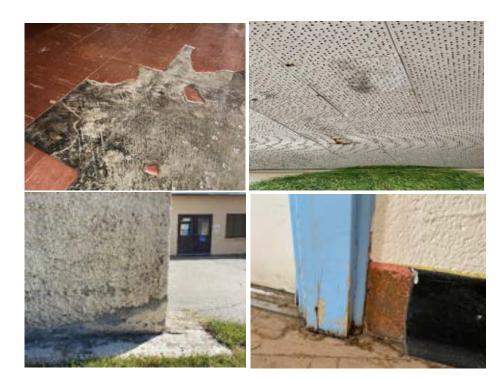
Photo No. 9.

Photographs show examples of damaged building materials observed during site visit, including exposed mastic from broken 9-inch by 9inch vinyl floor tiles, water damaged 12inch by 12-inch ceiling tile, flaking paint from the damaged stucco building exterior, and exposed mastic from broken wall trim.

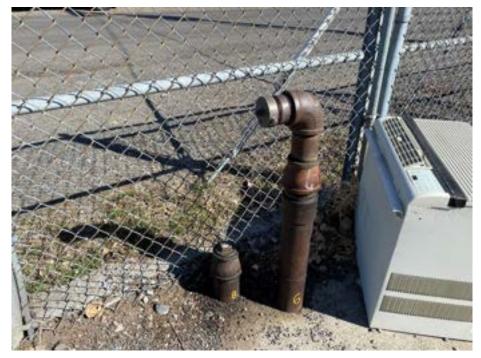
View of UST fill ports. Oil-staining and odor observed around fill ports.

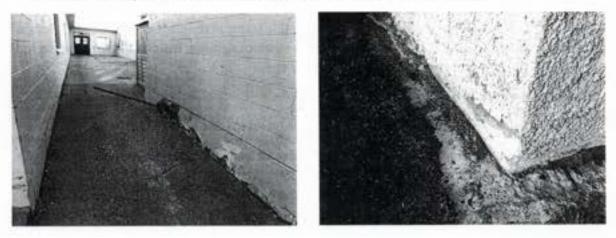
Foundations – The left picture shows a parge-coated concrete foundation for the 1958 classroom additions that is starting to crack and fall off in large pieces. The right photo shows a corner of the original structure where the foundation is starting to crumble.

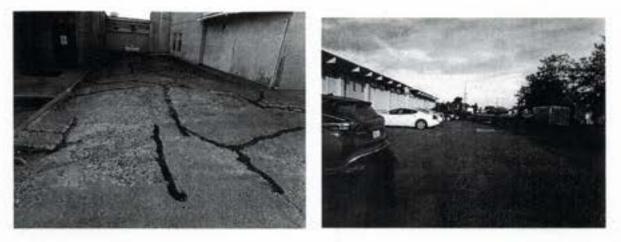
Roadways – The only parking for the school is the pull in street parking shown in the picture on the right. The picture on the left shows a roadway in the back of the school that is in very poor condition.

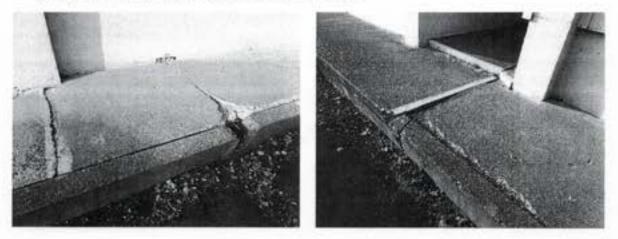
Curbs and Sidewalks – The sidewalks are a major concern at the school. Most of the walkways
are deteriorating because of concrete settling. The pictures below show only a few of the areas
of concern but there is damage throughout the school.

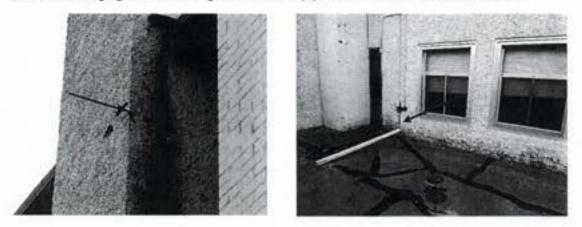
5. Storm/Drain System – The school's drainage system from the roof looks to be non-existent. Water runs off the roof at the lowest point. The picture on the left shows the extent of damage that this is causing to the building with full sections of stucco missing. The picture on the right shows a drainage gutter extending from where a pipe exits the side of the boiler room.

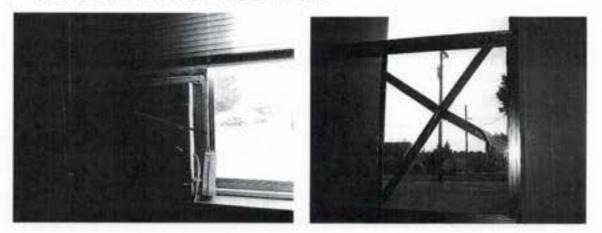
6. Exterior Windows – All of the exterior windows on the original building are single pane offering minimal insulation to the building. The picture on the left shows an air conditioning unit that is installed in a window with a large gap open to the environment. That gap was being covered by a piece of duct tape that has since fallen off. The picture on the right shows a damaged single pane window with duct tape acting as the repair.

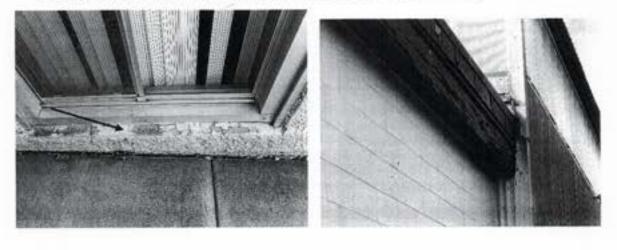
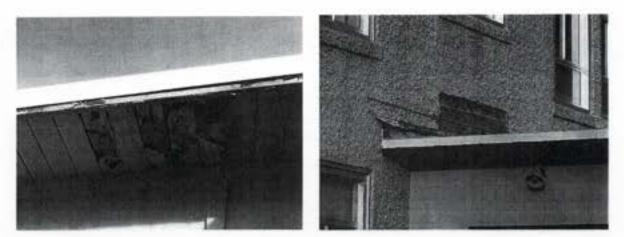
7. Exterior Siding – The siding on this school is of major concern and it is failing in many areas. The top left picture shows damage to a window sill that should have metal flashing which could prevent this damage. The picture on the top right shows some wood paneling that is starting to crack and splinter. The bottom left picture shows an overhang that needs to be refinished. The bottom right picture shows an area of the siding where the stucco is missing and the interior paneling is visible. This can easily allow moisture to penetrate the building

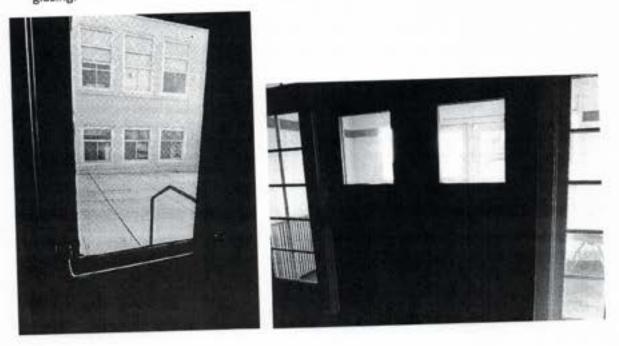
8. Exterior Doors – The exterior doors at this school are in fair condition. The main entrance doors to the school (right picture) look as though they are not used. The picture on the left shows an exterior door that has wire glass, which was common throughout the school. While this met the fire resistance ratings at the time of installation, it is dangerous to human impact because the wires can cause bad cuts. It is recommended to replace the windows with modern, fire rated glazing.

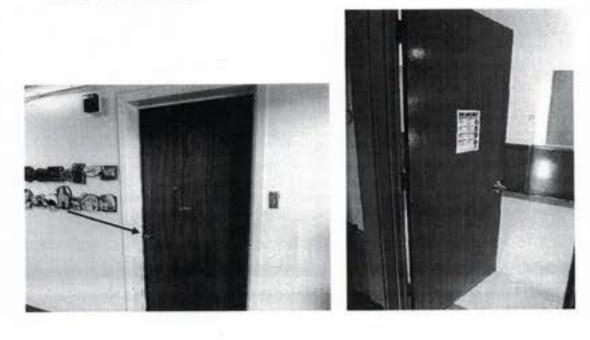
Interior Doors – The interior doors are all wooden and look aged. The picture on the left has a door that has a round door handle. This should be switched to a latch door to make steps towards ADA compliance.

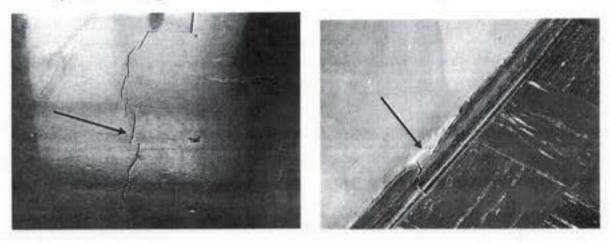
11. Flooring – The floor is a mix of VCT (Vinyl Composite Tile) and VAT (Vinyl Asbestos Tile). The VCT is in found in most of the hallways and in the 1958 classrooms additions. The areas of concern are the classrooms in the original building that have VAT flooring that is in poor condition. The picture on the left shows large cracks in the VAT flooring which can lead to asbestos exposure. The picture on the right shows VAT flooring with wall base that is falling off.

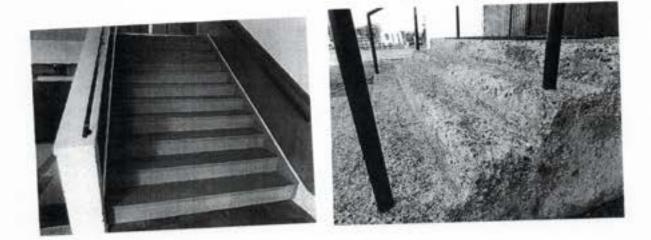
12. Stairs – The stairs at this school are of concern because it causes an ADA compliance issue. There are no ramps, elevators, or lifts provided. The picture on the left is the staircase at the main entrance of the school going up to the second floor and down to the first floor. The stairs in the right picture are extremely worn and connect the play shed to the playground behind the school.

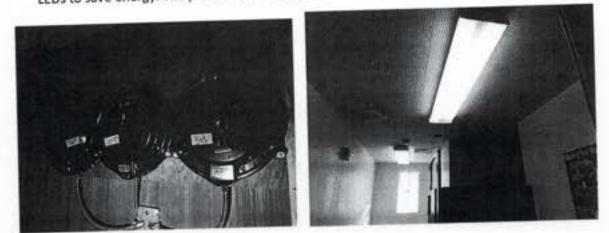
Lighting – The majority of the school has T8 florescent tube lights. These could be updated to LEDs to save energy. The picture on the left shows the old dimmers for the stage lighting.

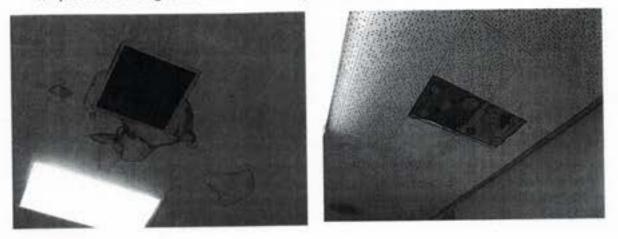
14. Ceilings – There is water damage visible in the ceiling tiles in multiple classrooms. The picture on the left shows the gym ceiling where it is observed that water is leaking in through the ducting. The picture on the right shows hard lid ceiling tiles that have fallen off.

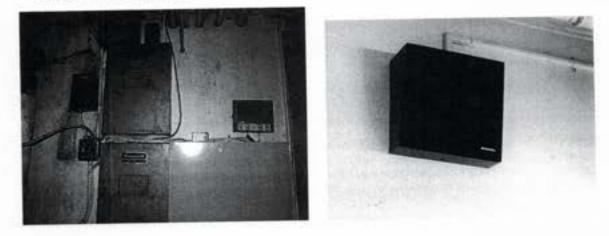
16. Technology/Communications/Controls – The picture on the left shows the very old Honeywell controls in the boiler room. The picture on the right shows the intercom system for the school. According to the district, this system does not function properly and only about half of the school receives messages.

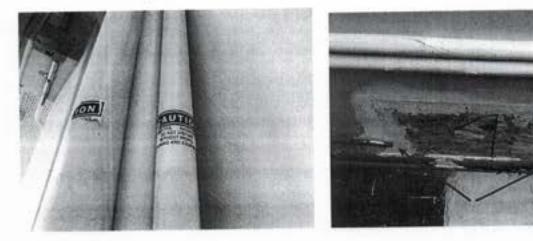
17. Plumbing – All of the heating piping for the school is insulated with asbestos insulation (left picture) and should be abated. The district mentioned it does not use any water treatment solutions for the heating water, but has had no internal corrosion issues. The picture on the right shows insulated cold water/hot water lines at the top going to a small electric hot water heater. The copper piping below those lines has a 1.5-foot section missing where some sort of unit/fixture was located. This copper pipe is connected to the hot water heater and is for the overflow if pressure builds up too high in the heater. If water does overflow, it will drain directly on to the floor in this small storage closet. The school is connected to city water and waste. It does not have any wells or septic systems.

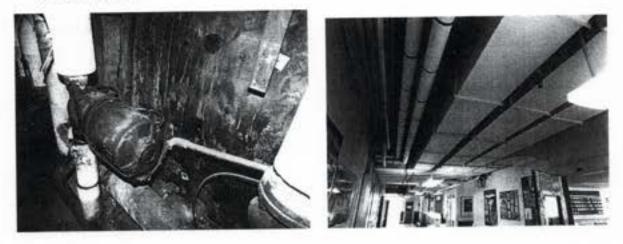
18. HVAC – The heating boilers are presumed to be from original construction and are well beyond their life expectancy. The picture on the left shows a pump behind the two boilers that displays the amount of the corrosion that is present in the boiler room. This heating system is in its final years and pending repairs that could meet or exceed replacement costs. The picture on the right shows asbestos insulated ducting and piping in the hallways of the school. The district commented that the school has not had working air handlers to provide the school with fresh air for several years.

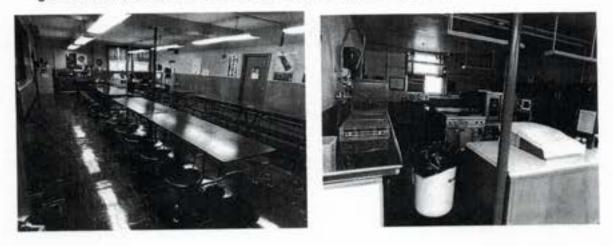
Kitchens – The kitchen and cafeteria in this school provide services for both the high school and grade school. Most of the equipment in this space is in fair condition.

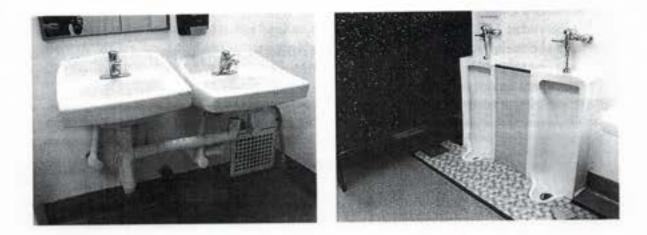
Restrooms – All of the restrooms in the school looked to be in fair condition. The piping for the sinks was insulated and the flooring and fixtures appeared to be in good condition.

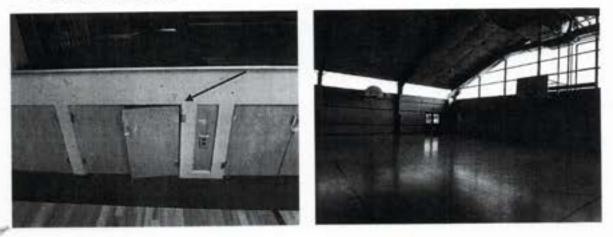
22. Stage, Auditoriums, and Gym – The auxiliary gym on the second story is in fair condition. The stage is set to one side of the gym and is also in fair condition. The picture on the left shows a storage door below the stage that is falling off. The picture on the right is of the play shed which is a highly utilized space.

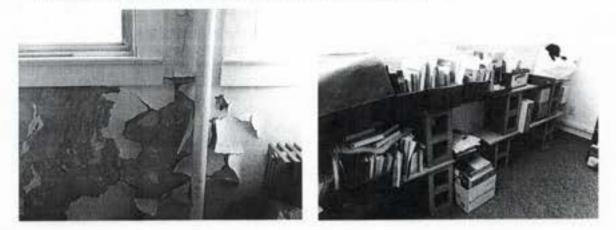
23. Classroom Spaces – There are multiple classrooms in the school that are to be used for storage. Those rooms are lacking of any upkeep; some with broken windows, others have peeling paint (left picture). The picture on the right shows classroom shelving that is made from wood planks and cinderblocks. The classrooms are in dire need of a modernization.

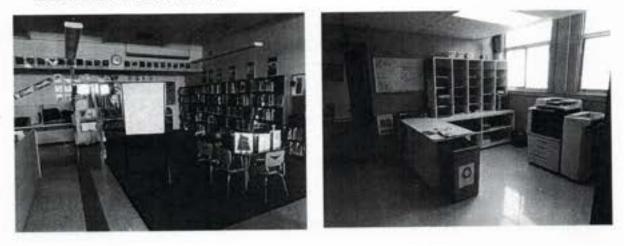
24. Office/Admin/Library Spaces – The library is in fair condition. The air handler that is on the other side of the wall of the library provides heat to the space, but reverberates through the wall, making the back corner of the library very loud. The office space is minimal and does not directly view the entrance for the school.

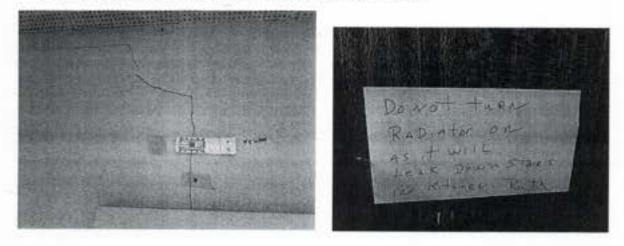
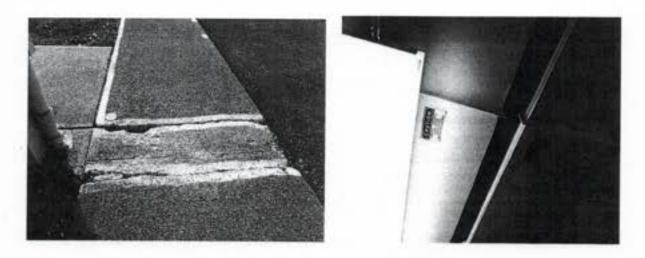
27. Safety/Health – The top left picture appears to be a method for monitoring the crack forming in the wall. This is concerning because there are multiple instances of this throughout the second floor and the building has not gone through any recent seismic testing. The top right picture is a note placed on a door of a storage area in the school warning to not turn on the radiator because it leaks downstairs into the kitchen. This radiator should be disconnected from the system and abandoned. The picture on the bottom left shows damage to the walkways. There are many of these walkways with uneven surfaces which are tripping hazards. The bottom right picture is of the asbestos covered HVAC ducting. This ducting is not being utilized and is exposed near the ceiling of the hallways. These unprotected pipes and ducting could be disturbed, allowing asbestos to chip off and drop onto the school hallways.
