HOME INSPECTION REPORT

4444 California St.
Berkeley, CA 94710

Marginal Summary

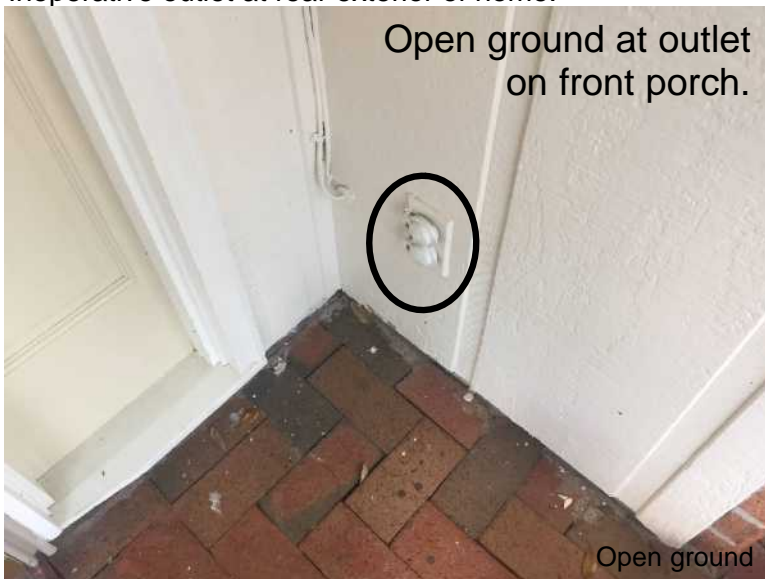
Open ground at outlet on front porch.

3. Exterior Electric Outlets: Weather protected, No GFCI protection - Recommend installation of GFCI outlets at all exterior locations to meet current safety standards.

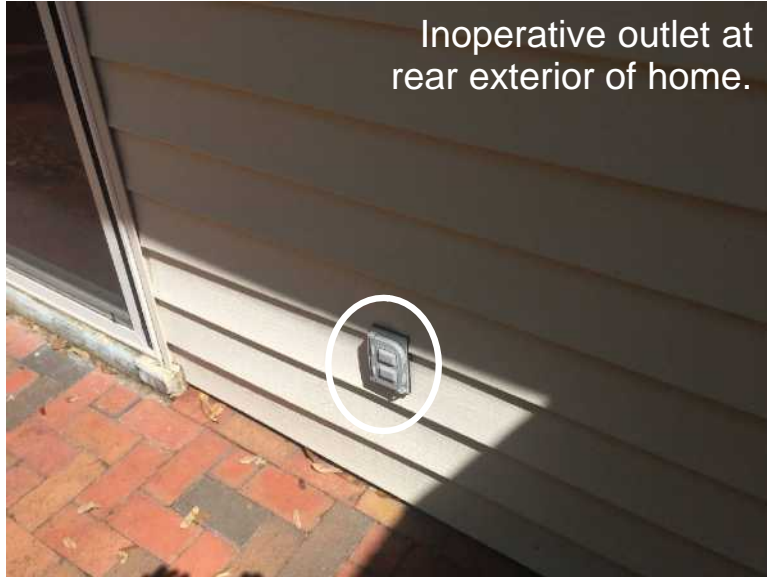
Inoperative outlet at rear exterior of home.

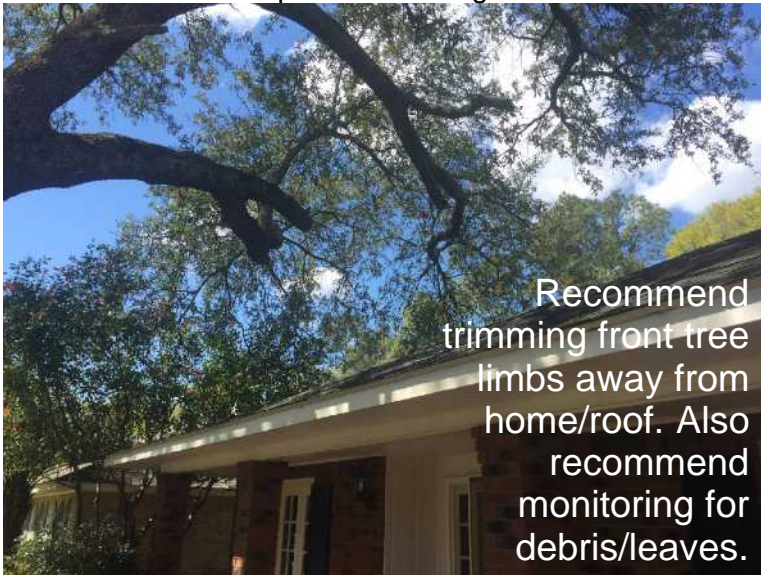
- Acceptable Driveway: Concrete - Typical cracking and settling, Concrete pitted and chipped
- Acceptable Walks: Concrete, Earth, Paver
- Acceptable Steps: Single brick risers into home
- Acceptable Patio: Brick
- Acceptable Deck: Trex boards
- Acceptable Balcony: Treated wood; cantilevered
- Acceptable Porch: Brick, Covered
- Acceptable Railings: Cast iron
- Acceptable Vegetation: Trees, Shrubs - All vegetation should be trimmed away from home to prevent depositing leaves, branches, etc. for falling on roof. This debris can cause excess wear on shingles and shorten the life span of the shingles/roof.

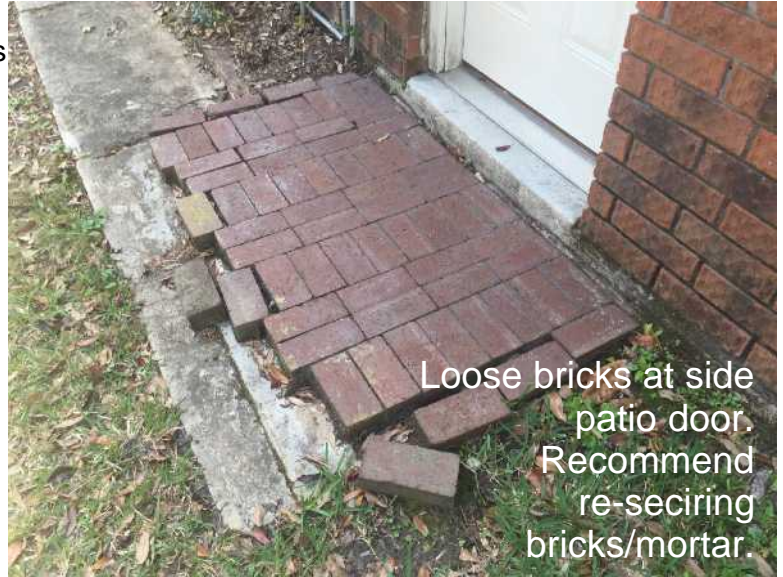
Acceptable Patio Door: French door, Wood with glass insert - Side patio door landing has loose bricks which may cause a trip/fall hazard

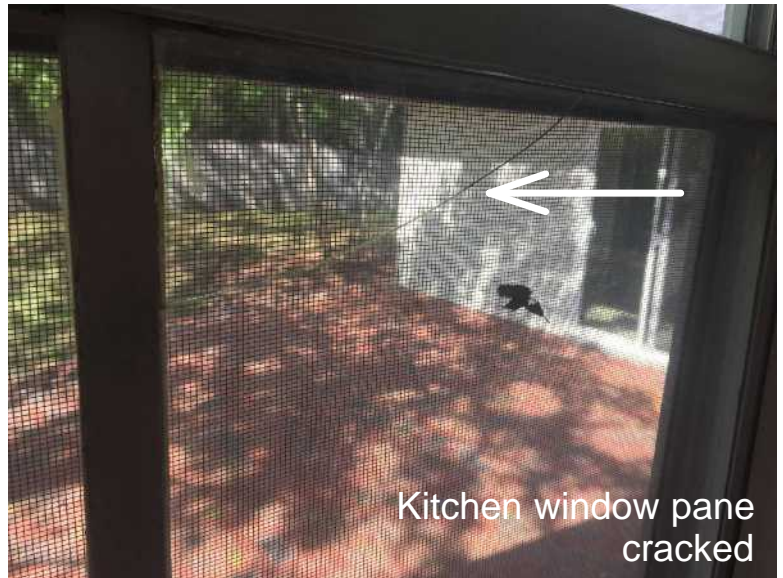
Acceptable Windows: Metal, Sliding - Kitchen window pane cracked. Recommend repair.

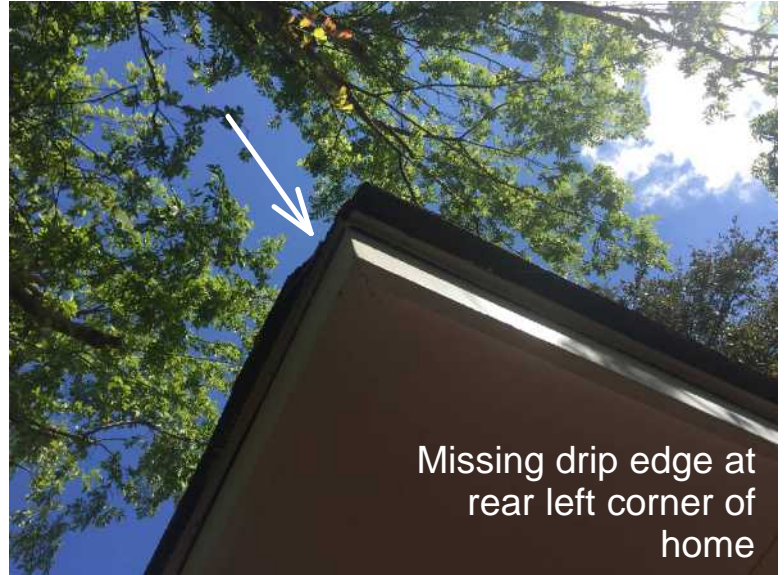
Acceptable Unable to Inspect: Inspected entire roof
Acceptable Material: Asphalt shingle - Missing drip
 edge at rear corner of home.
 Recommend repair to promote proper
 roof drainage.

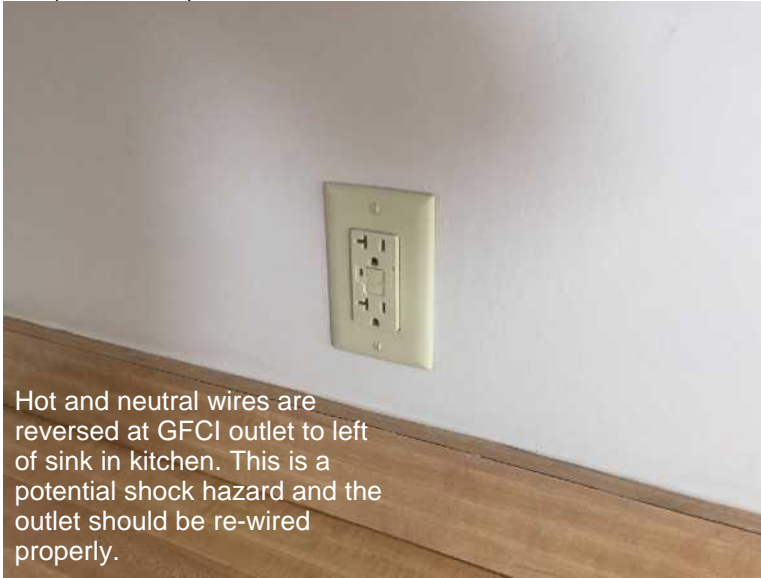
Hot and neutral wires are reversed at GFCI outlet to left of sink in kitchen. This is a potential shock hazard and the outlet should be re-wired properly.

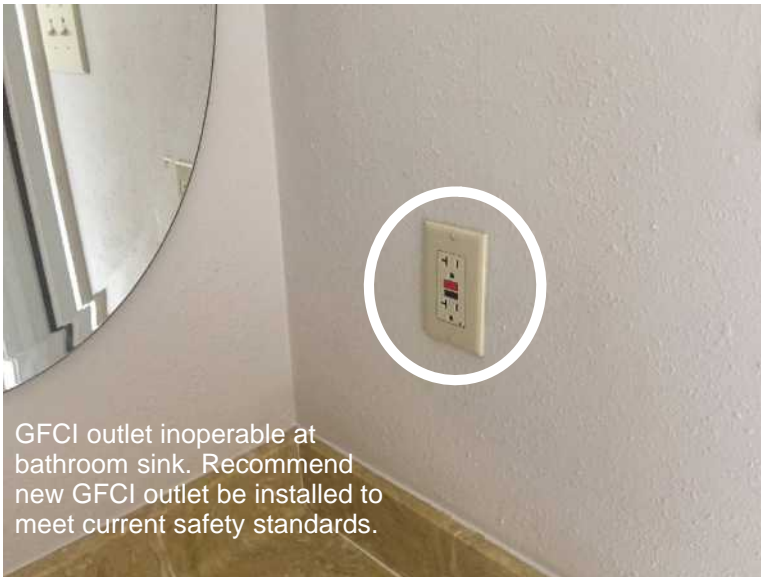
GFCI outlet inoperable at bathroom sink. Recommend new GFCI outlet be installed to meet current safety standards.

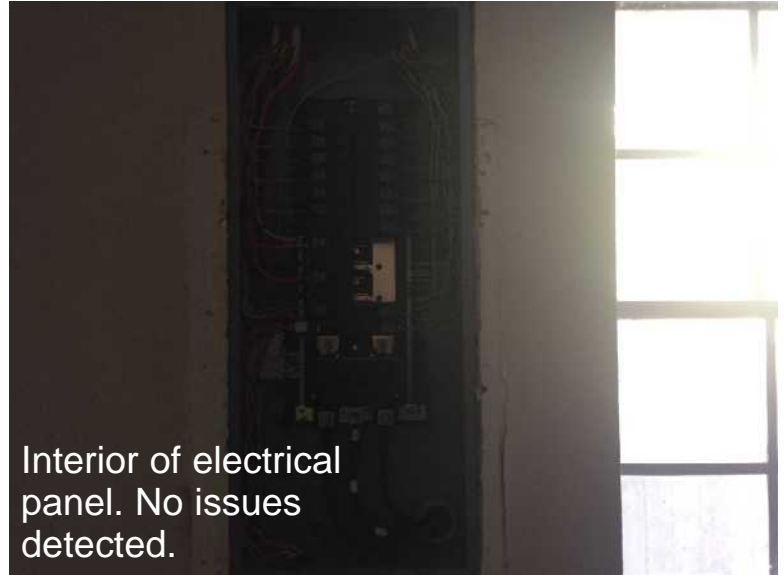
Interior of electrical panel. No issues detected.

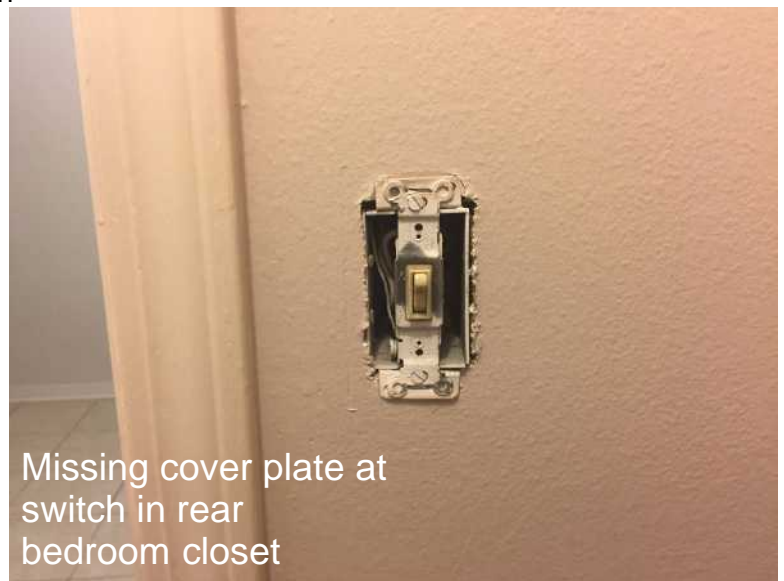
Acceptable Interior Electrical Outlets: 3 prong grounded - Missing cover plate at switch in rear bedroom closet. Recommend installation of cover to prevent potential shock hazard.

Missing cover plate at switch in rear bedroom closet

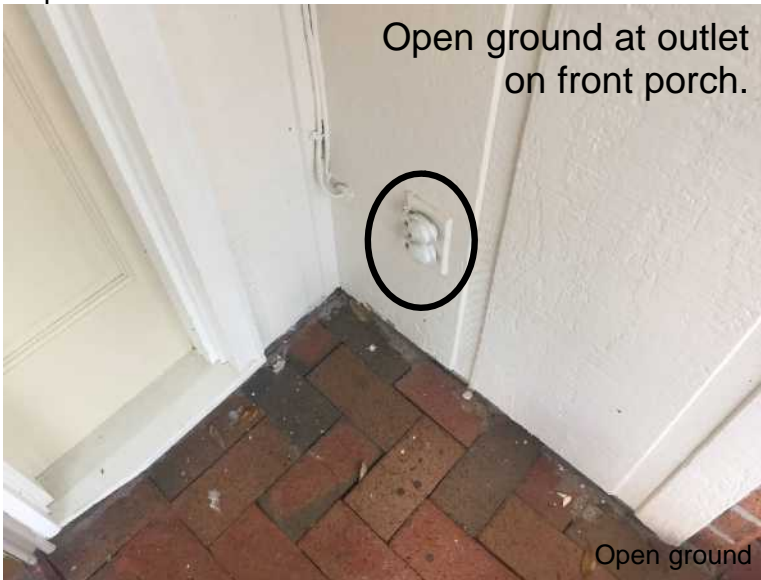
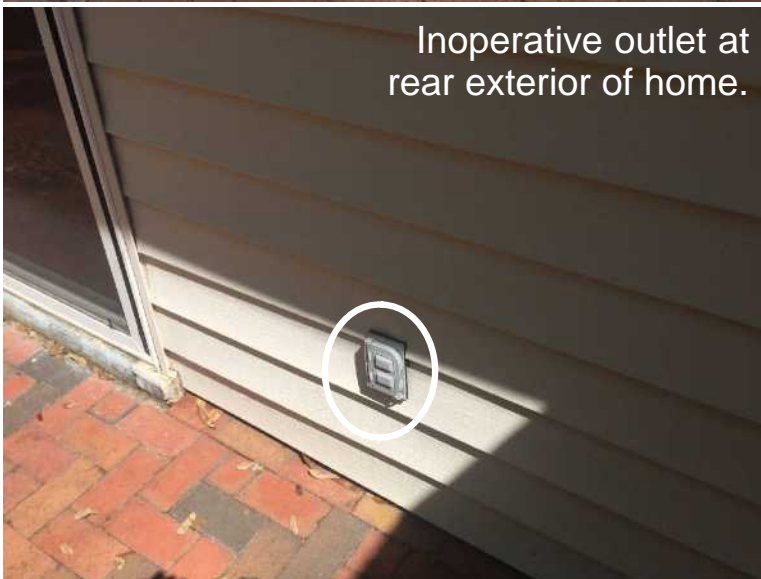
Open ground at outlet on front porch.

Inoperative outlet at rear exterior of home.

Marginal Exterior Electric Outlets: Weather protected, No GFCI protection - Recommend installation of GFCI outlets at all exterior locations to meet current safety standards.

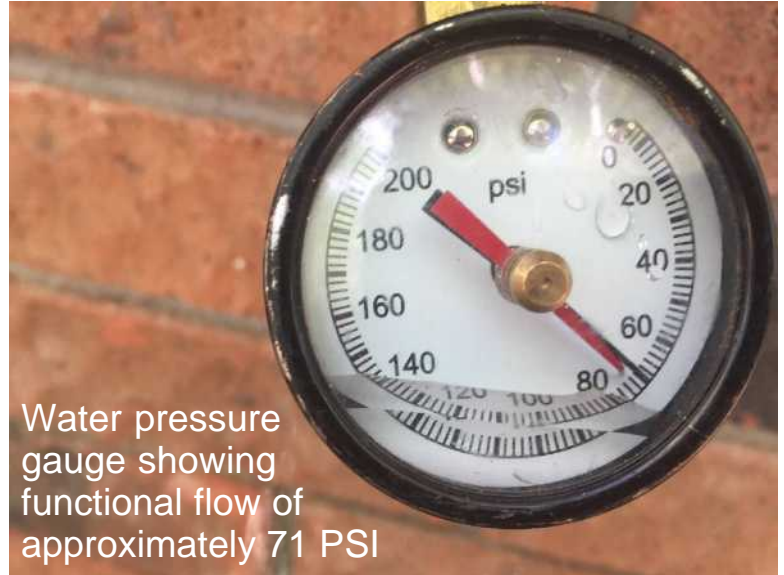
Water pressure gauge showing functional flow of approximately 71 PSI

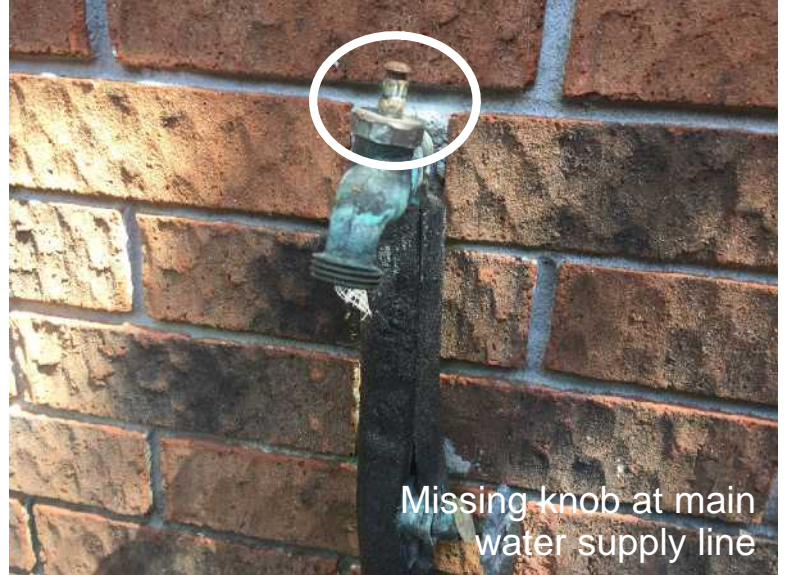
Acceptable Hose Bibs: Rotary
