**United States v. Brace et al., 17-cv-06, W.D. Pa.**  
**Expert Report: Ecological Functions and Connections**  
**of Wetlands and Waters at the Marsh Site,**  
**Waterford, Erie County, Pennsylvania**

Prepared for:  
U.S. Department of Justice

Prepared by:  
Robert P. Brooks, Ph.D.  
Brooks Consulting  
61 Aloha St.  
Port Matilda, PA 16870  
rpbrooks2@gmail.com, 814-880-7607

18 December 2017

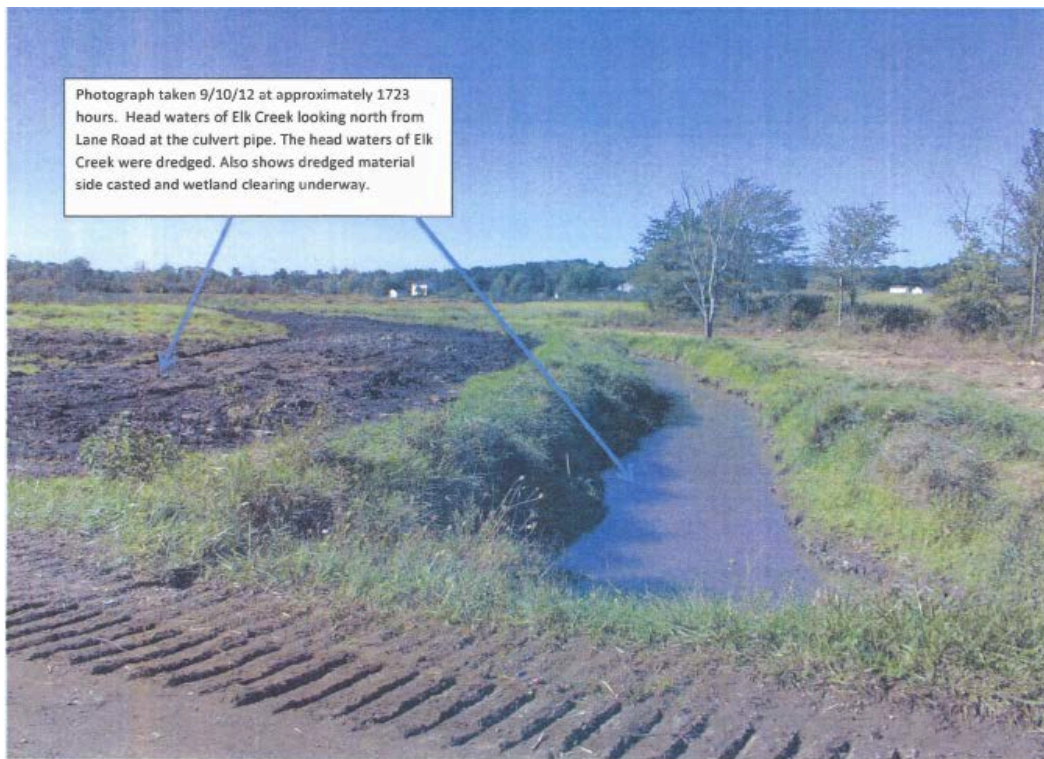
Figure 14. September 2012 photograph from Marsh Site inspection by Smolko; Elk Creek from Lane Road looking downstream (north) showing disturbed soils and side-casting from dredging Elk Creek.

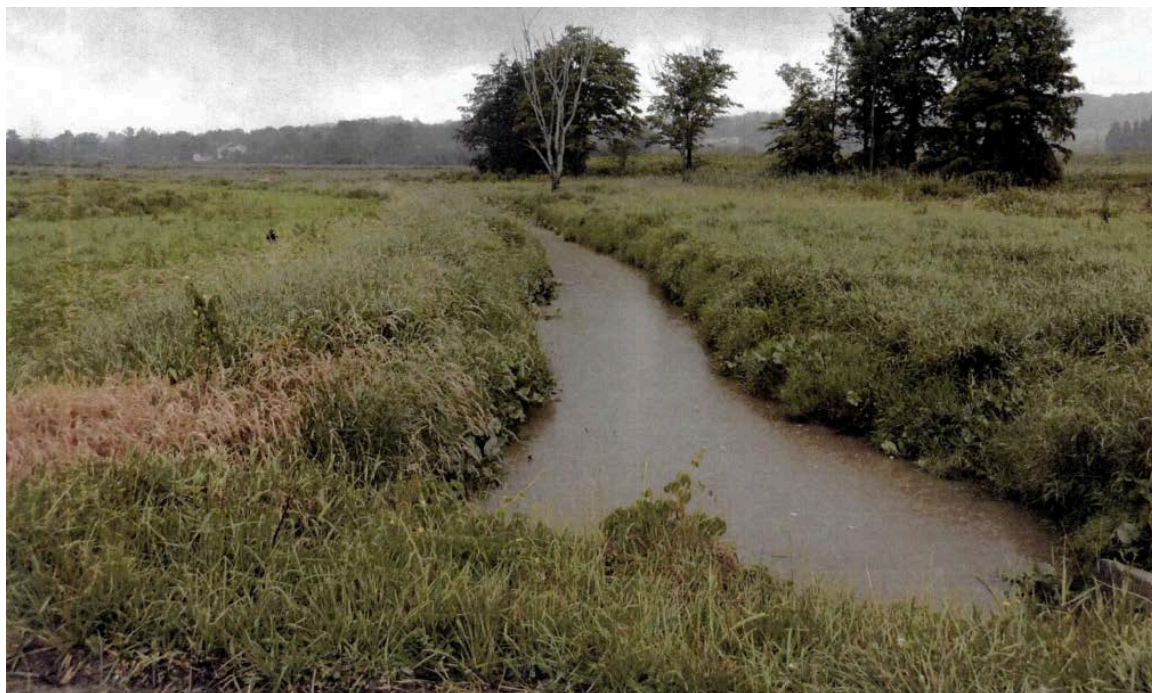
Figure 15. June 2013 photograph from Marsh Site inspection by EPA; Elk Creek from Lane Road looking downstream (north) showing recovering herbaceous vegetation after soil disturbance in 2012, and channelized reach of Elk Creek.

During the June 2013 inspection, new growth of hydrophytic vegetation was observed in portions of the site previously disturbed (Figures 15, Lane Road bridge). Based on the wetland delineation data sheets from three sample points, all located on the Marsh Site, hydrophytic plants were dominant, and soils showed hydric characteristics (i.e., chroma of 1 or 2, gleyed matrix, mottles). Surface hydrology was observed, so evidence of all three wetland parameters was present, indicating the presence of wetlands on the Marsh Site. Their Sample Point #1 was located near my Sample Point #6. Their other two points were located in the middle area of the Marsh Site. Heavy rains made obtaining additional soil samples difficult, and obscured some of the natural surface hydrology. A site inspection report from the same visit prepared by Scott Dudzic of the Pennsylvania Department of Environmental Protection (PADEP) dated 27 June 2013 described similar findings.

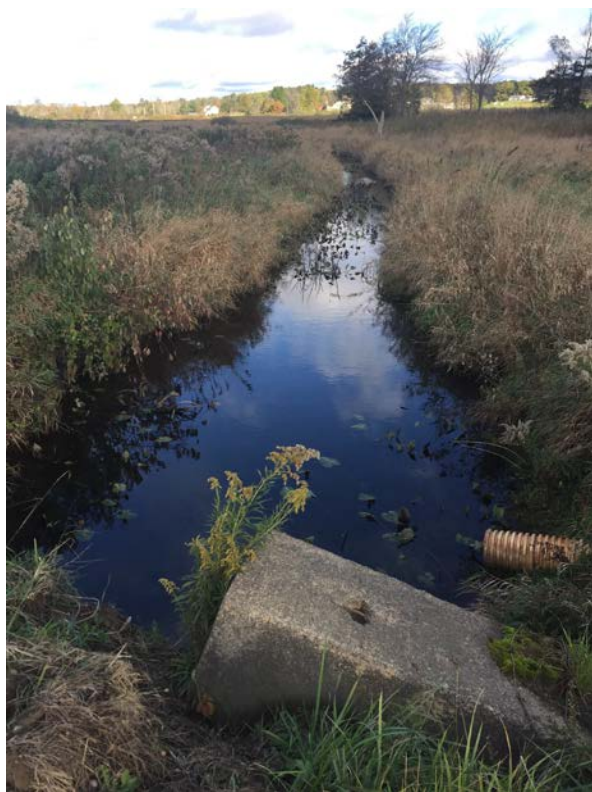
Figure 16. October 2017 photograph from Marsh Site inspection by Brooks; Elk Creek from Lane Road looking downstream (north) showing recovering herbaceous vegetation after soil disturbance in 2012, and channelized reach of Elk Creek.

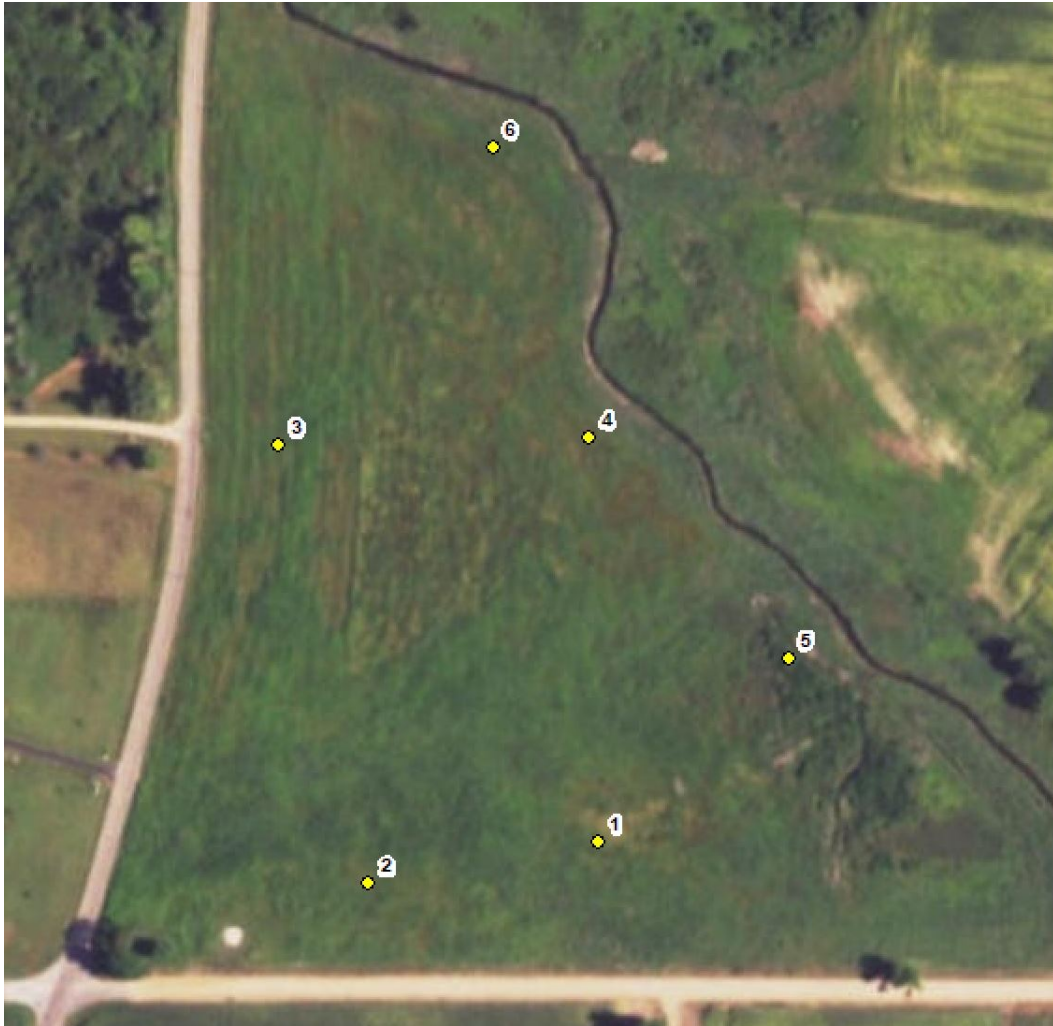
Figure 17. Approximate locations of six Sample Points for wetland identification protocol superimposed on a 2015 image of the Marsh Site from ESRI (Brooks Oct 2017).

On 16 October 2017, I chose and sampled the ecological characteristics of six points on the Marsh Site (Figures 2 & 17). The objective was to collect sufficient data to reach an independent opinion about the occurrence of wetlands on the Marsh Site and their connectivity to Elk Creek at the current time (October 2017), which is defined as *post-disturbance* (after the major land and water alterations by Brace in 2012). I also was tasked to consider the extent and condition of wetlands on the Marsh Site before the 2012 alterations; defined as *pre-disturbance*.

Sample Point #1 (Figure 17) – Located at (approx. lat-long: 41.9793548, -80.0456344), which is at the visual intersection of the gas well tank on Lane Road to the south, and the end of the tree row along the east side of Elk Creek downstream of the culvert on Lane Road. I chose this point because it was located upslope of the patch of alder shrubs in the southeast corner of the Marsh Site. The alder patch, later sampled as Sample Point #5, appeared to be quite wet, so I wanted to know the conditions upslope.

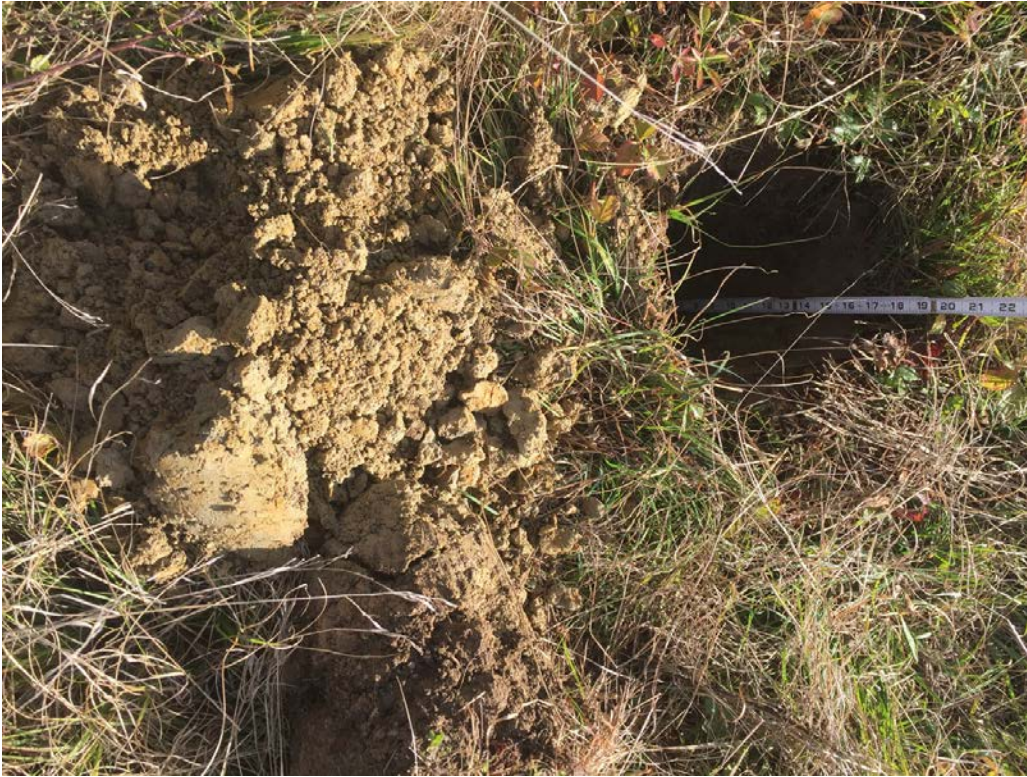
Figure 19. Marsh Site Sample #1 soil pit with profile (see text for description).

increasing to about 30% from 5-18 inches, with color of 7.5YR6/8. Soil texture from 0-5 inches was smooth, and an extended ribbon of 2.0 inches, indicating this is a silty clay loam. From 5-18 inches the soil had slight grit, and after moistening, a ribbon extended to 1.5 inches, indicating a texture of clay loam. Based on later laboratory analysis, the organic matter content from a sample taken at a depth of about 8-12 inches was quite low at 0.9% (Table 3). In summary, the soil at Sample Point #1 showed hydric characteristics (i.e., low matrix chroma, the presence of redoximorphic features; Figures 19 & 20).

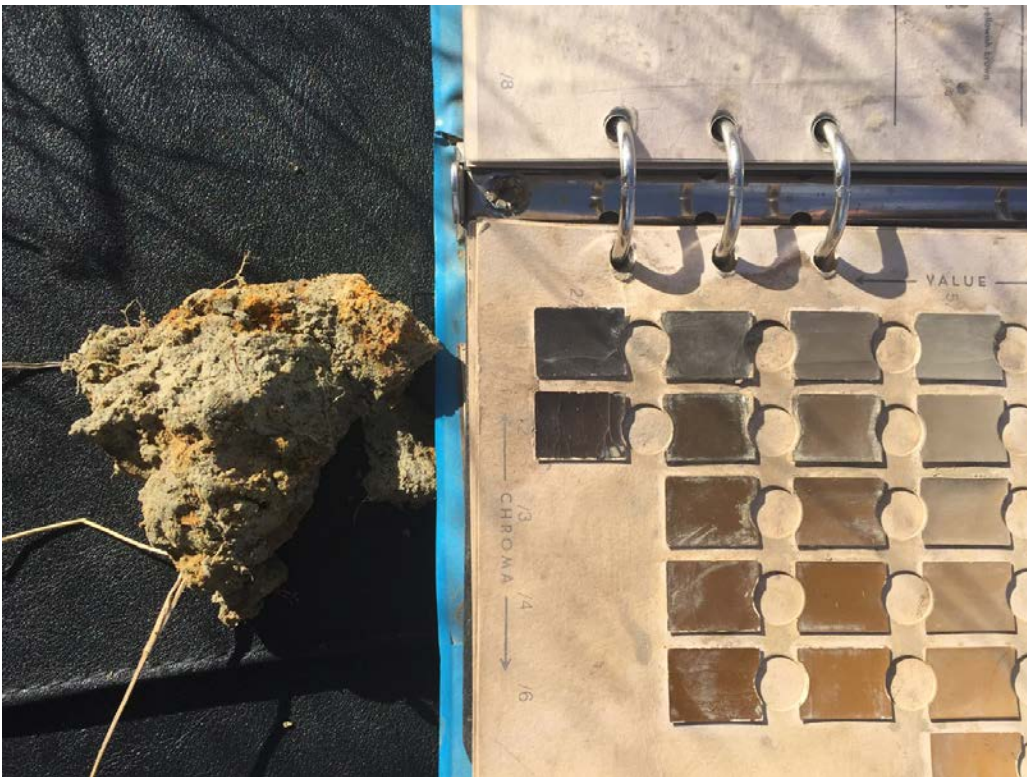
Figure 20. Munsell soil colors for Sample #1 showing hydric matrix, brighter mottles and oxidized rhizospheres (see text for discussion).

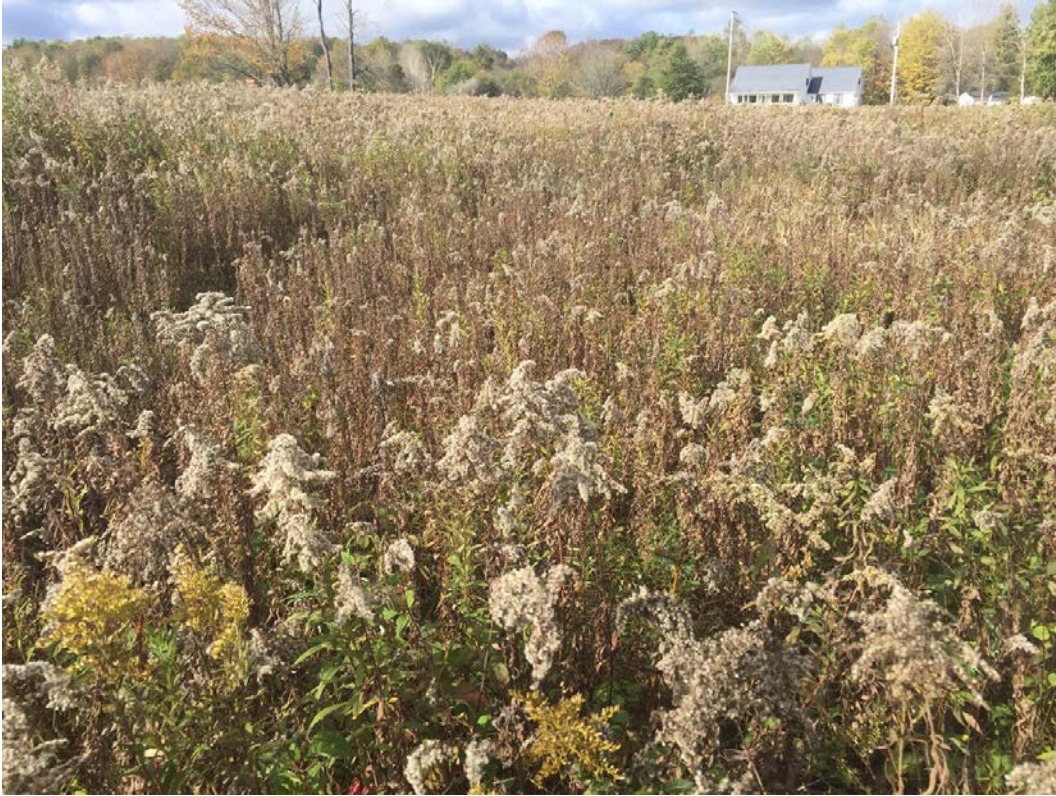
Figure 23. Marsh Site Sample#2 vegetation (looking west) (see text for description).

The vegetation in the vicinity of Sample Point #2 consisted of a combination of herbaceous and shrub species (Figure 23). The Dominance Test was positive for hydrophytic vegetation at 67% wetland species. There were no definitive hydrologic indicators at this point. Since normal circumstances do not exist at Sample Point #2, due to site alterations of hydrology and vegetation, the presence of all three wetlands indicators is not necessary to determine if the site is a wetland where a plausible explanation for the unconfirmed indicator is found. There was not sufficient detail available for the layout of the tile drainage and ditch network to estimate quantitative impacts on the Marsh Site, nor are there any known hydrologic measuring devices on site. The presence of a histosol (highly organic hydric soil), however, is a strong indicator that hydric conditions are present, especially when a viable hydrophytic plant community is present. Based on observations and the presence of a histosol, which develops over extensive time periods when conditions are sufficiently wet, there is active hydrology on this portion of the Marsh Site. Therefore, in my opinion wetlands are present at Sample Point #2 at the present time, despite efforts to alter the hydrology and vegetation in 2012.

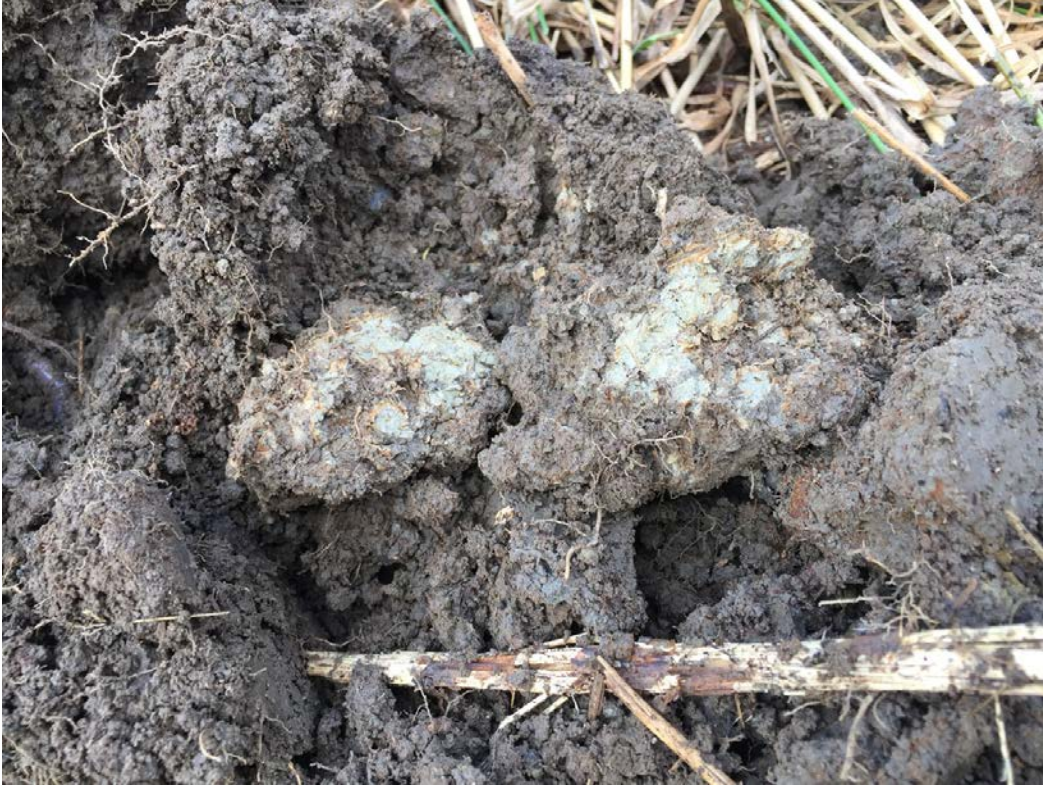
Figure 28. Marsh Site Sample #4 lower depth of soil pit and profile (see text for description).

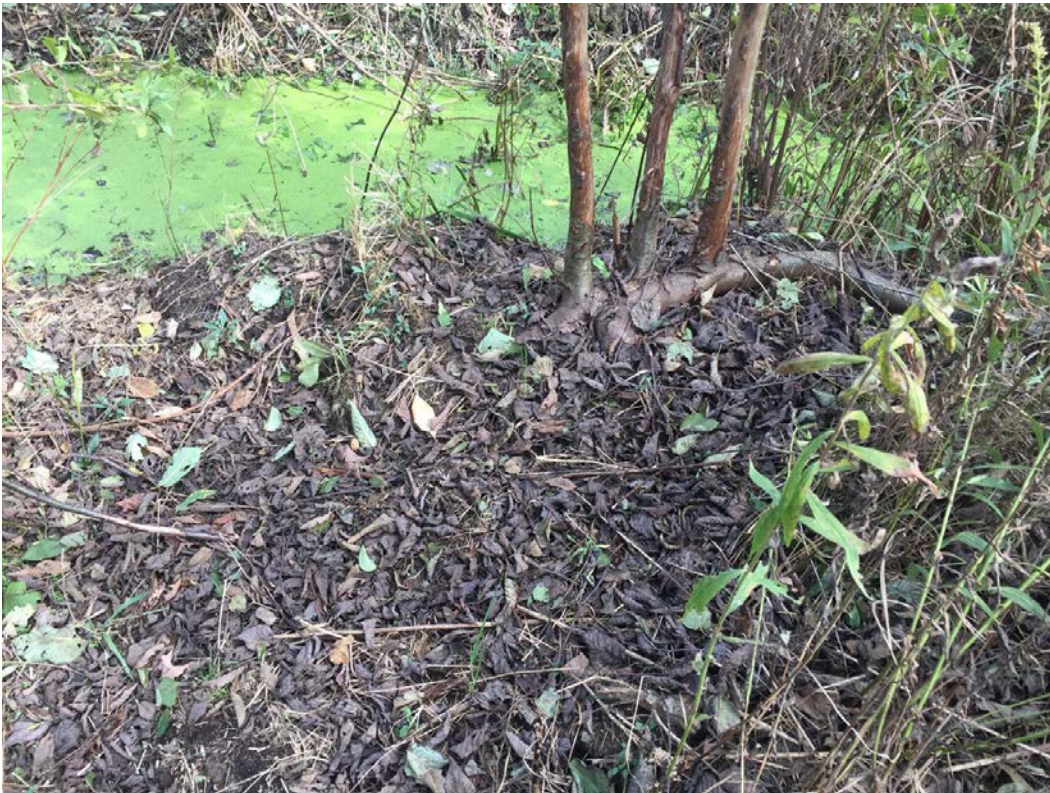
Figure 31. Marsh Site Sample #5 next to auxiliary duckweed-covered ditch flowing into Elk Creek.

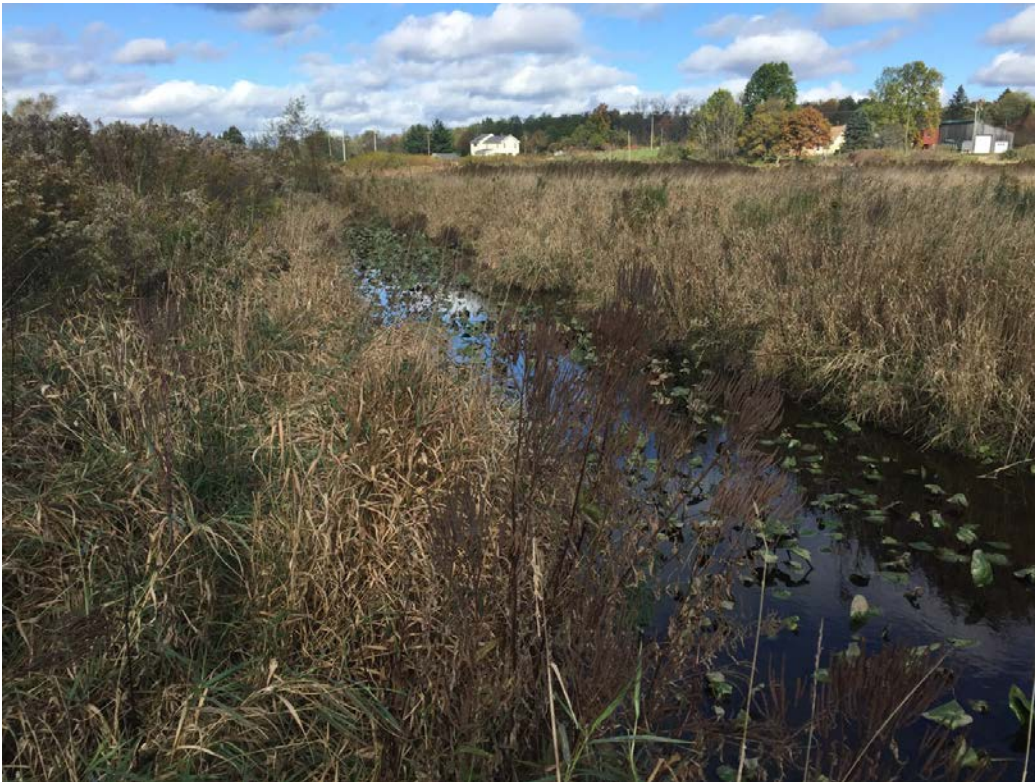
Figure 33. Elk Creek on Marsh Site near Sample #5 showing wetland and aquatic vegetation.

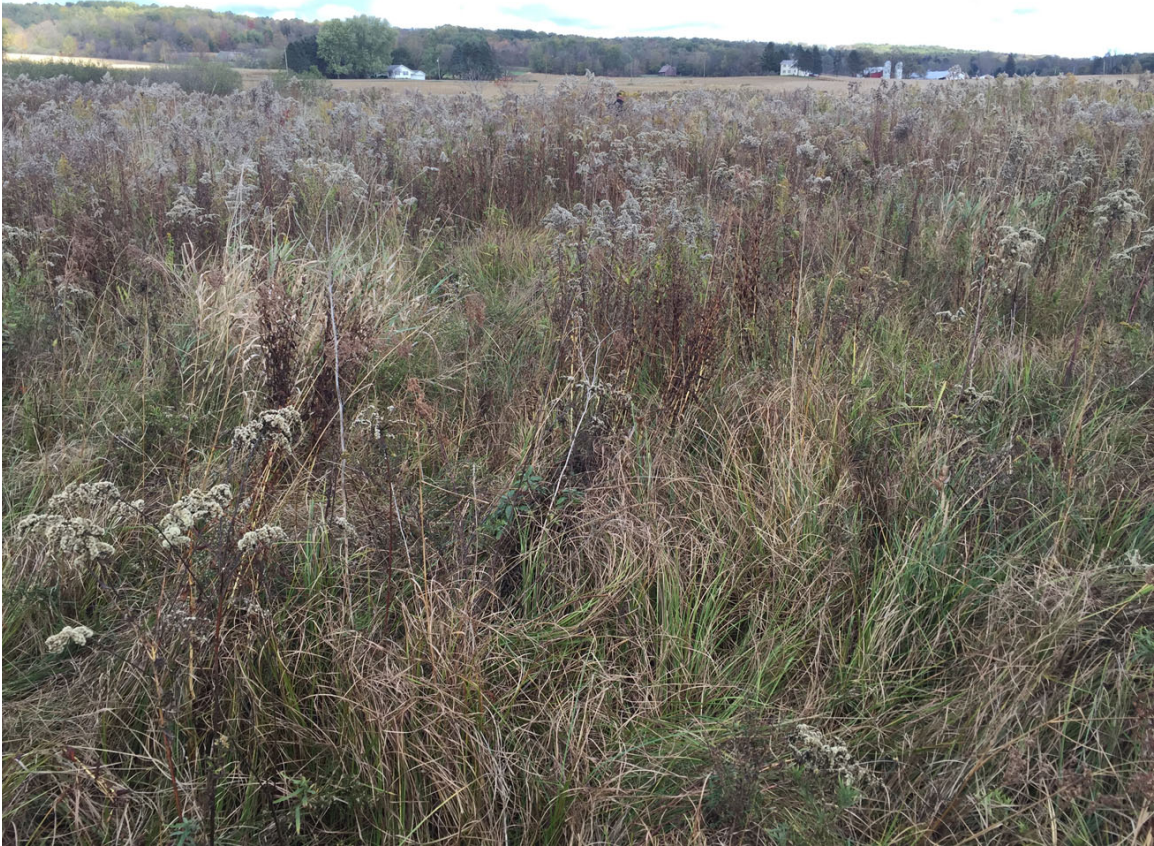
Figure 36. Marsh Site Sample Point #6 vegetation dominated by wetland plant species.

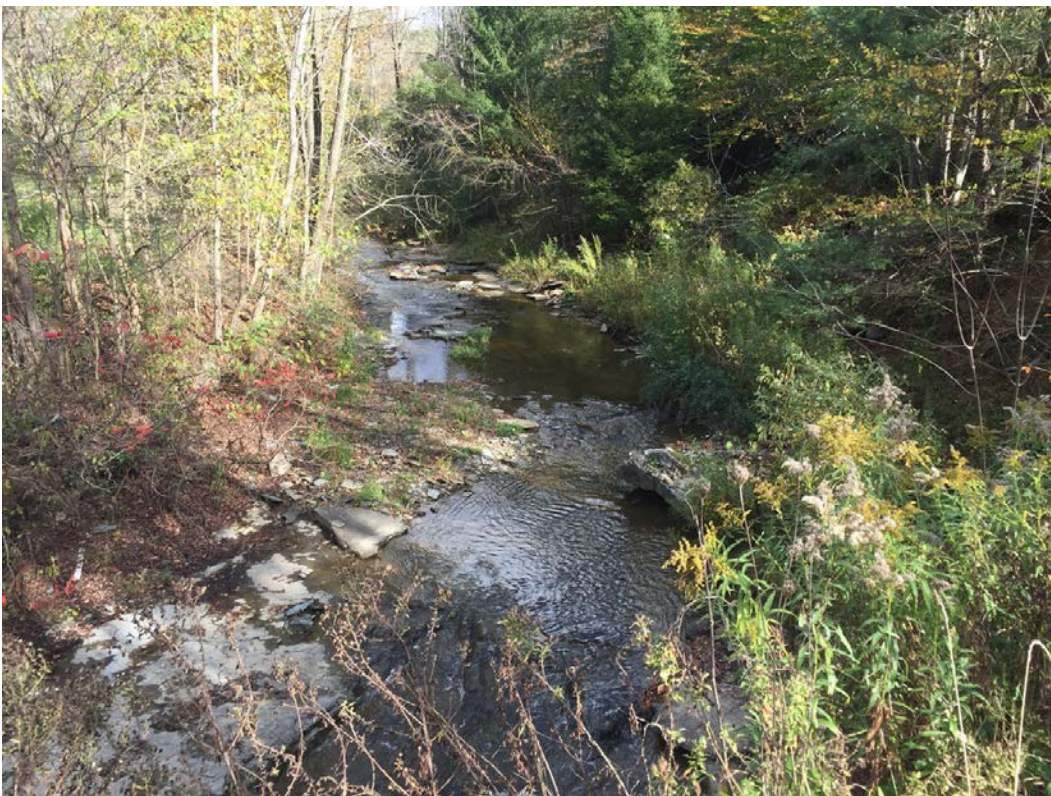
Figure 52. Hamot Road bridge looking upstream; stream bed rocky and relatively steep-sided, more incised than upstream portions of Elk Creek.

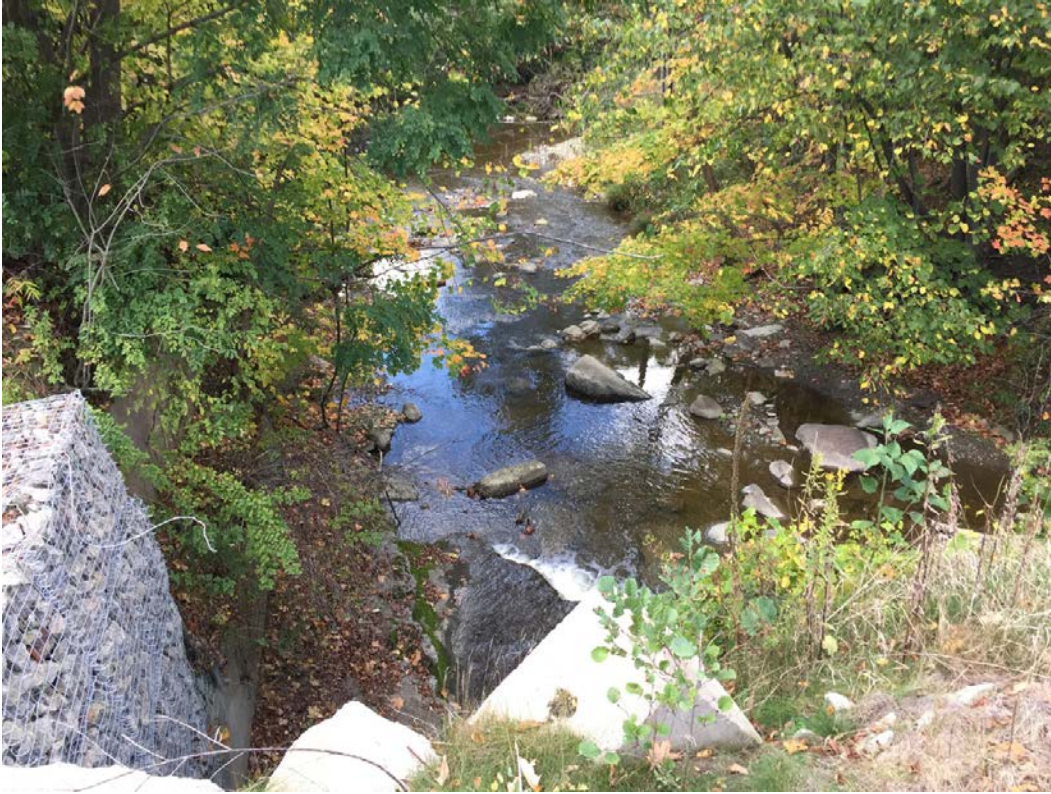
Figure 53. Elk Creek crossing under Oliver Road, steep-sided gorge; bridge supported by gabions.
