**Attachment 4**  
**Wetland Rapid Assessment Report**

**Wisconsin Department of Natural Resources**  
**Wetland Rapid Assessment Methodology – version 2.0**

<b>WETLAND IDENTIFICATION</b>								
Project name: Saxon Harbor Marina and Campground Reconstruction	Evaluator(s): Ann M. Key, PSS, PWS, WDNR Professionally Assured Wetland Delineator							
File #:	Date of visit(s): 09/08/17							
Location: PLSS: <u>Section 12, T38N, R01W</u>  Lat: <u>46.558449"N</u> Long: <u>-90.438495"W</u>  County: <u>Iron</u> Town/City/Village: <u>Town of Saxon</u>	Ecological Landscape:  Superior Coastal Plain  Watershed:  LS15 – Montreal River							
<b>SITE DESCRIPTION</b>								
Soils: Mapped Type(s): 444B – Gichigami-Ontonagon Complex, 0 to 6%  5285F – Rockland-Arnheim, frequently flooded complex, 0 to 70% slopes  Field Verified: Yes	<table border="1" style="width: 100%; border-collapse: collapse;"> <tr> <td colspan="2" style="padding: 5px;">               WWI Class: Unmapped, only 2-acre wetland symbols noted (T3K)             </td> </tr> <tr> <td colspan="2" style="padding: 5px;">               Wetland Type(s): Eggers and Reed: Hardwood Swamp             </td> </tr> <tr> <td style="width: 50%;

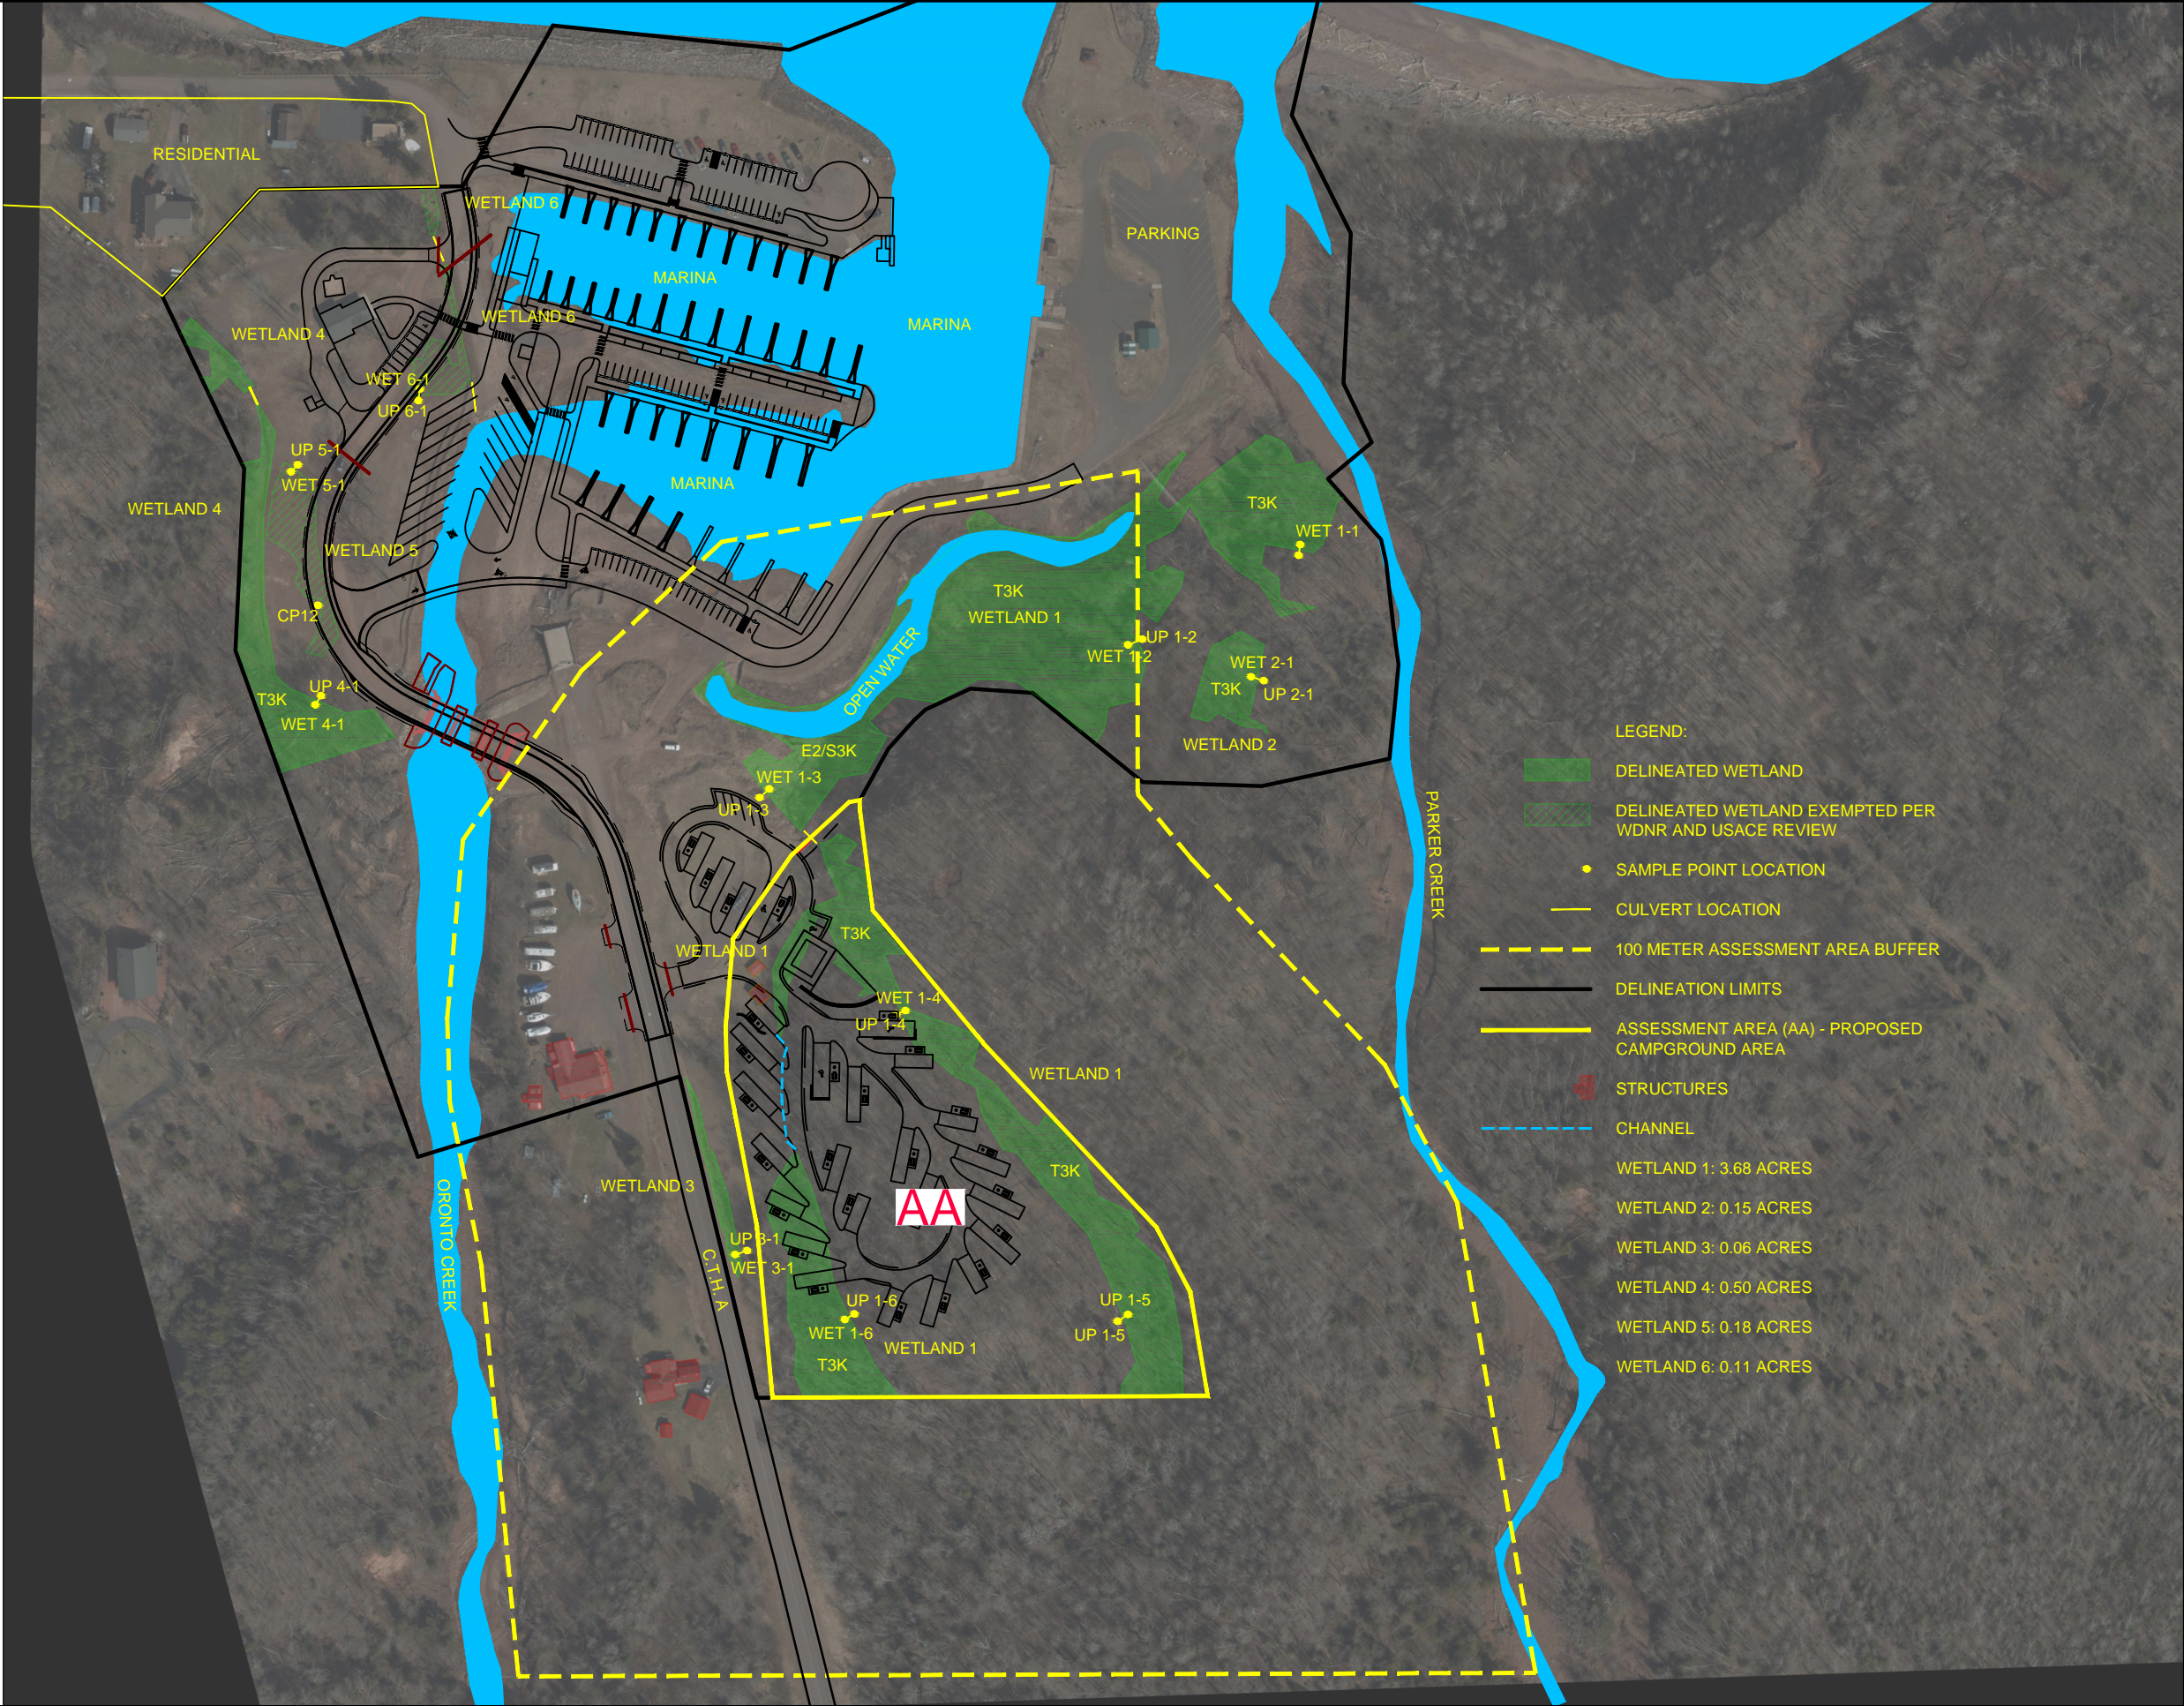
- LEGEND:
- DELINEATED WETLAND
  - DELINEATED WETLAND EXEMPTED PER WDNR AND USACE REVIEW
  - SAMPLE POINT LOCATION
  - CULVERT LOCATION
  - 100 METER ASSESSMENT AREA BUFFER
  - DELINEATION LIMITS
  - ASSESSMENT AREA (AA) - PROPOSED CAMPGROUND AREA
  - STRUCTURES
  - CHANNEL
- WETLAND 1: 3.68 ACRES  
WETLAND 2: 0.15 ACRES  
WETLAND 3: 0.06 ACRES  
WETLAND 4: 0.50 ACRES  
WETLAND 5: 0.18 ACRES  
WETLAND 6: 0.11 ACRES

WETLAND LOCATION MAP	APPROVED BY: AMK	THIS DRAWING AND ALL INFORMATION CONTAINED THEREON IS THE PROPERTY OF WETLANDS & WATERWAYS LLC, AND SHALL NOT BE COPIED OR USED EXCEPT FOR THE PURPOSE FOR WHICH IT IS FURNISHED.			PROJECT NUMBER: 444	FIGURE NO. <b>2</b>
	DRAWN BY: NLB	Wetlands & Waterways LLC				
SAXON SITE SEC. 12, T48N, R1W, TOWN OF SAXON, IRON COUNTY, WISCONSIN	DATE: 9/13/17					
	SCALE: 1"=200'

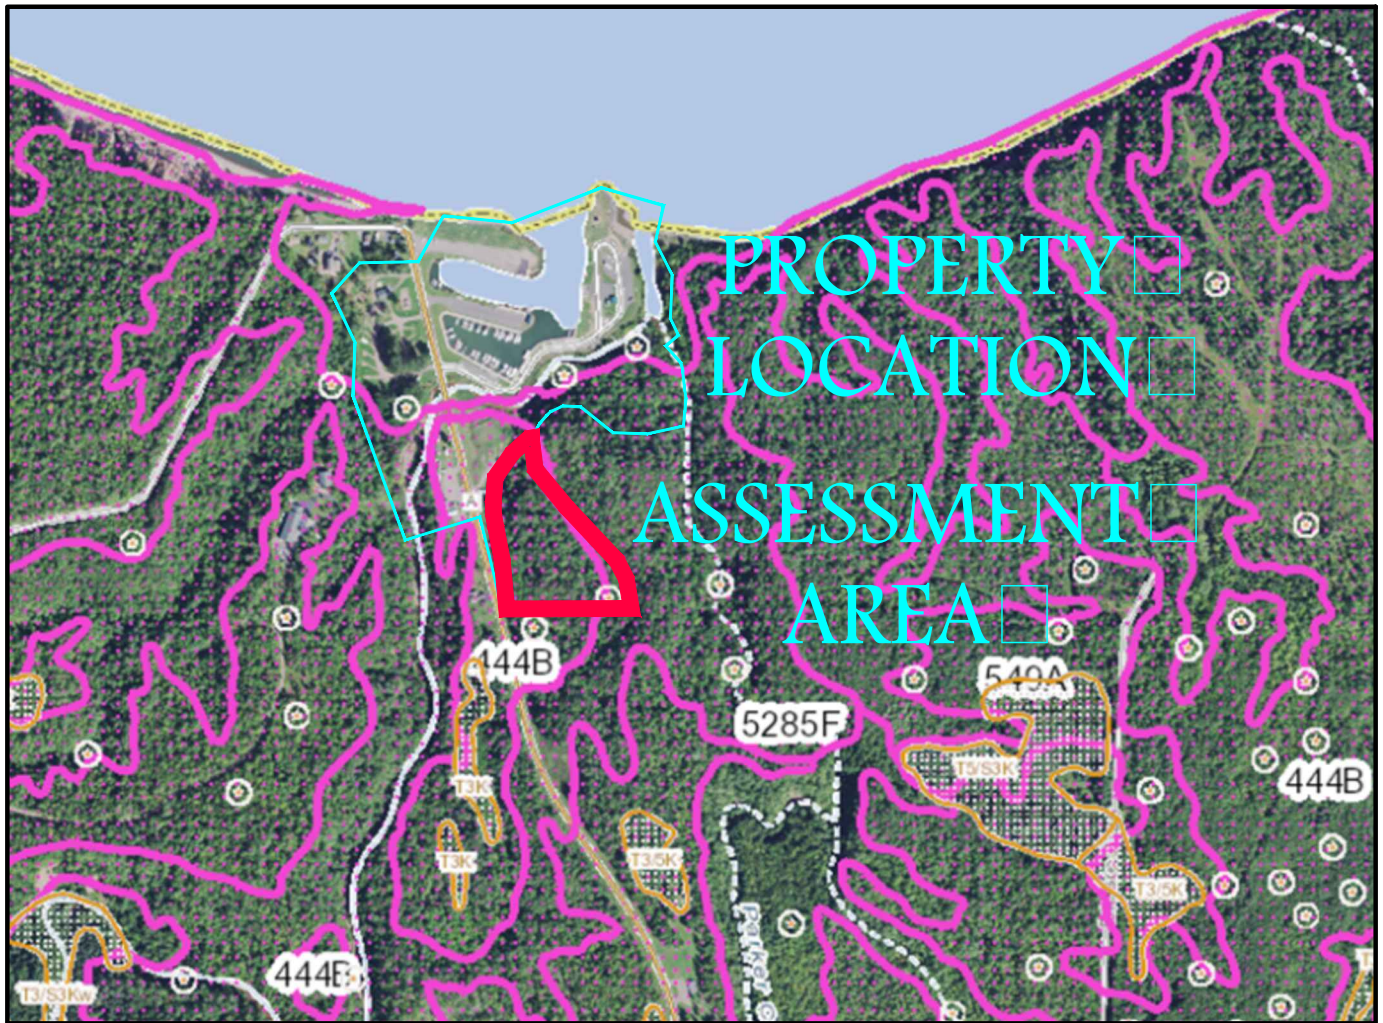
WISCONSIN WETLAND INVENTORY MAP	APPROVED BY: AMK	THIS DRAWING AND ALL INFORMATION CONTAINED THEREON IS THE PROPERTY OF WETLANDS & WATERWAYS LLC, AND SHALL NOT BE COPIED OR USED EXCEPT FOR THE PURPOSE FOR WHICH IT IS FURNISHED.	PROJECT NUMBER: 444
	DRAWN BY: NLB		
SAXON SITE SEC. 12, T48N, R1W, TOWN OF SAXON, IRON COUNTY, WISCONSIN	DATE: 4-13-17		FIGURE NO. <b>3</b>
	SCALE: NONE

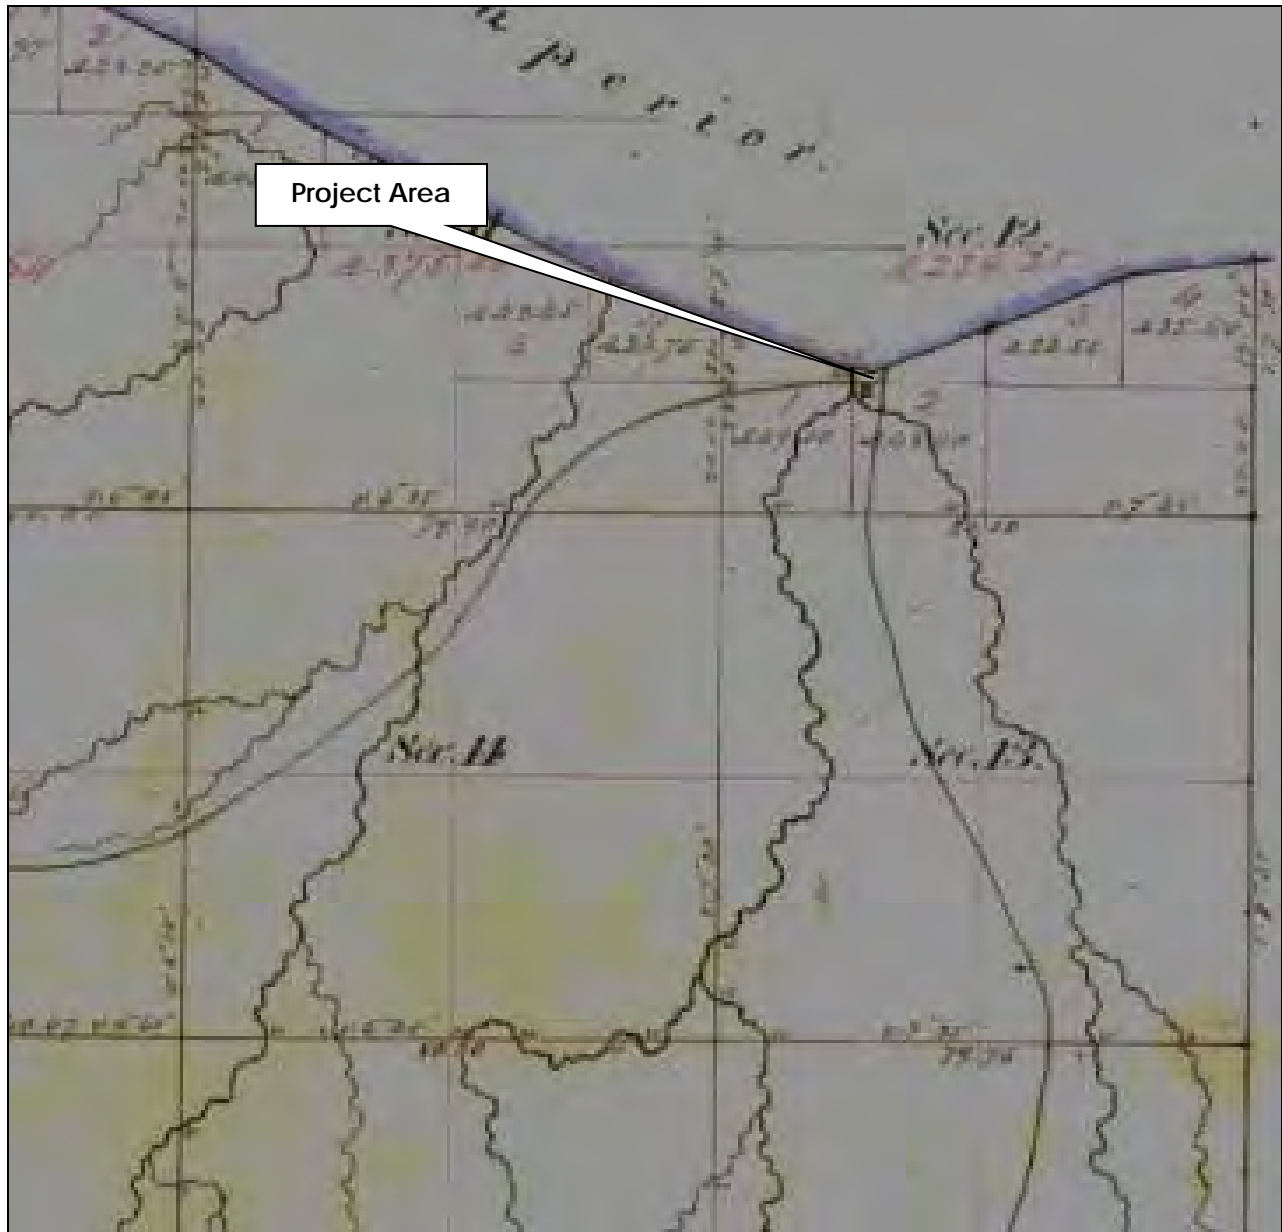
**Attachment 5. 1861 General Land Office Map.**

Note there is a structure, most likely the trading post, near the mouth of the river.

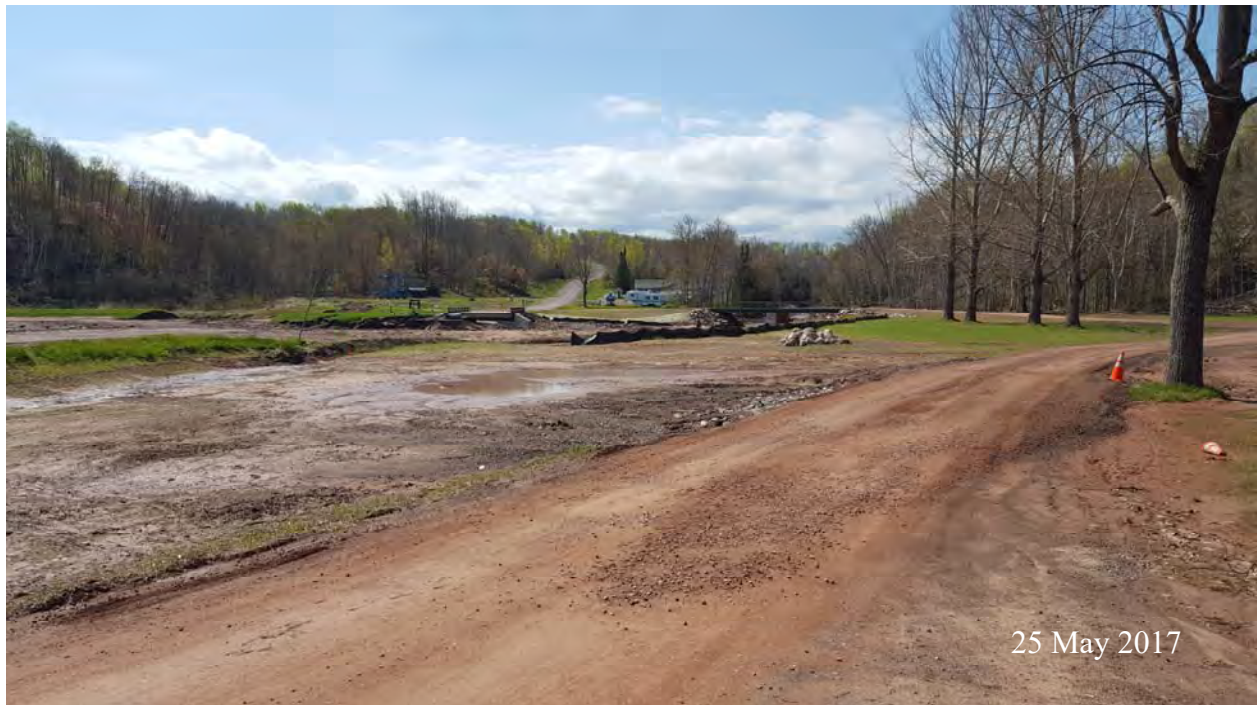
**Attachment 8. Photo of Project Area.**

View to the south. This is the location of the campground that was destroyed by flooding of the Oronto Creek which is just south and east of this 7 acre plot. Saxon Harbor rests immediately to the east. What we see in this picture is an improvised dirt road. The paved road was washed away. That fact along with this picture provides evidence of the force of the storm and flooding through the area. In addition, all topsoil and most surface vegetation was removed by the flooding.

Area #1 is seven (7) acres in size and the former campground totally destroyed by storm and flooding (see **Attachment 8**). The USDA Soil Survey for this area characterizes all soils in this area as Beach Soils. At the time of the current archaeological survey the entire top level of loosely packed sand (A Horizon) was completely stripped from the area by storm and flooding. The more firm hard packed sand was now the ground surface completely bare and exposed with little to no vegetation. This area was surface inspected and shovel tested at 5 to 10 meter intervals on a checkerboard pattern. The depth of testing was about 50 to 60 centimeters. The entire depth was sand.

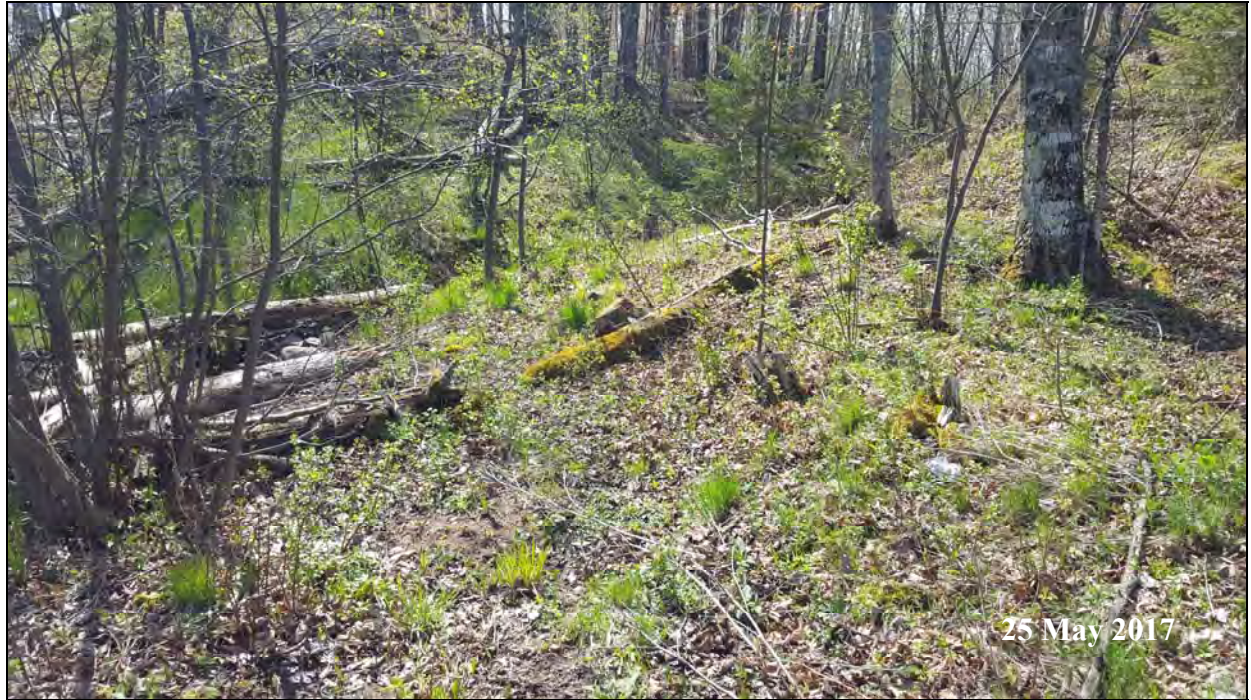
### Attachment 9. Photo of Project Area

This is a view within Area #2. View to the west from the center of the project area. Building on the left of the photo are warehouses, harbor for recreational boats on the right and parking areas in the center.

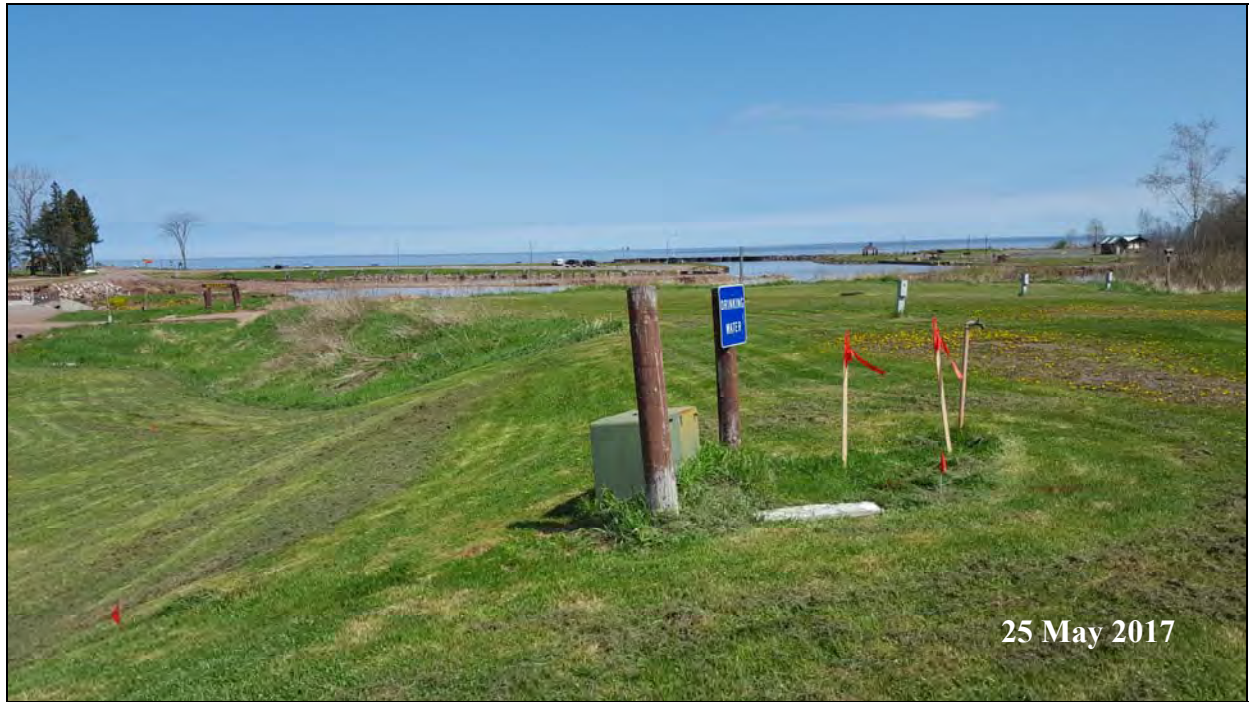
**Attachment 10. Photo of Project Area**

View to the north from the north end of Area #2. This photograph illustrates the landscaping on the north end of Area#2. The area has been landscaped with buried utilities for camping.

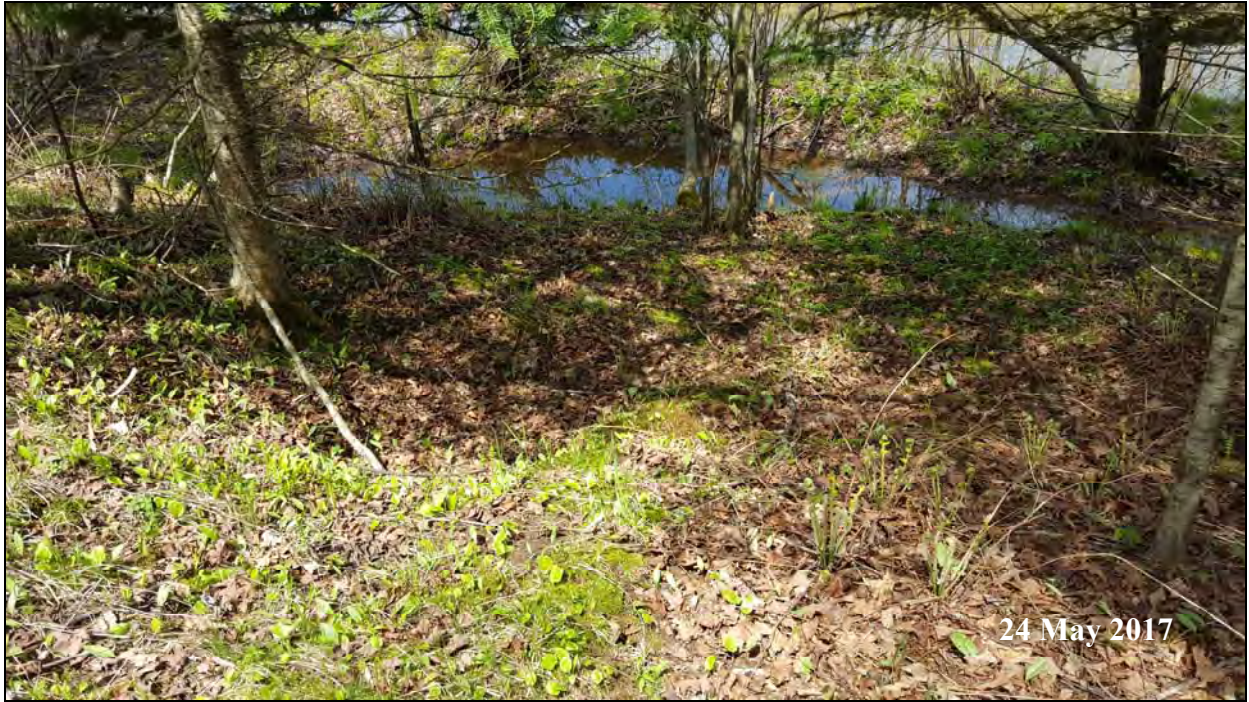
### Attachment 11. Photo of Project Area

View to the north with the Oronto Creek in the far background. The foreground is the location of depressions attributed to the Trading Post (IR-0018). There is also water in the middle ground of the photo. This area is all sand and the water in the middle ground appears to be of recent origin – most likely from the storm and flooding of the previous year. Behind the photographer in this photo is a small camping area with a picnic bench and fire pit. Clearly this area has been used as a wilderness campground for a many years. There is considerable pitting in the area some appears to be man-made – probably for camping reasons others are clearly the result of tree falls.

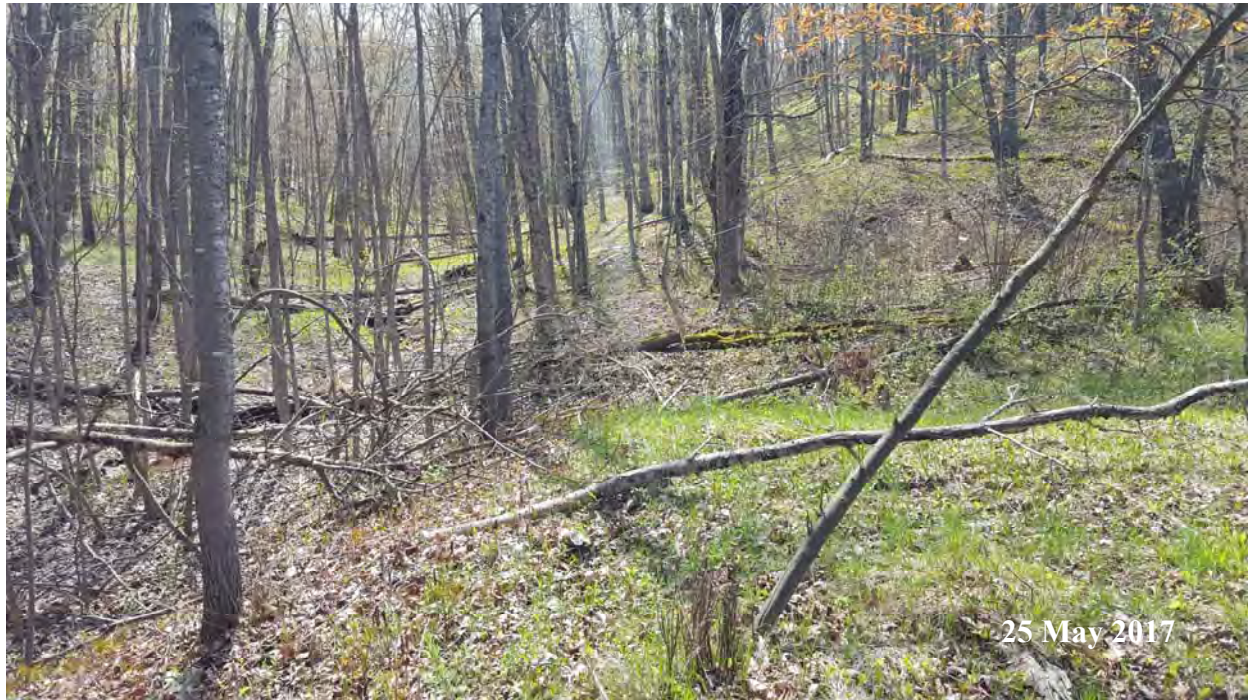
**Attachment 12. Photo of Project Area**

View to the south. This photo illustrates the topographic relief and ground cover in Area #3.

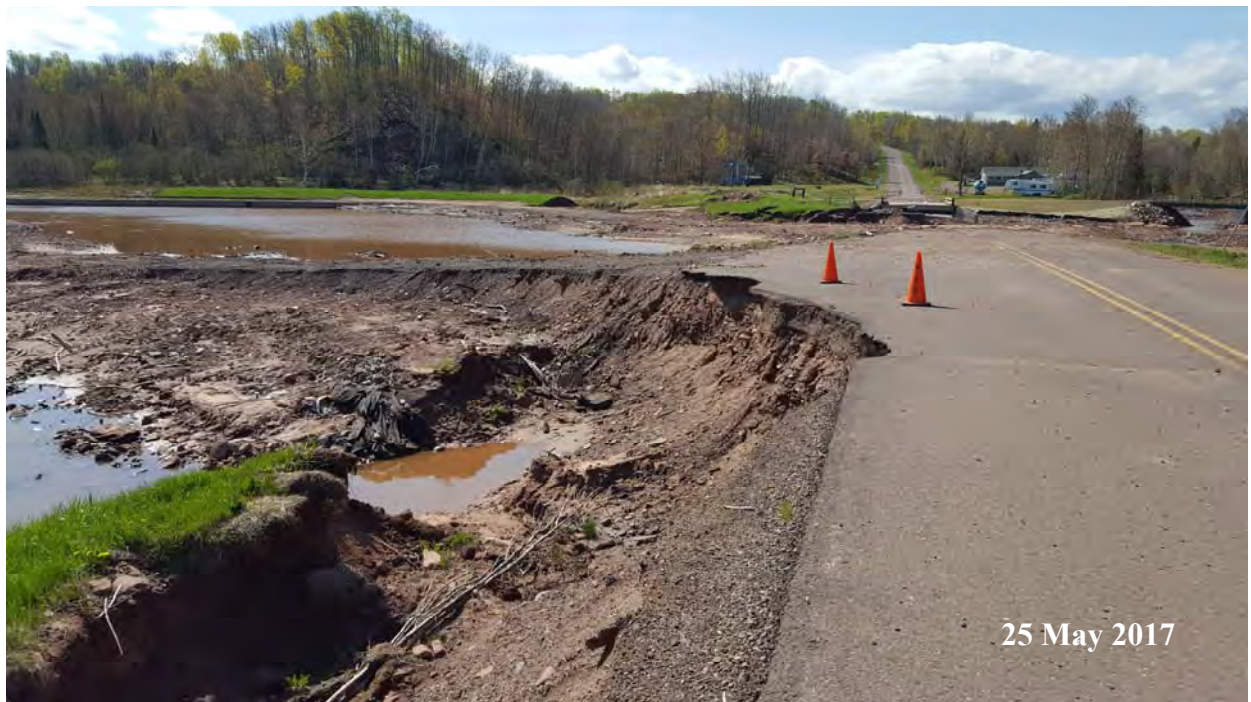
### Attachment 13. Photo of Project Area

View to the south. This is the western end of the Harbor Area. Lake Superior is behind the photographer. The area to the left was once an active harbor with slips and moorings. What land there was is gone.
