Truck Shop by Dave Sperry

Ever since I bought my LRE the horn didn't work. It was disconnected by the horns. When I reconnected it I could hear a slight noise but no honk. I started the engine and the honk wouldn't quit. So I stopped the motor and disconnected the horns. I tried to find a working pad and was told "Good Luck!".

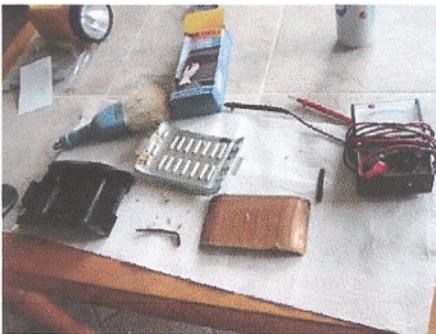
How to fix it; I took the two forward facing bolts holding the center pad off the steering wheel. I think it's called the "Omni" wheel for the square horn pad. Inside the plastic pad were two metal plates. One was galvanized steel with rolled ends & ridges and the other was flat copper with rolled ends. The galvanized plate was grounded by the bolts to the steering wheel. The copper plate had the hot wire going to a 90' tab that stuck thru a hole in the galvanized plate. Originally, there was a 1/16" thick foam gasket in between. It had adhesive on both sides. It kept the two plates apart. After 31 years the foam crumbled, the plates touched, and continuous horn. If you look at picture 2 you can see the leftover adhesive on the plates.

The object of the repair was to get something between the plates that was thick enough to keep them apart, thin enough so they would touch and honk when you pressed them and, not fall out.

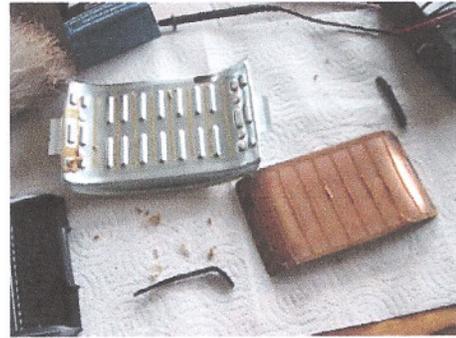
Preparation; Use a whisk broom to remove the crumbled foam. Remove the adhesive on the steel plate. I used my finger nail. I did not remove it on the copper plate for fear of bending it. Then rinse both plates with disc brake cleaner.

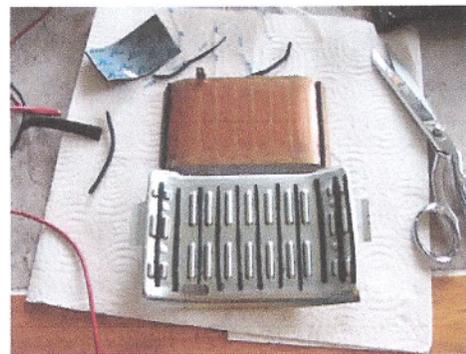
Velcro; To separate the plates I cut 1/16" wide strips of the loop section of self adhesive Velcro and stuck them on the steel plate where the old adhesive had been. See picture 4.

With each step you can look put the plates together and see if the ridges in the steel plate touch the copper one with no finger pressure. If they do touch, more Velcro. You can see the copper plate has very few Velcro strips. I eventually added one more on the curve of the copper plate. The fewer the better on the copper plate as you may bend it trying to get one off.

Now you put the plates into the horn pad. Be sure the 90' copper tab is in the middle of the hole in the steel plate. Next get a VOM and clip the leads to the two plates. If you have to squeeze before it shows continuity that's great. If not, take the plates out of the pad and look at where they may be hitting. More Velco there.

Install the pad back into the wheel & test. I did & it shorted on one side. I pulled everything out and added one Velcro strip on that side. I put it back in and now it works beautifully. Being nylon, the Velcro loop material should last a long time. Looking back, the only thing I would change is put a small piece of electrical tape over the hole on the steel plate below the copper tab.
