Reserve Study  
for the  
Corrotoman By The Bay Association  
Lancaster, Virginia

Service: Level 2 (Modified) / Update with Site Visit

5/28/2025; Revised 6/23/2025  
Client : 25-0146

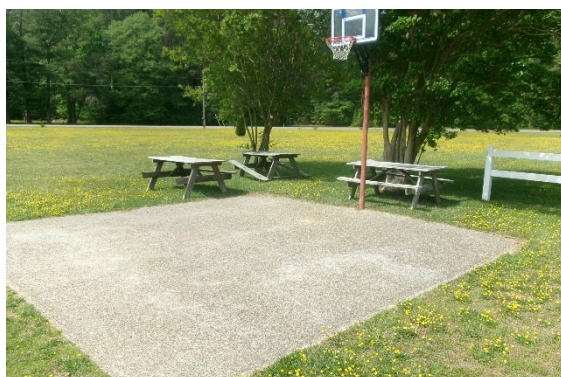
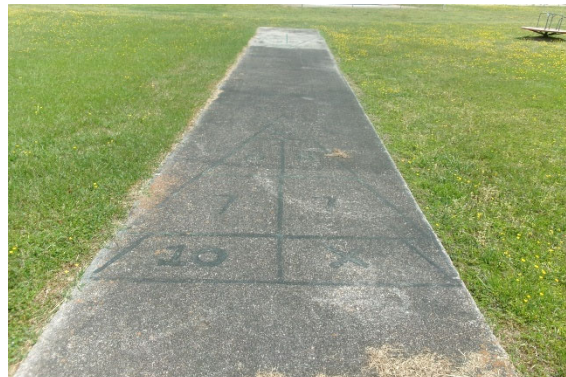
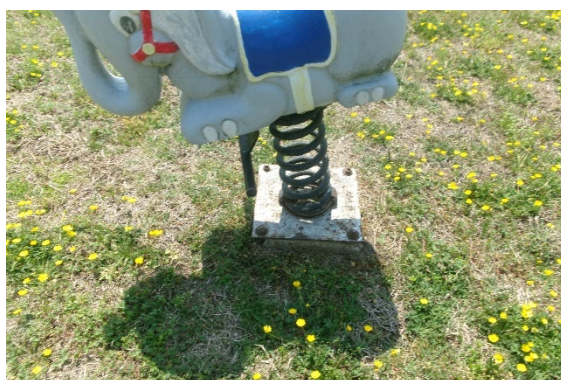
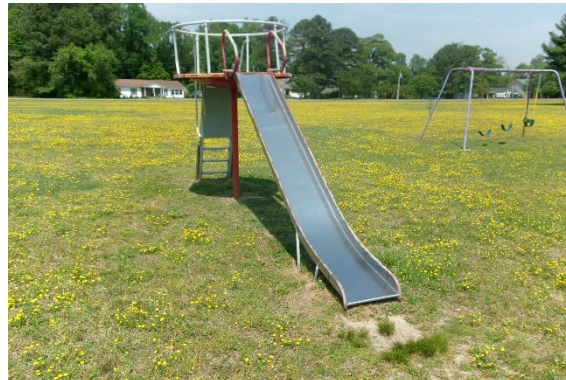
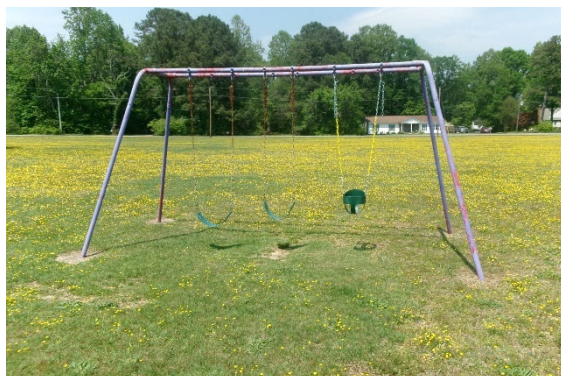
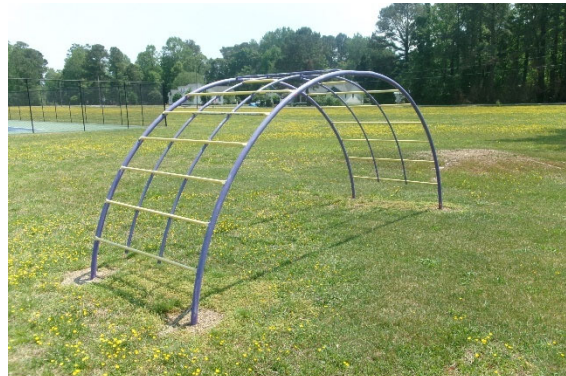
The children's play equipment in its current condition is a safety concern, as there are exposed mounting bolts and plates at the bases of the spring toys, and none of the play equipment has been provided with fall attenuating ground cover as is recommended by the U.S. Consumer Product Safety Commission's "Public Playground Safety Handbook", (Publication Number 325, <https://www.cpsc.gov/s3fs-public/325.pdf> ).

Blue Ridge Reserves recommends that the existing play equipment be closed to public use until such time as proper fall attenuating ground cover can be installed. We understand that the Association plans to replace the various existing stand-alone pieces of equipment with more modern modular multipurpose play structures within the next year or two.

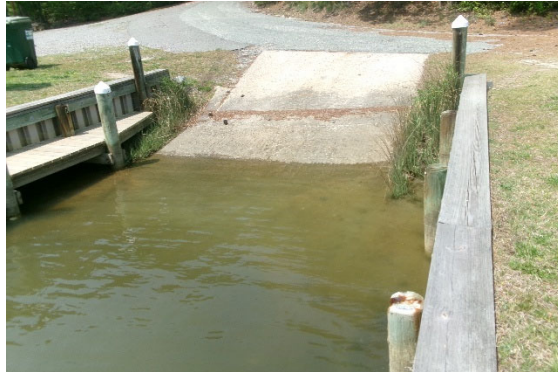
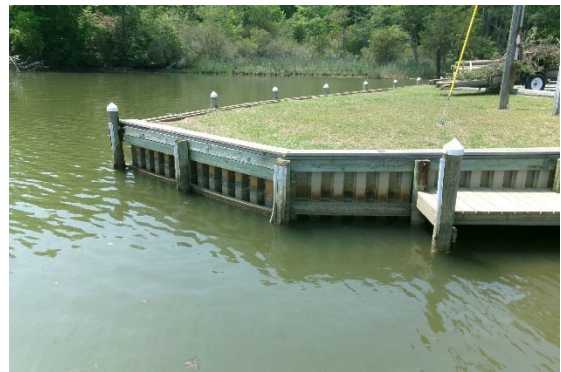
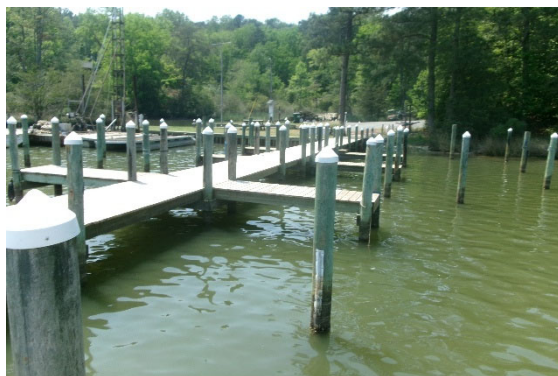
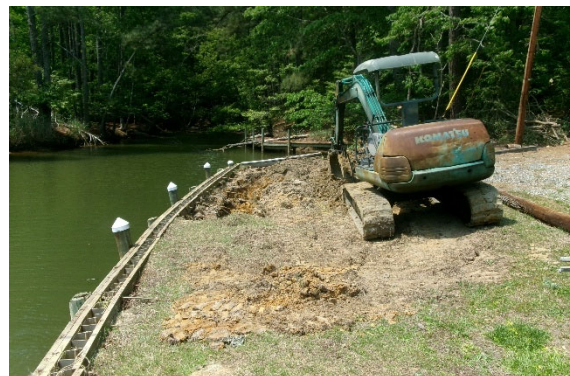
6. Boat Dock. The Association maintains approximately 1,300 square feet of wood boat dock, including finger piers. The facility also includes a concrete boat ramp, a deeper-water navigation channel, bulkhead structures and capping boards to retain soil from the waters' edge, stand-alone docking pilings, and a marina flagpole. The deck boards at the dock were reportedly replaced within the last year and appear to be in very good condition. The section

Note that we physically measured the current dock structure, including the finger piers, during our site visit and our quantity is about twice that of the square feet reported in the previous Miller-Dodson study. We have also updated the unit pricing estimates based on regional and industry standard published costs.

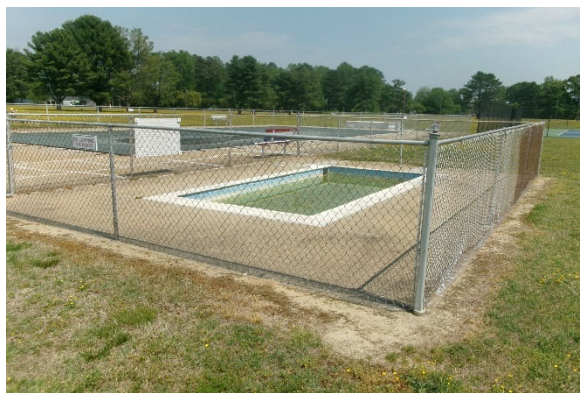
7. Swimming Pool Facility. The Association is in the process of completely replacing the outdoor swimming pool structure and related equipment and accessories. Component descriptions and costs have been provided by the Association based on actual contractor quotes for the work. This analysis assumes that the concrete swimming pool, equipment, and accessories, including a new pool equipment shed, will be new as of March 1, 2026.

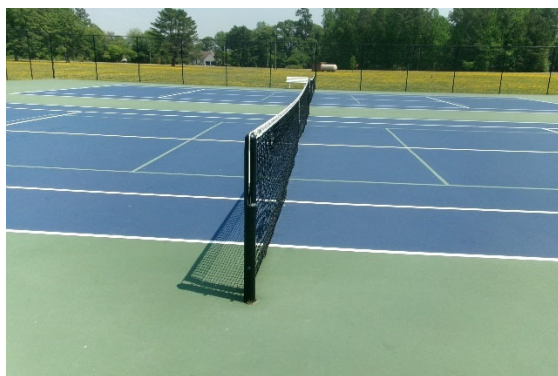
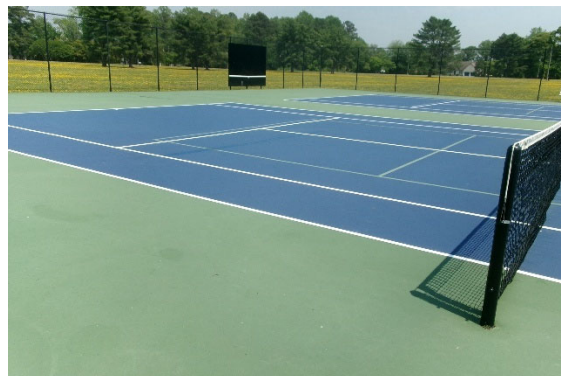
8. Tennis Courts. The Association has maintained the tennis courts in very good condition. We have utilized the quantities, aging, and cost information provided by the Association for these components.

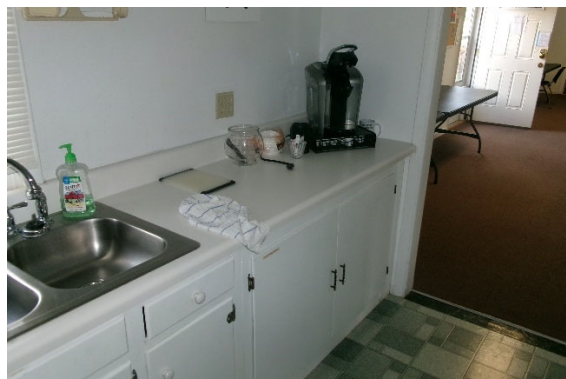
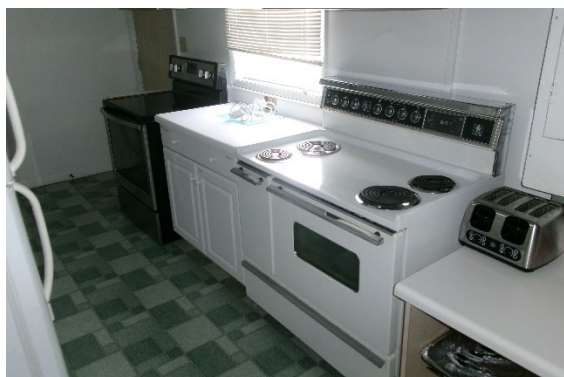
9. Clubhouse. The Association maintains a clubhouse building that consists of a multipurpose room, a kitchen, an office room, storage areas, and a men's and women's restroom accessible from the swimming pool side of the building. The building is conditioned by a split system central HVAC forced air system. There is an emergency electrical power generator at the building. Other current reserve components included for the Clubhouse include the asphalt roofing, the low-slope membrane roof, the vinyl siding, windows and exterior doors, restroom renovations, two electric water heaters, flooring, interior painting, the septic tank and drainage field, and kitchen renovation.

Note that the horizontal clapboard type vinyl siding at the Clubhouse and Storage Building was observed to be approaching the latter stages of typical useful service life. Particularly at southern elevations, the siding has become very brittle and chalky in appearance. We anticipate that the Association will want to replace the vinyl siding within the next 5 years.

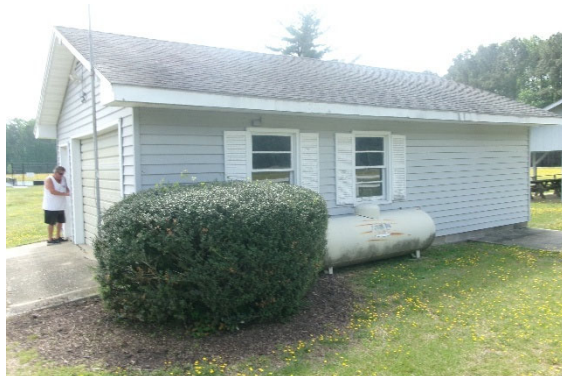
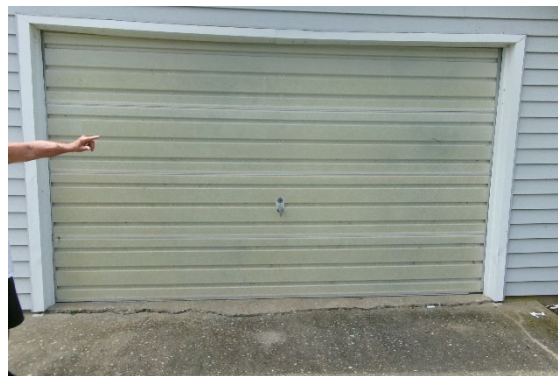
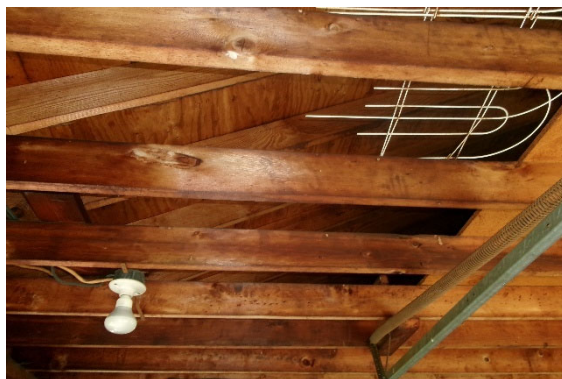
10. Storage Shed / Garage. The Association maintains a Storage Shed / Garage building near the Clubhouse. The storage building is equipped with windows and a fiberglass garage-type door.

Current reserve component items for the storage building include the asphalt shingle roofing, pedestrian and vehicle garage doors, and vinyl siding.

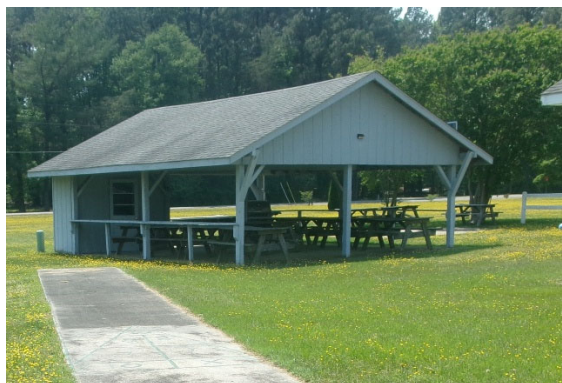
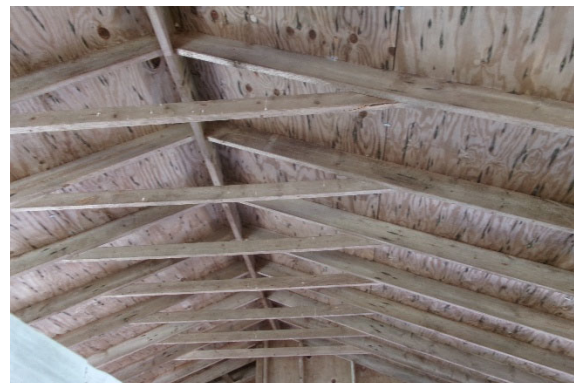
11. Picnic Pavilion / Shelter. The Association also maintains a Picnic Shelter, or 'Pavilion' structure, which consists of a wood framed open sided and steep asphalt-shingled roof. There is a small storage closet integrated into the back of the structure. Reserve components include the shingle roofing.

Please note that we did observe a structural concern at the Picnic Pavilion, where at least two (2) of the main horizontal wood beams appear to be pulling away from their wood column supports. This capital reserve study does not include detailed engineering structural inspections of the building structures. Blue Ridge Reserves recommends that a licensed professional structural engineer (PE) inspect the apparently separating beam conditions as soon as possible.

This analysis assumes that the Picnic Pavilion furniture and grilling equipment will be replaced as needed using other funds, as was indicated by the reserve component quantity data provided by the Association. Partial replacements of the concrete floor slab, and the small amount of wood siding have not been funded due to the costs estimated at less than \$2,000. Future update studies should consider adding these components to the reserve schedule.

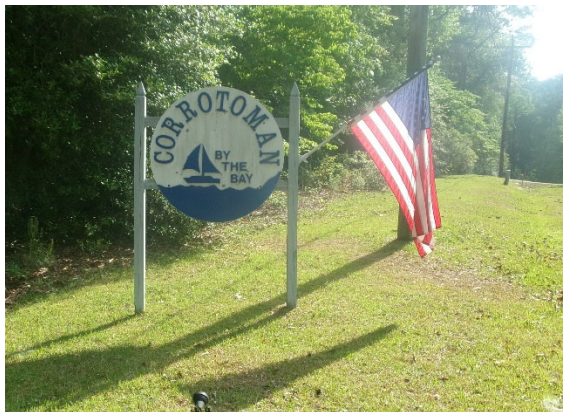
12. Community Sign. We have added a component line item for the eventual replacement of the community sign located on Corrotoman Drive before entering the main community. It is generally considered industry standard to include reserves for community identification signage, as this keeps the community looking fresh and well-maintained.

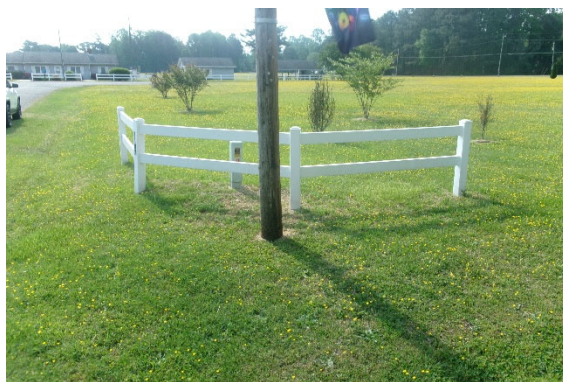
13. Fence. The Association maintains approximately 272 linear feet of white, two-rail, vinyl fence, with sections located at the main entrance to the Clubhouse, and between the Clubhouse parking lot and the front yard area. This type of fence will typically provide service life for some 35 to 40 years. The Association may wish to consider protecting the post bases from damage by lawn trimming equipment by spraying herbicide or installing metal shielding at the post bases.

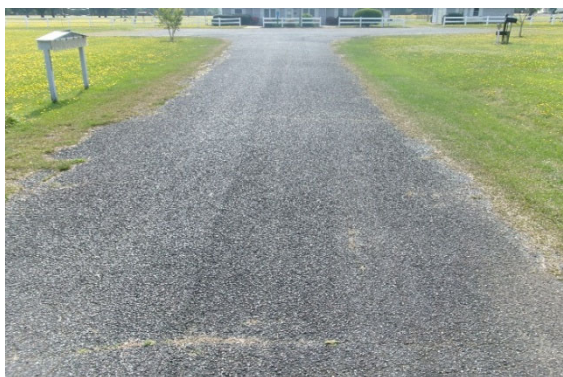
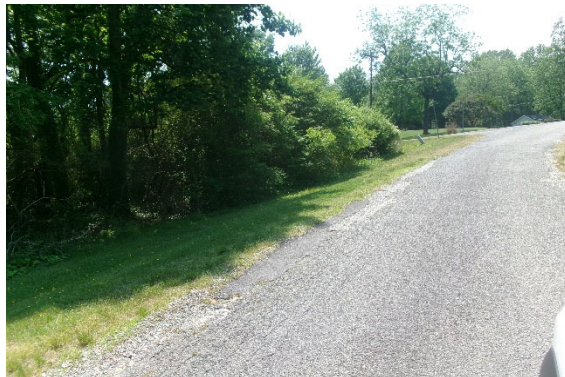
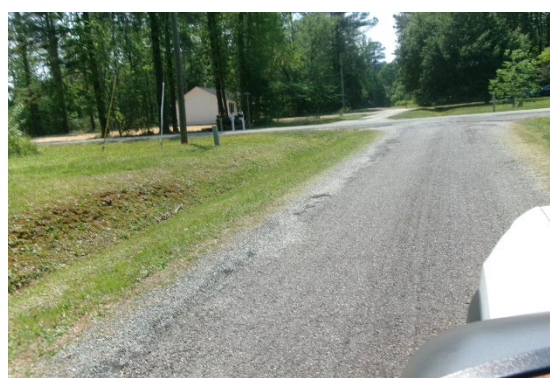
14. Asphalt Roadways and Parking Areas. The Association is responsible for six (6) different sections of asphalt paved roadway and parking area, comprising approximately 10,678 square yards, including Dock Road up to the gravel parking area at the marina, the Corrotoman Extension Road beyond the Bayview Drive loop, Cove Lane, East Highview Drive, Landsend East, and the entrance drive and parking lot at the Clubhouse. Quantities are based on measurements provided by the Association and have been converted to square yards for industry standard unit pricing.

With the exceptions of East Highview Drive and Landsend East, where we observed loss of pavement edge, patching, and alligator cracking, the asphalt pavements were observed to be in heavily weathered but fair and stable condition. Many sections of the existing asphalt roadways appeared to be a culmination of many years of 'chip and tar' applications which, after several applications, have formed a pavement structure. In general, the asphalt pavements appeared to be in fair to good condition for the community's age, with approximately 5% or less showing 'alligator' type cracking. Alligator cracking is a symptom of the pavement structure losing its structural integrity and indicates that these sections of road will likely need to be cut out or at least milled down prior to repaving.

We have estimated that the Association will want to resurface East Highview and Landsend East within the next 2 to 3 years, with the remainder of the asphalt pavements within approximately 7 years. The typical useful service life for asphalt pavement like this, with relatively light, residential usage, is generally considered to be 18 to 20 years. Based on our observations during our site visit we have used 24 years as a typical useful life (TUL).

The unit pricing used for resurfacing the asphalt pavements is based on approximately 5% of the total area being structurally patch by either local milling or excavation, and then a two-inch overlay of new compacted hot mix asphalt pavement installed. Because there are no curbs, gutters, or street sidewalks to maintain a vertical reveal on, there is no need to mill down the entire road surface. Milling and paving is generally about 1/3 higher cost compared to a simple overlay.

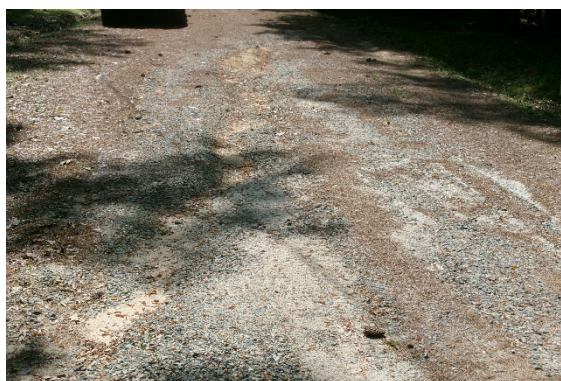
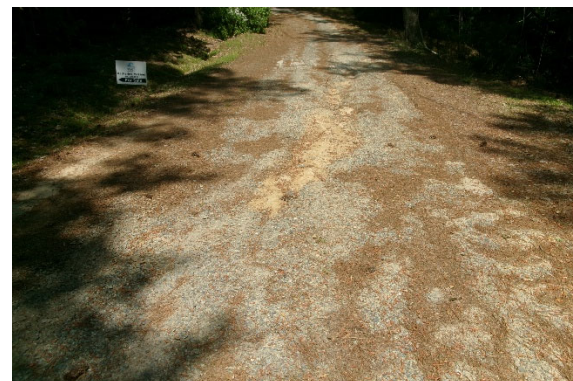
15. Gravel Roadways and Parking Areas. The Association also maintains approximately 25,958 square yards of gravel roadways located throughout the community, including Pine Place, Club View Drive, Landsend West, Ridge Road, Sutherland Street, Wishing Well Lane, Tiny Place, Windward Lane, Senior Creek Place, Middle Road, Evergreen Drive, Sandy Lane, Meadowview Drive, West Highview Drive, Forest Lane, the end of Dock Road, parking area at the dock, Landsend East, and Cove Lane. Again, quantities are based on measurements provided by the Association and have been converted to square yards for industry standard unit pricing. With the exception of less than a half-dozen small potholes developing at locations such as the entrance to Club View Drive, and a few wash-out eroded areas, we observed the vast majority of the gravel roads to be in stable relatively well-maintained condition during our site visit.

We understand that the Association typically needs to spend funds on localized power grading and replenishment of gravel operations every one or two years. How much to fund to repair potholes, repair local grading, and replenish the gravel surface is very much a 'best business decision' by the governing Board and depends largely on the preferences and tolerances of the community regarding aesthetic and ride comfort considerations. At some level the roads need to be maintained to repair occasional washouts and to maintain some level of erosion control and stabilization for the road structure. This analysis assumes that the gravel

roadways and parking areas will be inspected by the Association at least once a year, likely after winter snowplow operations if any, and spot grading and replenishment operations conducted as needed.

Based on a recent history of expenditure records provided for our review, we have preliminarily included funding for gravel replenishment and local grade repairs at a rate of approximately \$48,000 every 5 years, or roughly \$9,600 per year, or approximately \$1.85 per square yard every 5 years. The estimated funding requirement for the gravel roads is based on 5-year average projected costs for repairing local grading or washout issues and replenishment of gravel where needed. The lump sum amount does not necessarily need to be spent on Year 5, 10, 15, and so on, but the estimated annual funding requirement is based on 5-year average projected costs.
