**EVALUATING THE INSTALLATION AND PERFORMANCE OF MANUALLY  
DRILLED WELLS IN NORTH-EASTERN MADAGASCAR**

A REPORT

In Environmental Engineering

MICHIGAN TECHNOLOGICAL UNIVERSITY  
2013

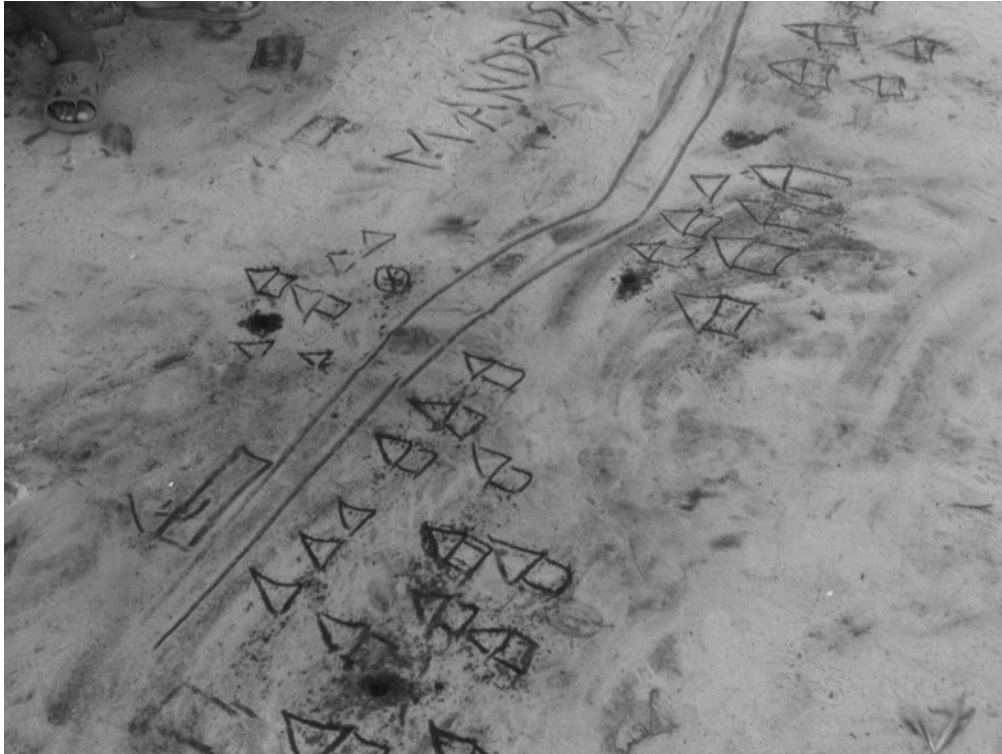
Figure 2. Rudimentary mapping exercise to discern layout of village before further investigation and selection of drill sites. Photo by author.

An estimated number of pumps per village was chosen during the desk study based on available population data. The number of wells was based on a 10-year design life and a 3% population growth rate. A mapping exercise was used to distribute this number of wells appropriately around the village, taking into consideration the distance between and surrounding users homes, possible pollution vectors and technical considerations (Figure 2). According to criteria, each site should be:

- at least 30 m from pollution source (latrine, contaminated hand-dug wells, trash pit, animal pen, river or pond, stagnant water);
- facilitate adequate drainage;
- less than 200 m from user homes to increase ownership and cut walking distance;
- at least 100 – 200 m between each well;
- equally dispersed throughout the village;
- at least 10 m from the road.

After the mapping exercise, the team then walked through the village to discuss the actual location with landholders and users. Once a site was selected, a document was written up with the landholder and GPS coordinates were recorded. BushProof would come later and drill a test well at this location.

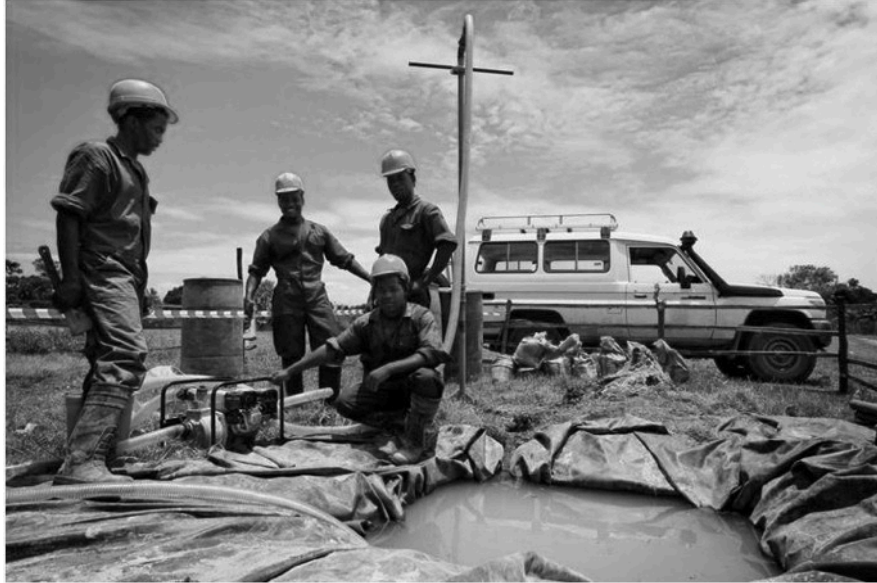
BushProof employed permanent and temporary drillers. Teams were made up of one *chef d'équipe*, or drill team leader, two assistant drillers and usually one part-time locally hired assistant (Figure 3). Most *chef d'équipe* have been with BushProof for more than two years and have considerable experience drilling throughout Madagascar. Seven drill teams were deployed for this project, as well as two masonry teams (consisting of two masons per team). Madrill teams drilled the wells, installed casings, developed and pumped the wells, and disinfected them. The masons constructed the sanitary slabs and installed fences.

Figure 3. Madrill team with equipment preparing to drill. Photo by author

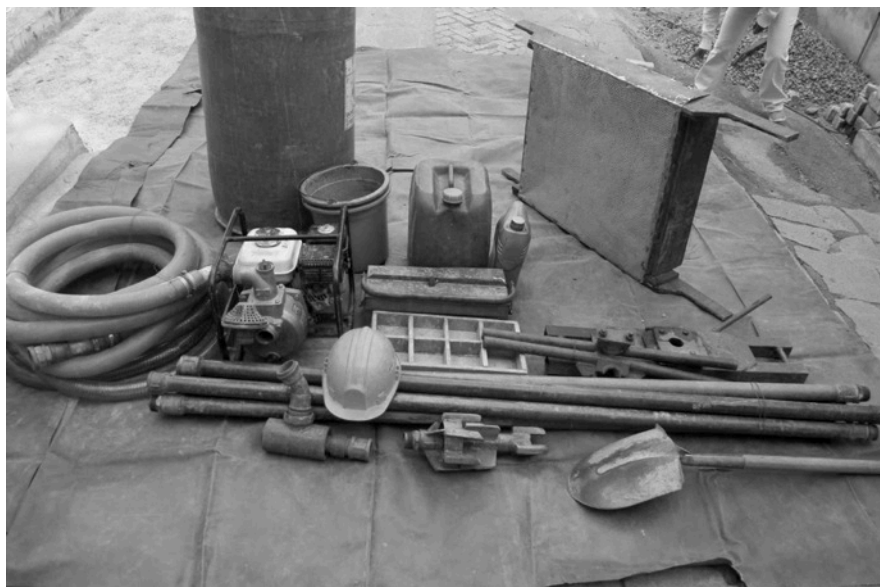
A complete list of materials used for Madrill can be found in Appendix 2 at the end of the report. Madrill equipment has a weight of roughly 250 kg (~550 lbs) and a cost of about 2000 USD (material costs alone). Figure 4 shows the approximate volume of the materials.

Figure 4. Complete Madrill kit. Photo by author

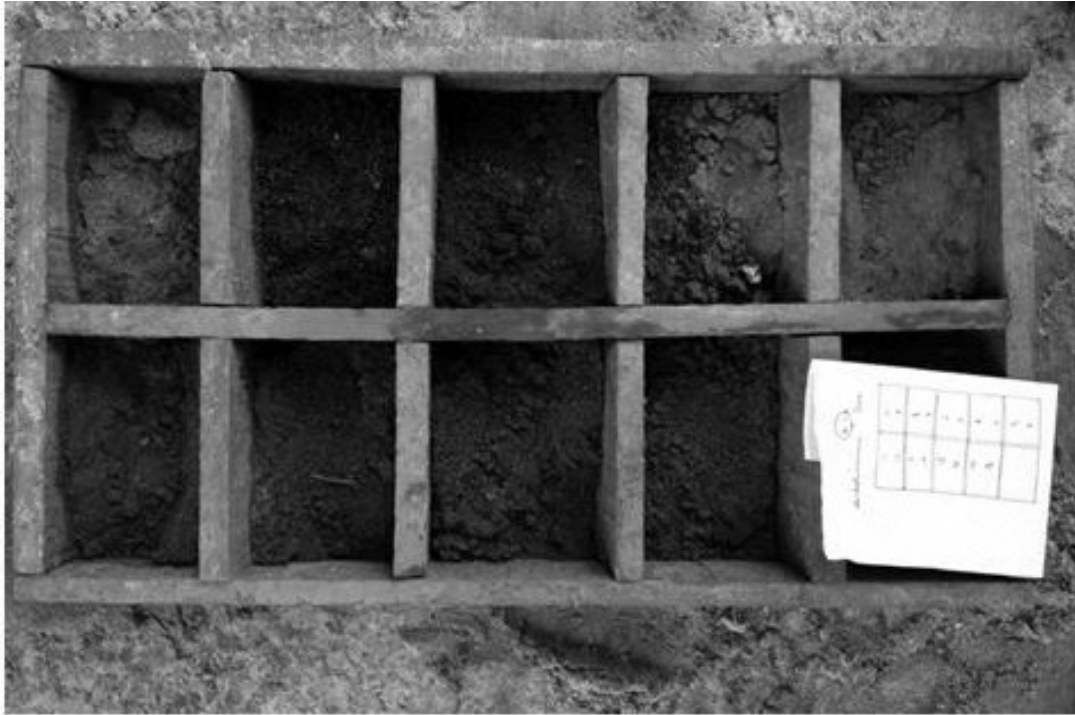
A 150 mm hole is drilled in this fashion until a promising aquifer material is observed in the soil samples (usually large grain sand). Samples were taken every meter drilled by observing and collecting the material settled out of the drill slurry. Each sample is stored

in a sample box (Figure 6) so that a rough profile of the formation characteristics can be observed.

Figure 6. Madrill sample box used for collecting soil samples from the drill slurry. Photo by author

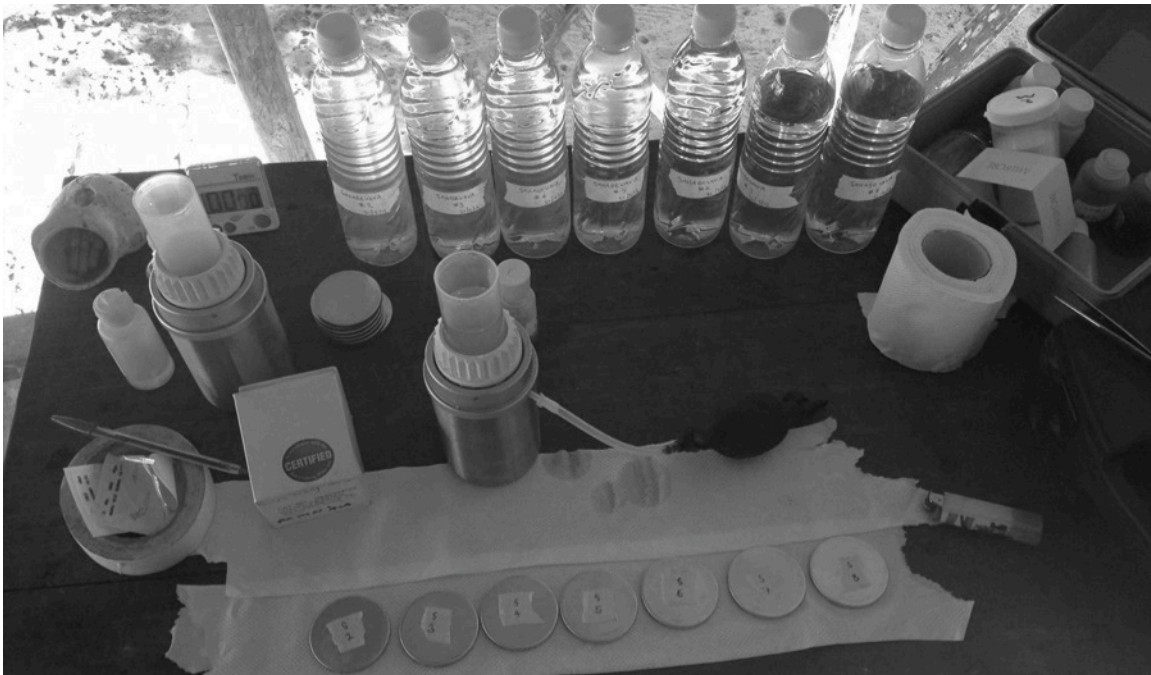
- TTC - membrane filtration (Delagua);
- Turbidity - turbidity tube (Delagua);
- Conductivity, pH and TDS - digital meter (Hanna Instruments);
- Arsenic - VisuPAS system (Palintest);
- Nitrate and Nitrite – color comparator (Palintest);
- Iron and Manganese–color comparator (Palintest);
- Chlorine residual – Pool tester and DPD1 reagent (Delagua).

Figure 8. Bacteriological testing using membrane filtration. Photo by author

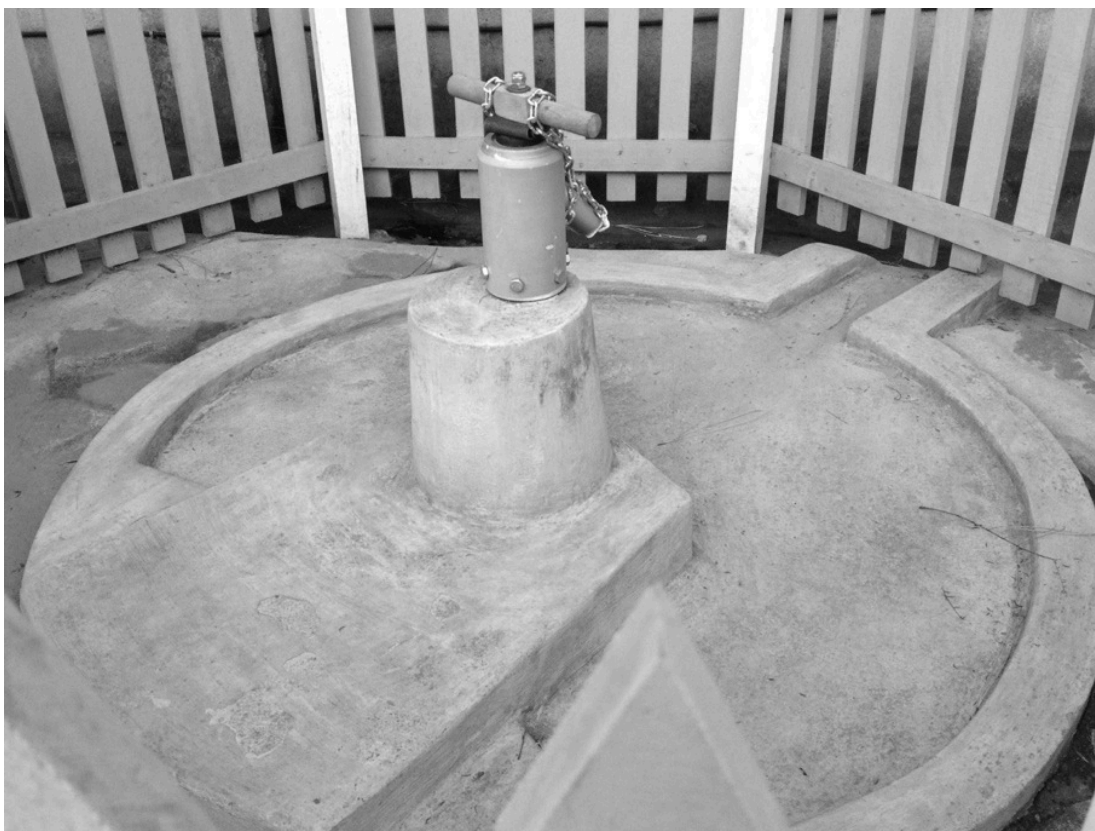
If water quality and quantity were deemed acceptable, the sanitary slab was installed. Figure 9 shows the slab, which includes a 1.5 meter diameter apron, drainage canal of 2 meters, pump support and foot pedestal. At the end of the drainage canal, a simple soak pit was installed by filling a 50 x 50 x 50 cm hole with large gravel. A new Canzee pump is then installed and a circular fence is constructed around the sanitary slab.

Figure 9. Completed well with Canzee, apron and drainage (note: the chain seen in the photo was not used on project pumps). Photo by author

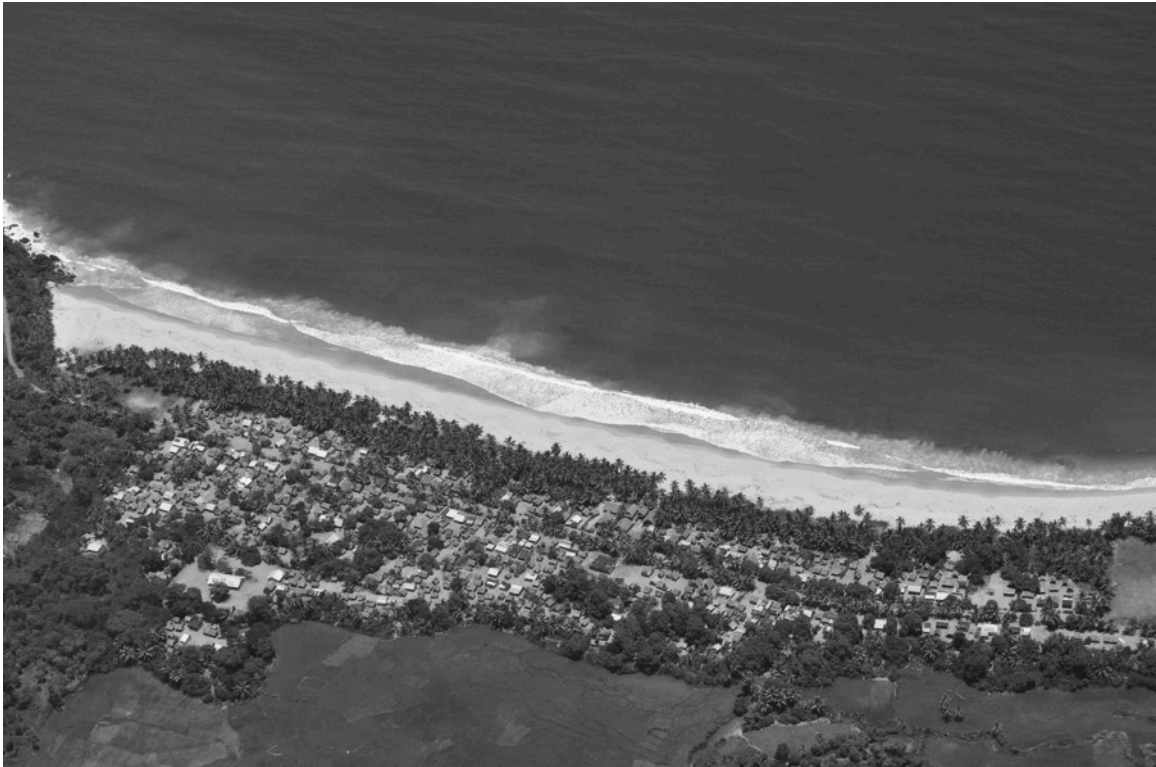
Figure 14. The village of Sahasoa. The village runs parallel to the coast for a distance of about 1.2 kilometers. At the widest point, it is only about 200m. The road is about 50m from the beach and runs through the length of the village. Photo by author

Boreholes were also sited according to distances from user homes and pollution sources. This was very difficult in villages where pit latrines were common, as the goal was to site boreholes close to homes but greater than 30 meters from latrines. Coastal villages were particularly difficult because the villages run lengthwise north to south on both sides of the main road, as seen in the example of Sahaso (Figure 14). In this village latrines were mainly on the beaches to the west, but also within the cluster of houses in the middle and at higher elevations to the east, where the terrain slopes up towards the mountains towards the north of the village. Unfortunately, again due to poor planning between project partners, little was being done to coordinate water supply activities with sanitation

activities. Villagers were being encouraged to use and increase the number of latrines at the same time new boreholes were being implemented. Problems were also encountered with animal pens (pig and cow) and distances from irrigated rice fields. While deeper borehole depths would be ideal in these circumstances to reduce risk of bacteriological pollution, the risk of saltwater intrusion was also an issue. Finding the right balance was a formidable task.

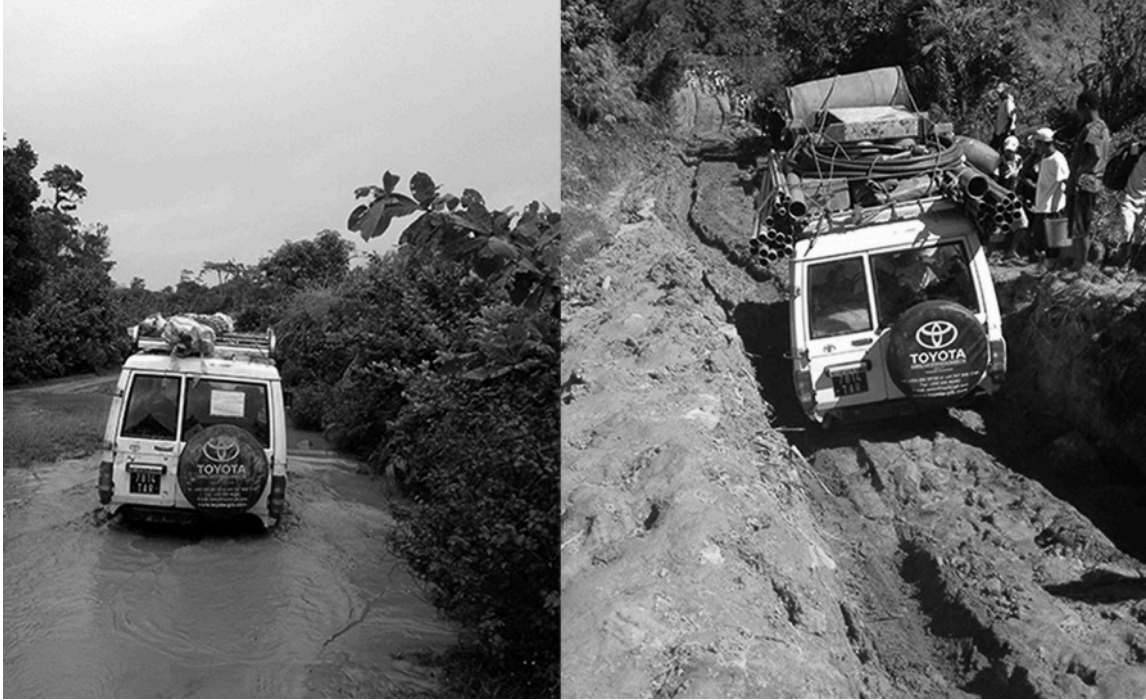
Figure 15. Road conditions caused constant logistical challenges. The BushProof vehicle was often inundated by floodwaters or stuck in mud for hours. Photo by author

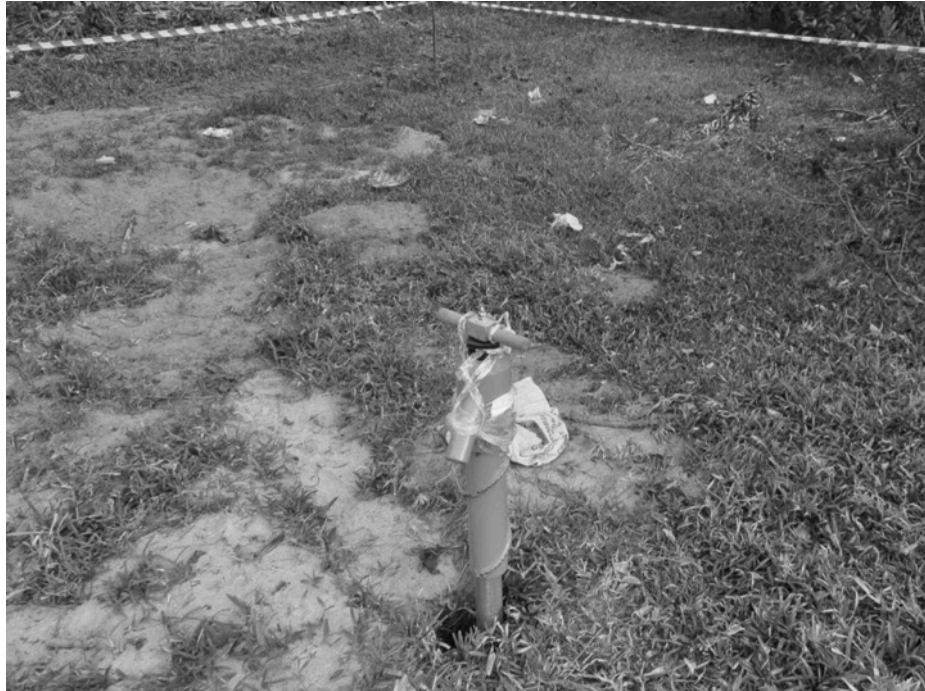
Figure 18. Borehole casing with Canzee pump ready for preliminary testing. Photo by author
