# THE MODEL T FORD ITS REPAIR, SERVICE, AND RESTORATION

## An Unexpected Tour Repair

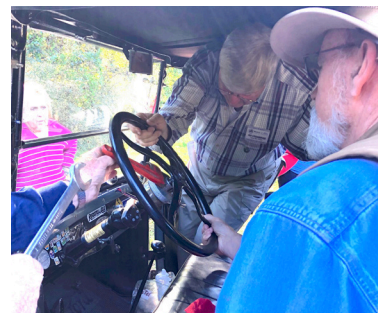
Able bodied helpers pulling and wrenching that stuck cover off!

With considerable help from fellow Model T'ers, we persuaded the steering case cover, with the pinion stuck tight, to come off the case with a lot of effort, a heavy pipe wrench, and jawed pliers! We removed the steering wheel nut, turned the front wheel to full travel, and while holding the steering wheel spider tight, twisted the cover around until it was free. The pinion shaft was still bound tight to the cover.

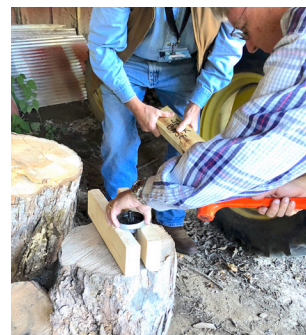
Wood 2x4's for base and soft hammer blows to no avail

I tried to do a field repair with support from other willing tour helpers, but we could not separate the pinion shaft from the cover while using a makeshift wood support and soft blow hammer. So, unable to continue the tour, my wife, Julia, and I were left behind to wait for the rollback tow truck to return the disabled T back to the hotel. Oh, the sadness and disappointment of realizing my error.

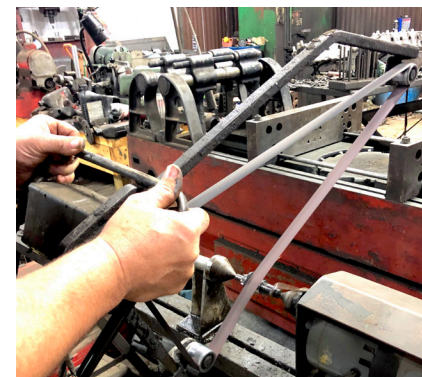
Burnishing pinion shaft with polishing cloth strip on lathe

The next morning, a local engine repair shop just five miles away provided the necessary tools and assistance. Shane, the shop proprietor, took pity on me and pushed that stuck pinion shaft out of the cover using a 20-ton press. It was stuck solid! Examination of the shaft showed a lot of galling and roughness, so with a quick spin between centers and using a crocus cloth strap, he burnished the shaft back to a usable condition. The steering case cover bushing was also too rough, but a travel back and forth in Shane's hands on a turning spindle reamer machine made the cover usable again.

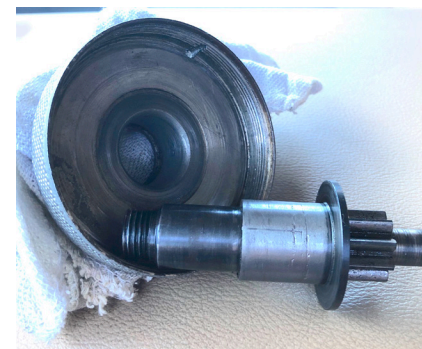
Re-worked steering case cover and steering pinion shaft

In retrospect, the cause of this problem was fitting that replacement cover without ensuring that the parts were clean enough, or that adequate lubrication was applied. For any moving parts on the T, oil and grease are the most important preventive measures and remedies you need to abate problems while touring!

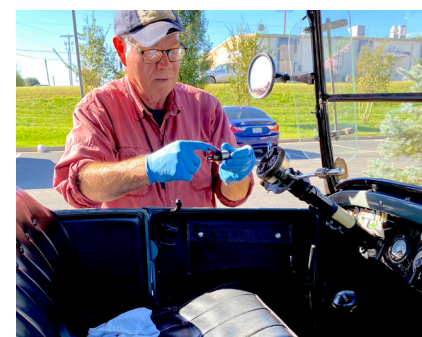
Installing pinion shaft into cluster, with lots of grease on shaft and cluster gears

Back at the hotel, we buttered up the case with fresh grease, applied a suitable smear to the cover bushing and the steering pinion shaft, replaced the re-worked pieces, and we were under way for that day's tour.

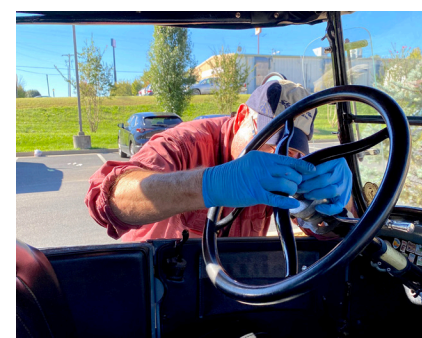
Fitting steering wheel back in place, and ready to go on tour again!

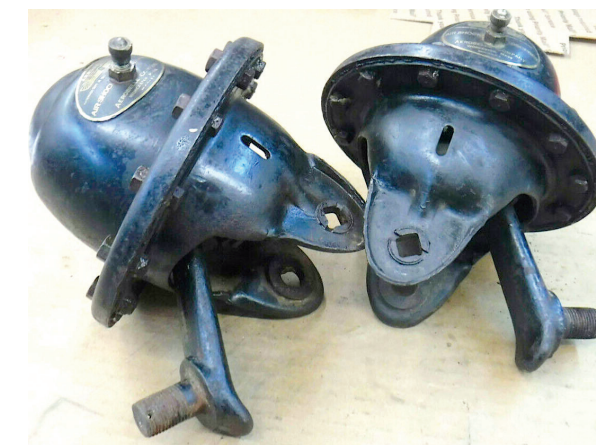
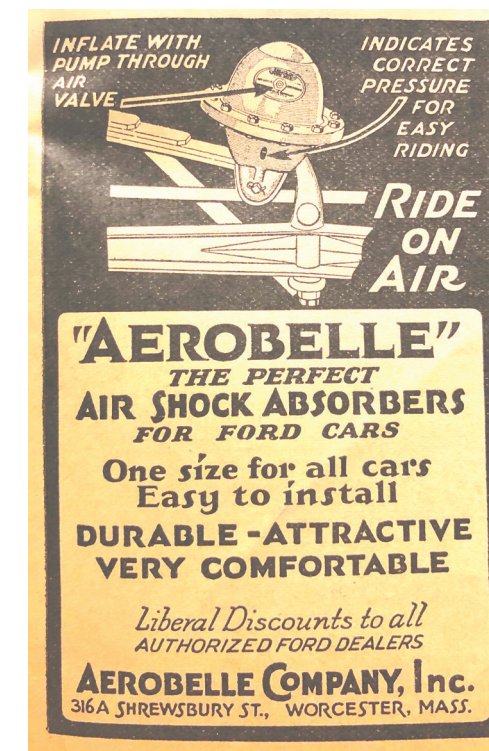
## Aerobelle Air Shock

This unique shock absorber for the Ford has a rubber bladder inside the dome-shaped shock that can be filled with air pressure - 'Ride on Air'!
