# Inspection Report

**Property Address:**  
SAMPLE ADDRESS  
SAMPLE TOWN NY 11111

<b>Date:</b> 3/4/2012	<b>Time:</b> 10:00 AM	<b>Report ID:</b> SAMPLE
<b>Property:</b> SAMPLE ADDRESS SAMPLE TOWN NY 11111	<b>Customer:</b> SAMPLE CUSTOMER	<b>Real Estate Professional:</b>

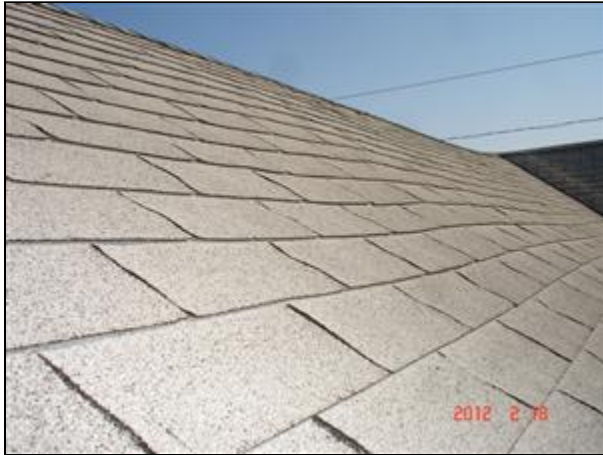
1.1 Item 1(Picture)

(1) Multiple layers noted. Shingles are aging and brittle. The roof covering is beyond the design life. Budget for replacement in the not-too-distant future. When re-roofing, strip existing layers including the original cedar shake and add new plywood sheathing.

(4) Suggest evaluation by a licensed roofing contractor to obtain estimates of repair. I recommend George Parsons Roofing. They can be reached at 516-437-7955.

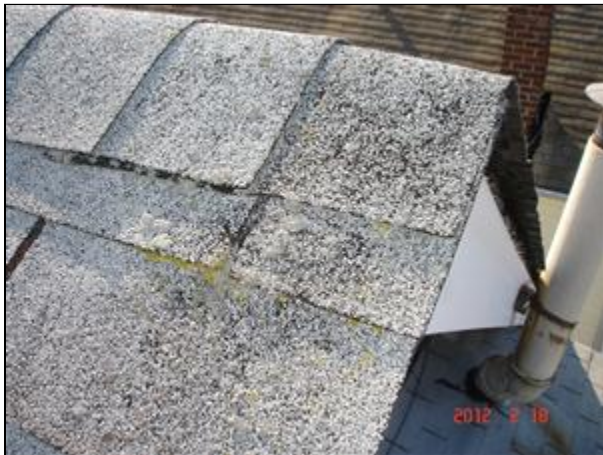
1.1 Item 2(Picture)

(2) Shingles are worn, with granular covering sparse in many areas.

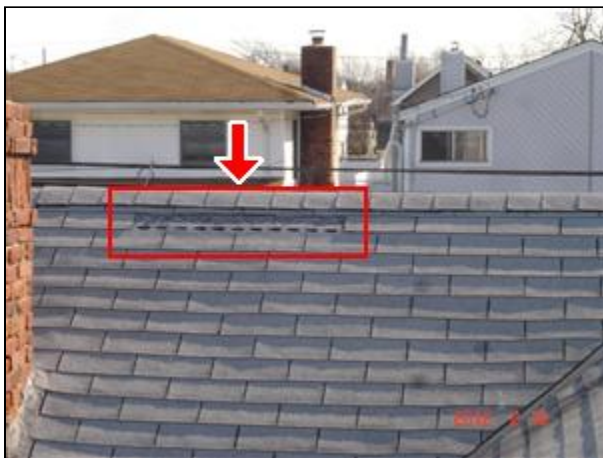
1.1 Item 3(Picture)

(3) Several damaged/broken shingles noted.

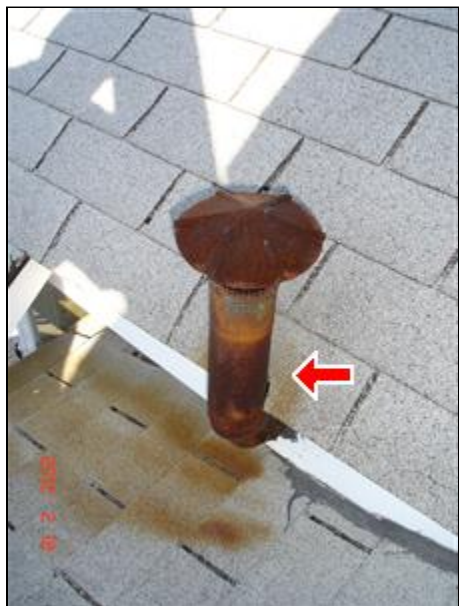
1.3 Item 1(Picture)

(1) Stack is rusting at the rear. Eventual replacement may be needed.

(2) All flashings at vent stacks should be checked periodically or if leakage occurs. Repair or seal as needed.

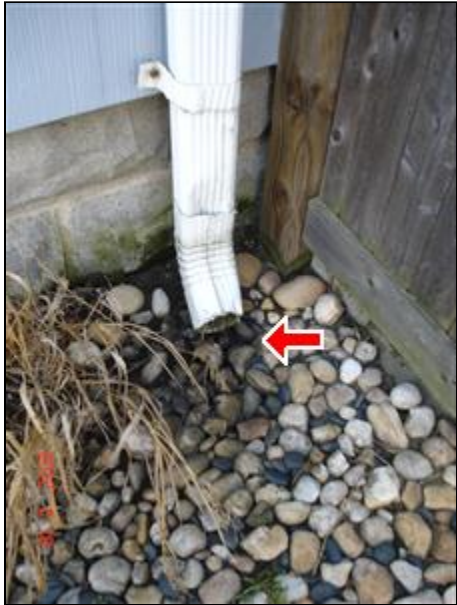
1.6 Item 1(Picture)

Recommend extending downspouts to drain water away from the foundation.

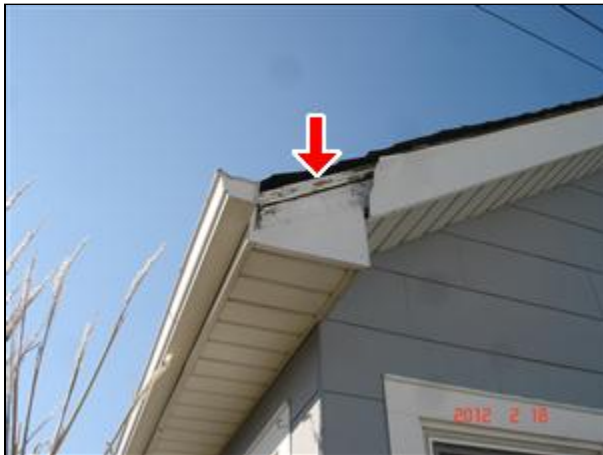
1.7 Item 1(Picture)

(1) Small piece of capping missing from the "pork chop" at the left front corner of house. Repair as needed.

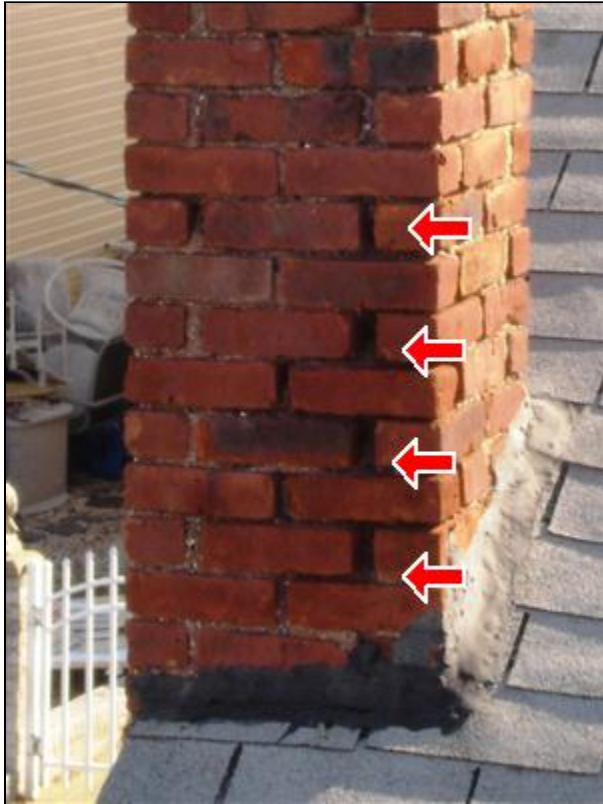
1.8 Item 1(Picture)

Re-pointing (new mortar between bricks) needed, suggest service by a licensed chimney professional.

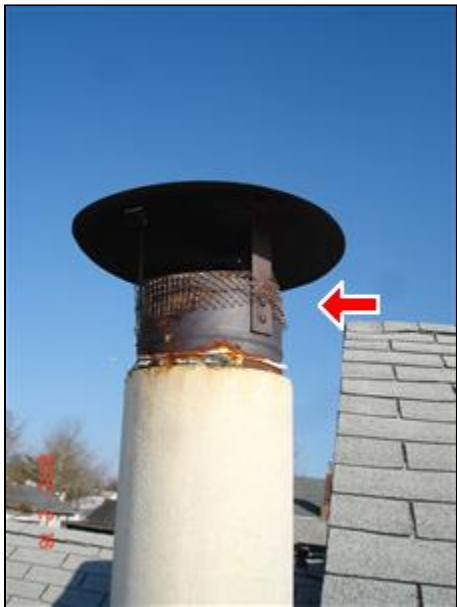
1.10 Item 1(Picture)

(1) Cap is rusting at the heating system chimney. Stainless steel chimney cap should be installed.

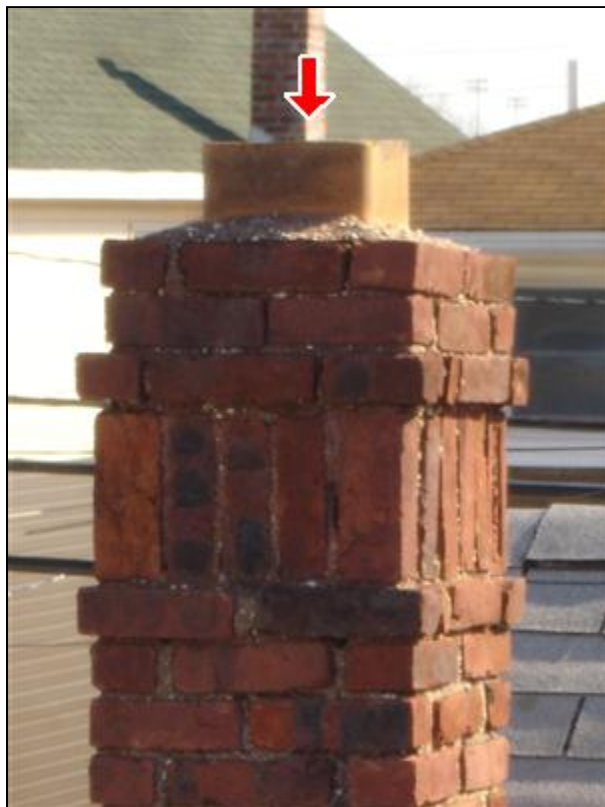
1.10 Item 2(Picture)

(2) No cap noted on the brick chimney. Stainless steel chimney cap should be installed to help preserve the chimney liner, and keep out rain, animals and leaves.

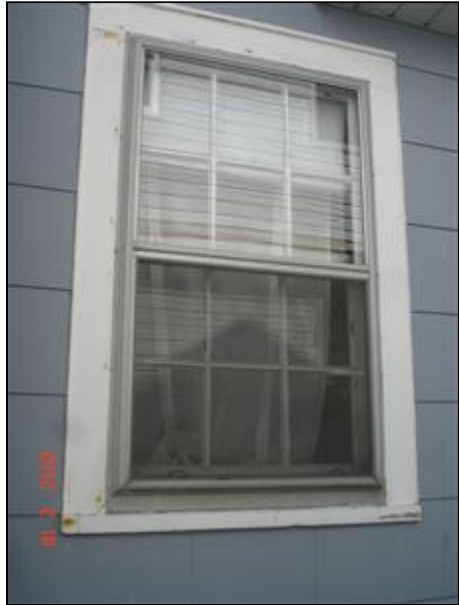
2.2 Item 1(Picture)

(1) Many old wood framed, single pane windows. Flaking paint and deteriorated glazing putty on some, replace or repair as needed. Storm windows are installed, making them fairly energy efficient.

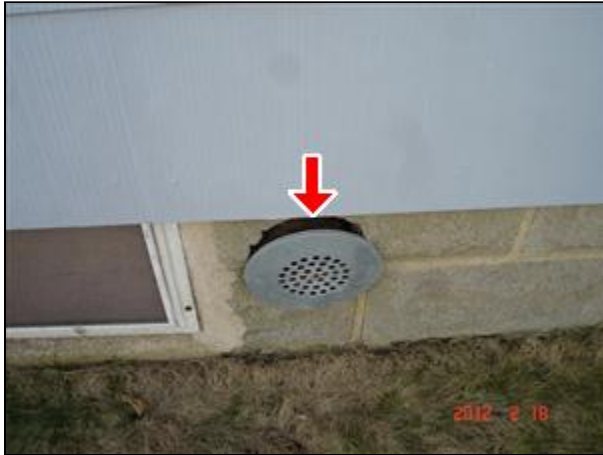
2.7 Item 1(Picture)

Gap noted around vent is a possible entry for rodents and/or insects. Seal as needed.

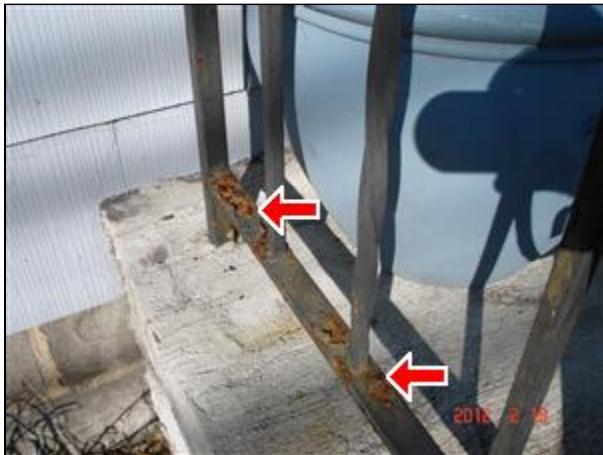
2.8 Item 1(Picture)

Steel railings are rusting. Suggest painting with Rustoleum, or some other rust inhibitor.

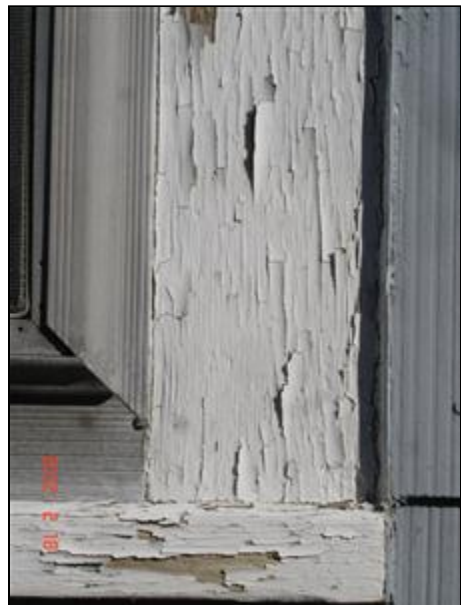
2.9 Item 1(Picture)

Flaking/peeling paint noted. Refinish as needed or cap with aluminum to protect from the weather.

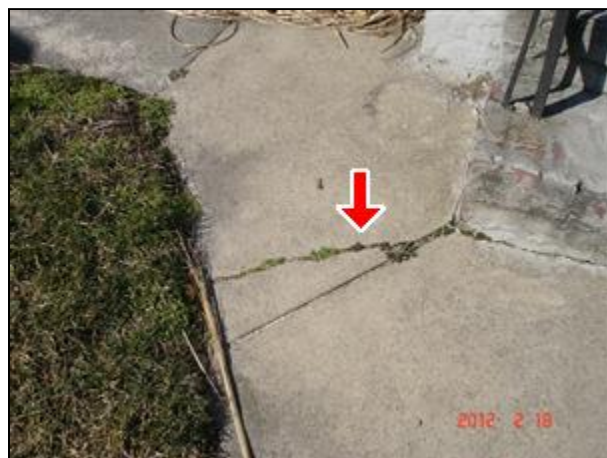
3.0 Item 1(Picture)

Typical cracks and spalling noted at the concrete walkways. Maintain as needed.

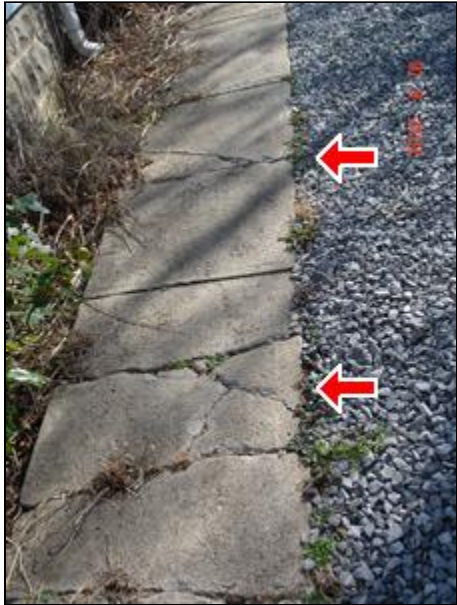
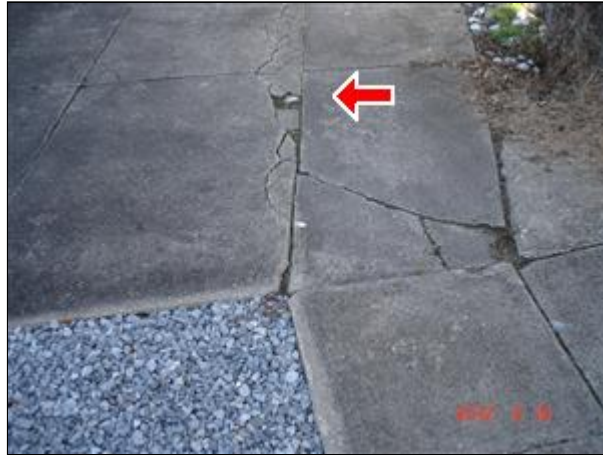
3.1 Item 1(Picture)

Typical cracks and spalling noted at the concrete driveway. Maintain as needed.

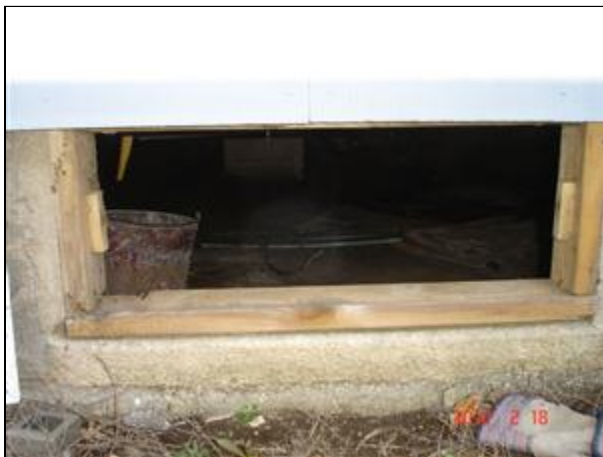
3.3 Item 1(Picture)

(1) The only entrances are the small windows around the foundation. The windows are too small to allow access. See FOUNDATION/CRAWLSPACE section for details.

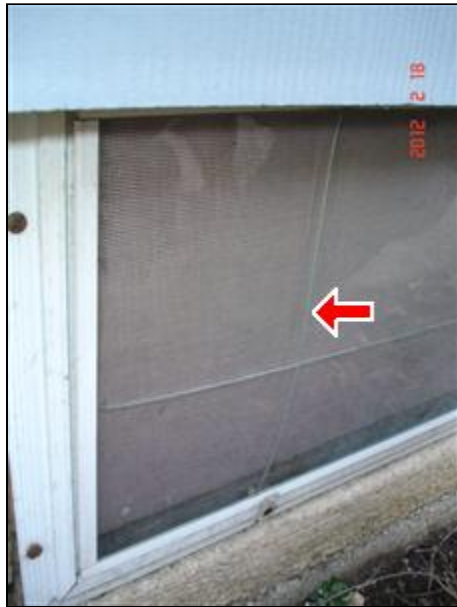
3.3 Item 2(Picture)

(2) Cracked glass noted. Repair as needed.

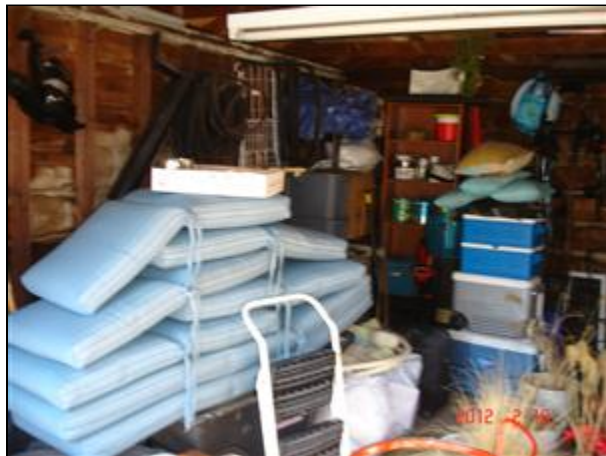
4.0 Item 1(Picture)

Stored items along the outside walls of the garage block full view, and prevent inspection of many areas.

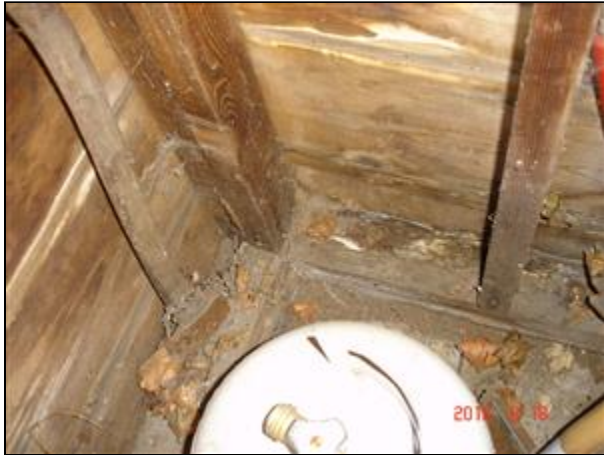
4.2 Item 1(Picture)

Leak stains noted and some decay. Maintain as needed.

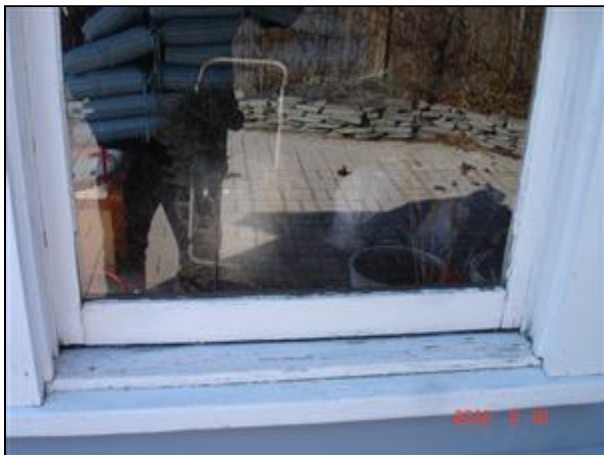
4.5 Item 1(Picture)

Old wooden window with some deteriorating glazing putty. Consider replacement.

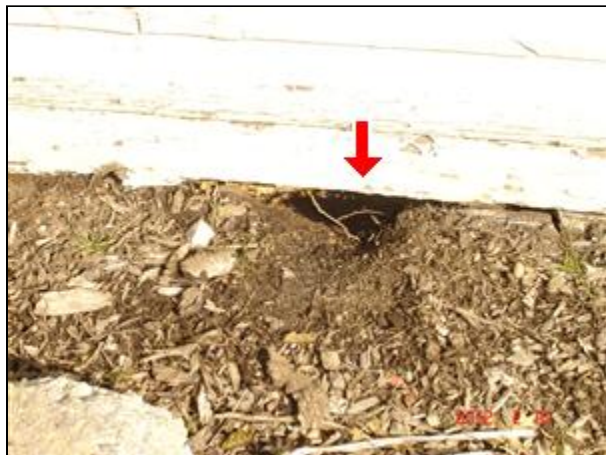
4.6 Item 1(Picture)

(1) Hole in left side has been dug away under the siding. This appears to be an animal entry. Repair as needed.

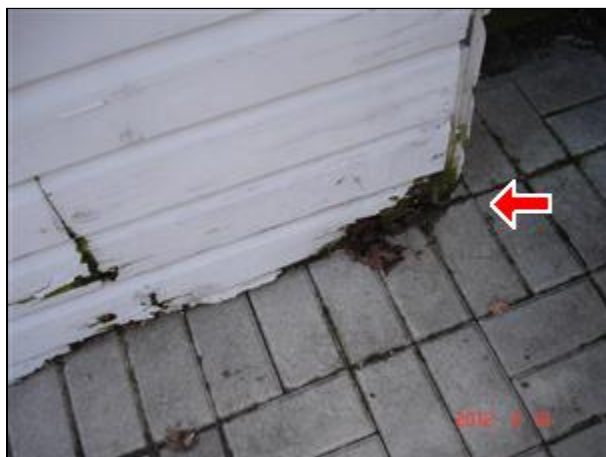
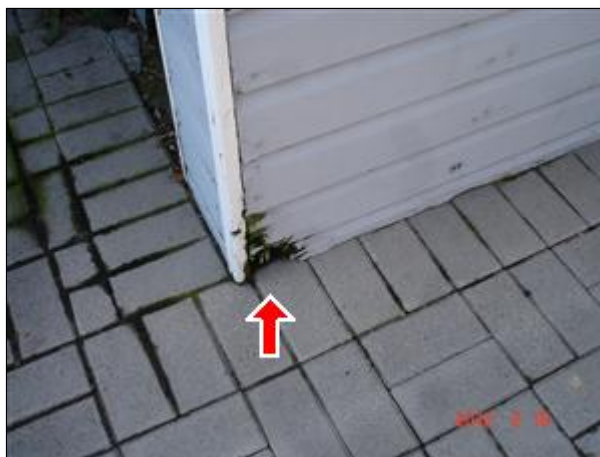
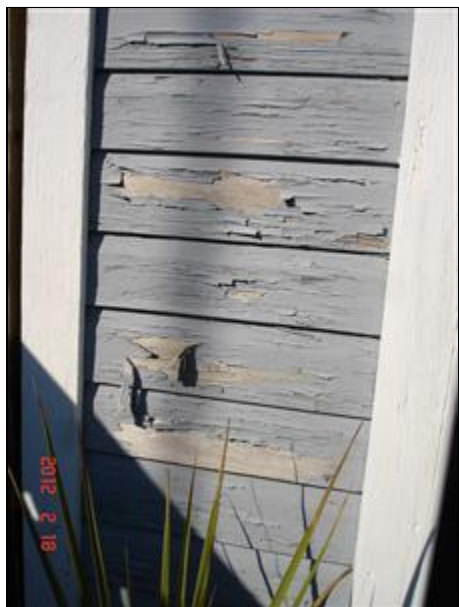
4.6 Item 2(Picture)

(2) Decaying siding in contact with the ground. Flaking/peeling paint. Repair and refinish as needed.

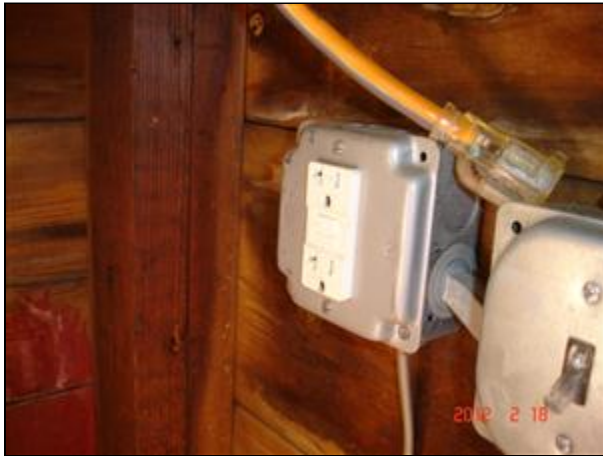
4.7 Item 1(Picture)

GFCI protected receptacles installed already in the garage for added safety.

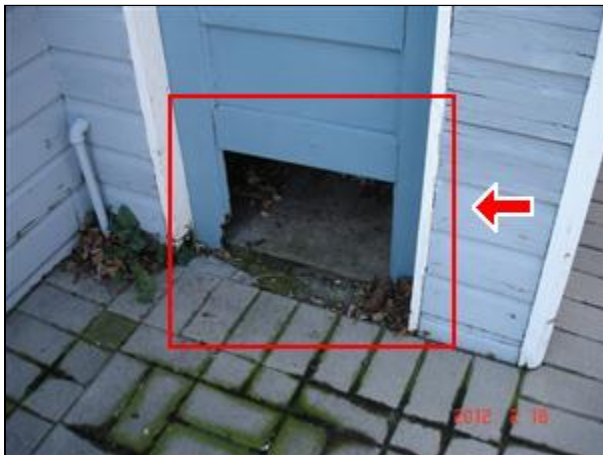
4.8 Item 1(Picture)

Bottom panel missing from old wooden door. Door does not function properly. Consider replacement.

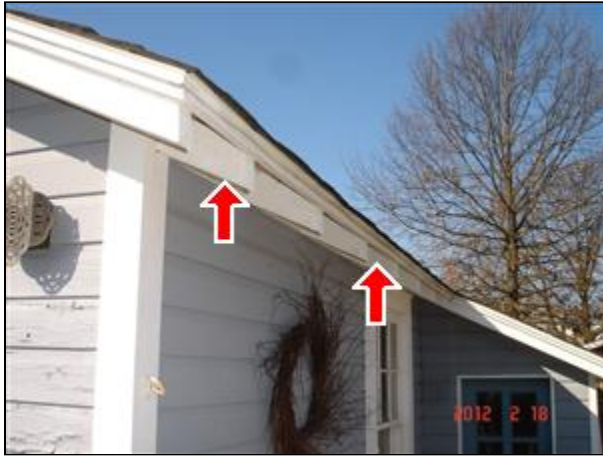
4.9 Item 1(Picture)

No gutters and leaders on garage. Consider adding for better drainage.

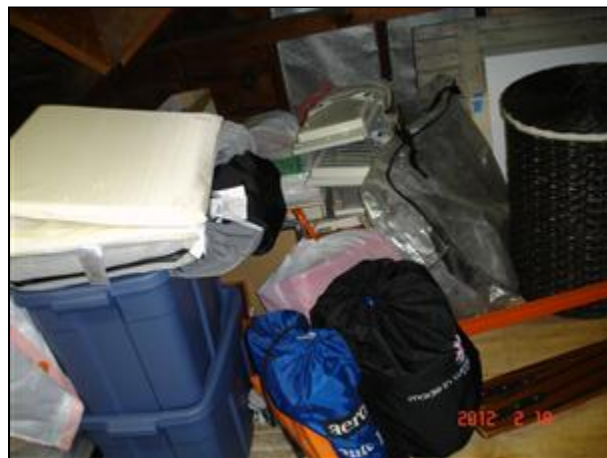
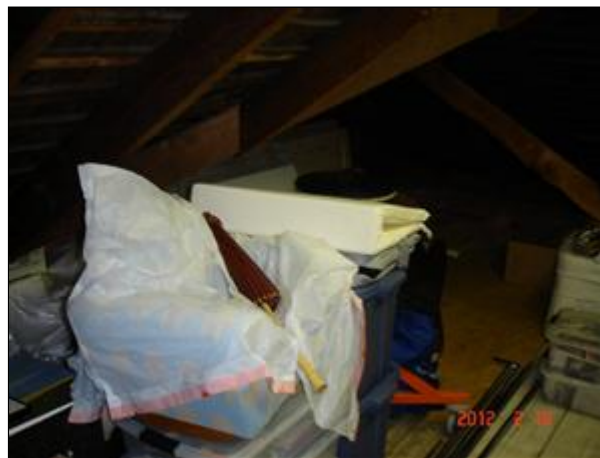
5.0 Item 1(Picture)

Inspection of attic space has many limitations, including but not limited to; insulation over framing, floor boards, stored items and inaccessible areas.

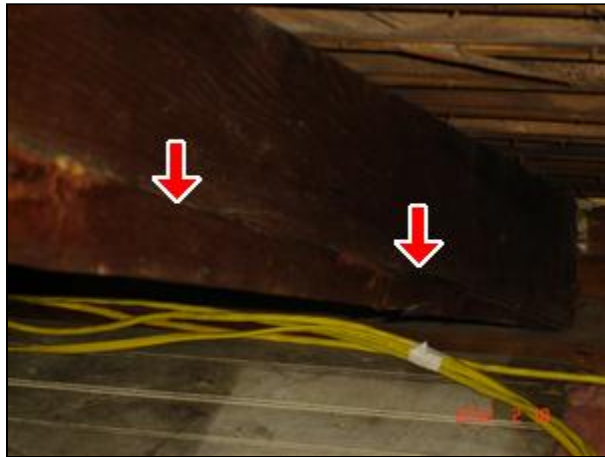
5.1 Item 1(Picture)

Cracked joist noted at right side. Have contractor reinforce joist as needed.

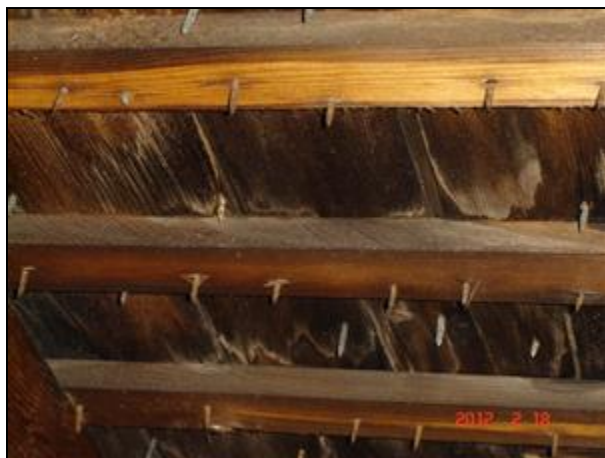
5.2 Item 1(Picture)

Original cedar shake under current layers of roofing. Suggest removal and replacement with plywood sheathing at time of re-roofing.

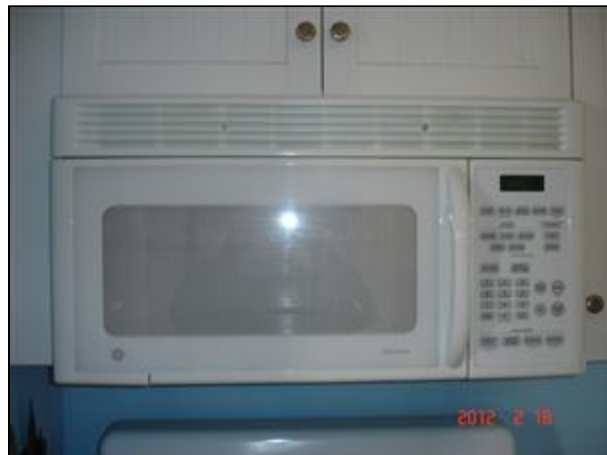
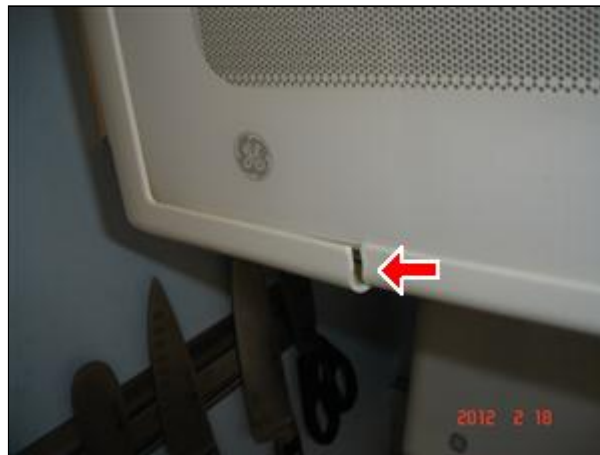
6.8 Item 1(Picture)

Cracked plastic on the microwave. Repair or replace as needed.

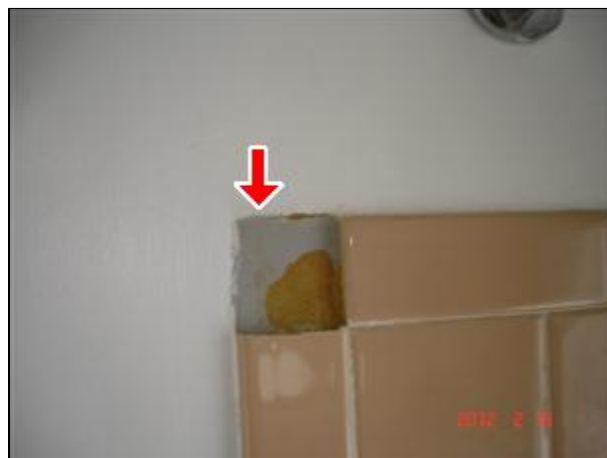
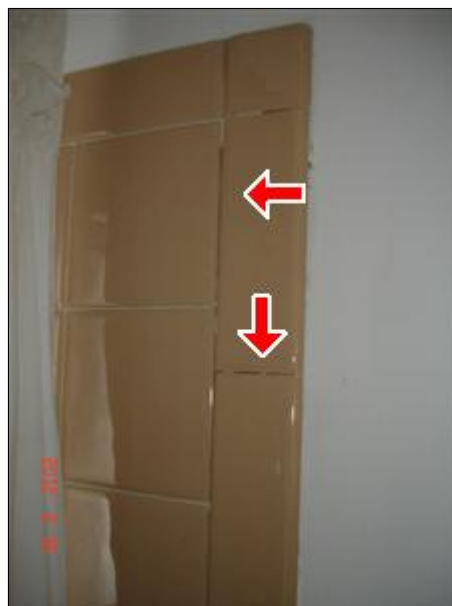
7.5 Item 1(Picture)

One missing tile noted outside the shower area. Grout needs work also outside the shower area. Repair and re-grout as needed.

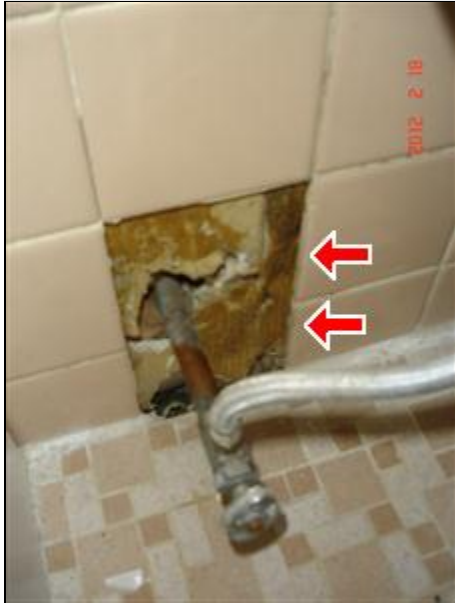
7.9 Item 1(Picture)

Missing tiles behind toilet base. Replace as needed.

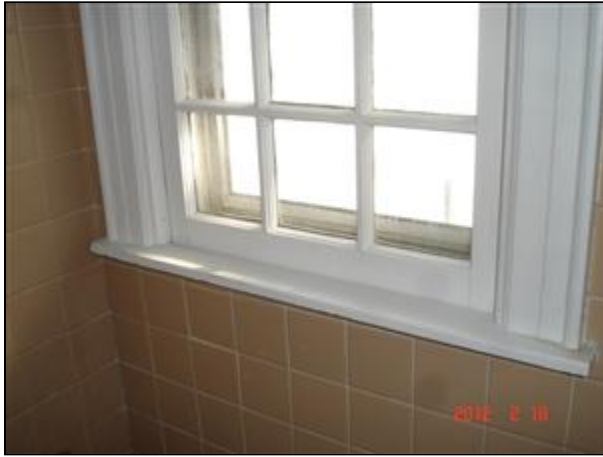
7.10 Item 1(Picture)

(1) Original wood frame, single pane window, consider replacement.

(2) Window in shower. Suggest a plastic curtain be installed and maintained over the window when a window is in the shower area. This is to prevent water from entering around the window frame and causing interior damage to the outside wall.

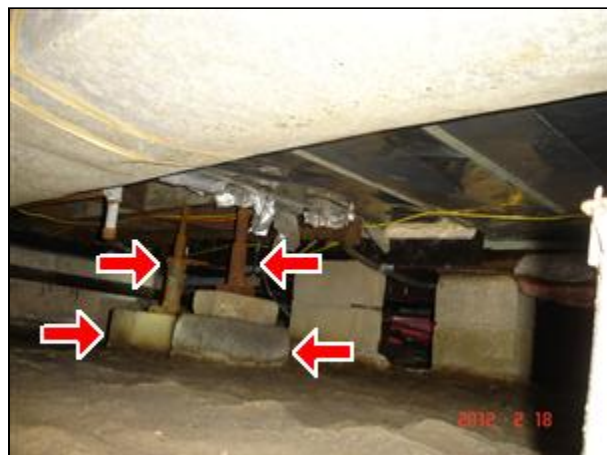
9.4 Item 1(Picture)

Temporary screw jack columns are noted, resting on concrete blocks. These screw jack columns are rusting. Steel lolly columns are recommended as the permanent solution, even though the temporary screw jacks could last many years.

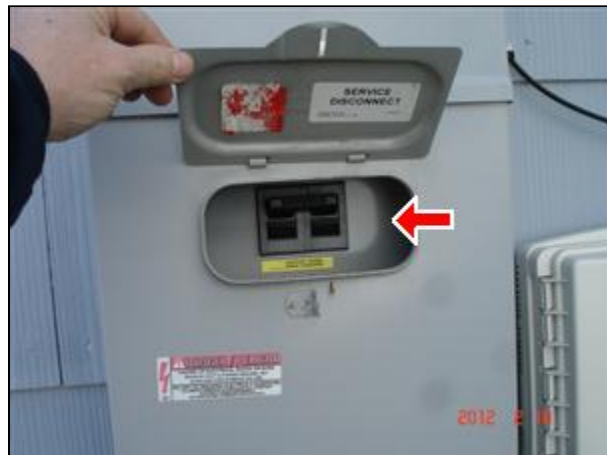
10.1 Item 1(Picture)

Noted, not tested. Located at outside, suggest a lock on the box.

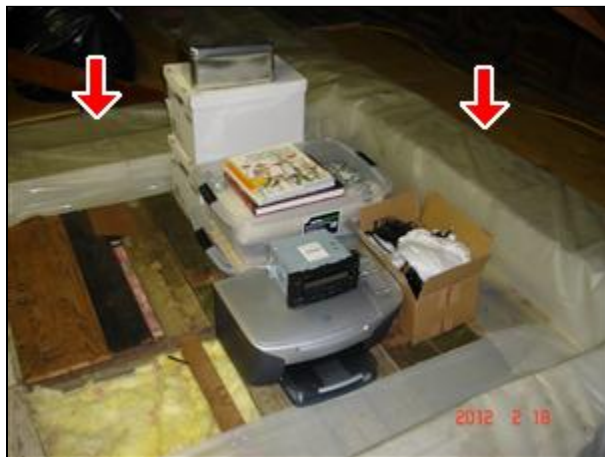
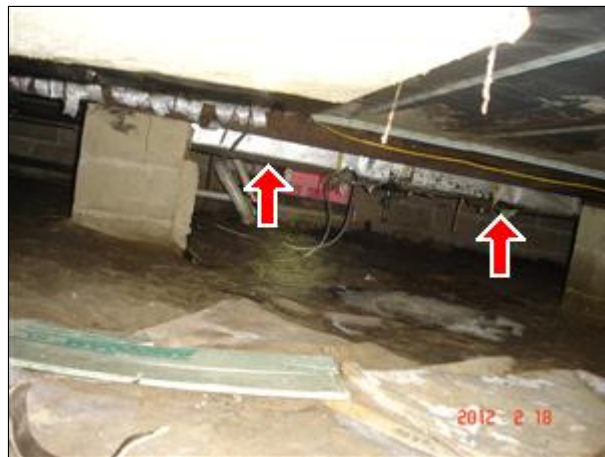
11.9 Item 1(Picture)

Duct insulation in attic and crawlspace may possibly contain asbestos. Not determined. Appears to be in good condition.

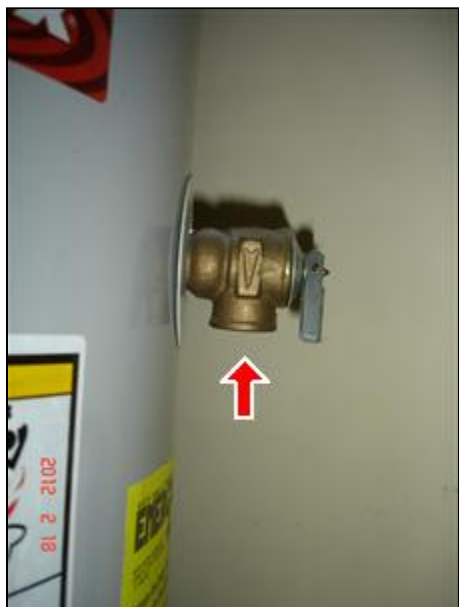
13.4 Item 1(Picture)

Noted, not tested. TPRV on water heater needs a 3/4 threaded pipe to extend within 6 of floor for safety. (PVC pipe may not be used).
