# Seabrook Island HOA

## Level 2 Reserve Study

**Report Period - 1/1/2016 to 12/31/2016**

# Executive Summary - Seabrook Island HOA - ID # 10759

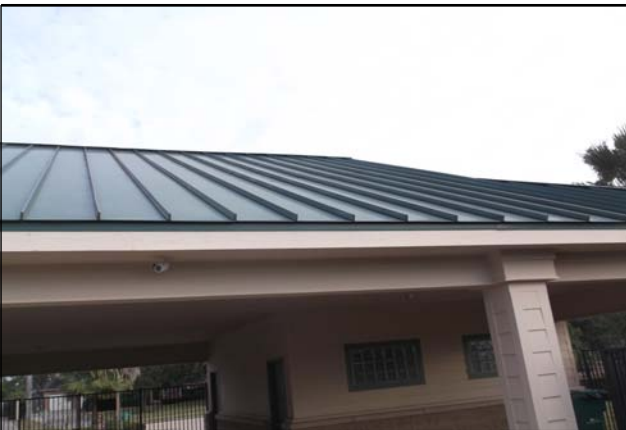
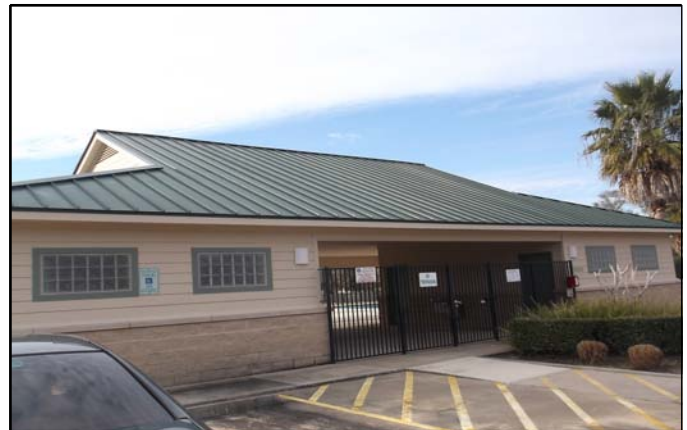
Although this type of roof may experience an extended life we recommend funding to replace it approximately every 30 years. Remaining life based on current age.

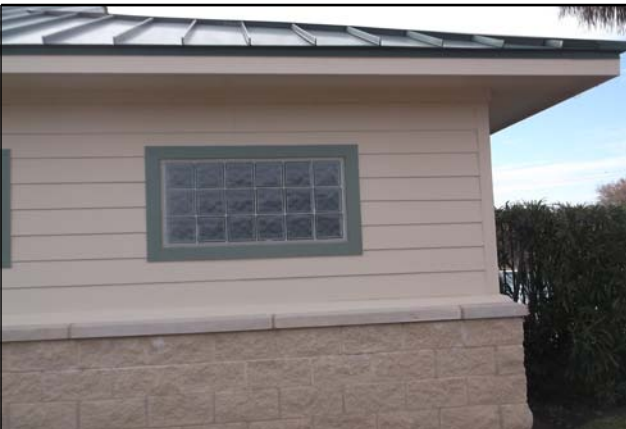
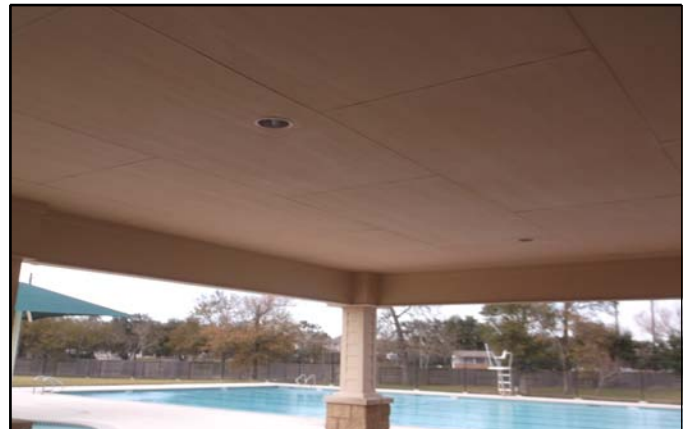
Comp # 201 Pool Building - Repaint

Painted surfaces are good condition. No staining and discoloration noted. Expect to repaint this building approximately every 8 to 10 years to maintain appearance and protect stucco. Remaining life based on current condition.

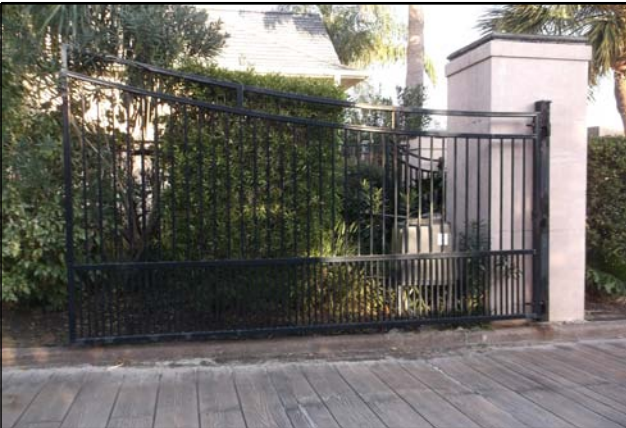
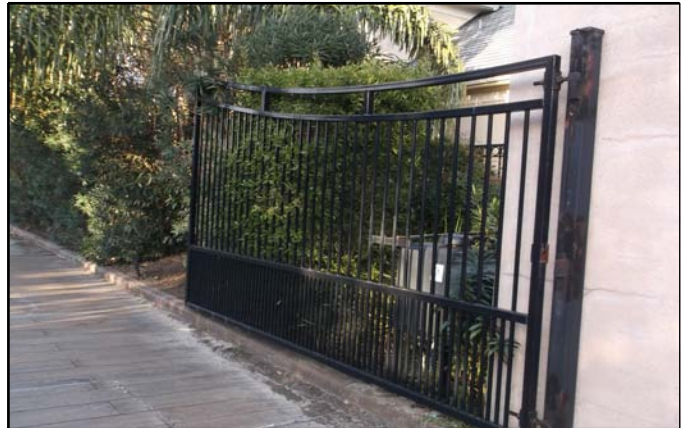
Comp # 206 Vehicle Gates - Repaint

Noted fading and minor surface rust. Due to proximity to the ocean we recommend painting this fencing approximately every 4 years. Repaint this year (FY 2008) based on current condition.

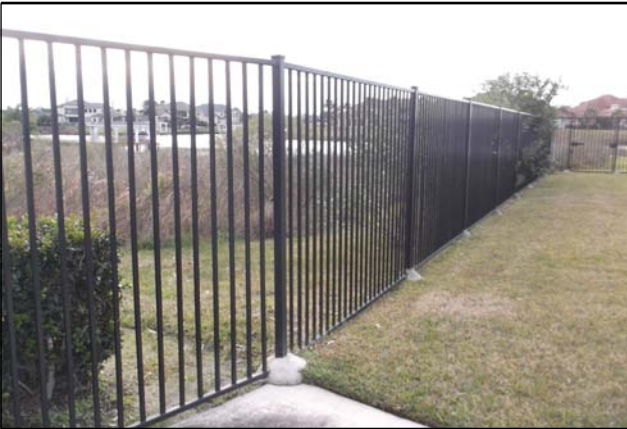
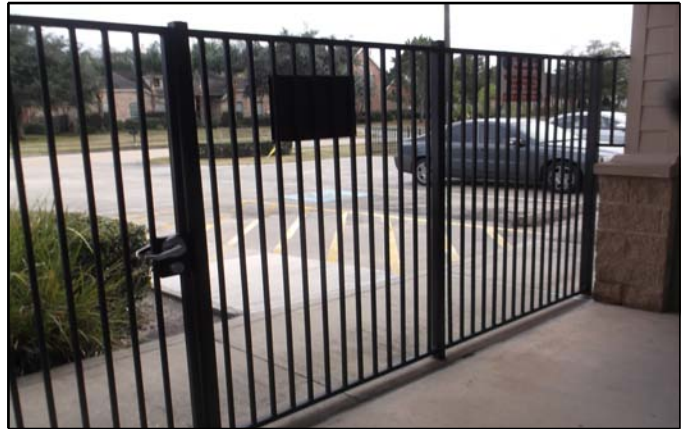
Comp # 207 Wrought Iron Fencing - Repaint

Painted wrought iron surfaces are in good condition, no rusting or paint loss noted. Repaint this component approximately every 5 years to maintain appearance and protect metal surfaces. Remaining life based on current condition.

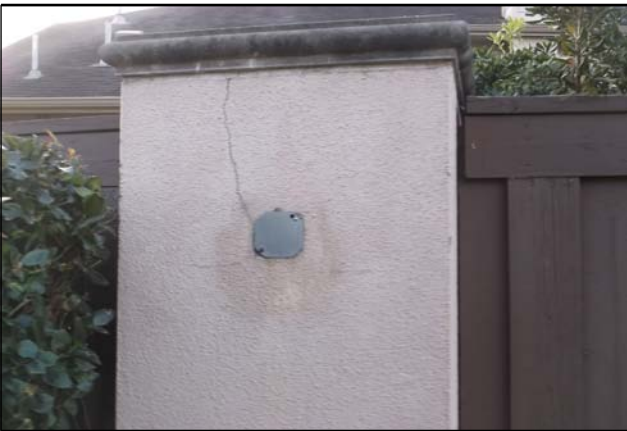
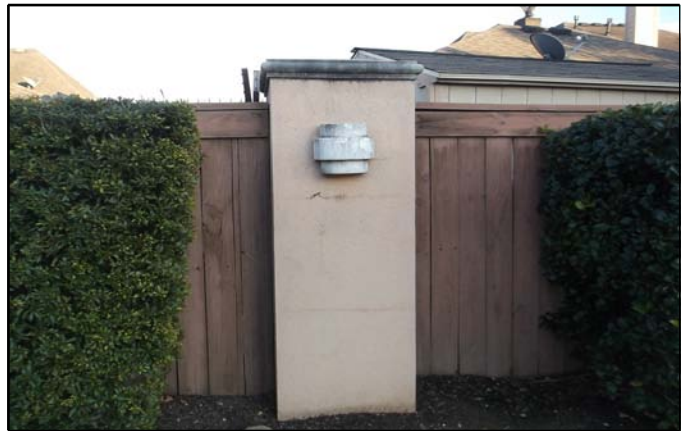
Comp # 208 Stucco Columns - Repaint / Repair

Painted block wall surfaces are generally in good to fair condition. No significant staining or marking noted. These surfaces should be painted approximately every 8 to 10 years to maintain appearance and prevent damage to stucco surface.

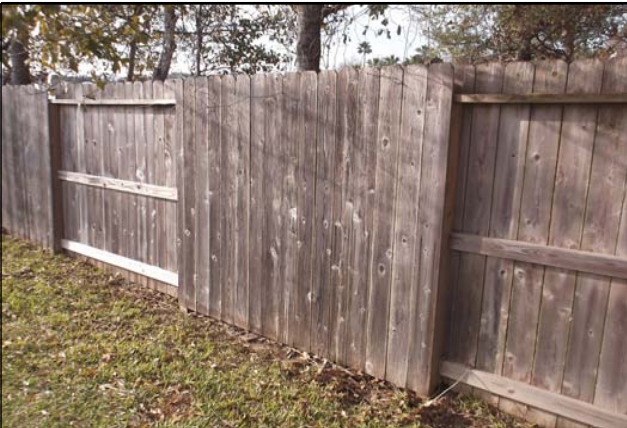
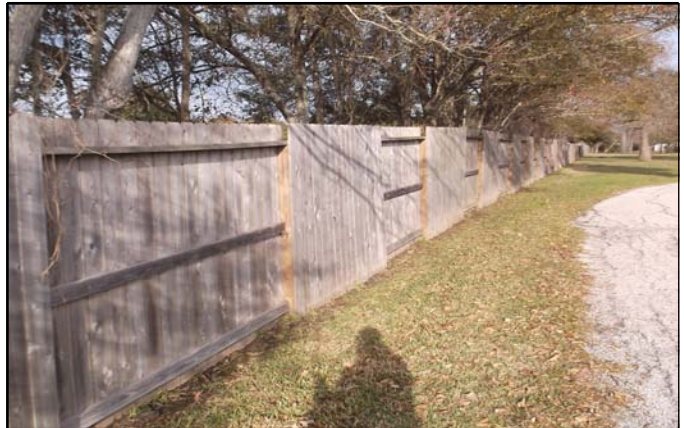
Comp # 209 Wood Fencing - Repaint/Reseal

We recommend resealing this fence approximately 5 years to ensure proper appearance and useful life. Remaining life based on current condition.

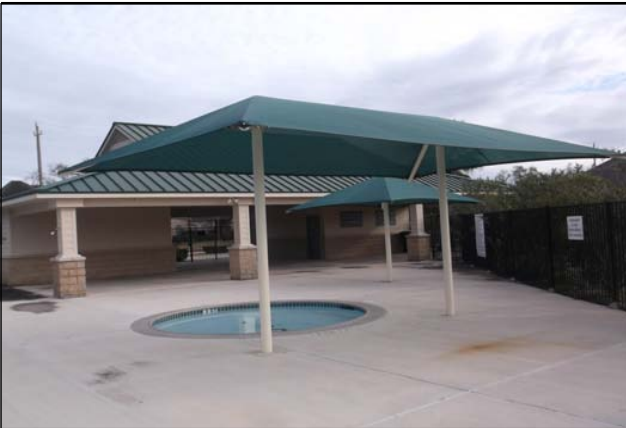
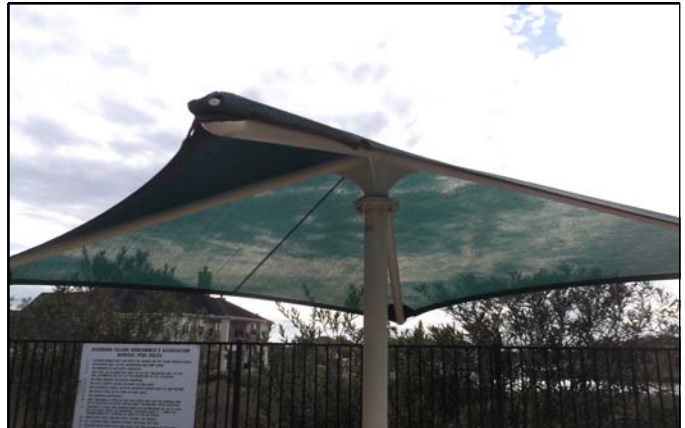
Comp # 212 Shade Structure Poles - Repaint

Client reports that these surfaces were painted in 2015. We recommend funding for a similar project approximately every 3 to 5 years.

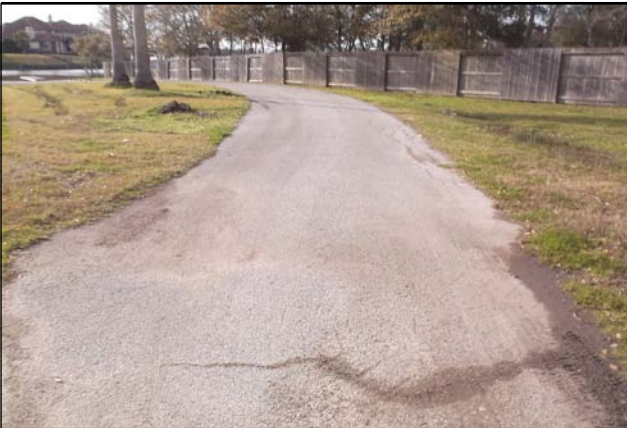
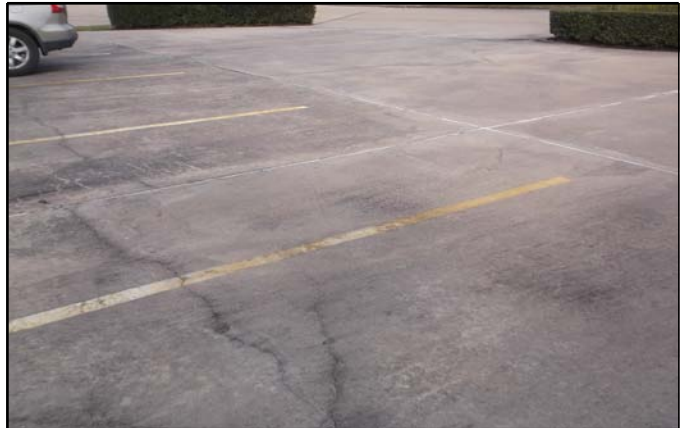
Comp # 401 Asphalt - Major Rehab.

Asphalt surfaces are in good condition.. Seal these surfaces regularly (see Comp# 402 Asphalt - Slurry Seal) to protect surface and ensure full life.

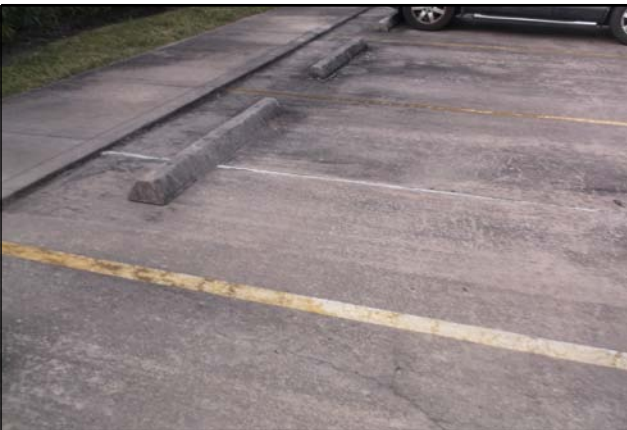
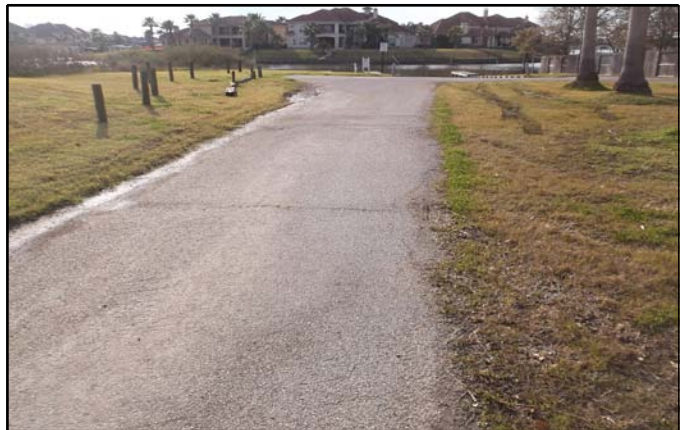
Comp # 402 Asphalt - Seal

Asphalt seal coat is in good to fair condition. No significant seal loss noted. Seal asphalt surfaces regularly to prevent premature overlay (see Comp# 401 Asphalt - Major Rehab). Remaining life based on current condition.

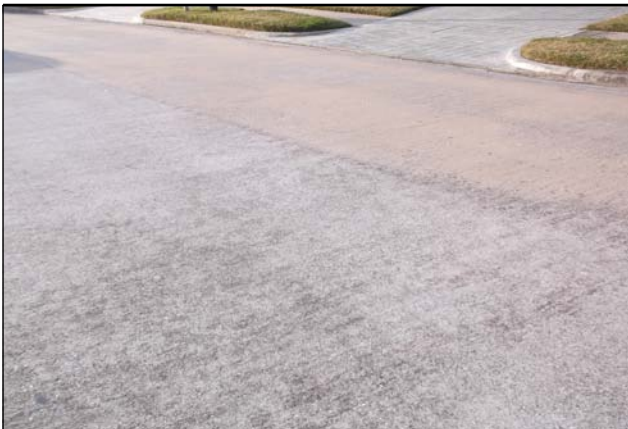
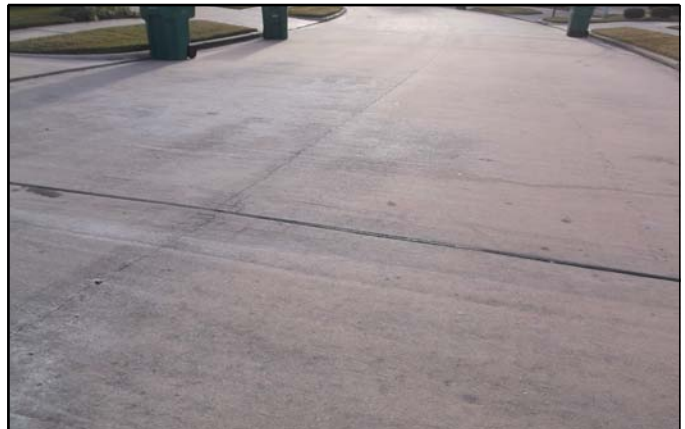
Comp # 403 Concrete - Repair/Replace

Concrete is generally in good condition. No significant cracking or structural problems noted at the time of site visit. No expectation to completely replace the concrete surfaces. We recommend making local repairs as necessary as an operating expense and funding to make more significant repairs approximately every 10 years.

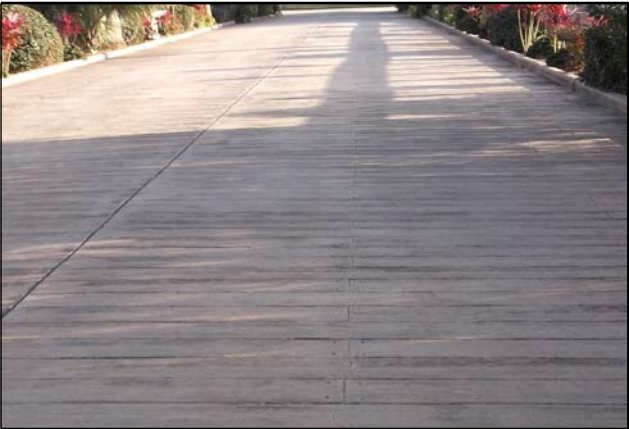
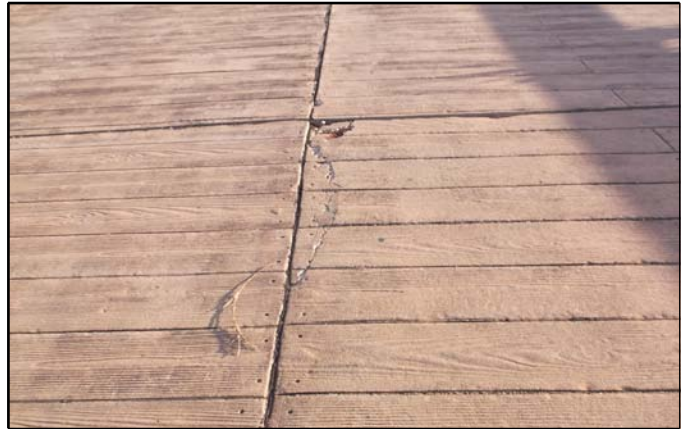
Comp # 404 Bridge - Repair

Wood planks and bridge are generally in good condition. No expectation to completely replace wood surfaces. We are funding to repair and replace damaged areas approximately every 5 years to ensure a full useful life from this component.

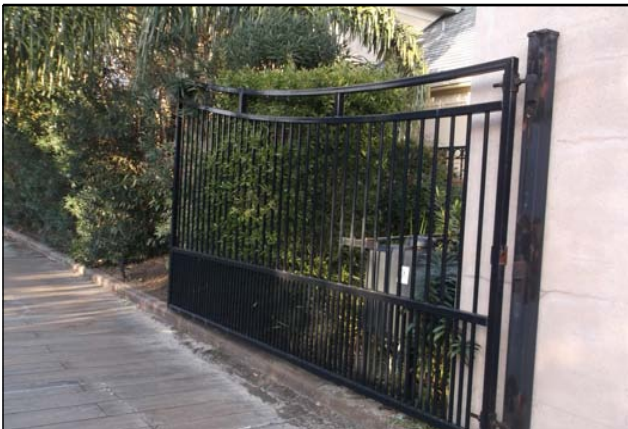
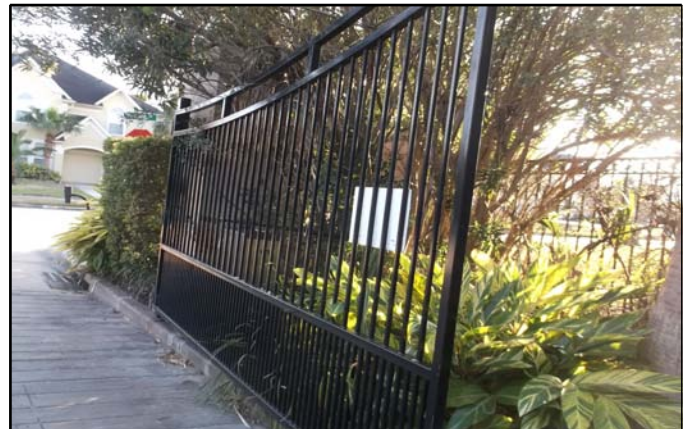
Comp # 504 Vehicle Gates - Replace

Although these gates may reach an extended life we recommend funding to completely replace them approximately every 25 to 30 years to ensure appearance and function. We have included funding for the replacement of the adjacent pedestrian gates and fencing at the same time.

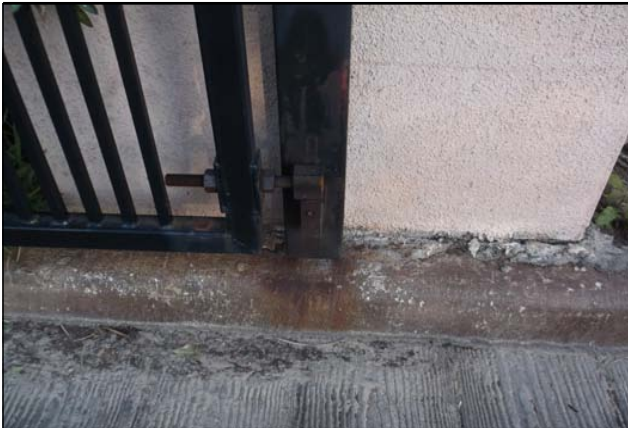
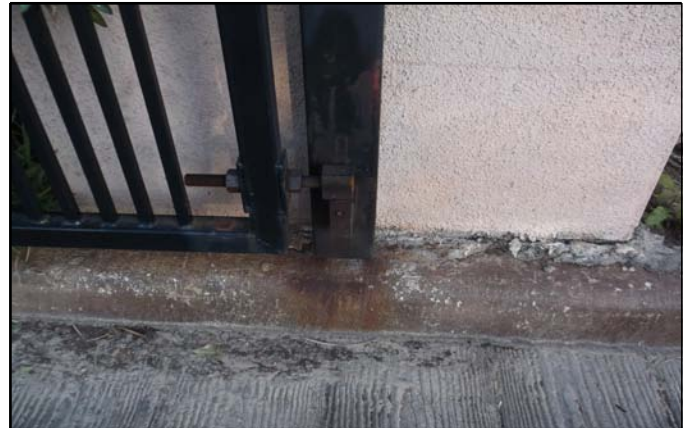
Comp # 505 Vehicle Gate Hinges - Replace

Although vehicle gates may reach an extended life the hinges will need to be periodically replaced to ensure proper function.

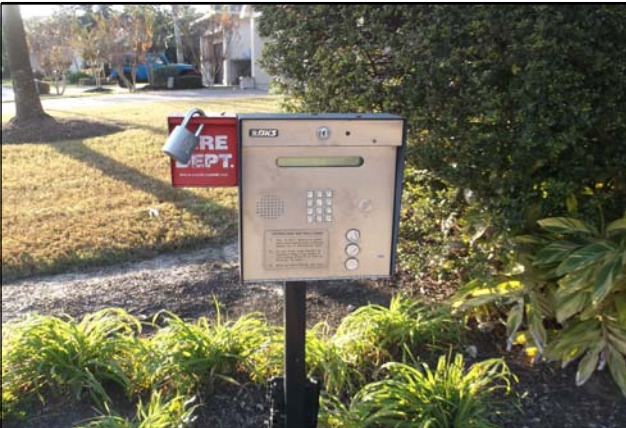
Comp # 506 Phone Entry System - Replace

No problems noted at the time of site visit. System was observed to be functioning normally. This type of system has a typical life expectancy of approximately 10 years. Remaining life based on current age and condition.

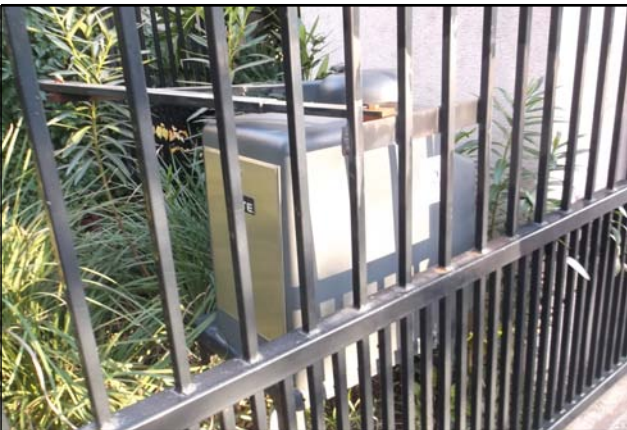
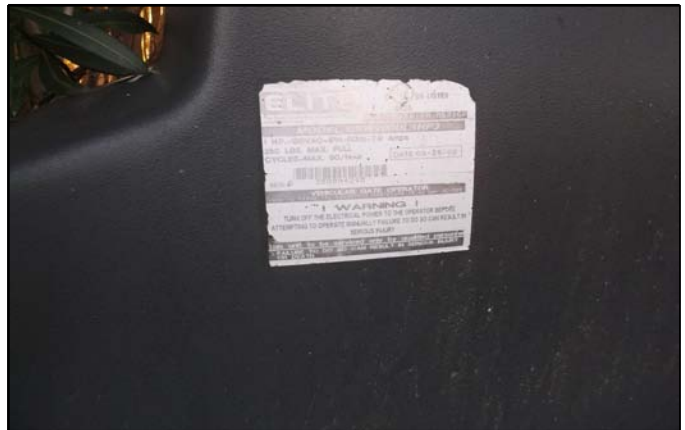
Comp # 507 Vehicle Gate Operators - Replace

Operators are near end of useful life. Expect to replace these in the near future, Operators have a typical useful life of approximately 10 years. Remaining life based on current age.

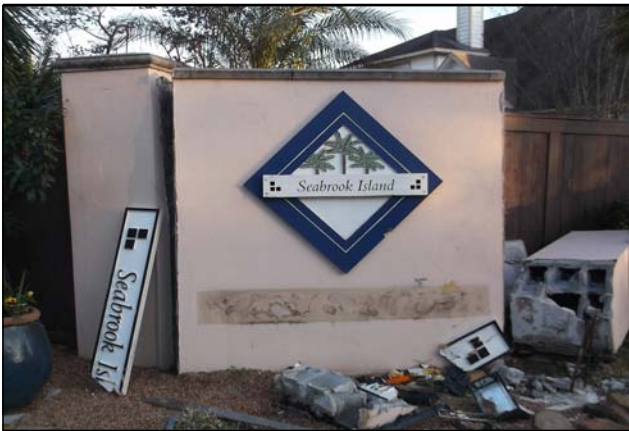
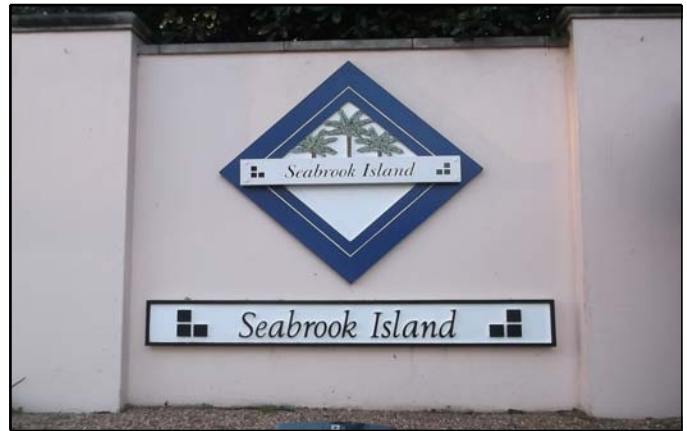
Comp # 801 Monument Signs - Replace

Although one sign was damaged due to an accident we are giving these monument signs a remaining life of 8 years to ensure they are replaced at the same time. Repair damaged monument as an operating or insurance expense and plan on renovating both monuments at the same time.

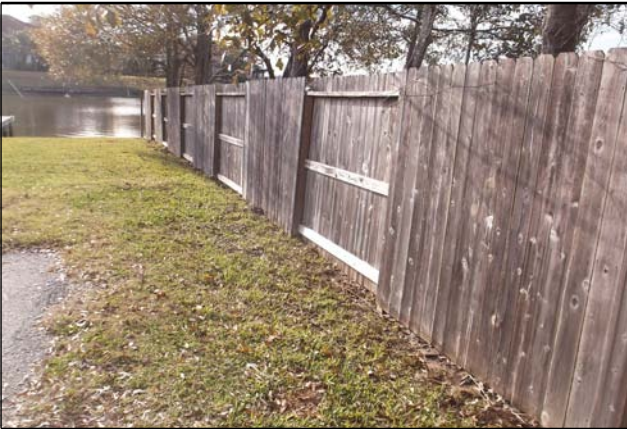
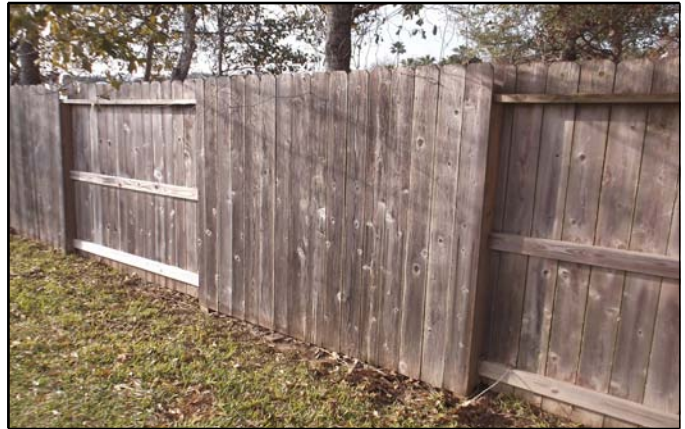
Comp # 1001 Wood Fencing - Replace

Wood fence is in fair condition. Noted warping and damage to several boards at the fence adjacent to the marina. Client reports that the association has been making local repairs to warped boards. Remaining life based on current condition.

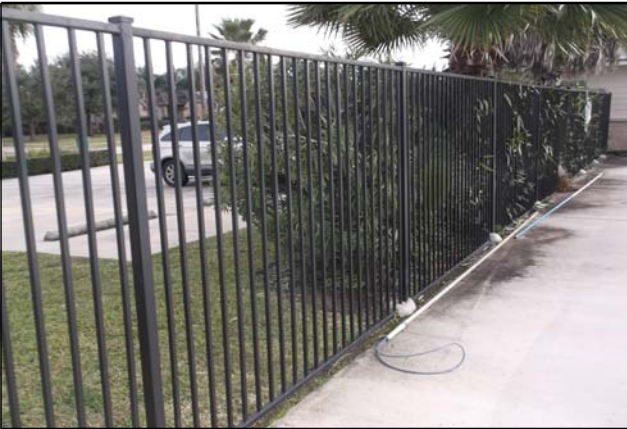
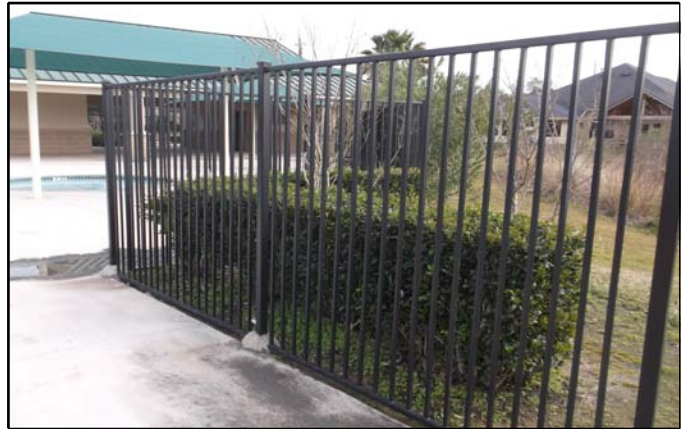
Comp # 1002 Wrought Iron Fencing - Replace

Fencing is in good condition. No significant rusting or structural problems noted at the time of site visit. With regular painting and maintenance, expect a useful life of 20 to 25 years from this component. Remaining life based on current age.

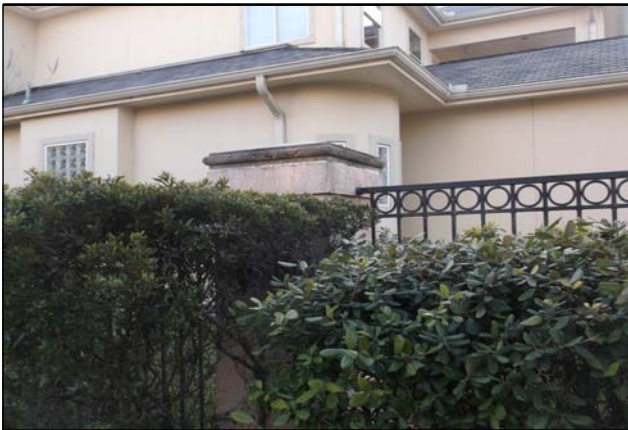
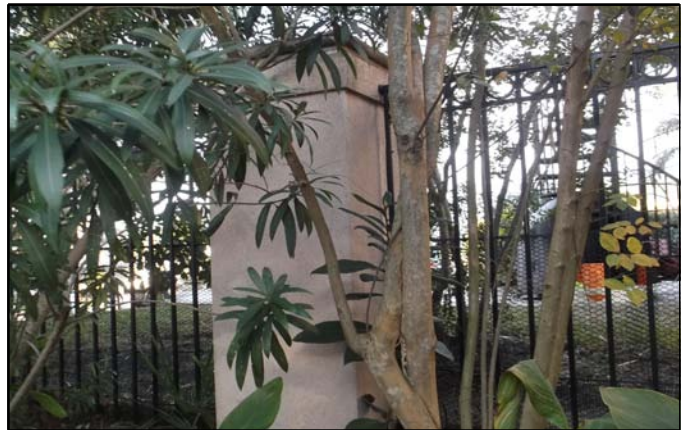
Comp # 1002 Wrought Iron Fencing - Replace (Not HOA)

Client reports that this fencing is the responsibility of the individual owners. No reserve funding necessary.

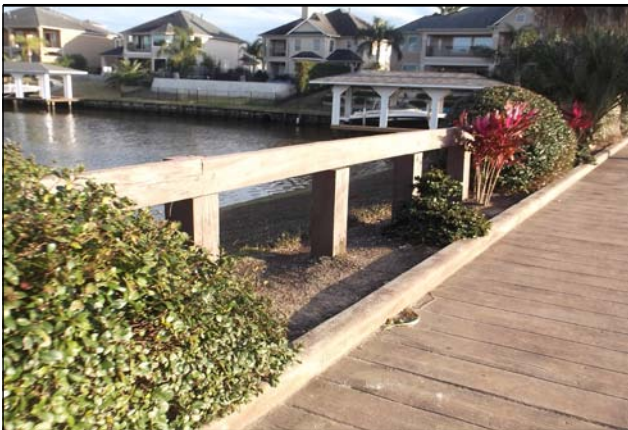
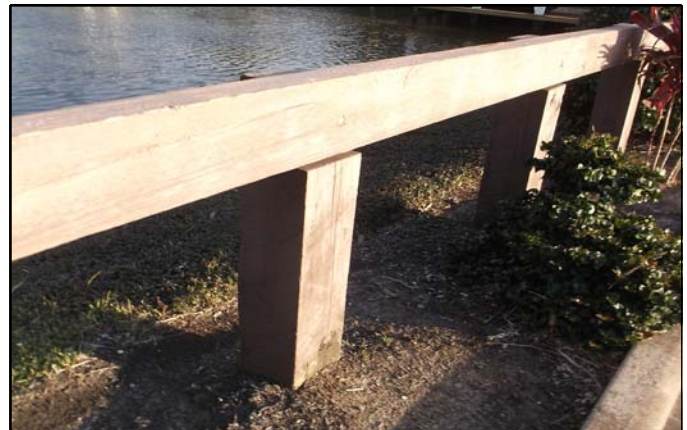
Comp # 1003 Wood Rail Fencing - Replace

No problems noted or reported with railing at time of site visit. Fencing is generally in good condition. We recommend funding to replace this fence approximately every 15 to 20 years.

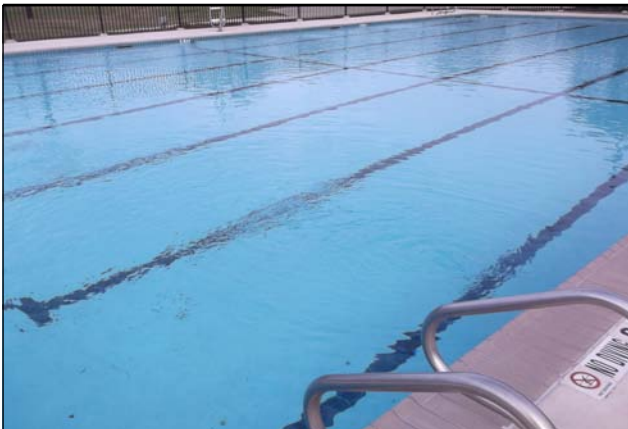
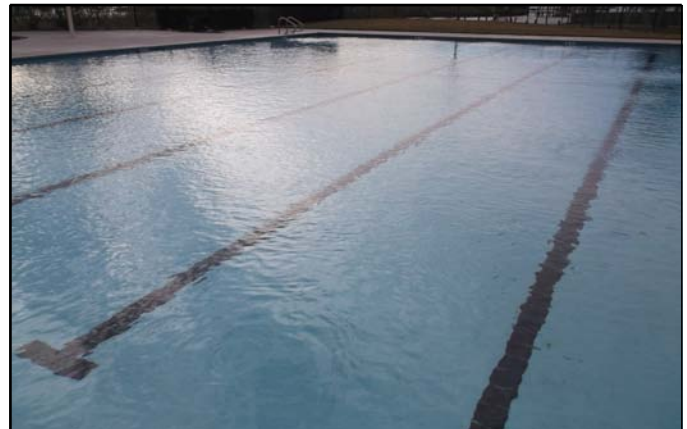
Comp # 1101 Pool - Resurface

Pool surface is in good condition. No concerns noted or reported at time of site visit. Perform regular, professional maintenance and keep debris from collecting at the bottom to ensure full life from this component. Remaining life based on current age and condition.

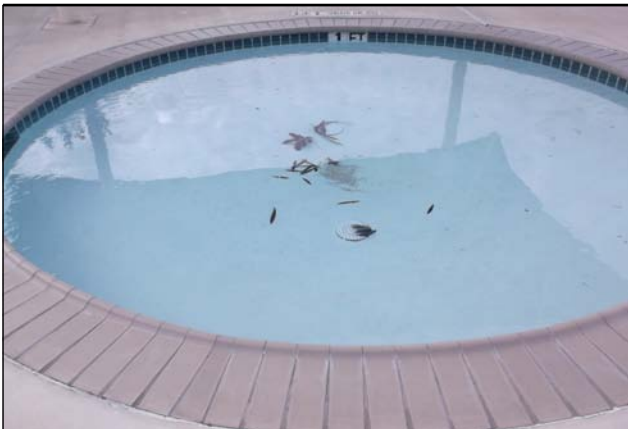
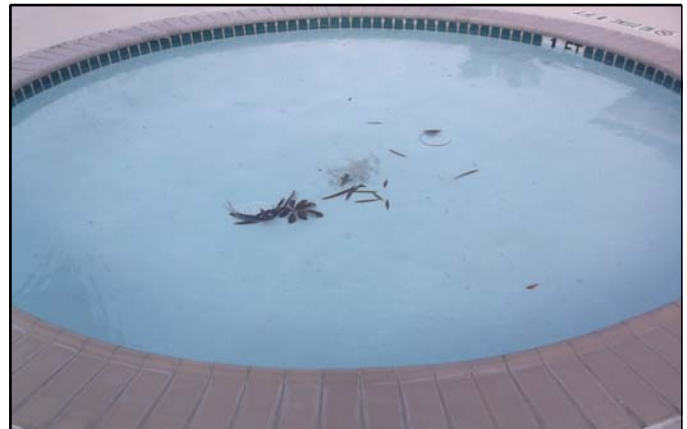
Comp # 1103 Wader - Resurface

No problems noted or reported with wader pool. This type of shallow wading pool typically requires resurfacing more frequently than a full sized pool because the entire pool floor is walked on. Reserve to resurface this wading pool on a 6 year schedule.

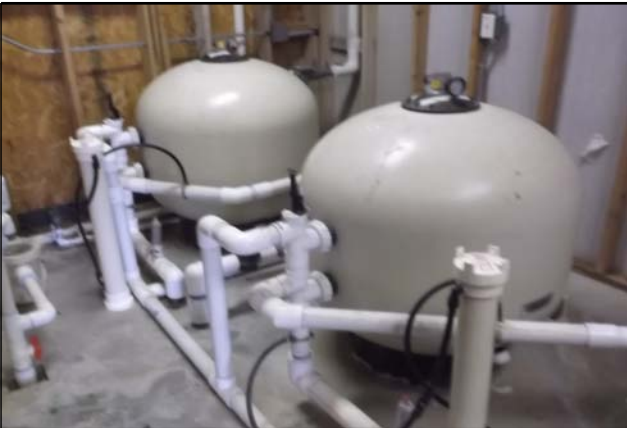
Comp # 1107 Pool Filters - Replace

Pool filter is in good condition. No problems noted at the time of site visit. This type of pool filter has a life expectancy of approximately 12 years. Remaining life based on current age and condition.

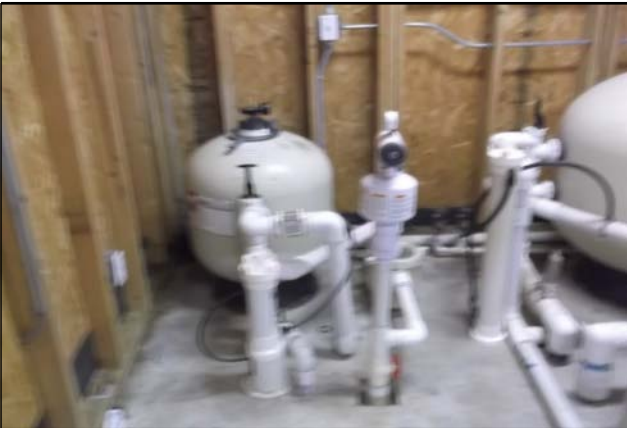
Comp # 1109 Wader Filter - Replace

Wader filter is in good condition. No problems noted at the time of inspection. Maintain filter professionally to ensure full life from this component.

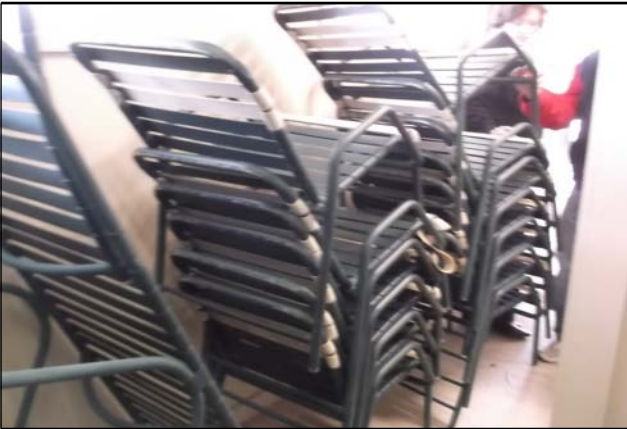
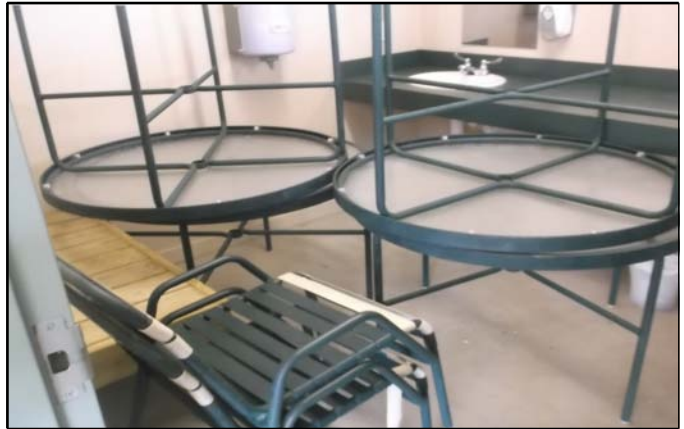
Pool furniture is in good condition. No broken straps or significant sun damage noted at the time of inspection. Expect a useful life of approximately 6 years from this component. Remaining life based on current age and condition.

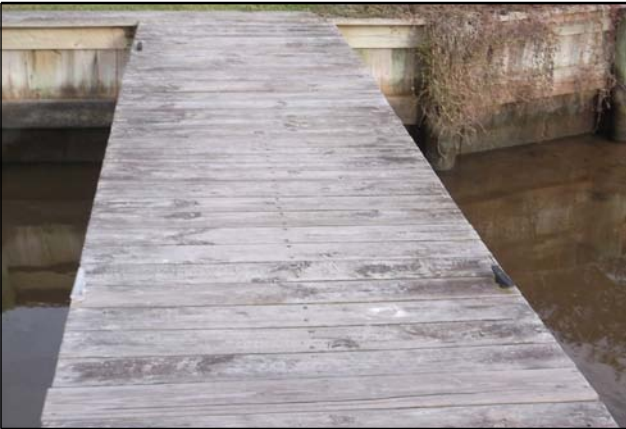
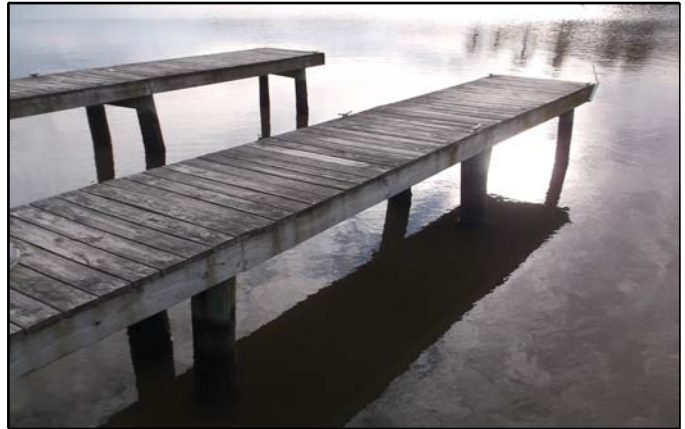
No problems noted or reported. We recommend funding to rebuild these docks approximately every 15 to 20 years. Expect to make minor repairs as well as to seal the wood surfaces as necessary as an operating expense to ensure full life.

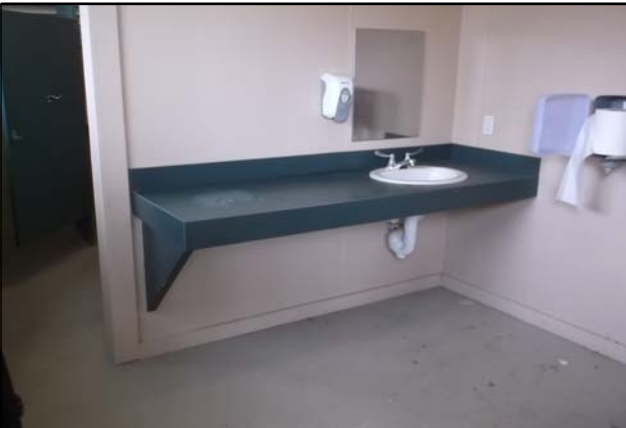
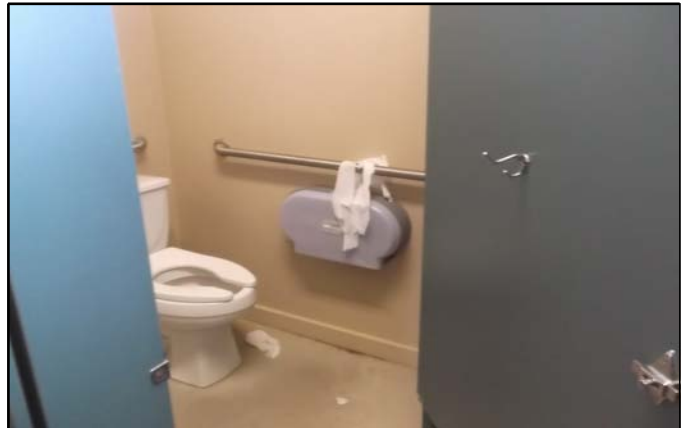
Comp # 1413 Restrooms - Remodel

Restroom interiors are in good to fair condition. Painted surfaces are bright and mark-free, countertop and fixtures are in good condition. Repaint restrooms as needed as an operating expense and expect to conduct a general remodeling of the restroom interiors approximately every 15 years to maintain appearance and keep up with current decorative tastes. Remaining life based on current condition.

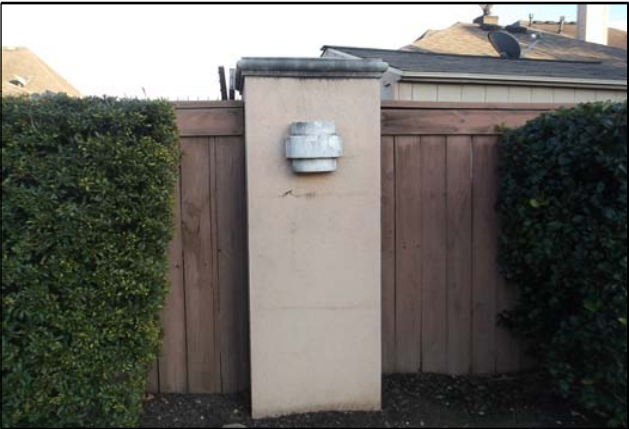
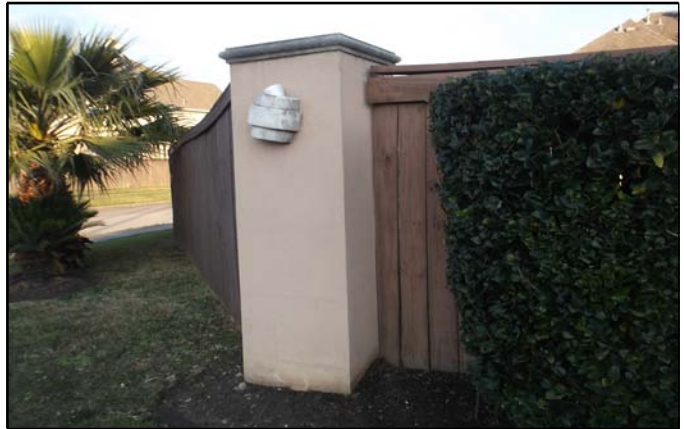
Comp # 1602 Wall Mount Lights - Replace

Lights are generally in fair to poor condition. Numerous missing and damaged lights. No significant pitting or discoloration noted. Expect to replace these lights approximately every 15 years to maintain appearance. Remaining life based on current age and condition.

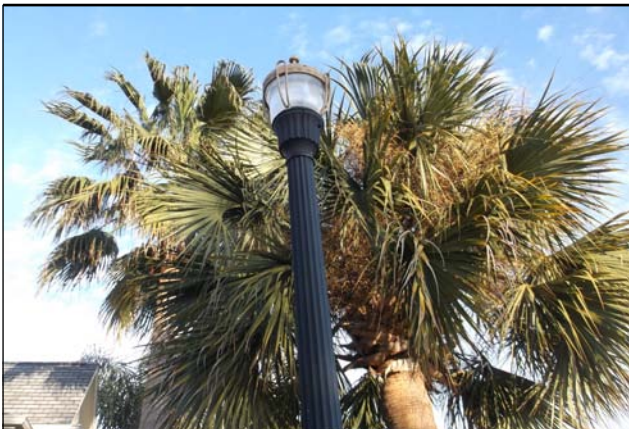
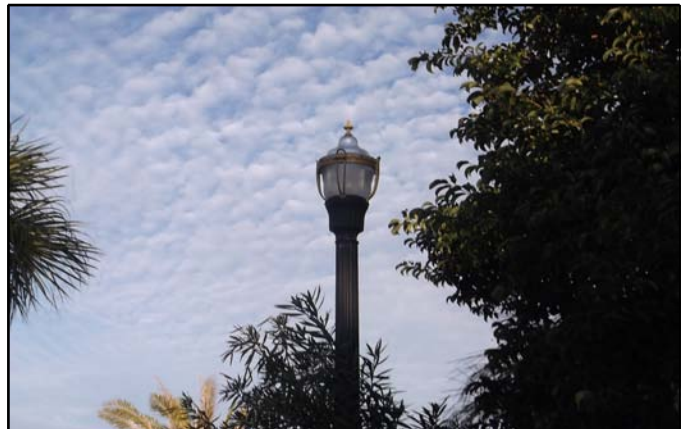
Comp # 1604 Pole Light Fixtures - Replace

No problems noted or reported. No expectation to completely replace the poles under normal circumstances. We recommend funding to replace the fixtures, make local pole replacements, and to generally refurbish the electrical approximately every 25 years.

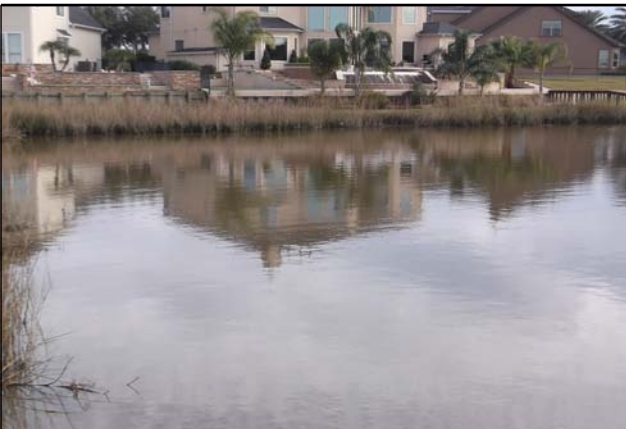
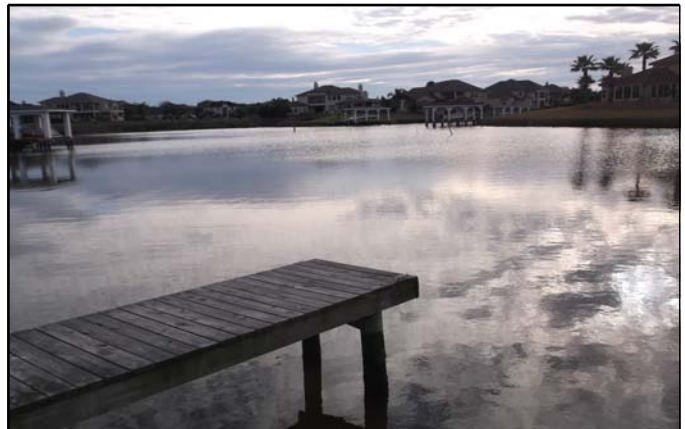
Comp # 2201 Boat Access - Desilting - Perform

Client reports that due to sand, silt, and sediment filling the waterway a desilting project is needed. We recommend funding to perform similar maintenance approximately every 15 to 20 years to ensure proper access. Client has directed us to fund for this project in 2023.

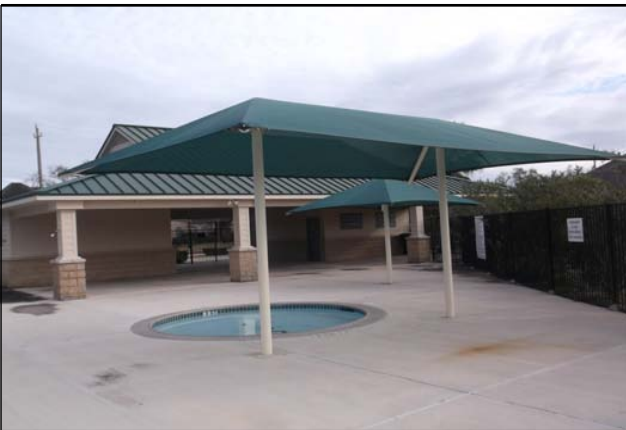
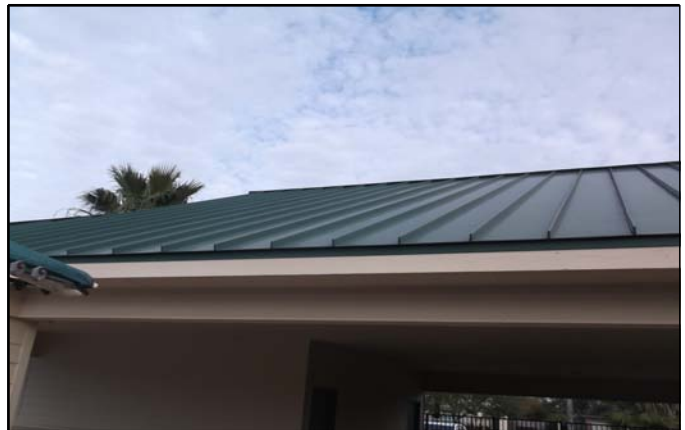
Shade structure is in good to fair condition. Although this component may reach an extended life we recommend funding to replace the shed approximately every 15 years to ensure appearance and function.

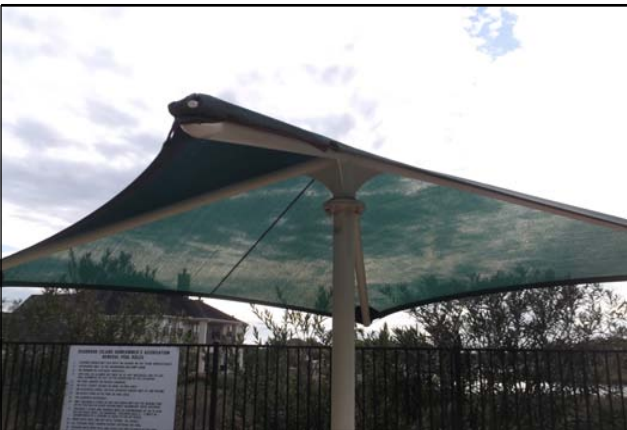
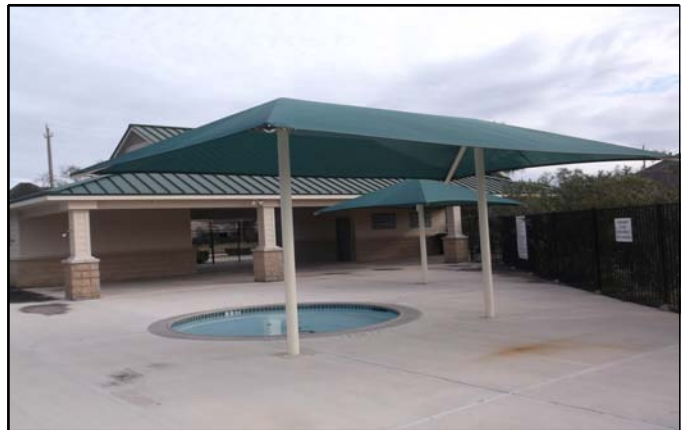
Comp # 2302 Shade Structure Awnings - Replace

Awnings are in good to fair condition. We recommend funding to replace these awning approximately every 8 to 10 years to ensure proper use and function. Remaining life based on current condition.
