The Journal of RCI

September 2014 • Vol. XXXII • No. 8 • \$12.00

Fasteners and Self-Sealability of Weather-Resistive Barriers

By Karl Schaack, RRC, PE

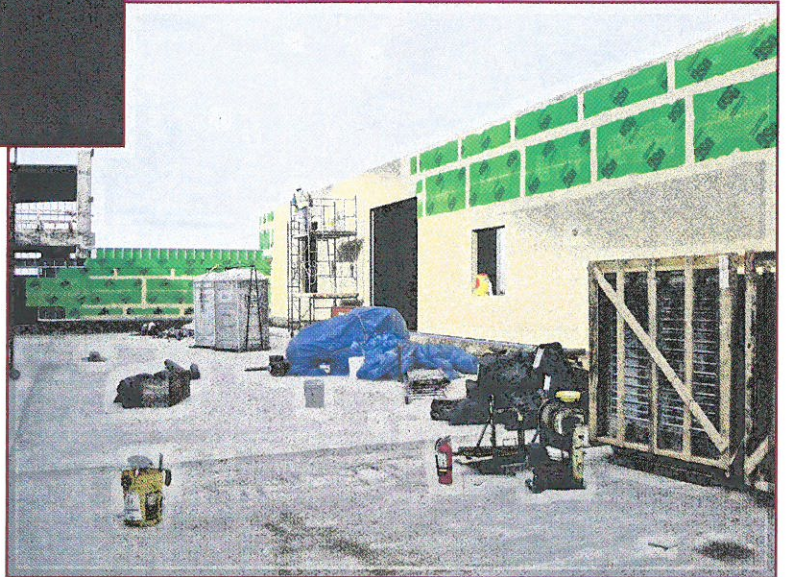
Photo 2 – Application of liquid-applied WRB.

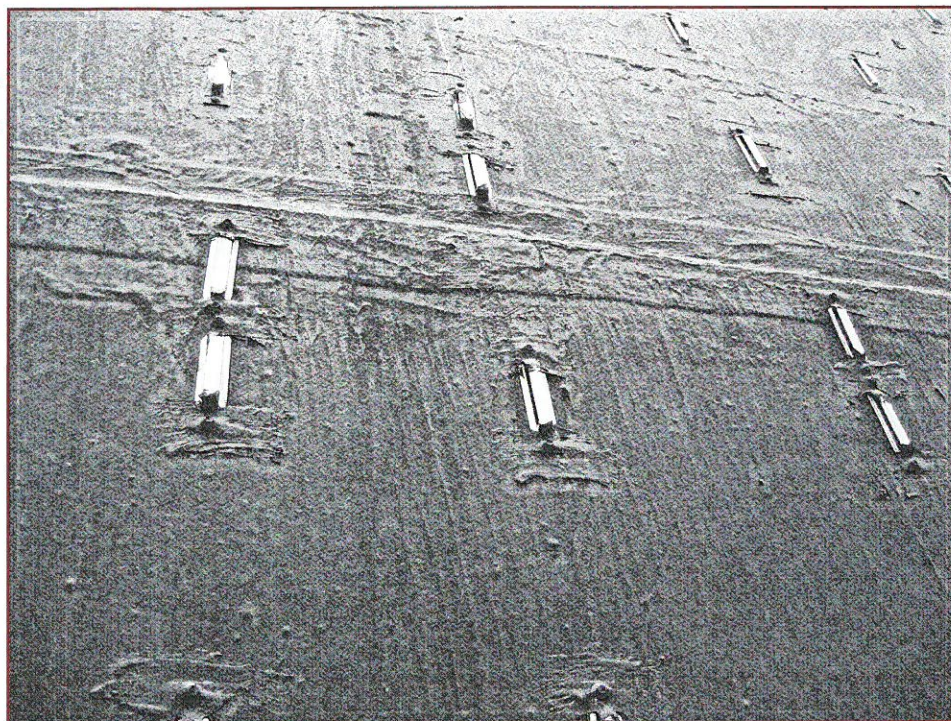
Photo 6 – Sealant applied over fastener heads securing brick ties.

Additionally, the heads of fasteners may need to be treated with a dollop of compatible sealant or trowelable version of the liquid membrane to provide a more suitable

seal (Diagram 3 and Photo 6). Another practice could include setting the masonry tie in “wet” liquid-applied WRB when securing to the substrate.

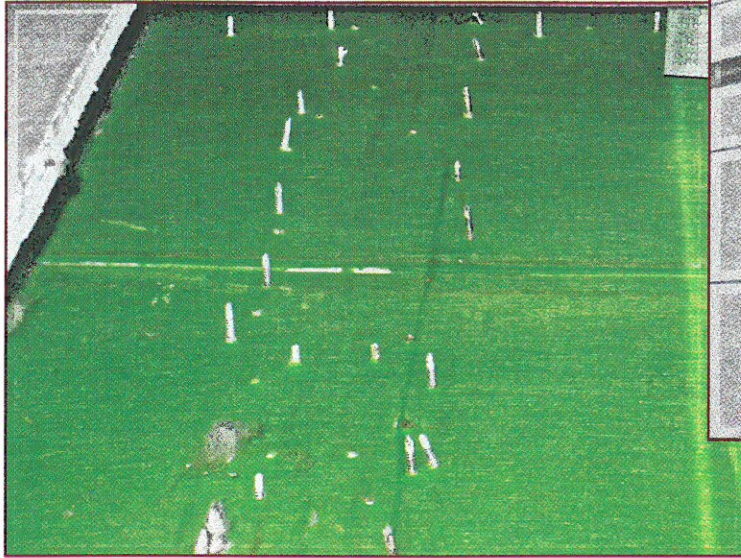
Photo 8 – Fasteners missing studs.

Upon initial visual inspection of the interior, the pointed ends of many screw fasteners were protruding through the exterior gypsum sheathing and not penetrating into any metal stud framing at numerous locations throughout the floors that did not have any interior finishes (Photo 8). These “missed” fasteners were typically located at

the reveals and expansion joints in the plaster. Some were located along corner and casing beads, and others were located in the field of the wall believed to be for general securement of the lath.

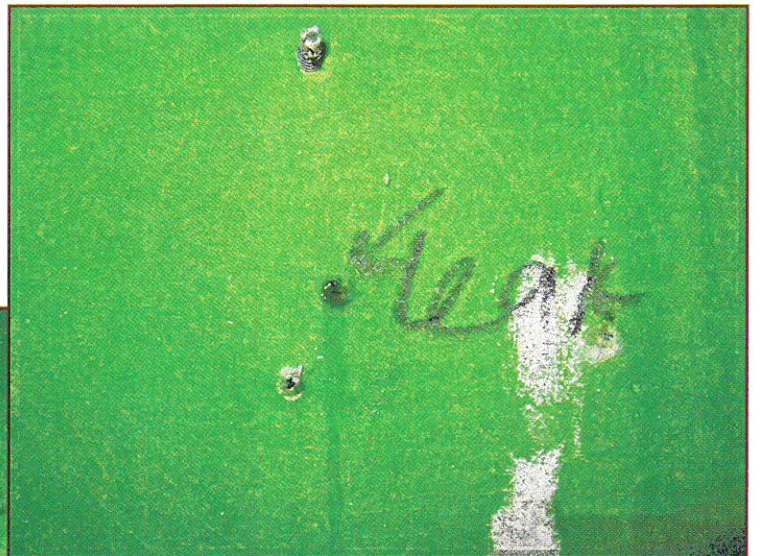
Photo 11 – Water leak at missing fastener hole in gypsum sheathing.

Other obvious entry points for moisture were unrepaired small holes through the air barrier material and sheathing where fasteners were presumably originally installed and subsequently removed—apparently due to their lack of contact with an adequate substrate (Photo 11).

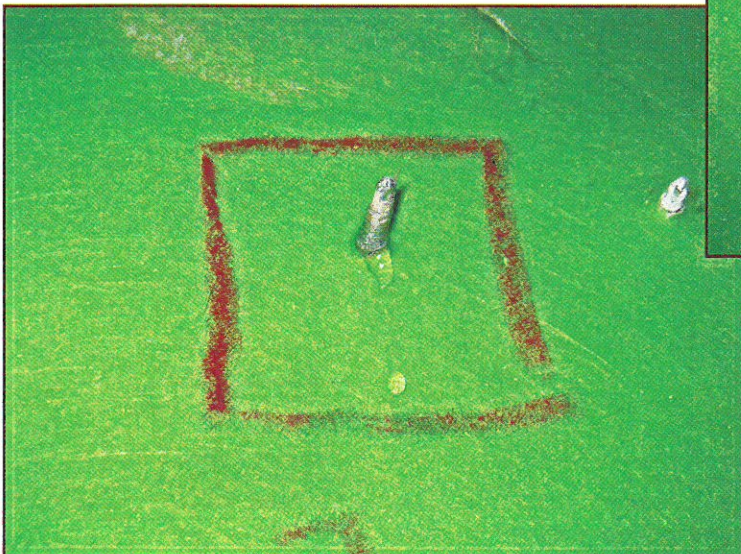
Photo 10 – Water dripping from fastener installed through gypsum sheathing.

the source, the moisture manifested itself in the building interior at the many “unsealed” fastener penetrations that were not installed into metal studs (Photo 10).

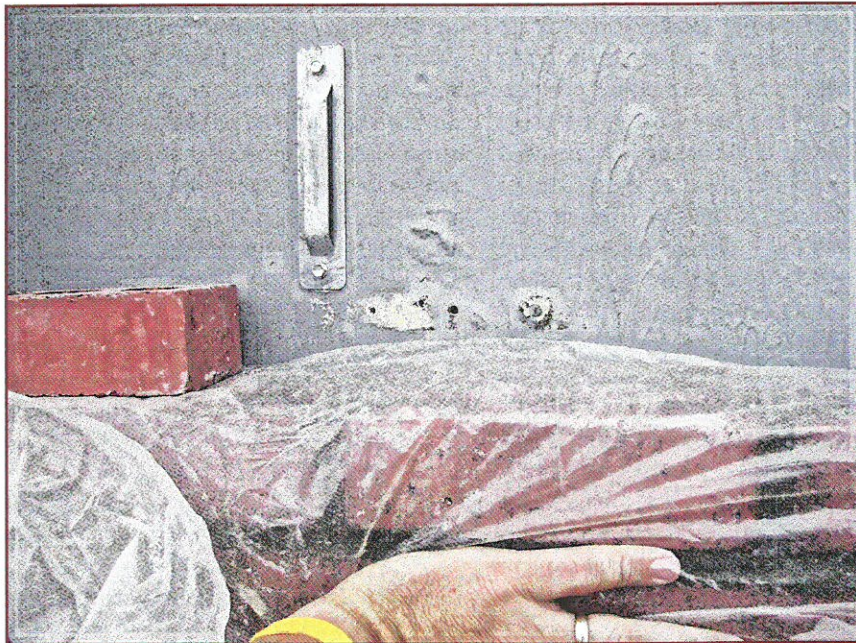
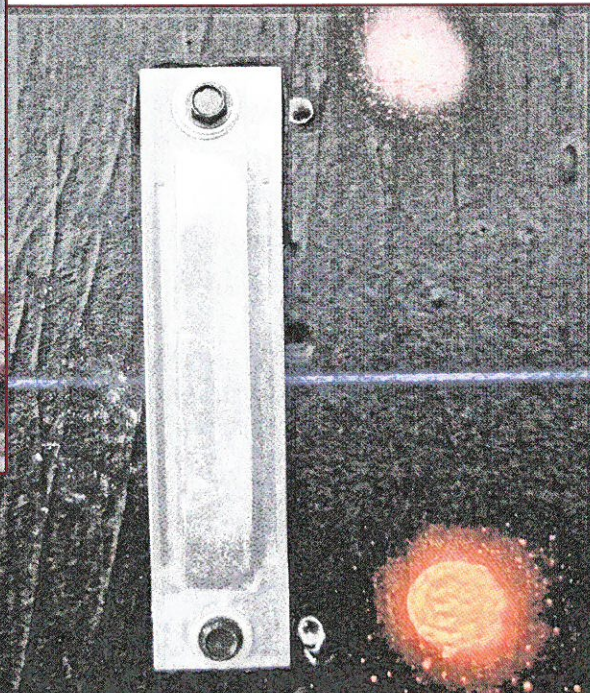
Photo 12 – Multiple holes in WRB.

Photo 13 – Holes in WRB adjacent to brick tie.

In the process of performing on-site inspections for building envelope commissioning or for general project requirements, PCI has observed many of the air barrier conditions noted in this article. One of the most common issues PCI observed has been holes in the WRB due to installation and removal of fasteners and lack of a subsequent suitable repair (Photos 12 and 13).

- Confirm fasteners engage with studs/ framing or a sound substrate.
- Avoid the use of supplemental fasteners, sometimes used incorrectly to attach accessories between studs like control joints and other accessories in stucco (required to be wire-tied between studs).
- Avoid errant fasteners that do not go through studs or that spin and create a larger opening and a loose connection (particularly in gypsum-based sheathing).
- Remove “loose” fasteners and seal the holes.
- Avoid the use of powder-actuated fasteners.
