# Az Superior Home Inspections

## **CONFIDENTIAL INSPECTION REPORT**

Example , Phoenix, Arizona 85050

8/25/2012 9:30 am to 3:30 pm

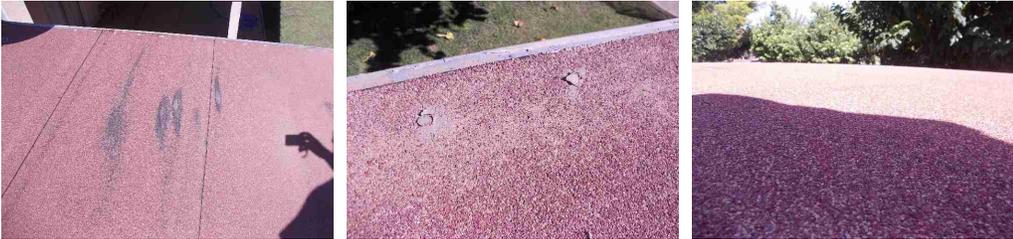
The roof has a flat-roofed addition, and flat roofs can be problematic if they are not properly maintained. They must be kept clean and inspected regularly. However, this flat roof needs serviced for the following reasons: E.G. The granules have been worn away more than likely from the tree limbs at one time not being maintained. There is also some blistering in a few spots. The flat roof appears to have been done by an amateur as nails

were used to secure the roof material, these nails were then sealed, but there are a few nails that have lifted. This roof has approximately two years of useful life and should be replaced. You may also elect to have an elastomeric roof coating rolled on to seal the roof and may be able to get an additional 5 years out of the roof. We can elaborate on this issue, but it should be serviced before the close of escrow or it may leak, because our service does not include any guarantee against leaks, although, at this time I see no evidence of leaking..

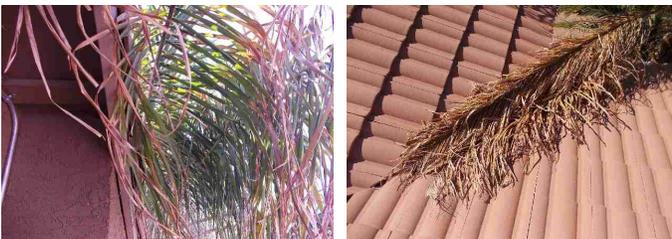
The roof needs to be cleaned and any foliage trimmed away to facilitate drainage. E.G. Palm tree in front should be trimmed, there are currently limbs laying on the roof valley that can impede the water drainage.

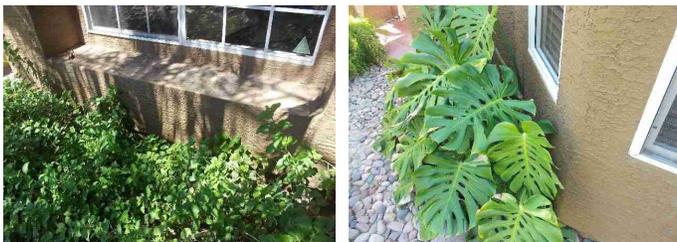
Vegetation is encroaching on the structure, and should be kept a minimum of twelve inches away for the general welfare of the walls and foundation.

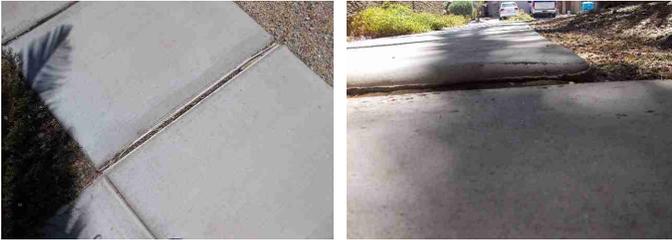
There is an offset in a walkway that could prove to be a trip-hazard. E.G. Deck-O drain on front entrance near driveway. Also walkway right outside front door.

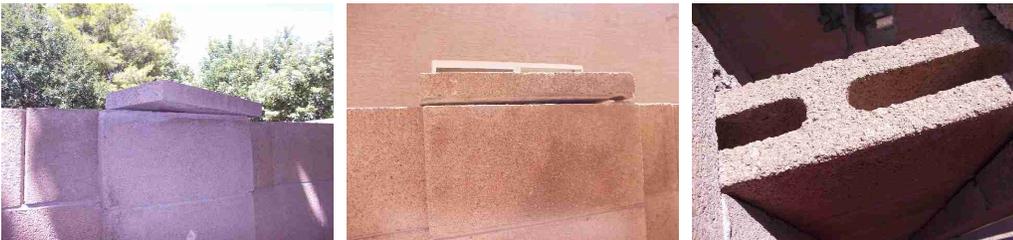
There are a couple loose fence caps that are loose and will need serviced. Also an open cell that can allow water to drain inside the wall and rust the rebar that will weaken the wall. E.G. One cap on east and west walls that should be secured. Also open cell near side gate on east side that should be filled in with mortar.

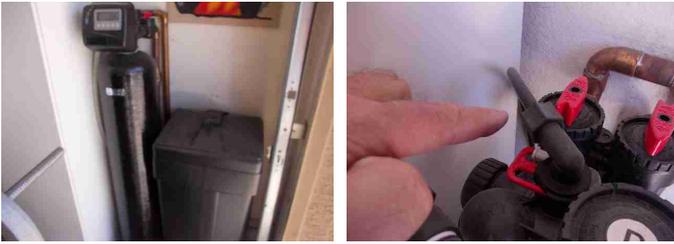
We are not required to inspect soft water conditioners, however, as a courtesy, we have run the system through a regen cycle and inspected for leaks. This system appears to be functional, but is leaking at the plastic pipe running from the control unit back into the salt reservoir.

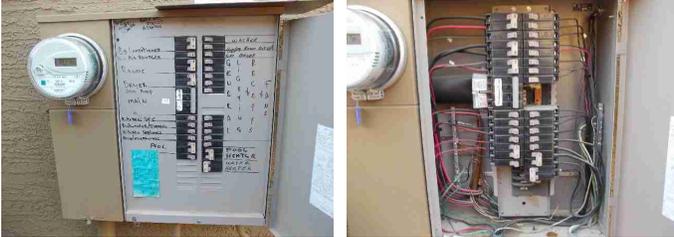
The residence is served by a 200 amp, 240 volt panel, located front west side of the house.

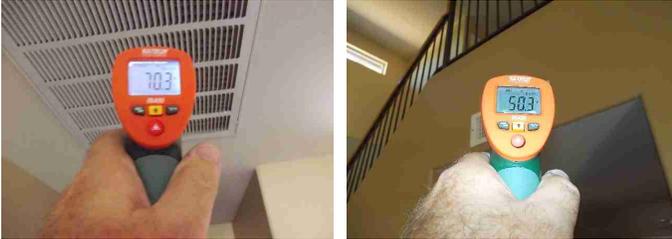
The air-conditioning responded and achieved an acceptable differential temperature split between the air entering the system and that coming out, of fifteen to twenty degrees. E.G. Split differential is 20 degrees.

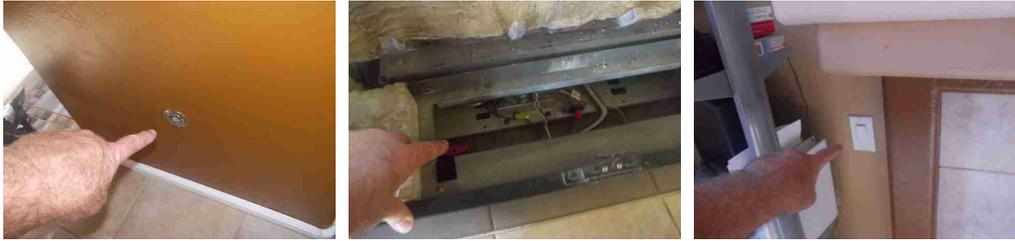
Living room has a gas fireplace. There is both an outside gas shut-off valve and a shut-off valve in the bottom of the unit where the gas control valve is located. This unit is controlled by a light switch as well. Once the pilot light is lit, the unit will operate from the wall switch. Unit is operational at this time.

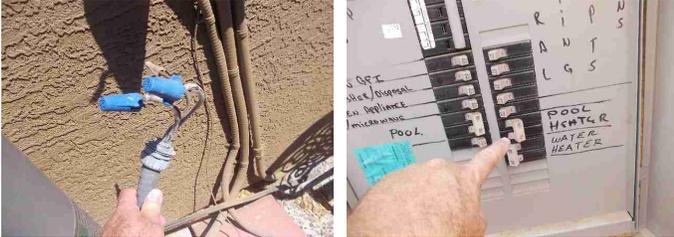
Electrical wires in the pool equipment area have been incorrectly terminated outside of an electrical junction box. They should be removed or correctly terminated inside a standard junction box. E.G. There are capped 240V wires that exist from where a pool heater used to be installed. I have verified that the circuit breaker is off. I would recommend that these capped wires be enclosed in a junction box so that if the circuit breakers would happen to be accidentally tripped on, the then "live" wires would not be exposed.
