Encapsulation & Dehumidification Case Study

Location: Maryville, Tennessee
Age of Home: 25 Years
Size of Crawlspace: 1,000 Sq. Ft.
Homeowner: Danny Burns
Installer: Thompson Waterproofing & Allied Pest Control

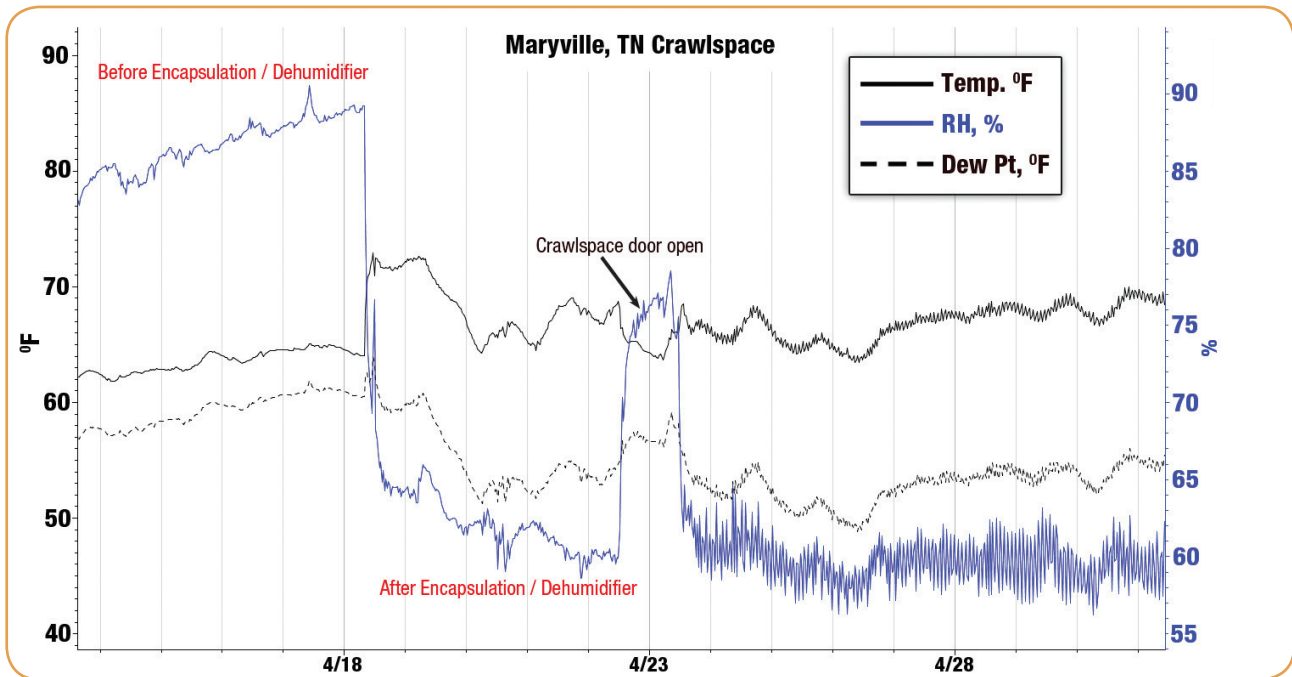
Results

Mr. Burns contacted Greg Gentry of Thompson Waterproofing & Allied Pest Control located in Knoxville, TN to inspect his crawlspace. “We noticed right away that there was lots of fungus, mold and standing water,” said Gentry. Gentry recommended installing a French drain with a sump pump, encapsulating the crawlspace and installing a Santa Fe dehumidifier. HOB0 data loggers were installed in the crawlspace to record humidity levels in the crawlspace before and after the encapsulation.

Lastly, a Santa-Fe Advance2 dehumidifier was installed with a condensate pump to remove any excess humidity. This will ensure the structure of the house remains durable, the indoor air quality in the rest of the home is healthy, and the crawlspace remains inhospitable for fungi, mold, dust mites, wood destroying insects, and other pests.

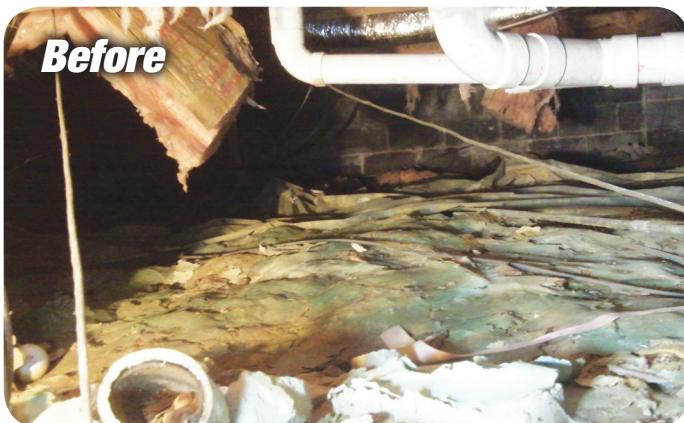
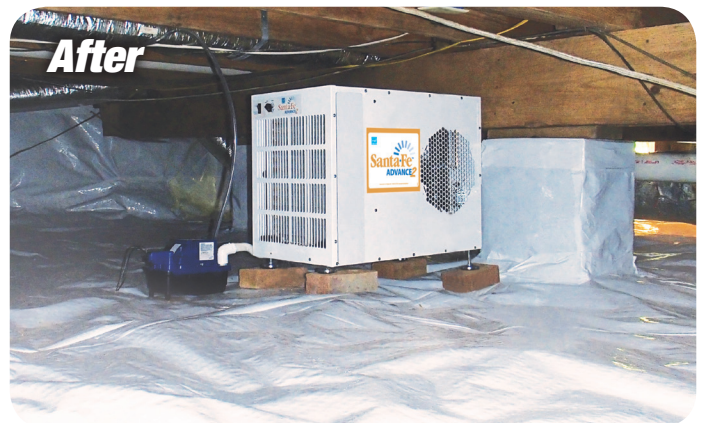
Prior to encapsulating the crawlspace the floor joists and walls were cleaned in order to remediate the existing fungus and mold. The wet fiberglass insulation and existing clear floor plastic was removed from the space. In order to help stop the infiltration of outside humid air into the space, all openings in the sidewalls, including vents and doors leading to the exterior were sealed.

Due to excess water intrusion around the foundation from the outside a French drain with a sump pump was installed to help mitigate standing water in the crawlspace.

The foundation and floor were lined with a crawlspace felt underlay to protect the vapor barrier from sharp objects like broken concrete or sharp stones. A reinforced polyethylene vapor barrier was used to prevent moisture from seeping into the crawlspace. Grade 12 Mil (or higher) is recommended for crawlspaces, as it is specifically designed to effectively block moisture and withstand the ground's natural alkaline qualities, which quickly break down in cheaper recycled materials, leaving the home unprotected. Proper installation of the vapor barrier is essential to controlling moisture, and as a result, minimizing the pest and fungi that thrive in a damp crawlspace.
