## **Replacing the Fuel Sending Unit in the Tank**

Recently I had to finally replace the fuel sending unit in my fuel tank on my 1978 Li'l Red Express. This is how I installed the new unit.

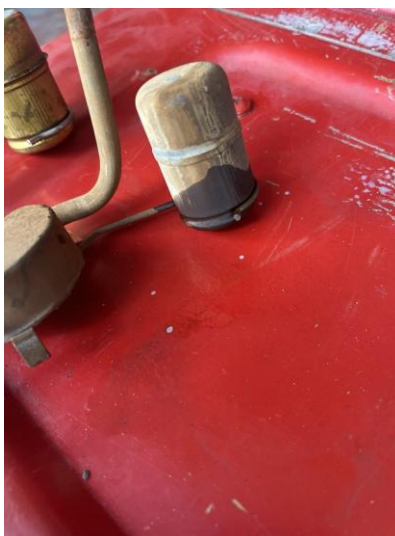
I was getting tired of seeing empty on the fuel gauge and found that the brass float on the sending unit was completely full of gas, once we removed the old sender, see pic.

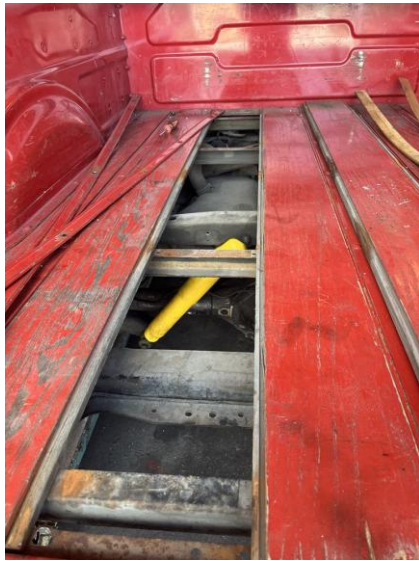
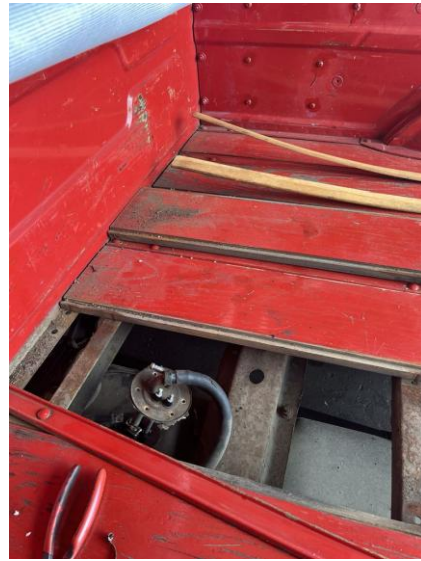
Fourth, remove the 6 carriage bolts from both skid strips on each side of the #3 board to gain access, this can be tricky and usually takes 2 people to get them out.

The only casualty I had was one skid strip carriage bolt had to be cut, to get the skid strip out. Not bad for being as old as it was.

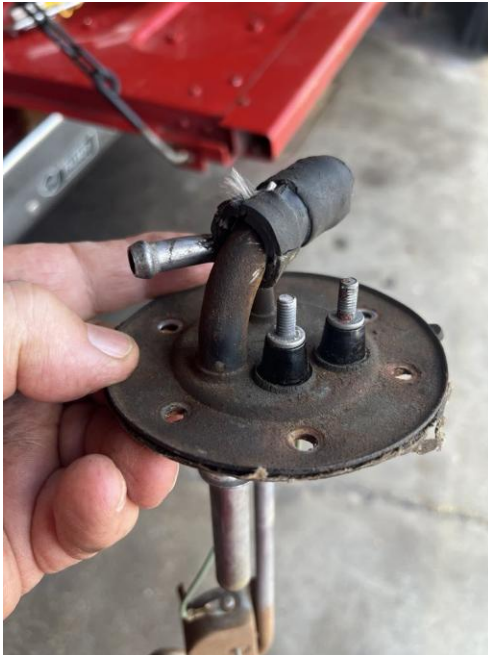
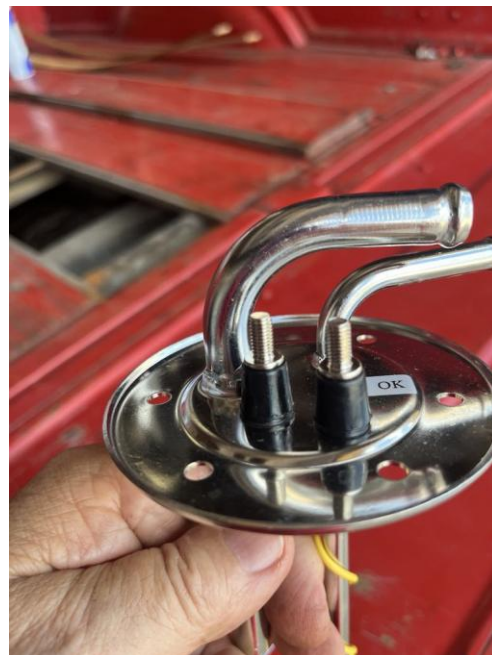
My original sender had the fuel line pointing to the outside of the bed and the vent line pointing to the inside of the bed, however, the new sender had both lines pointing to the inside of the bed, see pics.

The original fuel line was now too short to reach to the new sender, so we just installed a new, 4" longer rubber line. We replaced the old "crimp" type hose clamps with the new screw type clamps. The 6 Phillips head screws came out without any problem. I had sprayed the screws with PB Blaster a few days earlier, I don't know if this is the reason they came out, but they were no problem. We did have to cut the vent line at the sender; it would not come off. However, there was enough line left, so we didn't need to replace that line. The white wire is the ground and the blue wire with a black stripe is power for the gauge. They are just "push on" plugs, see pics.
