BATHYMETRIC MAPS

Round Lake had a bathymetric survey conducted in 2007 by LCHD (Figure 9). The maximum depth was 30.38 ft. and average depth was 8.64 ft. Lake volume was estimated 1986.64 acre-feet. LCHD recommends updating bathymetric map every 10 years. For a complete list of the morphometric table for Round Lake refer to Appendix B.

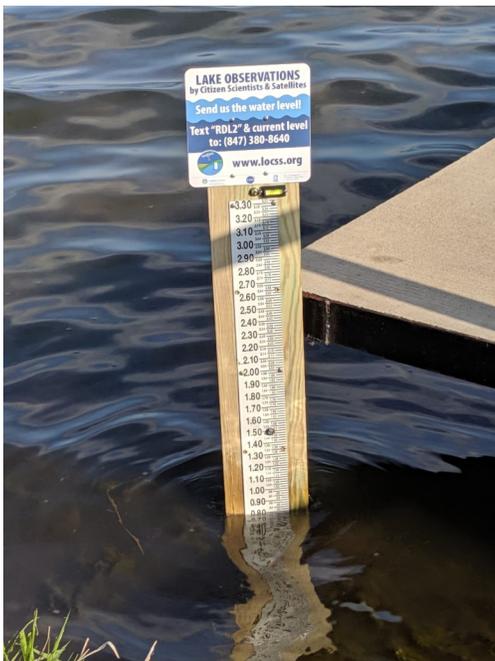
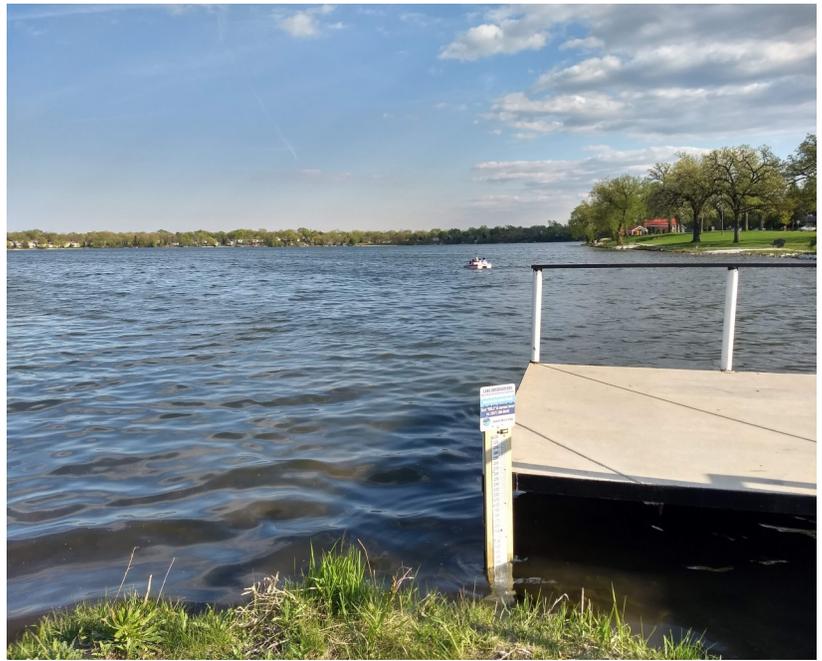
Figure 10: 2019 lake level readings on Round Lake

Locally, the lake level will help understand lake fluctuations on Round Lake. Residents are encouraged to submit lake levels. It's as easy as texting the lake level to the number provided on the post! It's important that the RLCC encourages park visitors and lake users to submit readings so there can continue to be good water quality data. 2019 was another wet year, with numerous heavy rainfalls (Figure 10).

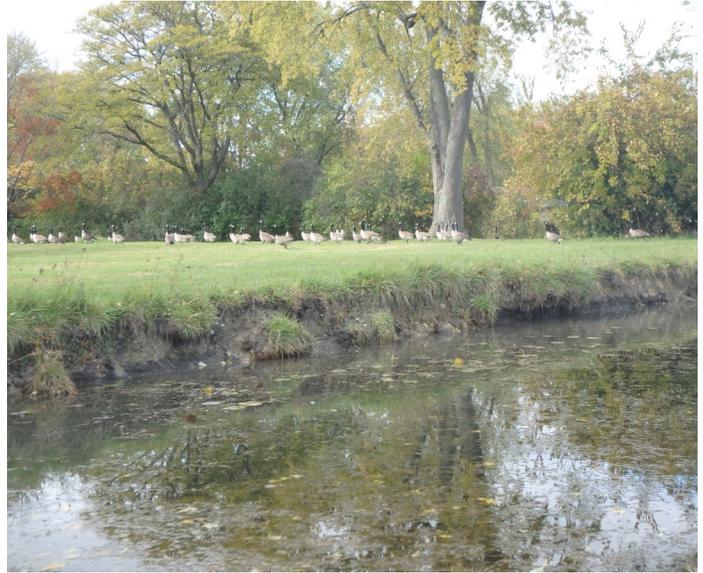
Figure 12: Example of erosion along Round Lake shoreline

Based on the 2019 data, 64.1% of Round Lake shoreline is eroding. 14% of the shoreline is considered moderate erosion. Figure 12 represents typical erosion conditions on Round Lake. Many homeowners have created artificial shorelines to minimize erosion including riprap and seawalls.

Round Lake could benefit from homeowners increasing buffer strip along their shorelines. Many homeowners have installed shoreline erosion mitigation (rip rap, sea walls) but keep mowed grass up to the edge of the lake. Figures 14 represent the typical buffer conditions around Round Lake, which is mowed turf grass up to the lakes edge. The Village of Round Lake has done a good job of installing buffers on the NE side of the channel on their park property. Buffers can be planted to fit personal preference in aesthetics choosing plants that bloom at different times, choosing specific height of plants, and colors.

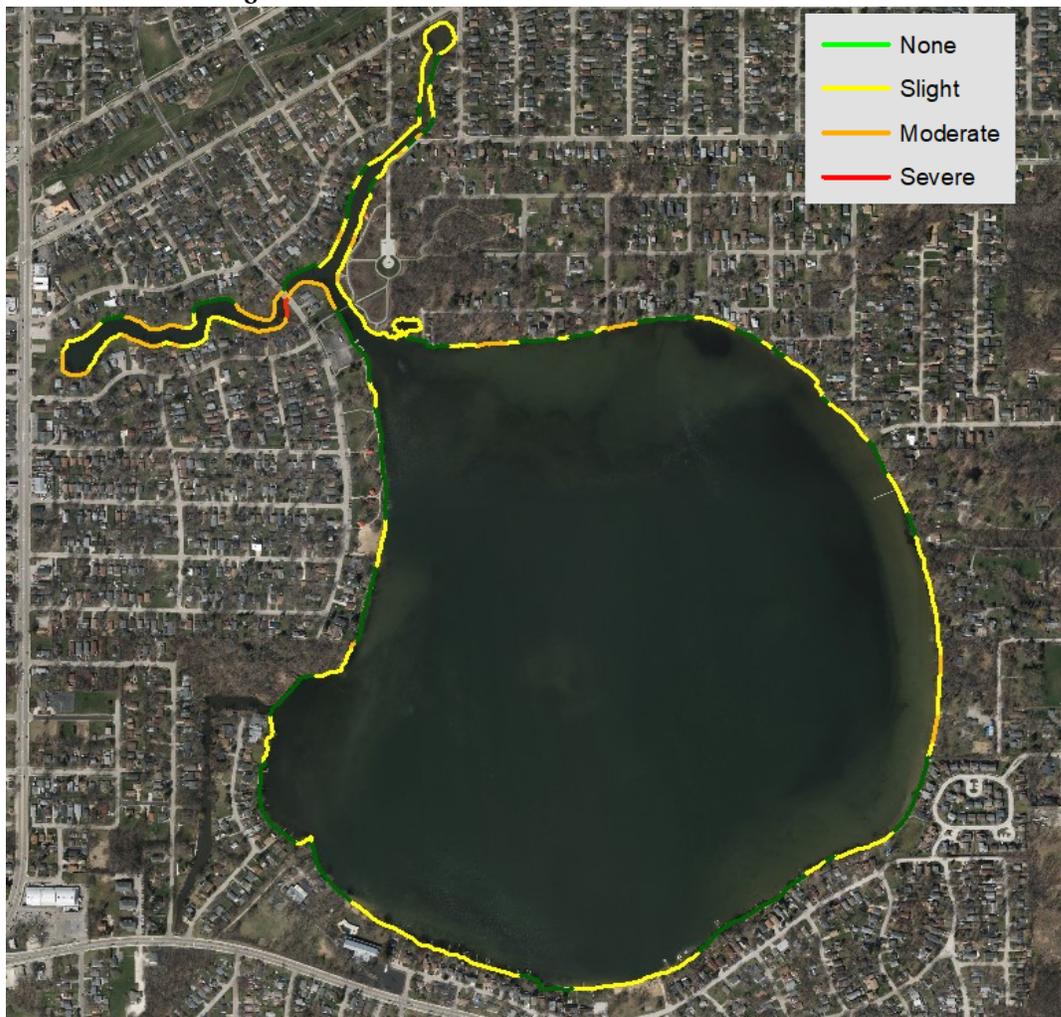
Figure 11: Shoreline Erosion Condition Round Lake, 2019

A shoreline erosion assessment was conducted on Round Lake in 2019 (Figure 11). The lake shoreline was evaluated for none, slight, moderate and severe erosion based on exposed soil and tree/plant roots, failing infrastructure and undercut banks.

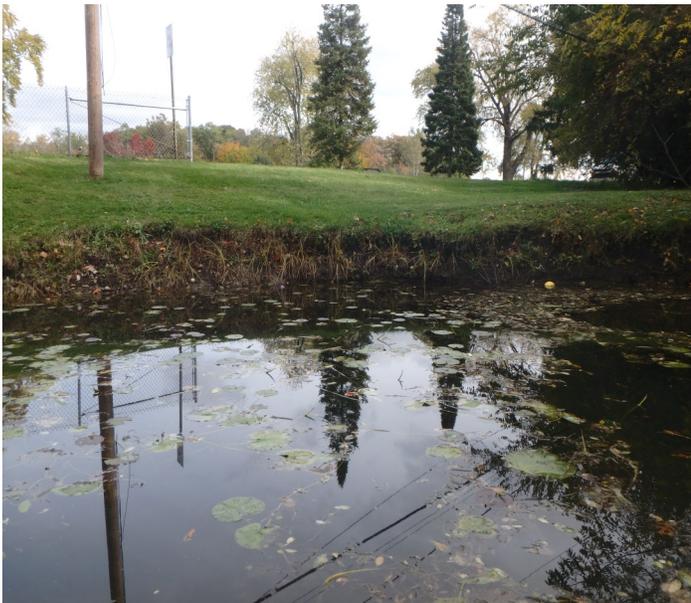
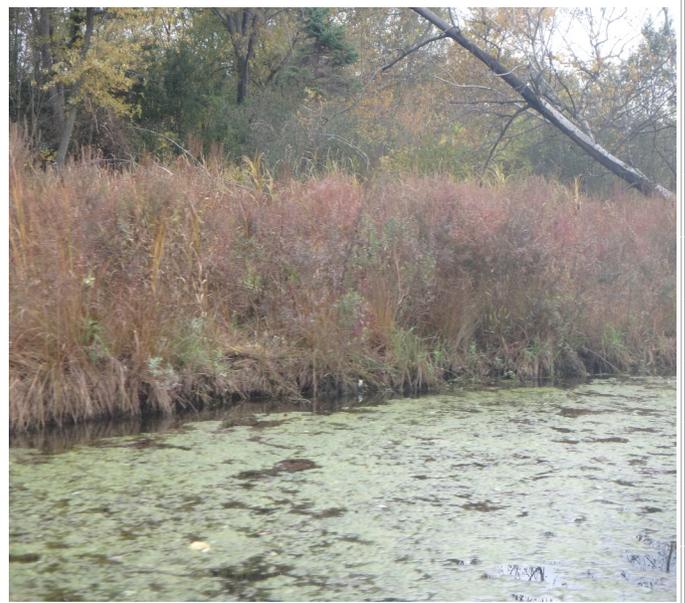
Figure 14: (Left) no buffer, mowed grass up to edge (Right) Buffer along shoreline.
