VETIVER SYSTEM APPLICATIONS IN SPAIN AND PORTUGAL

Dr. Paul Truong

TVNI and Veticon Consulting

SPAIN – INFRASTRUCTURE PROTECTION

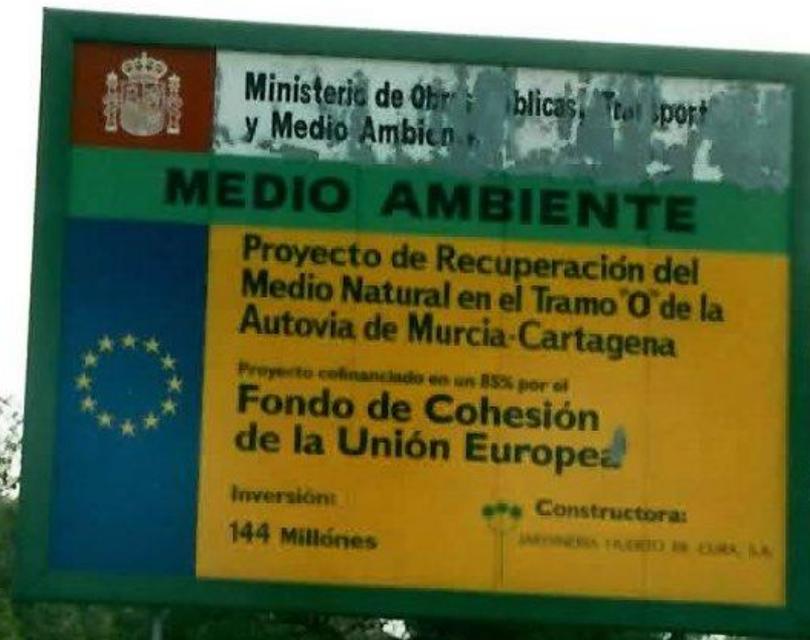
An EU funded project costing over USD1.1M, using *Atriplex alimus* to stabilise section of highway between Murcia and Cartagena

The plant failed to establish one year after planting despite intensive irrigation

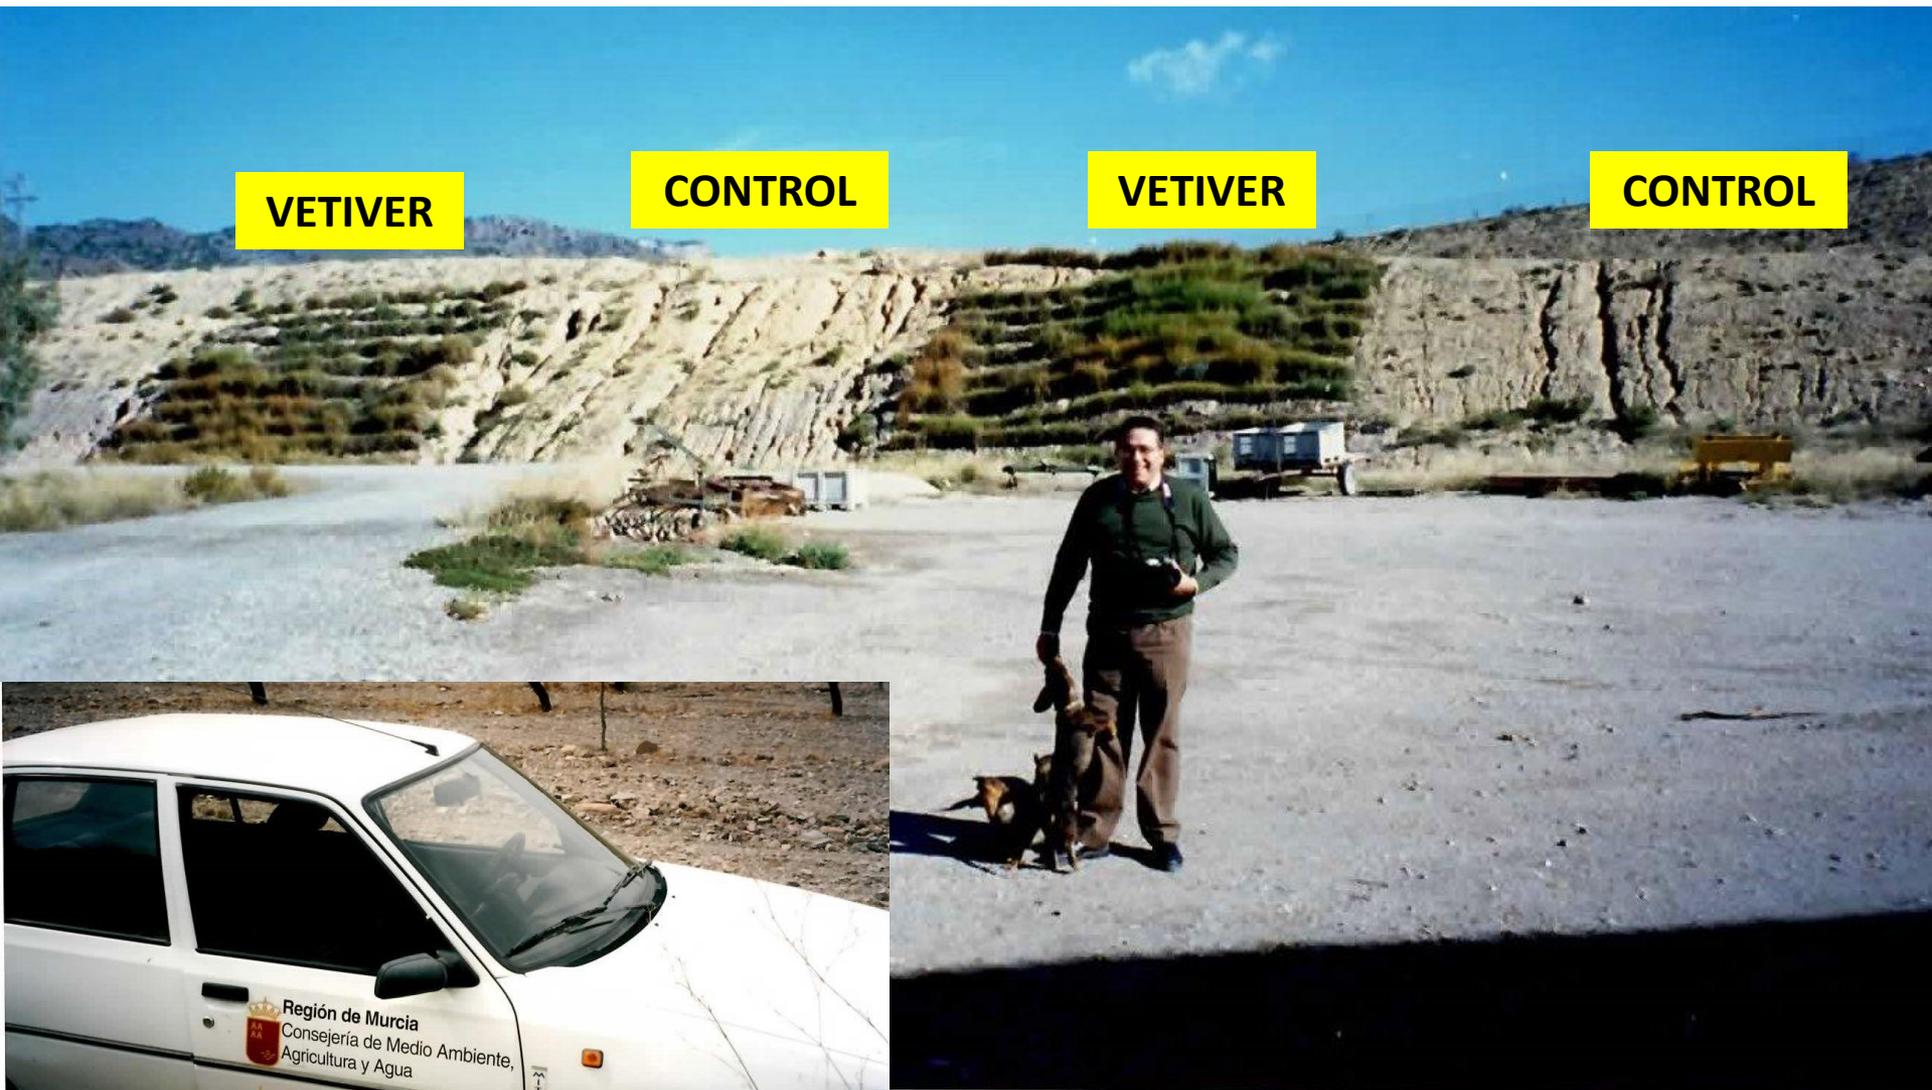
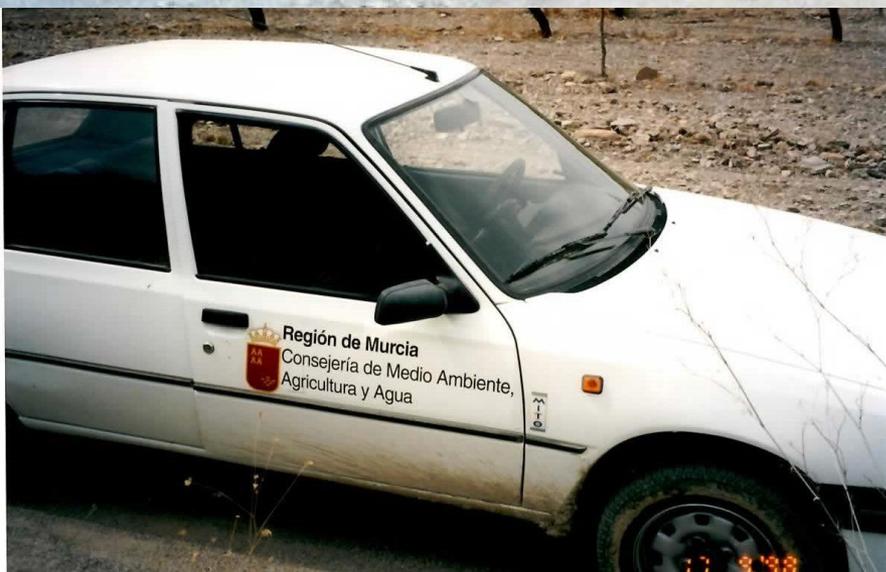
LORCA site in 1997, 3 YEARS AFTER PLANTING

Three years after planting at LORCA in 1997, Vetiver established well with drip irrigation during establishment phase (the first summer) and no further irrigation

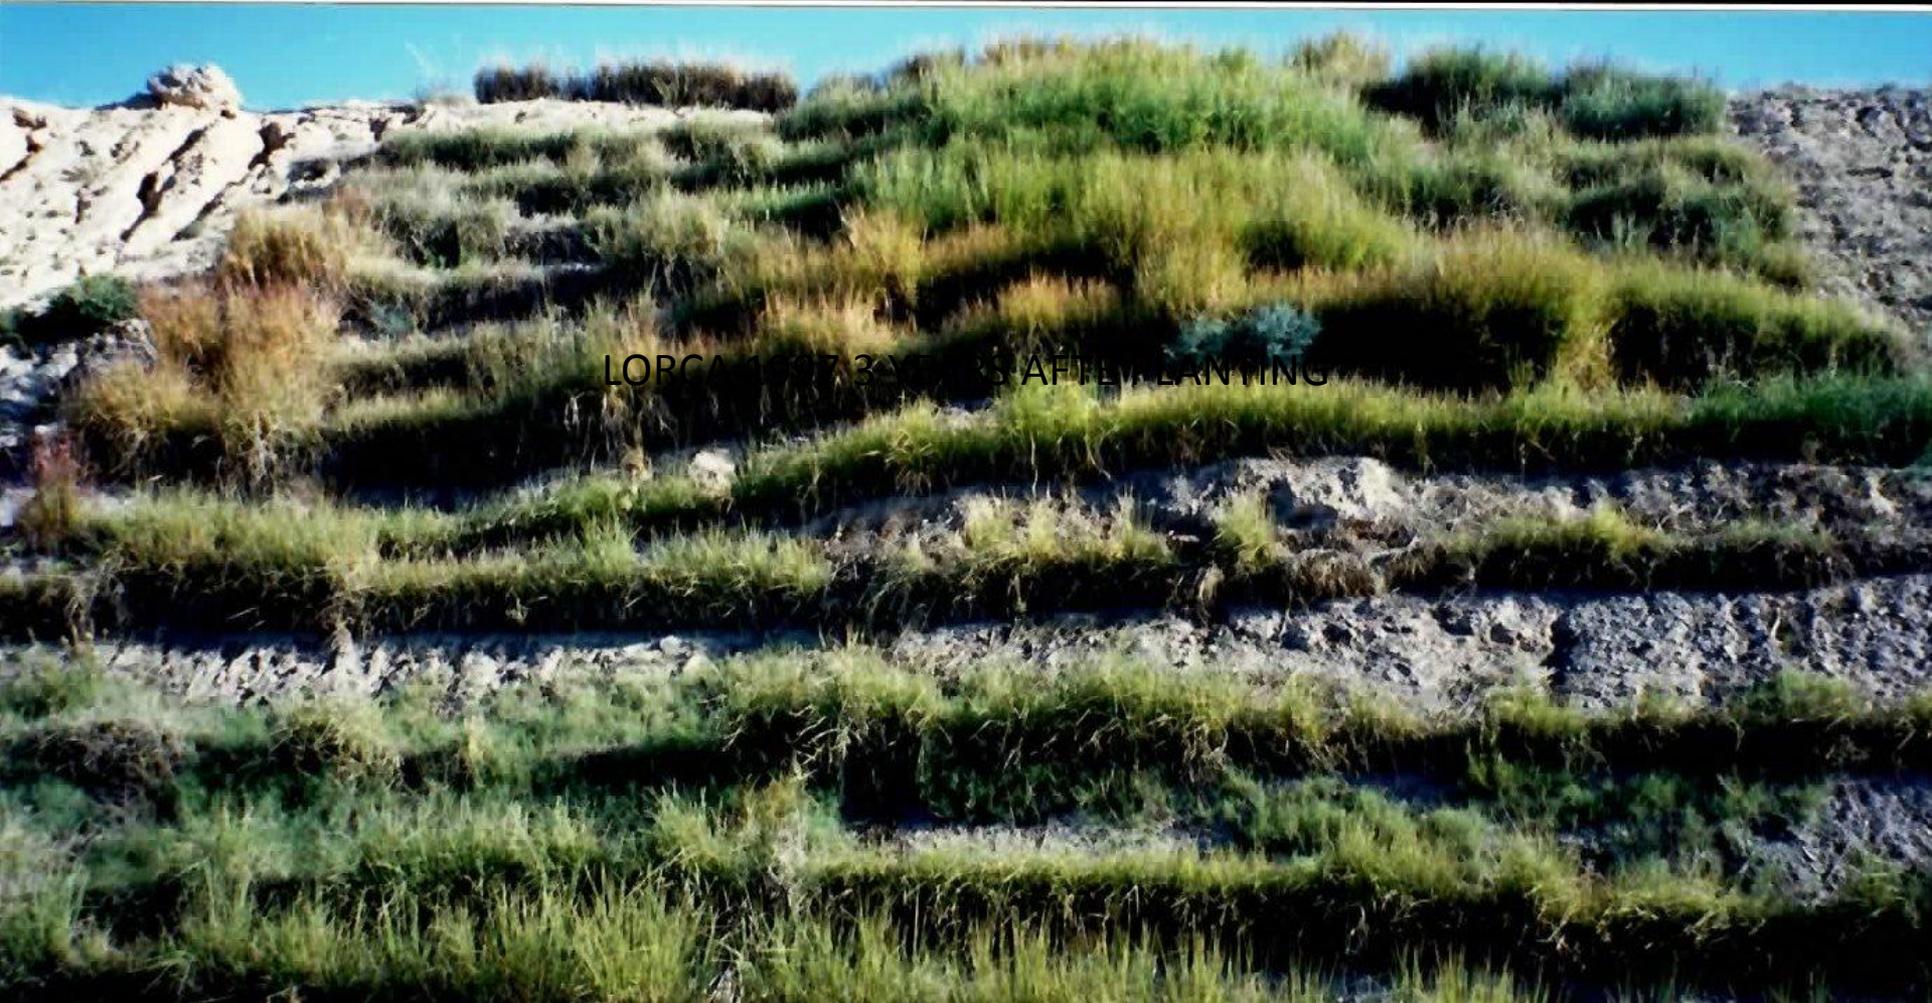
Excellent growth with no irrigation after 3 years

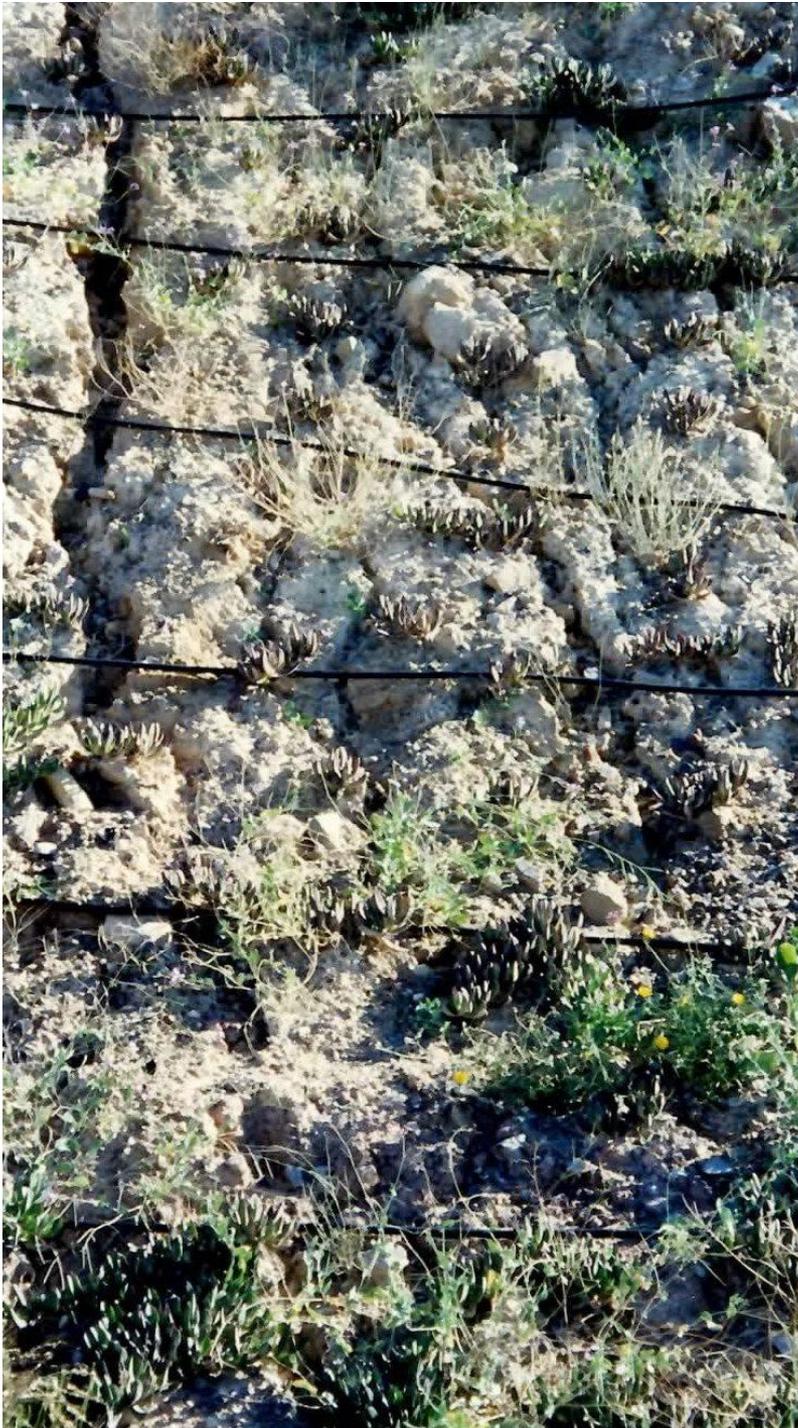
**Very few natural
colonisation of
native plants in
control plot**

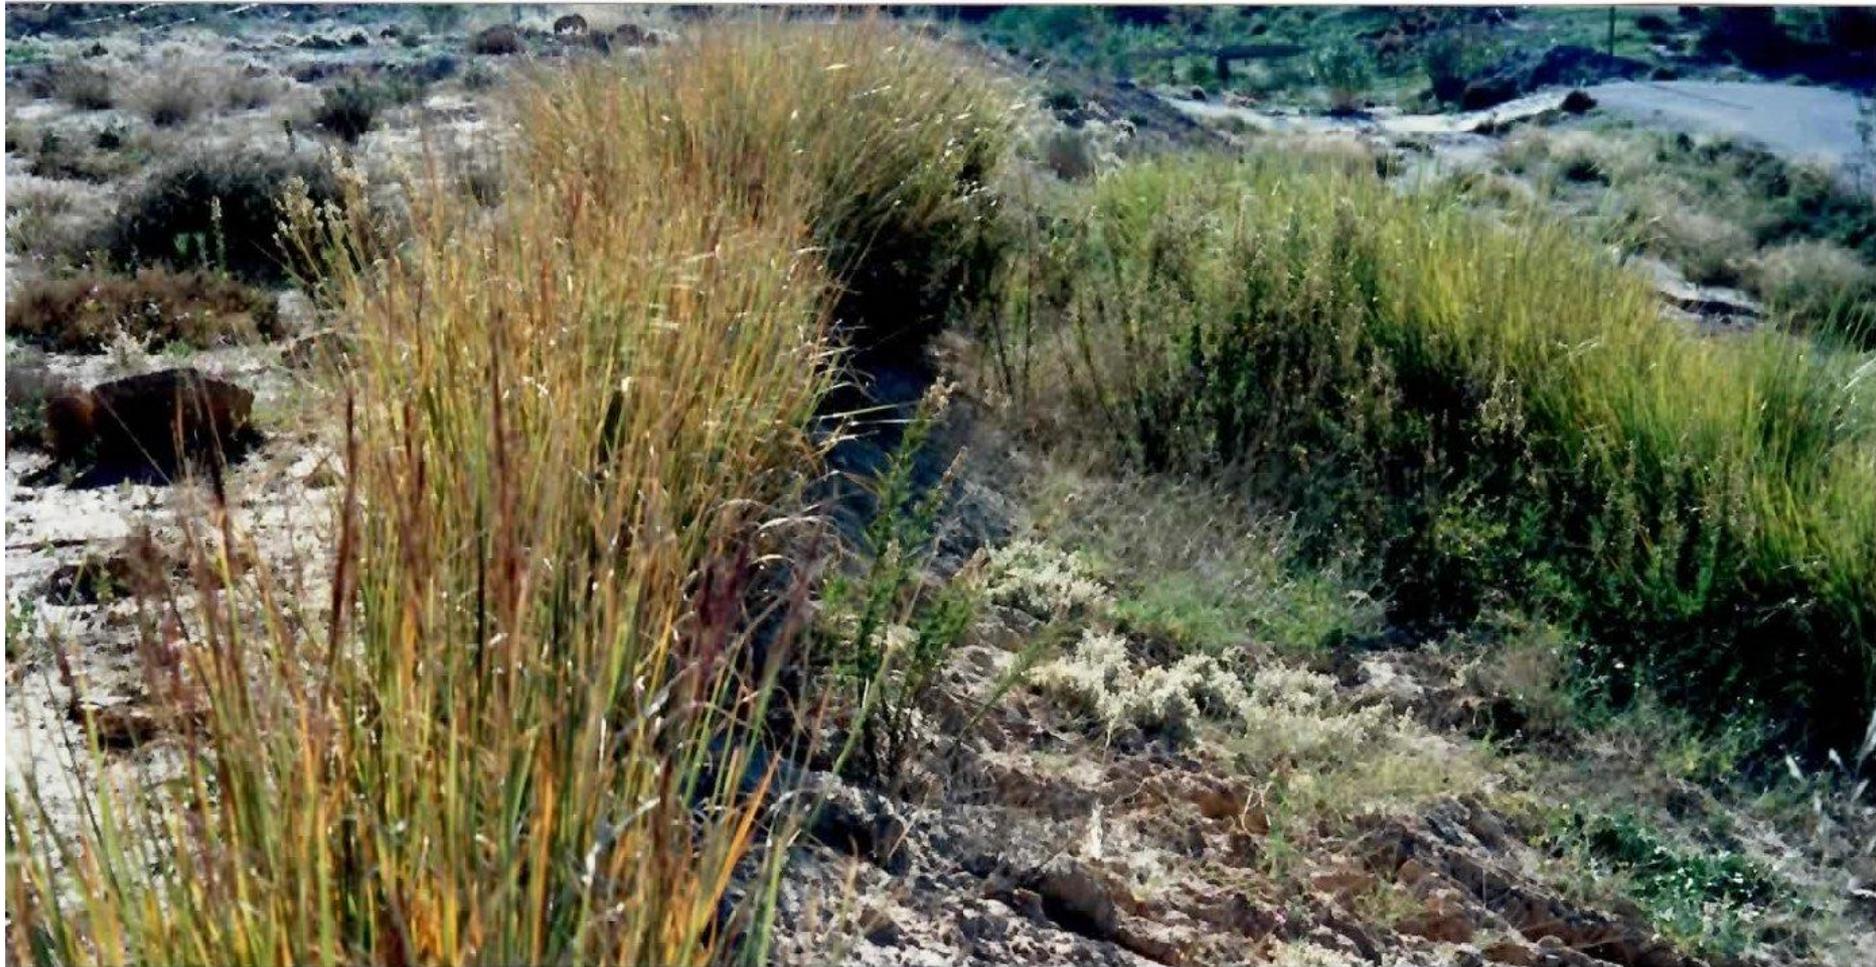
Excellent growth with no irrigation after 3 years on the drain at foot of the slope

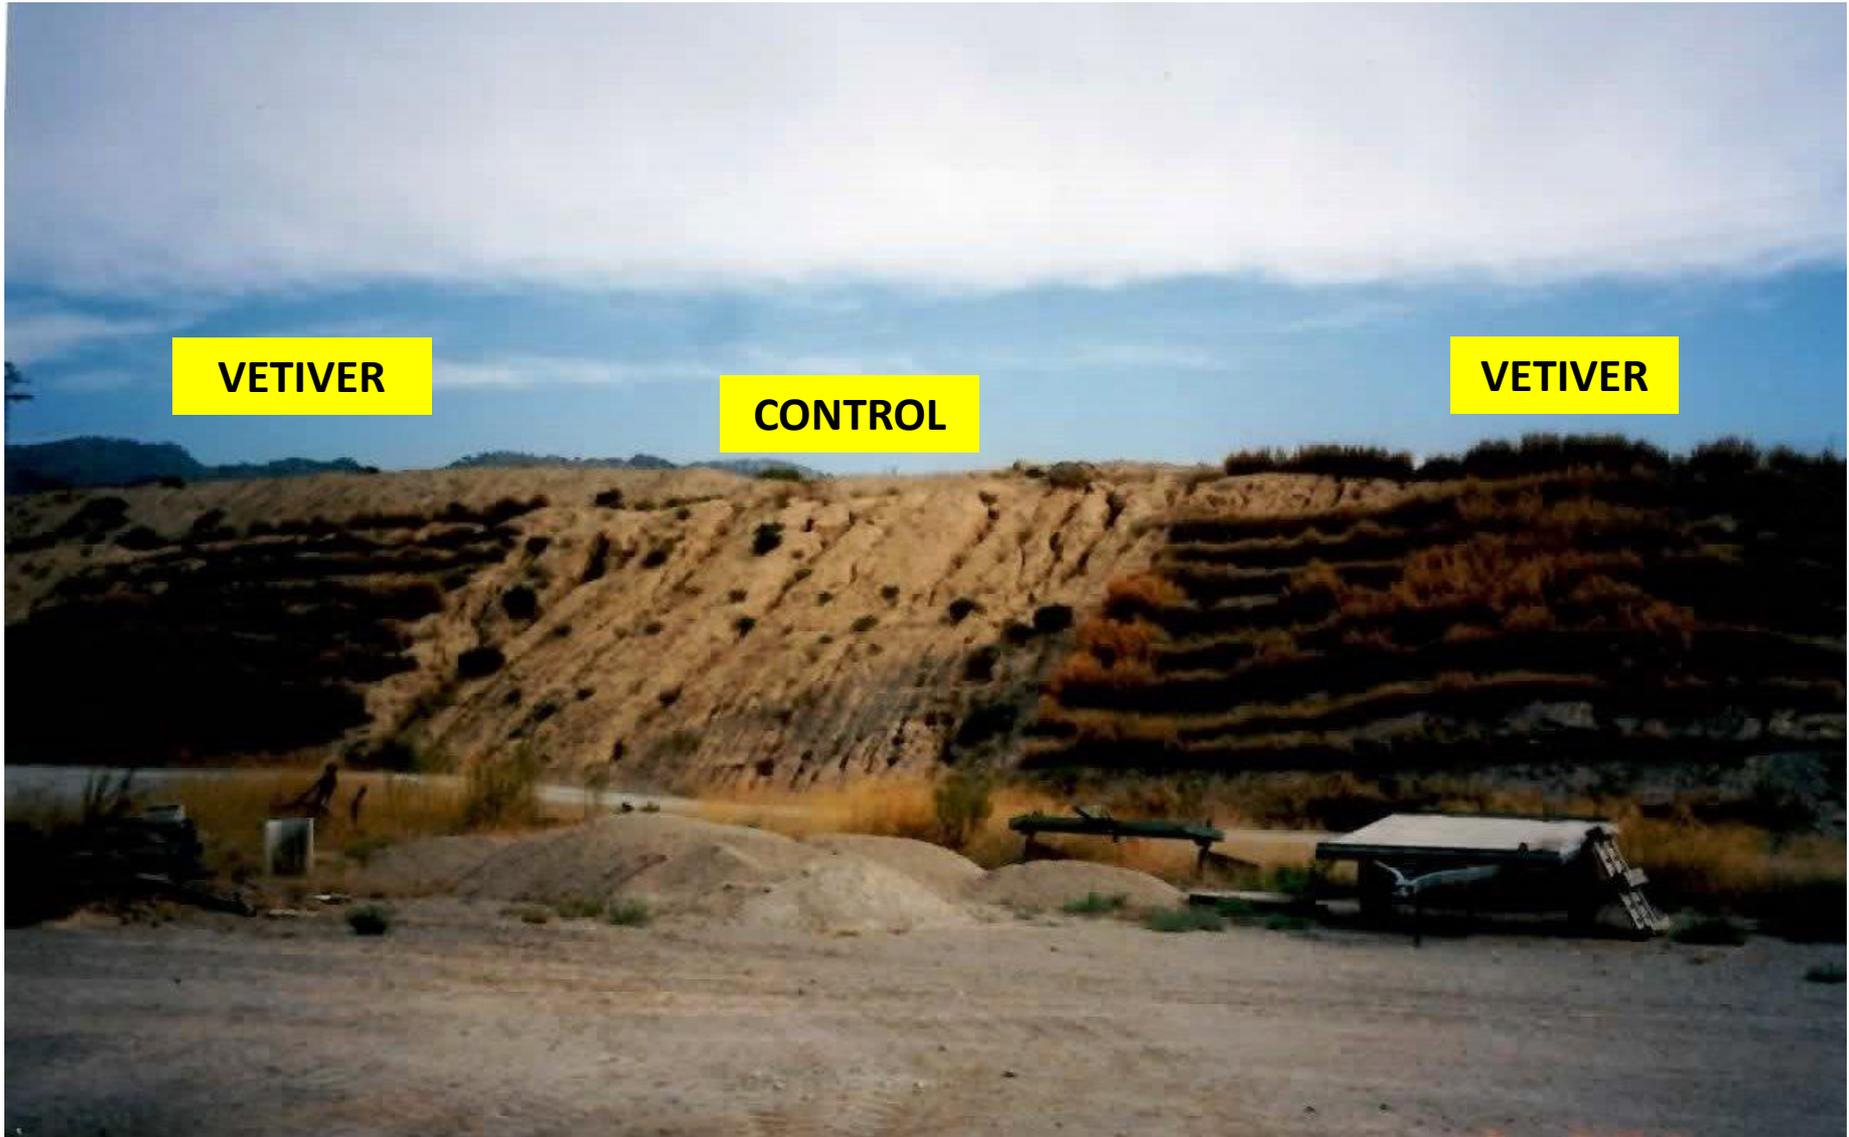
General view of Lorca site in 1998, 4 years after planting.

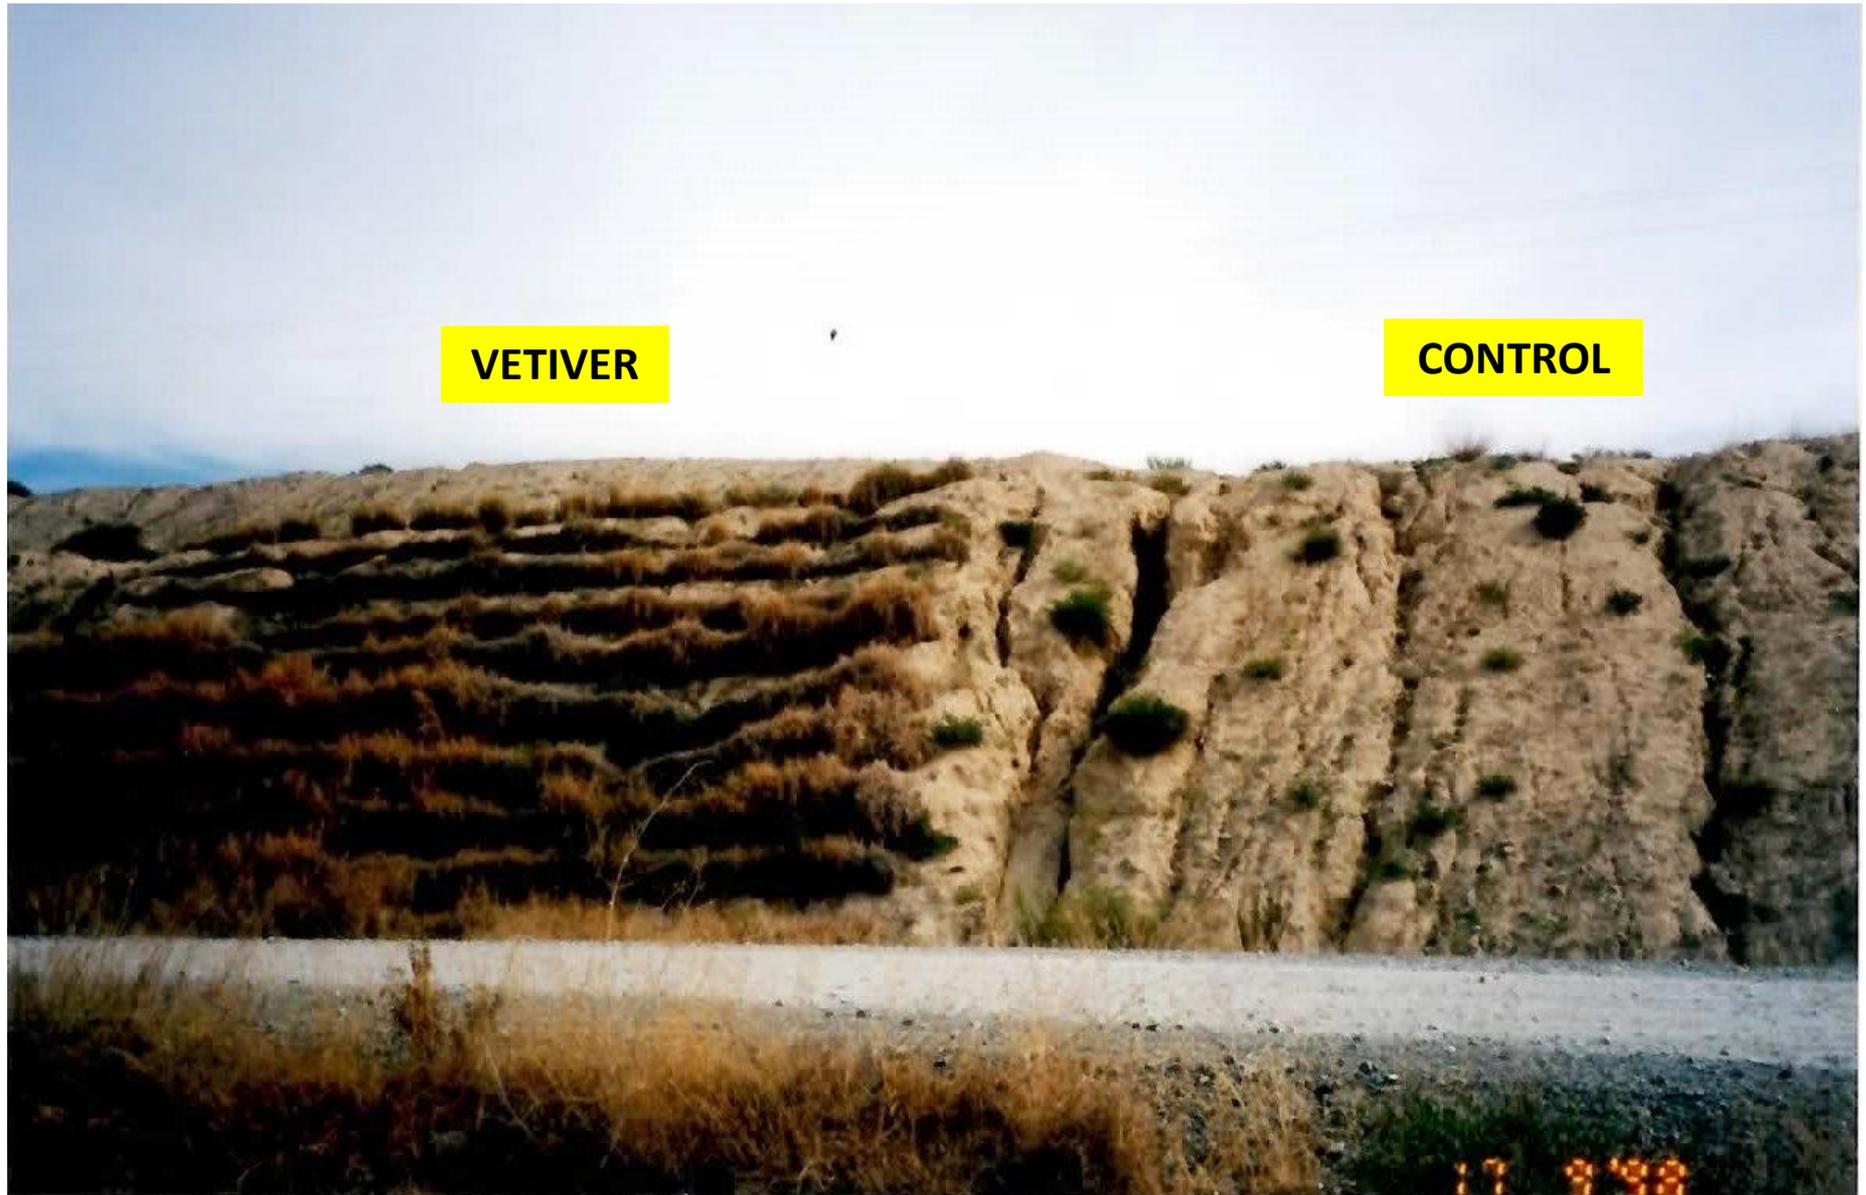
Contrast between vetiver and control plots at Lorca site, 4 years after planting.

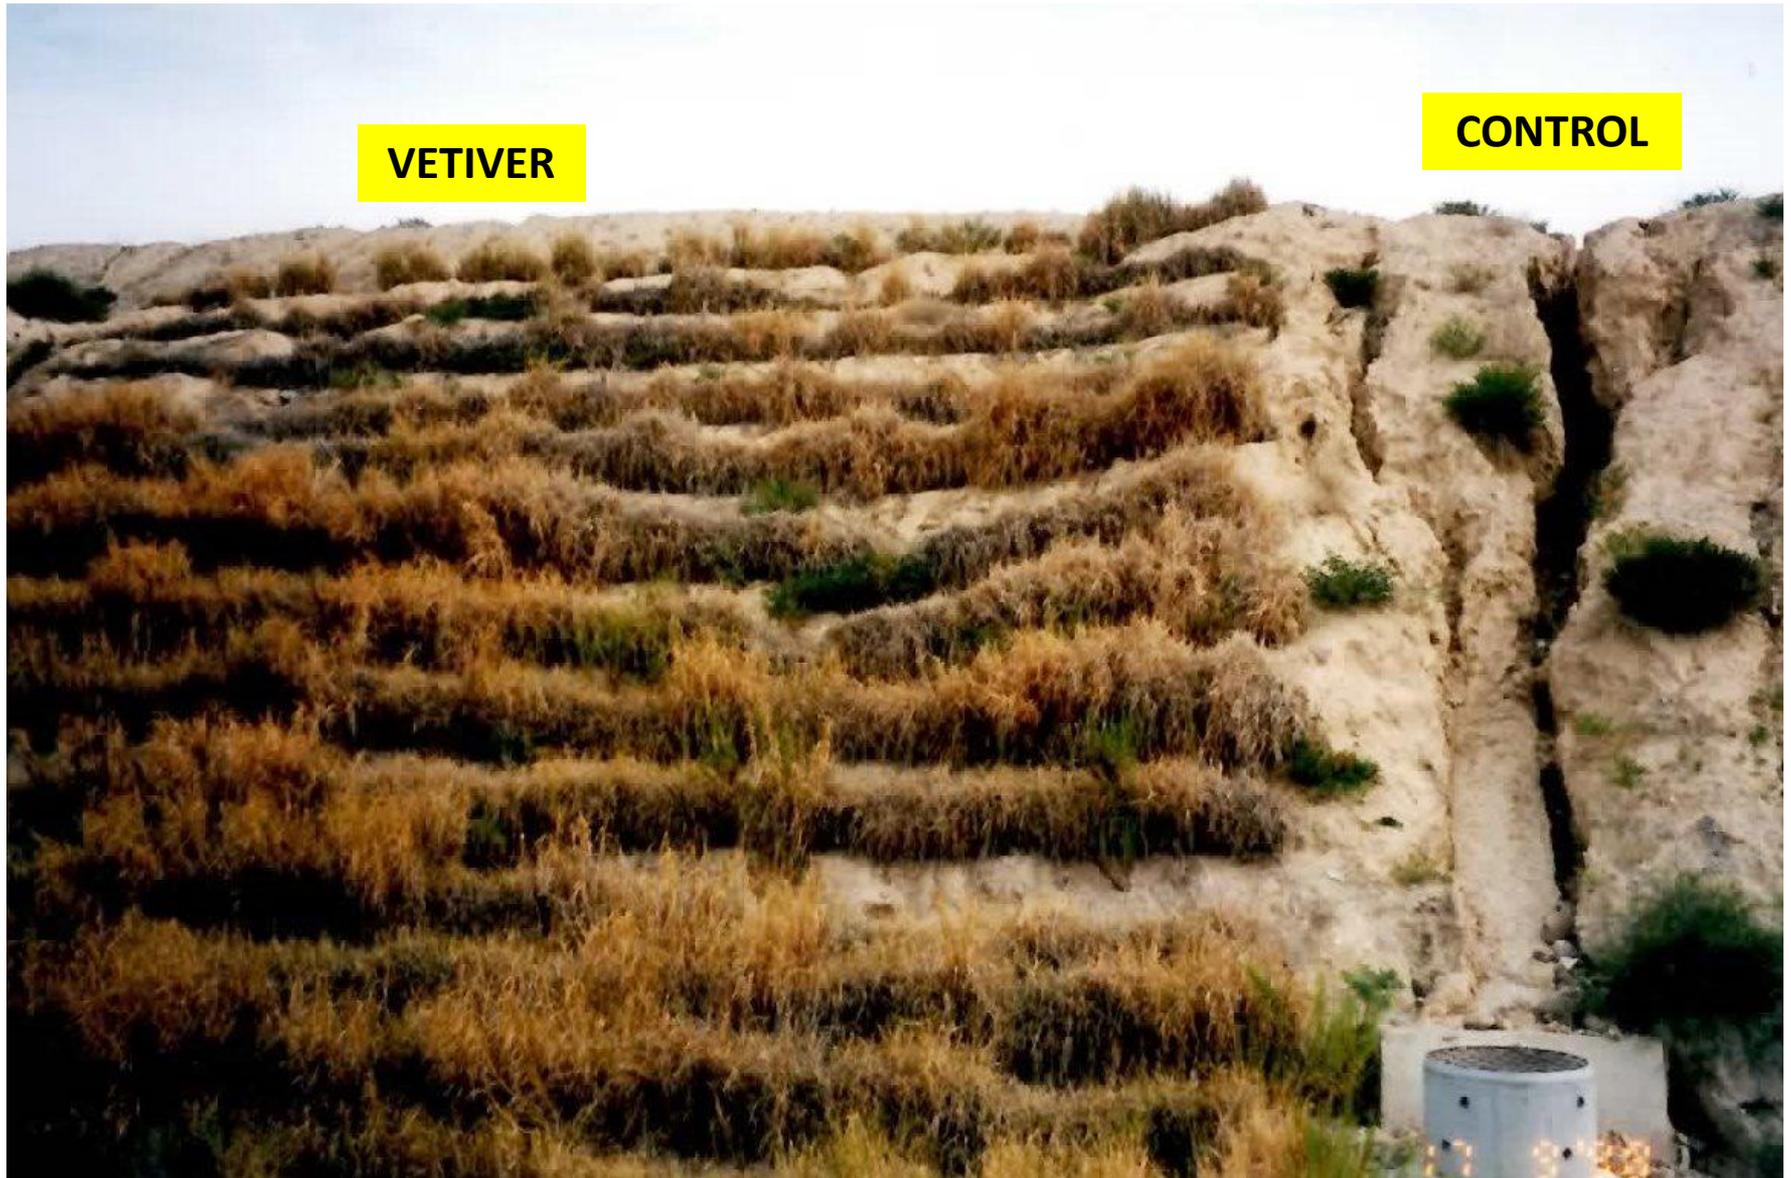
Contrast between vetiver and control plots at Lorca site with serious rill erosion in control plot.

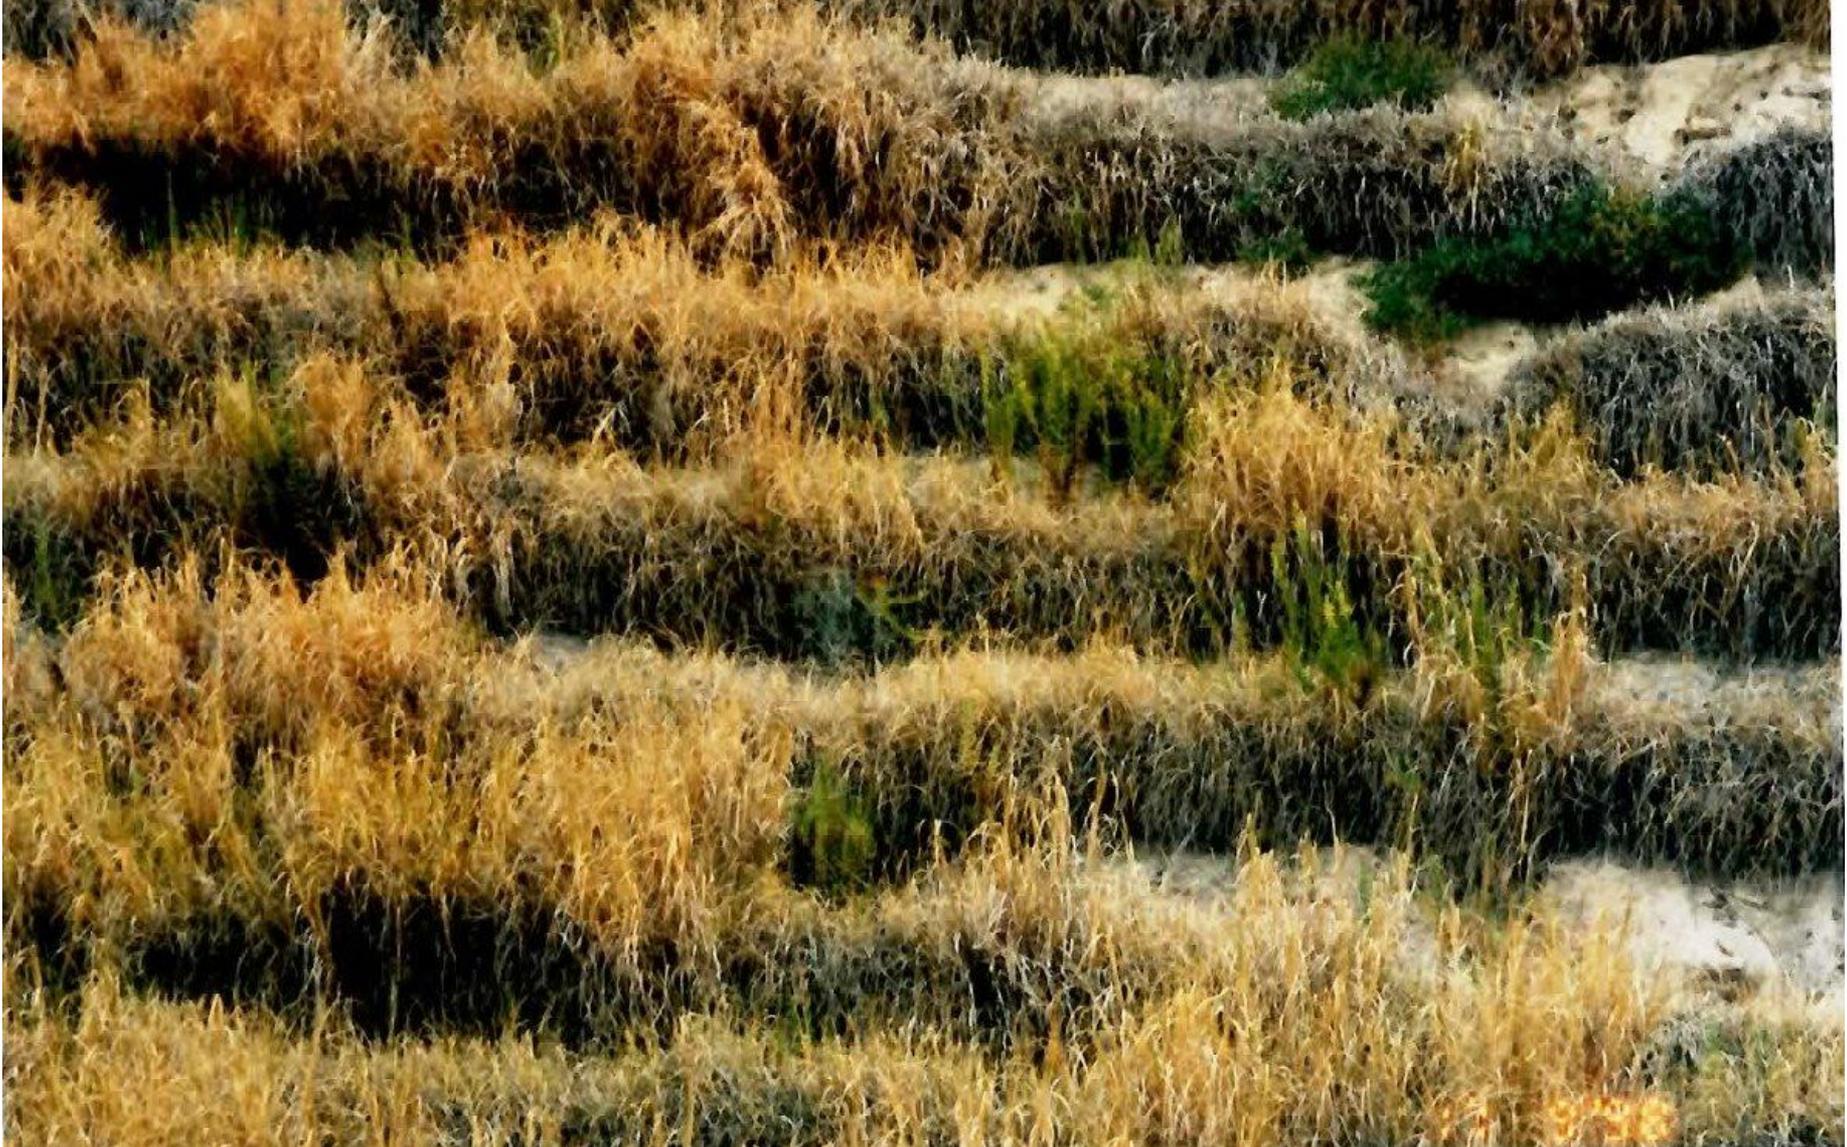
**Excellent vetiver growth with no irrigation at Lorca site,
4 years after planting.**

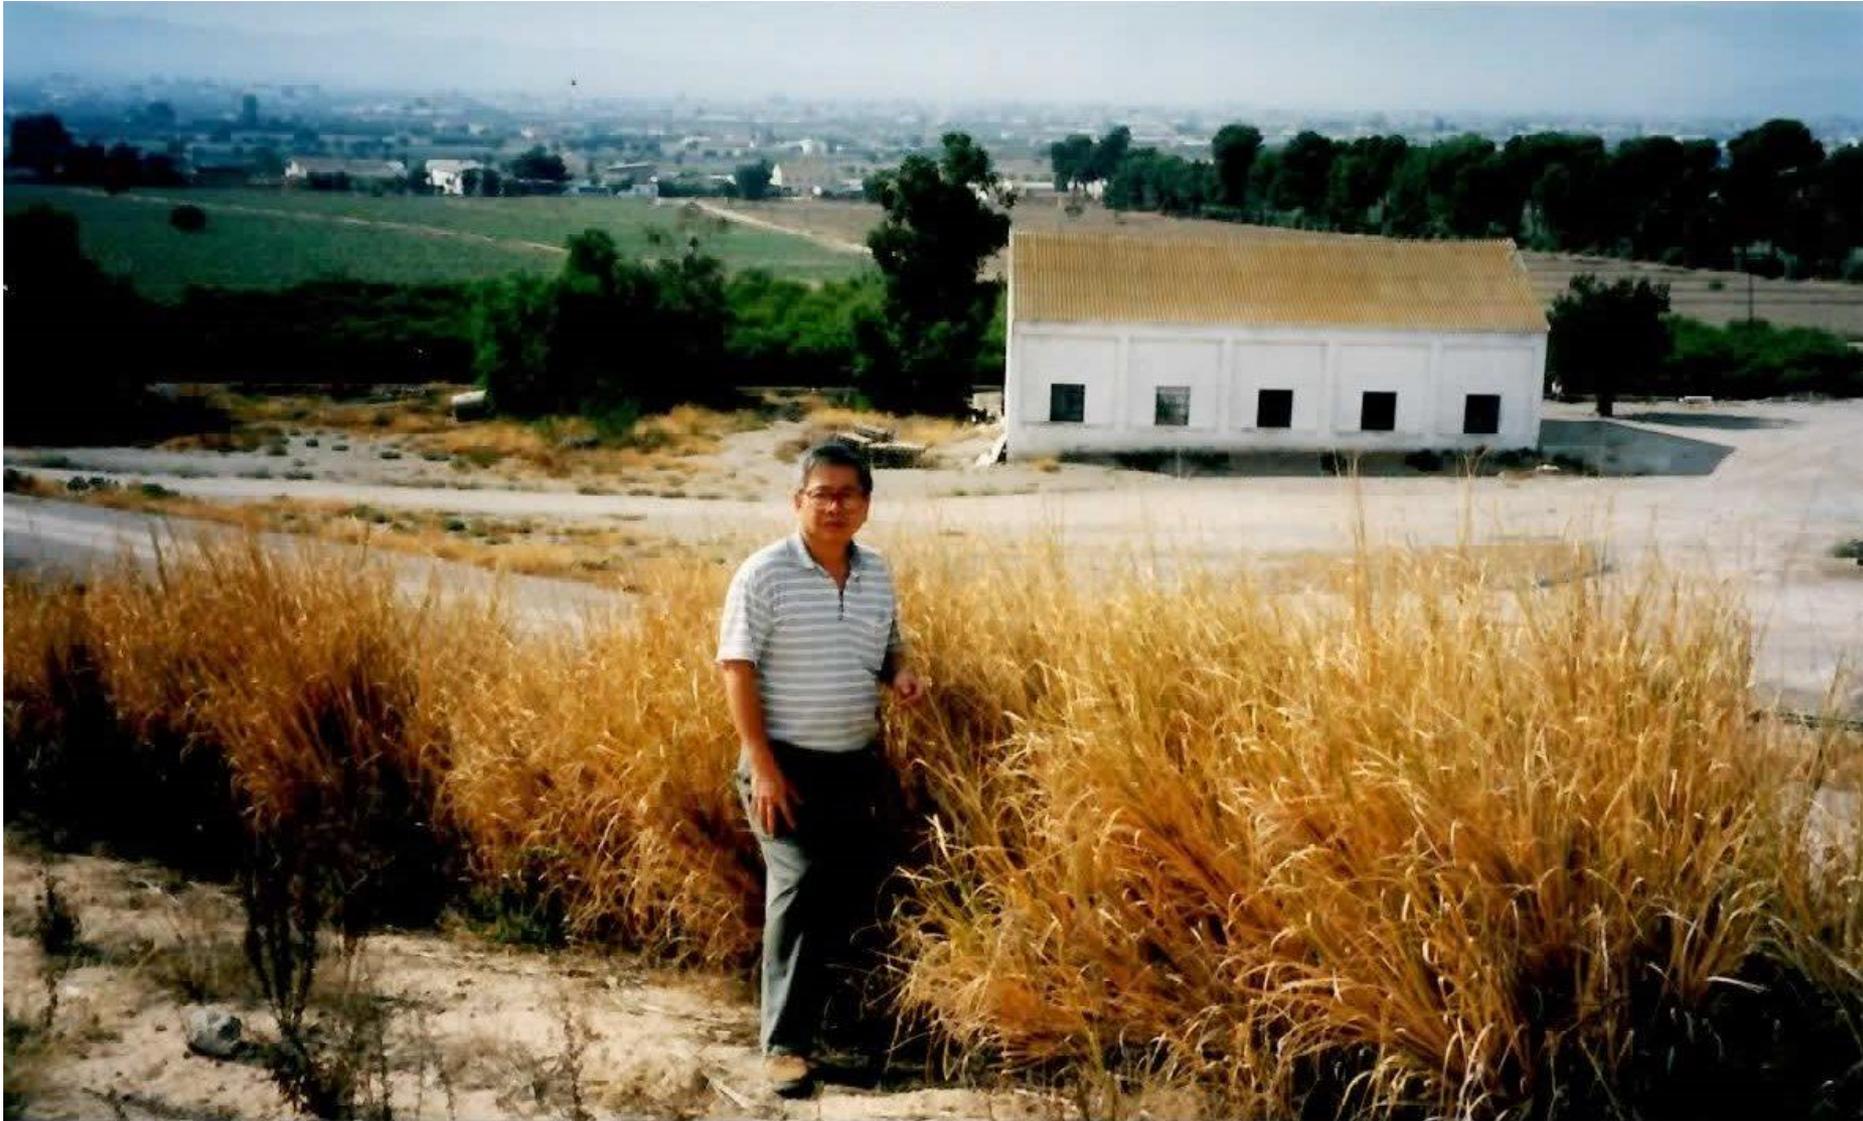
Four years after planting on drain at foot of the slope

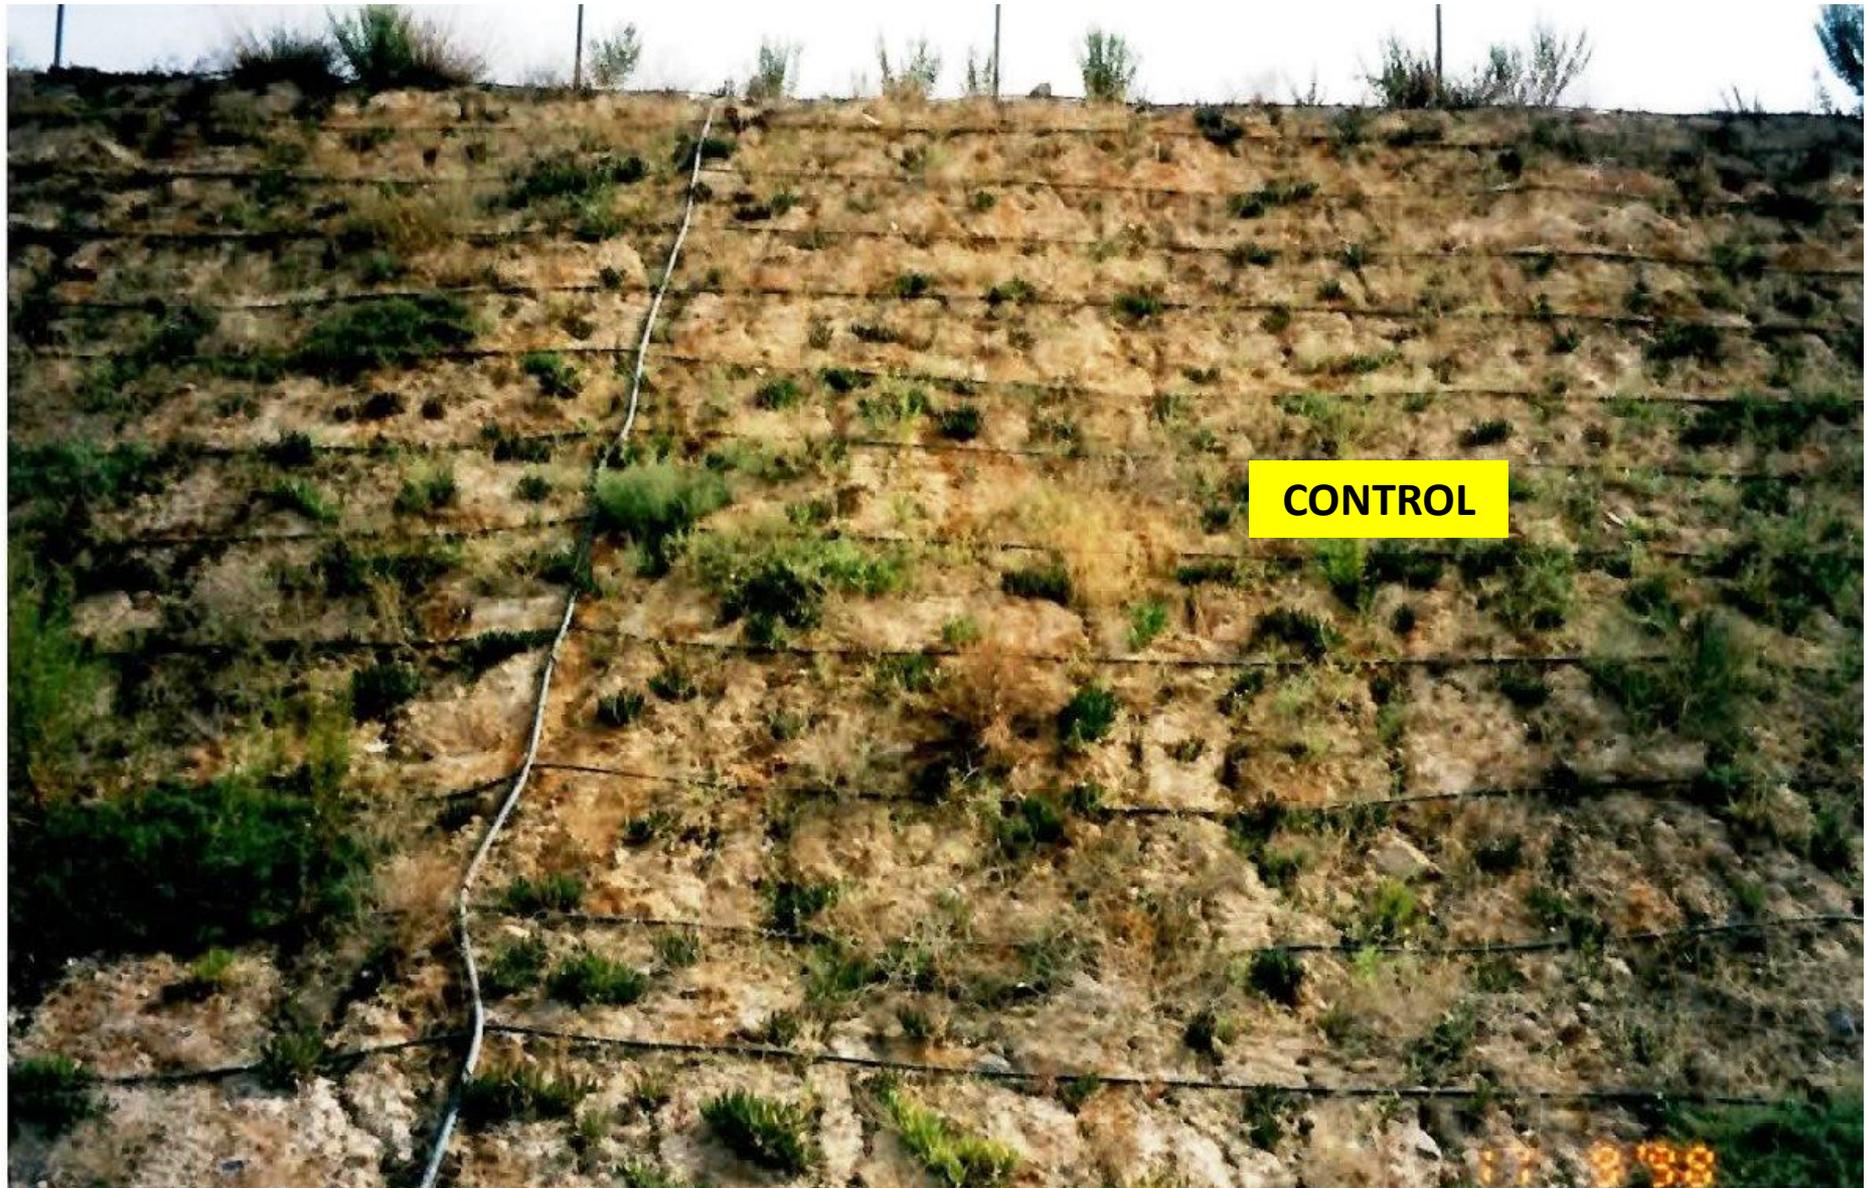
CONTROL PLOT Very little natural colonisation of native plants despite initial irrigation

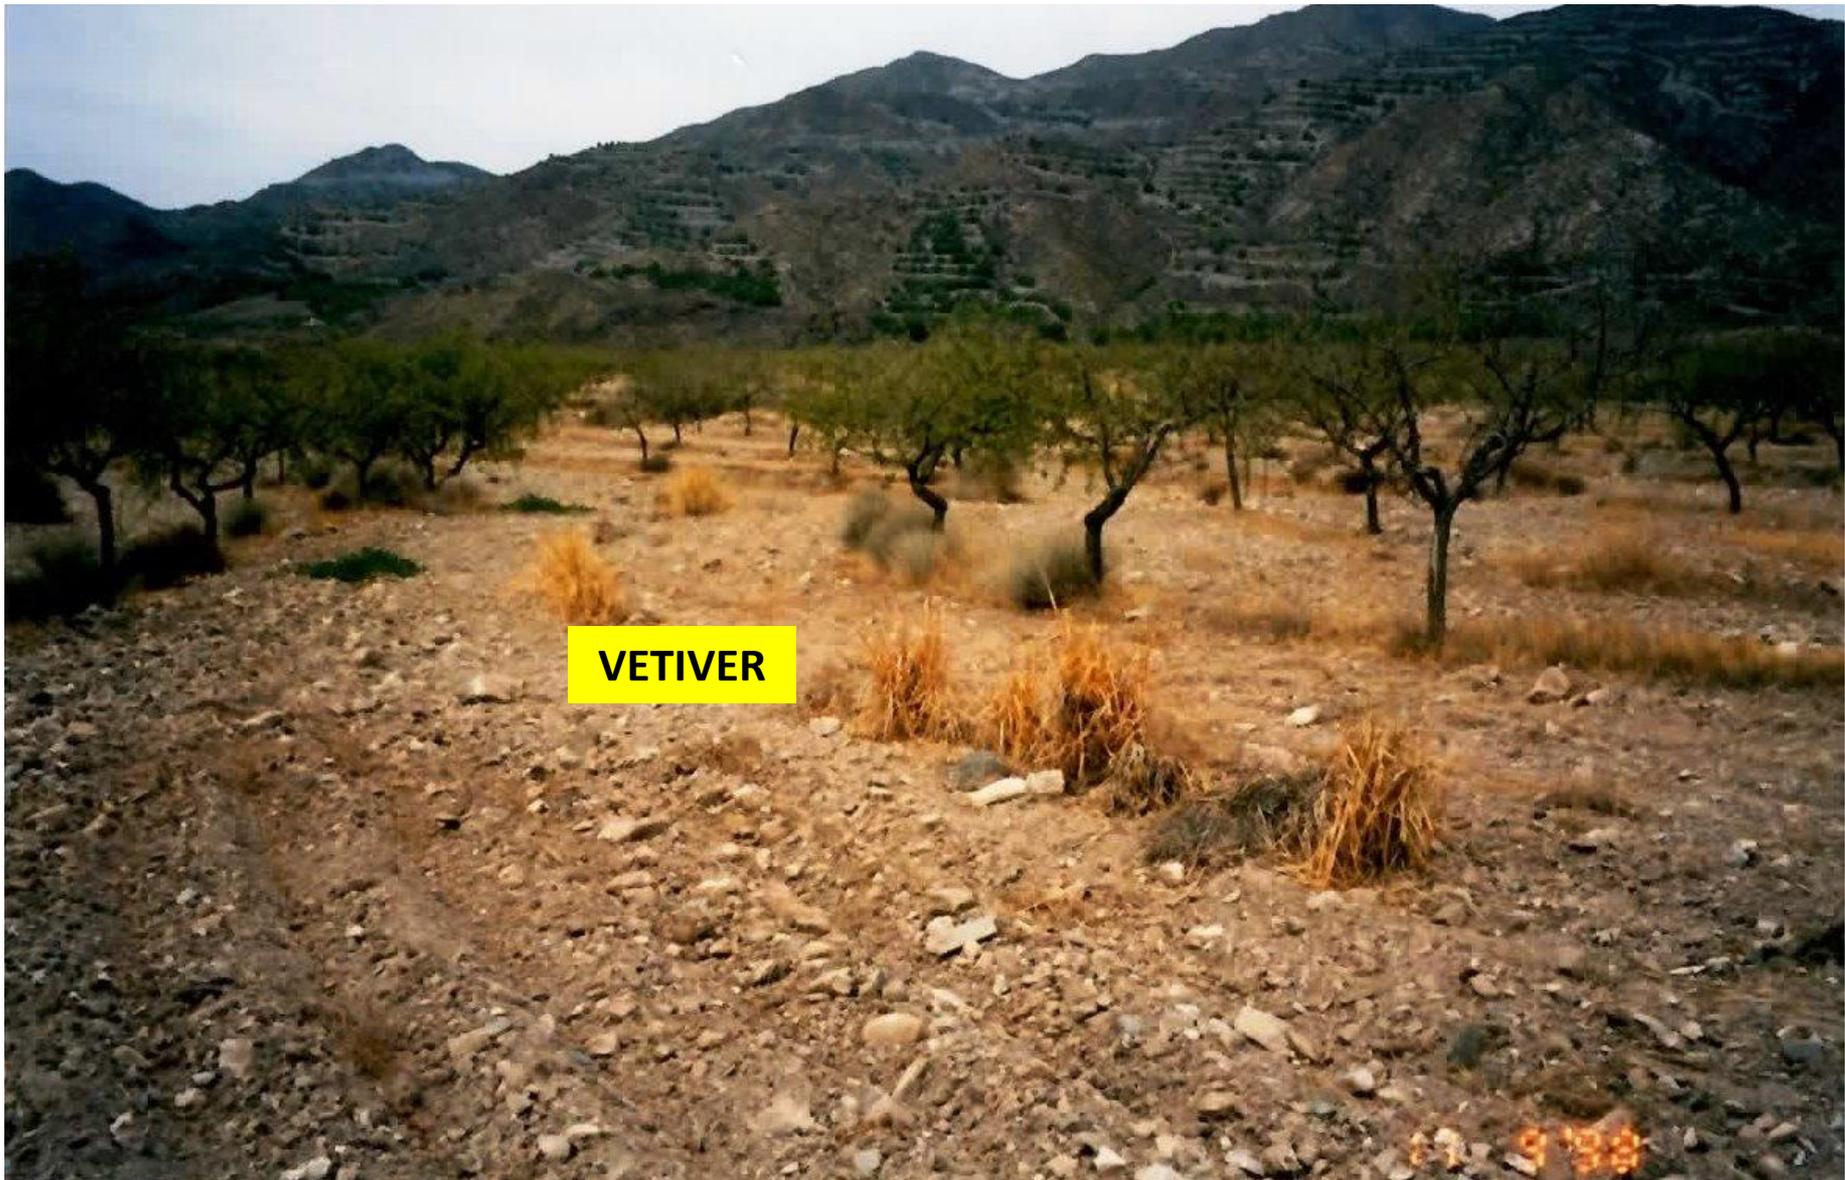
Vetiver row was accidentally sprayed with RoundUp
