VETIVER SYSTEM APPLICATIONS IN SPAIN AND PORTUGAL

Dr. Paul Truong

TVNI and Veticon Consulting

SPAIN – INFRASTRUCTURE PROTECTION

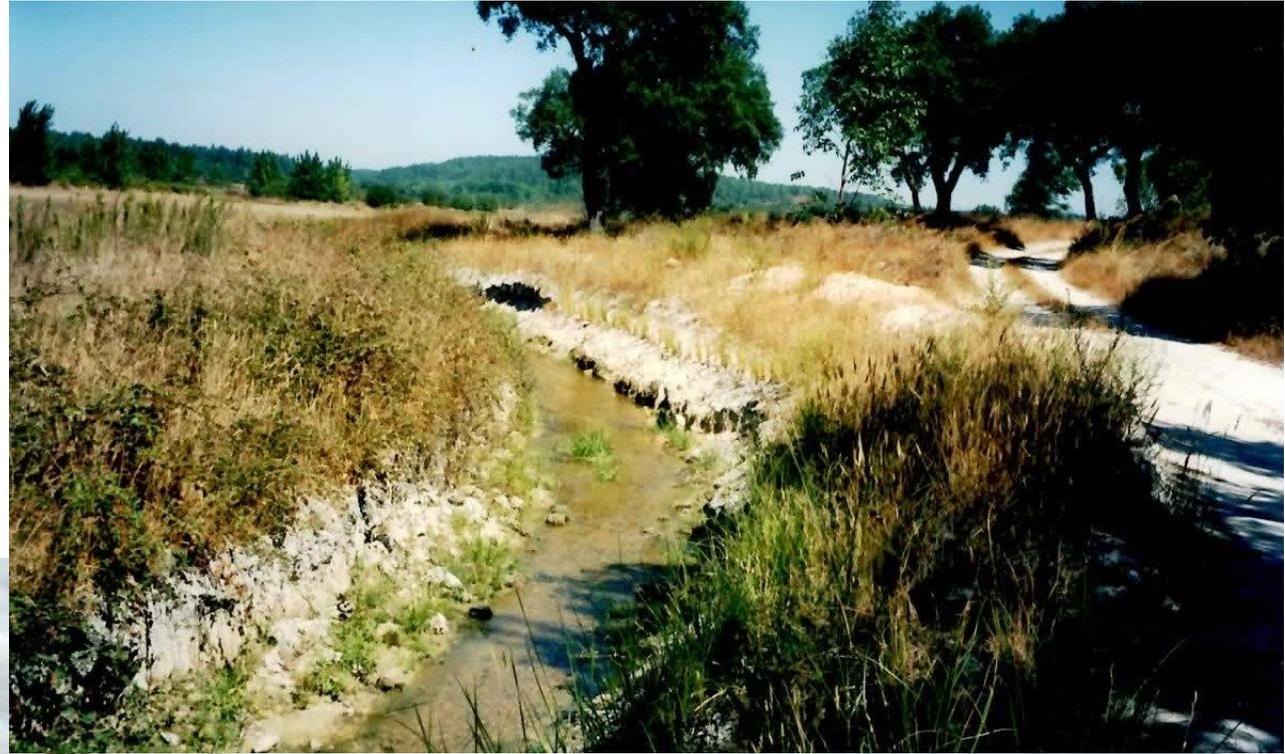
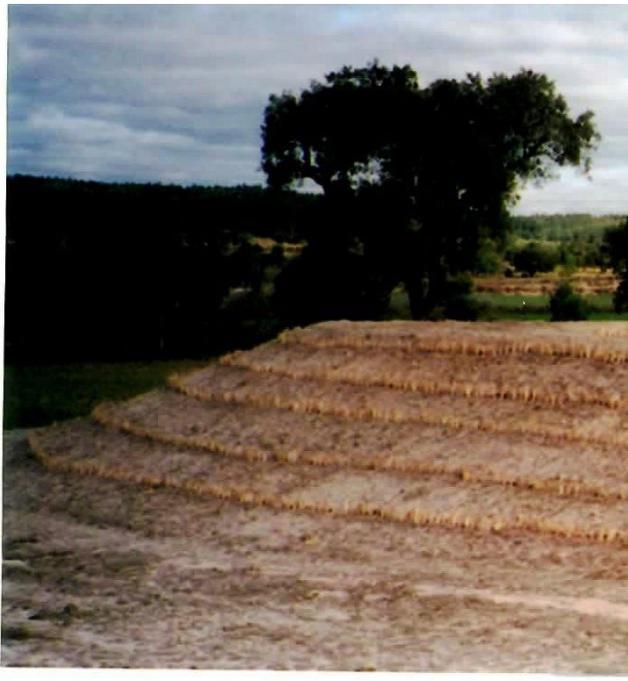
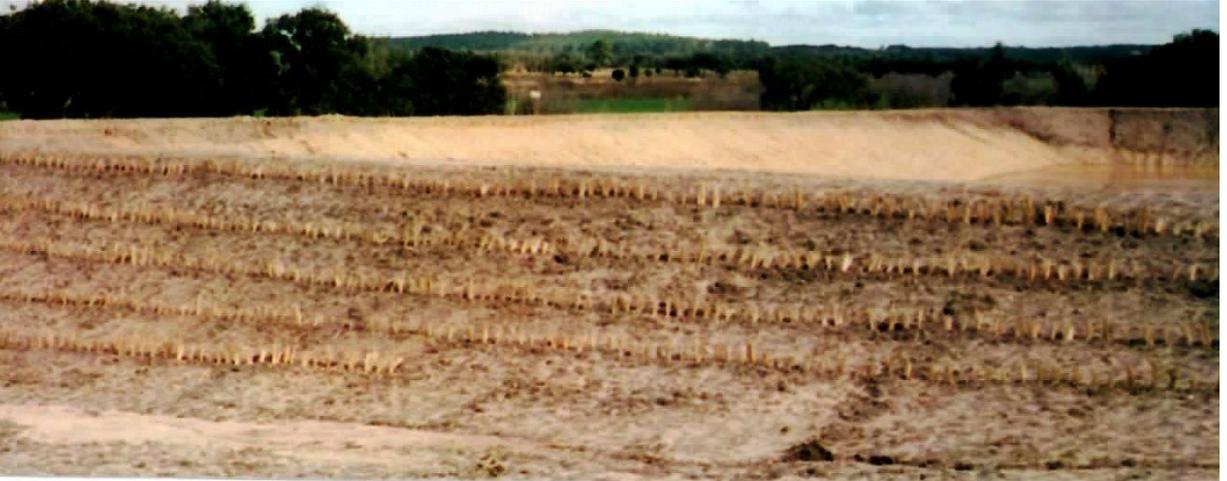
Antonio de Mello used vetiver to stabilise Creek bank, dam wall and other erosion control in his farm

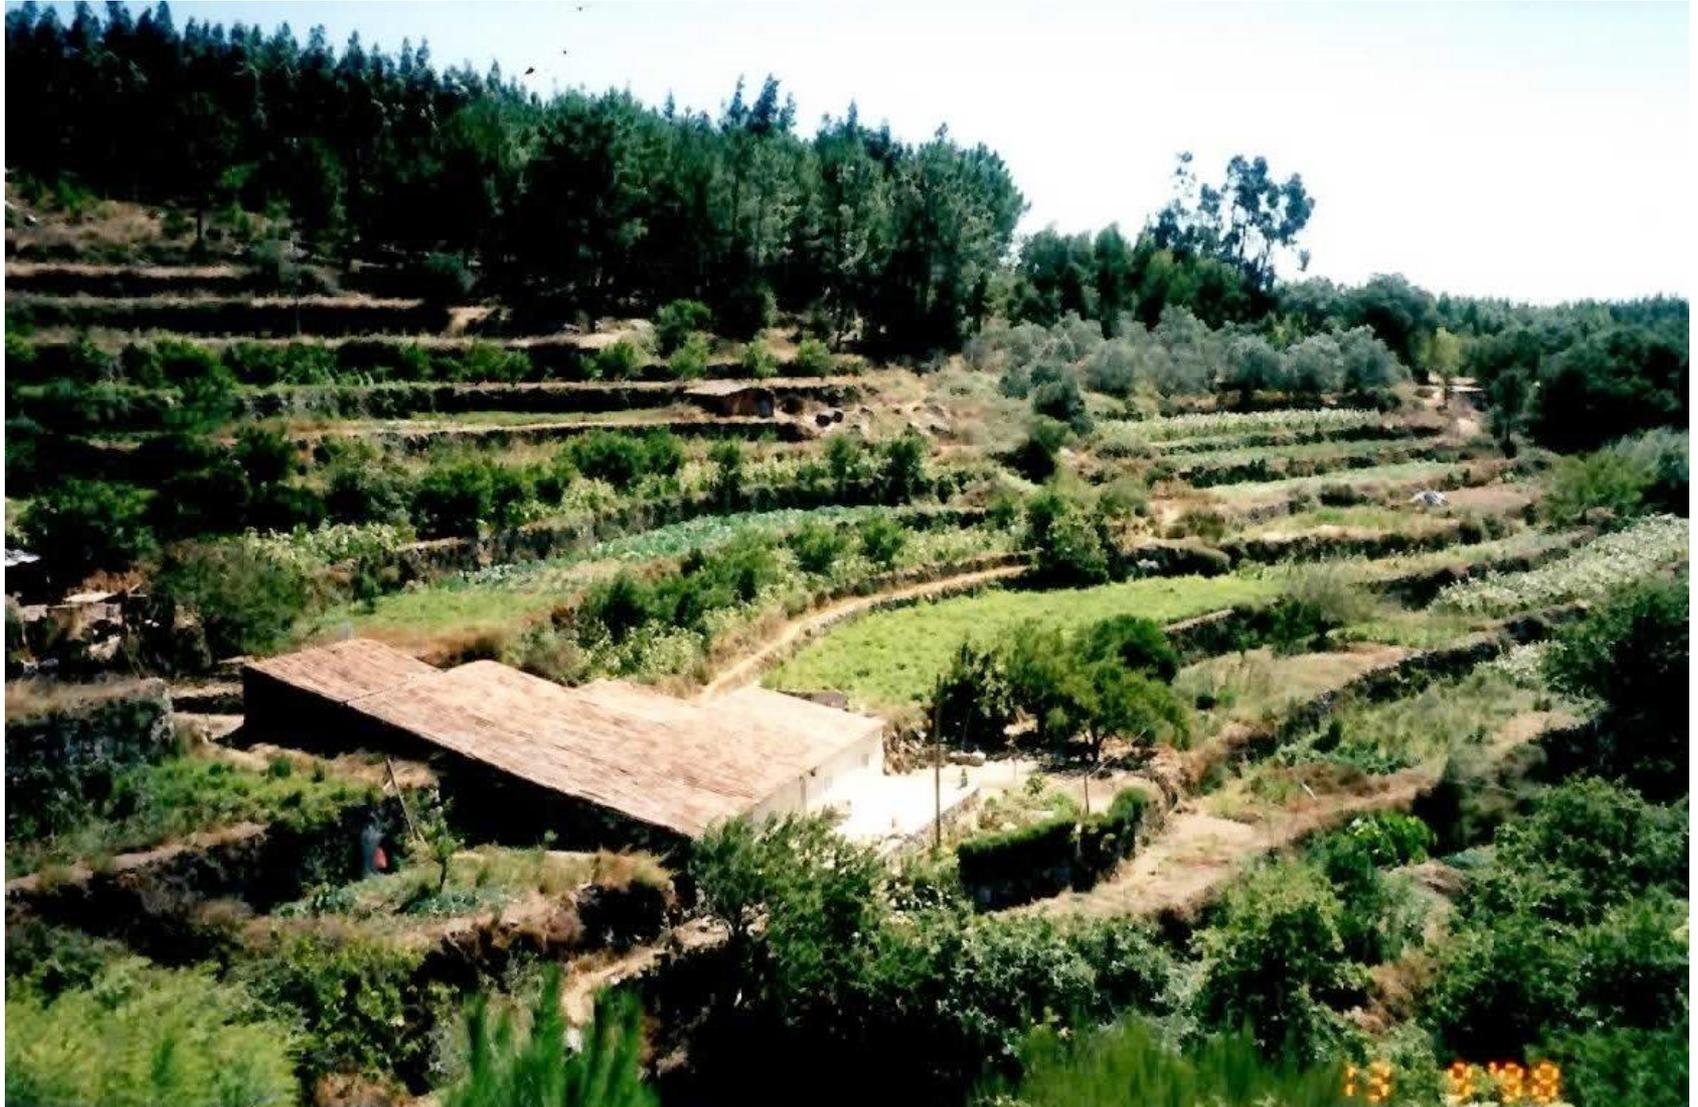
Ancient terraces at Monchique being used for horticultural production

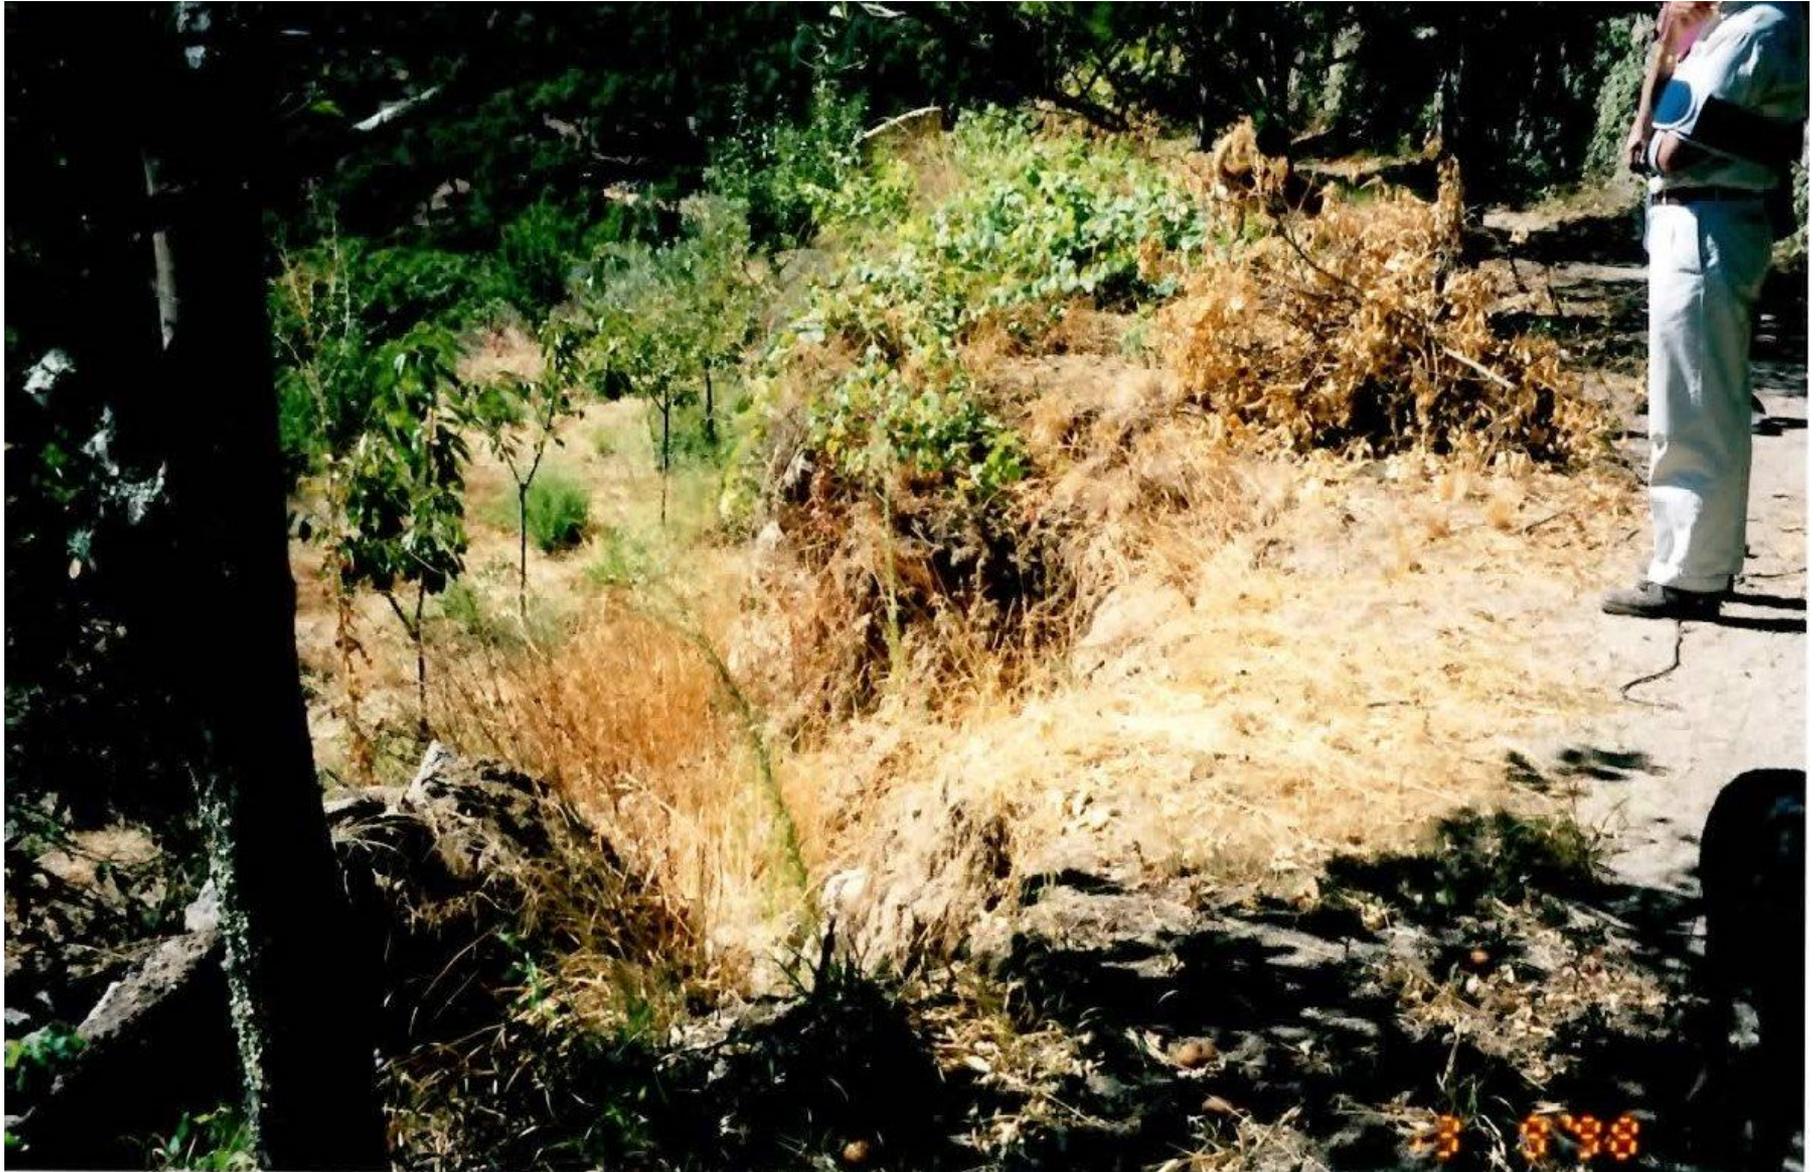
After centuries of neglect the terraces were collapsing. Vetiver grass was used to reclaim the terraces

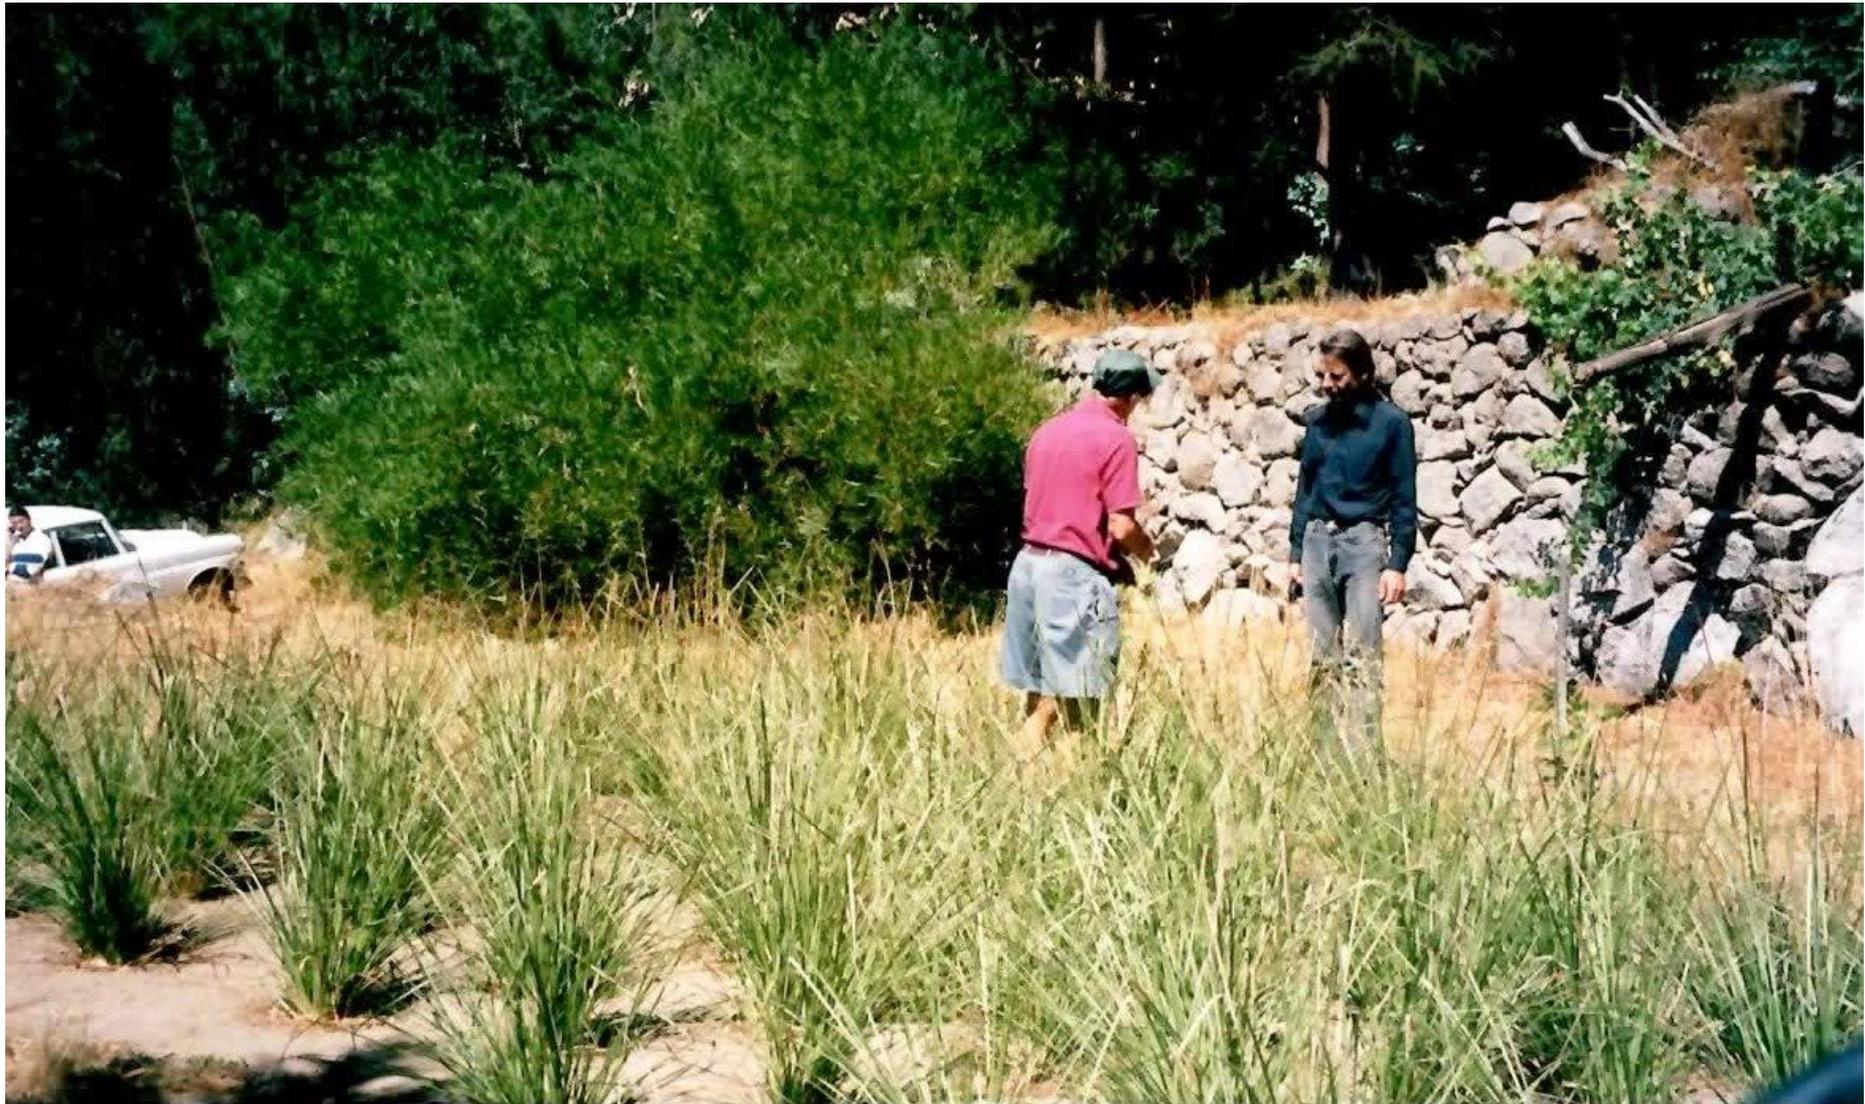
Onsite community nursery was established to provide planting materials for terrace restoration project

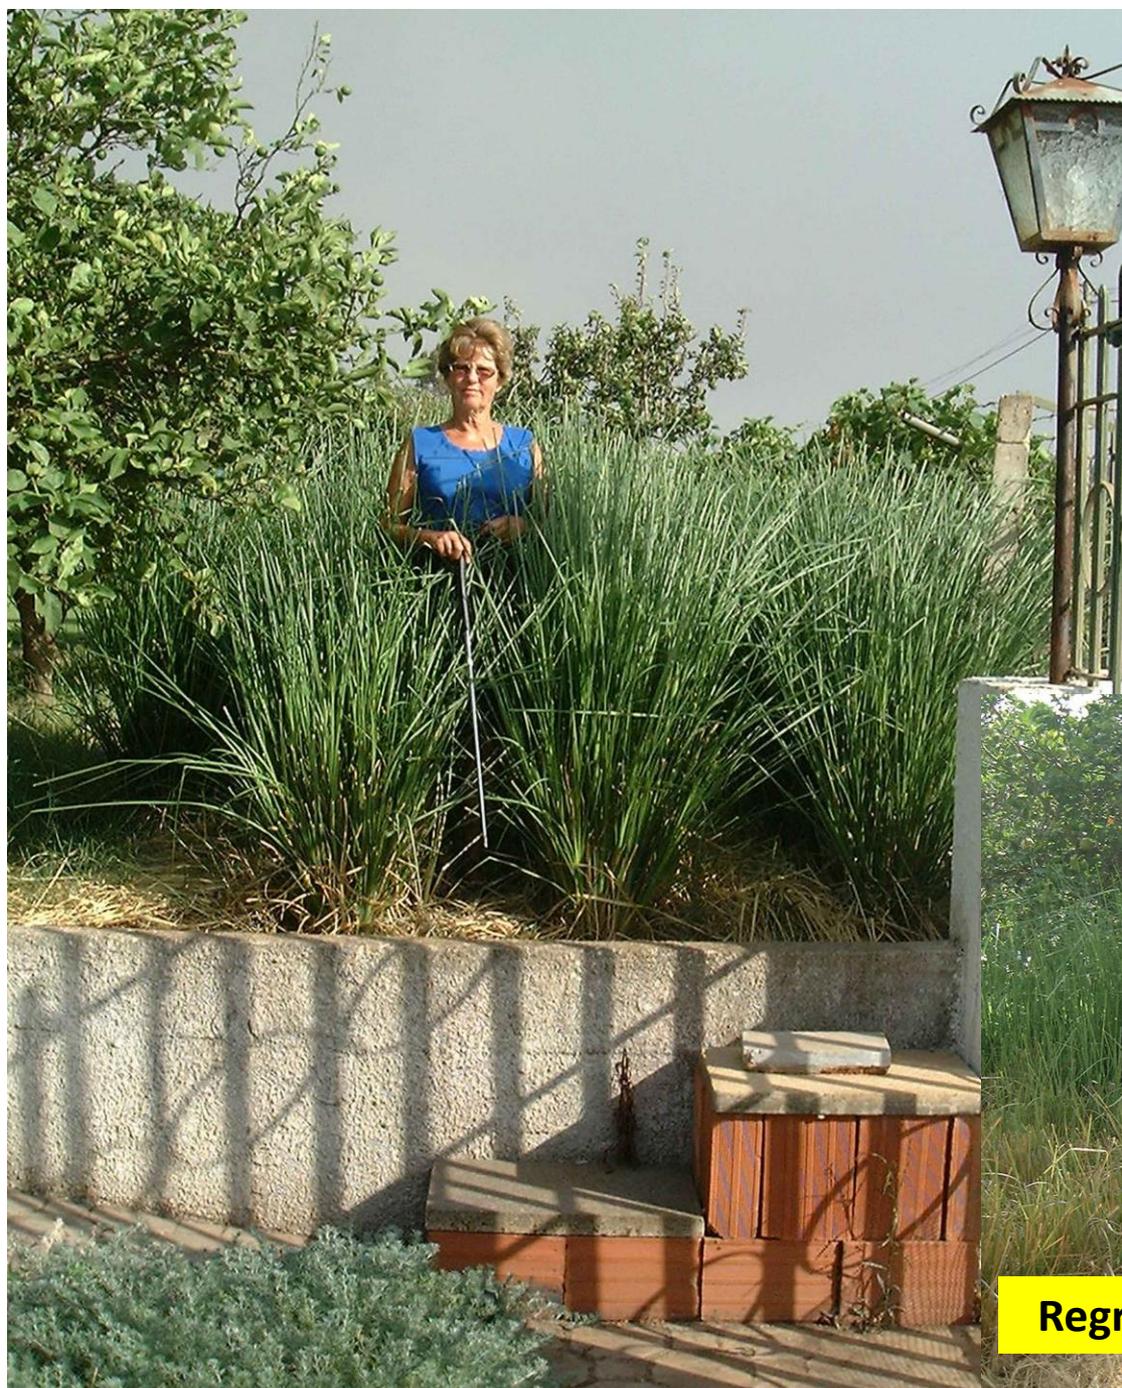
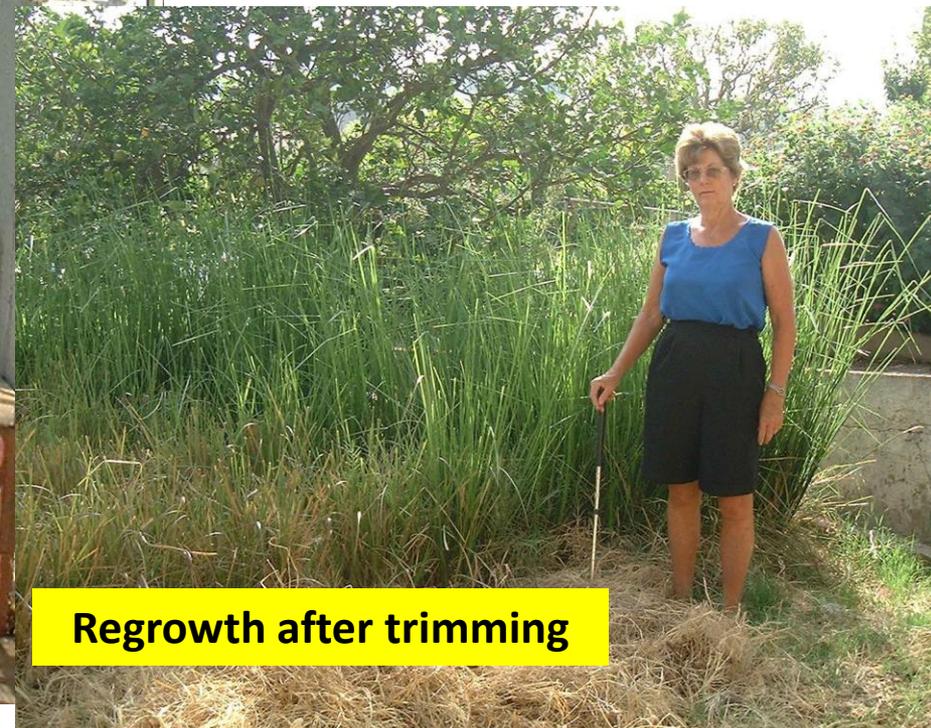
**Vetiver planting on
back yard to absorb
domestic sewage
effluent form septic
tank in Algarve**

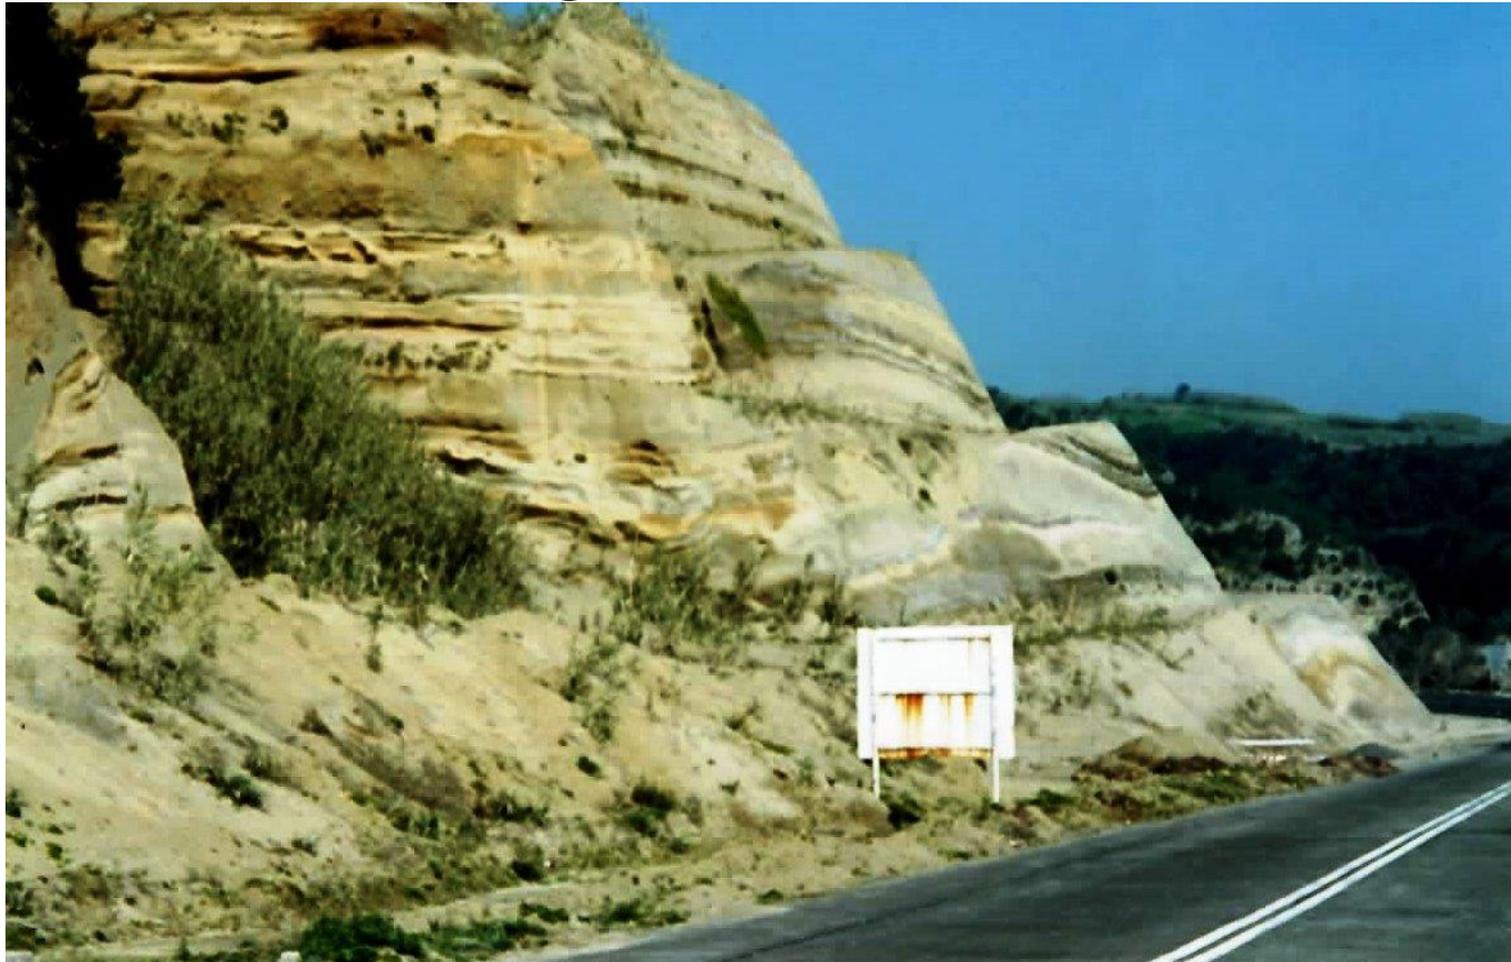
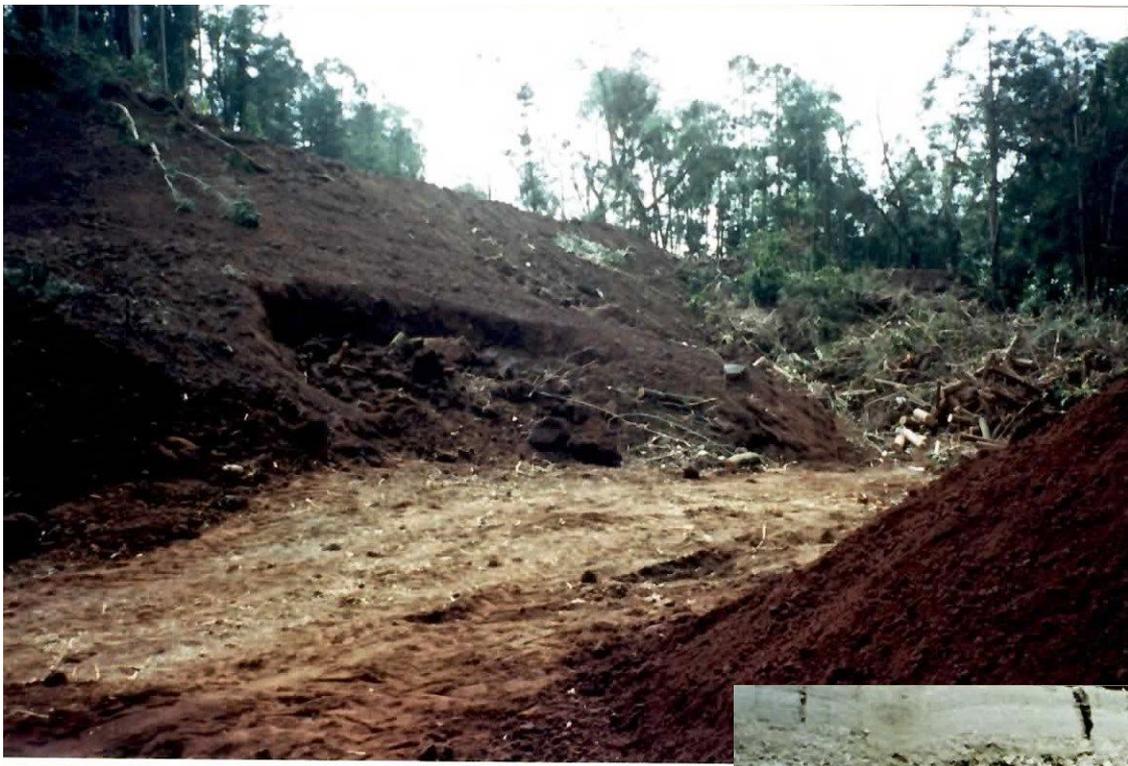
The potential use of Vetiver was also recognised for stabilising highly erodible steep slopes derived from volcanic pumice on Azore island. Frequent life threatening landslides occurred during the rain season

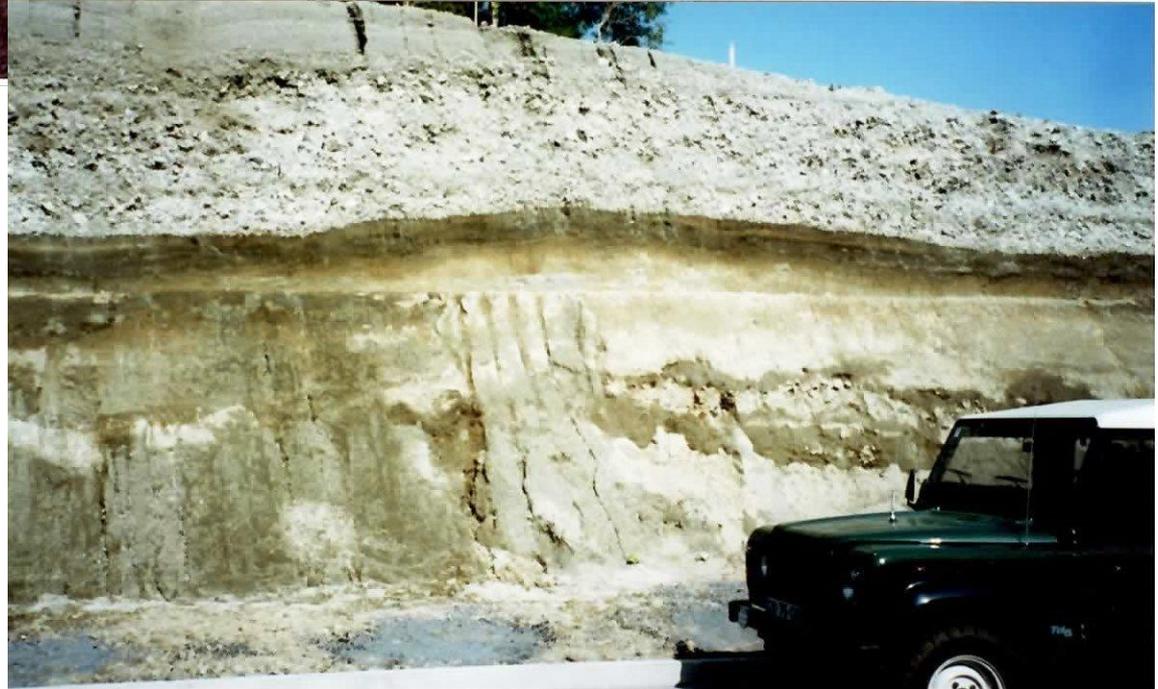
Frequent landslides and mudslides during the rain season
