Shoreline Erosion Advisory Service

A Resource for Shoreline Landowners and Communities

Aaron Wendt
Virginia Department of Conservation and Recreation

July 13, 2018
Westmoreland State Park
Montross, VA

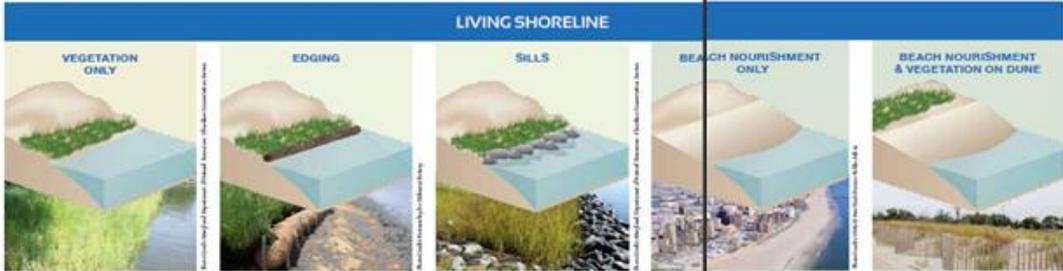
GREEN - SOFTER TECHNIQUES Small Waves | Small Fetch | Gentle Slope | Sheltered Coast

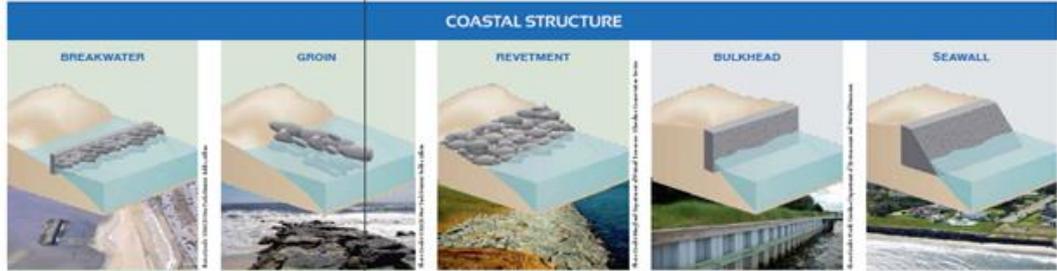
GRAY - HARDER TECHNIQUES Large Waves | Large Fetch | Steep Slope | Open Coast

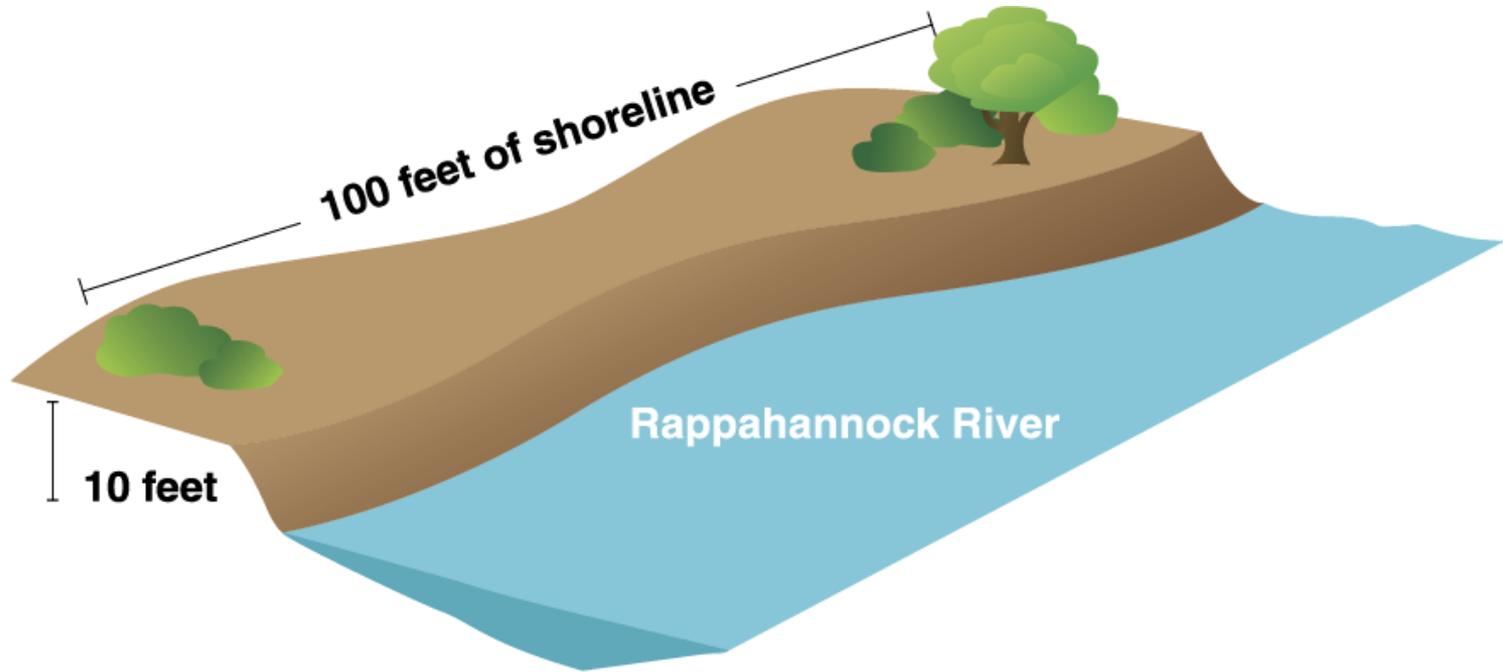
Annual erosion rate = 1 foot

46.8 tons of sediment
34 pounds of nitrogen
22.5 pounds of phosphorus

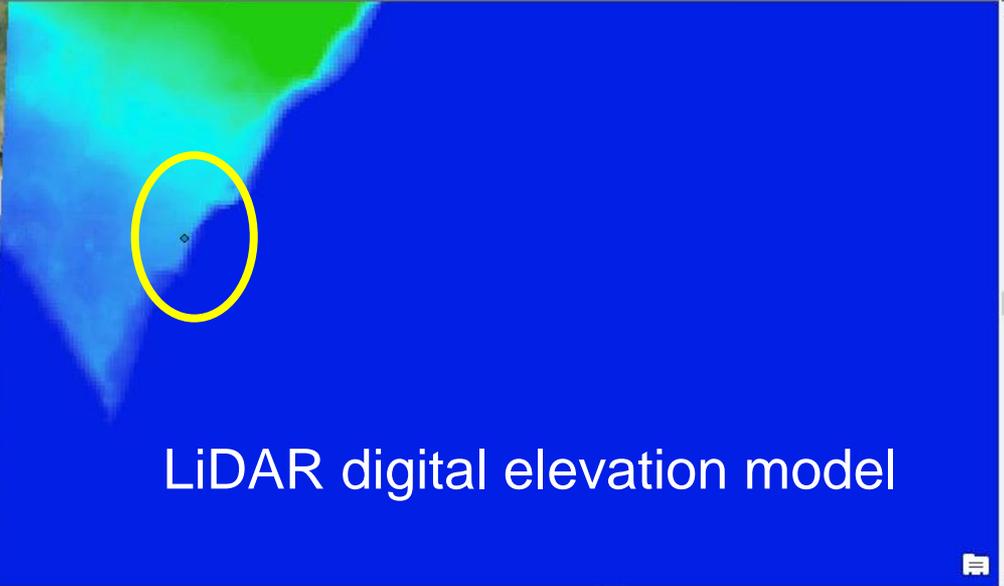
LiDAR digital elevation model

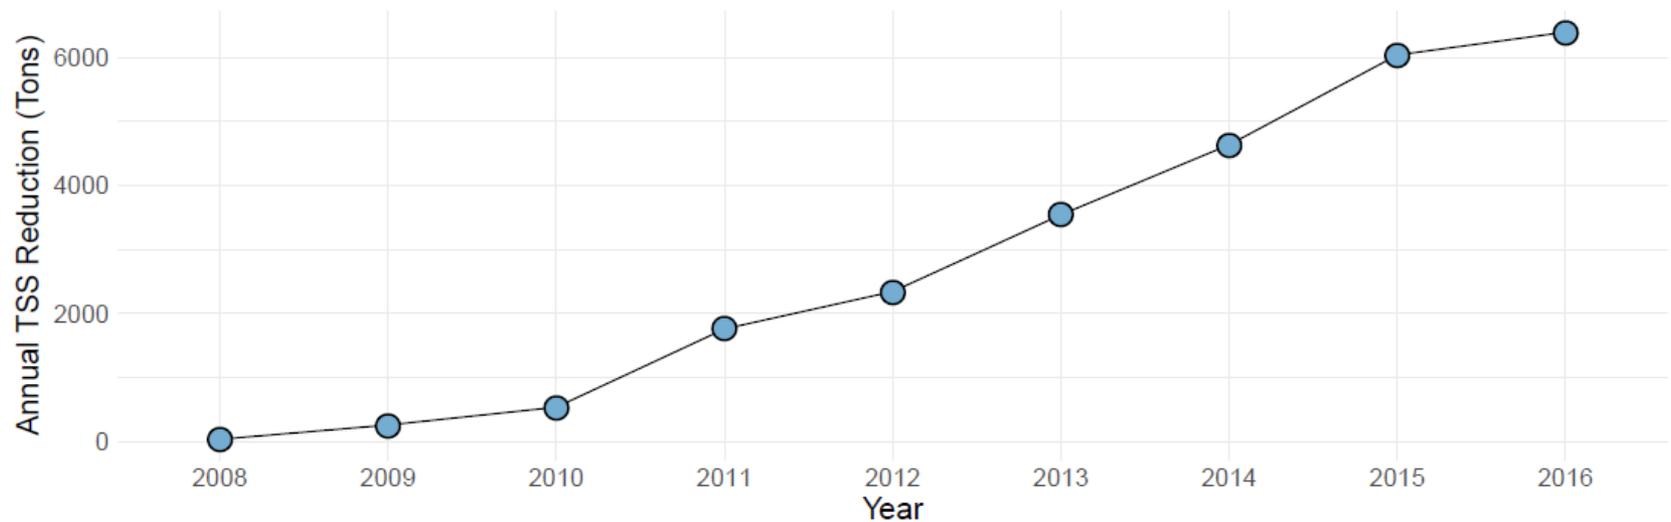
Cumulative Annual TSS Reduction

- 5 year BMP life
