# Sample Home Inspection Report

1000 S. Anywhere Street

August 19, 2011

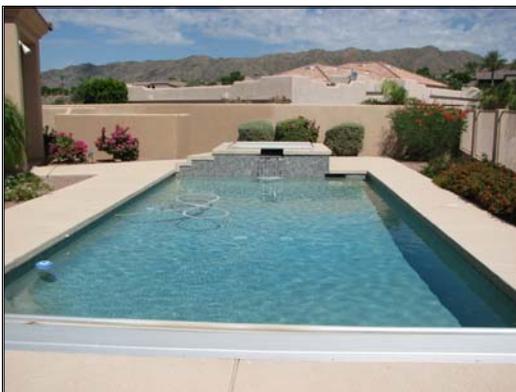
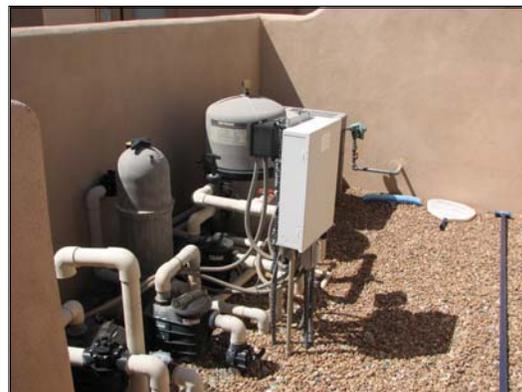
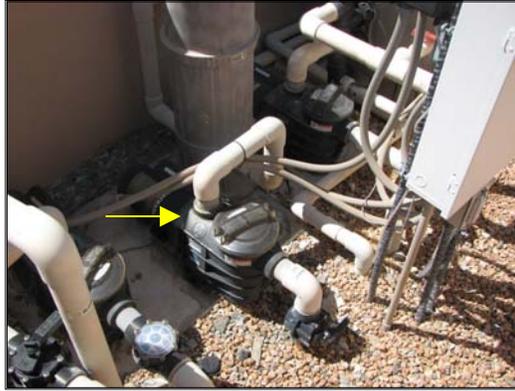
A leak was observed at the pool pump equipment (center pump/motor). We recommend further evaluation of the swimming pool equipment and repairs as appropriate by a swimming pool specialist.

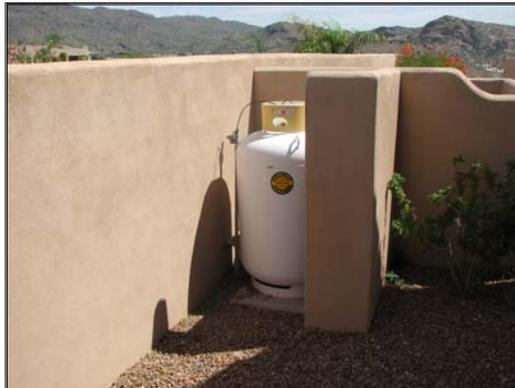
Note: The fuel source for the spa/pool is propane.

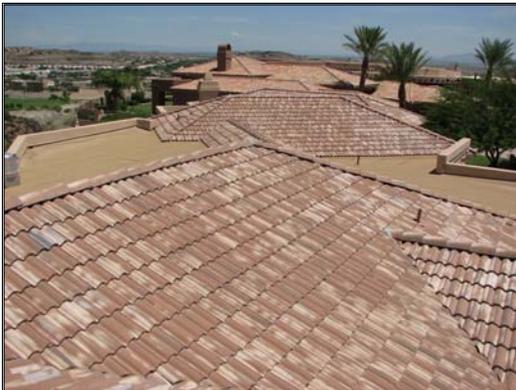
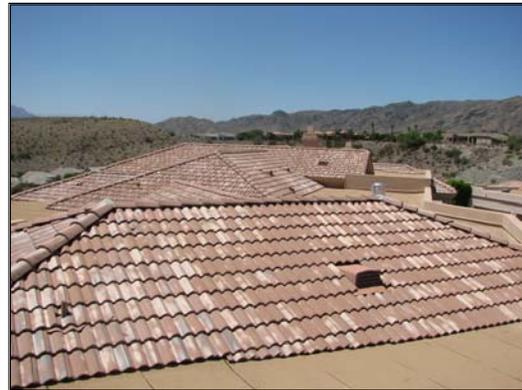
The roofing inspection was conducted from the roof. The roofing materials are a combination of concrete tile roofing and single-ply torch-down membrane.

A concrete tile roof consists of preformed, interlocking tiles that are cast from concrete and fastened to the substrate with metal clips or by either nailing or screwing. Concrete roofs are very durable, but care must be taken when walking on them as stepping onto tiles at the wrong location can crack them. These roofs when properly cared for have an expected service life in excess of 50 years.

A single ply torch-down membrane consists of a single layer of modified-bitumen that has been plasticized to make it more durable to weather. The term 'torch-down' derives from the fact that the membrane is generally fully adhered to the roof by heating it with a blowtorch as it is rolled out and bedded in a film of a compatible adhesive. Torch down roofs have an expected service life of between 15 and 30 years, depending on the grade of material, quality of protective coatings and level of maintenance the roof receives. This material is not recommended for roofs with a slope greater than 2:12.

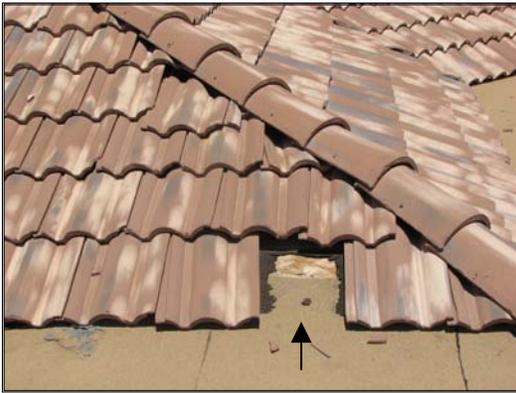
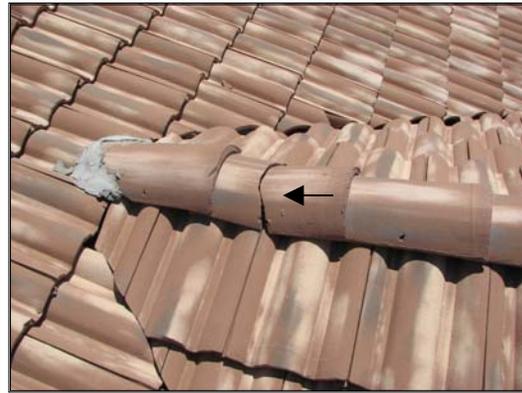
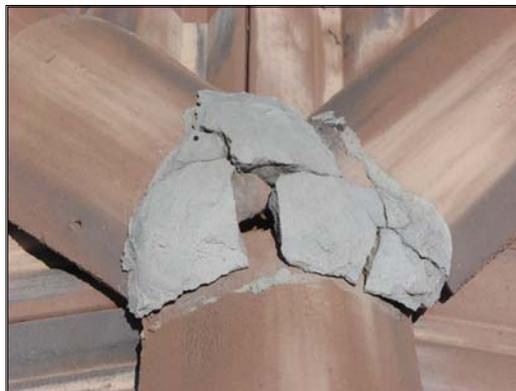
The roof appears to be in need of repair. Missing & loose roof tiles were observed above the south bedrooms. Tar/felt paper is missing – exposed roof sheathing is exposed where the tile is missing. Three or more roof tiles are cracked/broken. Mud caps are cracked and broken. We recommend a licensed roofing contractor further evaluate the roof and make corrections as appropriate.

This is a list of only those items readily apparent during our limited inspection of this roof system. We recommend the roof be further examined and repaired as necessary by a licensed roofing contractor.

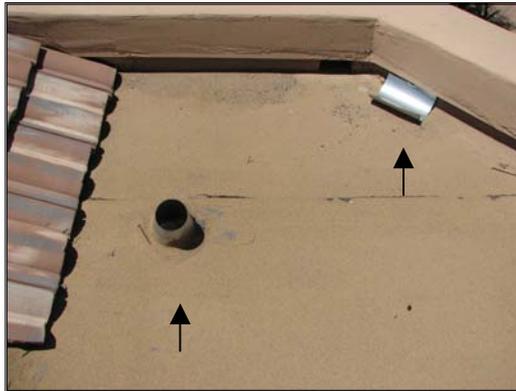
A missing T-cap (hood that covers an exhaust vent) is missing (lying on roof) at the north side of the roof (above master bathroom). Recommend repairs as appropriate.

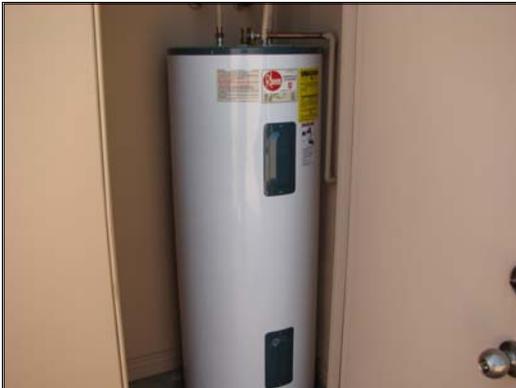
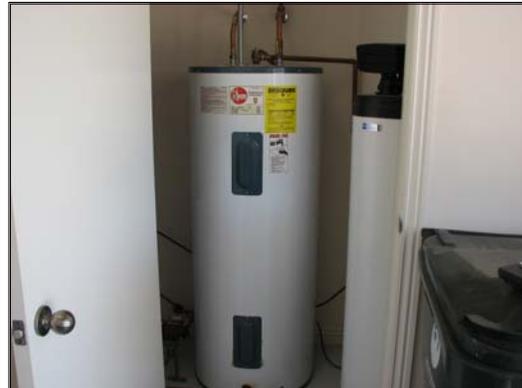
Two conventional storage tanks with 80 gallons of capacity provide hot water for the residence. The energy source for the hot water is electricity and is operational.

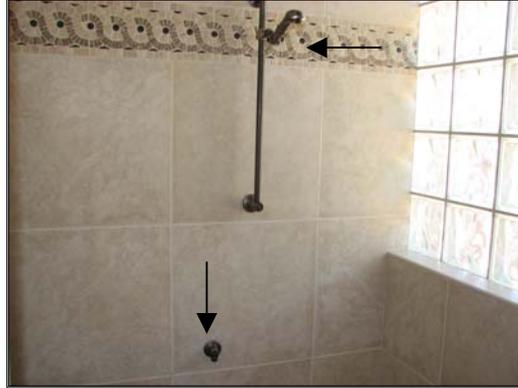
The master shower was observed with a missing showerhead hose to the auxiliary showerhead. Recommend a replacement as appropriate.

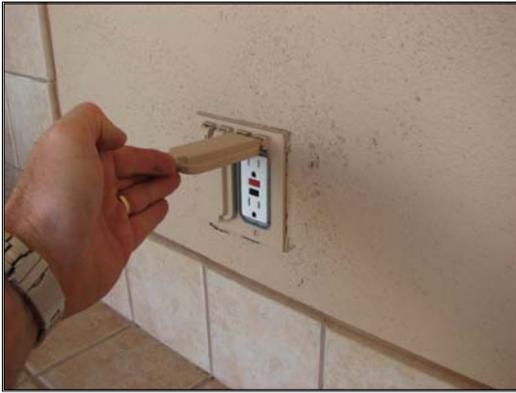
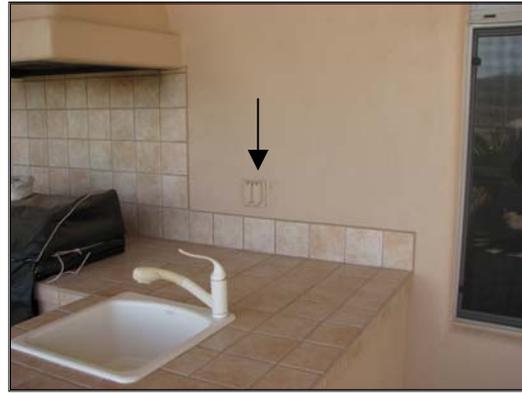
The ground fault circuit interrupter (GFCI) outlet at the back patio (behind BBQ & sink) will not trip when a ground fault is introduced to the circuit with a separate testing device. Since GFCI's are life/safety devices, they are designed to protect homeowners. We recommend immediate investigation and correction by a licensed electrician.

This is a list of only those items readily apparent during our limited inspection of the electrical system. A further examination by a qualified electrician is recommended.

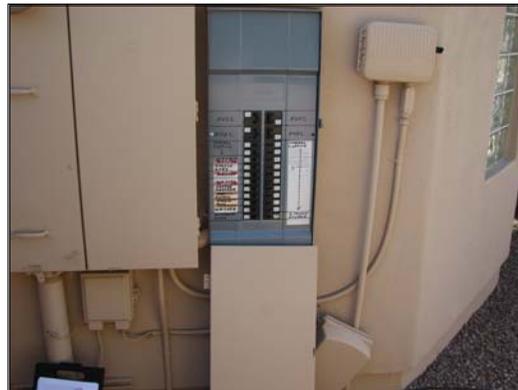
The sub panel at the north side of the property was found with a loose panel cover. Recommend repairs as appropriate.

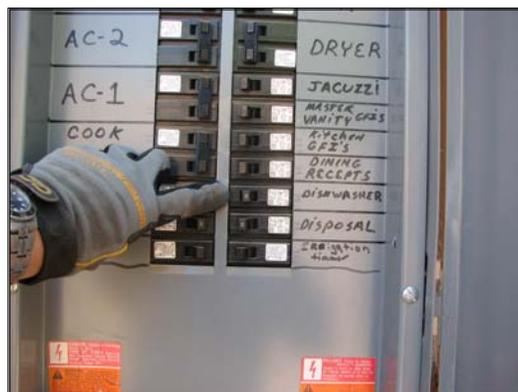
While operating both dishwashers simultaneously, breaker #26 inside the main service panel is tripping. We recommend further revaluation and correction by a licensed electrician.

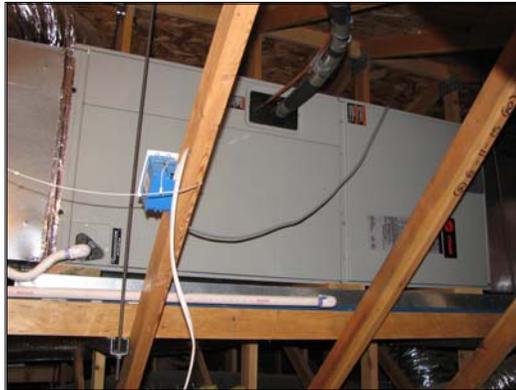
A heat pump system (qty 4) provides heat to the residence. The heat pumps are an air source type that gathers latent heat from the exterior air and transfers it to the interior coils in order to heat the home in winter. When used to cool a home the latent heat from the interior is gathered through the interior coils and transferred to the outside air. The disconnect switches for the heat pump are mounted within sight of each unit. The inside air handlers and evaporators are located in the attic. The thermostats for the systems are a electronic type and is located in multiple locations through out the home.

The ductwork for the heating system consists of insulated flexible ducts with insulated flexible type return ducting. The filters for this system can be found at the return air intake grills. The filters are a disposable type measuring 16" X 20" X 1" and 16" X 20" X 1".

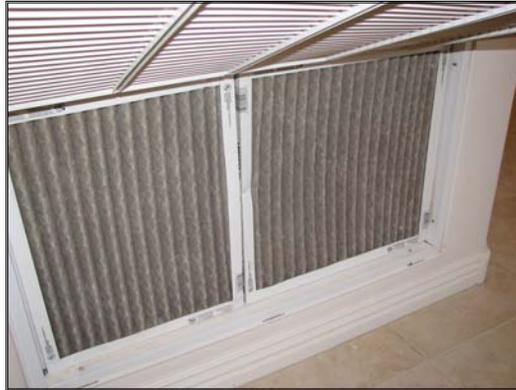
The furnace filters are dirty and should be replaced. Dirty air filters may restrict airflow, reduce comfort, increase costs, ice up evaporator and condensing coils, and shorten the life of the HVAC system.

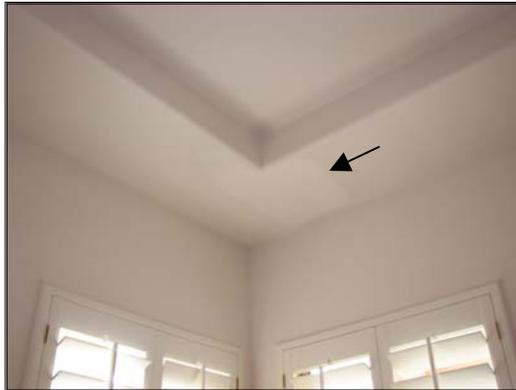
We noted a moisture-stained ceiling in the south bedroom (bedroom closest to the front entry). The moisture stain was dry at the time of the inspection. The area of the moisture stain has been repaired (textured and sanded). The adjacent bedroom was also observed with ceiling repairs. We can't say how this has affected those unseen areas behind the finished surfaces. We caution the client that whenever moisture stains have been observed, environmental hazards may be present. Further evaluation by a specialist may be appropriate. We recommend painting repairs as appropriate.

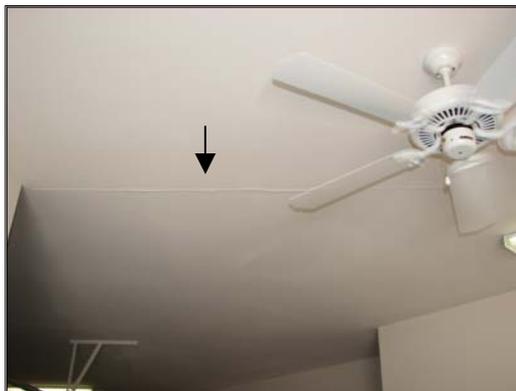
The ceiling of the garage was observed with a settlement crack that we believe is the result of structural movement caused by normal settling. Recommend patching and painting as appropriate.

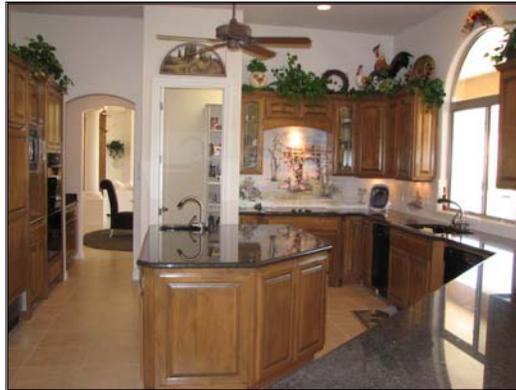
The kitchen is equipped with two dishwashers, two food disposers, range and two ovens, and a built in microwave oven.

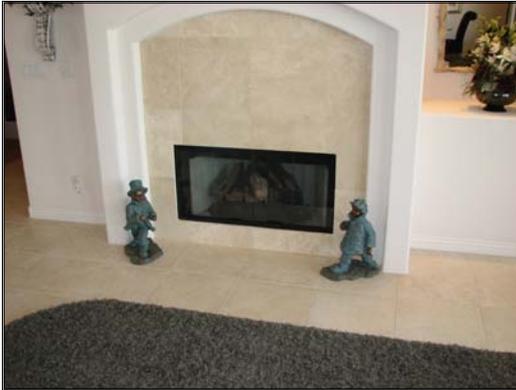
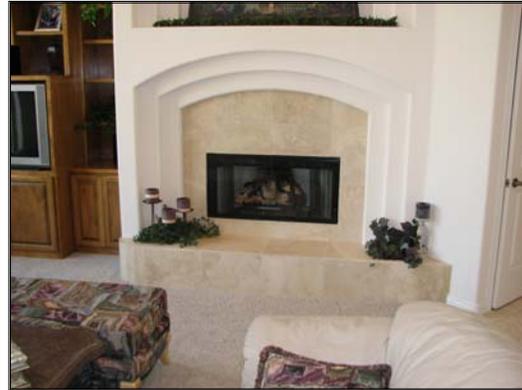
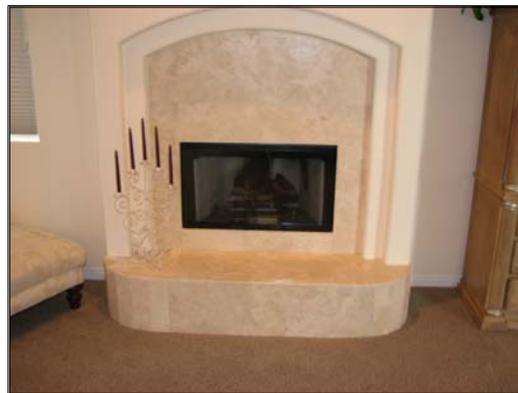
Combustion air is supplied by scavenging room air.

The fireplaces have firebrick liners with raised and floor hearths.
