# **TDI** **REFRIGERATION**

## **Vibration Analysis Report**

**April 22, 2013**

**Spectral Analysis Scan Report**  
Customer Name, City, CA. April 22,  
2013

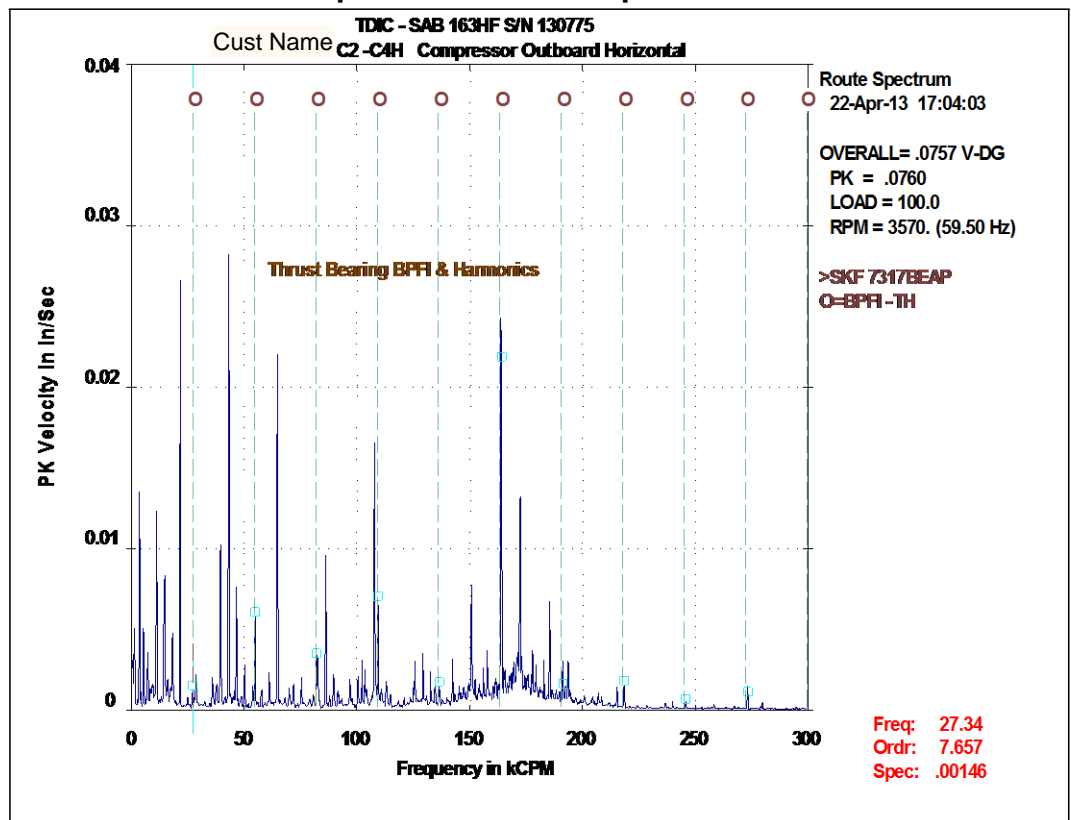
### Compressor Problem Spectrum

**Equipment:** C2, York SAB163HF, S/N 130775

**Title:** Bearing Fault, Rotary Screw Compressor, C4

**Fault:** Thrust BPF1 Fault

**Significant**

**Explanation:** The fundamental defect frequency, BPF1 "Ball Pass Frequency Inner Race" and its harmonics are appearing in the spectrum with rotating speed sidebands. Moderate impacting at the BPF1 frequency can be seen in the time waveform. The thrust bearings are in beginning stage 3 of the 4-part bearing failure scenario.

**Recommendation:** Continue to operate and start to closely monitor the bearings by increasing vibration survey frequencies to establish trending. Monitor for any increase in vibration amplitude and noise. Conduct another survey in 3-4 months.

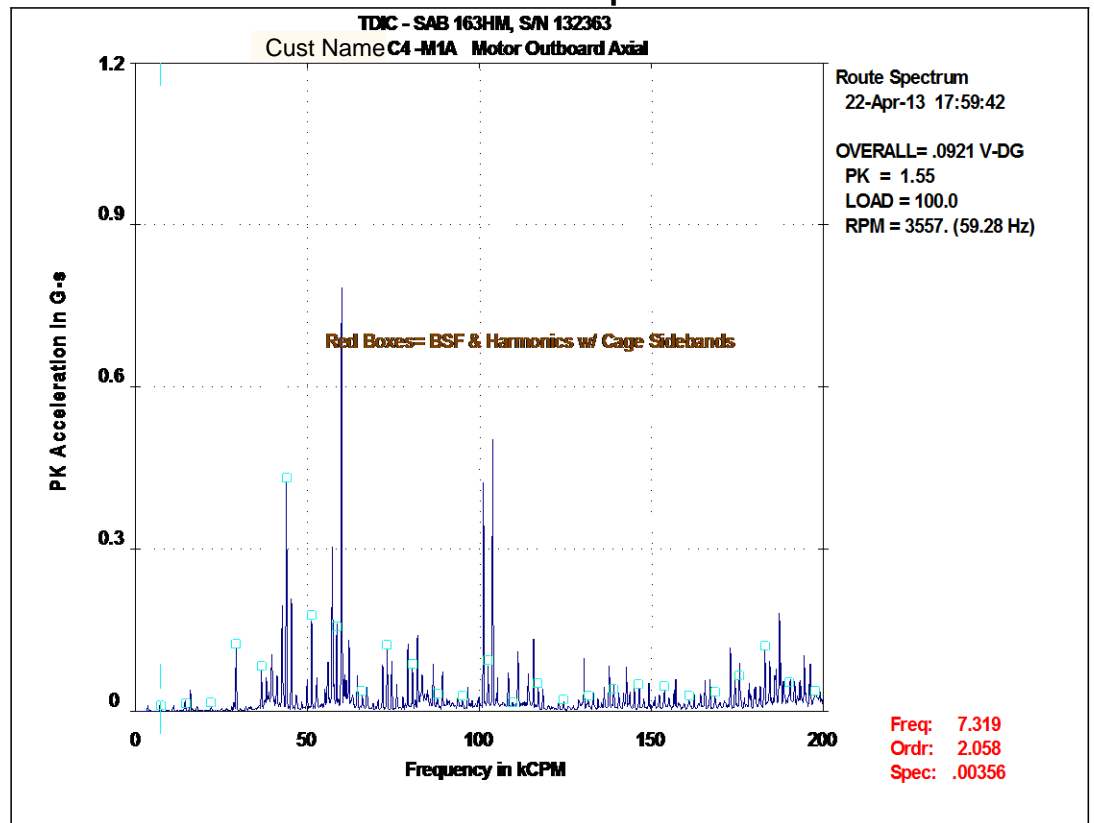
### Motor Problem Spectrum

**Equipment:** C4, York SAB163HM, S/N 132363

**Title:** Bearing Fault, AC Induction Motor, M1, M2

**Fault:** BSF/Cage Fault

**Significant**

**Explanation:** The fundamental defect frequency BSF "Ball Spin Frequency" and its harmonics are appearing in the spectrum with cage sidebands. This indicates asperities are forming on the balls of the bearing. Impacting is light at this time in the time wave form. The bearings are in stage 2 of the 4-part bearing failure scenario.

**Recommendation:** Continue to operate. Ensure the bearings are lubricated as per the motor manufactures lubrication frequency and grease type. Closely monitor for any increase in vibration amplitude and/or noise. Conduct another survey in 6 months.

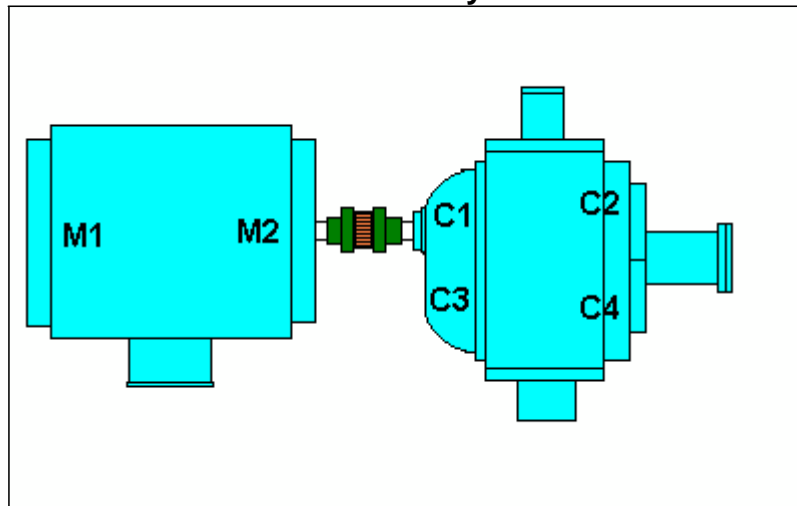
Vibration Survey Points

**Equipment:** C5, York SAB163HM, S/N 13238

**Explanation:** No faults were detected during this survey period.

**Recommendation:** Continue to operate as normal and conduct another survey in 6 months.
