# THE EVOLUTION OF *HARDBANDING* <sup>©</sup>

# The Evolution of Hardbanding

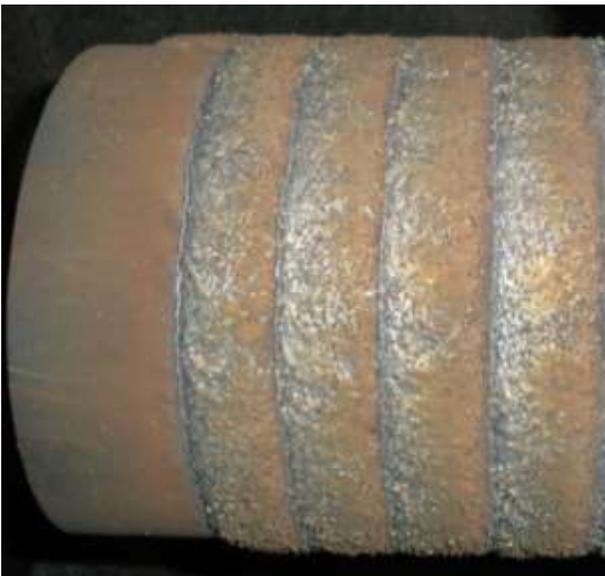
Casing “unfriendly” Hardbanding

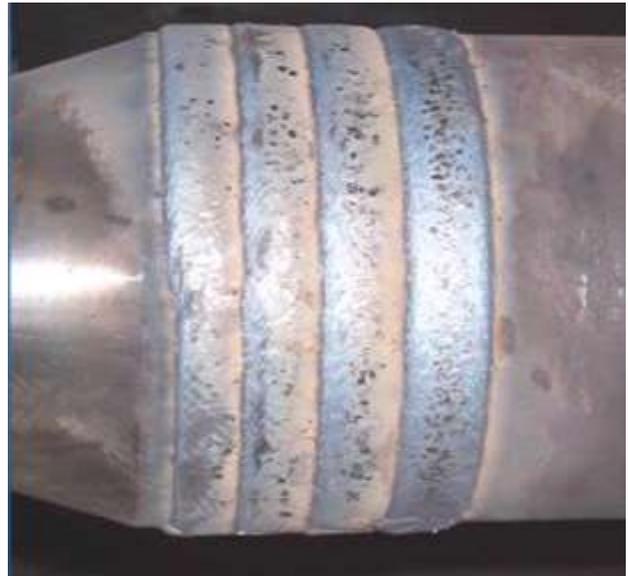
Casing “friendly” Hardbanding

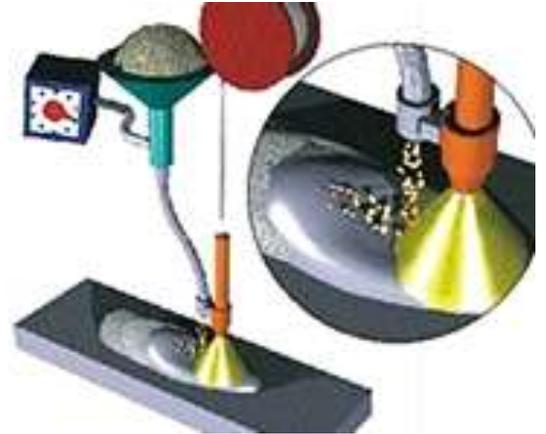
The mild steel welding wire acted as a matrix to hold the tungsten carbide particles. It was an easy choice since it was readily available. The tungsten carbide was used tool bits that were crushed to various sizes. However, as good as tungsten carbide is for abrasion resistance, the weak link is the soft mild steel matrix. As the mild steel matrix wears away during the drilling process, the tungsten carbide granules fall out.

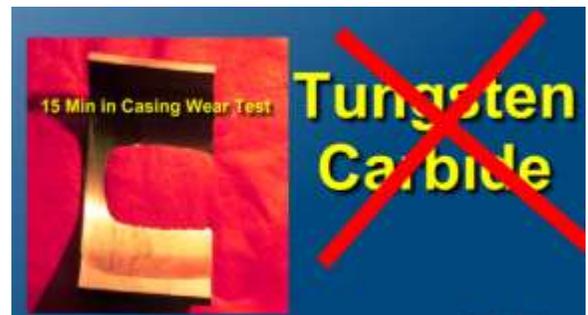
One approach was the development of Spherical Tungsten Carbide Pellets in 1978 which again were dropped into a soft mild steel weld matrix. Another approach was the development of "Casing Friendly" hardbanding wires that did not use tungsten carbide. As the "casing friendly" alloys without tungsten carbide were simpler to use and reduced casing wear substantially, they have become very popular. Tungsten carbide became taboo because of the concern for casing wear and fell out of favor as a hardband where casing wear could be an issue.

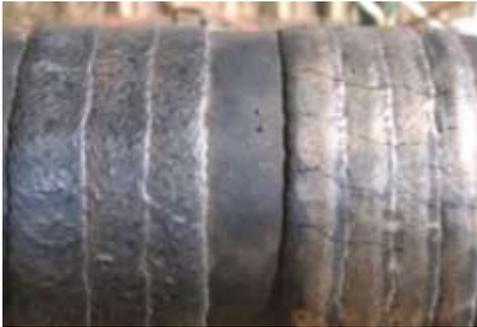
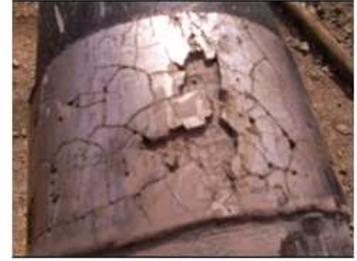
## No Cracks Vs Cracks in Casing Friendly Hardbanding:

There are more differences than just esthetic appearance between a non-cracking and a cracking casing friendly hardbanding wire. Certain hardbanding wires crack because of the fine carbides that form on grain

boundaries during cooling. As stress is generated by the shrinking weld deposit as it cools down, they will crack, or “cross check” to relieve the built up stress. This cracking, although good because it relieves the stress of the welded material, is detrimental as it is structurally unsound and now becomes a potential source of failure. If proper procedures are not followed during the reapplication of the hardbanding wire, the potential of spalling or “chunking” of the hardbanded wire could occur turning the “casing friendly” hardbanding into “casing unfriendly” and also cause problems for the tool joint.

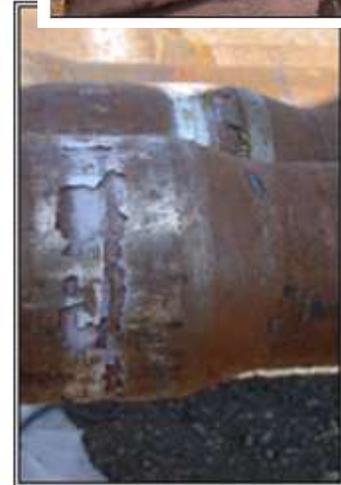
Example of Spalling

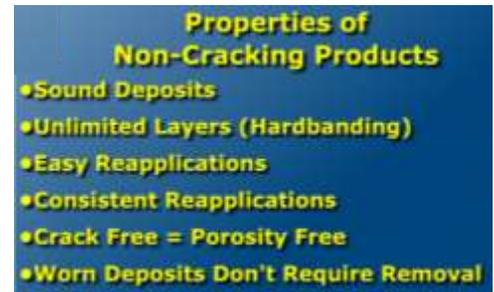
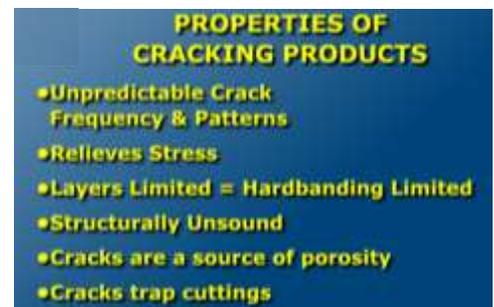
Product that does not crack, normally will rebuild very easy. In addition, as there are no cracks, foreign matter such as drilling fluids, abrasives and H<sub>2</sub>S cannot become entrapped, making reapplication even easier for the hardbander.

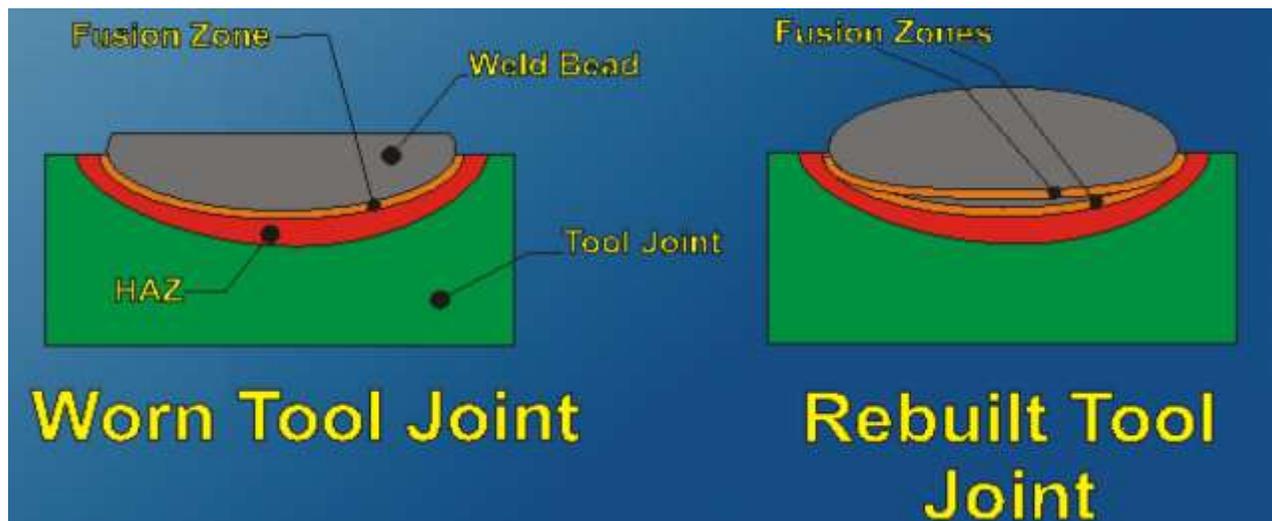
If the original application was a cracking hardbanding, the original hardband will have to be removed to the point that the reapplied hardband will penetrate past the original Heat Affected Zone (HAZ). If the material is not removed to this point, there is an increased risk of spalling or chunking of the hardband material due to the fine carbides that form on grain boundaries. The fact that there would be two fusion zones that have these weakened grain boundaries would create additional stress in the hardbanded wire.

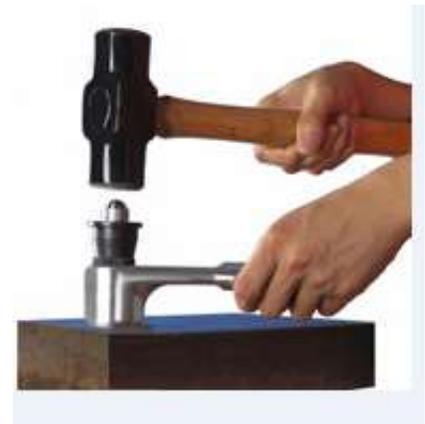
Hardness Tester

Hardness is a measure of the resistance of a material to indentation. This is determined by use of a machine which presses a steel ball into the material being tested. The result is a number that is expressed by the Rockwell hardness number - the higher the number, the harder the material.

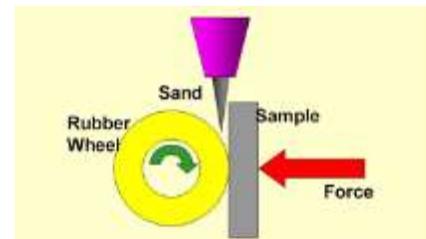
ASTM G65 Wear Test

Wear is the erosion of a hardband by being in contact with another media, such as the drilling mud or the casing. If this erosion is left unimpeded, the hardbanded material will wear fairly quickly, depending on the “hardness” of the base material.

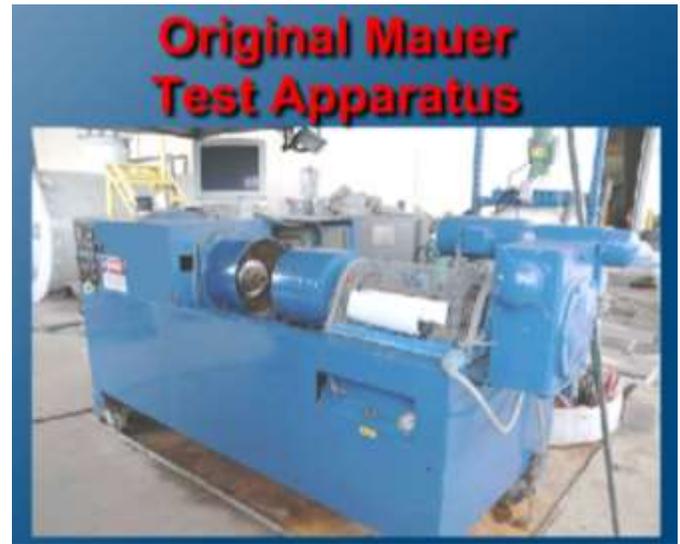
Around 2003 a company called Mohr purchased the testing equipment but encountered problems in recreating the same test results as had previously been achieved by Maurer Engineering. Because of this, Mohr decided to modify the equipment to achieve consistent, repeatable test results. In 2007, Mohr completed its modifications. As test results are not repeatable pre 2007, test data previous to 2007 is considered suspect.

Below are comparative differences from the early Mauer test on an unbanded 4145 tool joint, which was inconsistent in its test results. Compare this to the new Mohr test which is consistent in its test results.

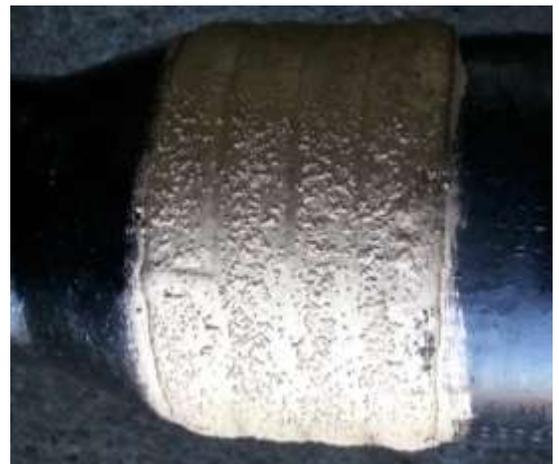
Duraband NC wire with Tungsten carbide particles

Duraband and Tuffband are unique for hardbanding. Unlike other wires that stress-crack and are unable to readily accept tungsten carbide particles into their matrix, Duraband and Tuffband are both non-cracking and rebuildable. Being a metal cored wire they also are able to accept tungsten carbide particles directly into the molten puddle, without cracking.
