Paper IBC 19-4

36th International Bridge Conference

Title: Case Studies of Bridge Failure due to Scour and Prevention of Future Failures

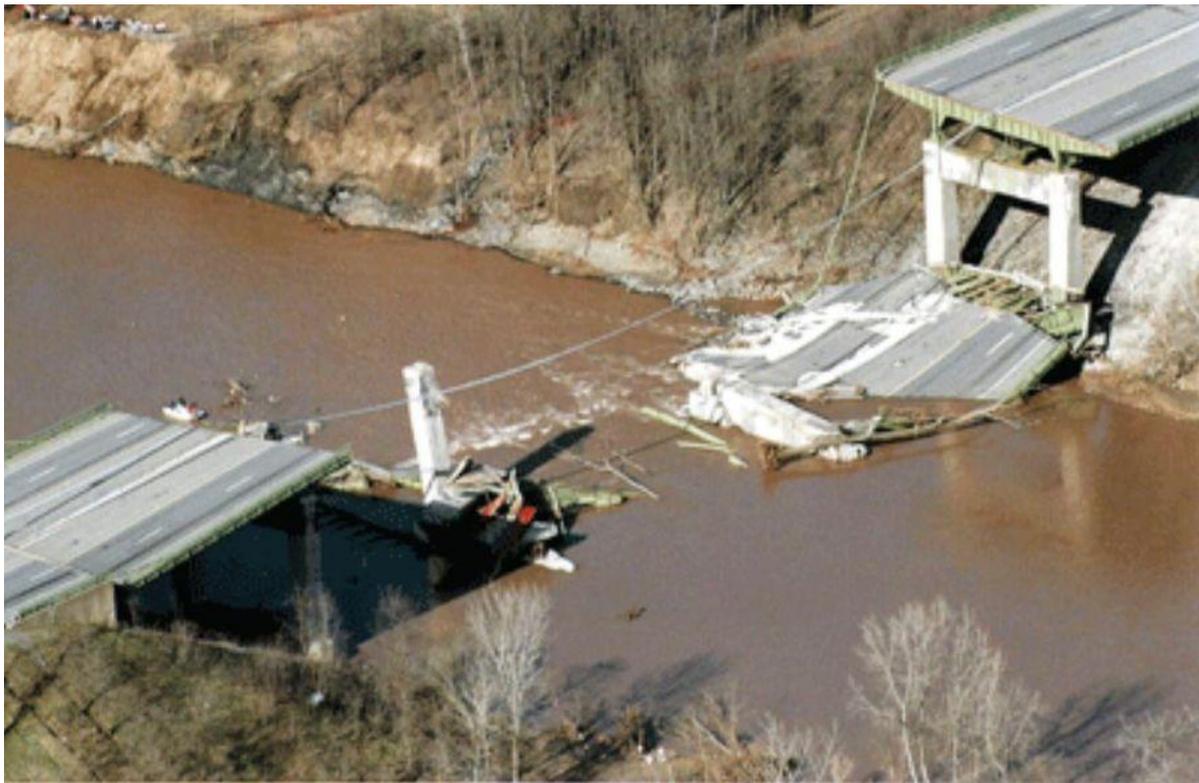
Figure 1. Schoharie Creek Bridge collapse (from Wikipedia https://en.wikipedia.org/wiki/Schoharie_Creek_Bridge_collapse)

Using a number of referenced investigations, Lin et al. (3) discussed the Schoharie Creek Bridge collapse of April 5, 1987 that left 10 people dead. This bridge had two spans over the Schoharie Creek near Amsterdam, New York. The bridge suffered severe scour after a spring flood, which caused collapse of Pier 3 and subsequent Spans 3 and 4 (Figures 1, 2, and 3). The 50-year flood event with a velocity of 4.6 m/s was a result of a combination of heavy rainfall and snowmelt, according to the NTSB (9). The high flood rate created an approximately 3 m deep scour hole around Pier 3. The Schoharie Creek Bridge was supported by spread footings with limited embedment into the riverbed. The spread footing under Pier 3 rested on highly erodible soils (i.e. layers of gravel, sand, and silt). Causes of the bridge failure were investigated after the bridge collapse.

It was found that the collapse was attributable to a number of design and maintenance deficiencies, such as insufficient embedment of the spread footing, the erodible bearing soil layer, the use of erodible backfill for the footing excavation, and inadequate riprap protection, inspection, and maintenance. The scour was aggravated by a combination of other factors. For example, the flood velocity was higher than anticipated in the original design; debris accelerated downward scour; berms increased the floodwater under the bridge; and a high hydraulic gradient formed between upstream and downstream in the spring. Failure was also related to insufficient design of the bridge structure for scour conditions. For example, the superstructure bearings allowed for the uplift and slide of the superstructure from the piers; simple spans without any redundancy were utilized; the lightly reinforced concrete piers had limited ductility; and deficient plinth reinforcement resulted in sudden cracking of the plinth instead of a hinging failure.

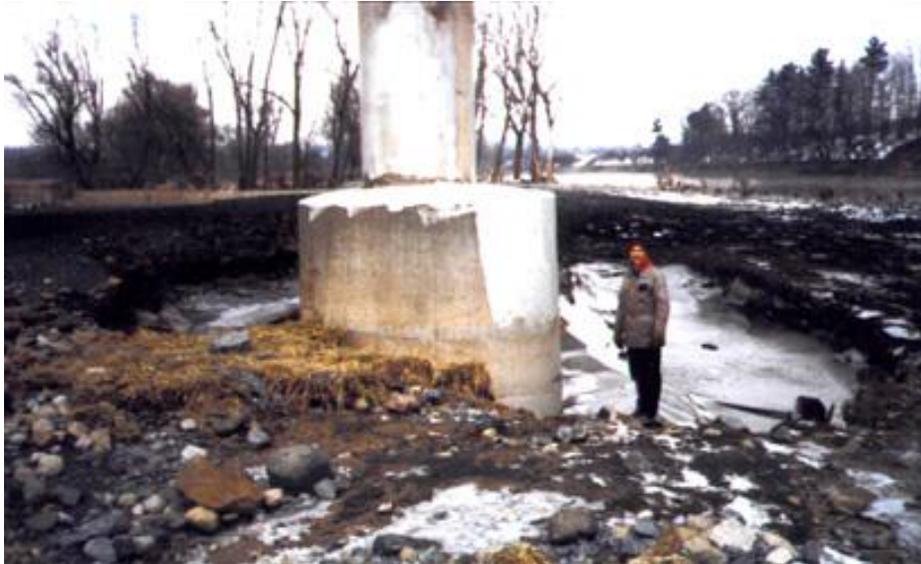
Figure 2. Photograph of a surviving Schoharie Creek bridge pier.

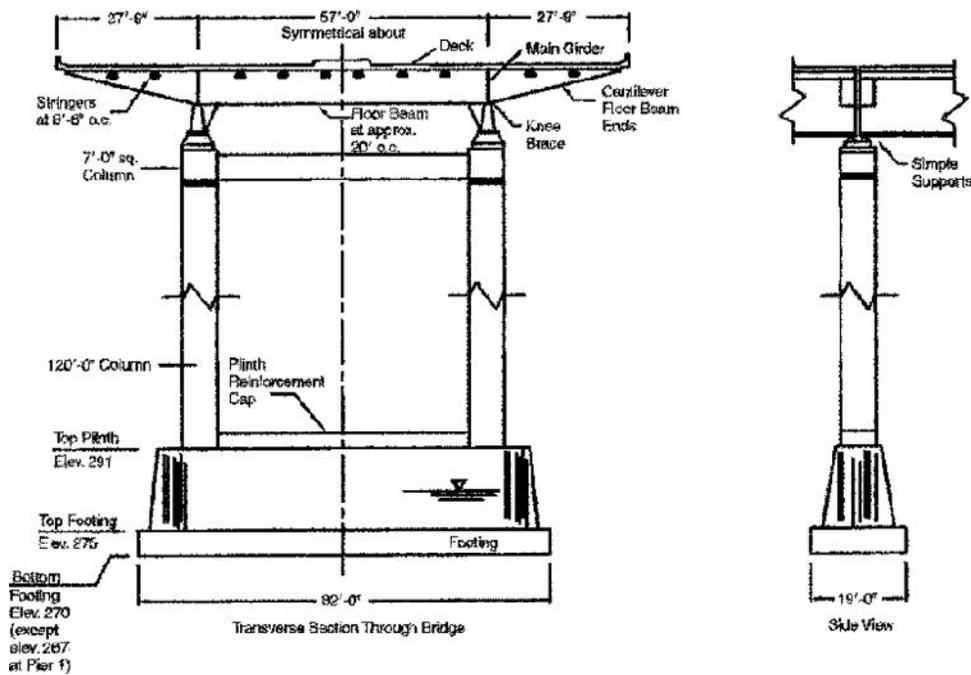
Figure 3. Sections showing the Schoharie Creek Bridge pier supported on a spread footing (From (9), NTSB, 1988).

For the Schoharie Creek Bridge collapse, the estimated cost of the disaster and for recovery was at least \$45M, as mentioned above. Of the \$42M in civil lawsuits, at least \$10M was awarded. For the bridge pier shown in Figure 3, it would cost today about \$250K for installation of a stainless steel retrofit scAUR™ with VorGAUR™ for one pier under dry weather conditions. Given about a factor of 2 inflation factor since 1987, this would have been about \$125K in 1987. Thus, for about \$250K in 1987 or 0.45% of what was eventually spent, both piers could have been protected permanently from scouring vortices for all water flow speeds.

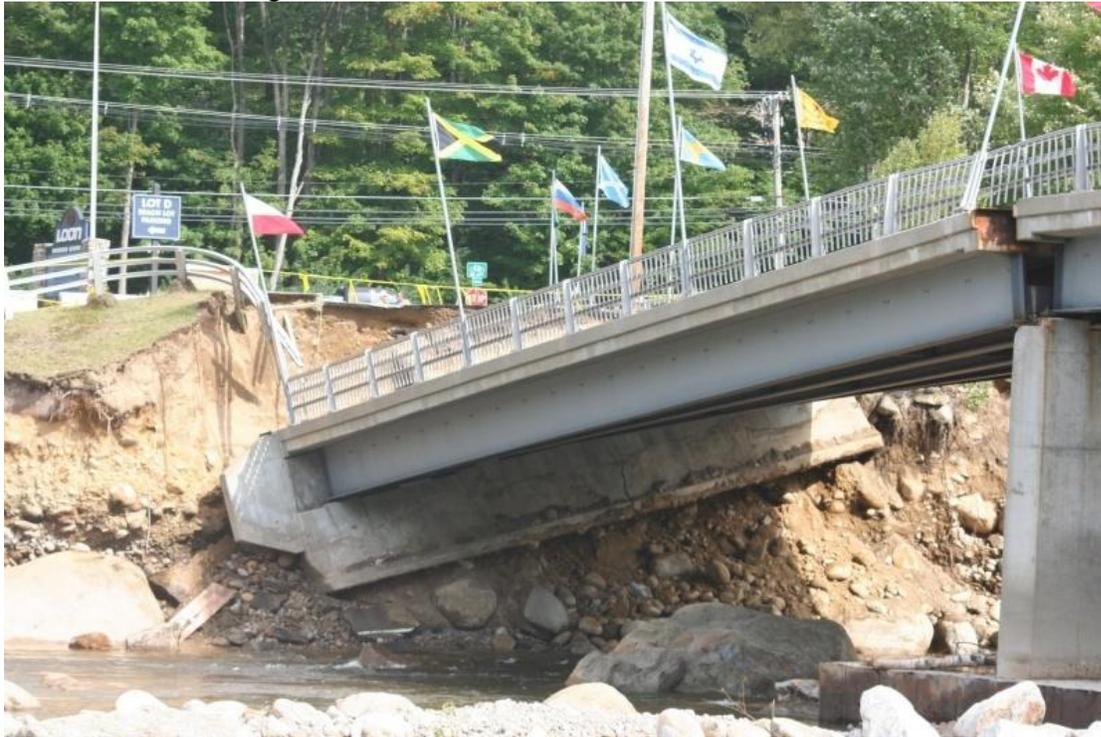
In August 2011 high water due to Tropical Storm Irene washed out an abutment of the Loon Mountain Bridge (Figure 4). This bridge abutment was on the outer bank in a bend in the river, so swirling flow brought high velocity into the outer river bank, causing quick erosion and loss

of soil and rock under the concrete part of the abutment. Temporary repairs of the bridge were made, but a new bridge was constructed at a cost of over \$9 million (11).

Figure 4. Photo of the failed Loon Mountain Bridge abutment.

For the Loon Mountain Bridge abutment collapse, about \$8M was spent on temporary repairs and a new replacement bridge. For either the spill-through (Figure 11) or wing-wall (Figure 12) abutment, it would have cost about \$71K in 2011 to install stainless steel retrofit scAUR™ with VorGAUR™ components PRIOR to the collapse. Thus, for less than 0.9% of what was spent after the abutment collapse, the abutment could have been permanently protected from scouring vortices for all water speeds.

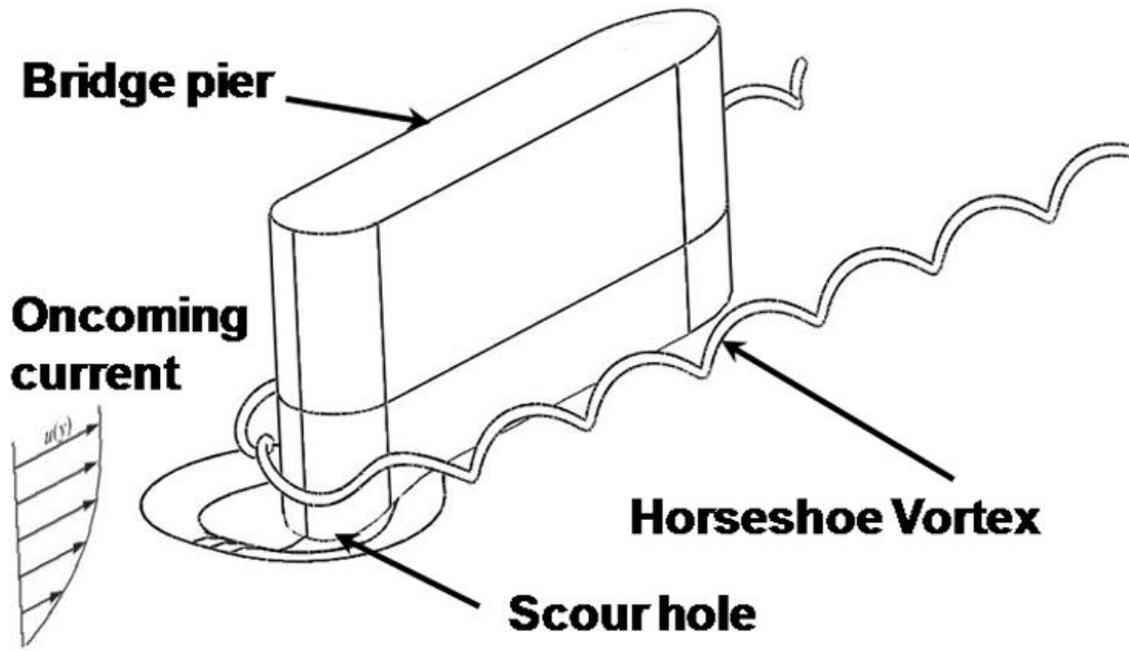
The bridge foundations in a water current, such as piers and abutments, change the local hydraulics drastically because of the appearance of large-scale unsteadiness and shedding of coherent vortices, such as horseshoe vortices. Figure 5a is a sketch of the horseshoe vortex formed around the base of a pier by a separating boundary layer. The horseshoe vortex produces high bed shear stress, triggers the onset of rock and soil scour, and forms a scour hole (12). The "strength" of a horseshoe vortex varies with the approach velocity U times the width W of the pier nose or UW (See www.noscour.com.) Note that a wider pier nose exacerbates the scouring velocities on the river bed. The 19 foot wide Schoharie Creek pier nose created intense scouring horseshoe vortices.

Figure 5a. The formation of a horseshoe vortex around the bottom of a bridge pier with no scouring-vortex prevention.

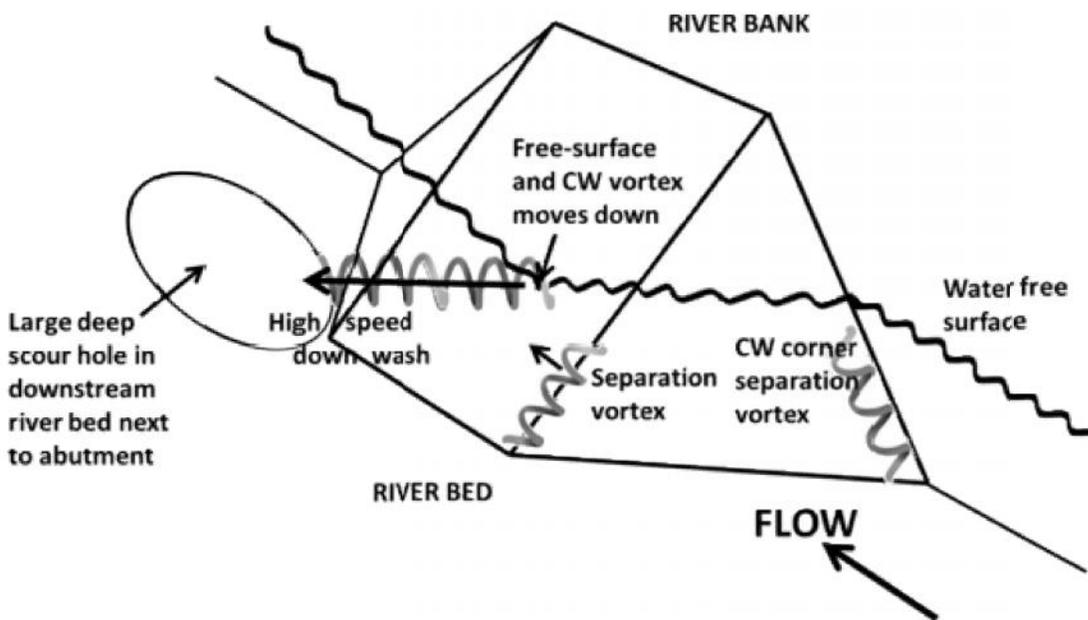
Spill-through abutment without scour countermeasures

The flowfield around an abutment is also highly three-dimensional and involves strong separated vortex flow (13). For the spill-through abutment with no scour protection, the flow is accelerated around the contraction and separated downstream of the contraction leading edge as shown in Figure 5b (12). There is a free surface level difference before and after the contraction leading edge due to the free surface vortex formation. The spill-through abutment has the scour hole at the downstream of the model with the similar order of depth of the vertical square corner wall due to the free surface vortex generated at the leading edge of the contraction.

Figure 5b. Flow structure around the spill-through abutment with no scouring vortex protection.

all of the scouring vortices shown in Figure 5b. Figure 12 shows a scAUR™ with VorGAUR™ design for a wing-wall abutment. Had either of these designs been used with the original construction of the Loon Mountain Bridge, the abutment would not have failed. Even after the 2011 collapse of the abutment, these designs and protective bank technologies could have been used to repair the bridge and prevent bank erosion, rather than incur the cost of a new bridge.

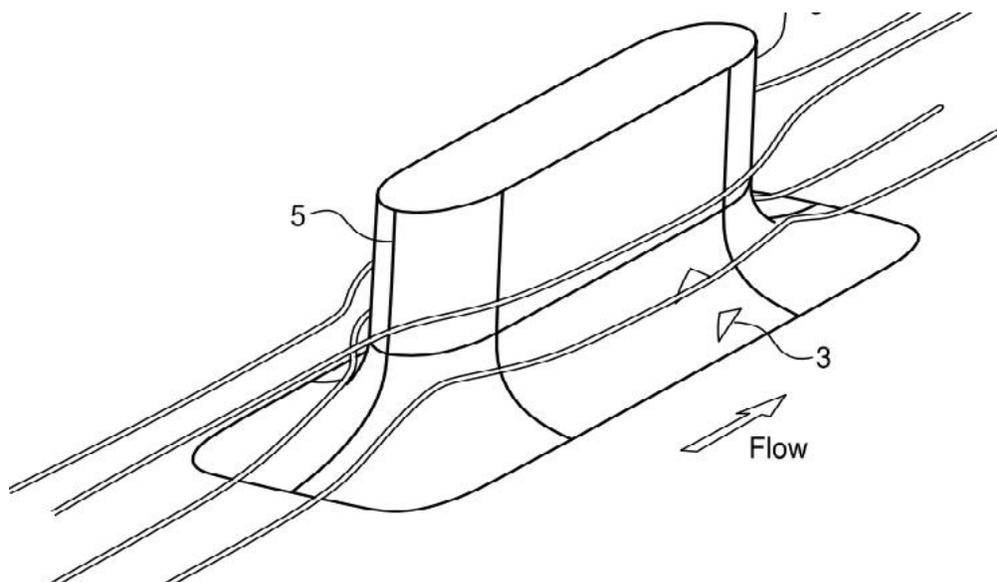
As discussed in more detail by Simpson and Byun (12, 14), using the knowledge of how to prevent the formation of discrete vortices and separation for junction flows (15, 16, 17) prior to the NCHRP-IDEA-162 project, AUR developed, proved using model-scale tests, and patented new local-scouring-vortex-prevention sCAUR™ products. The sCAUR™ design fundamentally alters the way the river flows around a pier or abutment. The sCAUR™ scouring-vortex preventing fairing, US Patent No. 8,348,553, and VorGAUR™ tetrahedral vortex generators, US Patent No. 8,434,723, are practical long-term permanent solutions. Piecewise continuous slope and curvature surface versions from sheet metal have been proven to produce the same result (US Patent no. 9,453,319, Sept. 27, 2016). A hydraulically optimum pier or abutment fairing prevents the formation of highly coherent vortices around the bridge pier (Figure 6) or abutment and reduces 3D separation downstream of the bridge pier or abutment with the help of the VorGAUR™ vortical flow separation control (Figure 6). This is in contrast to a fairing shape used in an unpublished FHWA study which did not prevent scour for flows at angles of attack. Versions for high angle of attack flows use a dog-leg arrangement. A modified tail provides addition scour prevention for piers that are close together.

Figure 6. sCAUR™ fairing around a pier (5) with VorGAUR™ vortex generators (3) that produce no scouring vortices.

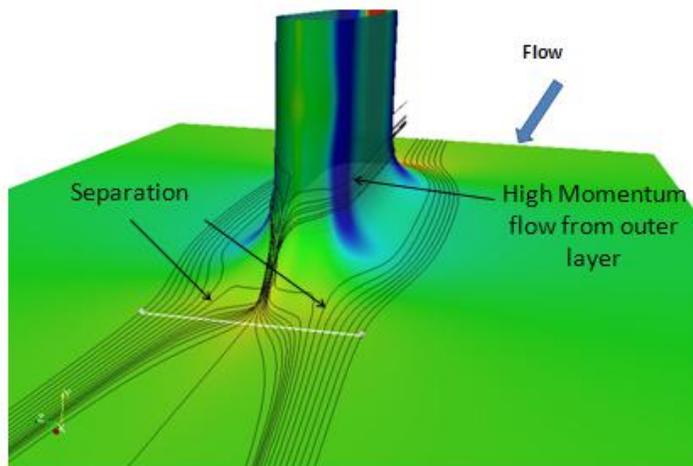
Low Reynolds Number Case - Near wall streamlines pass through
 $X/t = 7.24$ and $Y/t = 0.013$

Figure 7. Low Reynolds number case CFD calculated flow streamline patterns around a scAUR™ streamlined bridge pier fairing. Flow indicates no discrete vortex formation on nose and sides (12).

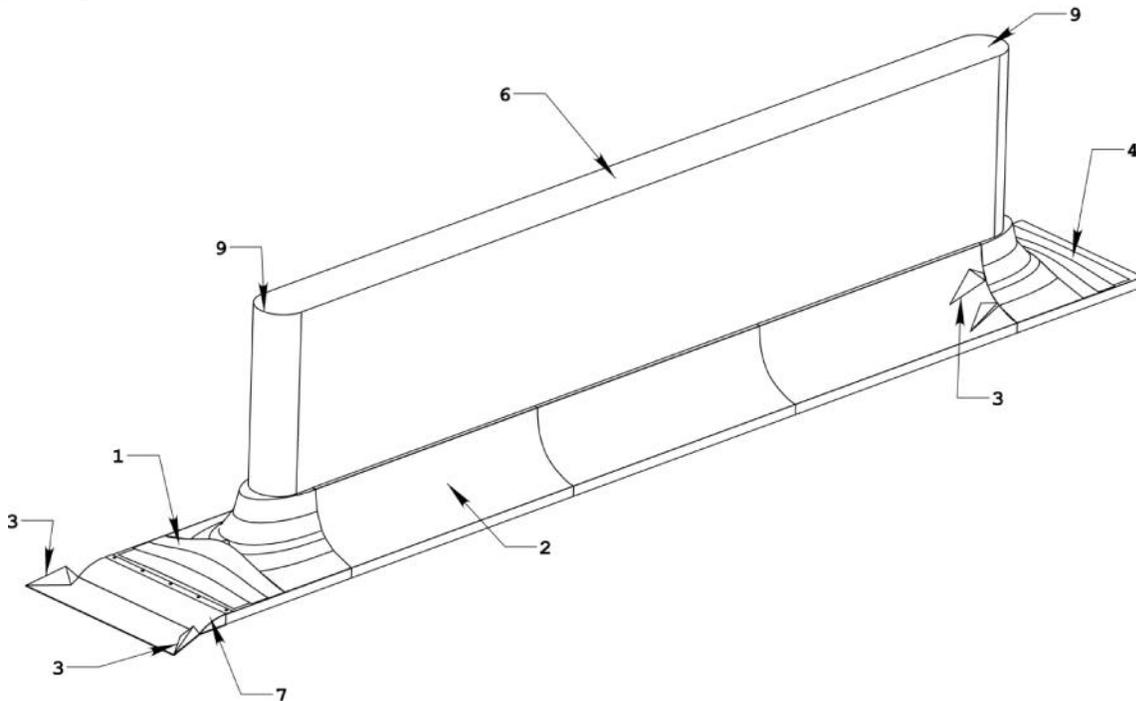
The basic scAUR™ fairing design for a retrofit to the Schoharie Creek Bridge piers is shown in

Figure 8. The ramp portion and vortex generators (Figure 9) add protection of the exposed sides of the pier by bringing soil and rocks toward the pier. Figure 10 shows example stainless steel construction of the scAUR™. Because the Schoharie Creek Bridge pier is 19 feet wide, a new proprietary transition section has been developed that fits between a 9 foot wide leading edge ramp portion and fairing nose (Figure 9) and the maximum pier width. As discussed below with the Costs, had this design been implemented before 1987, there would have no bridge failure due to scour.

Figure 8. Flow from left to right. Drawing of a full-scale sheet metal scAUR™ retrofit fairing with VorGAUR™ for a pier (6) with piece-wise continuous concave-convex curvature surfaces, with individual sections or pieces of nose surface (1); for the side of the pier (2); and the stern or tail, with individual sections or pieces of surface (4). The leading edge ramp (7) and pier foundation protecting VGs (3) are mounted on leading edge plate and (3) mounted on (1) and (2) protect the foundation from open-bed scour.

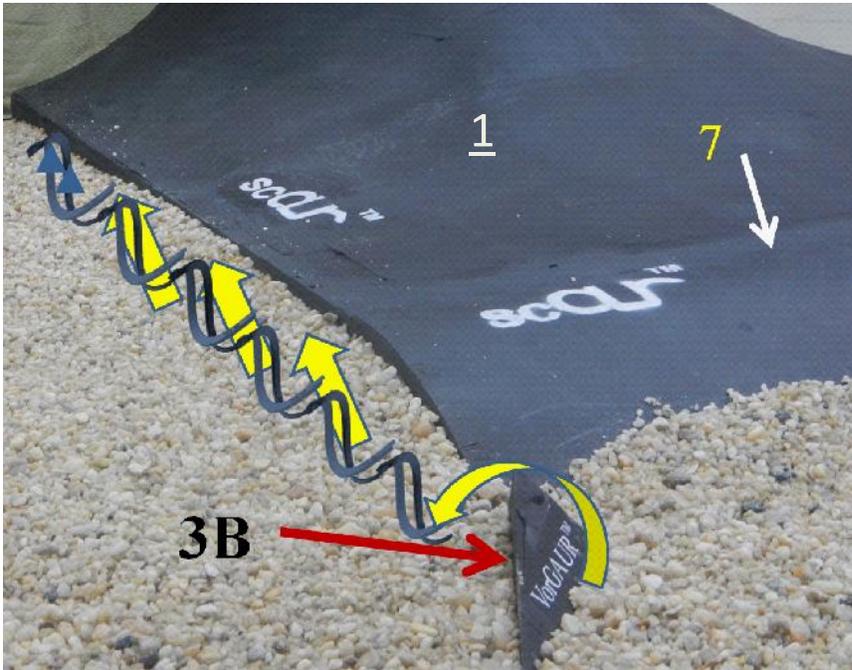
Figure 9. Illustration of a VorGAUR™ vortex generator at left upstream ramp (7) corner that creates a CCW vortex that brings open-bed scour gravel toward the foundation.

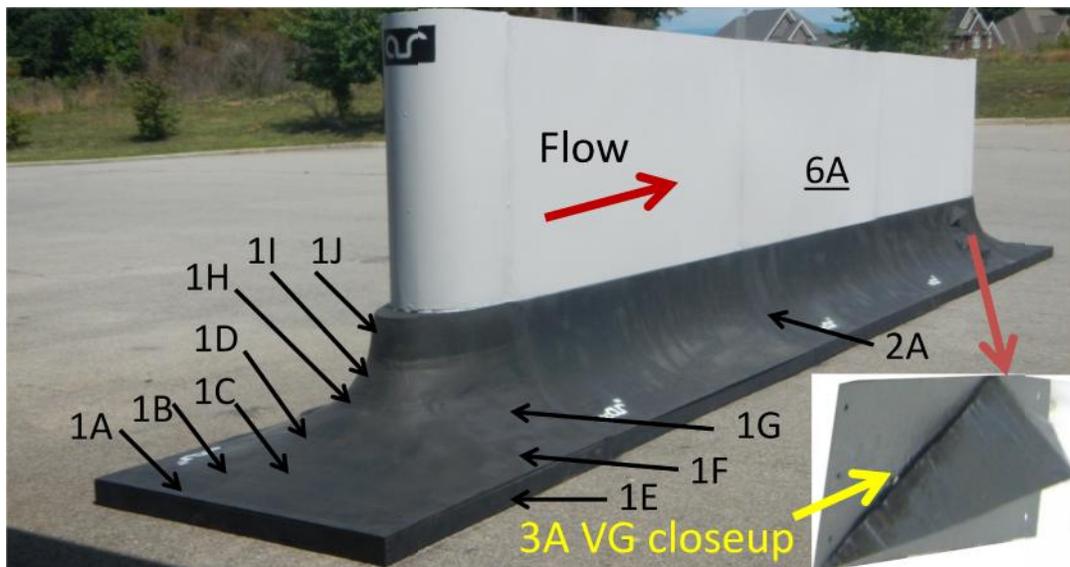
Figure 10. Example stainless steel scAUR™ retrofit (black) for a pier. VorGAUR™ vortex generators create CW vortices that bring low-speed flow up to prevent scour.

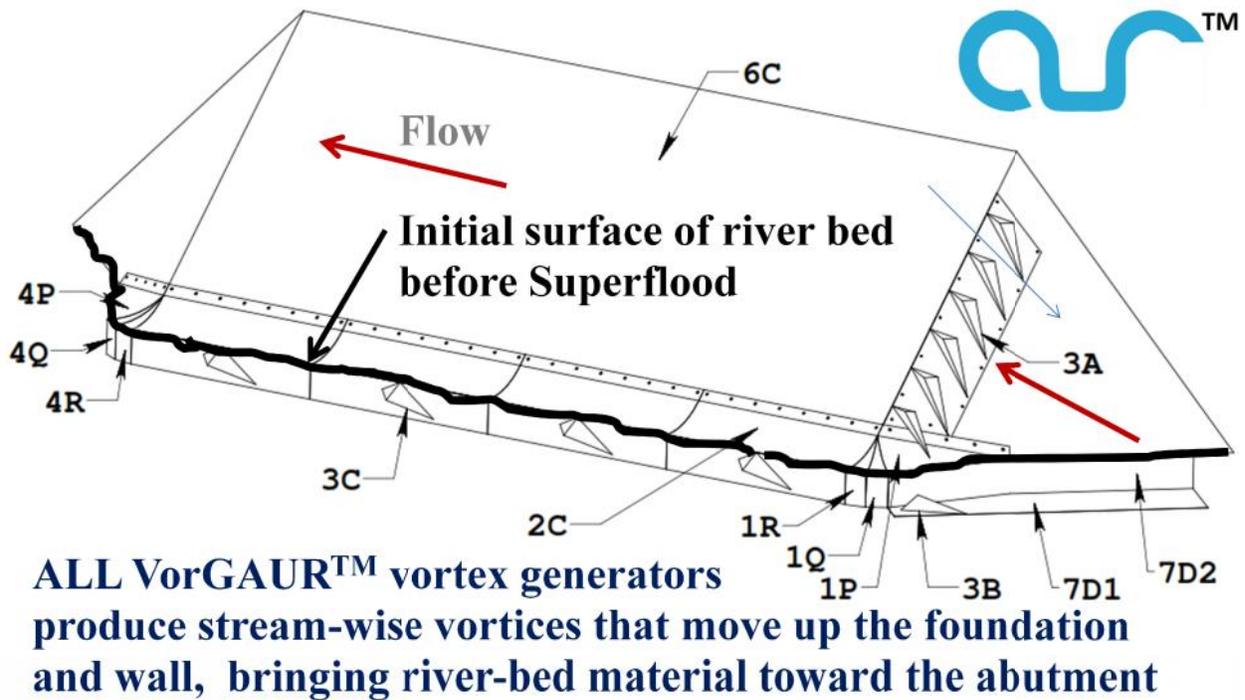
Figure 11 shows a scAUR™ with VorGAUR™ design for a spill-through abutment that prevents

Figure 11. Drawing of full-scale sheet metal scAUR™ retrofit fairing with VorGAUR™ for a spill-through abutment (6C) with piece-wise continuous concave-convex curvature surfaces consisting of individual sections or pieces of surface (1P), (1Q), (1R), (2C), (4P), (4Q), and (4R) within definable tolerances that produce the same effects as continuous concave-convex-curvature surfaces. Vortex generators (3A) reduce the flow separation and free-surface vortex effects while VG (3B) mounted on leading edge horizontal plate (7D1) connected to vertical plate (7D2) and VG (3C) protect the foundation from open-bed scour. Patent drawing (US Patent 9453319).

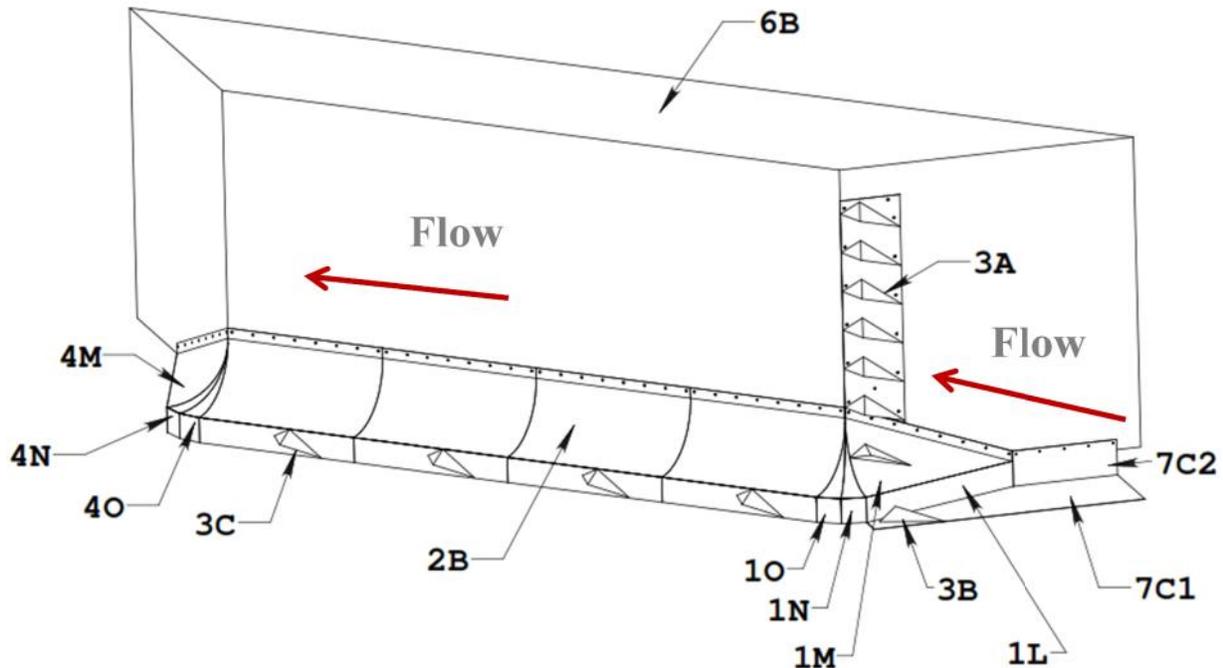
Figure 12. Drawing of full-scale sheet metal scAUR™ retrofit fairing with VorGAUR™ for a wing-wall abutment (6B) with piece-wise continuous concave-convex curvature surfaces consisting of individual sections or pieces of surface (1L), (1M), (1N), (1O), (2B), (4M), (4N), and (4O) within definable tolerances that produce the same effects as continuous concave-convex-curvature surfaces. Vortex generators (3A) reduce the flow separation and free-surface vortex effects while VG (3B) on leading edge horizontal plate (7C1) that is connected to vertical plate (7C2) and VG (3C) protect the foundation from open-bed scour. Patent drawing (US Patent 9453319).

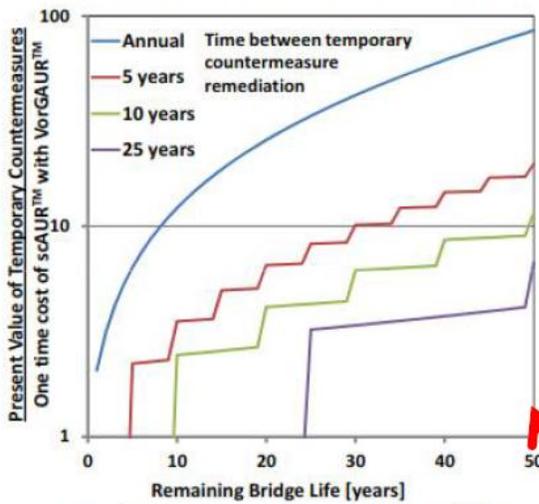
Figure 13. Economics of stainless steel retrofits.

Costs of temporary countermeasures obtained from a number of published sources. Computed with 7% inflation and 5% tax exempt interest. **Example of a bridge with six piers and two abutments requiring protection.**

- Temporary scour countermeasures (TSC) carry compounding future costs (monitoring, inspections, engineering, remediation) with **real present value.**
- scAUR™ is a permanent sustainable scour prevention measure with a **one-time cost. Stainless steel costs ½ as much as concrete.**
- **scAUR™ prevents catastrophic failure risk and liability due to local scour and saves >90% of present value of TSC.**
- The methods of HYRISK used to compare scAUR™ to temporary countermeasures.
 - Risks from temporary countermeasures incur substantial costs and liabilities.
 - Failure probabilities yield the costs that are implicitly assumed by the bridge owner due to risk.

There is no situation where scAUR™ and VorGAUR™ products cost more than current countermeasures, as shown in Figure 13 for stainless steel retrofits. There is no situation where any type of scour is worse with the use of the scAUR™ and VorGAUR™ products than without them. The more frequent that scouring floods occur, the more cost effective are scAUR™ and VorGAUR™. Clearly, scAUR™ and VorGAUR™ products are practical and cost-effective for US highway bridges (14).
