**United States v. Brace et al., 17-cv-06, W.D. Pa.**  
**Expert Report: Ecological Functions and Connections**  
**of Wetlands and Waters at the Marsh Site,**  
**Waterford, Erie County, Pennsylvania**

Prepared for:  
U.S. Department of Justice

Prepared by:  
Robert P. Brooks, Ph.D.  
Brooks Consulting  
61 Aloha St.  
Port Matilda, PA 16870  
rpbrooks2@gmail.com, 814-880-7607

18 December 2017

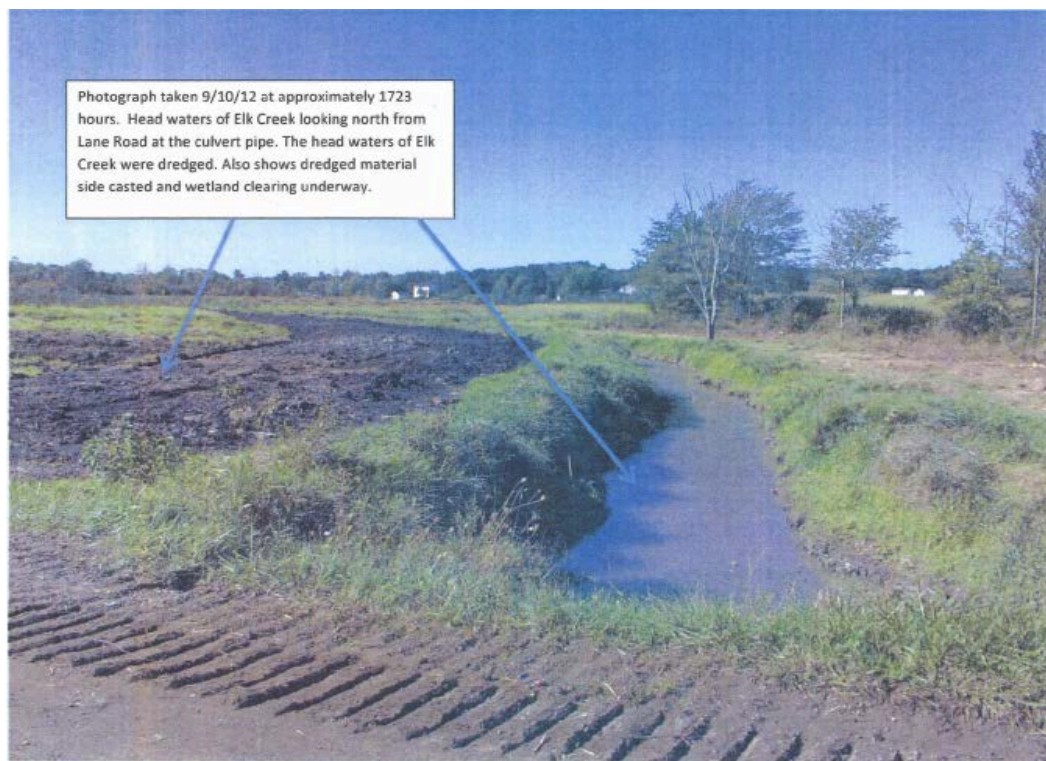
Figure 14. September 2012 photograph from Marsh Site inspection by Smolko; Elk Creek from Lane Road looking downstream (north) showing disturbed soils and side-casting from dredging Elk Creek.

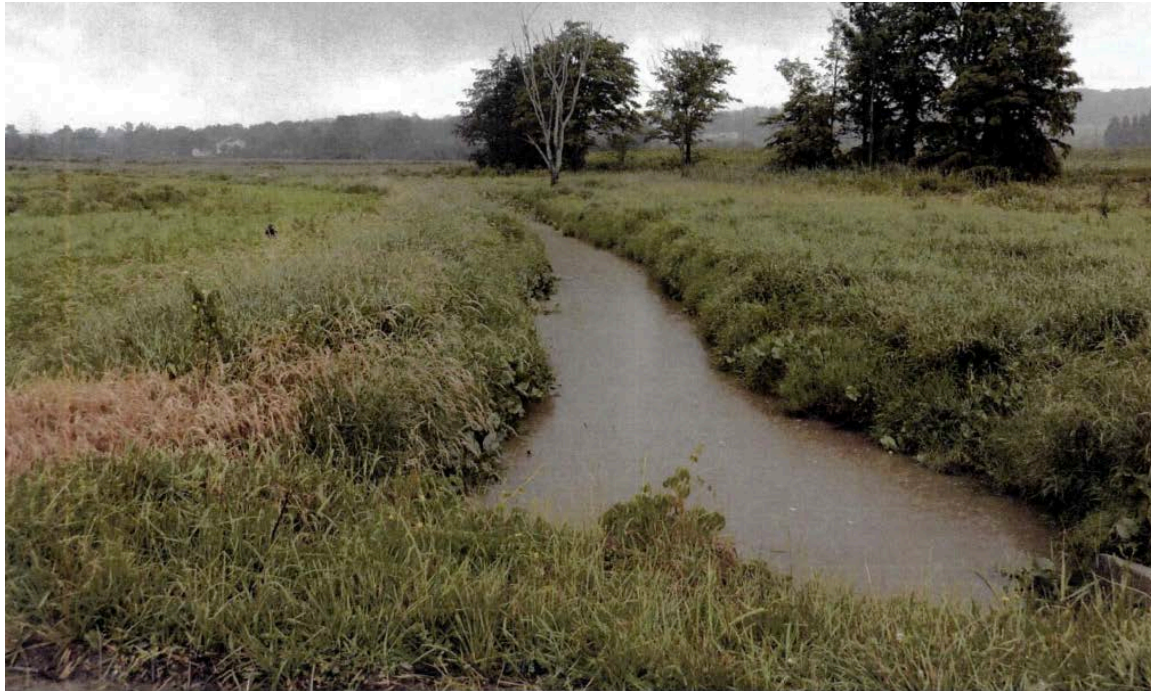
During the June 2013 inspection, new growth of hydrophytic vegetation was observed in portions of the site previously disturbed (Figures 15, Lane Road bridge). Based on the wetland delineation data sheets from three samples points, all located on the Marsh Site, hydrophytic plants were dominant, and soils showed hydric characteristics (i.e., chroma of 1 or 2, gleyed matrix, mottles). Surface hydrology was observed, so evidence of all three wetland parameters was present, indicating the presence of wetlands on the Marsh Site. Their Sample Point #1 was located near my Sample Point #6. Their other two points were located in the middle area of the Marsh Site. Heavy rains made obtaining additional soil samples difficult, and obscured some of the natural surface hydrology. A site inspection report from the same visit prepared by Scott Dudzic of the Pennsylvania Department of Environmental Protection (PADEP) dated 27 June 2013 described similar findings.

Figure 15. June 2013 photograph from Marsh Site inspection by EPA; Elk Creek from Lane Road looking downstream (north) showing recovering herbaceous vegetation after soil disturbance in 2012, and channelized reach of Elk Creek.

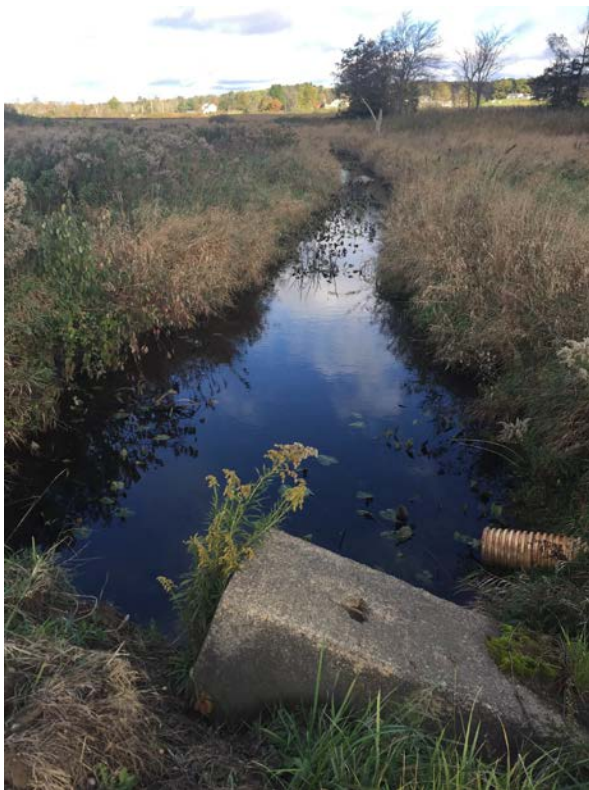
Figure 16. October 2017 photograph from Marsh Site inspection by Brooks; Elk Creek from Lane Road looking downstream (north) showing recovering herbaceous vegetation after soil disturbance in 2012, and channelized reach of Elk Creek.

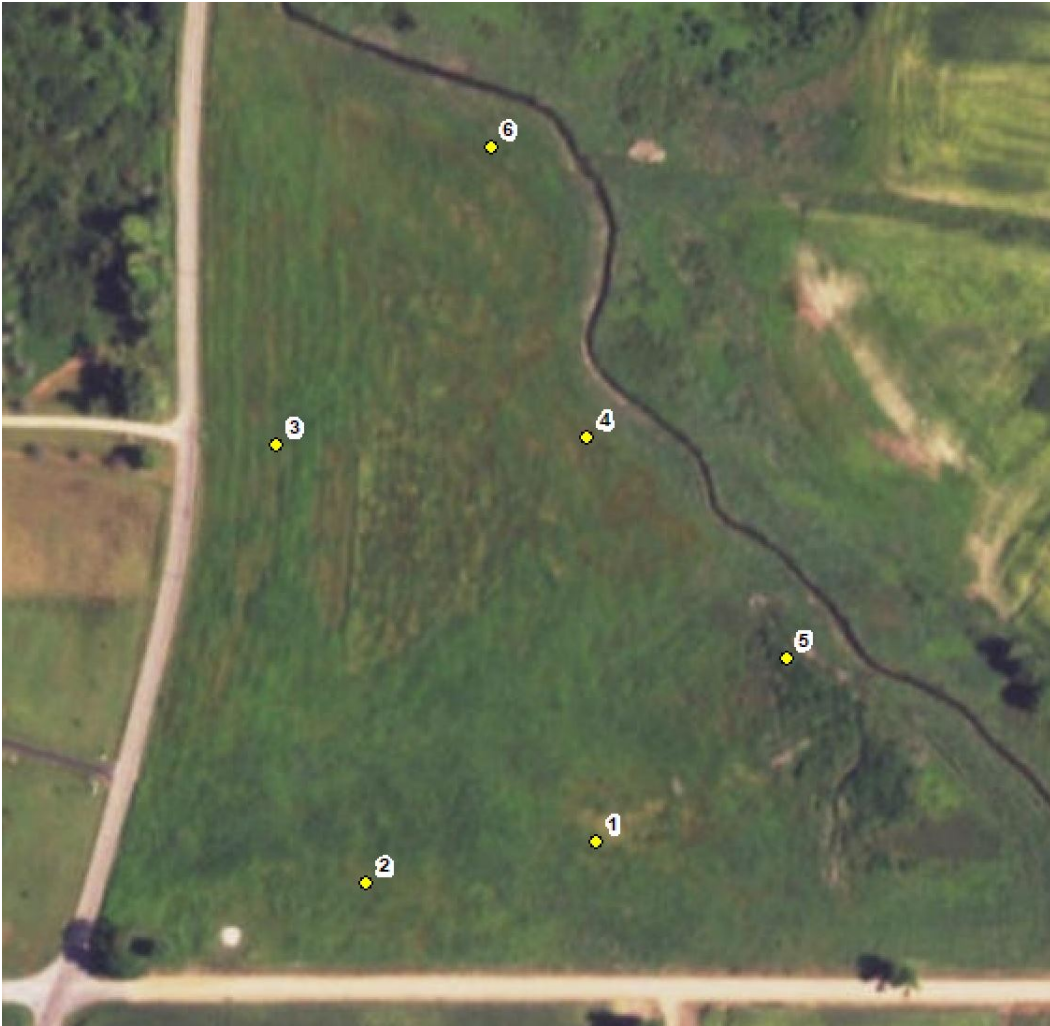
Sample Point #1 (Figure 17) – Located at (approx. lat-long: 41.9793548, -80.0456344), which is at the visual intersection of the gas well tank on Lane Road to the south, and the end of the tree row along the east side of Elk Creek downstream of the culvert on Lane Road. I chose this point because it was located upslope of the patch of alder shrubs in the southeast corner of the Marsh Site. The alder patch, later sampled as Sample Point #5, appeared to be quite wet, so I wanted to know the conditions upslope.

Figure 17. Approximate locations of six Sample Points for wetland identification protocol superimposed on a 2015 image of the Marsh Site from ESRI (Brooks Oct 2017).

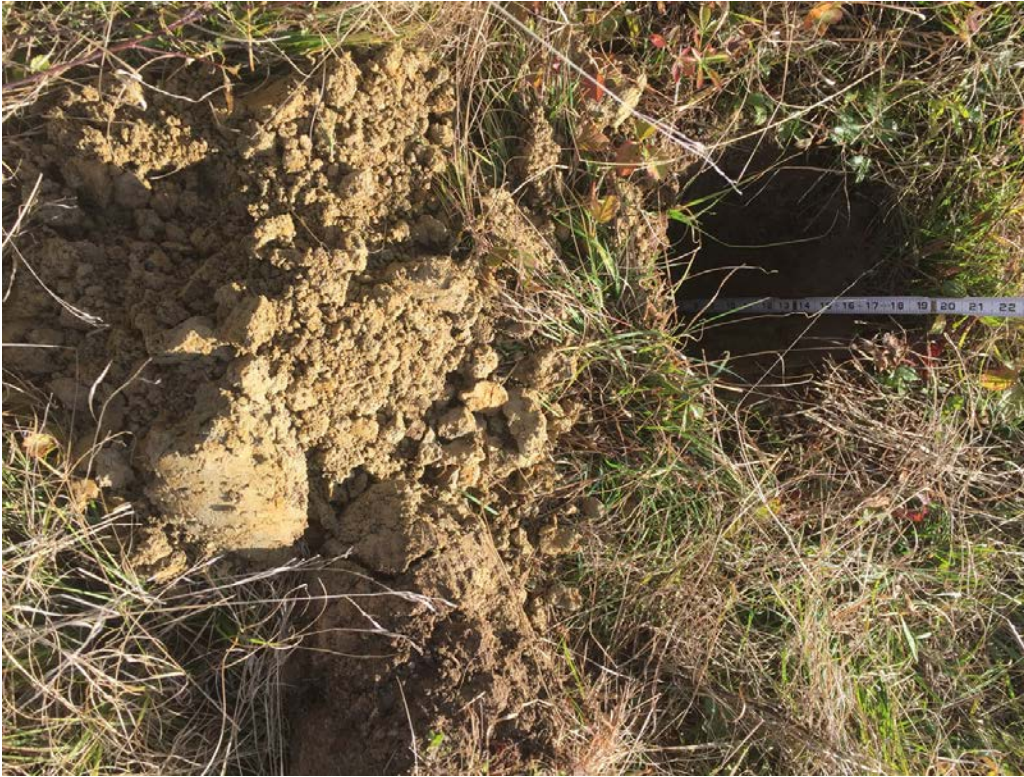
increasing to about 30% from 5-18 inches, with color of 7.5YR6/8. Soil texture from 0-5 inches was smooth, and an extended ribbon of 2.0 inches, indicating this is a silty clay loam. From 5-18 inches the soil had slight grit, and after moistening, a ribbon extended to 1.5 inches, indicating a texture of clay loam. Based on later laboratory analysis, the organic matter content from a sample taken at a depth of about 8-12 inches was quite low at 0.9% (Table 3). In summary, the soil at Sample Point #1 showed hydric characteristics (i.e., low matrix chroma, the presence of redoximorphic features; Figures 19 & 20).

Figure 19. Marsh Site Sample #1 soil pit with profile (see text for description).

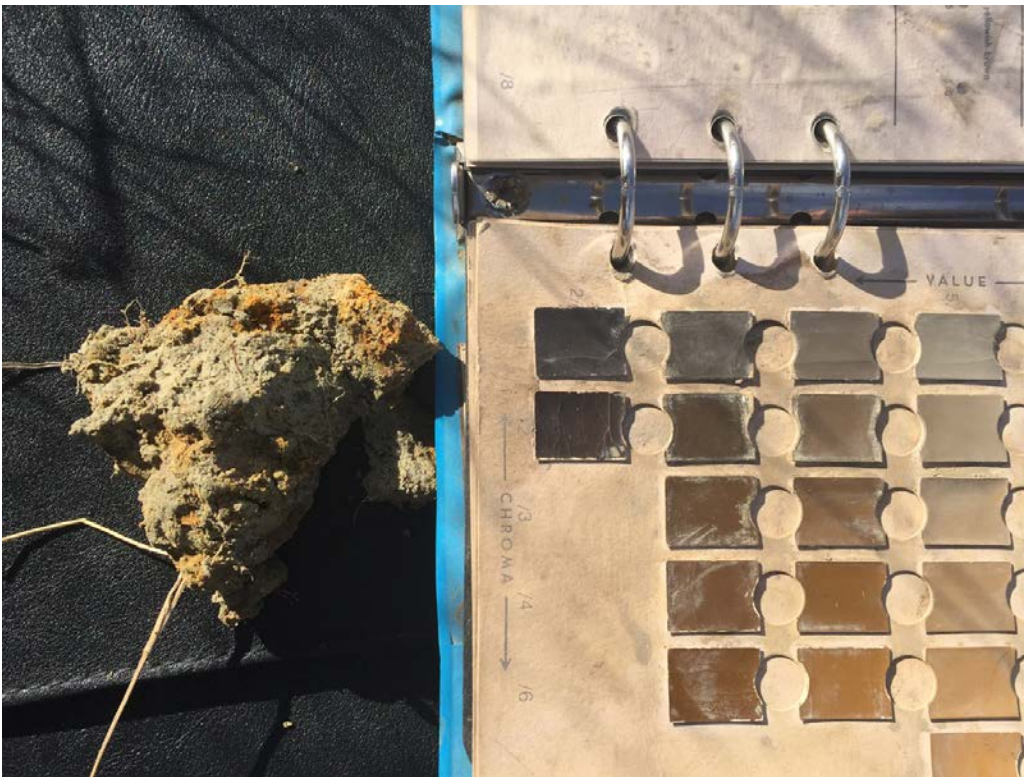
Figure 20. Munsell soil colors for Sample #1 showing hydric matrix, brighter mottles and oxidized rhizospheres (see text for discussion).

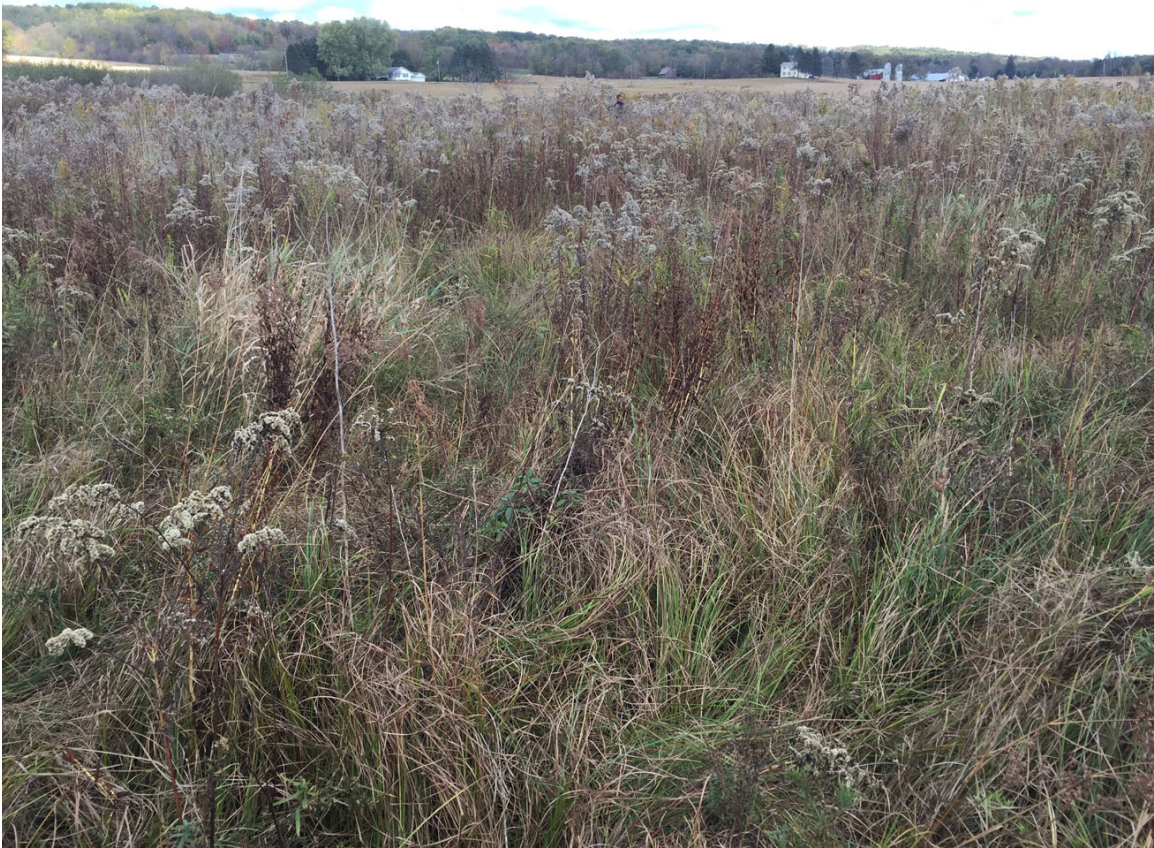
Figure 36. Marsh Site Sample Point #6 vegetation dominated by wetland plant species.

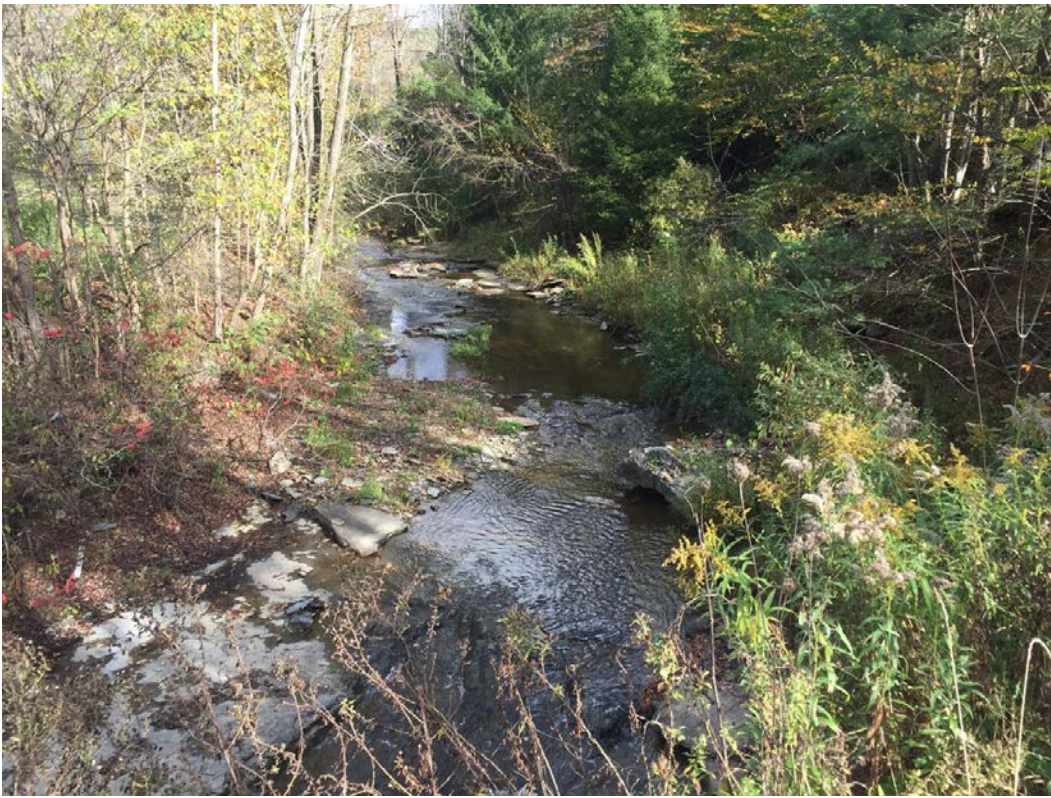
Figure 52. Hamot Road bridge looking upstream; stream bed rocky and relatively steep-sided, more incised than upstream portions of Elk Creek.

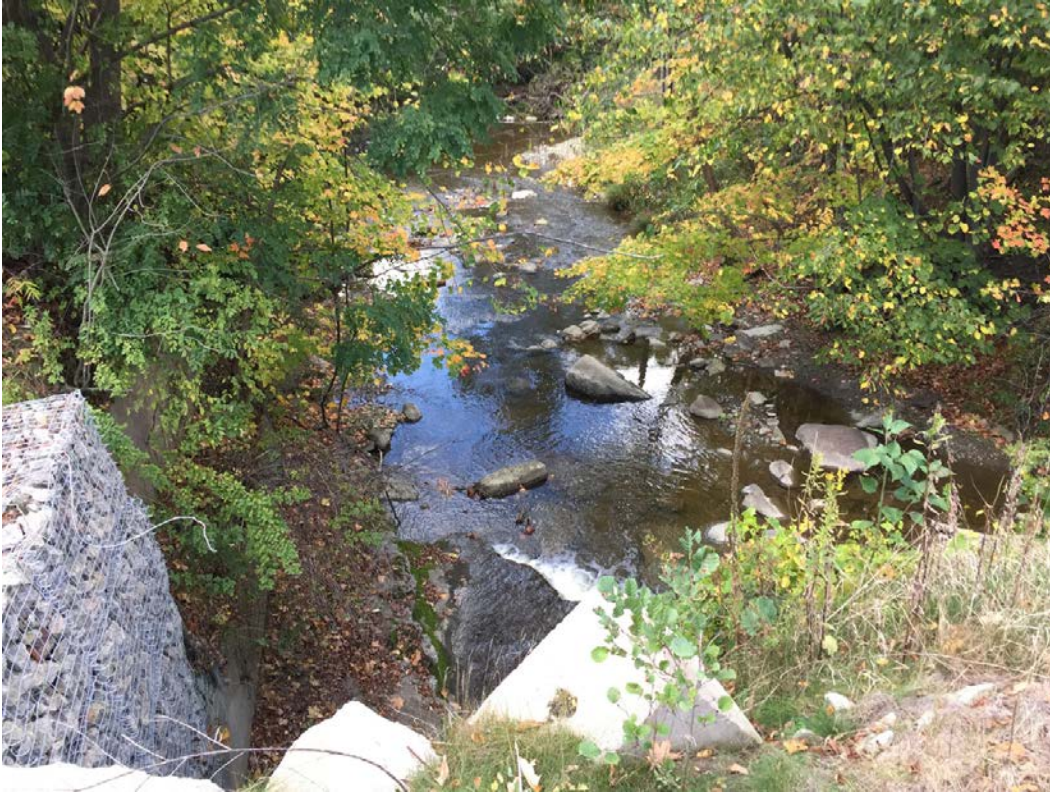
Figure 53. Elk Creek crossing under Oliver Road, steep-sided gorge; bridge supported by gabions.

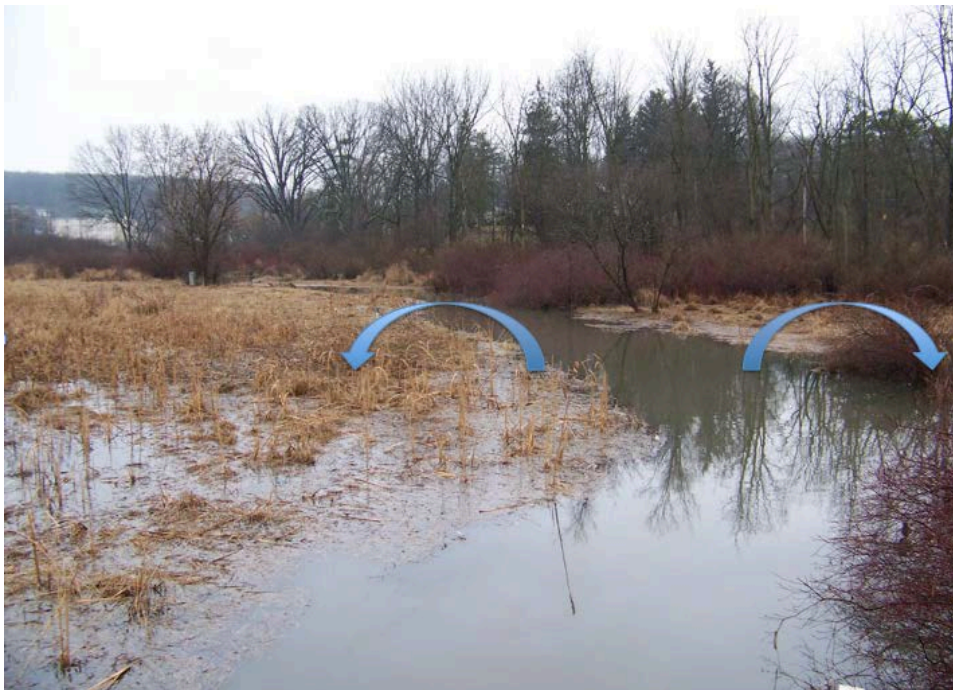
Figure 58. Example of overbank flooding of a similar sized stream where the stream is connected to the floodplain allowing frequent movement of water from the stream to the floodplain and from the floodplain back to the stream channel (Photograph by R. Brooks from central Pennsylvania).
