**NCDOT Survey #15, Edwards House (GF-8177)
7210 Burlington Road, Whitsett, Guilford County
Guilford County PIN 8834376181**

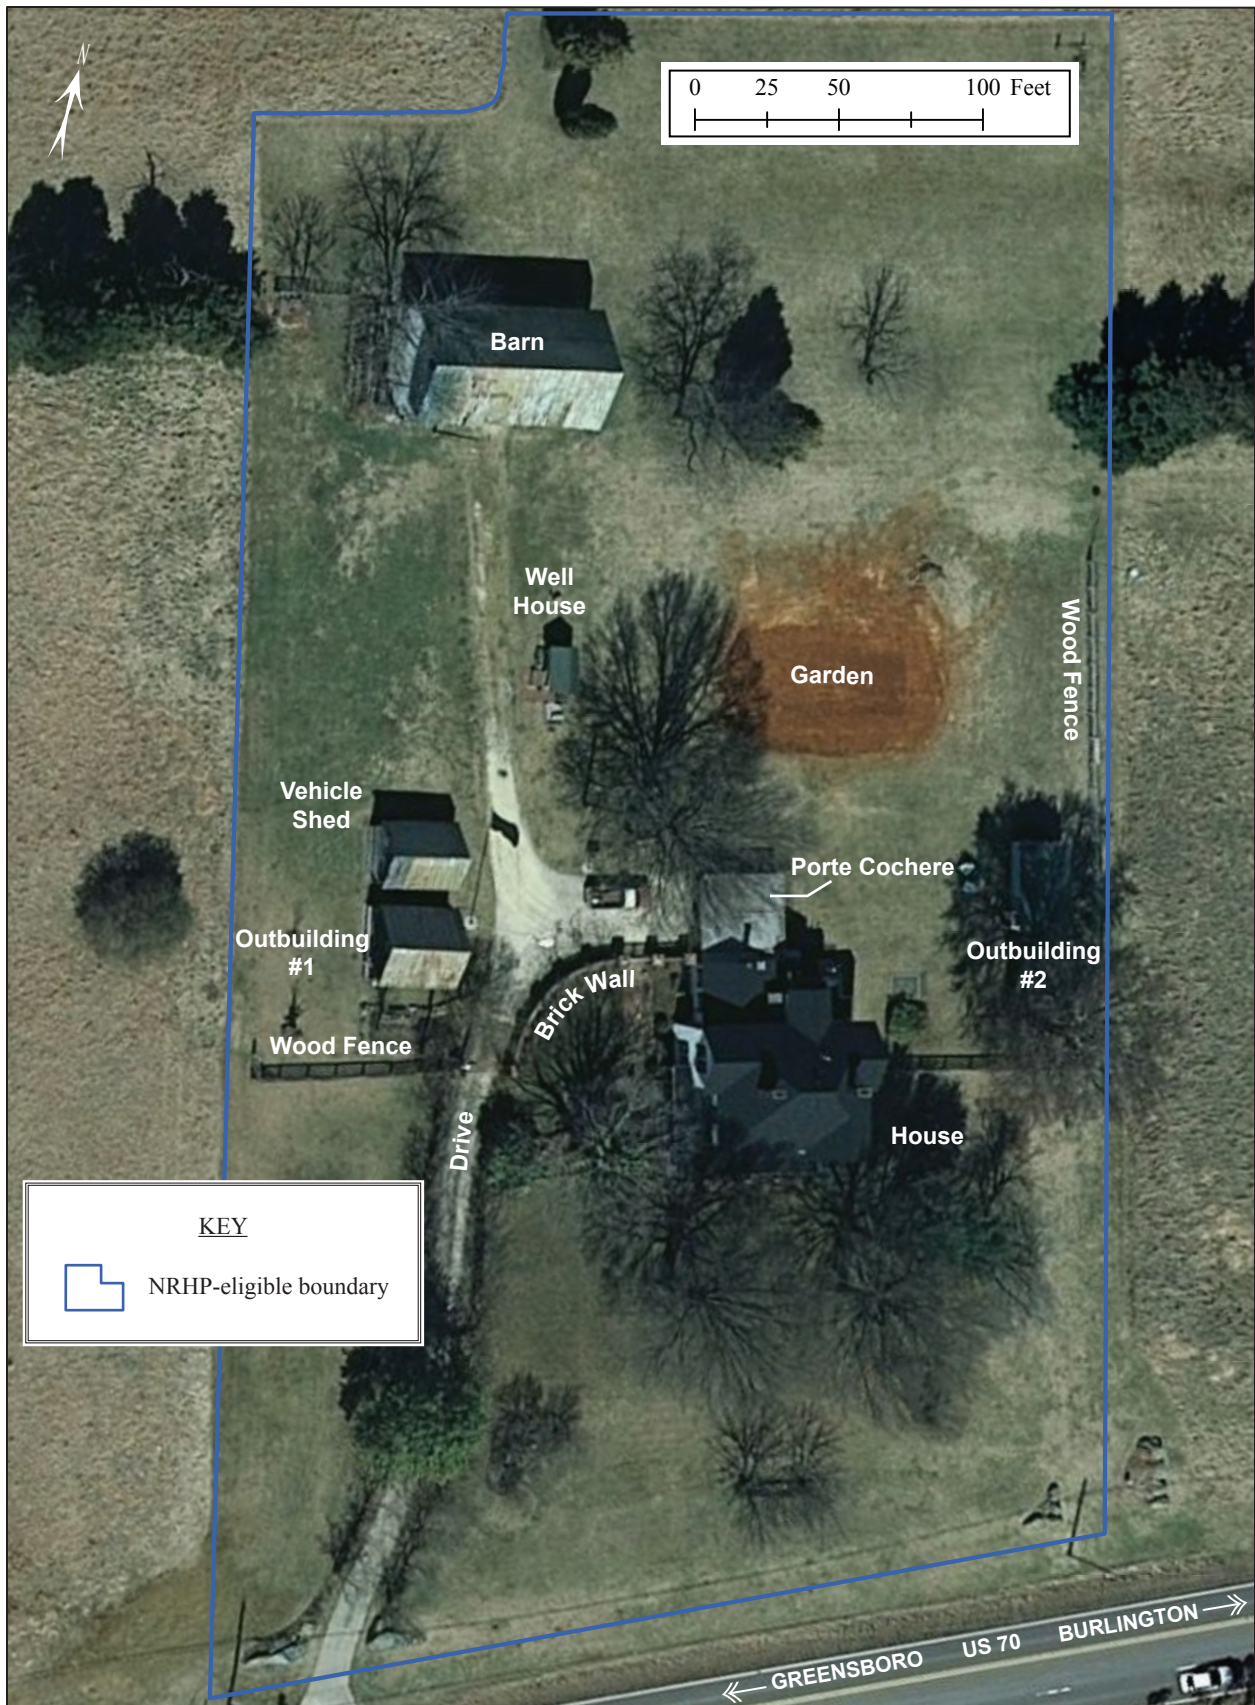
Figure 50. NCDOT Survey #29, Cyrus Augustus Wharton House (GF-2121), 6709 Burlington Road, Guilford County, aerial photograph (2010) showing recommended NRHP boundary.

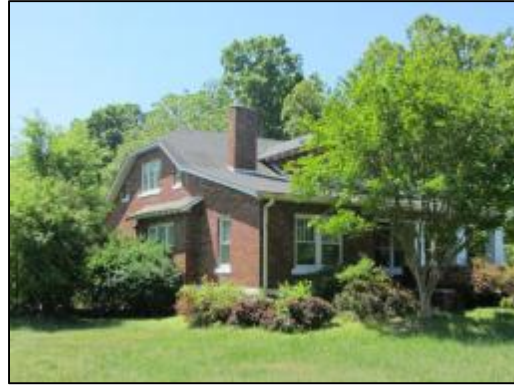
*NCDOT Survey #15, Edwards House (GF-8177),
7210 Burlington Road, looking southwest.*

Property Description: Set on a brick foundation, the one-and-one-half-story, three-bay Craftsman-style dwelling and garage were constructed by J.P. Edwards and wife Sally in 1935. It is of wood-frame construction with common-bond brick veneer. Painted concrete is used for the window sills, as a belt course around the entire building, and as caps for the porch piers and rear brick steps. The clipped-gable roof is clad with asphalt shingles, features two interior brick chimneys, an exterior-front chimney, and has a shallow pitch that breaks on the north side to form a shed roof over the incised three-bay wraparound porch with battered posts. A single dormer with clipped-gable roof, exposed rafter ends, and a tripartite window with 4/1 double-hung wood sash windows is centered on the north façade. A second dormer with clipped-gable roof, exposed rafter ends, and a double window with 4/1 double-hung wood sash windows is centered on the south elevation.

The front (north) porch has battered wood columns set on brick piers with concrete caps. A second shed-roofed porch, this one enclosed by a wood knee-wall and screening, is located on the south. A shed-roofed window bay with exposed rafter ends and a tripartite window with 4/1 double-hung sash is located at the east and west gable ends. The fenestration consists of 4/1 double-hung sash windows with wood molding. Smaller windows with 1/1 sash flank the attic windows on the gable ends. On the east wall beneath the porch is a decorative roundel consisting of a single circle of header bricks enclosing a painted concrete circle with a square-inside-a-square design.

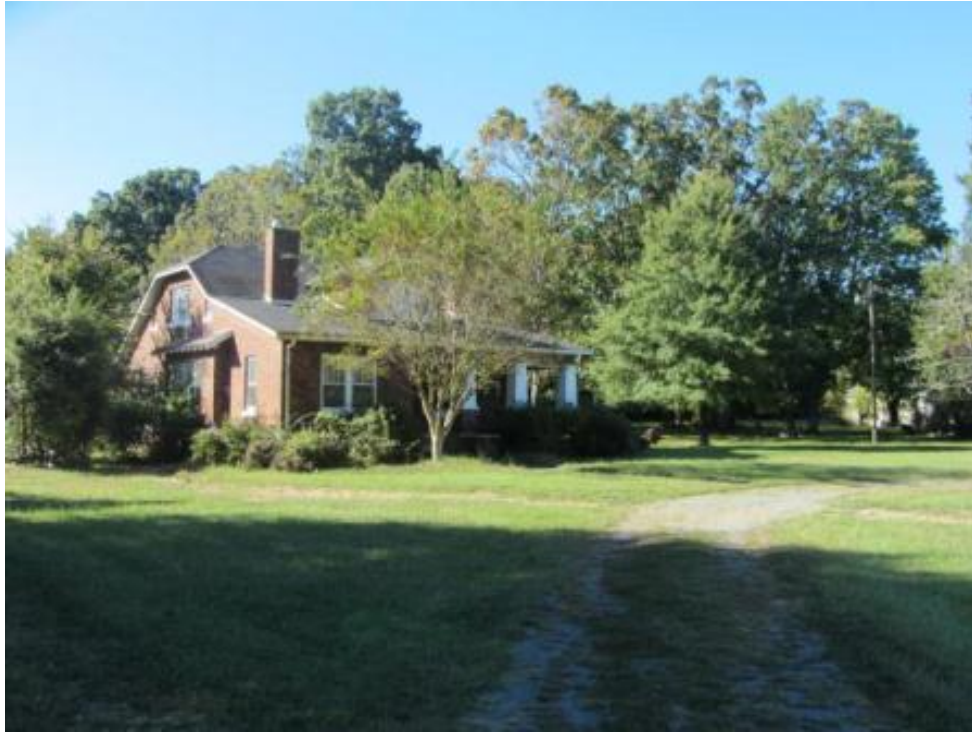
Figure 52. NCDOT Survey #15, Edwards House (GF-8177), 7210 Burlington Road, Guilford County, northeast elevation and surrounding property, looking southwest with driveway in foreground.

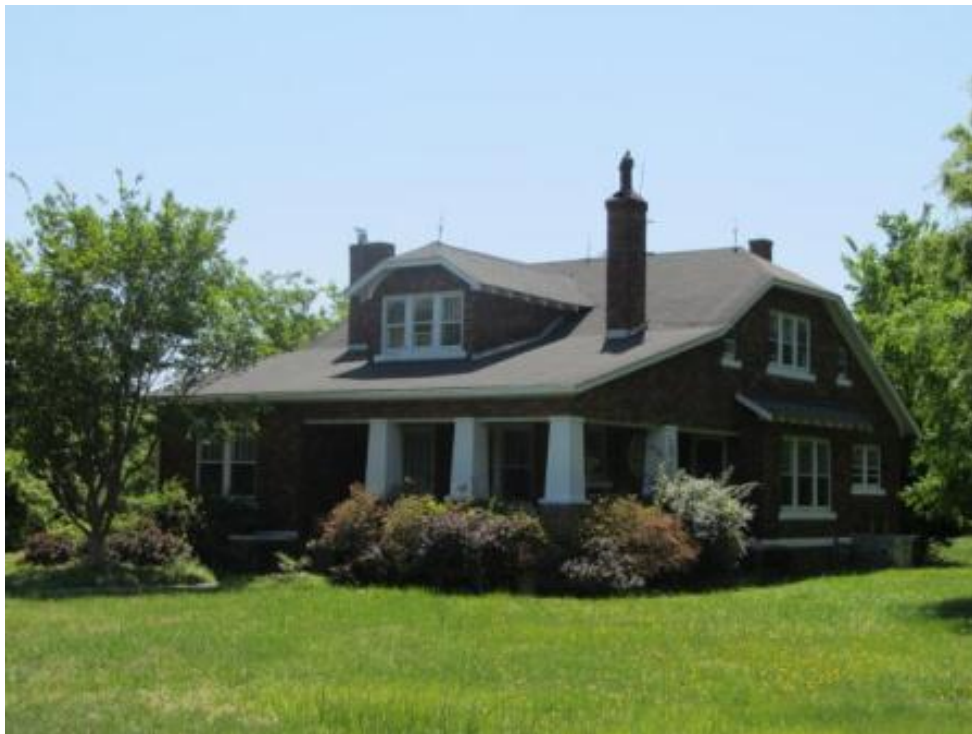
Figure 53. NCDOT Survey #15, Edwards House (GF-8177), 7210 Burlington Road, Guilford County, northwest elevation, looking southeast.

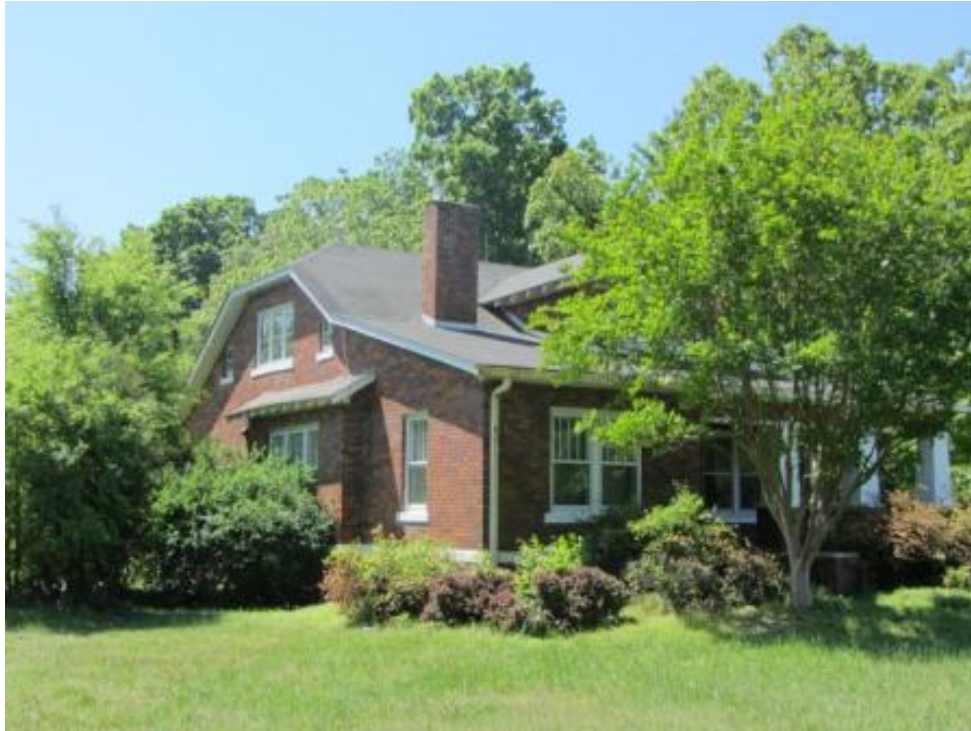
Figure 54. NCDOT Survey #15, Edwards House (GF-8177), 7210 Burlington Road, Guilford County, northeast elevation, looking southwest.

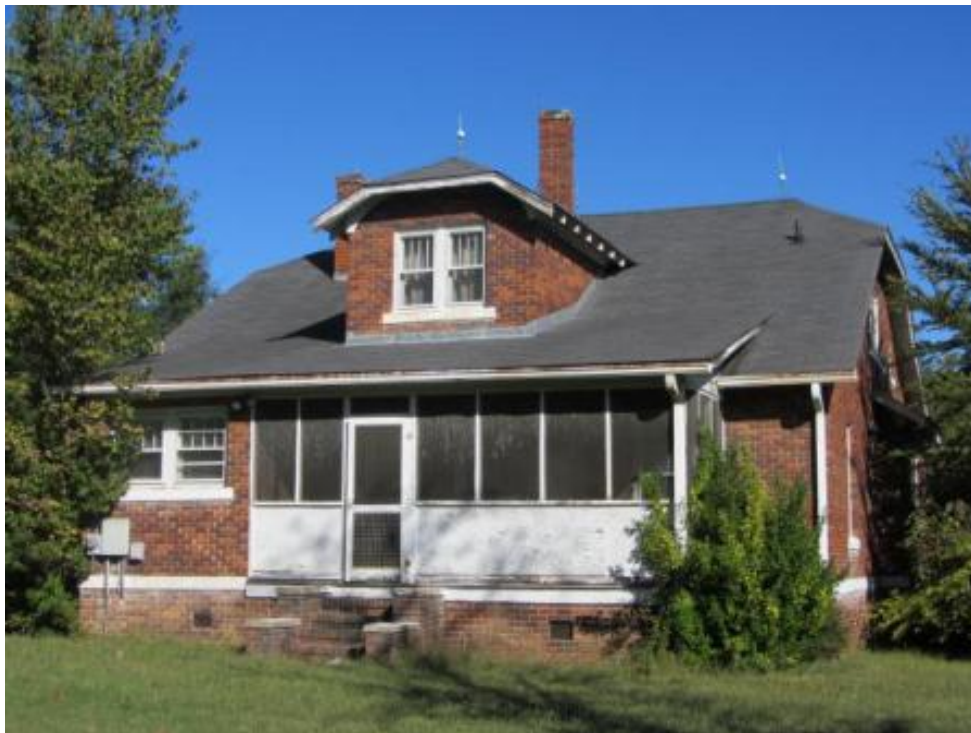
Figure 55. NCDOT Survey #15, Edwards House (GF-8177), 7210 Burlington Road, Guilford County, south elevation, looking north.

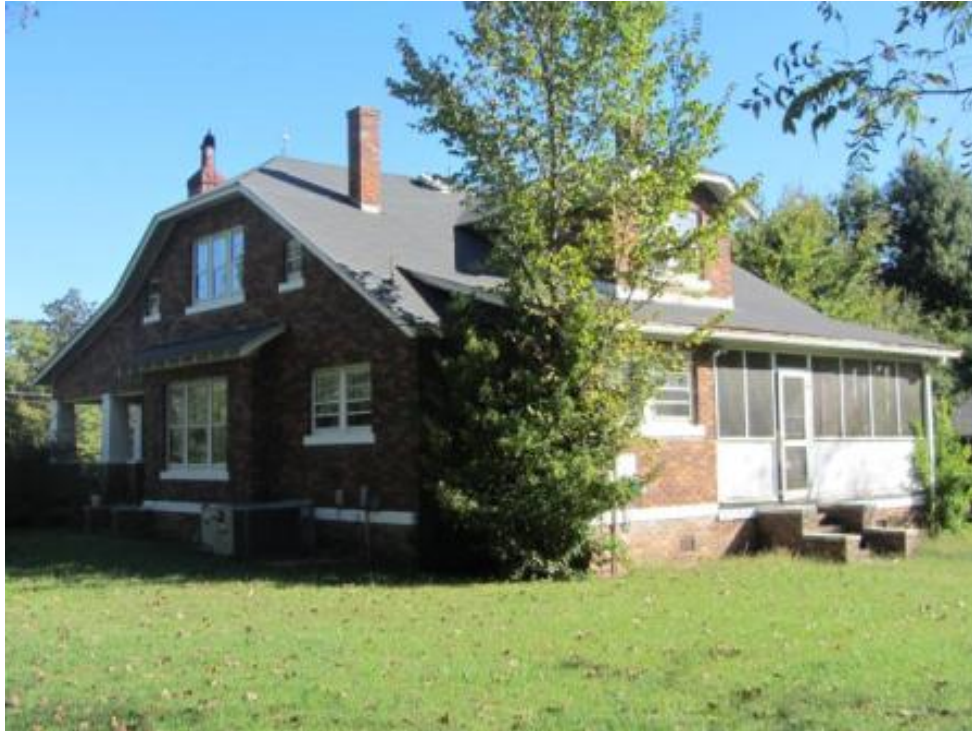
Figure 56. NCDOT Survey #15, Edwards House (GF-8177), 7210 Burlington Road, Guilford County, southwest elevation, looking northeast.

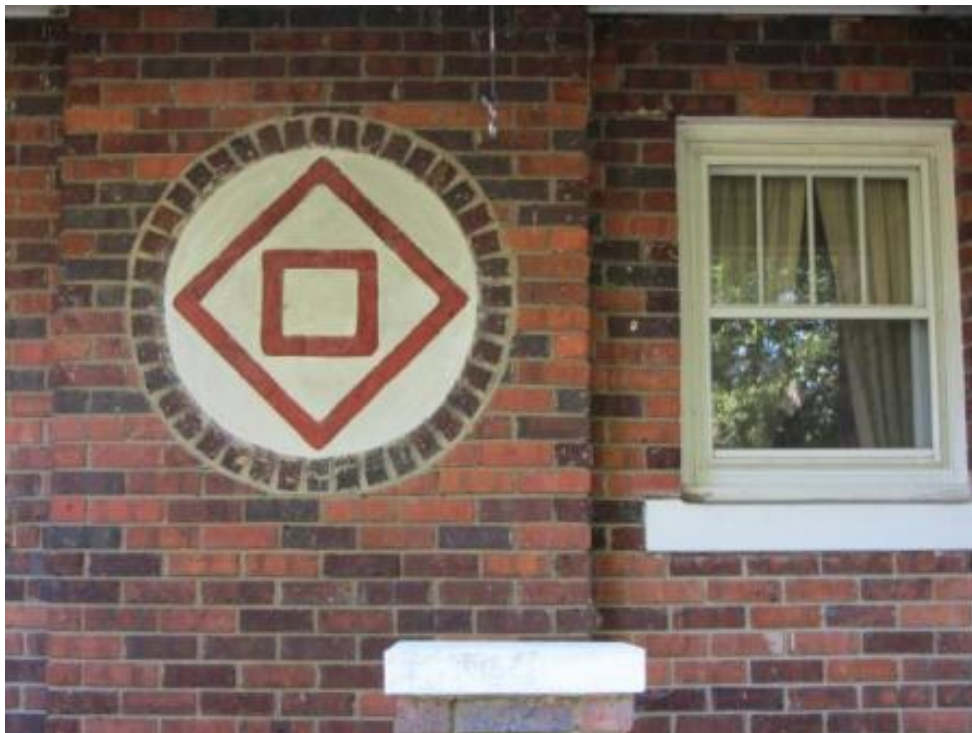
Figure 57. NCDOT Survey #15, Edwards House (GF-8177), 7210 Burlington Road, Guilford County, detail of west wall beneath porch with decorative roundel, looking east.

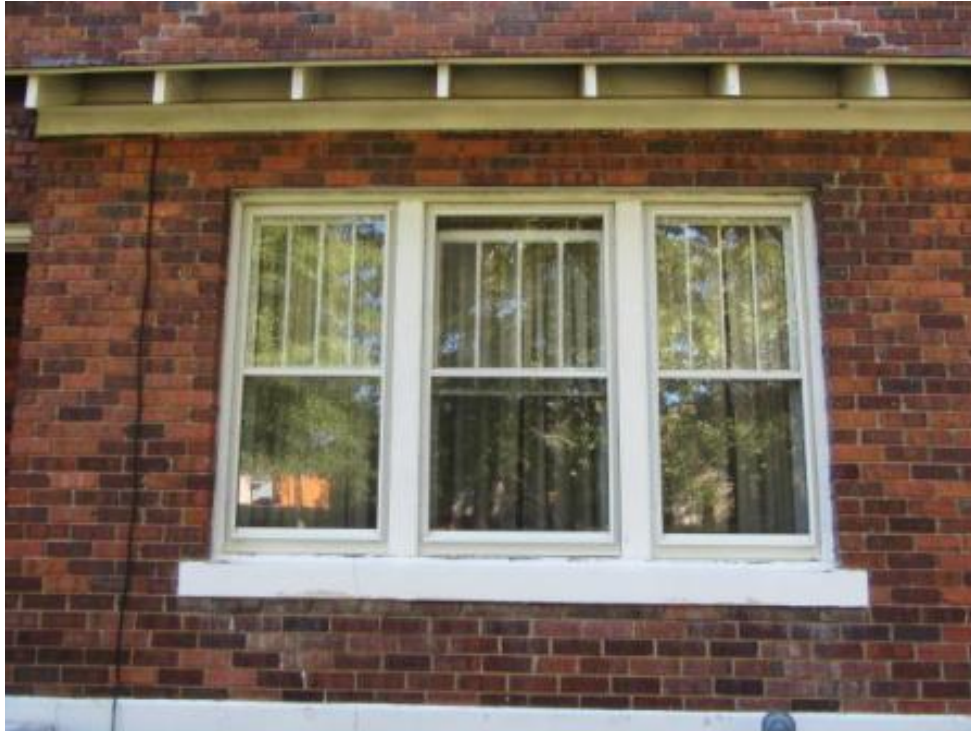
Figure 58. NCDOT Survey #15, Edwards House (GF-8177), 7210 Burlington Road, Guilford County, detail of typical tripartite window, west window bay, looking east.

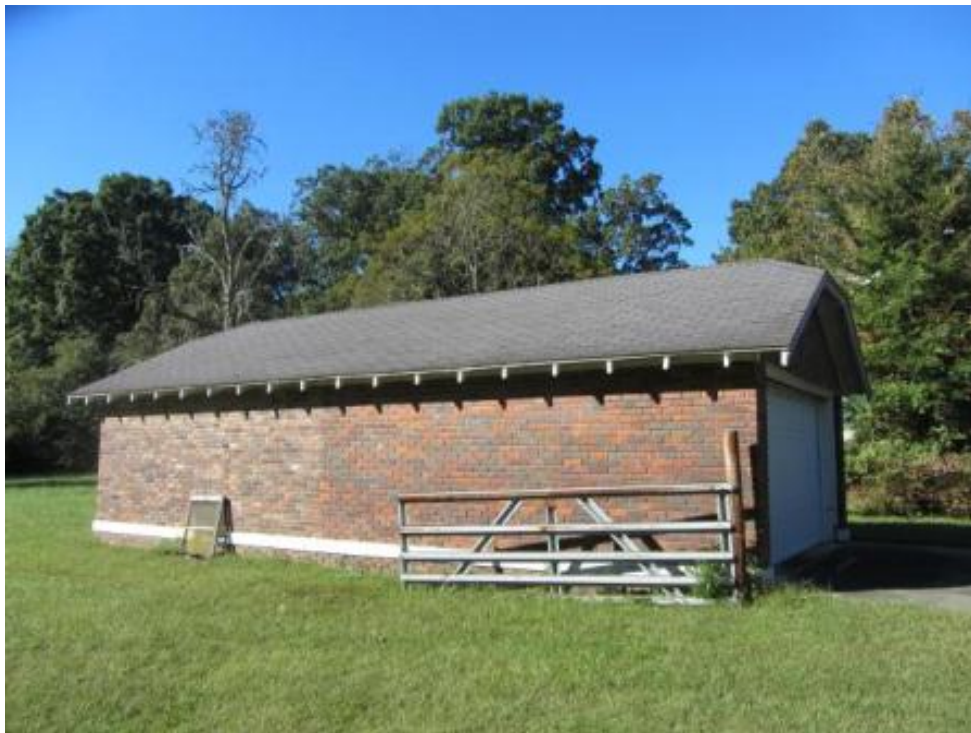
Figure 59. NCDOT Survey #15, Edwards House (GF-8177), 7210 Burlington Road, Guilford County, garage, east elevation, looking southwest.

Located a short distance to the east of the main house is the one-story, one-bay frame-with-brick-veneer garage built at the same time as the house. The garage is oriented to the north and has a replacement roll-up metal garage door. The front-gable roof has clipped gable ends. On the west is a centered single-leaf wood door with a paneled lower half and a 6-light window on the upper half. To its right is a paired window with 6/1 double-hung sash.

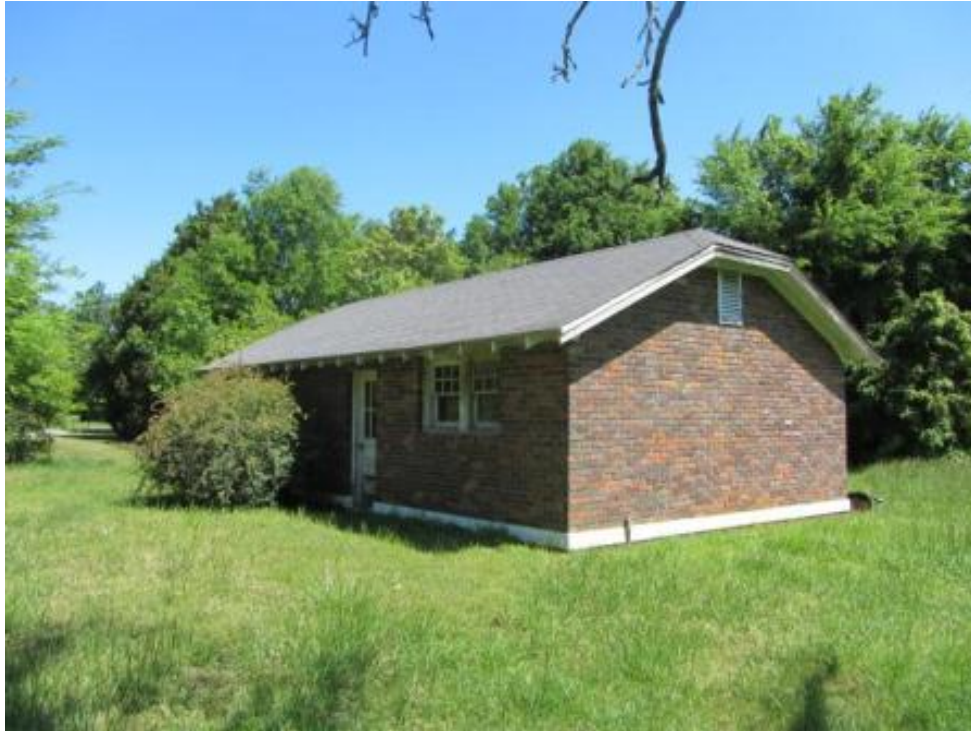
Figure 60. NCDOT Survey #15, Edwards House (GF-8177), 7210 Burlington Road, Guilford County, garage, southwest corner, looking northeast.

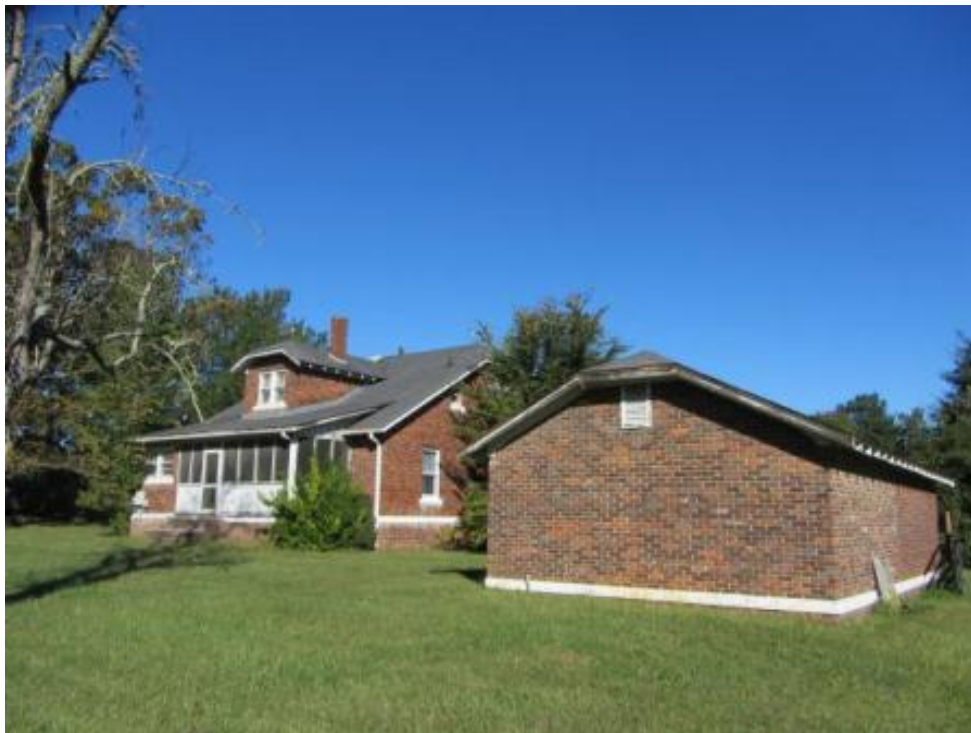
Figure 61. NCDOT Survey #15, Edwards House (GF-8177), 7210 Burlington Road, Guilford County, view of house and garage in foreground, looking northwest.
