VETIVER SYSTEM TECHNOLOGY FOR INFRASTRUCTURE PROTECTION

Dr. Paul Truong
TVNI Technical Director
Director for Asia and Oceania,
Brisbane, Australia

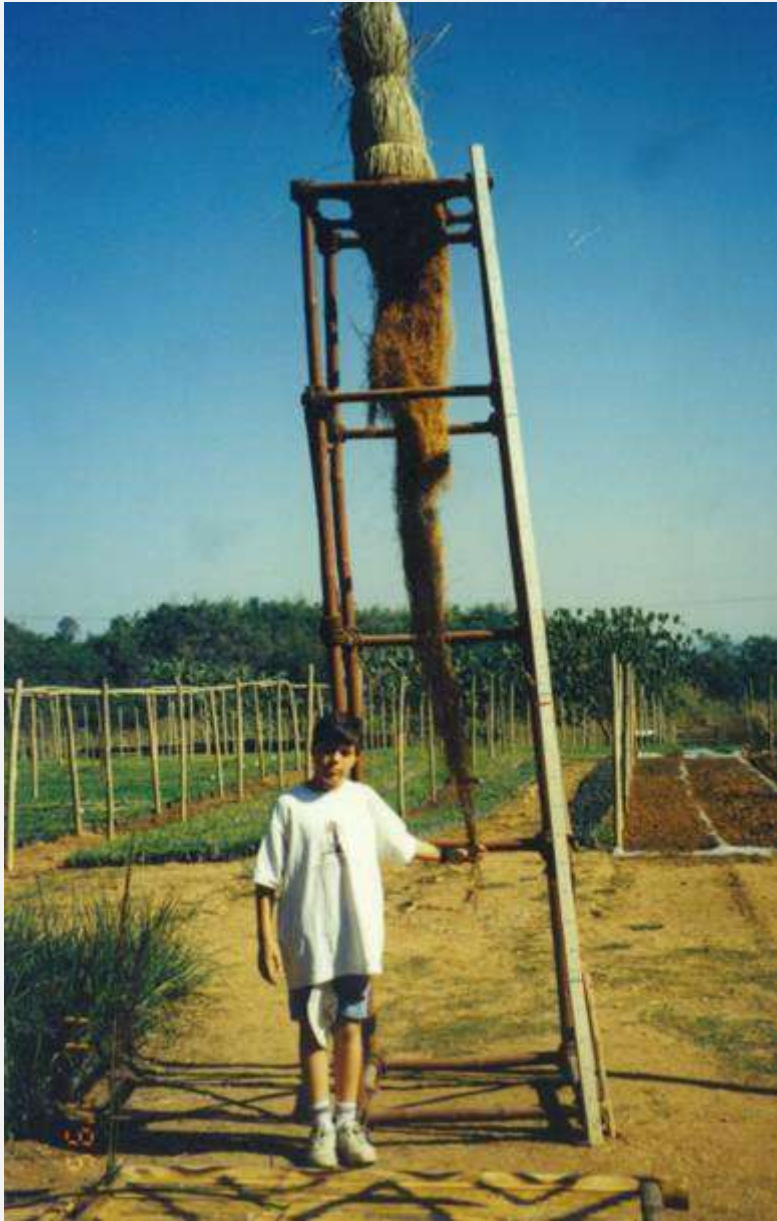
One year old plant with 3.3m deep root system

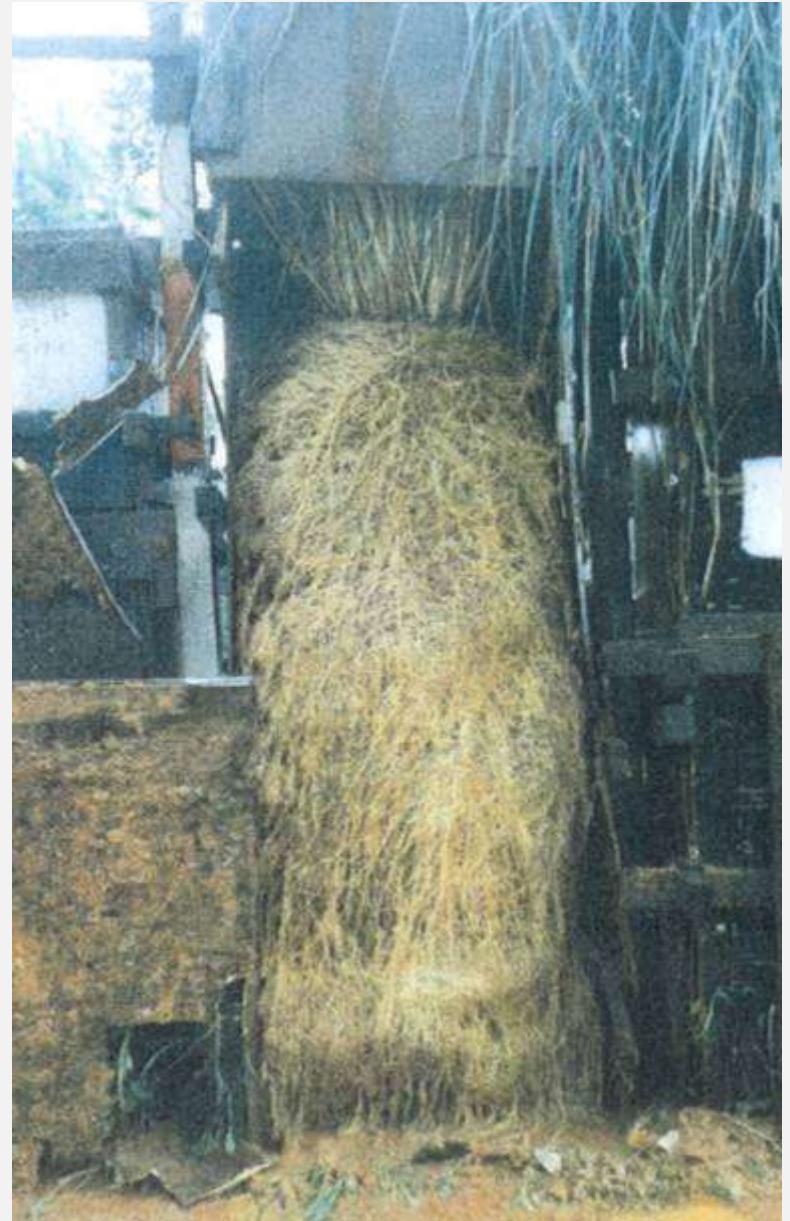
Vetiver roots have a **tensile strength of 75 Mpa, equivalent to 1/6 strength of mild steel reinforcement.**

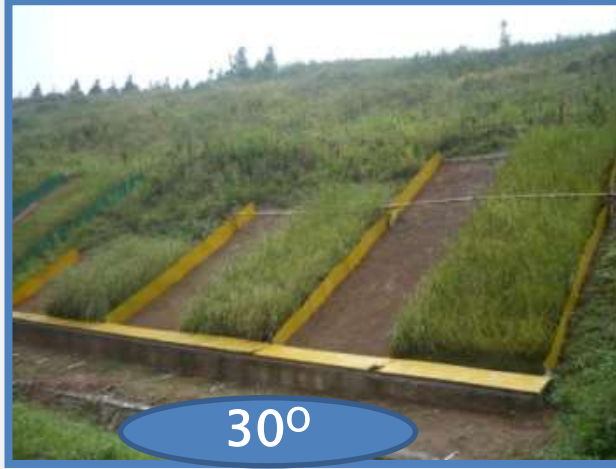
Soil Type: Silty Clay Loam **Stability Index:** Unstable 3 Month Old, West Java

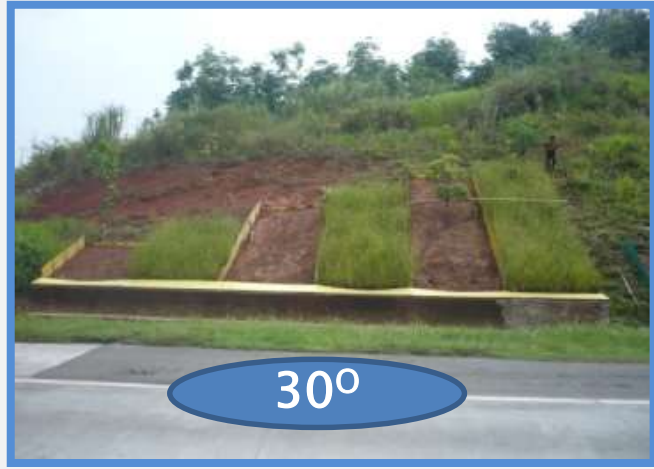
Soil Type: Dusty Clay **Stability Index:** Unstable 3 Month Old, West Java

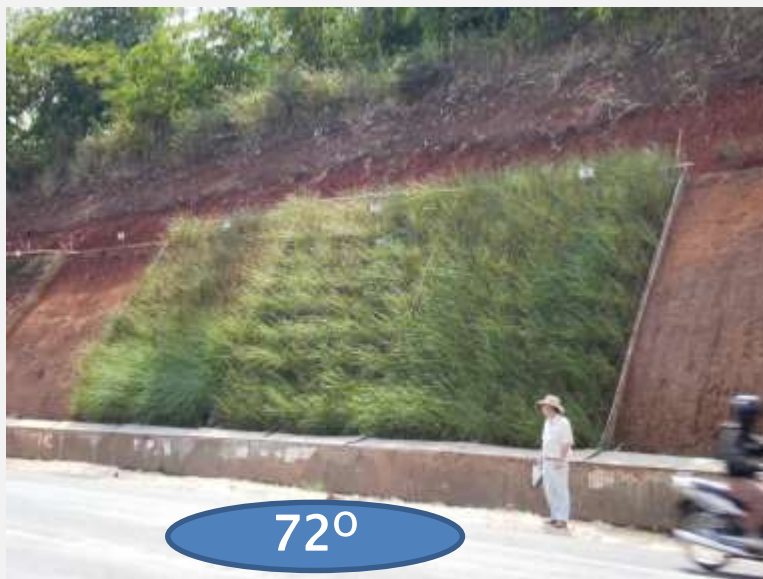
72°

Soil Type: Clay Loam

Stability Index: Stable

4 Month Old

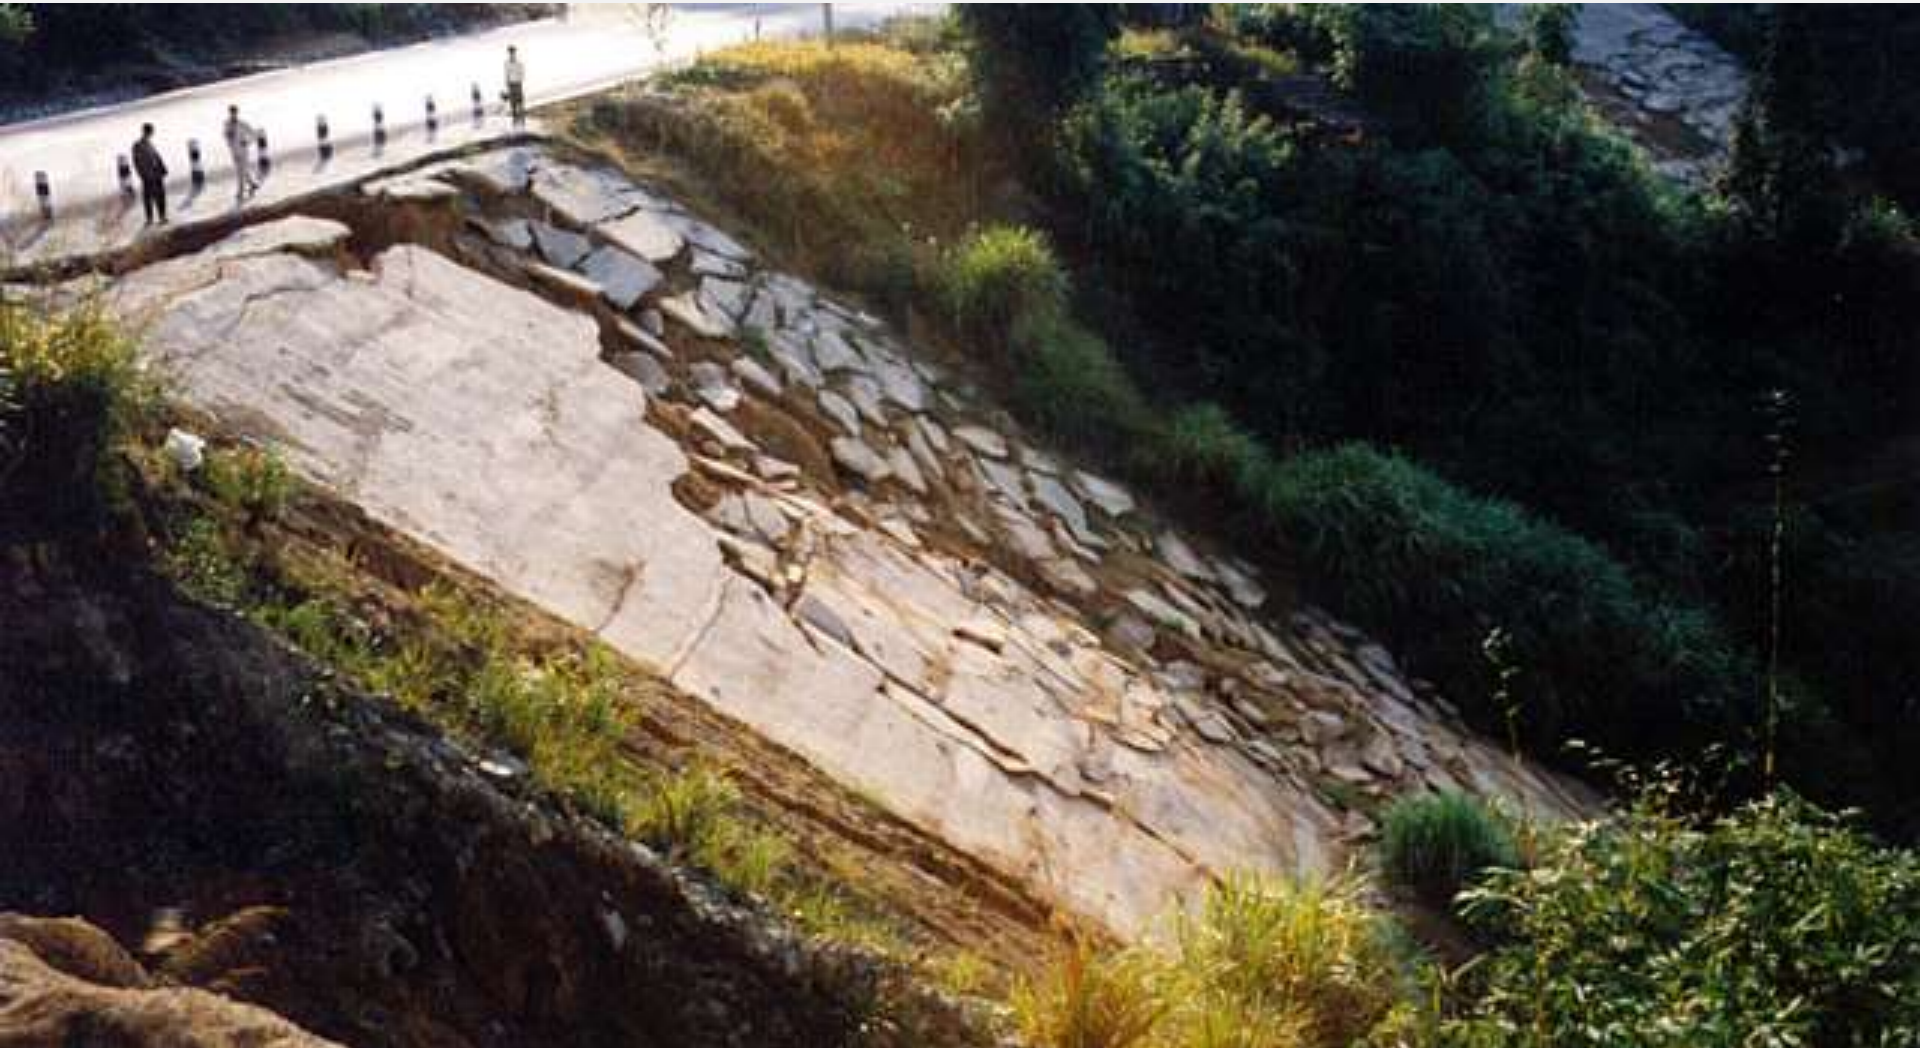
Shotcrete failed to protect this road batter slope during typhoon in southern China.

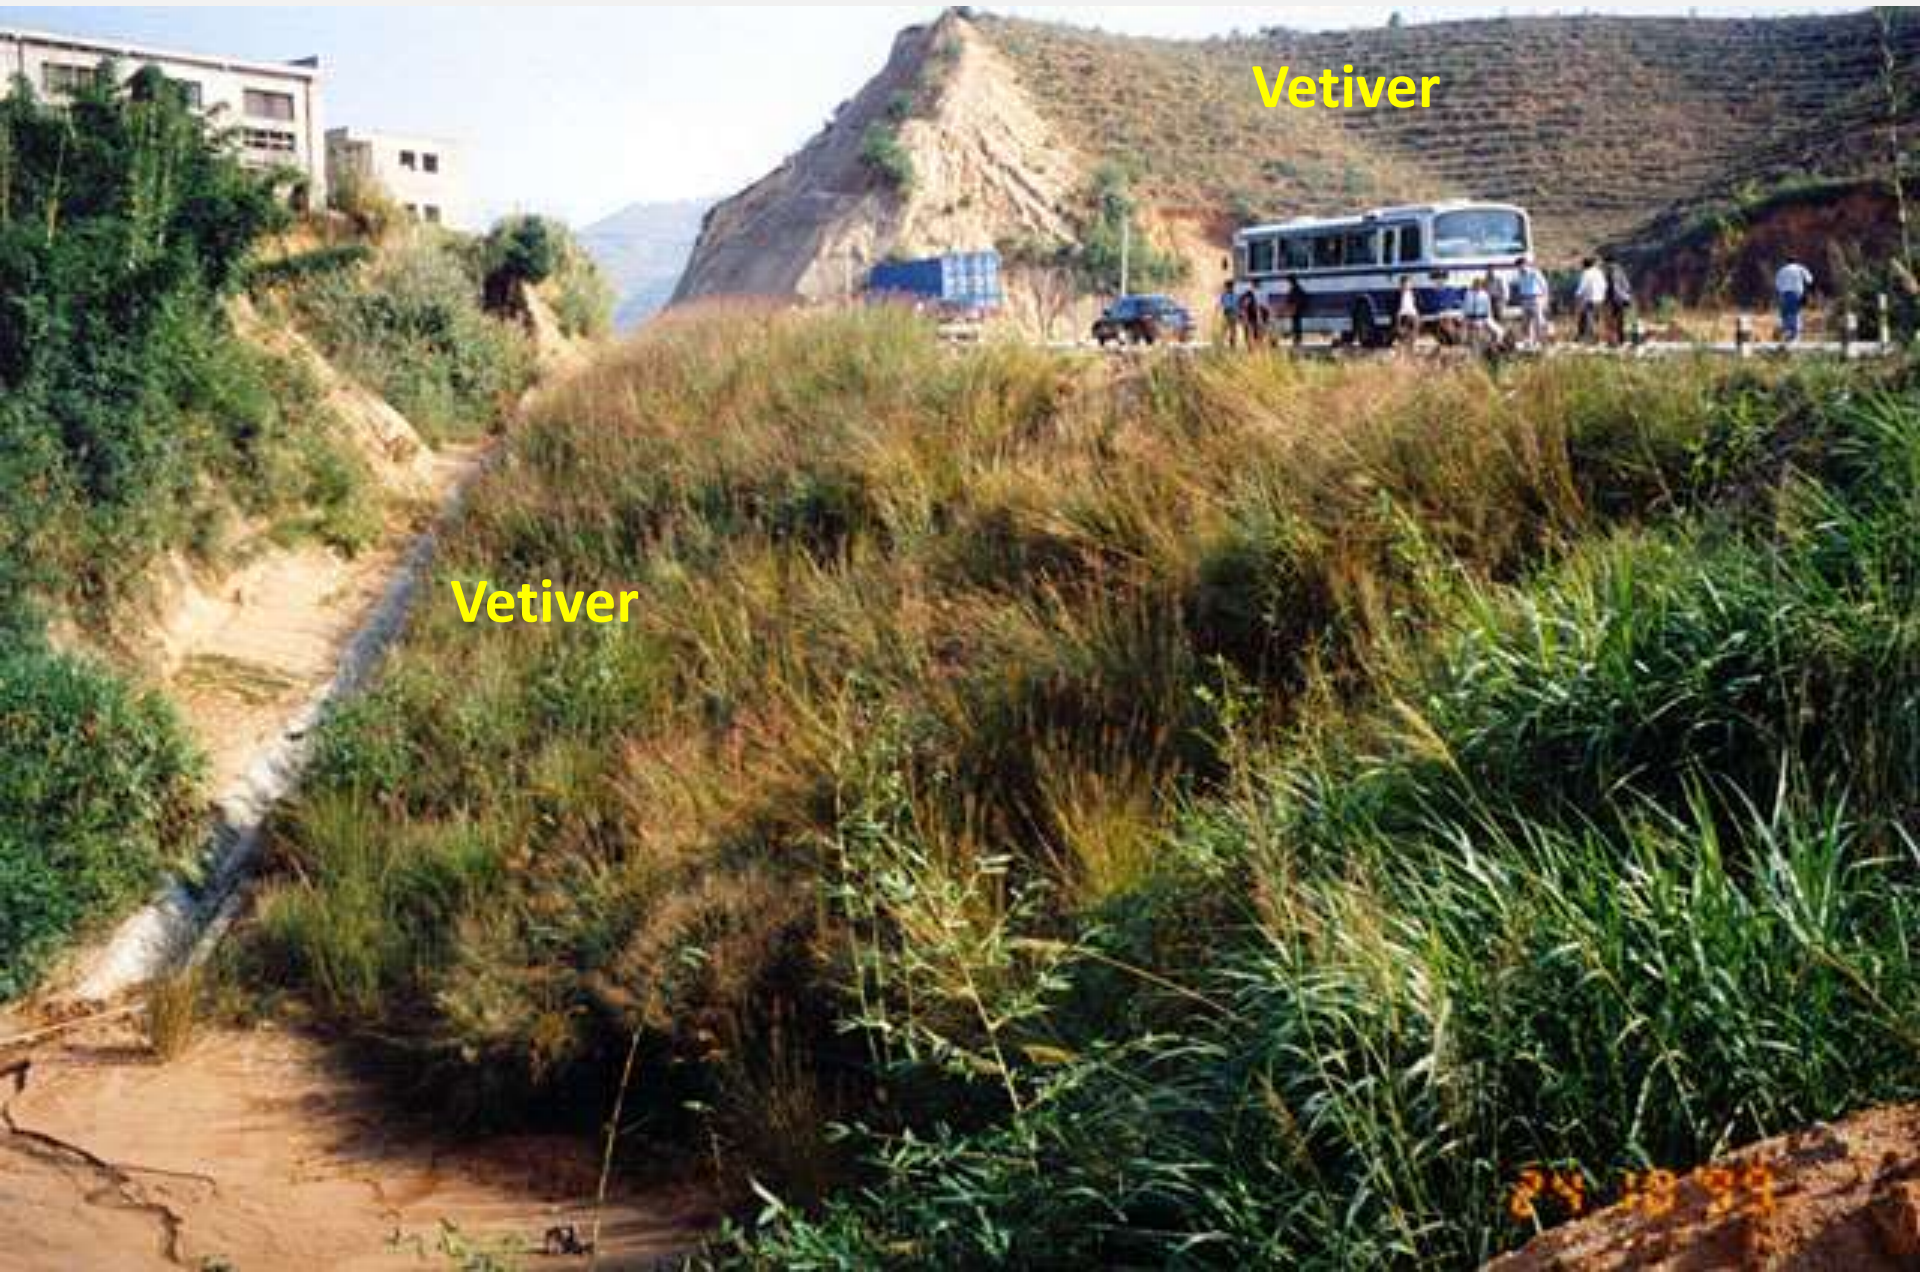
On the same road, at the same time a batter fully stabilised by vetiver

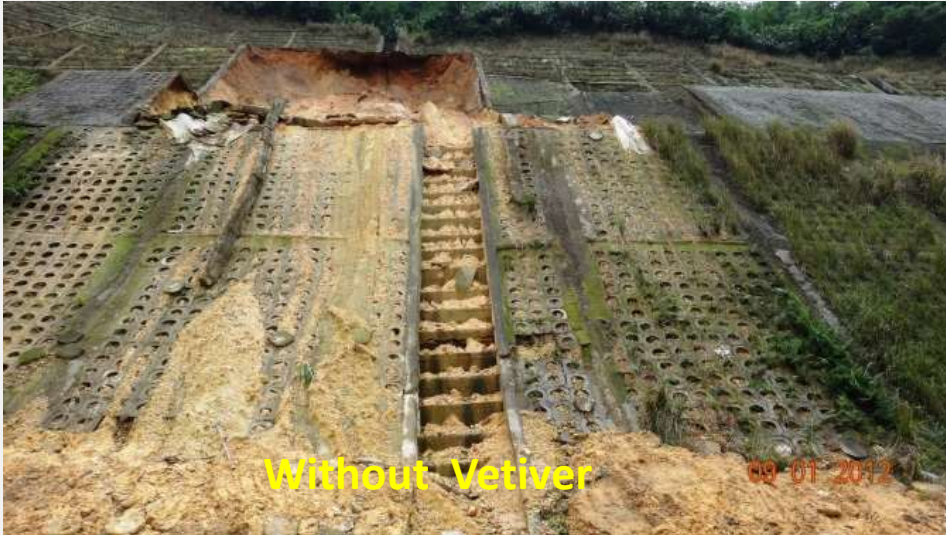
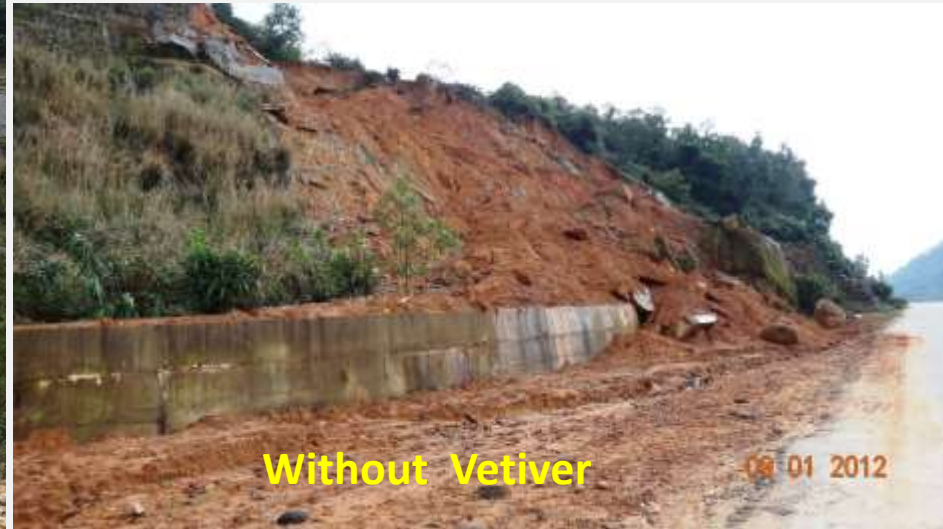
The concrete cellular surface failed to protect the slope in Vietnam

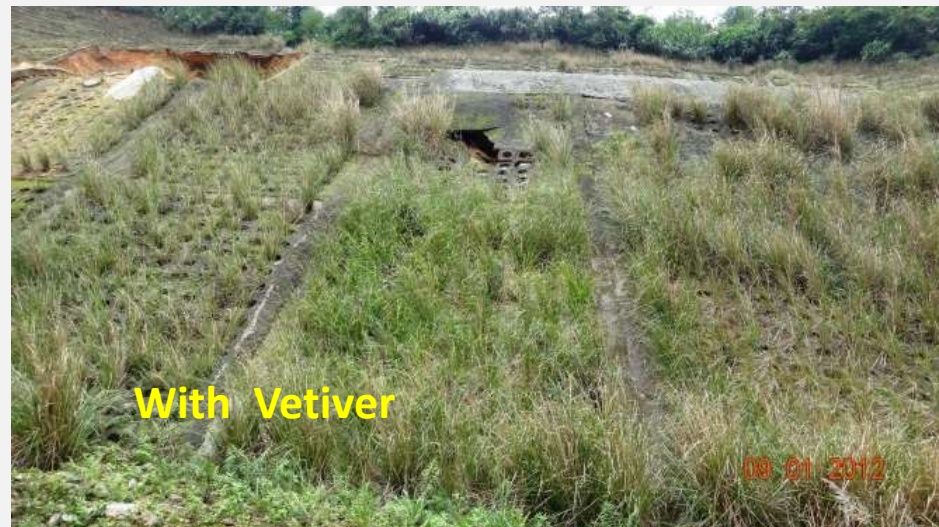
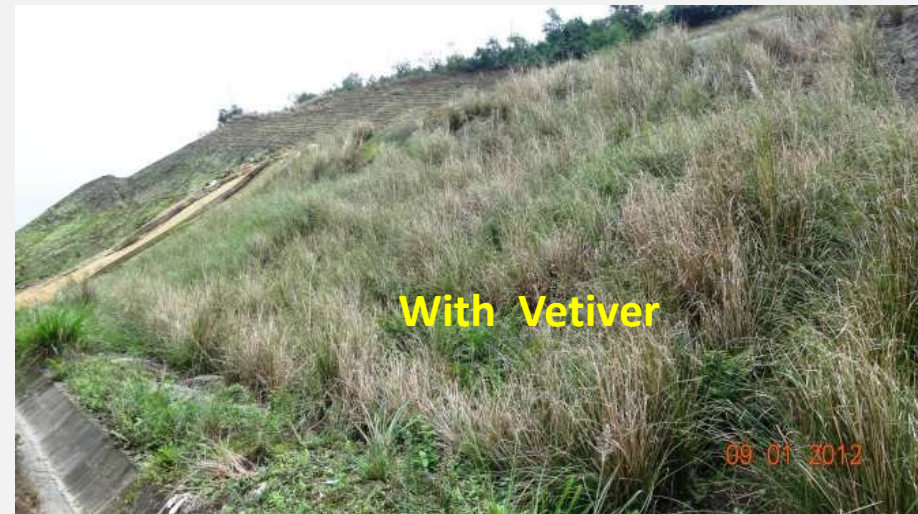
But the slope was fully protected when Vetiver was planting into the holes

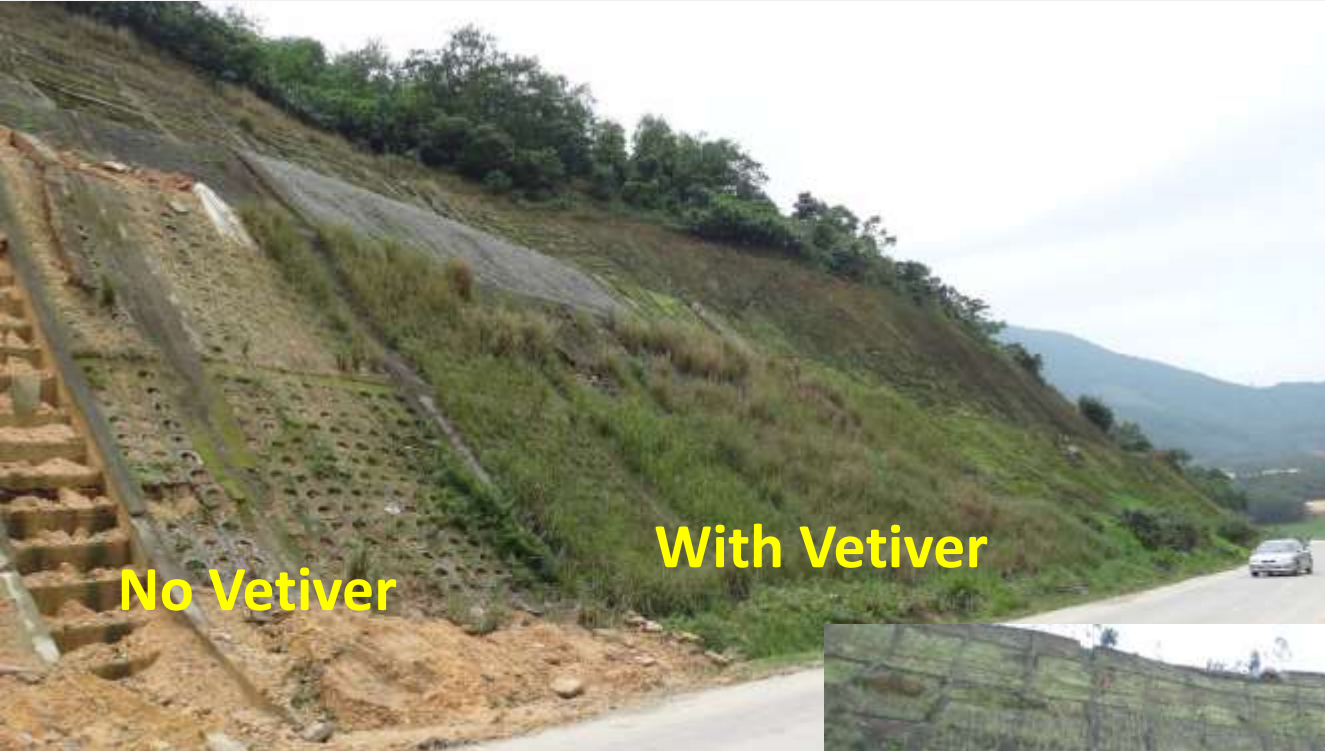
Without Vetiver reinforcement, concrete blocks by themselves could not protect slope in long term

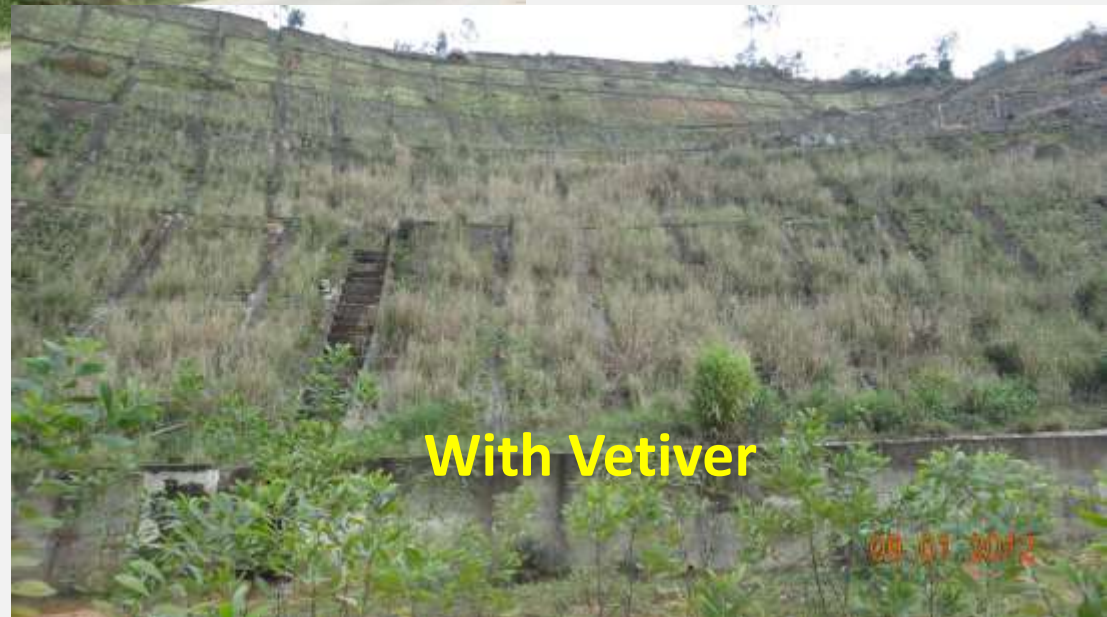
Vetiver in combination with concrete block fully stabilised this slope

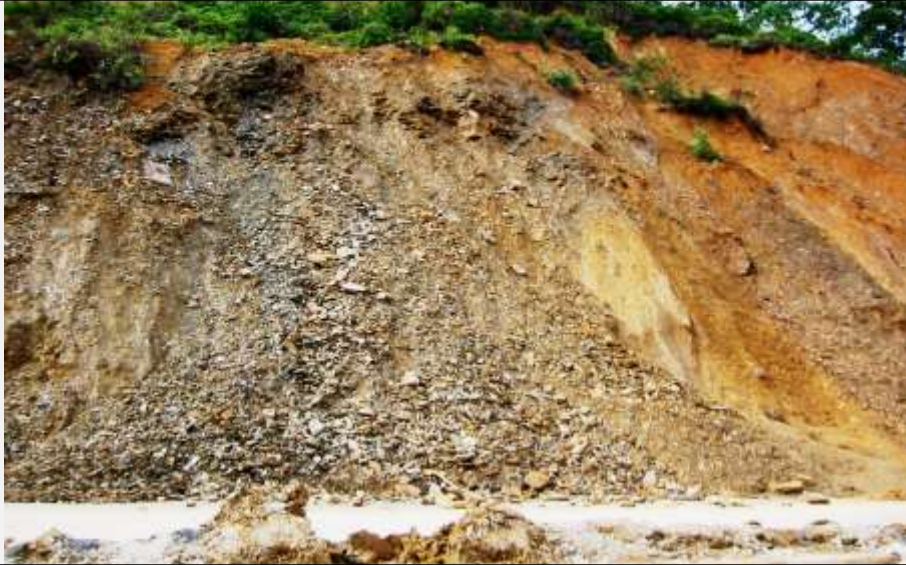
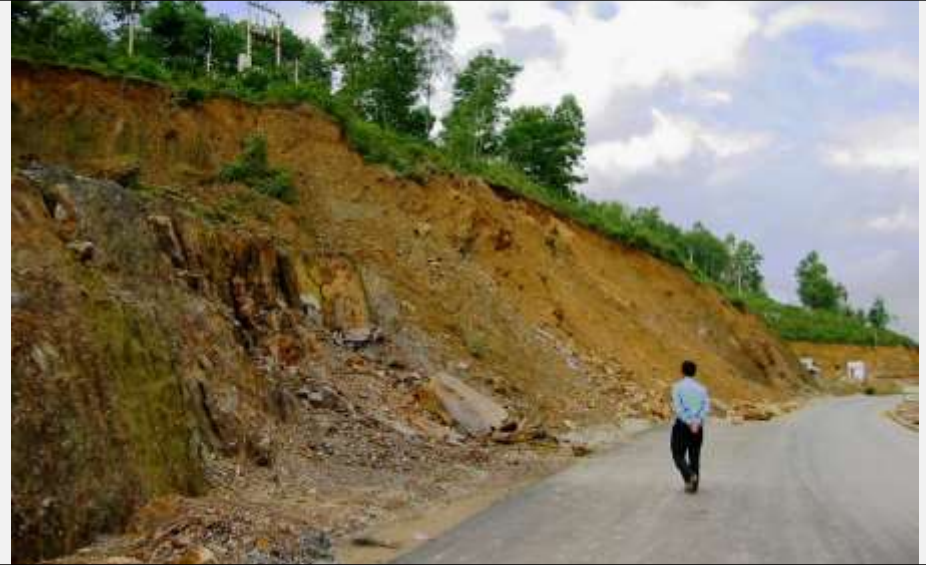
Erosion started while bitumen paving in progress

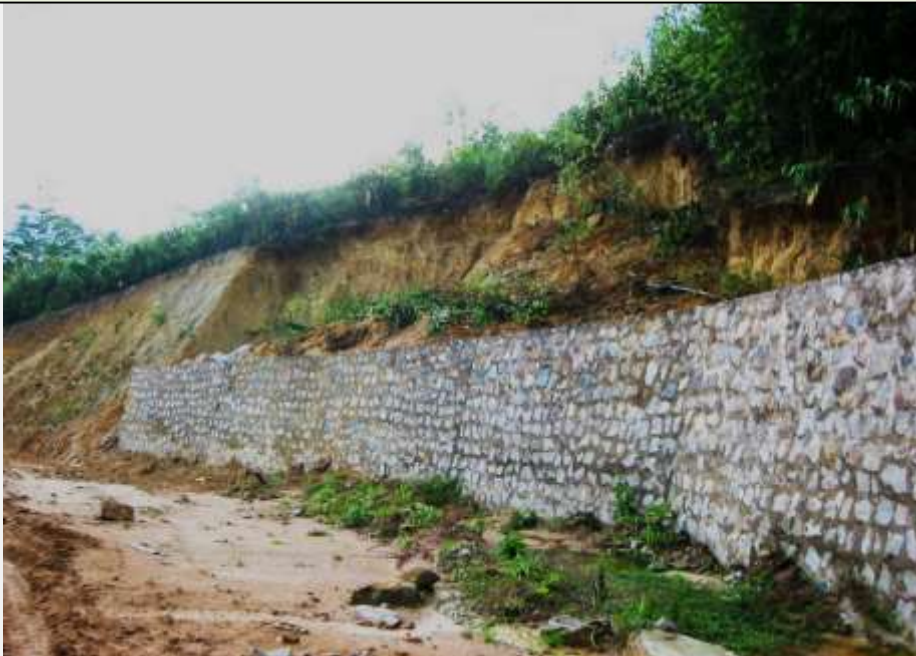
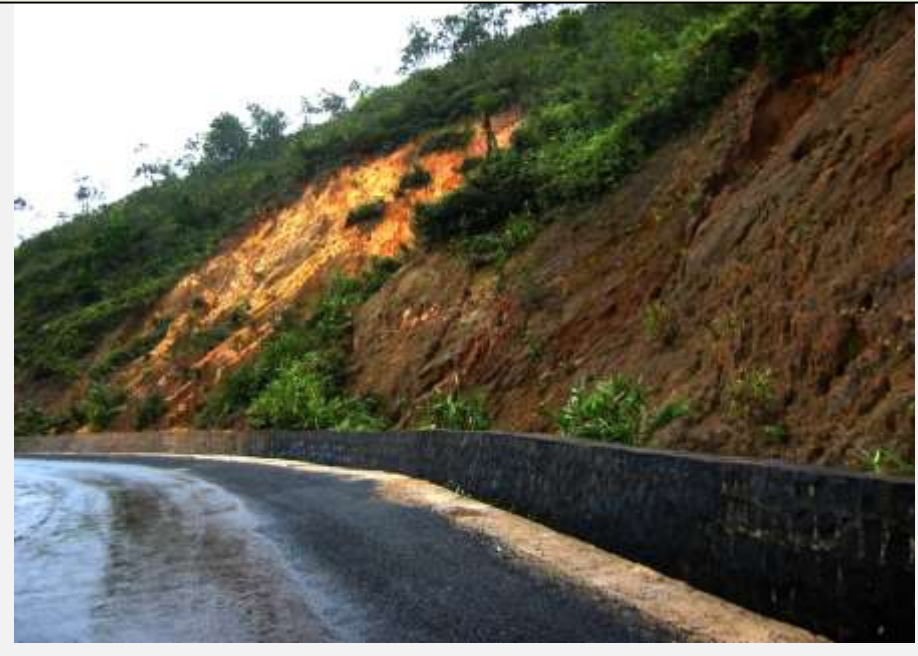
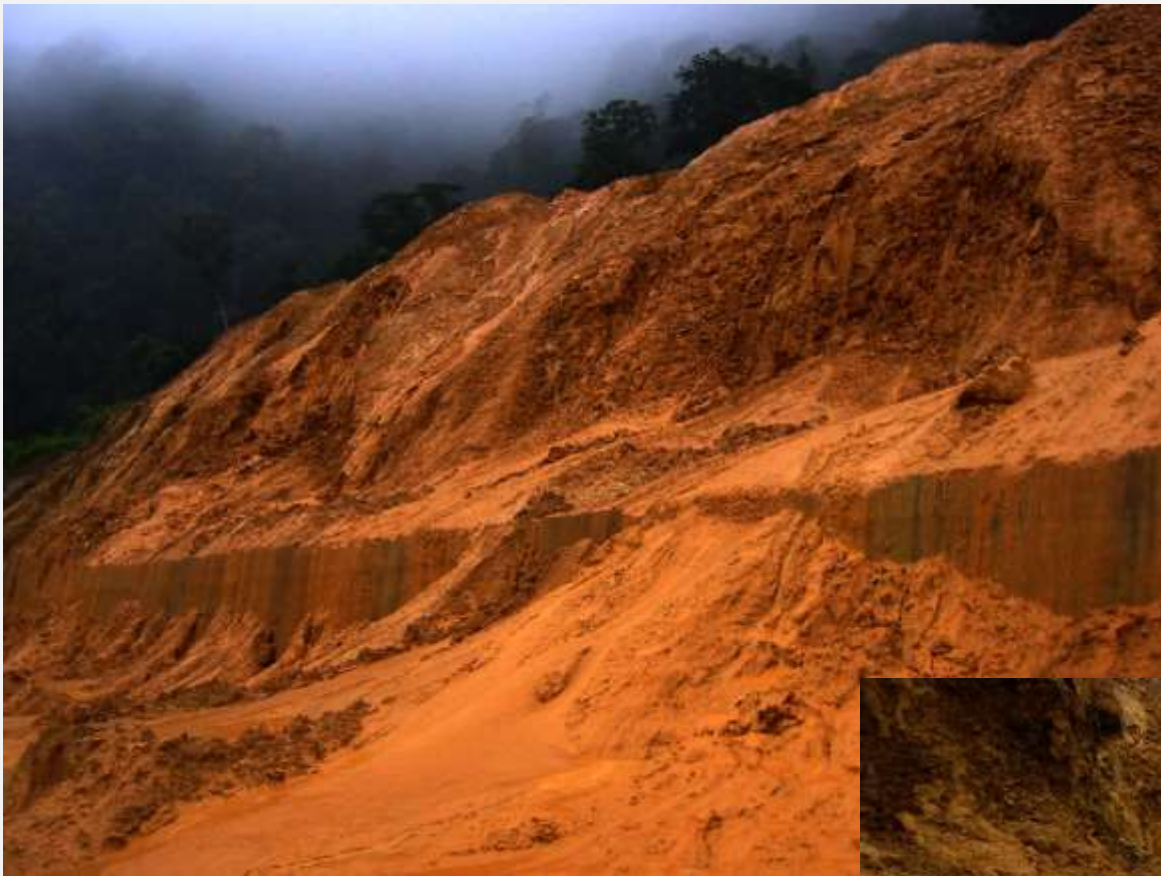
Conventional hard structure solution: Small and large retaining walls

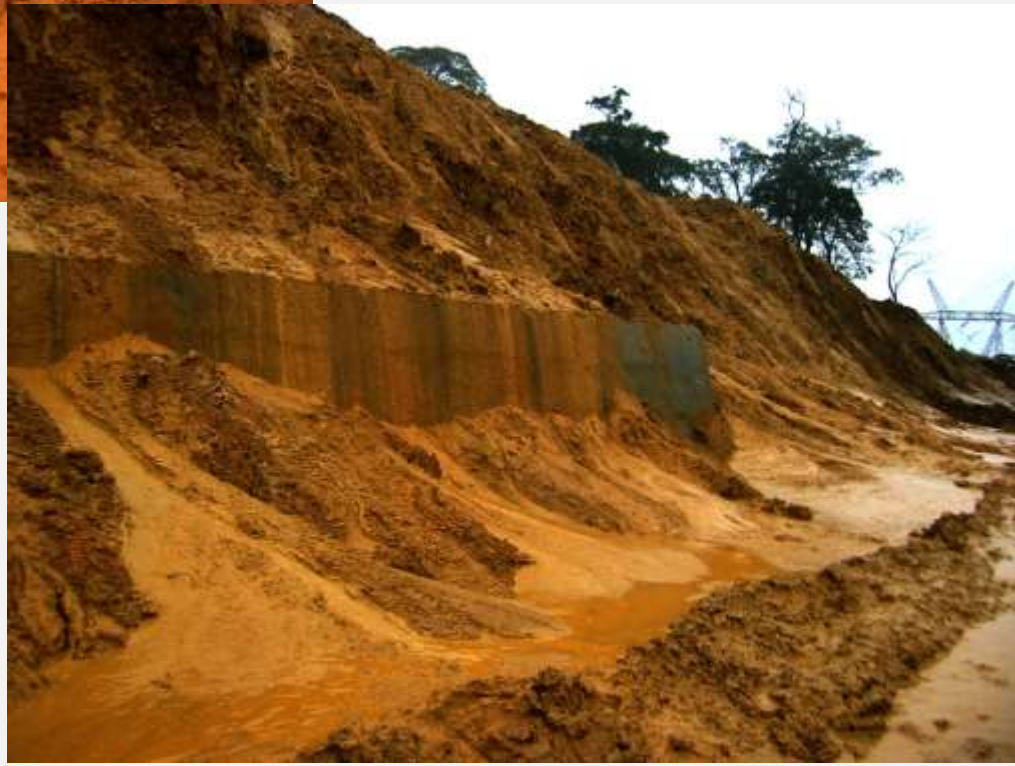
But these massive and costly retaining walls by themselves did not stop erosion during the typhoon season

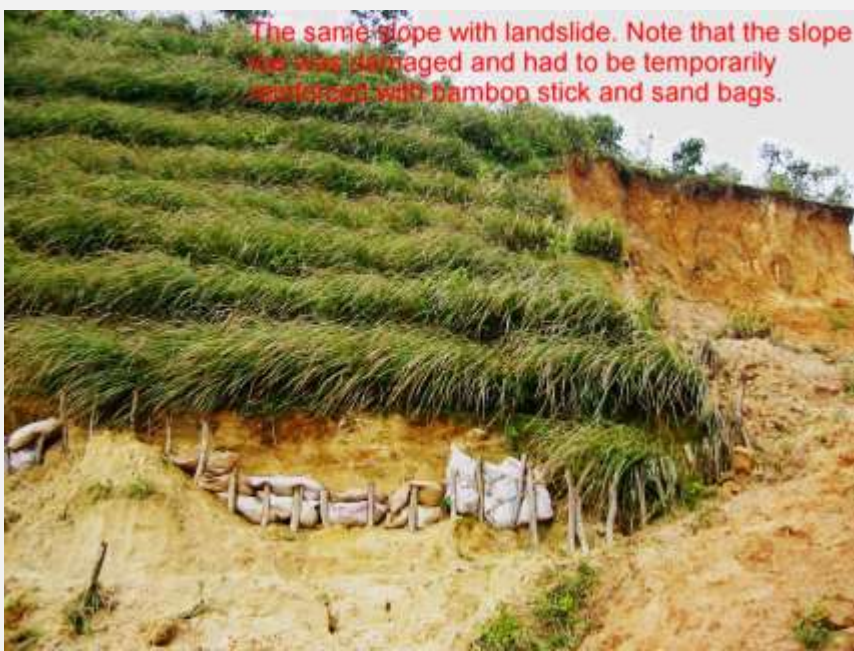
The same slope with landslide. Note that the slope toe was damaged and had to be temporarily reinforced with bamboo stick and sand bags.

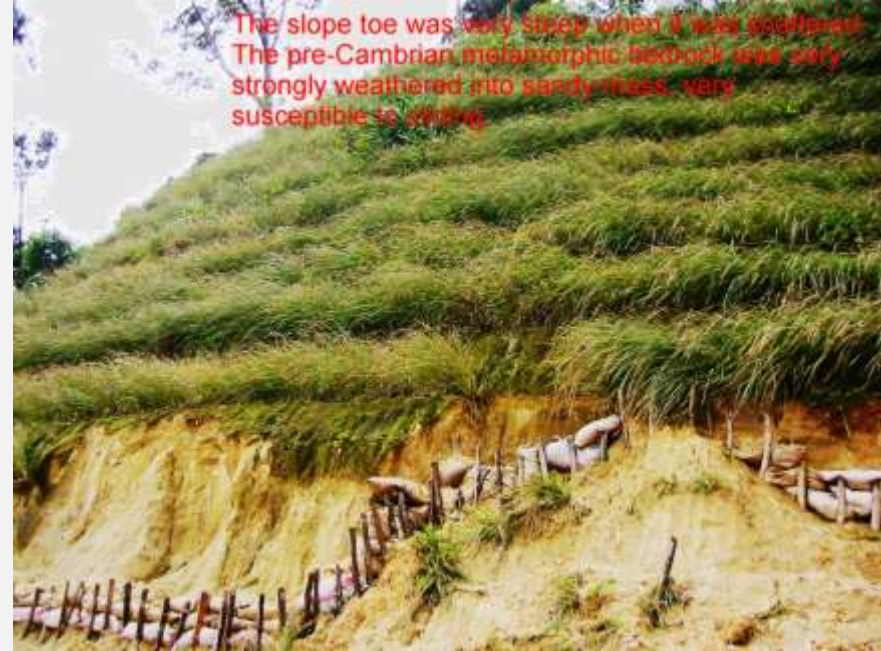
The slope toe was very steep when it was weathered. The pre-Cambrian metamorphic bedrock was very strongly weathered into sandy mass, very susceptible to sliding.

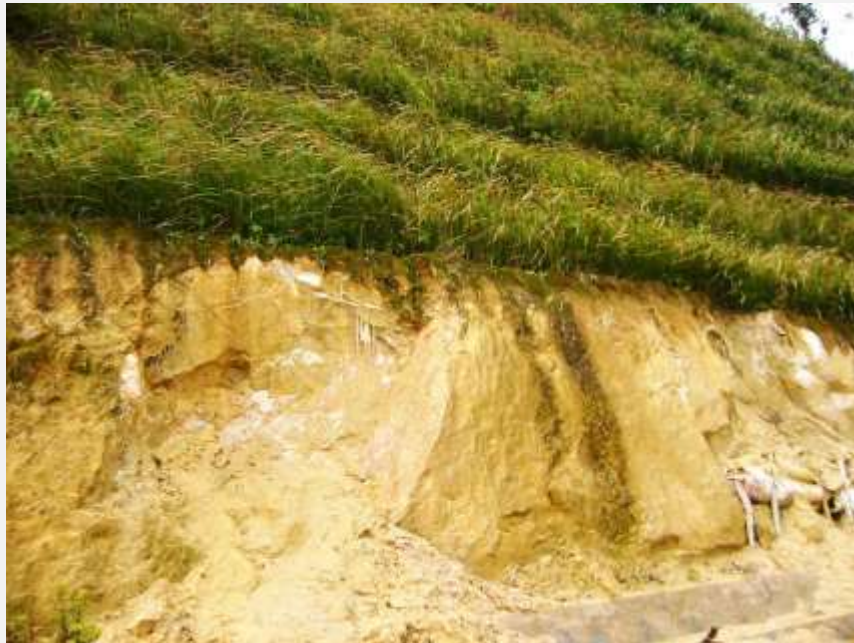
Ten month old planting, good growth but toe slope should be protected

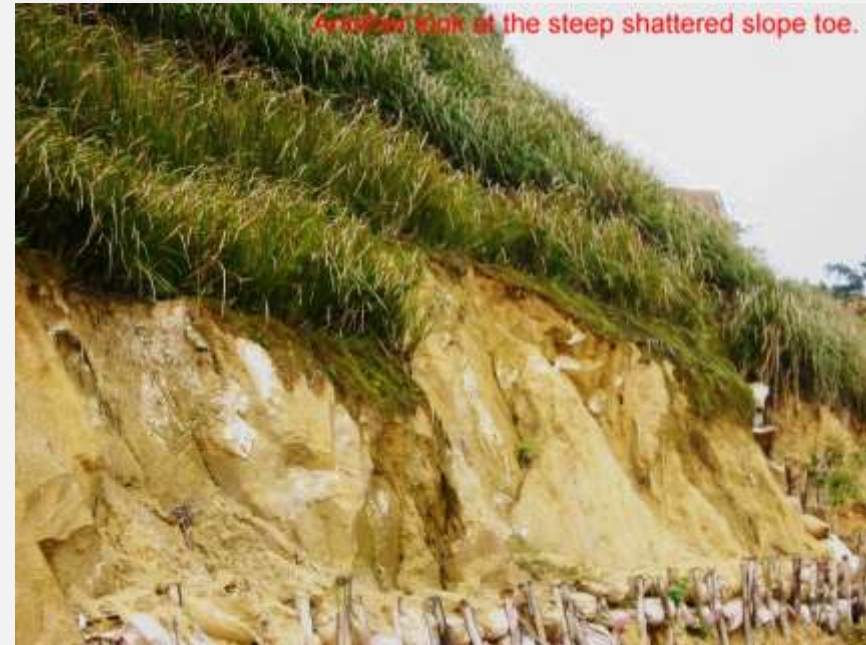
Another look at the steep shattered slope toe.

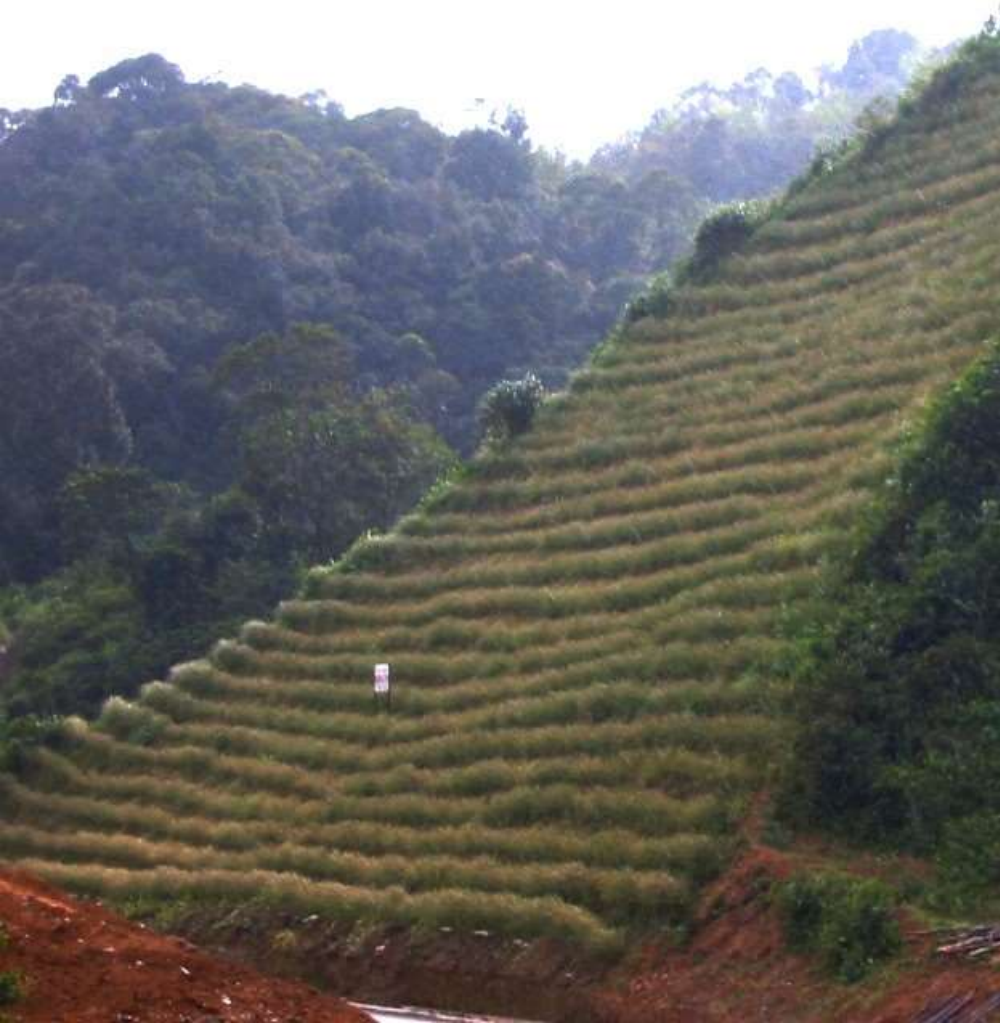
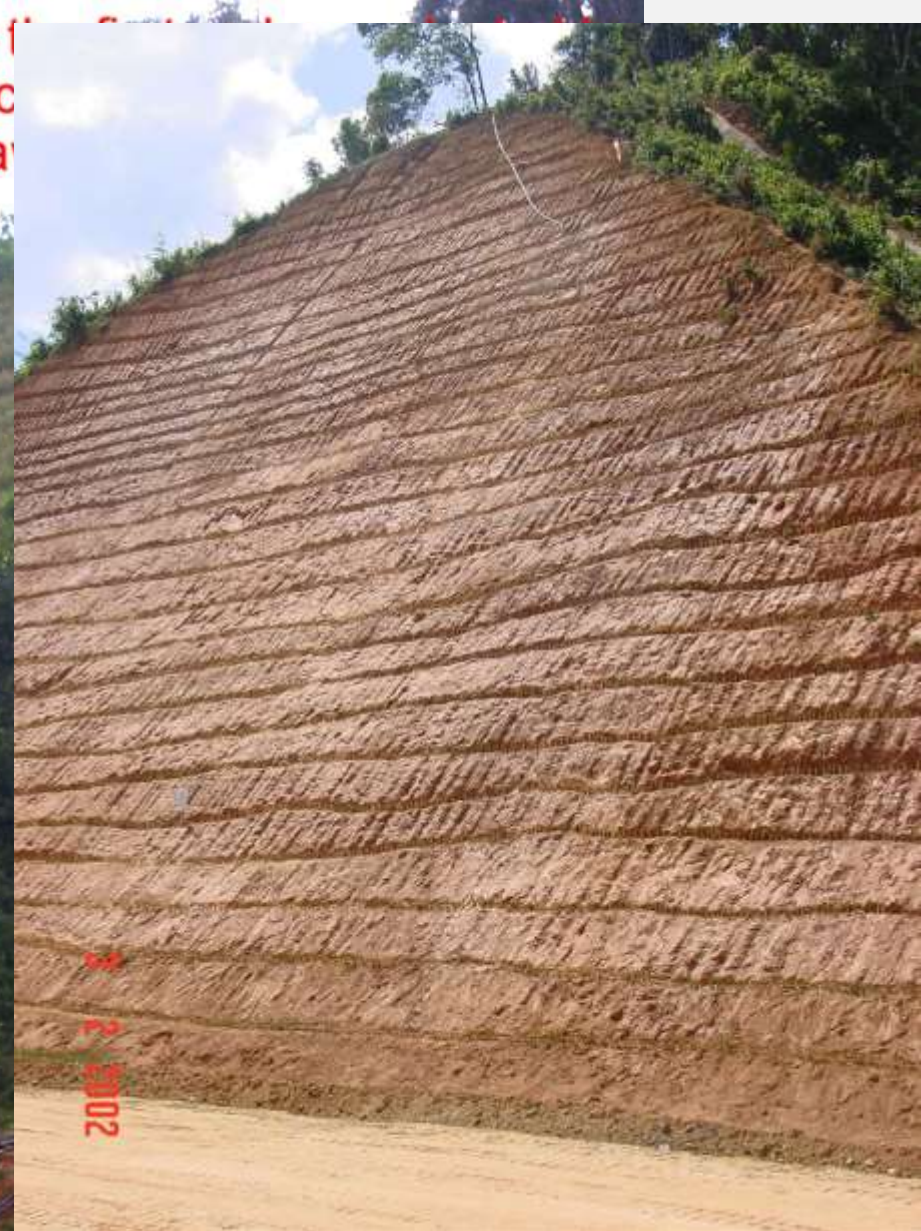
Despite badly designed (no benching and Internal drainage), this very steep batter was successfully stabilized 3 years after planting. Survived several typhoons

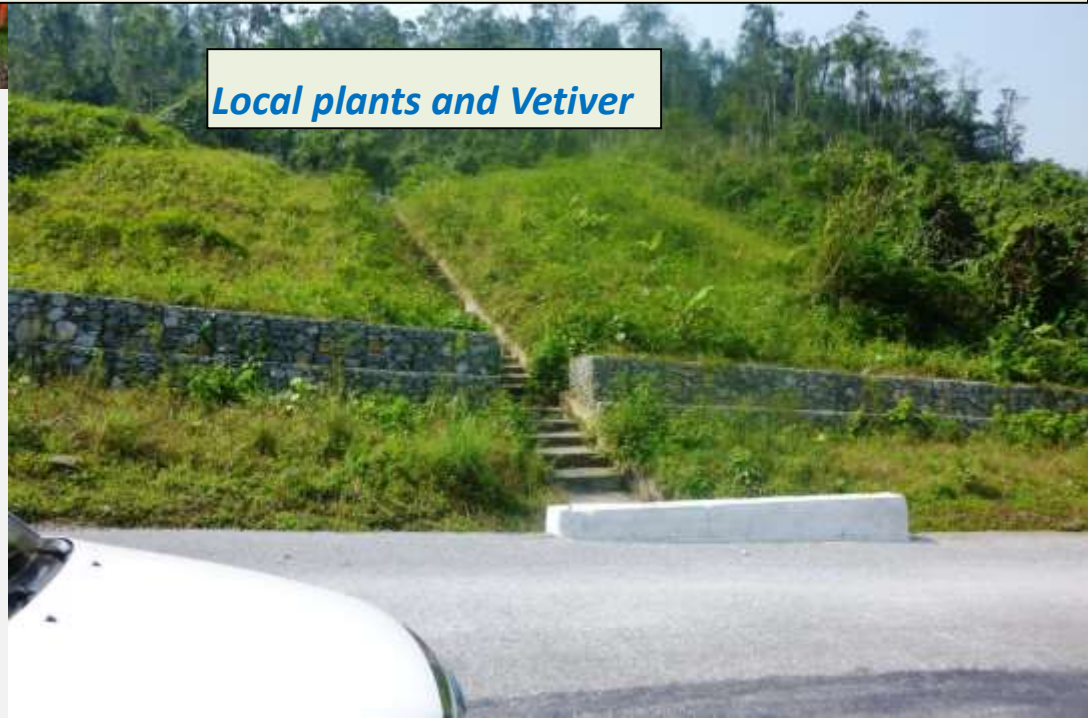
14 years later, some vetiver left but mostly endemic plants
