**NCDOT Survey #51, Reece House (GF-8209)  
5917 Burlington Road, Guilford County  
Guilford County PIN 8804989832**

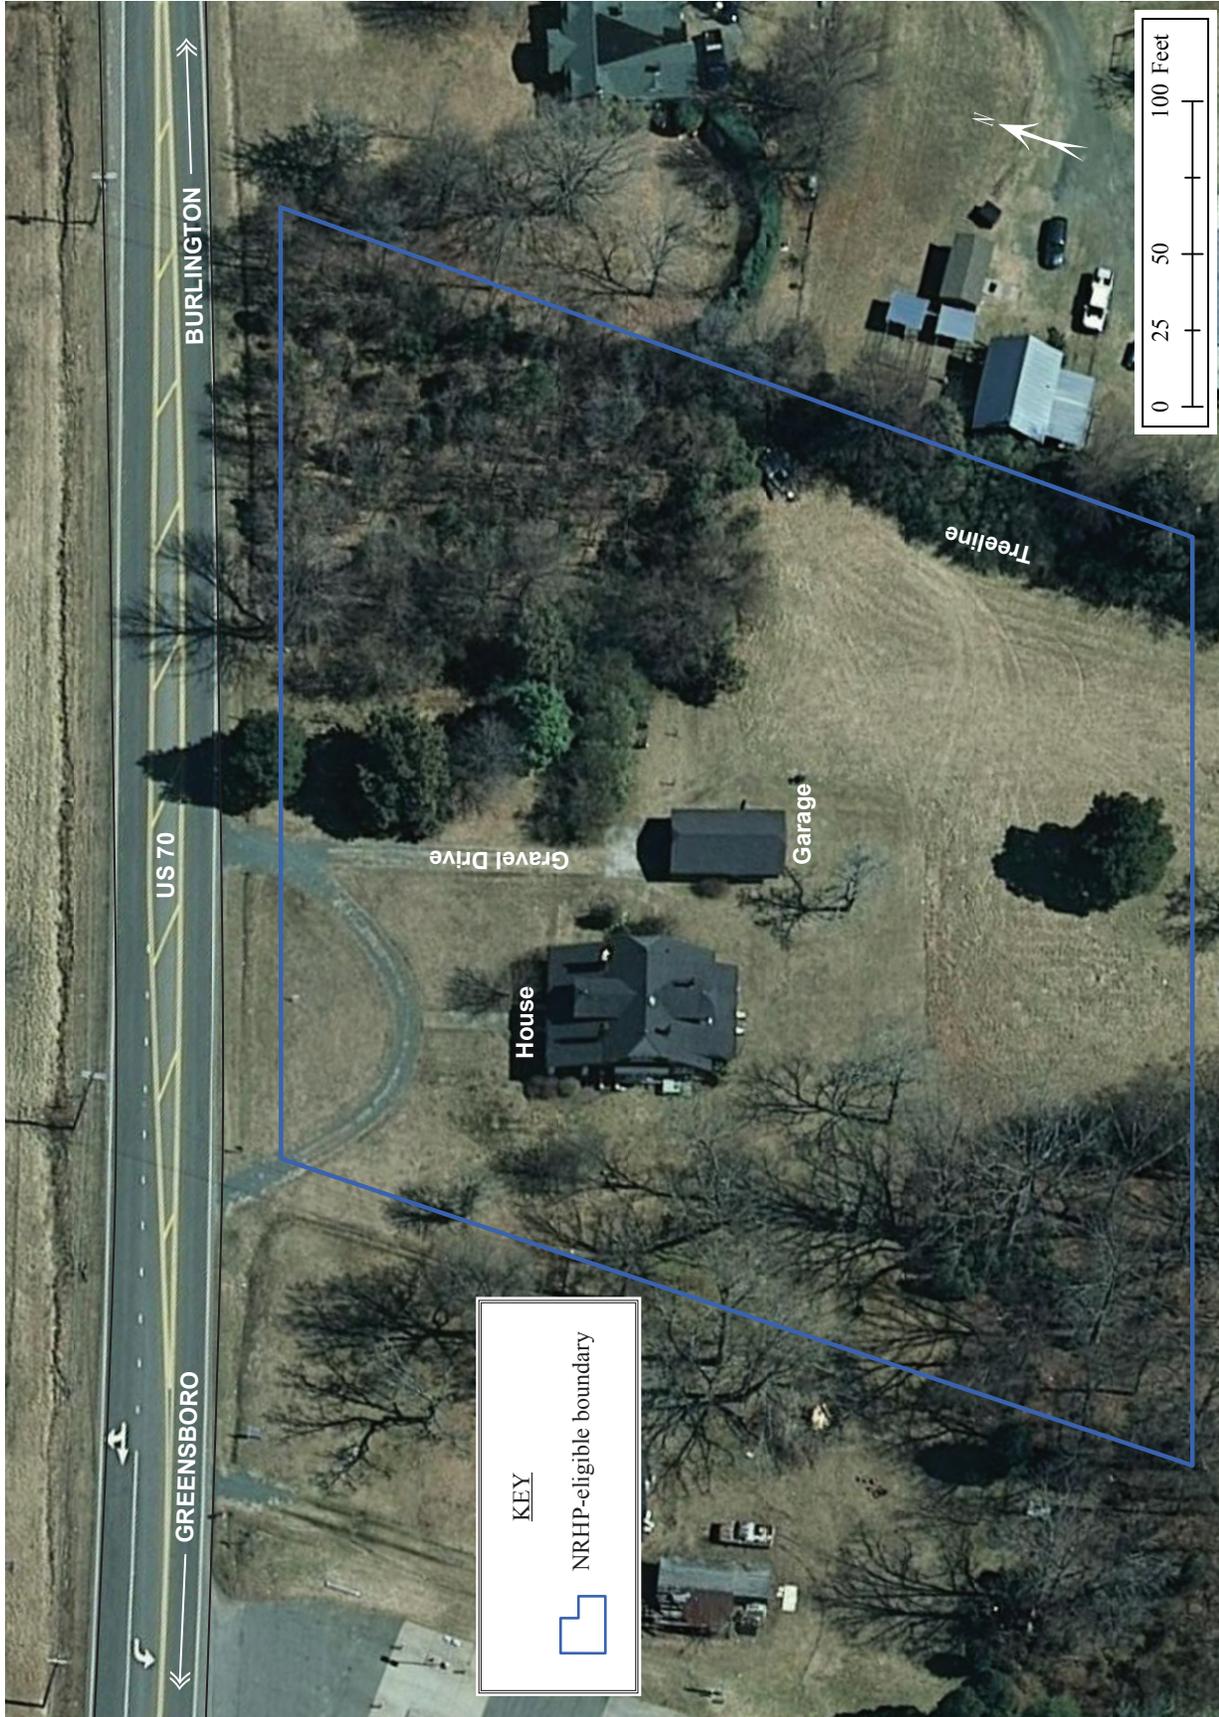
Figure 62. NCDOT Survey #15, Edwards House (GF-8177), 7210 Burlington Road, Guilford County, Guilford County, aerial photograph (2010) showing recommended NRHP boundary.

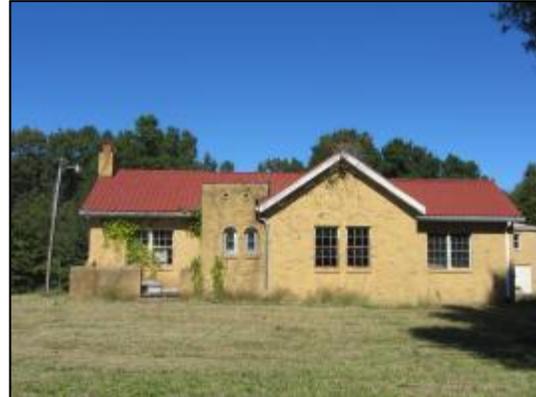
*NCDOT Survey #51, Reece House (GF-8209),  
5917 Burlington Road, looking north.*

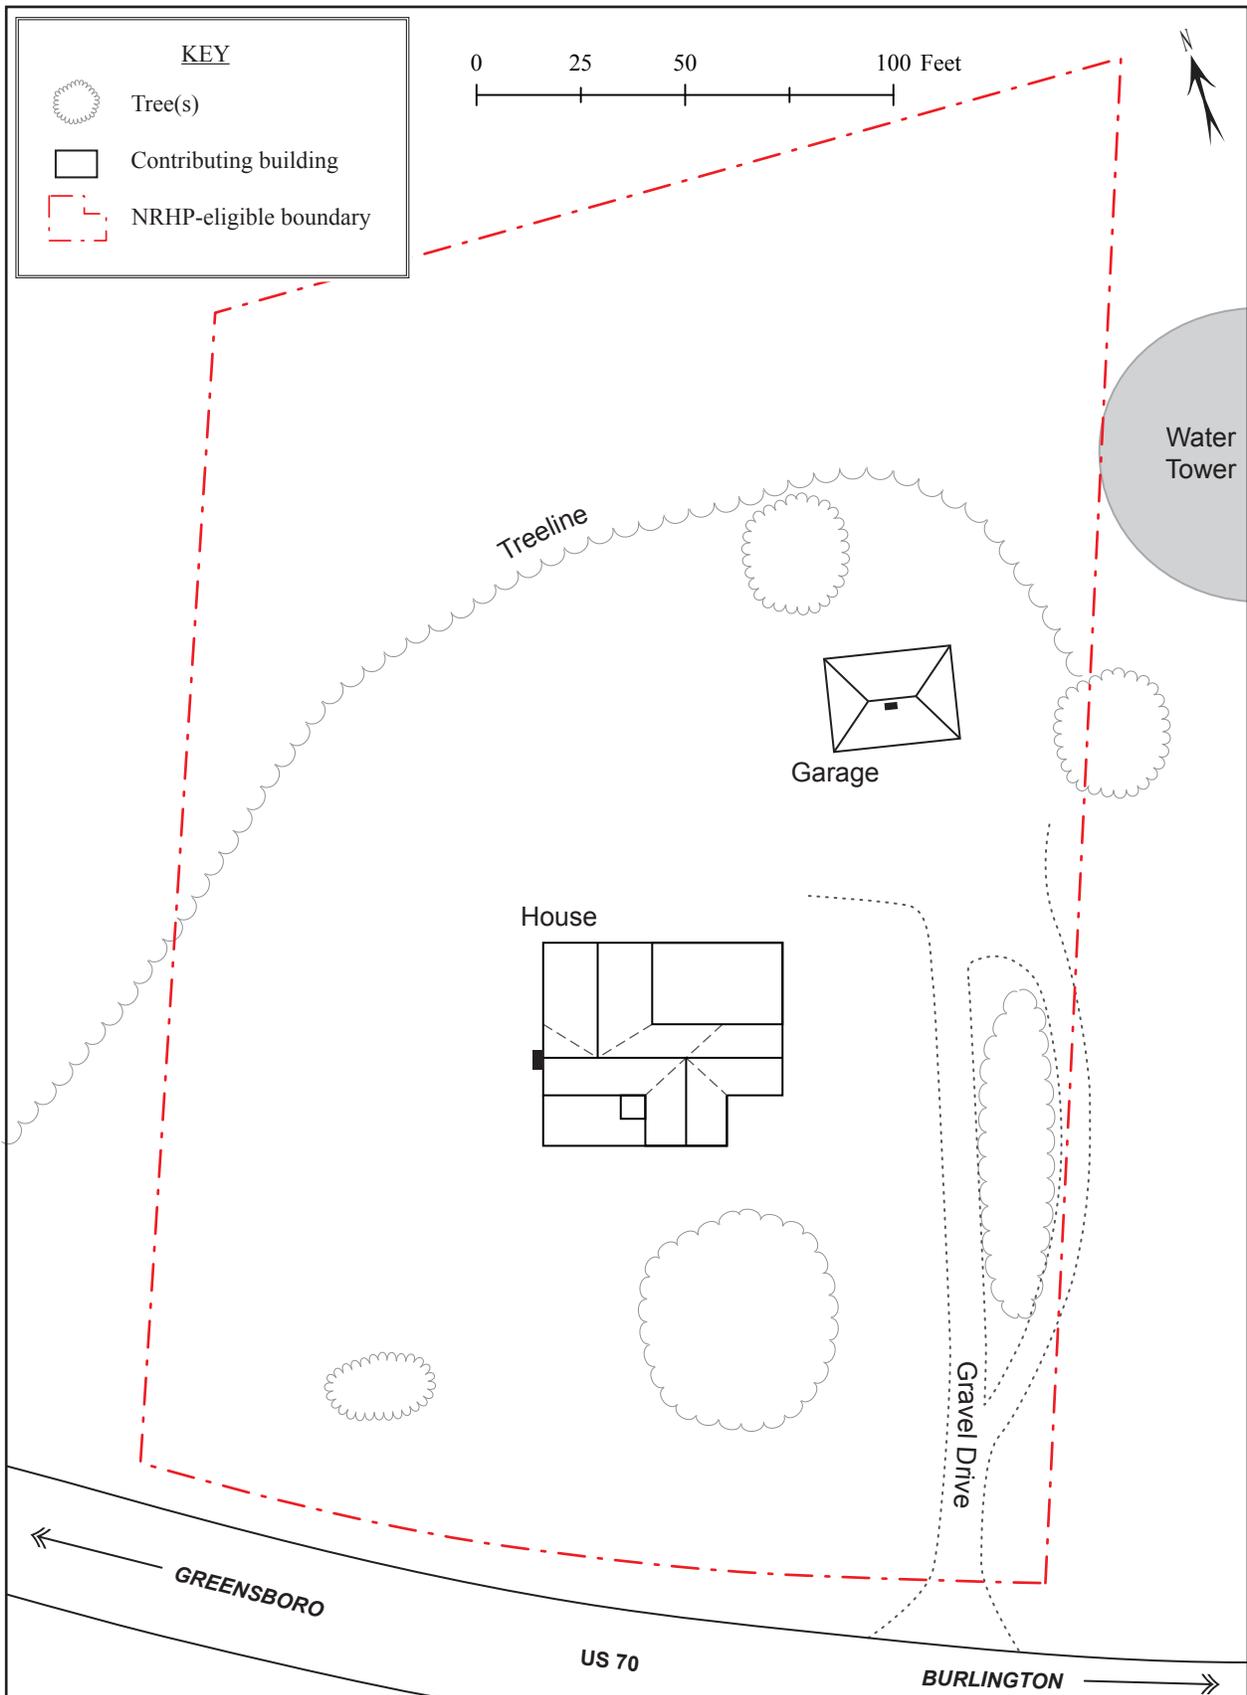
Figure 63. NCDOT Survey #51, Reece House (GF-8209), 5917 Burlington Road, Guilford County, site plan and recommended NRHP boundary.

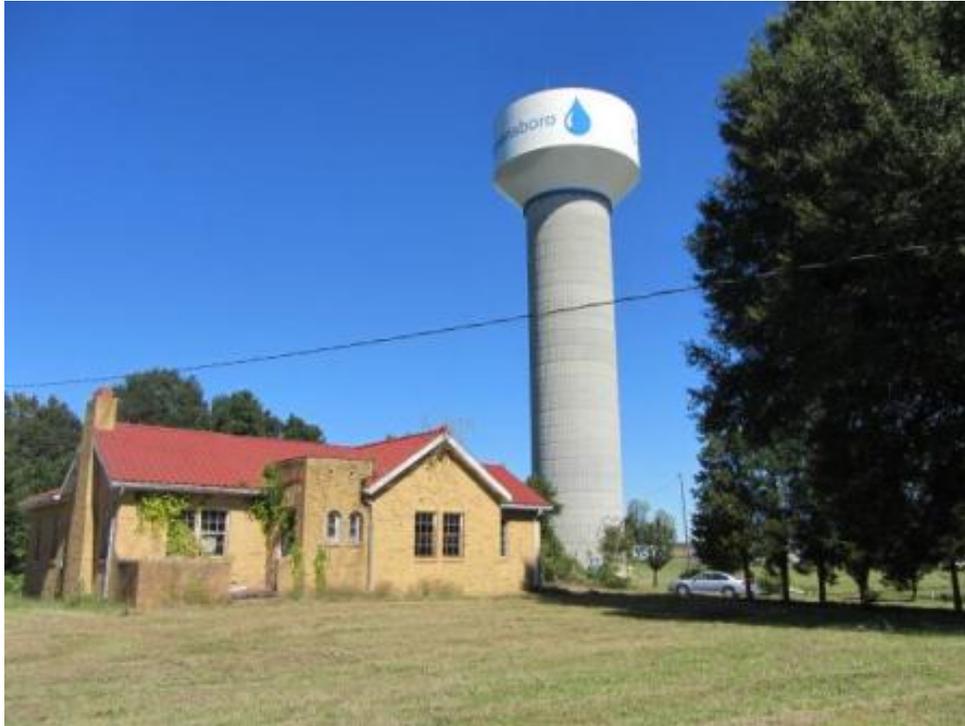
Figure 64 NCDOT Survey #51, Reece House (GF-8209), 5917 Burlington Road, Guilford County, view looking northeast with house in foreground and City of Greensboro water tower in the background.

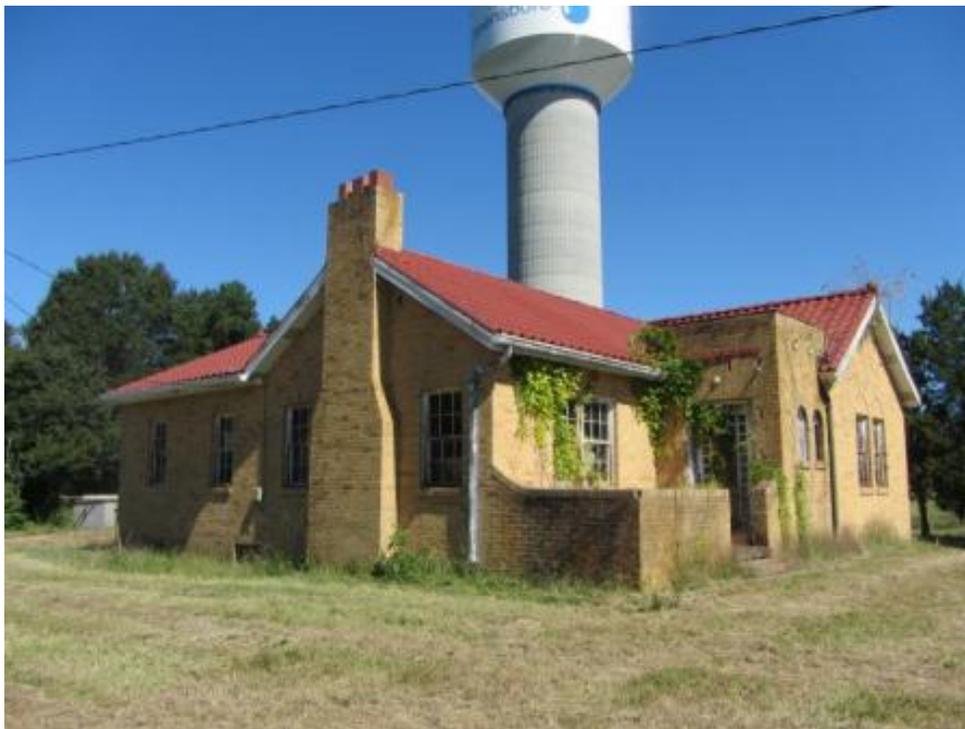
**Property Description:** Set on a brick foundation with a partial basement, the one-story, four-bay dwelling and garage were constructed sometime between 1926 and 1930. It is of wood-frame construction with common-bond yellow brick veneer. The house has a side-gable roof clad with red clay barrel tiles, with cross-gable eaves on the north and south. A partially exposed brick chimney is on the west gable end. There is a one-bay, one-story, flat-roofed entrance tower set within the southwest corner of the main block and the south eave. On the south face of the tower are two arched window openings with header brick trim and arched double-hung sash with stained glass diamond-shaped lights. The main entrance is on the west face and features a single-leaf wood door with full-height, narrow-width, multi-pane sidelights. A waist-high brick wall partially encloses the entrance patio. Secondary entrances with single-leaf wood doors consisting of a three-panel wood lower half and a 6-pane upper half are located on the east and north elevations. Each secondary entrance has a set of concrete-and-brick steps. Fenestration consists of single and paired 6/6 double-hung metal sash windows with header-bond brick sills. Two paired windows on the south façade are topped by blind arches formed by a single row of raised header bricks.

Figure 65. NCDOT Survey #51, Reece House (GF-8209), 5917 Burlington Road, Guilford County, view of façade and west elevation, looking northeast.

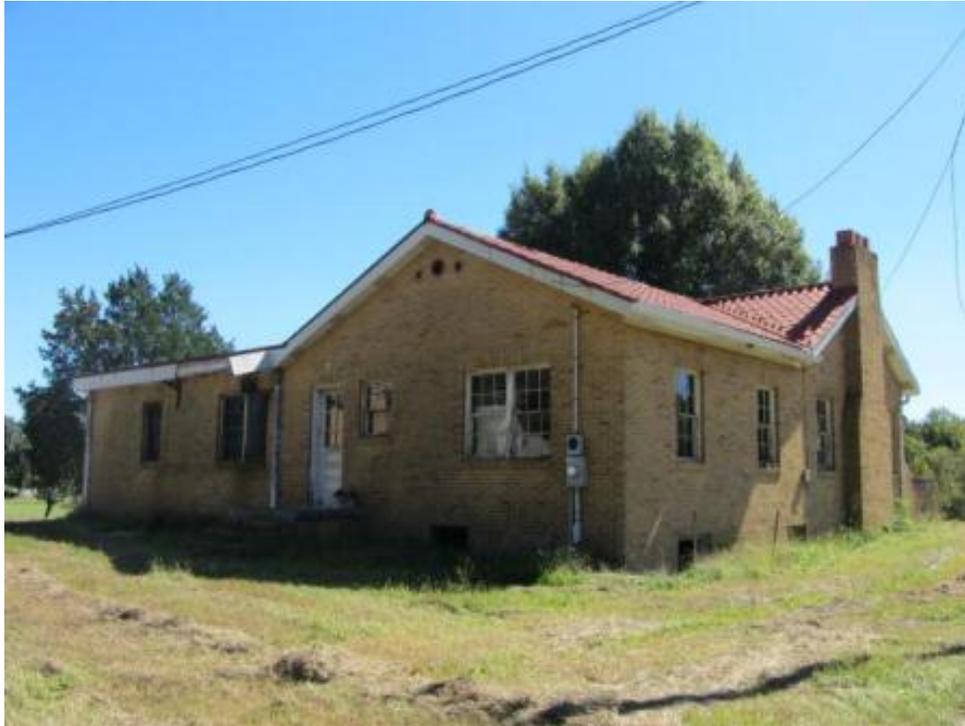
Figure 66. NCDOT Survey #51, Reece House (GF-8209), 5917 Burlington Road, Guilford County view of north elevation (left) and west elevation (right), looking southeast.

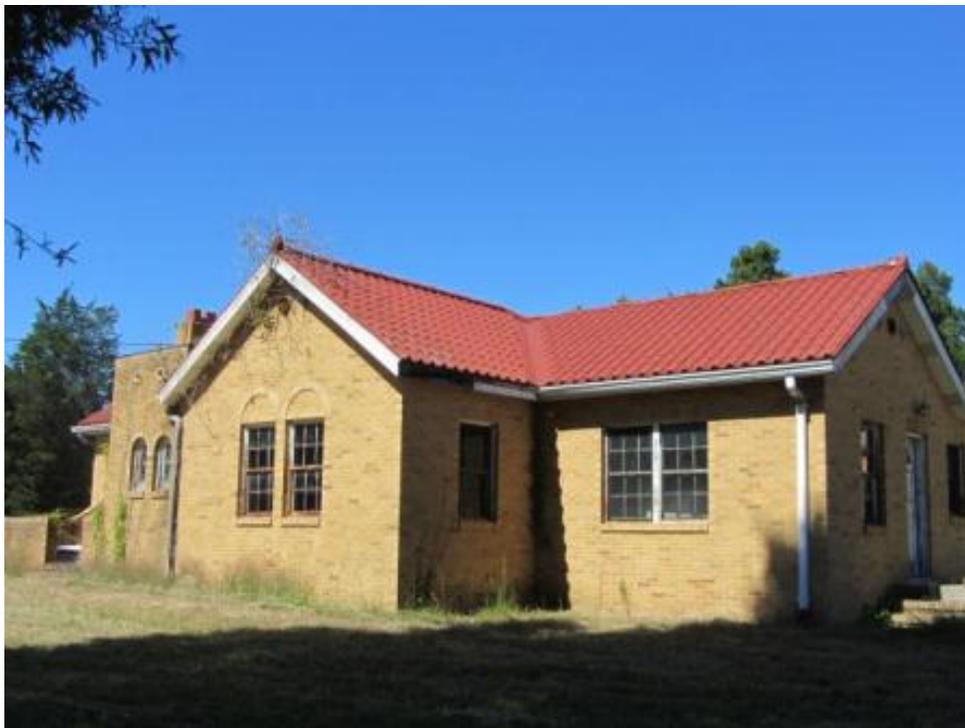
Figure 67. NCDOT Survey #51, Reece House (GF-8209), 5917 Burlington Road, Guilford County, view of north gable ell (left), looking northwest.
