How to Avoid Thermal Sensor Damage & Out of Tolerance Conditions

Overview

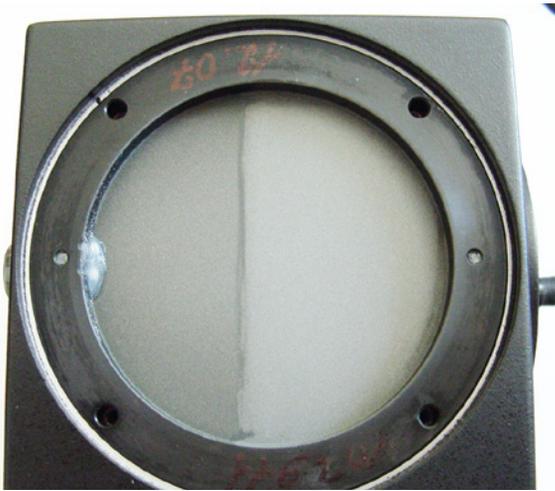
Fig. 1 Gradual Contamination on the left, after cleaning on the right. The type of contamination on this disc is undetermined, but notice how uniform the foreign material is deposited. Only a trained technician can quickly identify this type of contamination.

Explanation: Many times an out of tolerance condition can be explained simply by surface contamination induced by environmental conditions. Unfortunately, due to the different environments that sensors are used in, it is nearly impossible to conclude exactly what causes the contamination in each scenario. Welding environments are a common source of contamination; however any environment may allow foreign material to be deposited on the sensor if care is not taken. Grease from fingerprints is another common source of contamination and it can be burnt into the surface of the absorber. The use of a form of combustible material to determine beam location prior to sensor use can also contaminate your sensor. Burn paper or any other combustible material used near the sensor can slowly deposit contaminants onto the surface. Unfortunately the contamination can be gradual and uniform in distribution, preventing the end user from noticing a change in the shade of the coating Please refer to Figures 1 and 2.

A simple way to test for this is to compare the color of the coating between many different sensors of the same model or coating type. If there is a large deviation in shade, one of the discs might be contaminated.

The first step is to determine the source of the foreign contaminants. Then steps should be taken to isolate the sensor from future contamination. Storing the sensor in the proper container when not in use is sometimes all that is necessary to prevent long term contamination. Also a brief blast of compressed dry air prior to applying laser power goes a long way in preventing the build up of foreign material. We do not recommend any cleaning to be done except by our trained technicians when the sensor is sent for repair/recalibration as any change to the absorber surface will cause a deviation in readings. Please also refer to the overheating section below, as overheating may be a source of contamination.

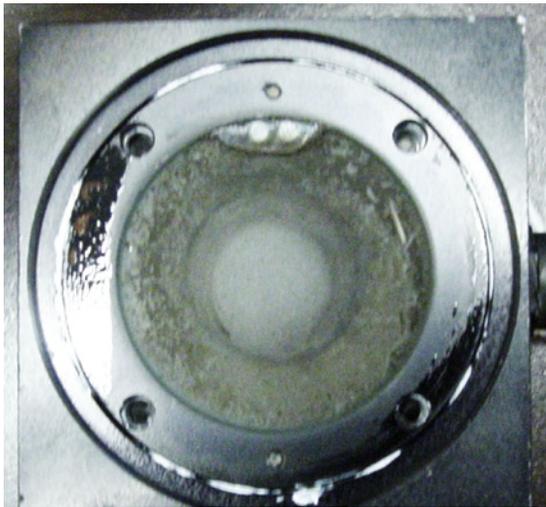
Fig. 4 This is a great example of a combination of the two types of damage resulting from overheating as described above. Notice that the central region has a large ring of damage. Also notice that the grease has begun to fail and is starting to migrate onto the surface of the absorber. This disc must be replaced.

Two types of damage can occur from overheating of the sensor housing. The first is coating failure. This is fairly common and will result in a large discoloration of the coating surface. This discoloration is not removable by cleaning. In this situation the absorber must be replaced due to inconsistent absorption across the surface. Refer to Figures 3 and 4.

The second type of damage is grease contamination. When the disc is overheated, the thermal coupling grease between the sensor and its housing will begin to deteriorate. This can, and often does, result in a ring of grease contamination that slowly migrates onto the surface of the absorber. Grease contamination typically does not affect the readings in the far infrared region; however near infrared and shorter wavelengths will read greater than actual once contaminated. In most cases, disassembly, regreasing, and cleaning of the absorber by our technicians can remedy this issue without the need for costly disc replacement. Any time the grease of a sensor is disturbed, the single shot energy as well as the response time are typically no longer within specification. Please refer to Figures 4 and 5.

Corrective Action: To prevent overheating, please refer to the limitations of the sensor as outlined in the specification sheet originally sent with the sensor when new. A proper heatsink as well as taking care not to exceed the temperature limit of the disc will prevent this type of damage from occurring.

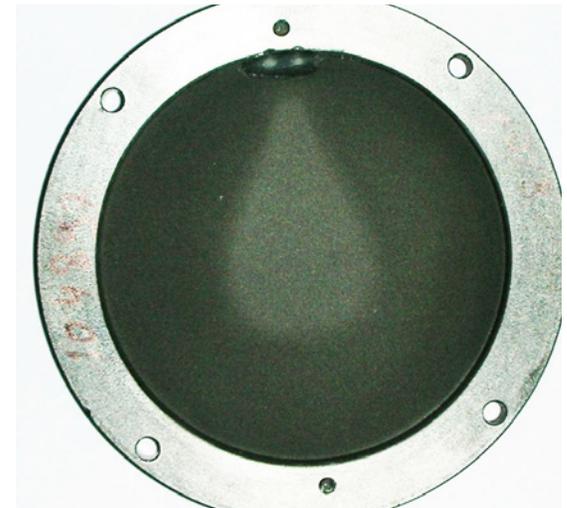
Fig. 5 Pictured here is an example of grease contamination from overheating only. Notice that it has not quite made it to the center of the absorber. This disc could likely be cleaned and put back into service, although that is not always the case.

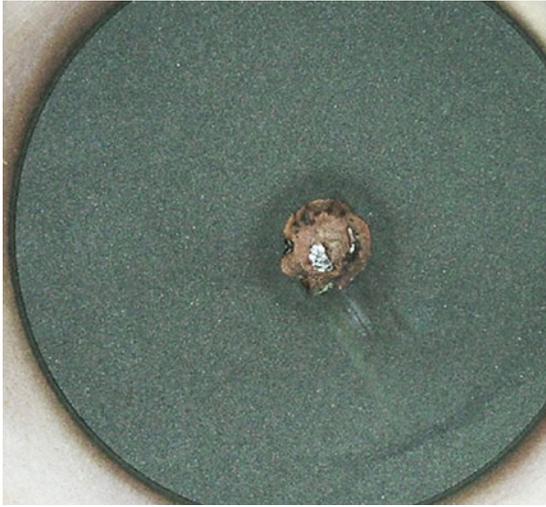
Fig.7 Another example of excessive power density. This was a high power water-cooled disc. The spot size must be increased to prevent this type of damage.

Corrective Action: To prevent localized overheating of the coating, the simplest solution is to expand the laser beam to a size that will greatly reduce the power and energy density. 1/3 of the aperture diameter is usually a good size, although larger can be used if necessary to prevent damage. This will prevent nearly all problems related to average power density. If the beam is already as large as possible, please contact one of our customer service representatives and we will help find a solution for your specific situation. We have many different coatings designed to hold up to specific laser systems better than others. For pulsed lasers we have what are called volume absorbers that absorb the energy pulses in a manner that distributes the heat through a surface. This results in significantly higher energy density limits if you are having damage due to pulsed laser systems.

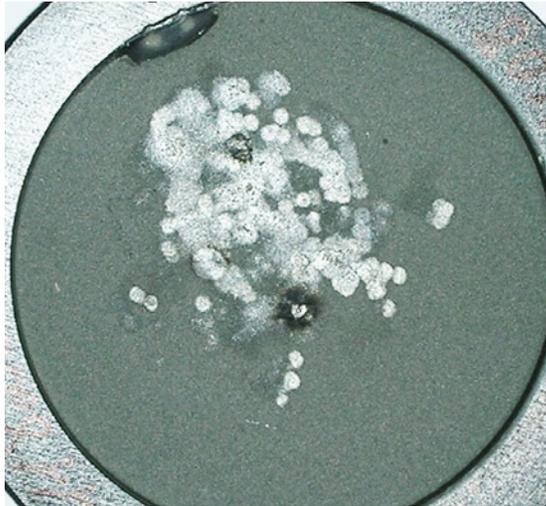
Fig. 11 This is classic damage caused by excessive energy density. Notice that the coating is being damaged one layer at a time. The users in this case likely noticed a change in the readings on the meter, and therefore moved the position of the beam around to new areas as they used it.

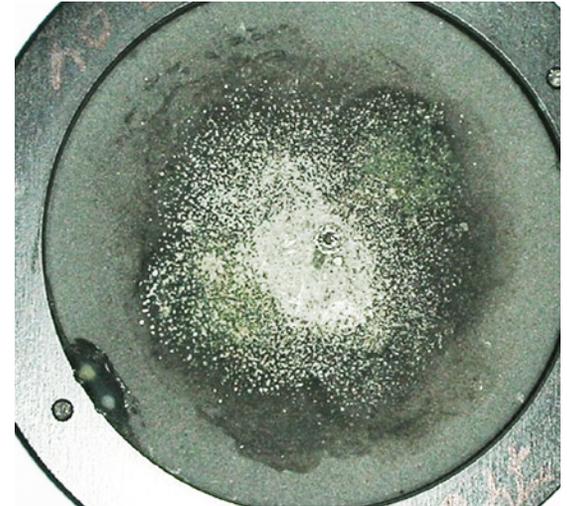
Fig. 13 This is the same damage as shown in Fig. 12, simply after significantly more pulses. Notice that the coating is now completely gone in the center. Once the coating turns shiny or white, the reading is typically lower than actual.
