# Restoration of Building Facades

A comprehensive repair guide for facade restoration professionals

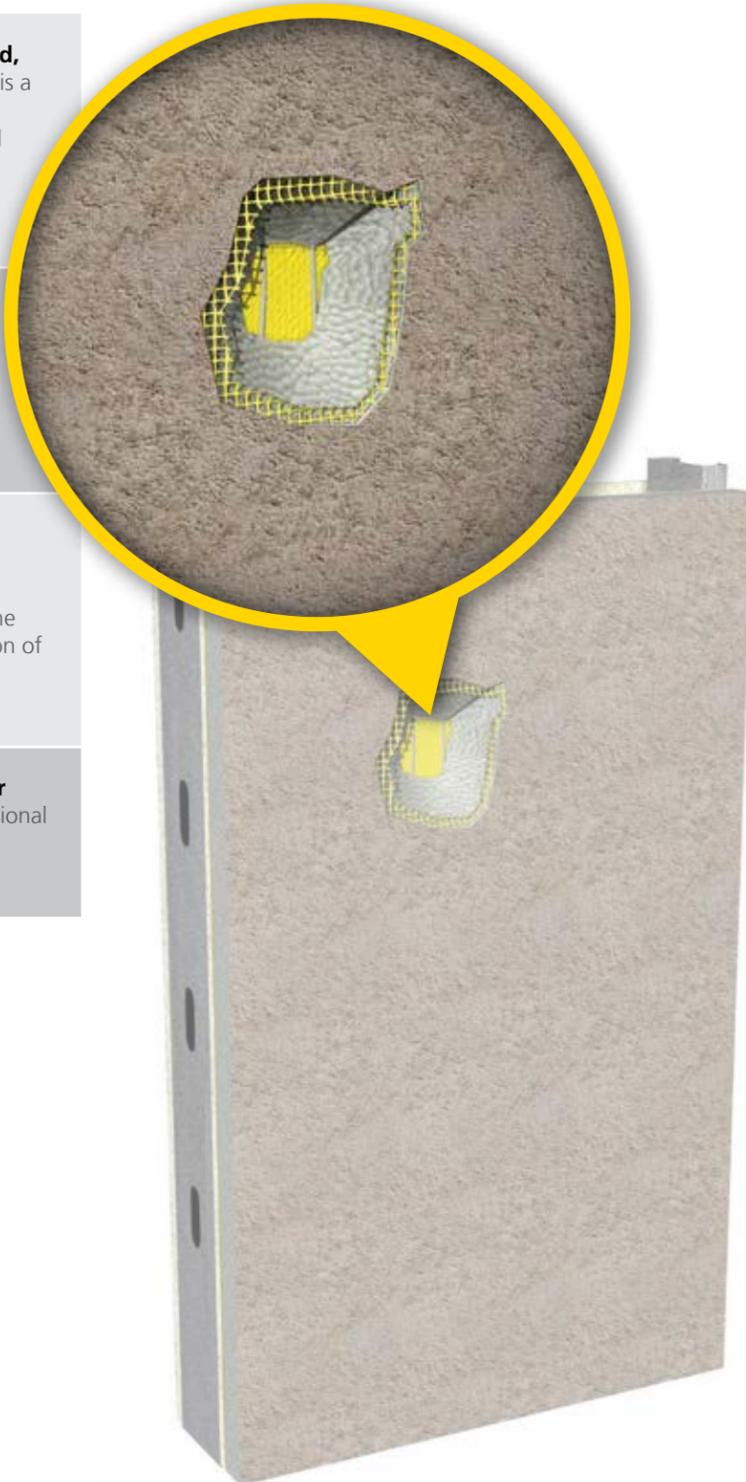
IMPACT DAMAGE

**When EIFS with standard mesh is punctured or cracked, the system is vulnerable to water intrusion.** If the EIFS is a barrier system, water penetration will not drain and may damage the substrate. The risk of water damage is reduced if the EIFS is a drained system in which the water-resistive barrier provides additional protection. However, either system should be repaired as soon as possible.

**A Level 2 project will repair the damage and restore the integrity of the water-shedding surface.** This repair can be made either as part of regular EIFS maintenance or as preparation for refinishing. The scope of work does not address water-related damage inbound of the EIFS.

**When the damaged EIFS is cut away for repair, the underlying substrate or water-resistive barrier can be examined.** If there is no evidence of water penetration or impact damage to these layers, the repair can proceed. If the repair is part of a complete refinish, an additional application of Sto base coat with Sto Armor Mat embedded will greatly increase impact protection.

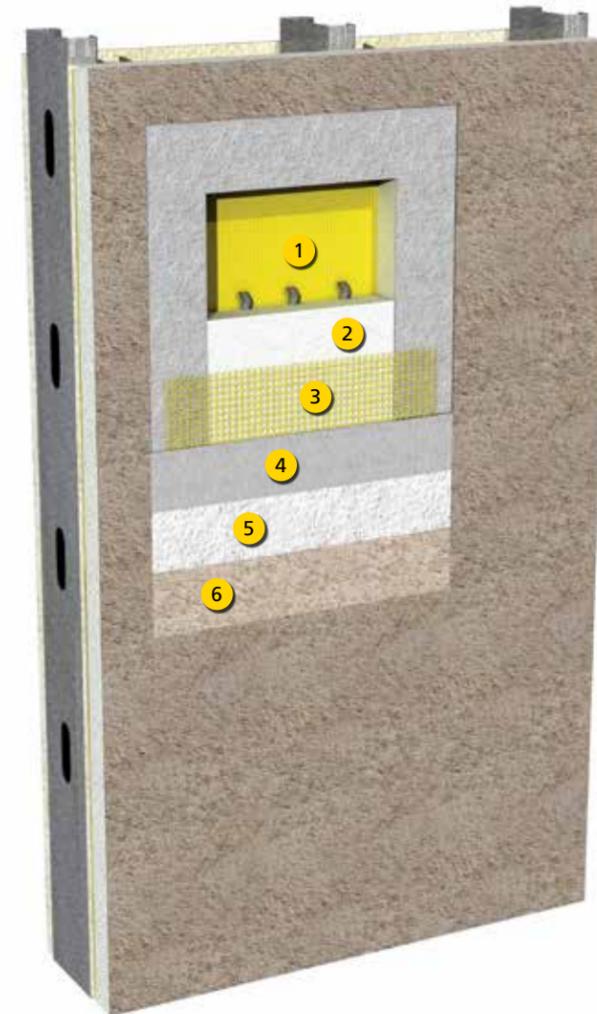
LV2 reStore — DAMAGE REPAIR AND APPEARANCE RESTORATION

- 1 **Cut out** the damaged portion of the EIFS.
- 2 **Repair** the EIFS as per Sto Detail 74.06.
- 3 **Optional:** For added impact resistance, recoat the wall with Sto base coat and Sto Armor Mat. Allow to cure.
- 4 **Apply Sto base coat and mesh** to the prepared surface. Allow to cure.
- 5 **Apply tinted Sto primer** appropriate for the finish selected.
- 6 **Refinish the wall** with the specified Sto materials.

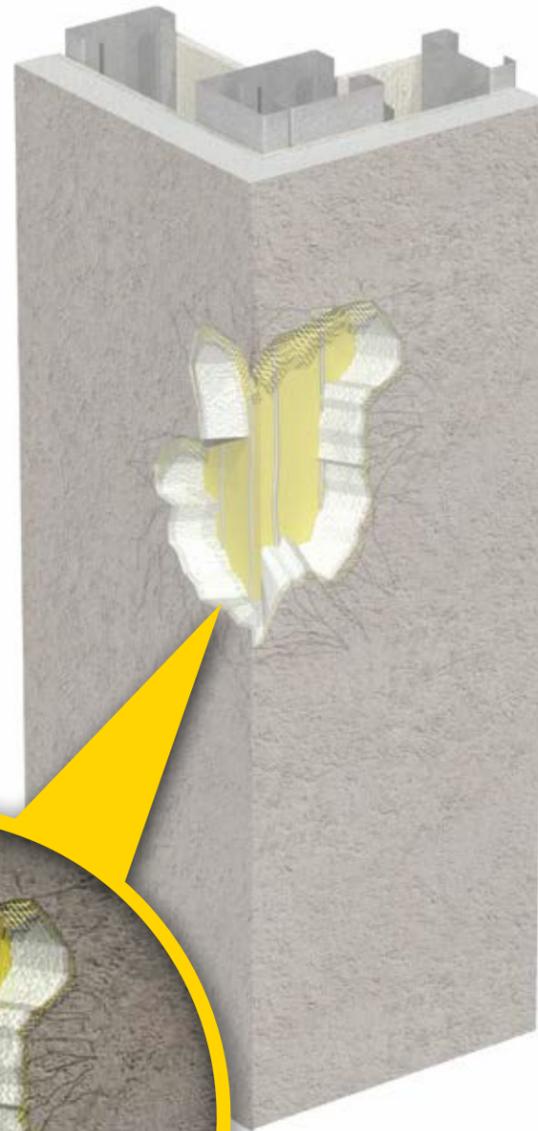
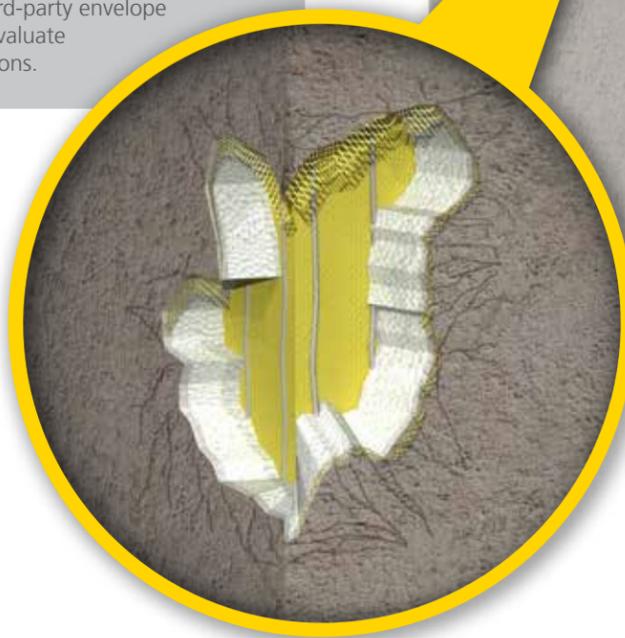
## IMPACT DAMAGE TO CORNERS

**Standard double-wrapped EIFS corners at grade are more vulnerable to damage and water intrusion than walls reinforced with high impact mesh.** In an EIFS barrier system, water penetration will not drain and may damage the substrate. The risk of water damage is reduced if the EIFS is a drained system. However, with either system the corner should be repaired as soon as possible.

**A Level 2 project will repair the damage and restore the integrity of the water shedding surface.** The repair can be made either as part of regular EIFS maintenance or as preparation for recoating. The scope of work does not address water-related damage inbound of the EIFS.

**With the damaged EIFS corner is cut away, the underlying substrate or water-resistive barrier can be examined.** If there is no evidence of water penetration or impact damage to these layers, the repair can proceed. If the repair is part of a complete recoat, an additional application of Sto base coat with Sto Armor Mat embedded will greatly increase impact protection.

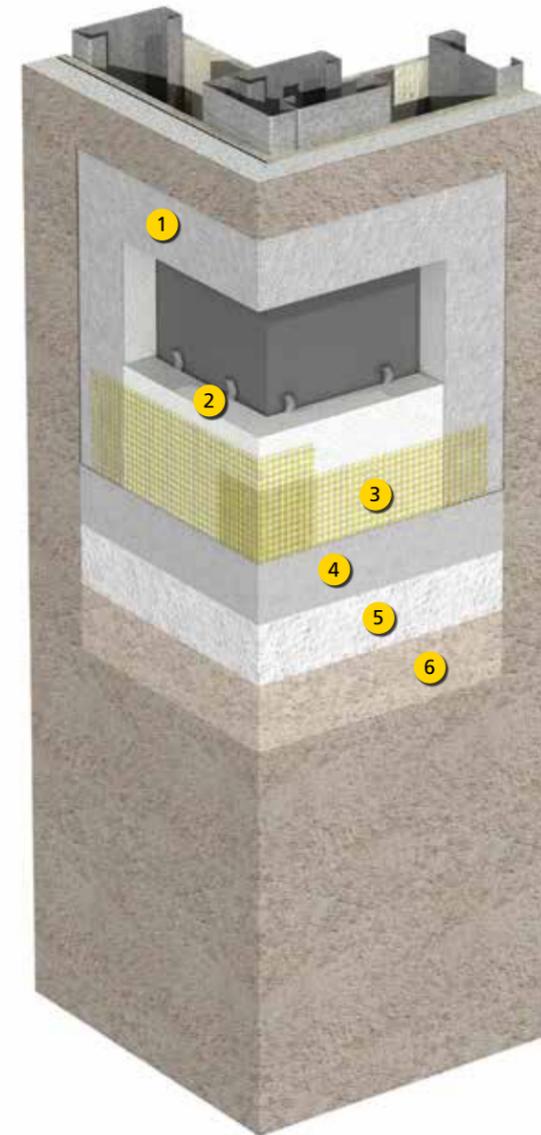
## LV2 reStore — REPAIR AND RESTORATION OF CORNER

- 1 **Cut out** the damaged EIFS corner back to the substrate.
- 2 **Repair** the EIFS as per Sto Detail 74.08.
- 3 **Optional:** For added impact resistance, recoat the wall with Sto base coat and Sto Armor Mat Mesh. Allow to cure.
- 4 **Apply Sto base coat and mesh** to the prepared surface. Allow to cure.
- 5 **Apply tinted Sto primer** appropriate for the finish selected.
- 6 **Refinish the wall** with the specified Sto materials.

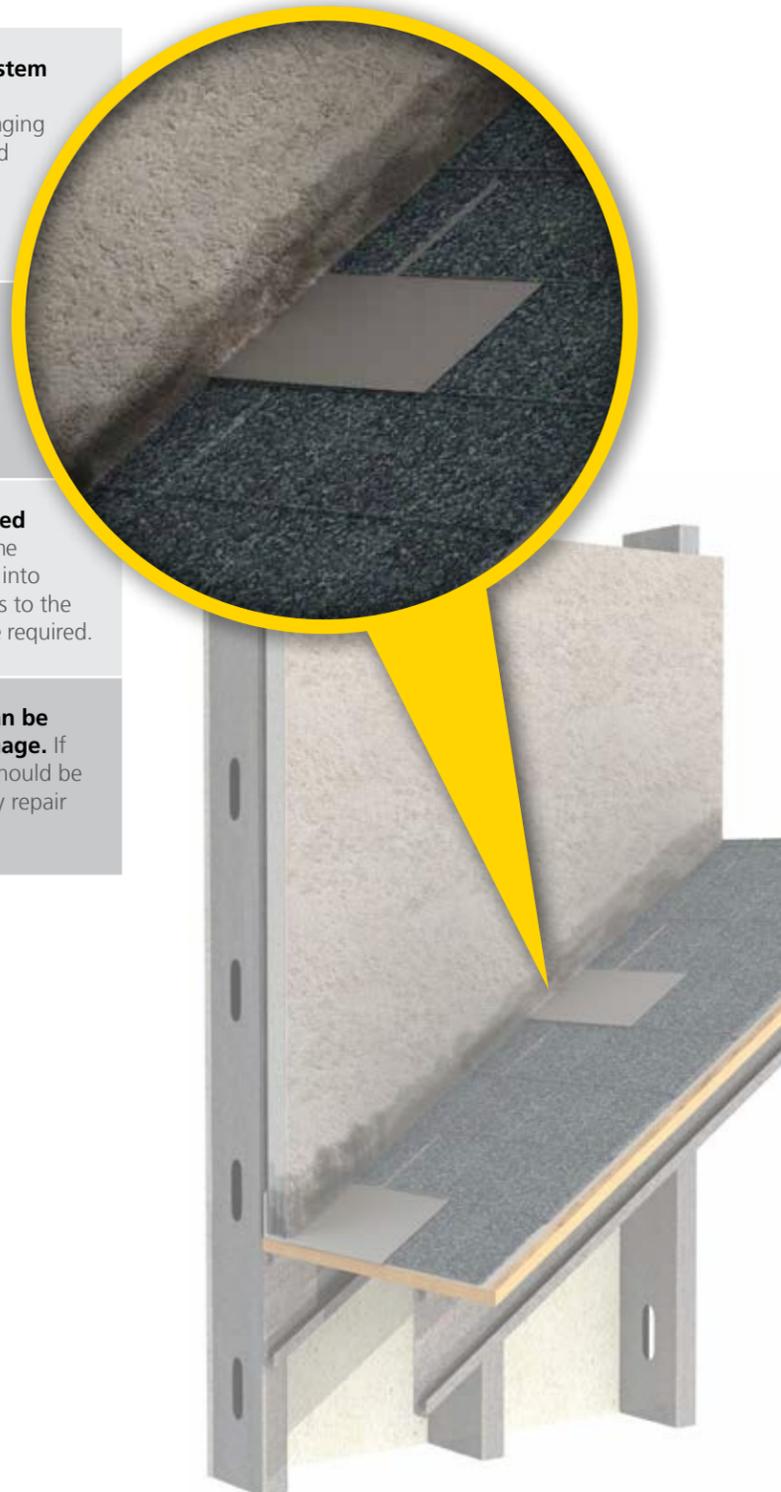
INADEQUATE SEPARATION BETWEEN ROOFING AND EIFS

**Traditional EIFS detailing recommends that the system terminate 2" (50 mm) above finished roofing.** This clearance allows re-roofing to take place without damaging the EIFS. In addition, the clearance allows for leaves and other natural debris to be cleared by wind or regular maintenance, preventing moisture retention in the debris from staining and deteriorating the finish.

**As part of a Level 2 restoration, the EIFS will be modified in compliance with industry recommendations.** This repair may be undertaken as part of regular EIFS maintenance, as preparation for re-roofing, or as a restoration of the finish.

**The EIFS termination will be cut away and refinished with the required separation above the roofing.** The repairs may require incorporating the roof step flashing into the waterproof air barrier behind the EIFS. Modifications to the diverter flashing at the bottom of the slope may also be required.

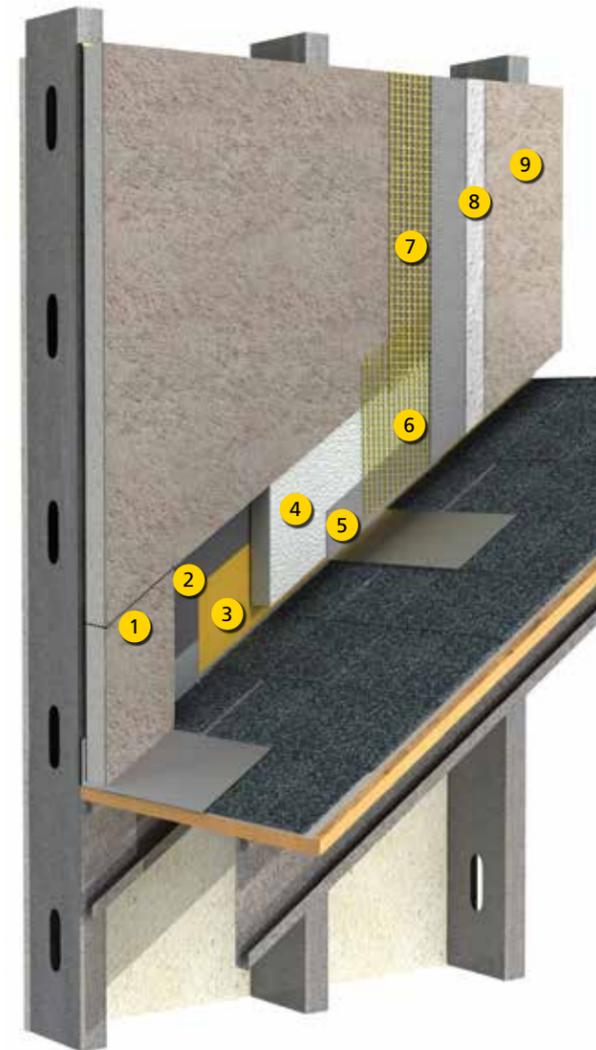
LV2 reStore — RESTORE SEPARATION AND REPAIR EIFS

- 1 Cut the EIFS back to the water-resistive barrier,** and to a height of 8" to 12" (200 to 300 mm) above the finished roof.
- 2 Remove old adhesive** from the substrate.

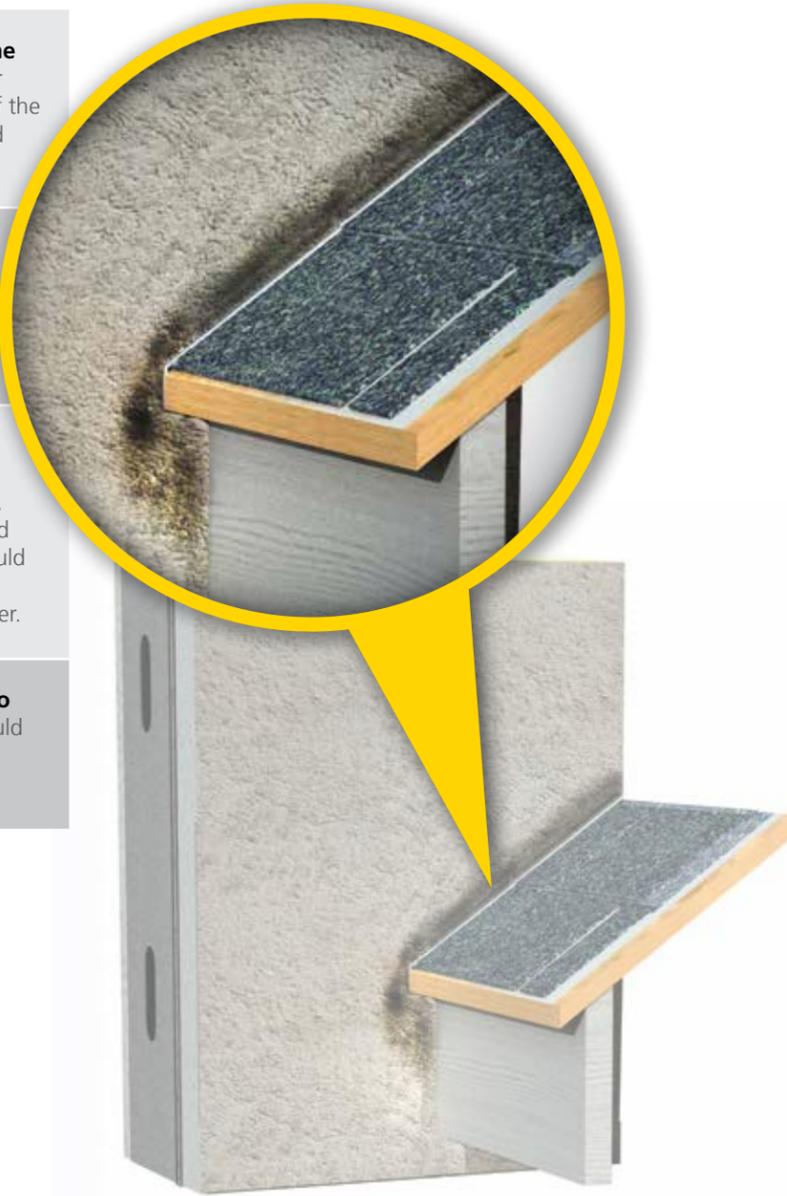
## MISSING OR INCORRECTLY INSTALLED DIVERTER FLASHING

A diverter or 'kick-out' flashing is the termination of the roof step flashings. If the diverter is missing, inadequate or installed incorrectly, there is a potential for water to drain off the roof into the cladding assembly below. Often, sealant is used as an inappropriate alternative to a diverter flashing.

Installing a diverter flashing adds an essential component to the water-shedding system at the roofline. If the repair is made in good time, i.e., before sealant fails, damage from water penetration into the wall can be avoided.

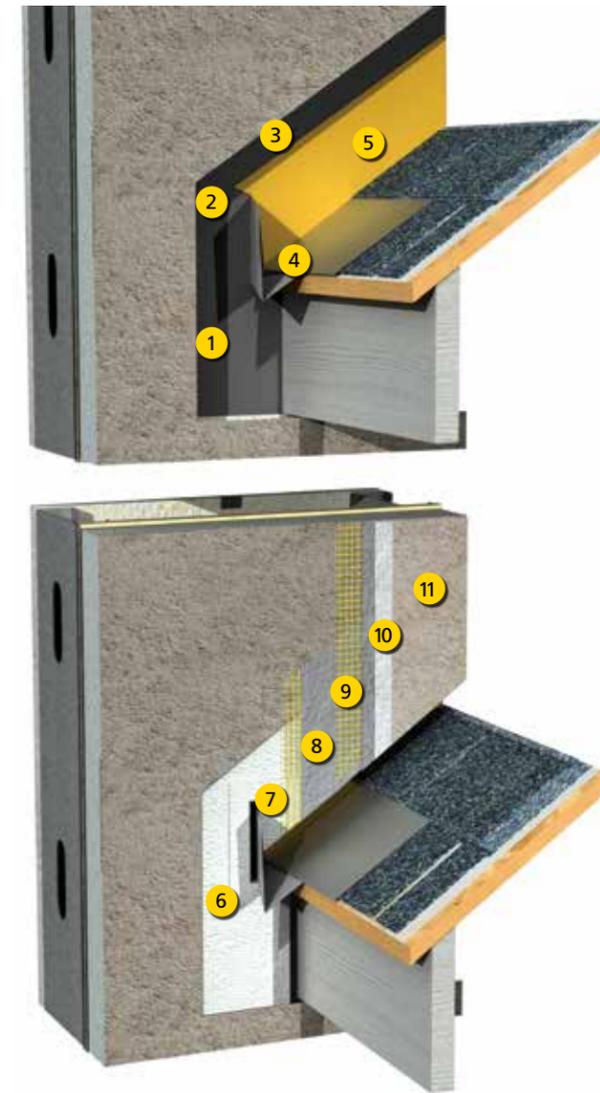
## LV2 reStore — DIVERTER INSTALLED AND EIFS REPAIR

- 1 Remove EIFS approximately 12" (300 mm) all around the position where the new diverter will be installed.
- 2 Remove old adhesive from the substrate.

- 3 Repair any damage to the water-resistive barrier.
- 4 Slide the new diverter flashing under the step flashing and roof edge flashing.
- 5 Integrate the waterproof air barrier with the roof step and diverter flashings by applying Sto RapidSeal to the substrate and lapping it onto the upturned edge of the flashing.

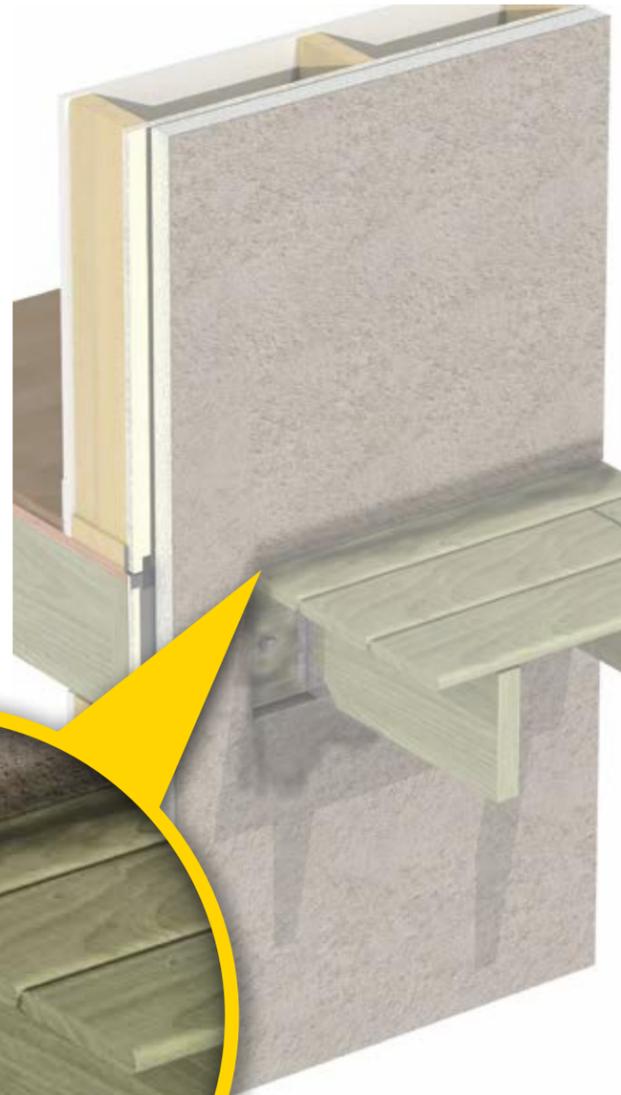
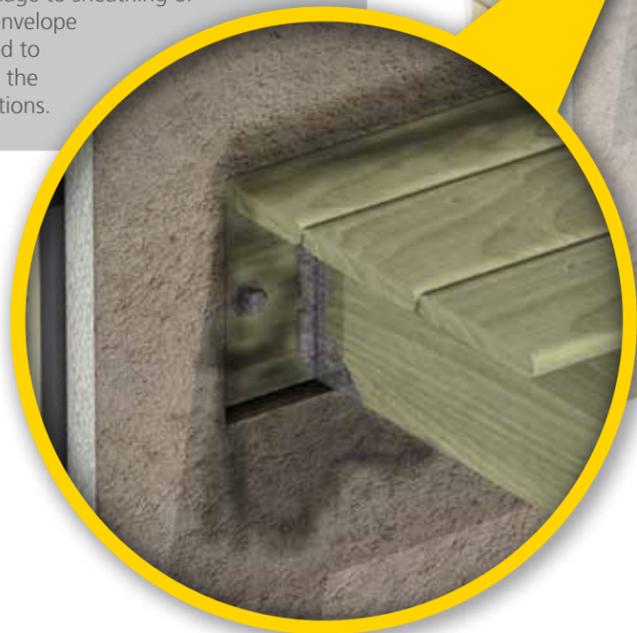
**Wood decks installed directly against a house are extremely difficult to waterproof properly.** EIFS installed down to the deck surface may restrict ventilation and drying at the deck connection. Water accumulation in the area of the connection can result in deterioration of the deck and potential penetration into the house framing.

**A Level 2 restoration is limited to repairing the EIFS around the deck and recoating the wall.** Structural work to the deck or connections to the house are outside the scope of the EIFS restoration but should be coordinated as required with the EIFS work.

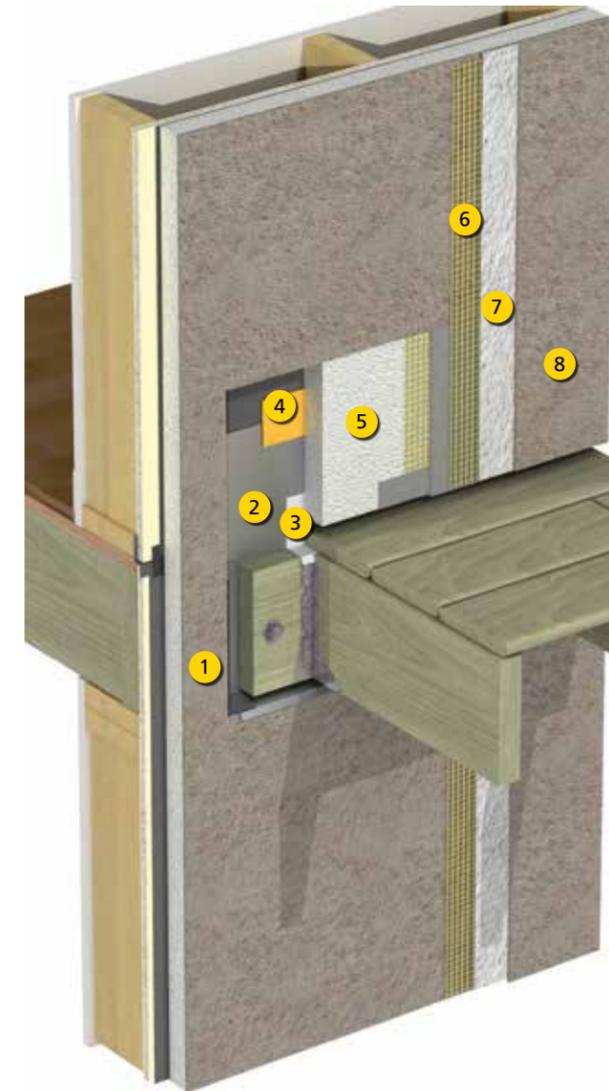
LV2 reStore — FLASHING INSTALLED AND EIFS REPAIR

- 1 **Cut back** the EIFS far enough from the deck to accommodate installation of flashing and repair of the EIFS.
- 2 **Integrate the installation** of flashing with any required deck remediation.
- 3 **Install flashing** to protect the substrate and direct water away from the deck connection.
- 4 **Integrate the flashing** with the StoGuard air and moisture barrier.
- 5 **Repair** the EIFS terminations as per Sto Detail 72.50.
- 6 **Apply Sto base coat and mesh** to the prepared surface. Allow to cure.
- 7 **Apply tinted Sto primer** appropriate for the finish selected.
- 8 **Refinish the wall** with the specified Sto materials..

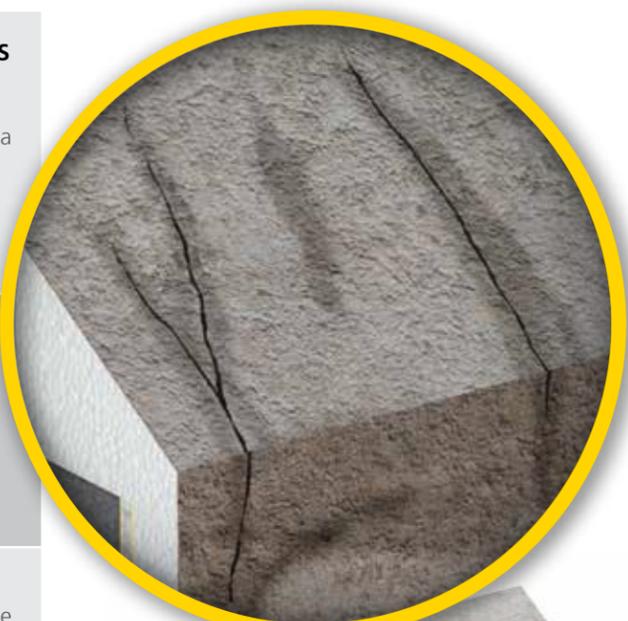
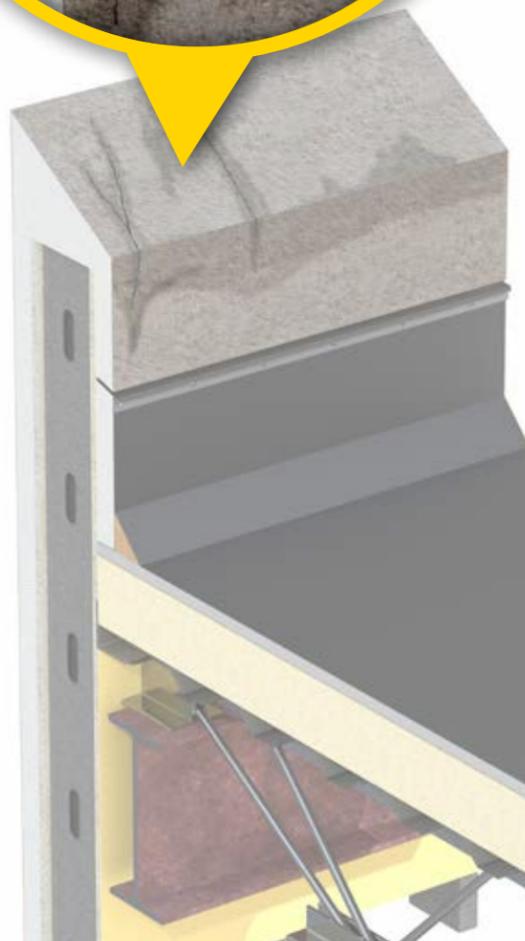
DAMAGED PARAPET CAP

**EIFS parapet caps were popular design features when EIFS were introduced.** The sharp top edge is subject to physical damage, and the sloped surface endures more weathering than the vertical walls, increasing maintenance requirements. If this is a barrier installation, damage to the EIFS lamina could result in water penetration from the outside and increased air leakage from the interior. All damage to the cap should be repaired as soon as possible.

**There are two potential solutions for the parapet repair.** The preferred, long-term solution will involve replacement of the parapet cap with an airtight, waterproof membrane and metal cap flashing. The alternative is to restore the existing EIFS parapet cap with layers of water-resistant coatings that will minimize water penetration, improve durability and reduce maintenance.

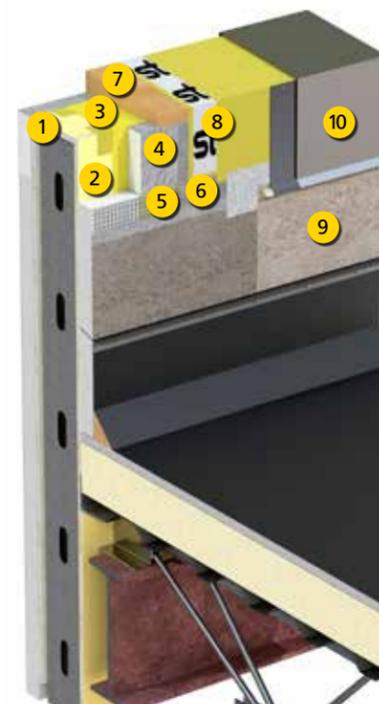
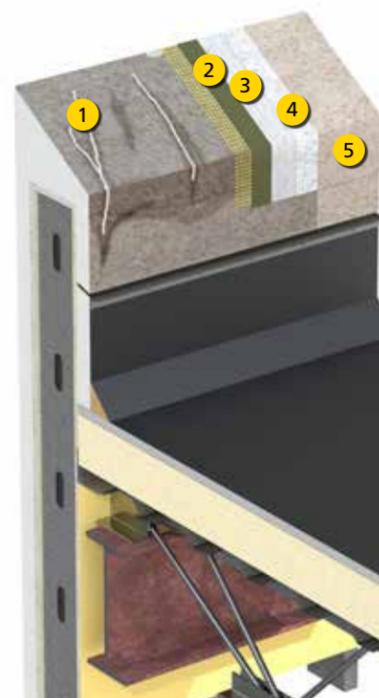
LV2 reStore — REPLACED OR RESTORED PARAPET CAP

## PARAPET CAP REPLACEMENT

- 1 **Remove the EIFS parapet cap and cladding** to a level 8" to 12" (200 to 300 mm) below the top edges of the substrate.
- 2 **Remove old adhesive** from the substrate.

- 1 **Clean and repair** existing parapet cap following Sto's maintenance instructions.
  - 2 **Apply a layer of Sto Flexyl and mesh** to the exposed surface, lapping onto the vertical wall surfaces 3" to 6" (75 to 150 mm). Allow to cure.
  - 3 **Apply tinted Sto primer** appropriate for the finish selected.
  - 4 **Apply Stolit Freeform** to the primed sloped surface and trowel to a smooth finish. Protect from the elements until dry.
- Integrate the parapet cap repairs** with the restoration of the EIFS finish below the parapet.
- 5 **Coat the Stolit Freeform** with StoColor Acryl Plus.

**A parapet cap restored to its original appearance will require additional long-term maintenance.** Replacing the EIFS cap with a metal cap flashing will increase protection from physical damage, and reduce maintenance by deflecting water away from the wall surface. If evidence of water penetration is present or the repair is complicated by the roofing interface, a third-party envelope professional should be retained to evaluate conditions and make recommendations.

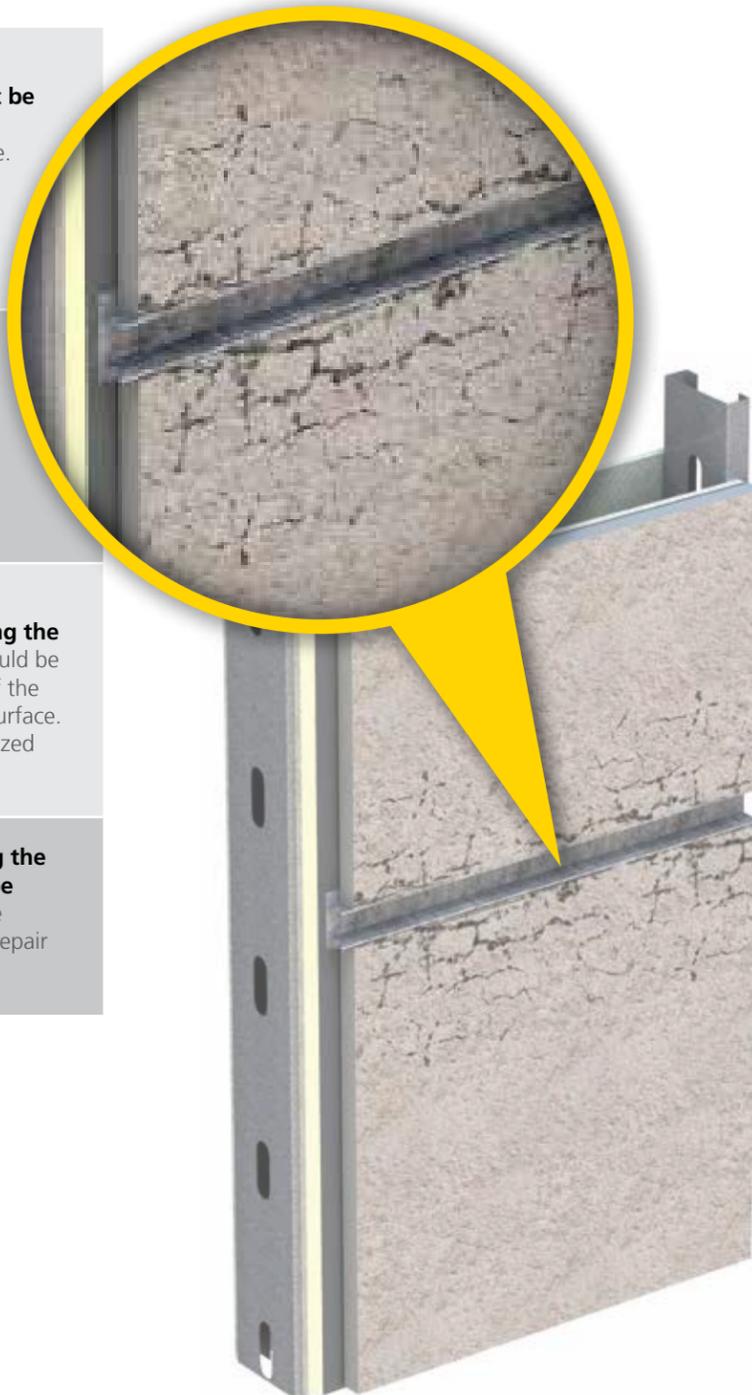
## DETERIORATED STUCCO AT HORIZONTAL REGLET INTERFACE

**Metal one-piece reglets, designed to be decorative elements, have no movement capability and cannot be used as stress relief joints in stucco.** If used for this function, cracking will occur at the stucco/reglet interface. In addition, these metals (anodized aluminum or galvanized steel) are vulnerable to corrosion, especially in coastal environments, if the protective coating is damaged.

**A foam build-out overclad will avoid removal and replacement of the horizontal reglet while extending the life cycle of the stucco cladding assembly.** Repair should be undertaken in conjunction with the Level 2 restoration of the stucco wall to ensure protection of the water-shedding surface. If both horizontal and vertical one-piece reglets were utilized then a Level 3 overclad is recommended.

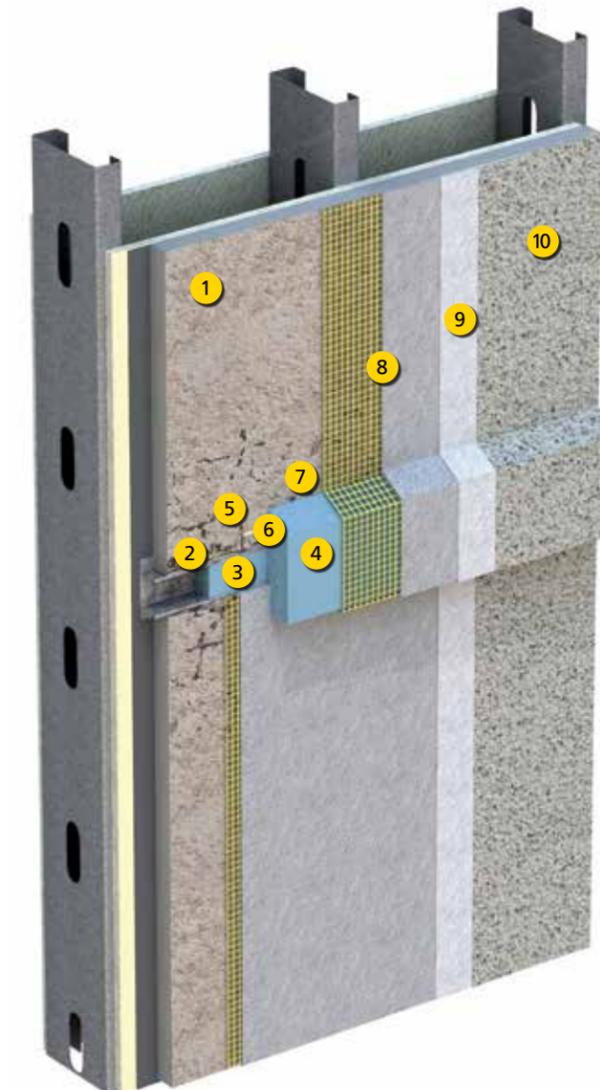
## LV2 reStore — FOAM BUILD-OUT OVERCLAD

- 1 **Clean entire stucco surface** to remove all contaminants and loose materials.
- 2 **Seal stucco cracks** along the reglet with an acrylic sealant.

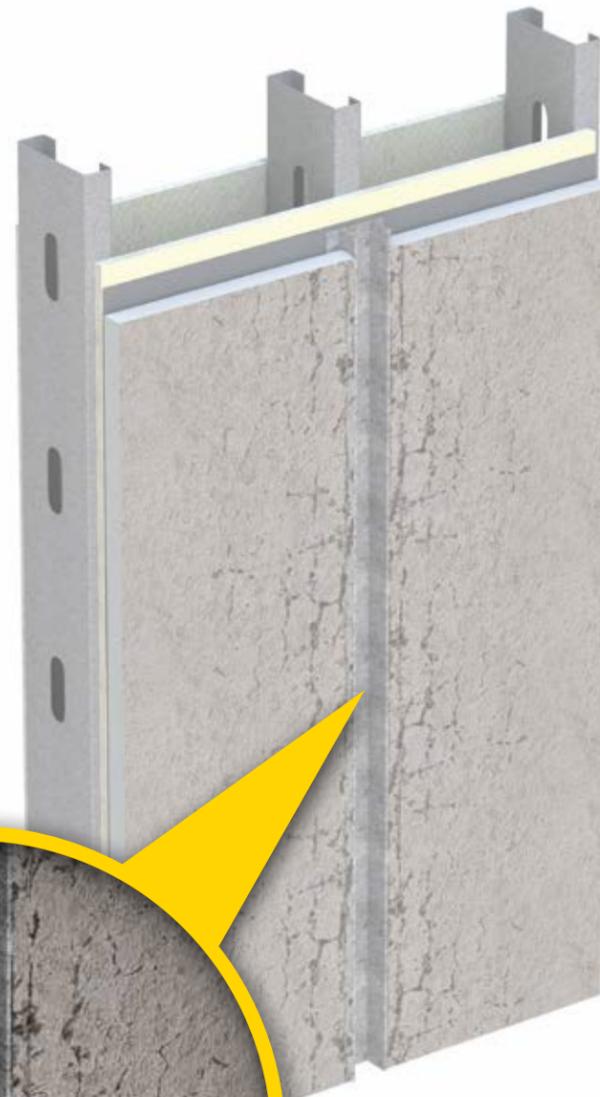
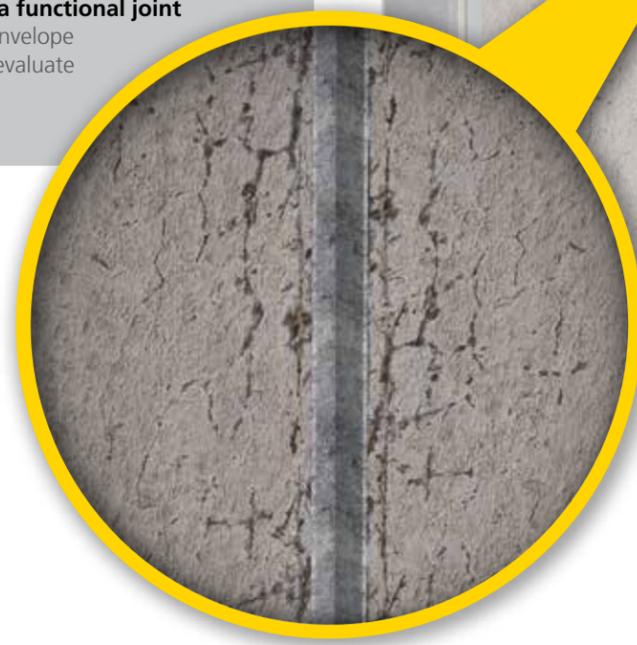
- 1 **Clean entire stucco surface** to remove all contaminants and loose materials.
- 2 **Seal stucco cracks** along the reglet with an acrylic sealant.

- 3 **Install a tightly fitting foam insert** into the cavity of the reglet so that it fits flush with the existing surface.
- 4 **Prepare a protective foam build-out** as per Sto Detail 72.20.72 to be installed over the reglet.

**A foam build-out overclad will avoid removal and replacement of the vertical reglet while extending the life cycle of the stucco cladding assembly.** Repair should be undertaken in conjunction with the Level 2 restoration of the stucco wall to ensure protection of the water-shedding surface. If both horizontal and vertical one-piece reglets were utilized then a Level 3 overclad is recommended.

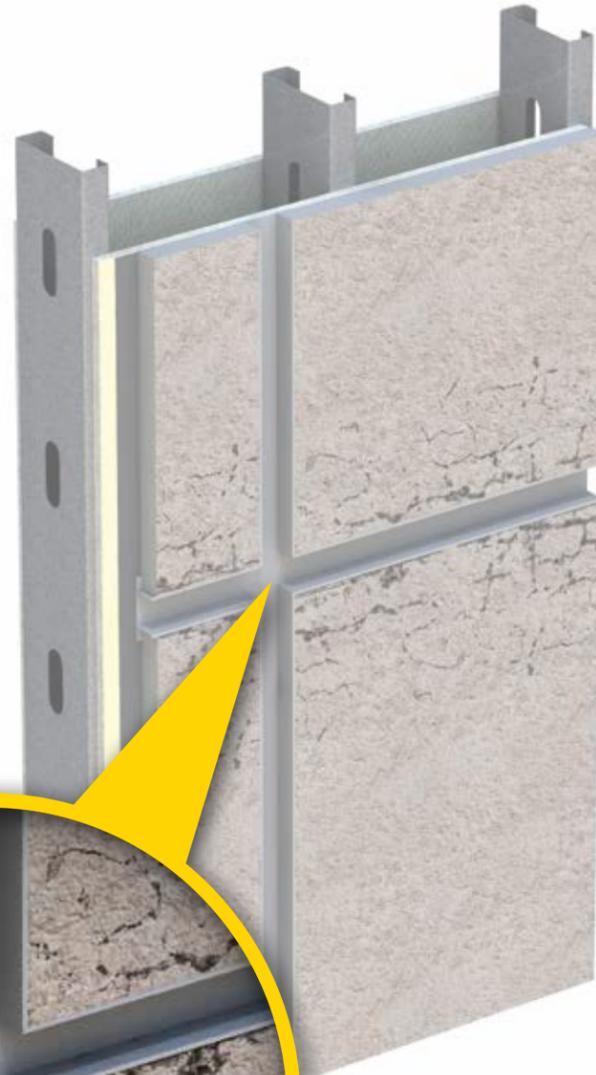
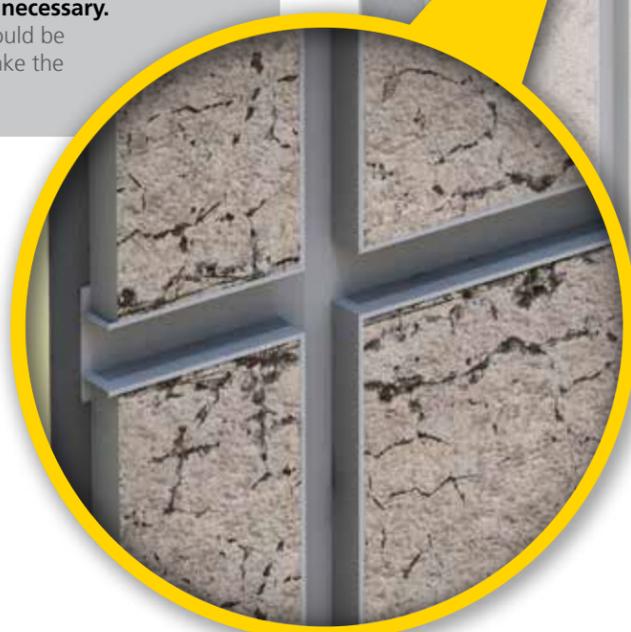
# Horizontal and Vertical Reglets

**A StoTherm ci overclad will avoid removal and replacement of the reglet while extending the life cycle of the cladding assembly.** StoTherm ci will also enhance the wall's thermal control by reducing thermal bridging and air leakage. The repair must link to the corresponding protection planes of adjacent enclosure assemblies.

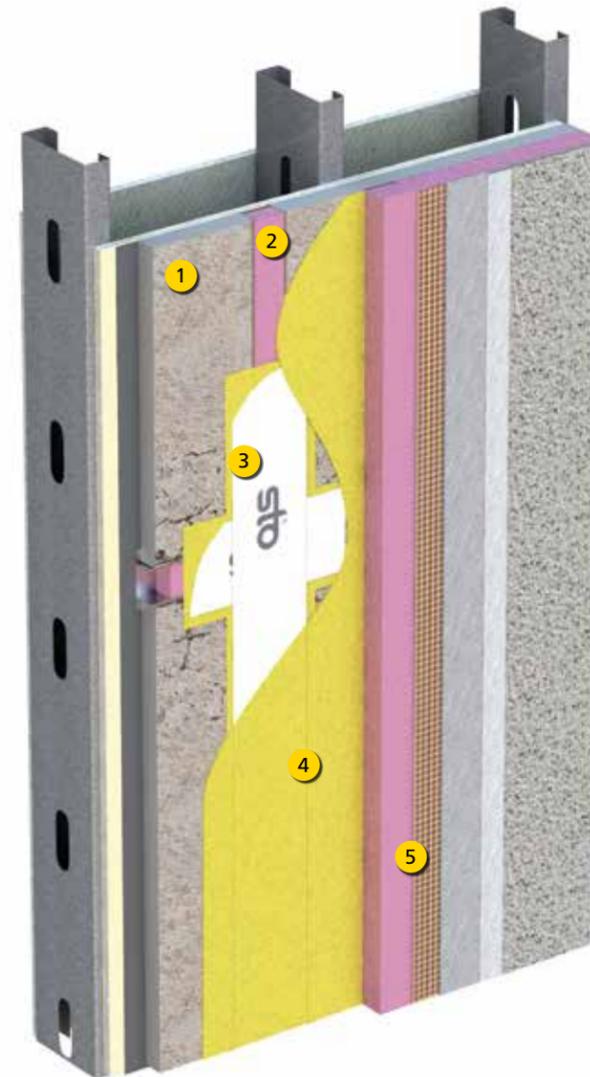
LV3 reStore — STOTHERM CI OVERCLAD

- 1 **Clean entire stucco surface** to remove all contaminants and loose materials.
- 2 **Install a tightly fitting foam insert** into the cavity of the reglet so that it fits flush with the existing surface.
- 3 **Install Sto barrier membrane** over the reglets as per Sto specifications and details.
- 4 **Apply StoGuard® air and moisture barrier system** over the stucco surface.
- 5 **Install StoTherm ci** over the wall surface with the specified Sto decorative finish.

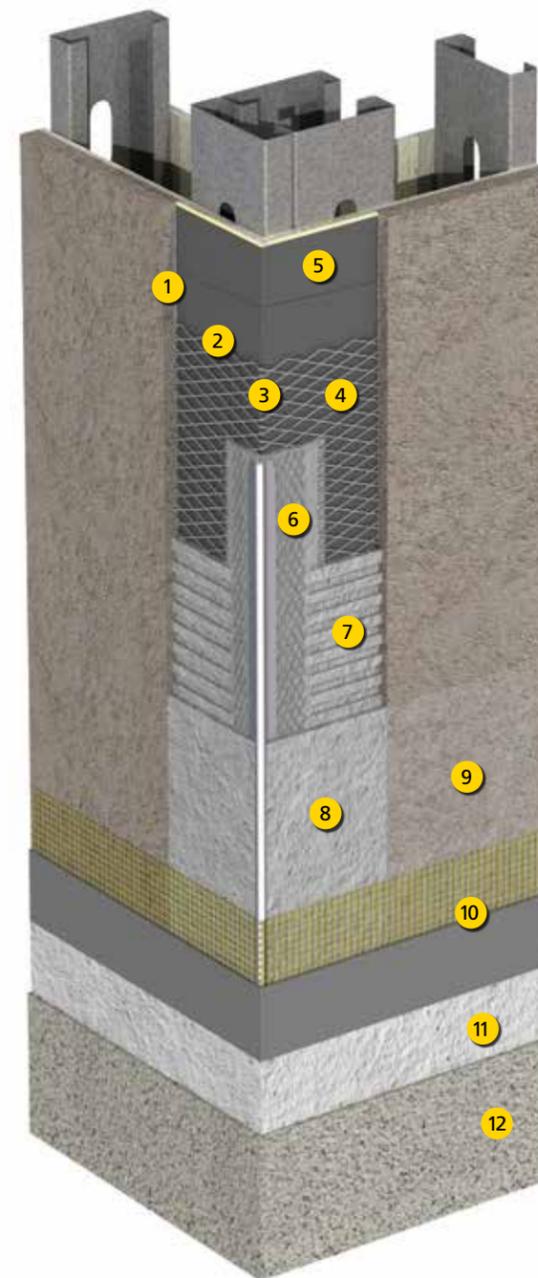
LV2 reStore — CORNER BEAD RESTORATION

- 1 **Cut the stucco back** to the lath approximately 6" (150 mm) on each side of the corner. Remove the stucco down to the lath.
- 2 **Carefully remove fasteners** or ties supporting the corner bead.

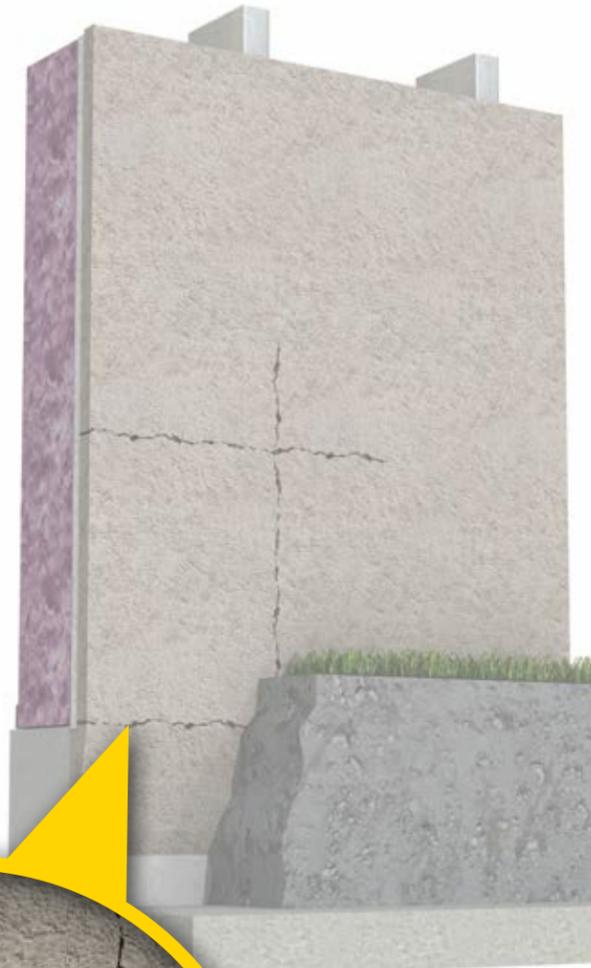
# Stucco on Frame Wall at Grade

**With landscaping removed, the stucco and sheathing can be cut away from the base of the wall and the stucco termination repositioned.** Repairs will use more damage-resistant materials and incorporate the required flashing. The repair will create a drainage path from behind the stucco and increase protection against water penetration.

**If there is water damage inbound of the sheathing, or if it is not possible to maintain effective drainage away from the building after finished grade is lowered,** a third-party envelope professional should be retained to evaluate conditions and make the necessary repair recommendations.

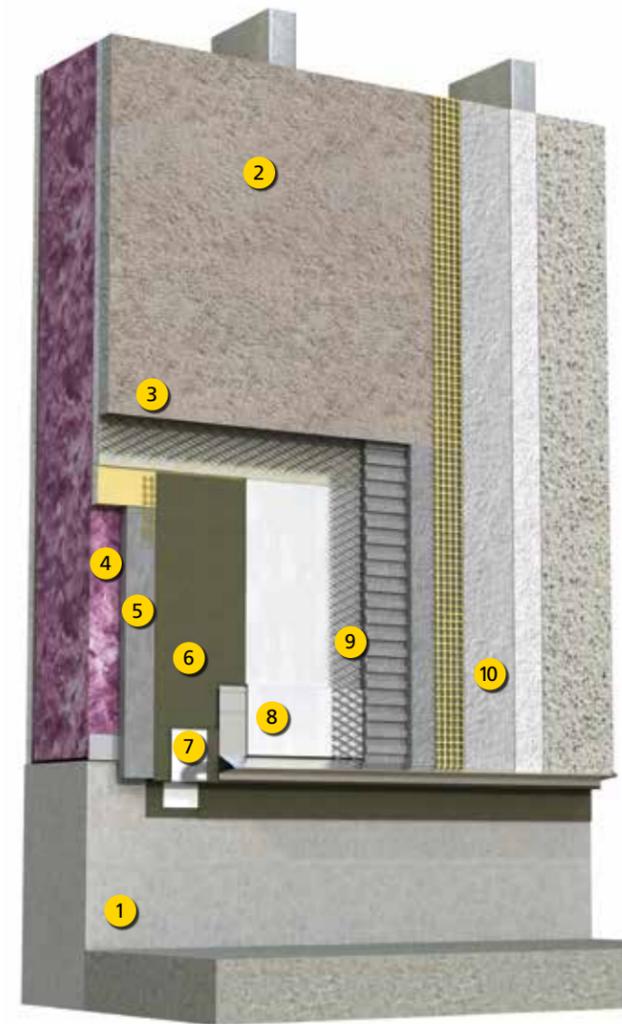
LV2 reStore — STUCCO RESTORED ABOVE GRADE

- 1 **Clear away landscaping and soil** from the stucco and foundation.
- 2 **Remove loose finish and repair cracks** and surface damage as per Sto Repair and Maintenance Guide.

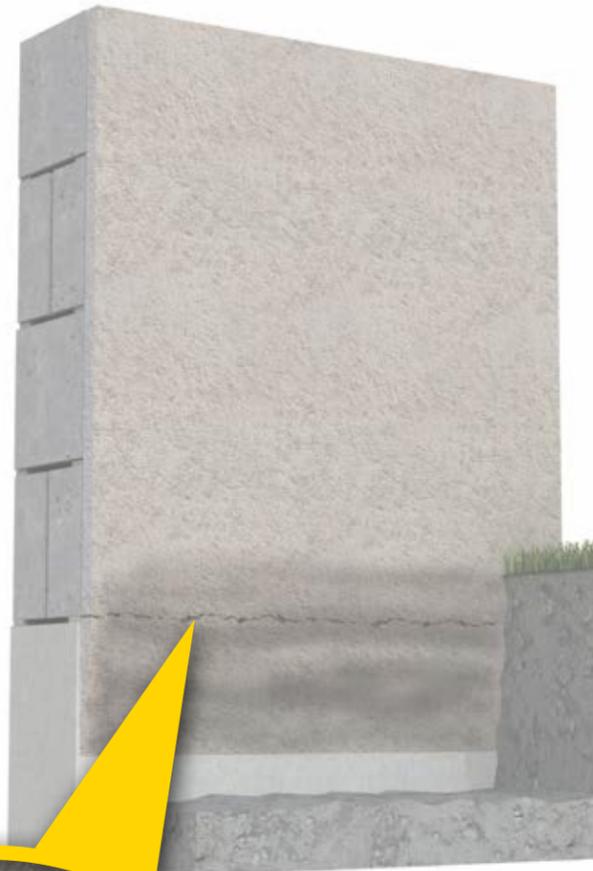
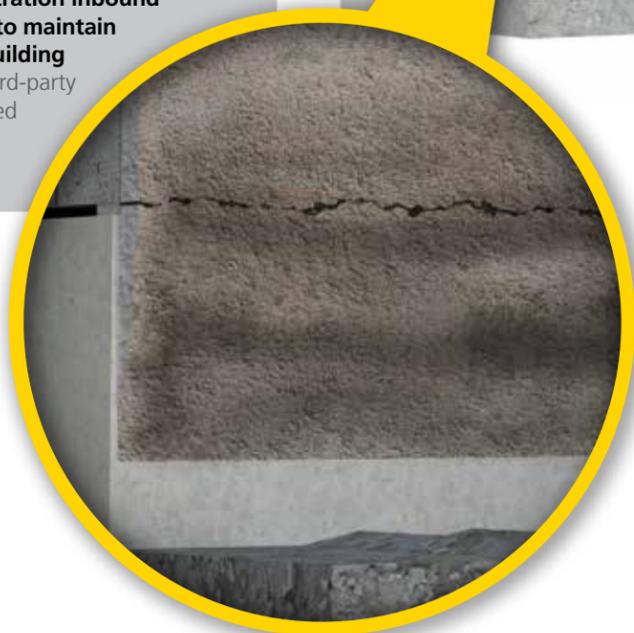
# Stucco on CMU Termination at Grade

**With landscaping removed and the stucco termination cut away, the repair can be made as an integral part of refinishing the wall or as a stand-alone repair.** The new termination will include waterproofing layers and code-compliant flashing to direct water away from the wall. Keeping water away from the foundation is outside the scope of the repair, but will require regrading the landscape away from the building or adding drains.

**If there is damage from water penetration inbound of the masonry, or if it not possible to maintain effective drainage away from the building after finished grade is lowered,** a third-party envelope professional should be retained to evaluate conditions and make the necessary repair recommendations.

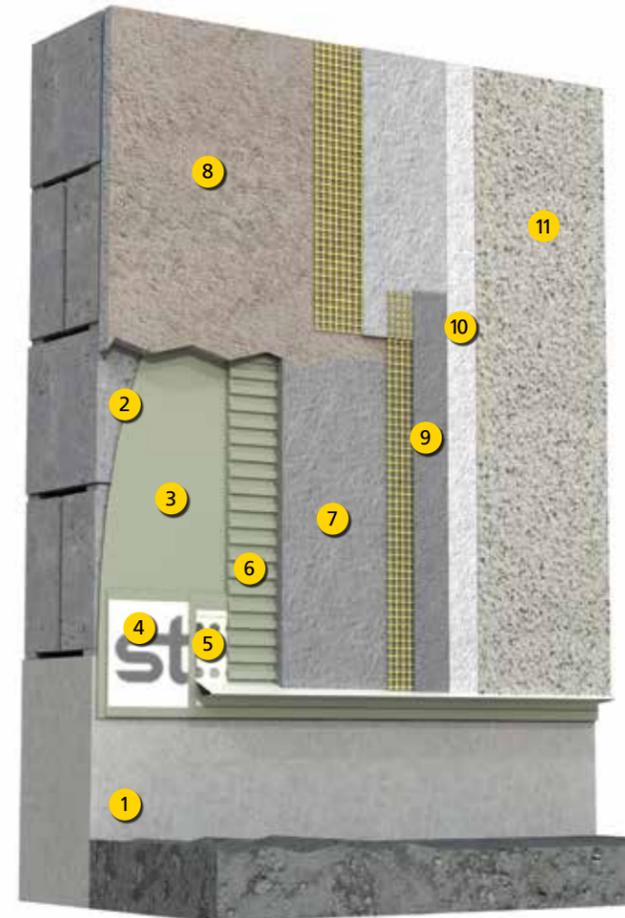
LV2 reStore — FLASHING INSTALLATION AND IMPROVED WATER RESISTANCE

- 1 **Clear landscaping and soil** a minimum of 8" (200 mm) below the top of the foundation.
- 2 **Remove the stucco from the base of the wall** to a height of approximately 16" (400 mm) above the foundation. Remove all loose material and dust from the surface of the CMU and concrete foundation.

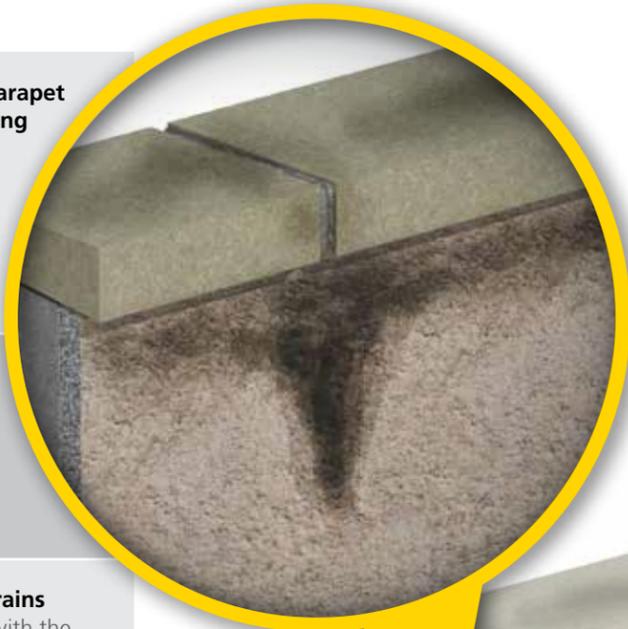
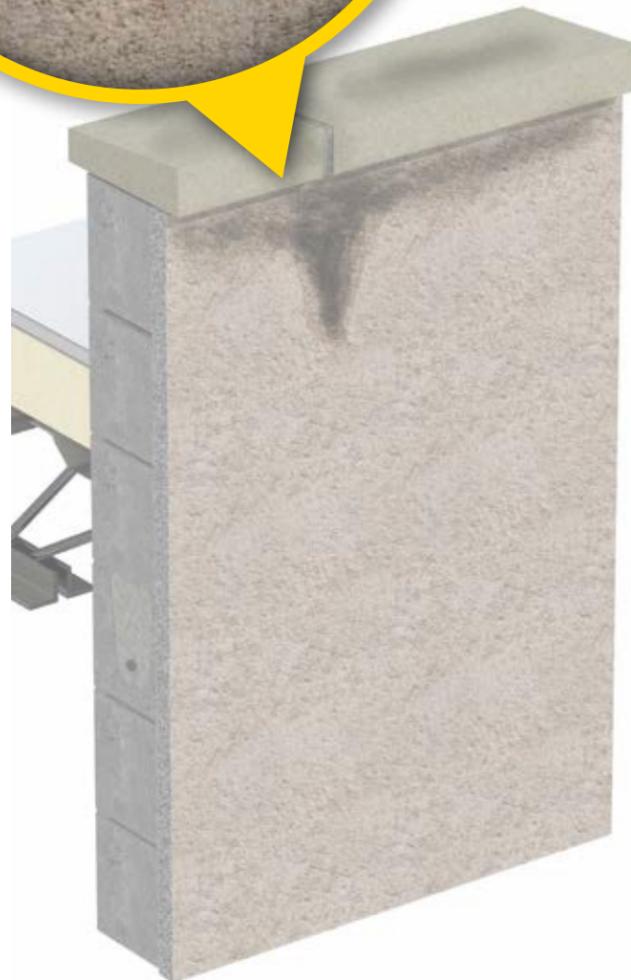
# Concrete Parapet Cap

The slope of the cap can be modified so water drains towards the roof. Waterproof coatings, integrated with the new wall finish, will further improve the parapet's water resistance. Where specified, the inner face of the parapet wall may be refinished, integrating the waterproofing with roof membranes and flashings.

An escalation of the repair will be advisable if water penetration at the cap joints or through the parapet wall has led to deterioration of the cap connections. If the cap is loose or connections show signs of deterioration (e.g., spalling or rust staining), a third-party envelope professional should be retained to evaluate conditions and make the necessary repair recommendations.
