# Restoration of Building Facades

A comprehensive repair guide for facade restoration professionals

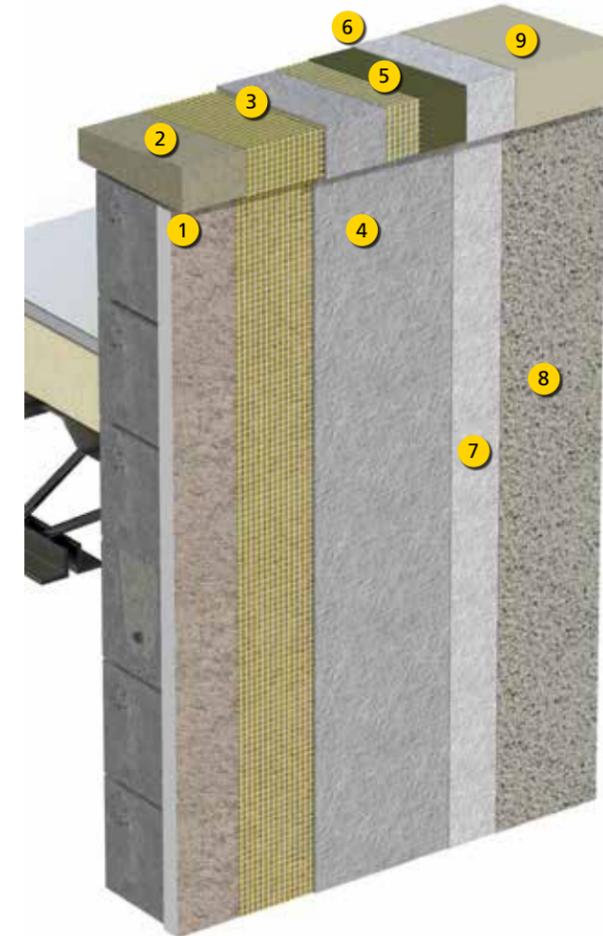
- 1 Remove dirt accumulations on the parapet cap and on the face of the wall.
- 2 Clean and repair the cap mortar joints.
- 3 Using additional applications of Sto base coat, increase the slope of the parapet cap towards the roof.
- 4 Apply Sto base coat and mesh to the prepared surface, wrapping over the parapet cap and, ideally, terminating at the roof flashing. Allow to cure.
- 5 Install an application of Sto Flexyl and Sto Mesh over the recoated parapet cap.
- 6 Where specified, continue the Sto Flexyl to the back side of the masonry parapet and integrate with the roof membrane and flashing.
- 7 Apply tinted Sto primer appropriate for the finish selected.
- 8 Refinish the wall with the specified Sto materials.
- 9 Coat the parapet cap with two coats of StoColor Acryl Plus.

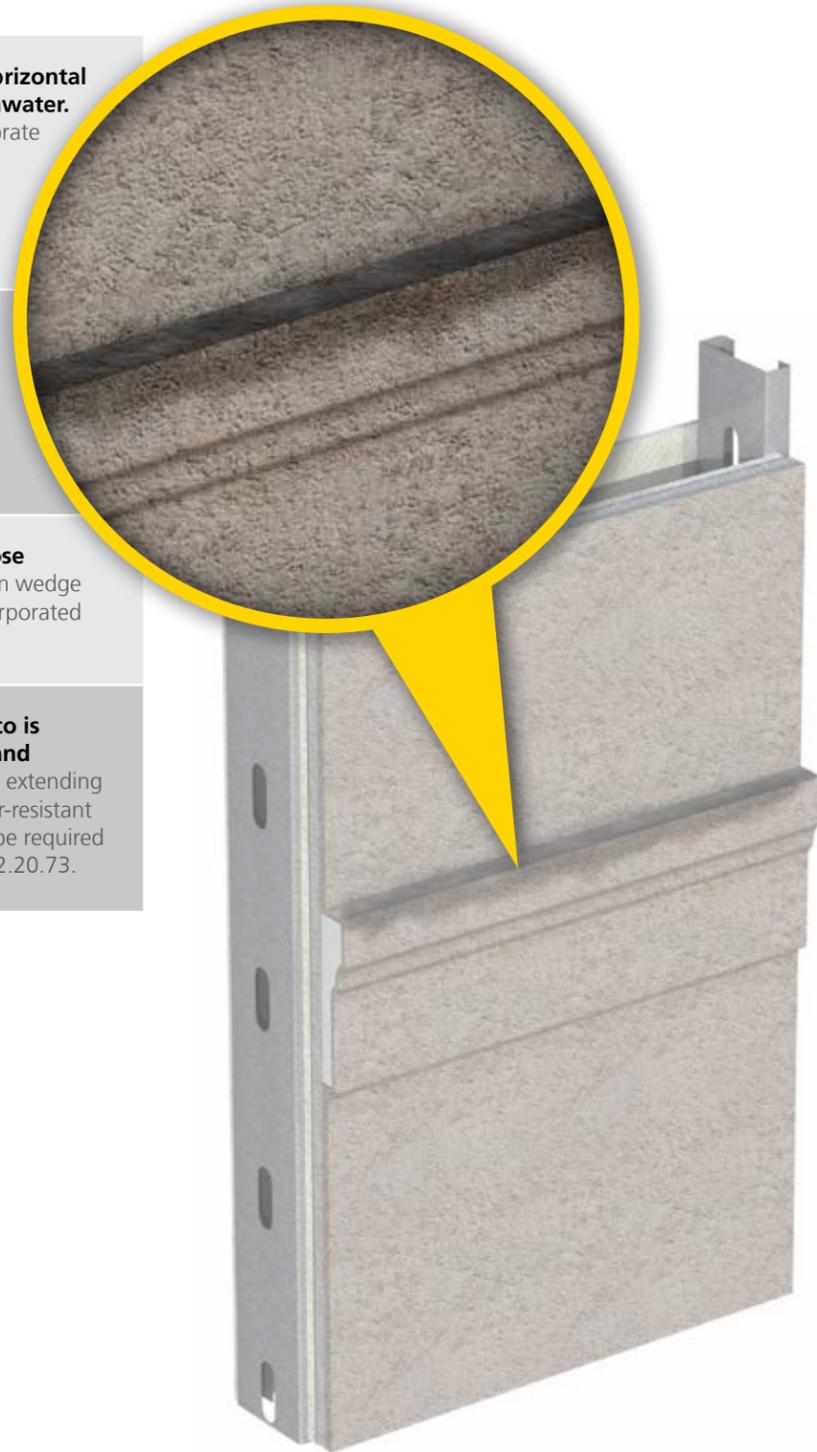
# Feature Profile

**The profile and wall will be cleaned and any loose finish removed prior to refinishing.** A simple foam wedge will be added to the top edge of the profile and incorporated into the new finish.

**If the profile is damaged or its bond to the stucco is compromised, the profile may require removal and replacement.** If the profile is large and unprotected, extending out from the stucco more than 4" (100 mm), a water-resistant base coat such as Sto Flexyl or a metal flashing may be required to improve long-term durability. Refer to Sto detail 72.20.73.

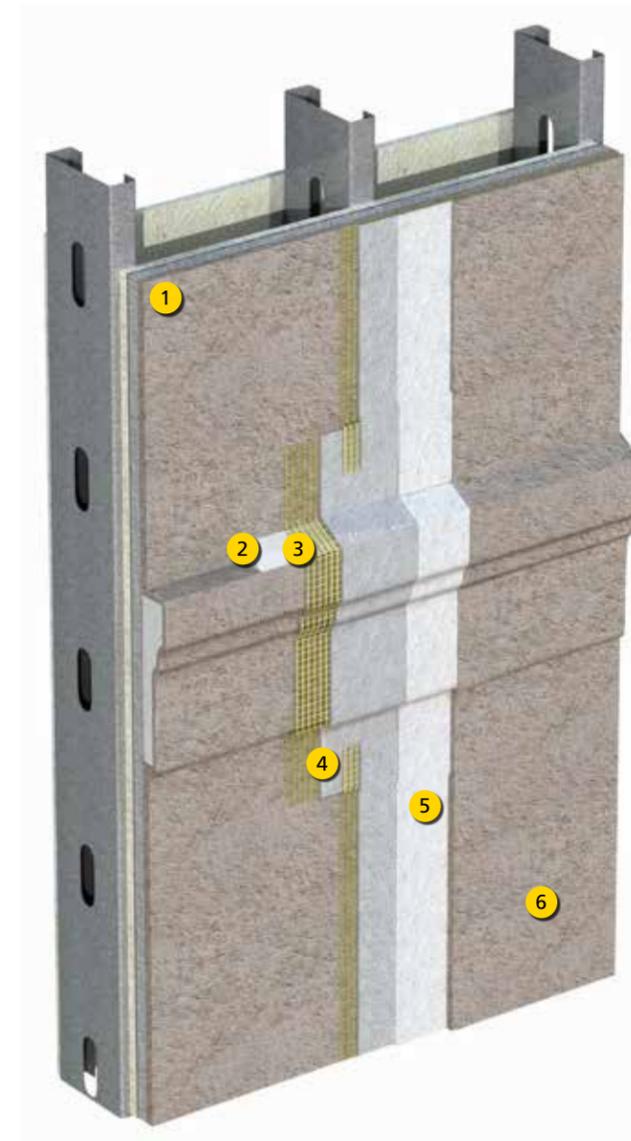
- 1 **Clean the wall**, removing all dirt and loose material.
- 2 **Bond a foam wedge** to the top of the profile with Sto adhesive, increasing the slope to a minimum 1:2 (27°). In climates where snow and ice may accumulate, increase the slope to 1:1 (45°).
- 3 **Allow the adhesive to cure for 24 hours**, then rasp the foam wedge so that it is even with the face of the profile.
- 4 **Apply Sto base coat and mesh** to the prepared surface and foam profile. Allow to cure.
- 5 **Apply tinted Sto primer** appropriate for the finish selected..
- 6 **Refinish the wall** with the specified Sto materials.

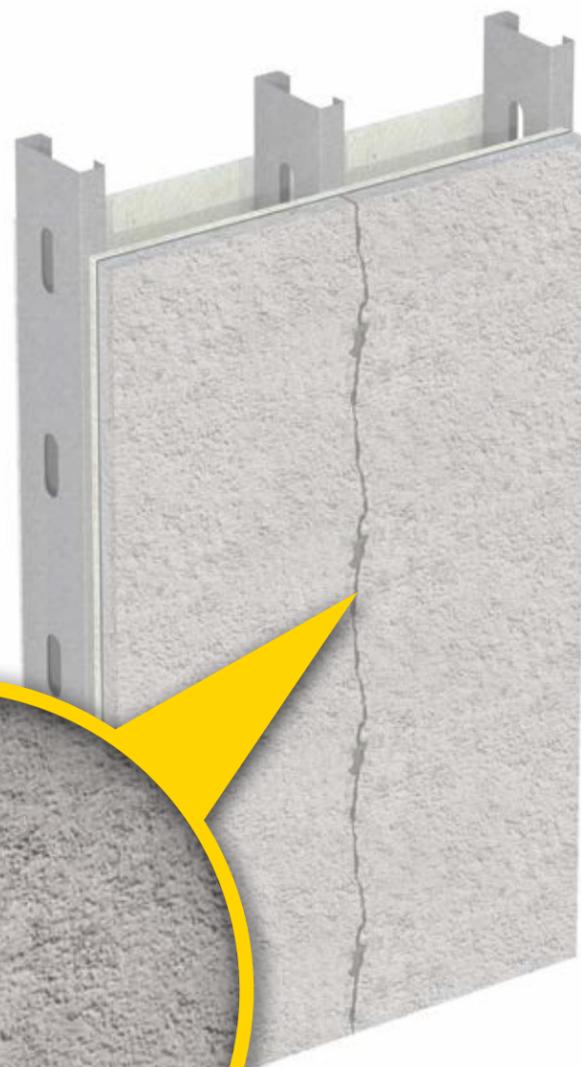
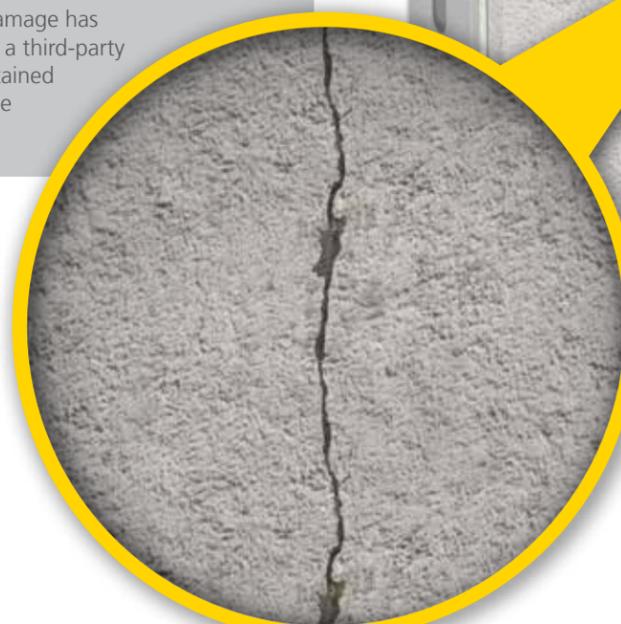
# Crack Through Stucco

**It is likely that a functional joint will be required.** The joint, which will run the full height or width of the stucco panel, may be installed as a stand-alone repair or as part of a complete facade restoration.

**A more extensive problem exists if there is damage to the water-resistive barrier, or corrosion of the lath or mechanical connections.** If the damage has progressed beyond a Level 2 repair, a third-party envelope professional should be retained to evaluate conditions and make the necessary repair recommendations.

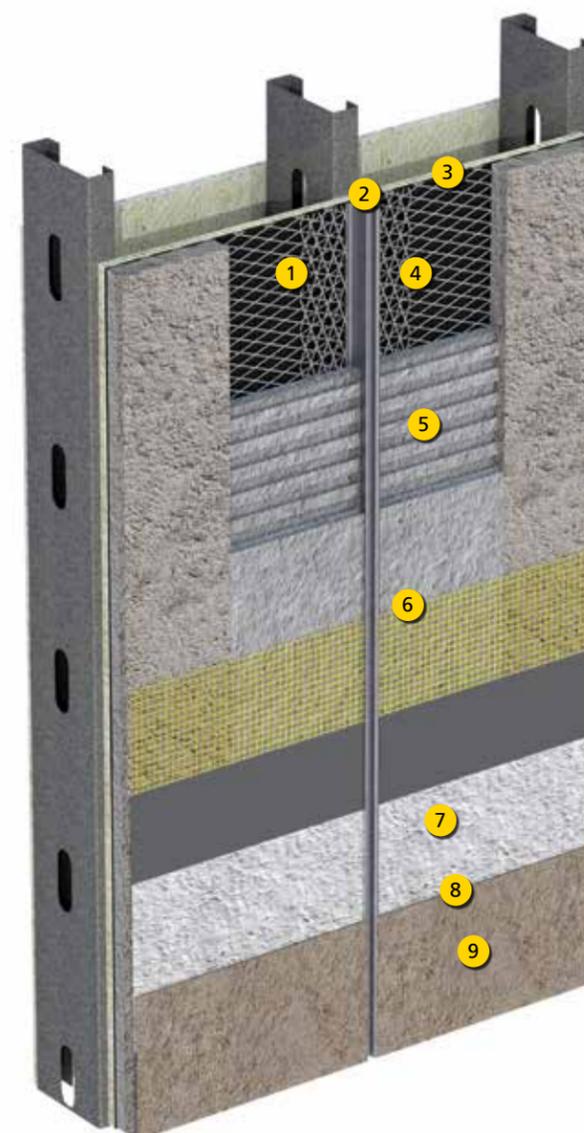
**1 Between horizontal joints,** remove stucco to a minimum width of 4" (100 mm) on each side of the crack, exposing the lath.

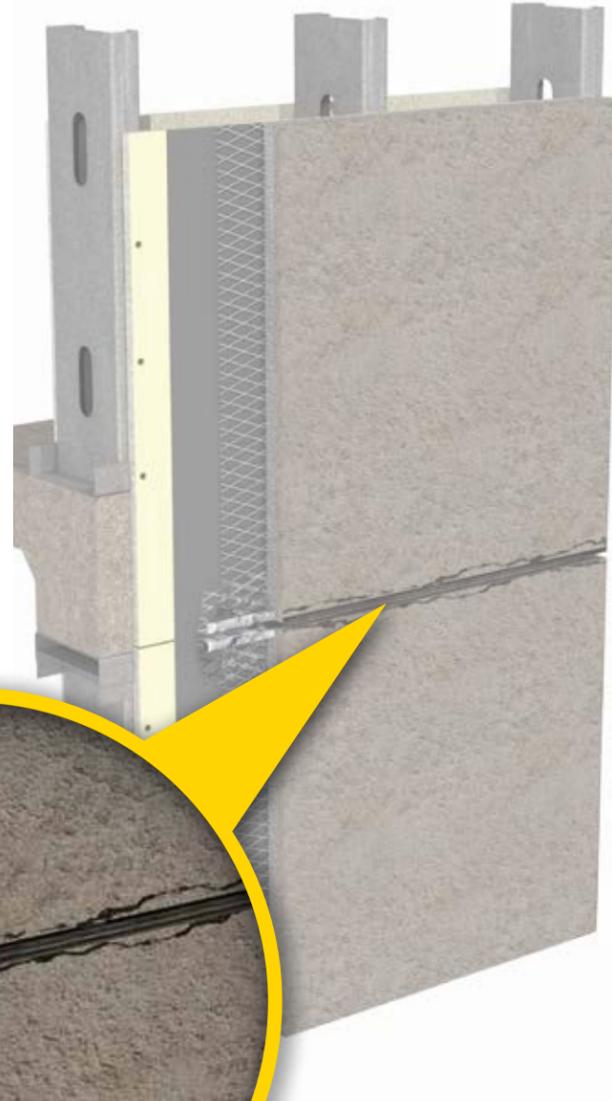
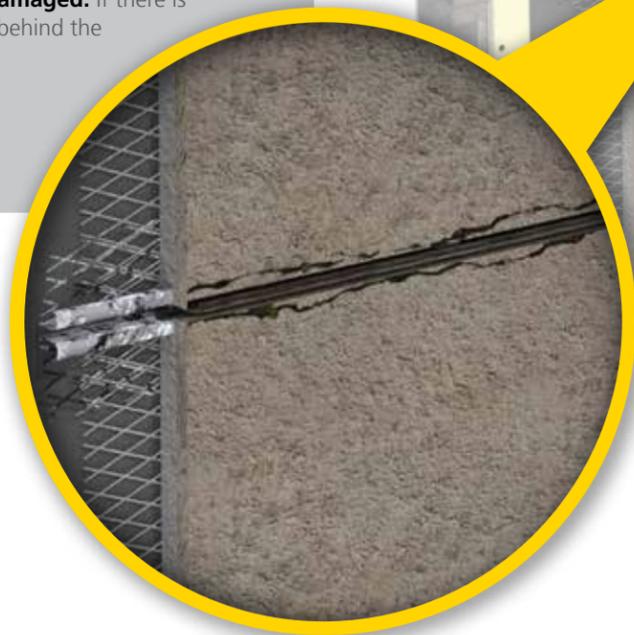
# Floor-Line Joints and Flashing

**An effective functional joint option is back-to-back casing beads with integrated flashing to direct water to the exterior.** The stucco and failed joint must be removed, and the lath cut for insertion of flashing behind the water-resistive barrier. The new joint can then be installed.

**If water has intruded behind the cladding, further evaluation is necessary to ensure that the lath and water-resistive barrier are not damaged.** If there is any evidence of water penetration behind the water-resistive barrier, a third-party envelope professional should be retained to evaluate conditions and make the necessary repair recommendations.

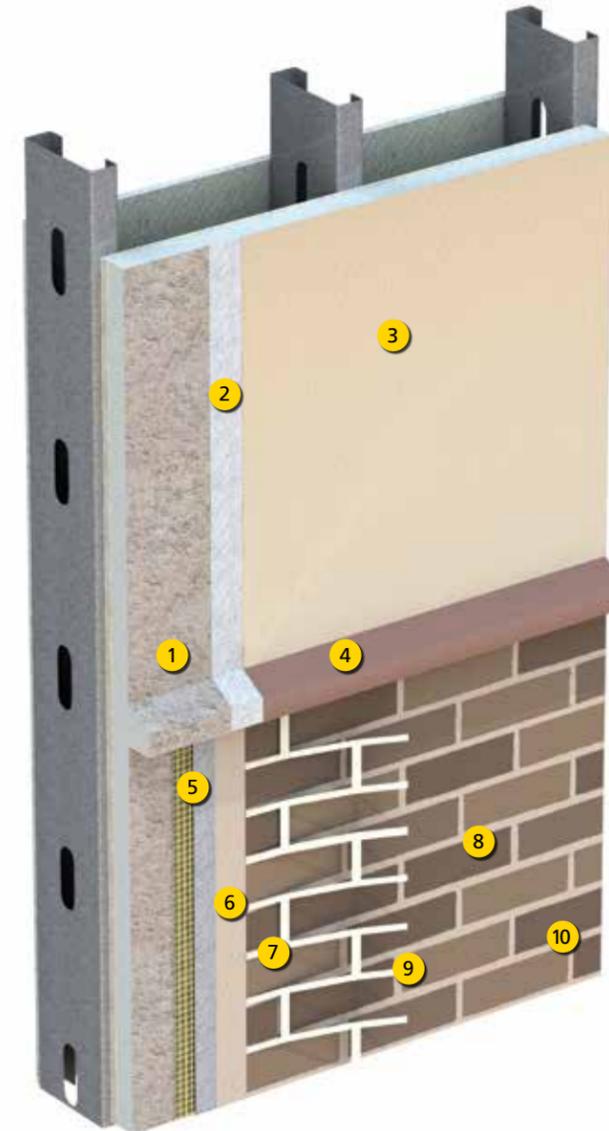
LV2 reStore — REJUVENATION WITH STO CREATIV BRICK

- 1 **Repair cracks and damage** as per Sto Maintenance Guide. Clean the surface and remove loose or damaged finish.
- 2 **In the area above the wainscot**, prime the wall with Sto Primer tinted appropriately for the new finish color.
- 3 **Recoat the selected area** with StoColor Lotusan or StoColor Acryl Plus.
- 4 **Protect the exposed surface** of the wainscot with StoColor Acryl Plus.
- 5 **Apply Sto base coat and mesh** to the prepared surface below the wainscot. Allow to cure.
- 6 **Apply StoPrime UV tinted** to match the selected mortar color.
- 7 **Position the brick** template on the StoPrime UV.
- 8 **Trowel on the selected** Sto Creativ Brick finish and texture to match appearance desired.
- 9 **Remove** the brick template.
- 10 **Tint the finish** to match the selected color and appearance using StoTique.

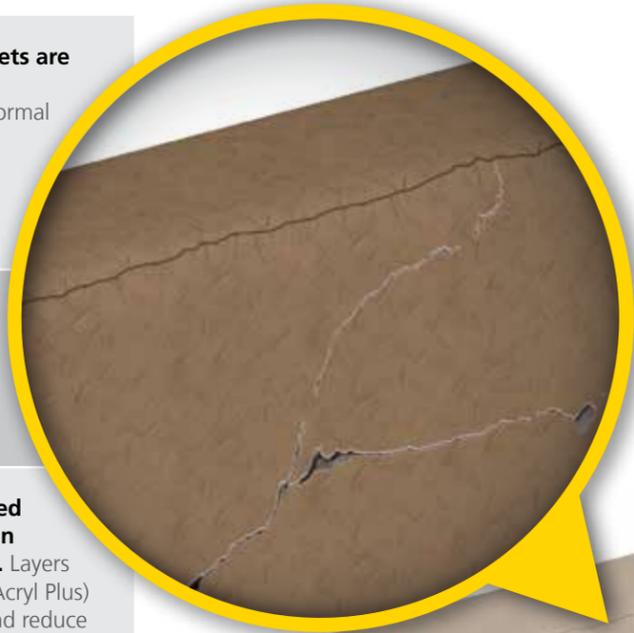
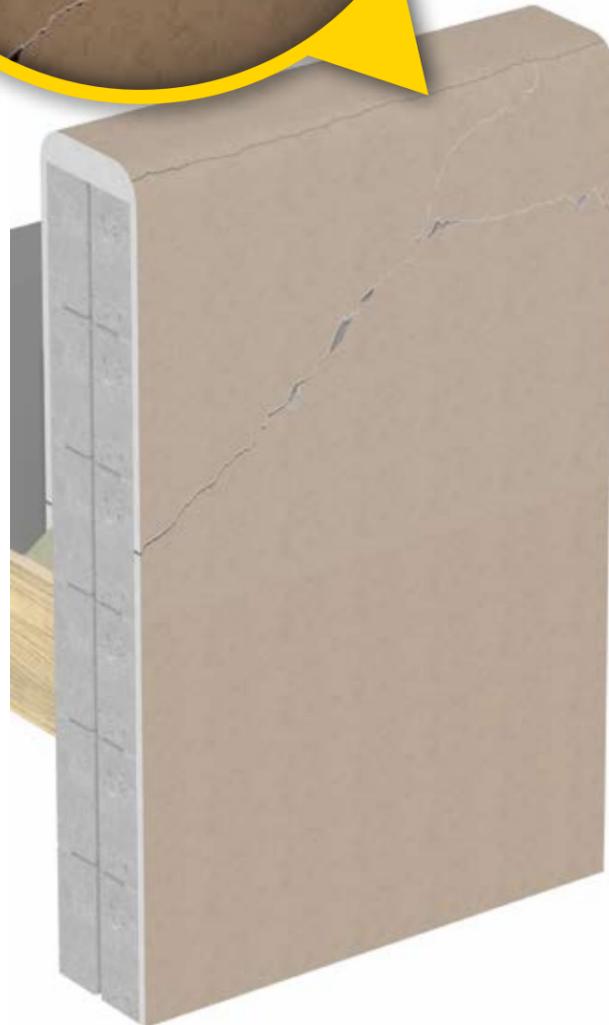
# Stucco Parapet Cap

**The curvature of the parapet cap is easily modified with additional stucco so water and dirt will drain towards the roof and away from the visible wall.** Layers of water-resistant coatings (e.g., Sto Flexyl, StoColor Acryl Plus) will minimize water penetration, improve durability and reduce maintenance.

**This type of parapet cover should only be used in hot, dry climates and only under advisement.** For long-term durability and performance, a metal cap flashing is the preferred solution. Walls should be refinished with vapor-permeable materials. It is essential that stucco and masonry be dry before refinishing.

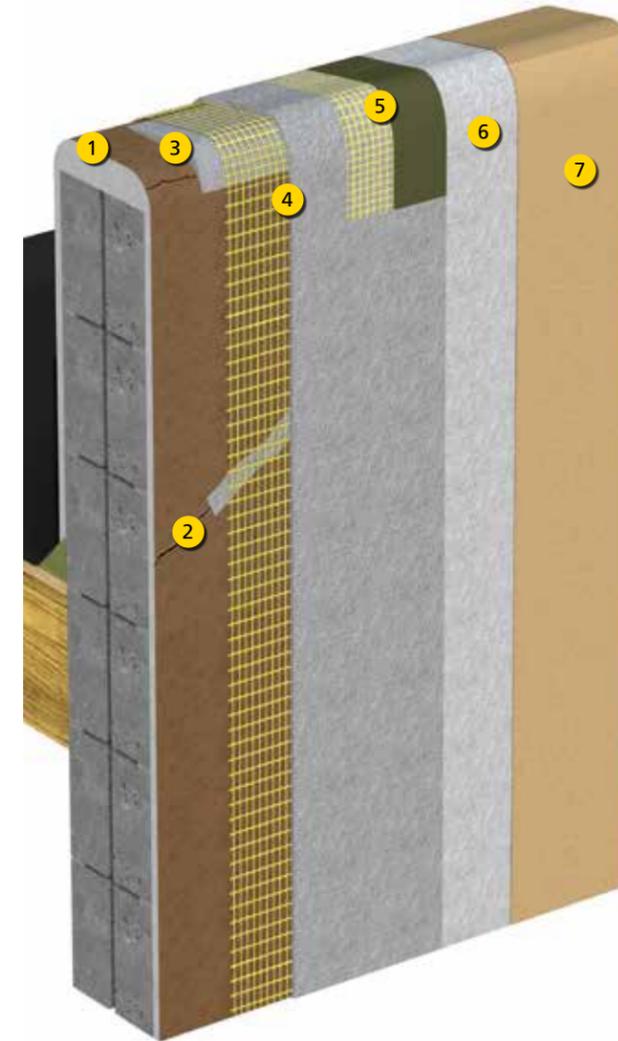
LV2 reStore — IMPROVED WATER RESISTANCE AND DURABILITY

- 1 **Remove all loose material and finish** from the top of the parapet. Clean the wall as per Sto's instructions.
- 2 **Repair** cracks.
- 3 **Direct drainage toward the roof** by modifying the slope of the cap, using additional stucco.
- 4 **Apply Sto base coat and mesh** to the prepared surface and over the modified parapet. Allow to cure.
- 5 **Install Sto Flexyl and mesh** over the parapet cap and down 6" (150 mm) on each face of the wall, feathering out the edges. Allow to cure.
- 6 **Apply tinted Sto primer** appropriate for the finish selected.
- 7 **Refinish the wall** with the specified Sto materials.
- 8 **For increased durability**, apply two coats of StoColor Acryl Plus to the exposed top surface of the parapet.

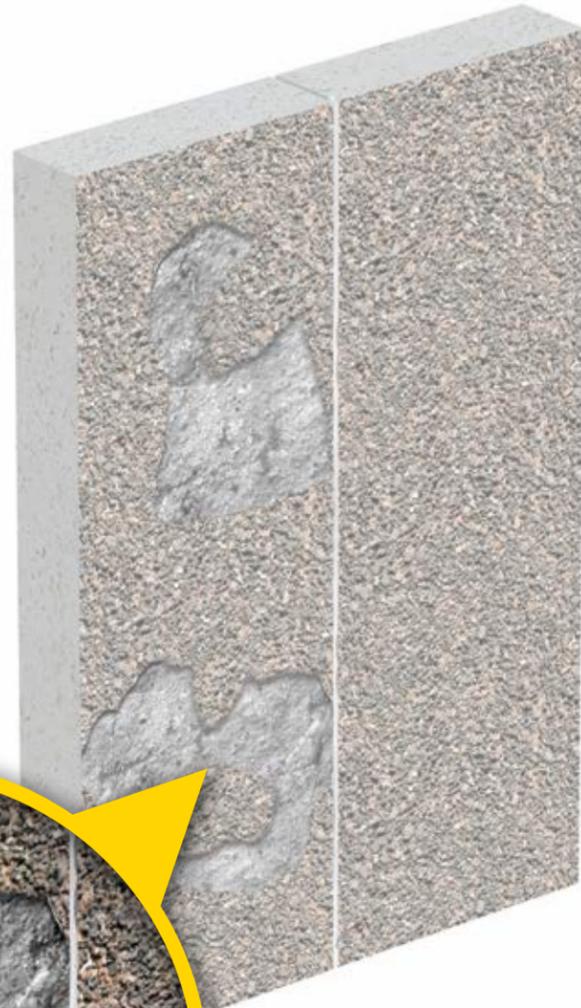
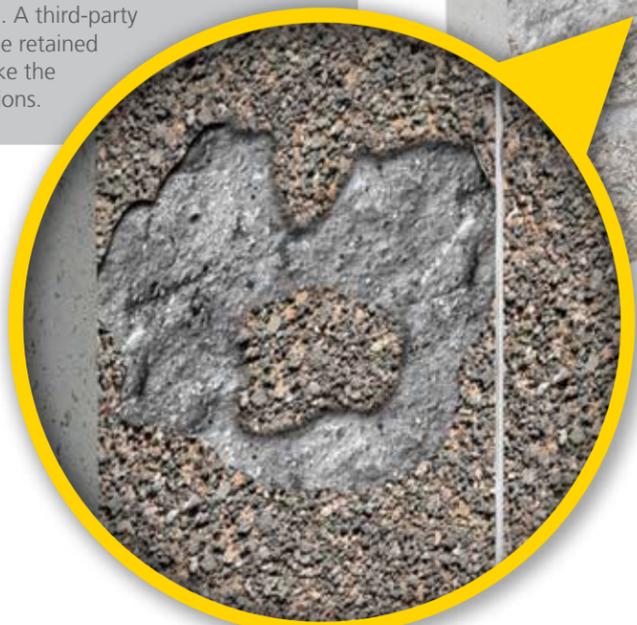
# Deteriorated Precast Concrete

**Refinishing the wall will make a significant change in the building's appearance and perception of its value.** Adding three-dimensional profiles and a recoat that showcases fresh colors and finishes will transform the building.

**Damage and deterioration of the concrete may have progressed to the steel reinforcing.** If there are signs of rust or distress in the concrete that may be related to structural reinforcement, further repairs to the concrete and reinforcement may be required. A third-party envelope professional should be retained to evaluate conditions and make the necessary repair recommendations.

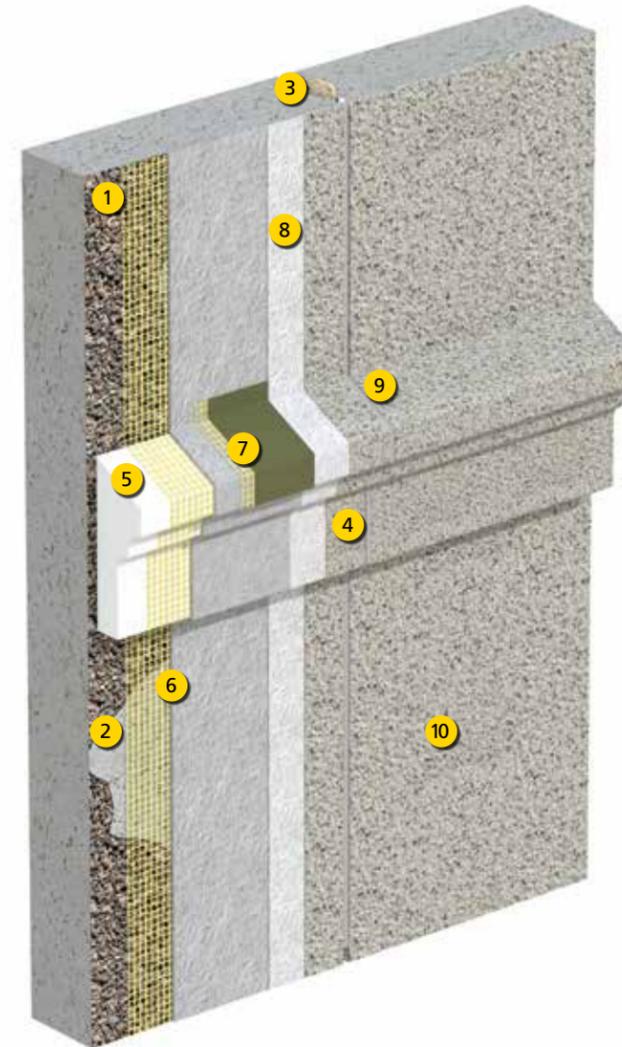
LV2 reStore — PRECAST REFINISHED WITH ARCHITECTURAL FEATURES

- 1 **The surface of the concrete should be pressure washed** and any loose finish removed.
- 2 **Fill any holes** and level the surface with Sto Leveler.

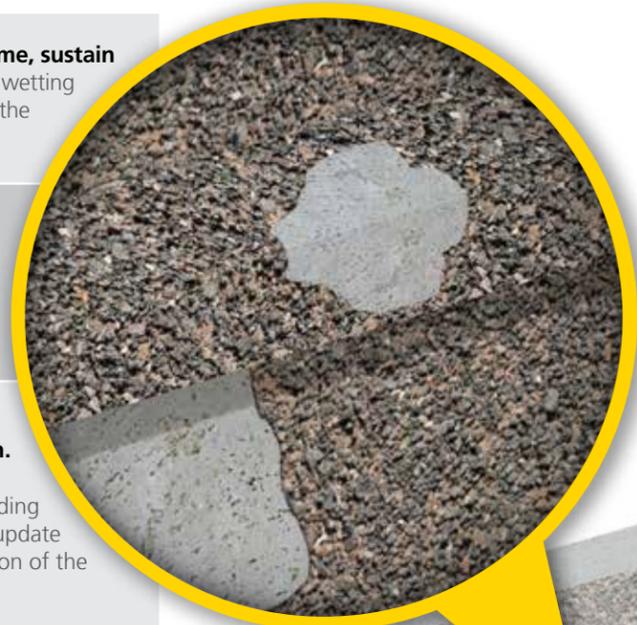
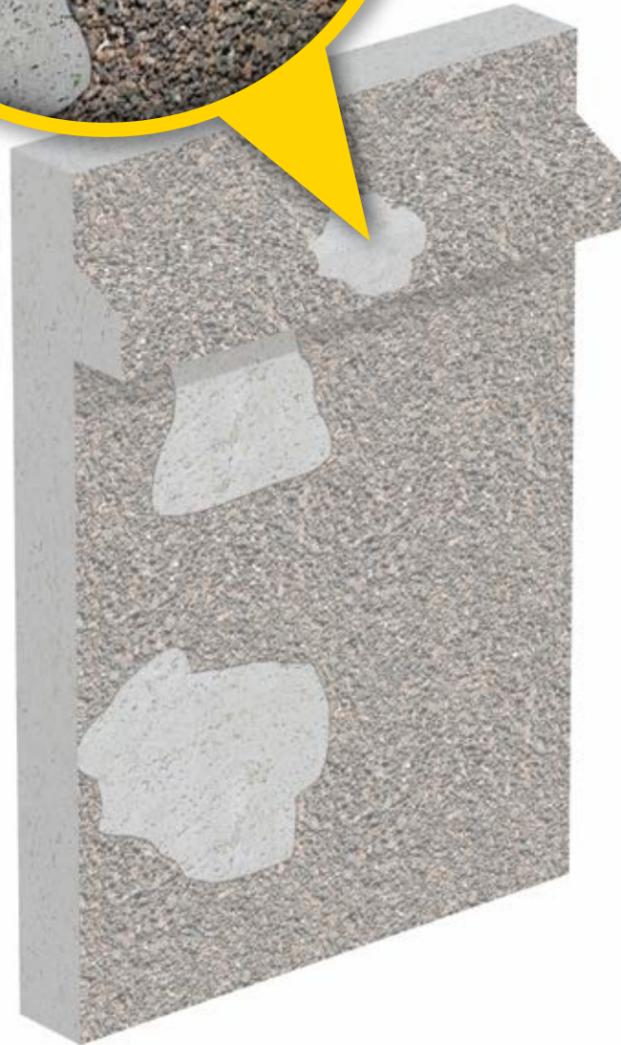
DETERIORATED CONCRETE PROFILES

The projecting profiles on a facade may, over time, sustain damage. Accumulations of snow and ice or regular wetting from rain will accelerate deterioration. Aesthetically, the facade is compromised but the substrate is sound.

A Level 2 restoration is indicated when the precast remains structurally sound. Damage to the wall surface and projecting profile is limited to surface deterioration and has not progressed to the reinforcing steel.

- 1 **Pressure wash** the precast to remove loose finish and dirt.
- 2 **Patch areas** where the finish has been damaged to create a level surface.
- 3 **Apply Sto base coat and mesh** to the prepared surface. Allow to cure.
- 4 **Trowel an application** of Sto Flexyl and mesh onto the exposed surface of the concrete feature, lapping onto the wall above and the face of the profile. Allow to cure.
- 5 **Apply tinted Sto primer** appropriate for the finish selected.
- 6 **Refinish the wall** with the specified Sto materials.
- 7 **For extended durability** of the finish on the profile, coat the exposed surface with two applications of StoColor Acryl Plus tinted to match the finish.

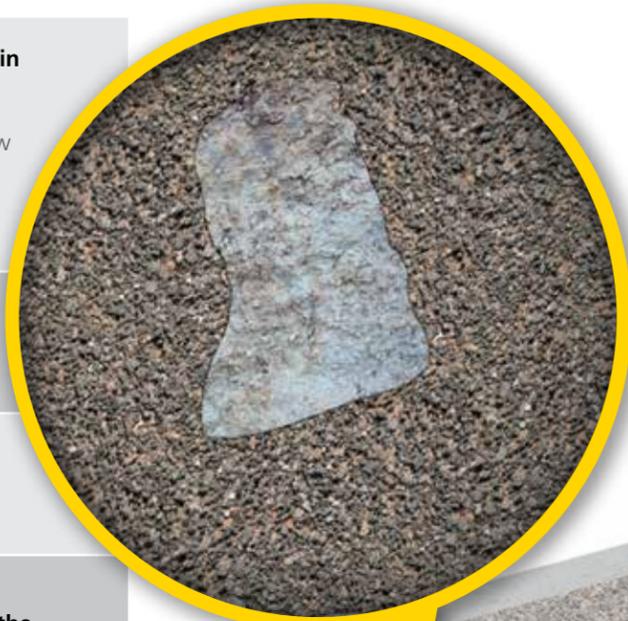
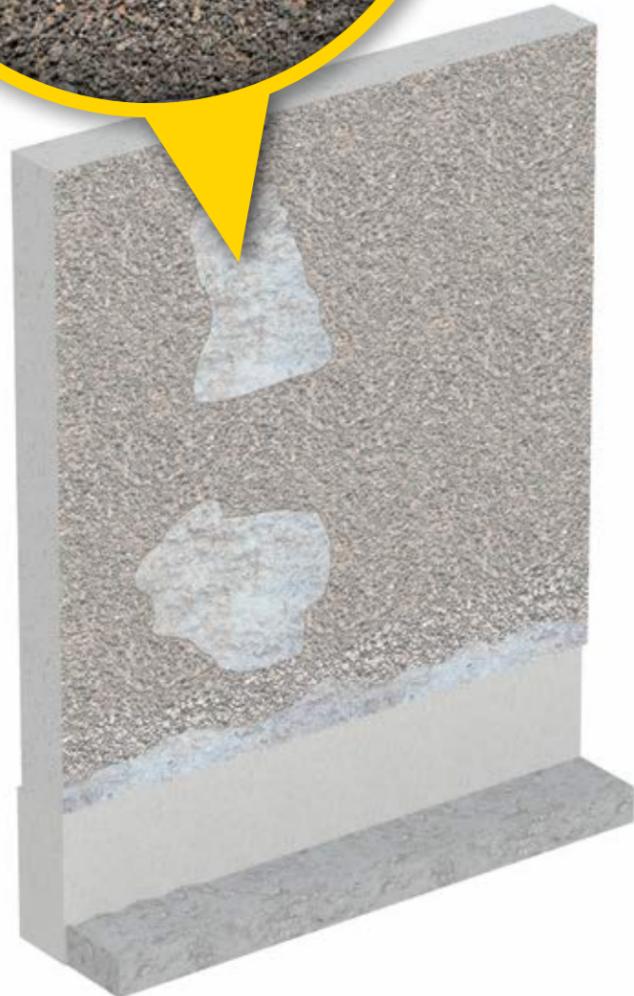
CONCRETE DETERIORATED BY SNOW AND WATER

Winter weather or constant dampness can result in damage to the base of a wall. Snow, salt and slush routinely get piled against walls during sidewalk and driveway clearing. The damp, coupled with freeze/thaw conditions, will cause deterioration of finishes. Salt that penetrates the concrete will accelerate corrosion of reinforcing steel if not corrected.

A Level 2 restoration will waterproof the concrete base. The repair is undertaken ahead of any serious deterioration of the concrete.

- 1 **Pressure wash** the wall to remove dirt and loose finish.
- 2 **Remove efflorescence or salt stains** with a mild acid solution or cleaner following local environmental requirements.
- 3 **Patch and level** any locations where the finish has been removed.
- 4 **Apply Sto base coat and mesh** to the prepared surface. Allow to cure.
- 5 **Install Sto Flexyl and reinforcing mesh** over the area of the wall subject to snow buildup or wetness.
- 6 **Apply tinted Sto primer** appropriate for the finish selected.
- 7 **Refinish the wall** with the specified Sto materials.
- 8 **In areas subject to snow build-up or wetness**, apply one or two layers of StoColor Acryl Plus.

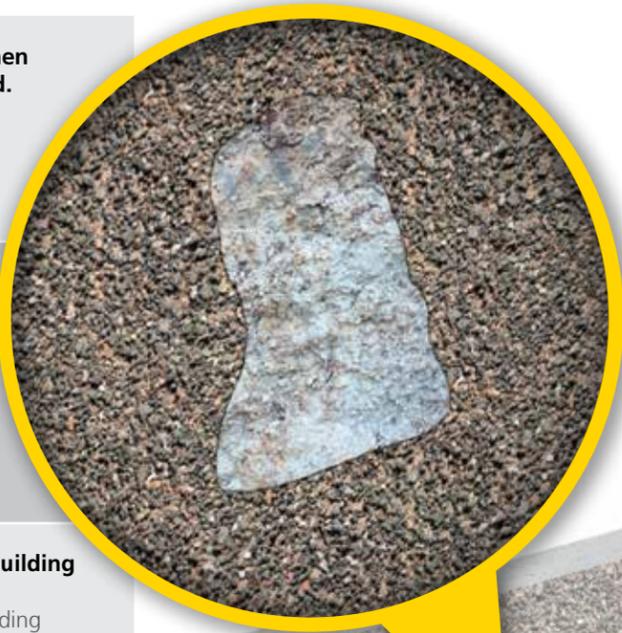
**Damage and deterioration of the concrete may have progressed to the steel reinforcement.**

Signs of rust or spalling are indications of deteriorated rebar. If these are present, A third-party envelope professional should be retained to evaluate conditions and make the necessary repair recommendations.

**1 Pressure wash** the wall to remove dirt and loose finish.

**3 Cover the wall** with StoGuard air and moisture barrier.
