Journal of The Roof Consultants Institute

## *Walking on Roofs:* Safety and Damage Prevention

# Don't Tread On Me

## Guidelines & Helpful Hints for Walking on Roofs

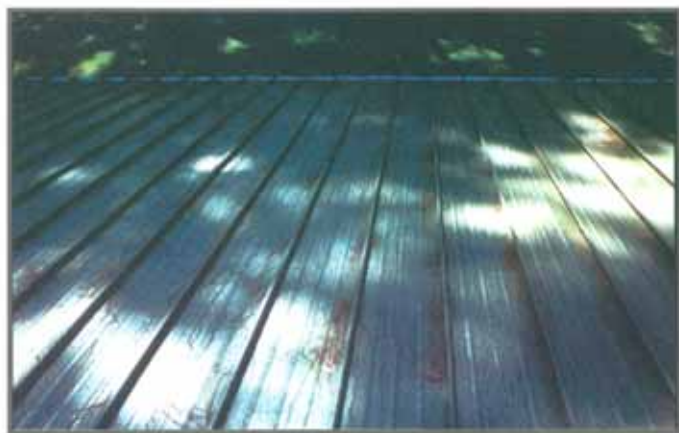
Early morning dew and pine needles on metal panel roof system.

The occurrence of dew and/or frost early in the day can create similar hazards as those caused by inclement weather.

Other naturally-occurring events that can create dangerous conditions include the accumulation of pine needles and/or leaves on the roof surface. These items, combined with surface moisture, will most likely create an extremely slick surface or conceal a potential hazard. Saps and other types of oily emissions from trees or other vegetation which may overhang a roof area, can also create slickness on a smooth roof surface by itself or combined with surface moisture. Ponding or standing water on roof surfaces due to inadequate drainage will often lead to silt deposits and/or result in the promotion of algae growth within the area subjected to the ponding water. The source of this water can be either weather-related or due to condensation discharge from HVAC equipment on the roof. These conditions can create treacherous footing, even on low-slope roof constructions with smooth surfaces.

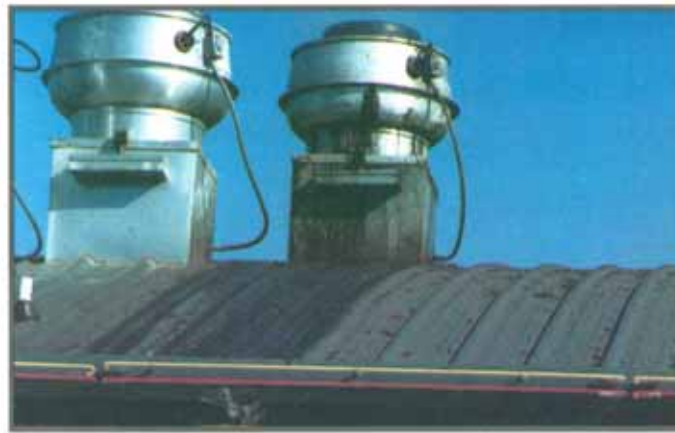
Grease discharged on surface of metal panel roof system.

Manmade emissions and/or contaminants such as grease and/or oil from HVAC equipment, exhaust vents, and facility operations (i.e., jet fuel at airports, grease exhaust vents above restaurants) can become deposited on the roof, consequently creating slippery surfaces for smooth-surfaced roof coverings. Other manmade types of elements such as sawdust and metal shavings (both commonly created during the construction/installation of the roof) can also create difficulties when accessing a roof.

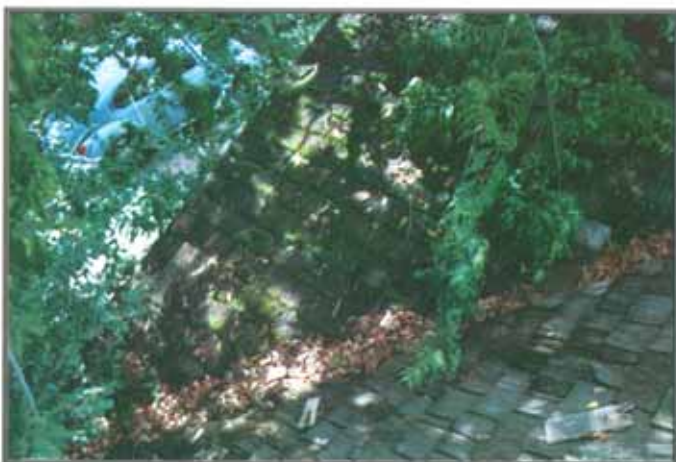
*Moss growth on wood shingle roof covering.*

algae/moss growth on the surface of the shingle, particularly in shaded areas of the roof. Algae/moss growth on the surface of wood shingles fosters problematic conditions that can prevent adequate foot hold. In addition, the ridge cap shingles are typically the least supported of the shingles due to the nature of the installation and are often thinner sections of wood. Therefore, walking on the ridge of a wood shingle roof covering should be avoided to prevent resultant damage.

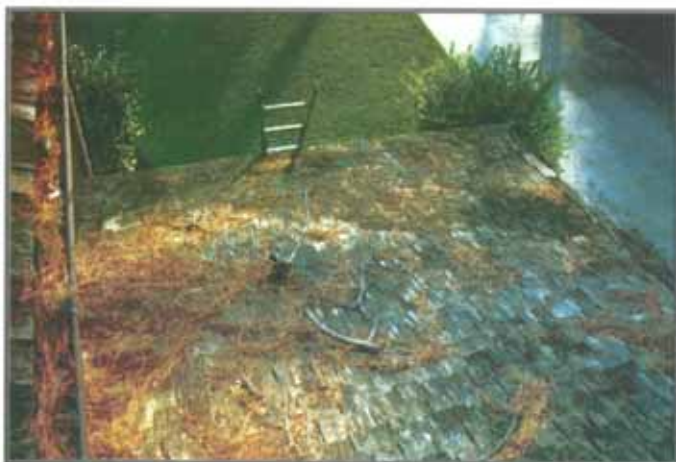
*Pine needle accumulation on wood shingle roof covering.*

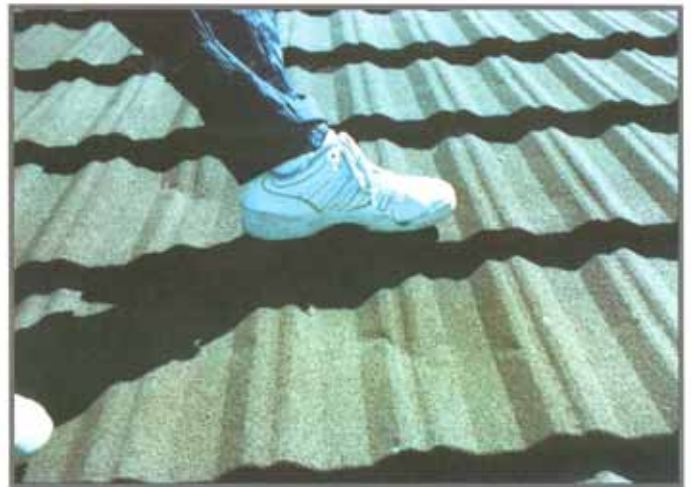
*Proper foot position on metal tile panels.*

installed over wood battens and joined to each other by snap-lock types of seams at the ends and sides. Since the panels are installed over battens, the portion of the panel between the battens is unsupported. Foot pressure applied in the field of the panel can cause permanent depressions. An individual should position footholds on the overlapped portions of the panels that are located over the wood battens. This particular portion of the panel is more resistant to foot impact.

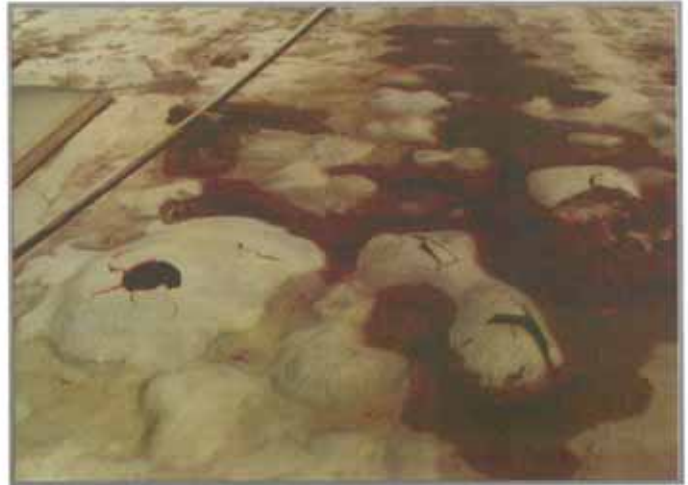
*Blisters in spray-applied polyurethane foam roof system.*

Similar to built-up roof systems, blisters and/or raised delaminated areas can be present in spray-applied polyurethane foam (SPUF) roof coverings. SPUF is installed in either single or multiple layers or lifts. A single lift commonly has an overall thickness of one inch. When a blister or delaminated area occurs, the top layer(s) separate(s) or become detached from the underlying substrate. This delaminated portion and relatively thin section of foam becomes unsupported and can easily be damaged by foot impact.
