## BC-1 & 2 COUPLER REPAIR & REPLACEMENT

IN THE EVENT YOUR ROASTER BEGINS TO MAKE A CLICKING NOISE FROM BACK AREA NEAR MOTOR YOU MAY NEED TO REPAIR OR REPLACE THE DIRECT DRIVE COUPLER. HERE ARE SOME INSTRUCTIONS FOR REPAIR OR REPLACEMENT:

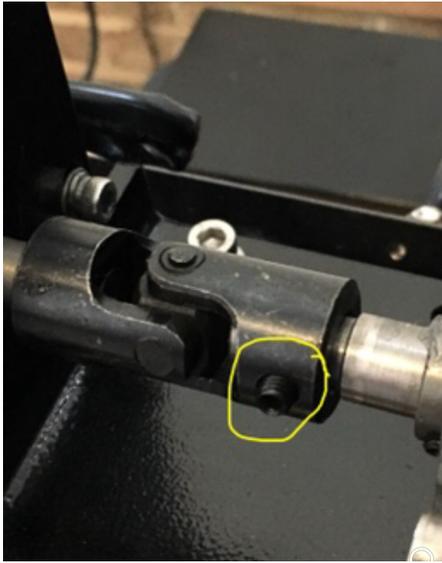
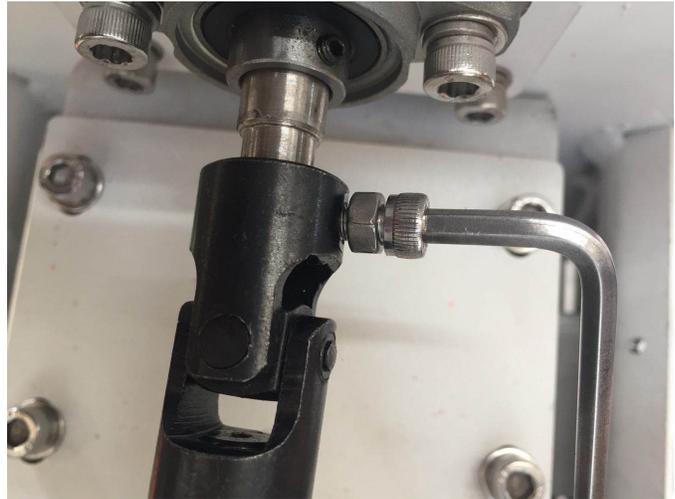
TWO SET SCEWS ON COUPLER:

In the event your roaster either begins to make a ticking noise from back side or the drum has issues not turning properly it may mean the set screws on the Motor shaft coupler have come loose. You can remove drum housing cover and tighten but it may be best to replace set screws with heavy-duty bolts:

Can be replaced with Heavy-Duty bolts with locking Nut. You can also grease coupler at joint

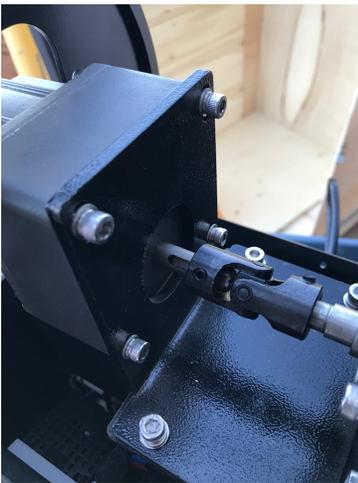
If you need to replace coupler you will need to loosen motor from motor mount and loosen the bolts or set screws on coupler to remove it:

Loosen the 4 bolts that hold motor to mount and loosen couple set screws or bolts then remove motor and replace coupler. Next reassemble

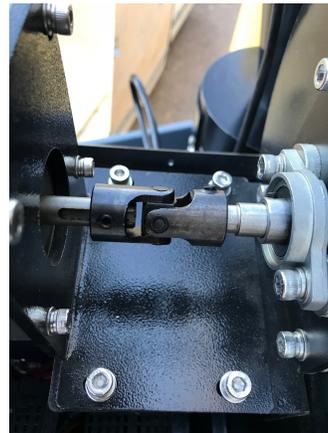
If you need to replace aback bearing this would be a good time to do that as well.

You can replace back bearing by removing motor & coupler. You may need a bearing puller tool.
