United States v. Brace et al., 17-cv-06, W.D. Pa.
Expert Report: Ecological Functions and Connections
of Wetlands and Waters at the Marsh Site,
Waterford, Erie County, Pennsylvania

Prepared for:
U.S. Department of Justice

Prepared by:
Robert P. Brooks, Ph.D.
Brooks Consulting
61 Aloha St.
Port Matilda, PA 16870
rpbrooks2@gmail.com, 814-880-7607

18 December 2017

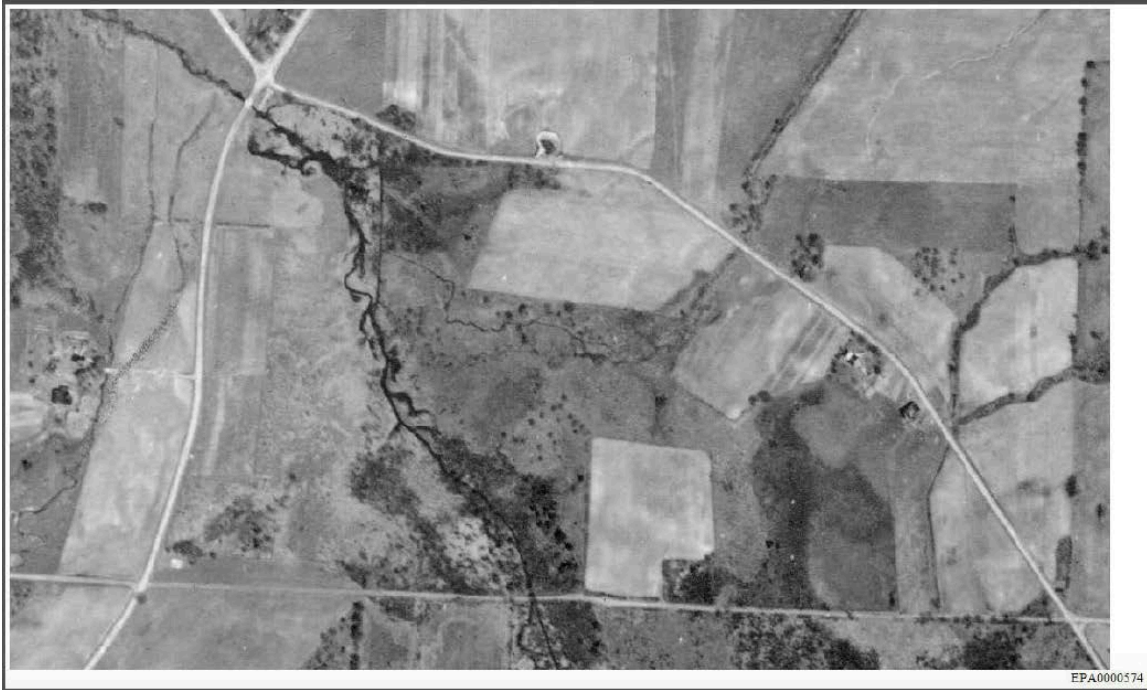
Figure 3. 1939 aerial photograph of the Marsh Site (B&W; obtained from DOJ).

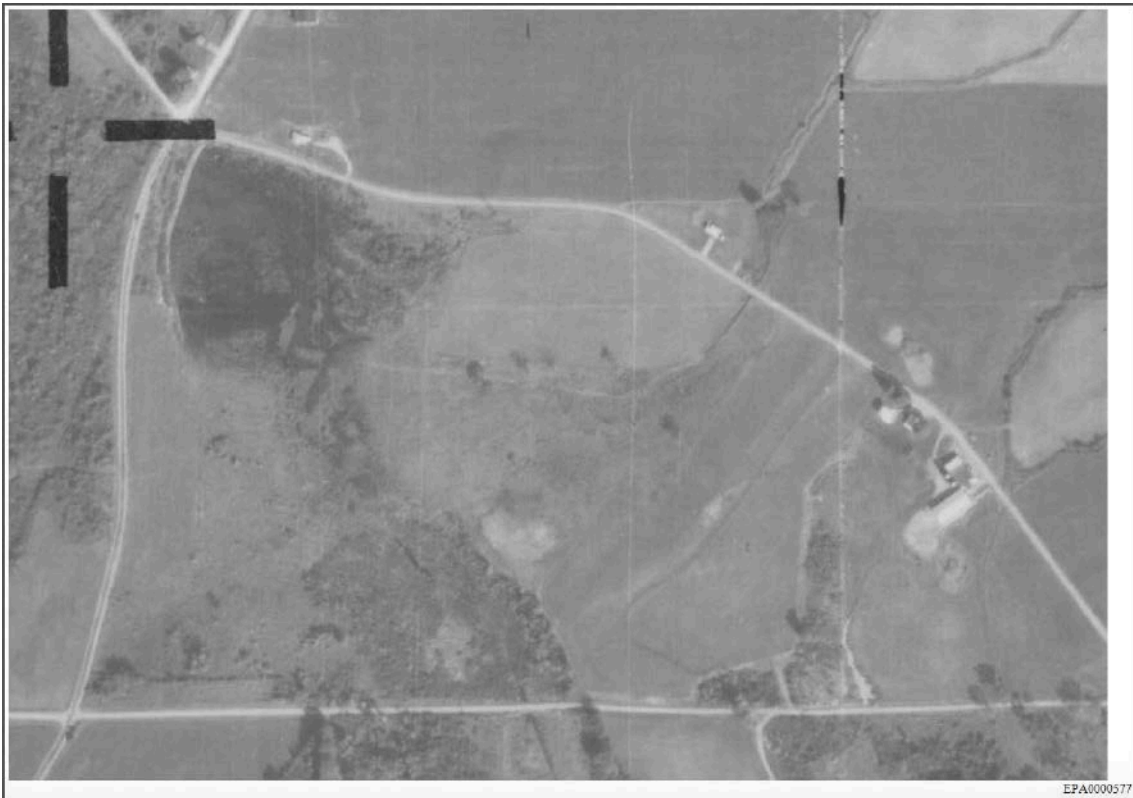
Figure 4. 1968 aerial photograph of the Marsh Site (B&W, obtained from DOJ).

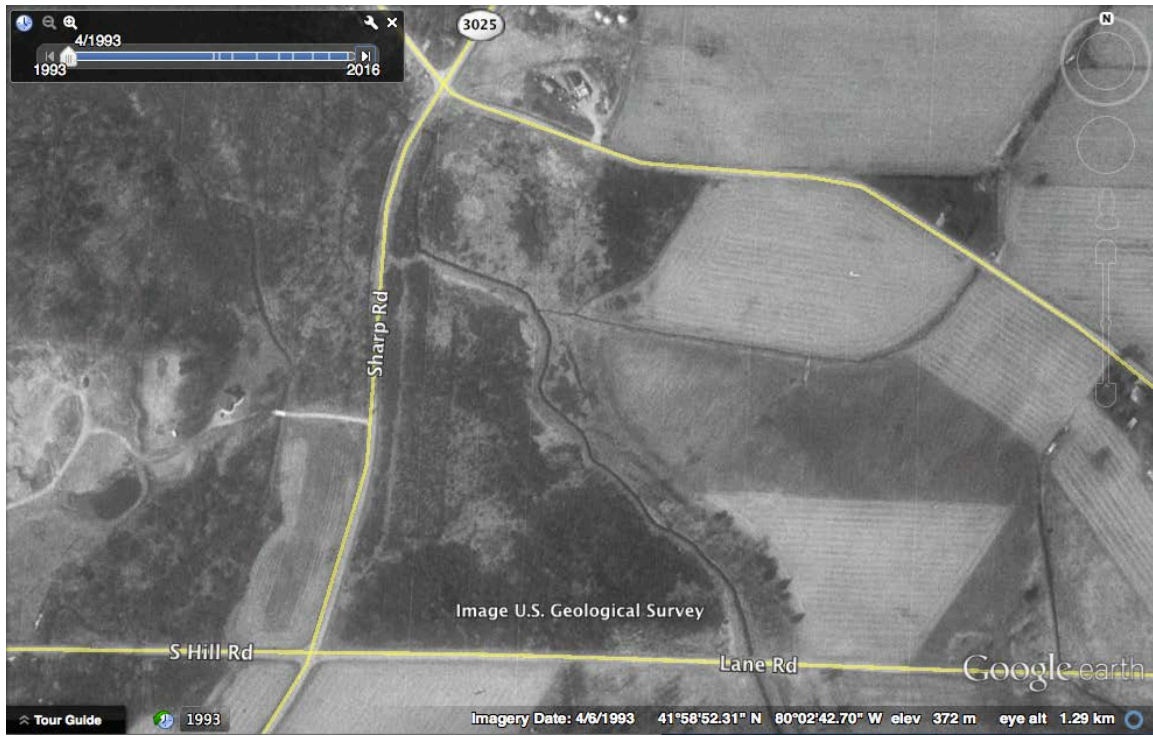
Figure 5. 1993 aerial photography of the Marsh Site (B&W; Google Earth).

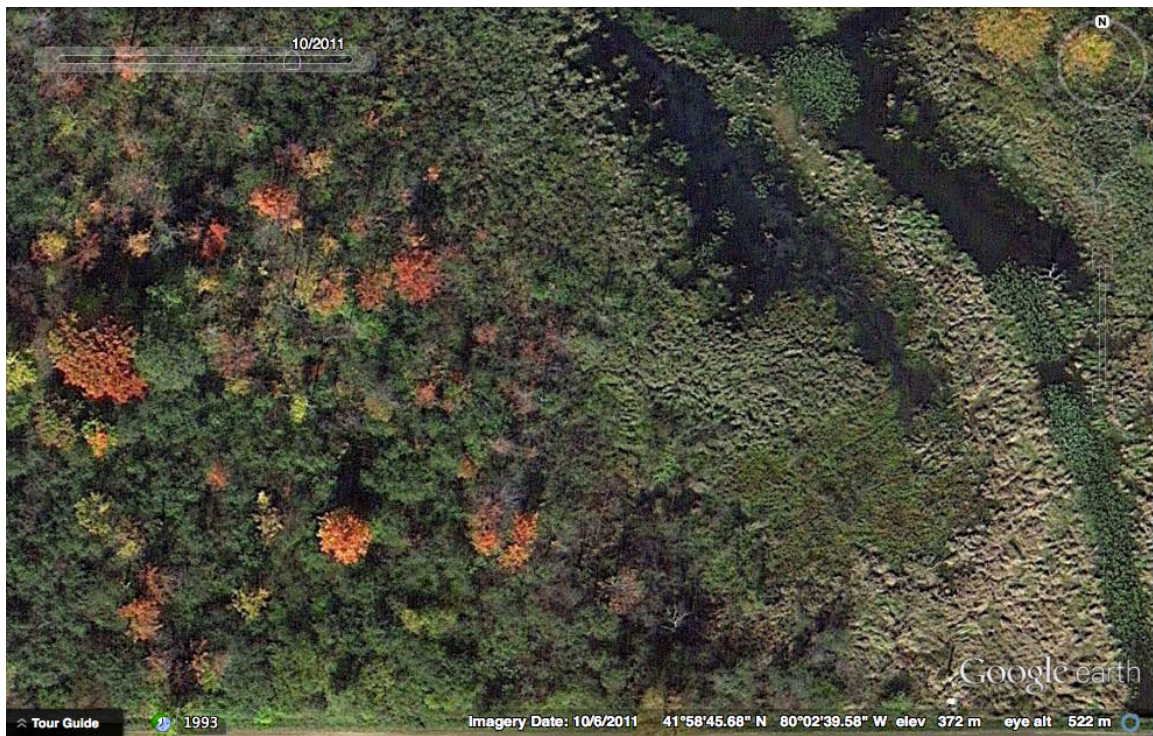
Figure 8. 2011 aerial photograph – close-up of southeast corner of the Marsh Site (Google Earth).

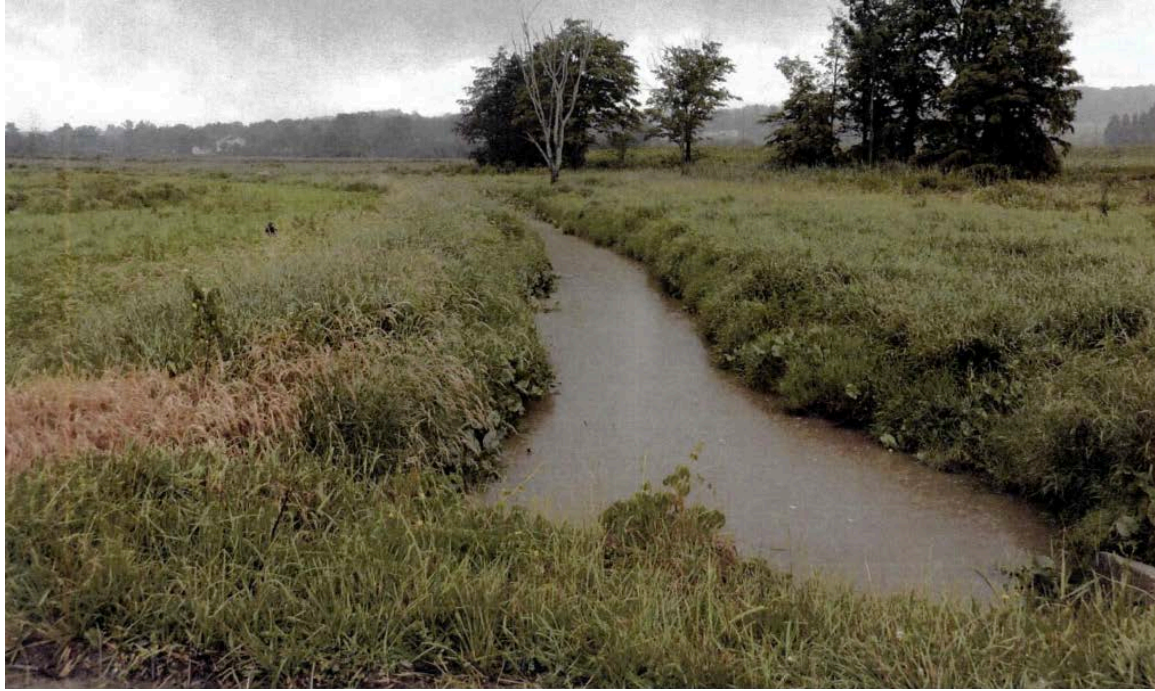
During the June 2013 inspection, new growth of hydrophytic vegetation was observed in portions of the site previously disturbed (Figures 15, Lane Road bridge). Based on the wetland delineation data sheets from three samples points, all located on the Marsh Site, hydrophytic plants were dominant, and soils showed hydric characteristics (i.e., chroma of 1 or 2, gleyed matrix, mottles). Surface hydrology was observed, so evidence of all three wetland parameters was present, indicating the presence of wetlands on the Marsh Site. Their Sample Point #1 was located near my Sample Point #6. Their other two points were located in the middle area of the Marsh Site. Heavy rains made obtaining additional soil samples difficult, and obscured some of the natural surface hydrology. A site inspection report from the same visit prepared by Scott Dudzic of the Pennsylvania Department of Environmental Protection (PADEP) dated 27 June 2013 described similar findings.

Figure 15. June 2013 photograph from Marsh Site inspection by EPA; Elk Creek from Lane Road looking downstream (north) showing recovering herbaceous vegetation after soil disturbance in 2012, and channelized reach of Elk Creek.

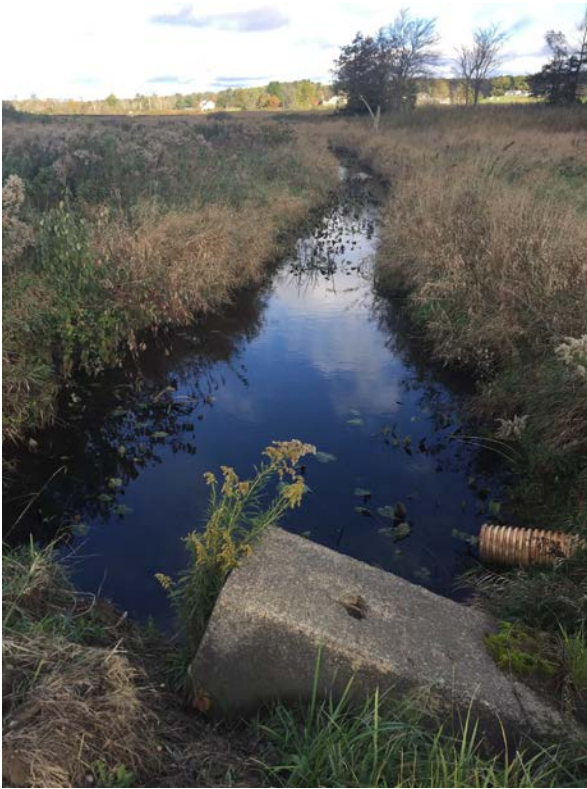
Figure 16. October 2017 photograph from Marsh Site inspection by Brooks; Elk Creek from Lane Road looking downstream (north) showing recovering herbaceous vegetation after soil disturbance in 2012, and channelized reach of Elk Creek.

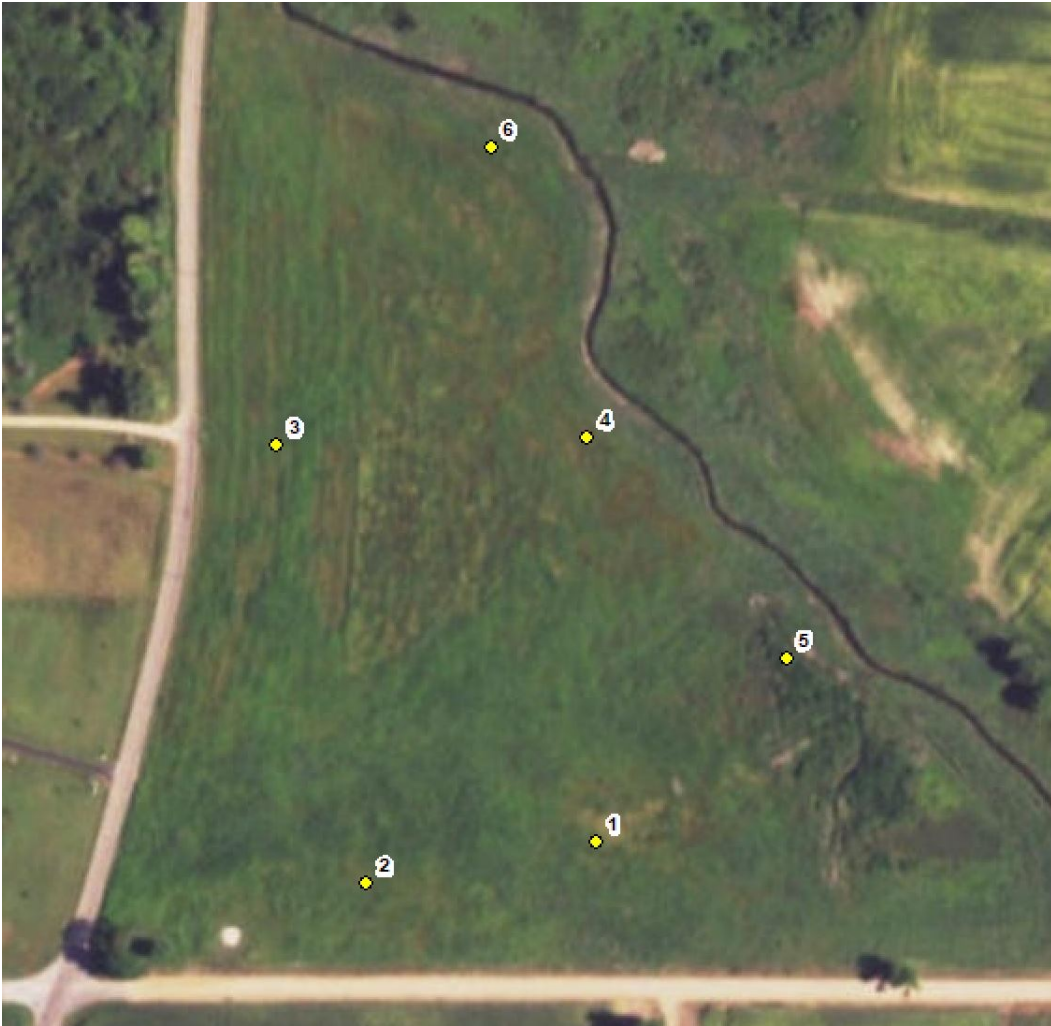
On 16 October 2017, I chose and sampled the ecological characteristics of six points on the Marsh Site (Figures 2 & 17). The objective was to collect sufficient data to reach an independent opinion about the occurrence of wetlands on the Marsh Site and their connectivity to Elk Creek at the current time (October 2017), which is defined as *post-disturbance* (after the major land and water alterations by Brace in 2012). I also was tasked to consider the extent and condition of wetlands on the Marsh Site before the 2012 alterations; defined as *pre-disturbance*.

Sample Point #1 (Figure 17) – Located at (approx. lat-long: 41.9793548, -80.0456344), which is at the visual intersection of the gas well tank on Lane Road to the south, and the end of the tree row along the east side of Elk Creek downstream of the culvert on Lane Road. I chose this point because it was located upslope of the patch of alder shrubs in the southeast corner of the Marsh Site. The alder patch, later sampled as Sample Point #5, appeared to be quite wet, so I wanted to know the conditions upslope.

Figure 17. Approximate locations of six Sample Points for wetland identification protocol superimposed on a 2015 image of the Marsh Site from ESRI (Brooks Oct 2017).

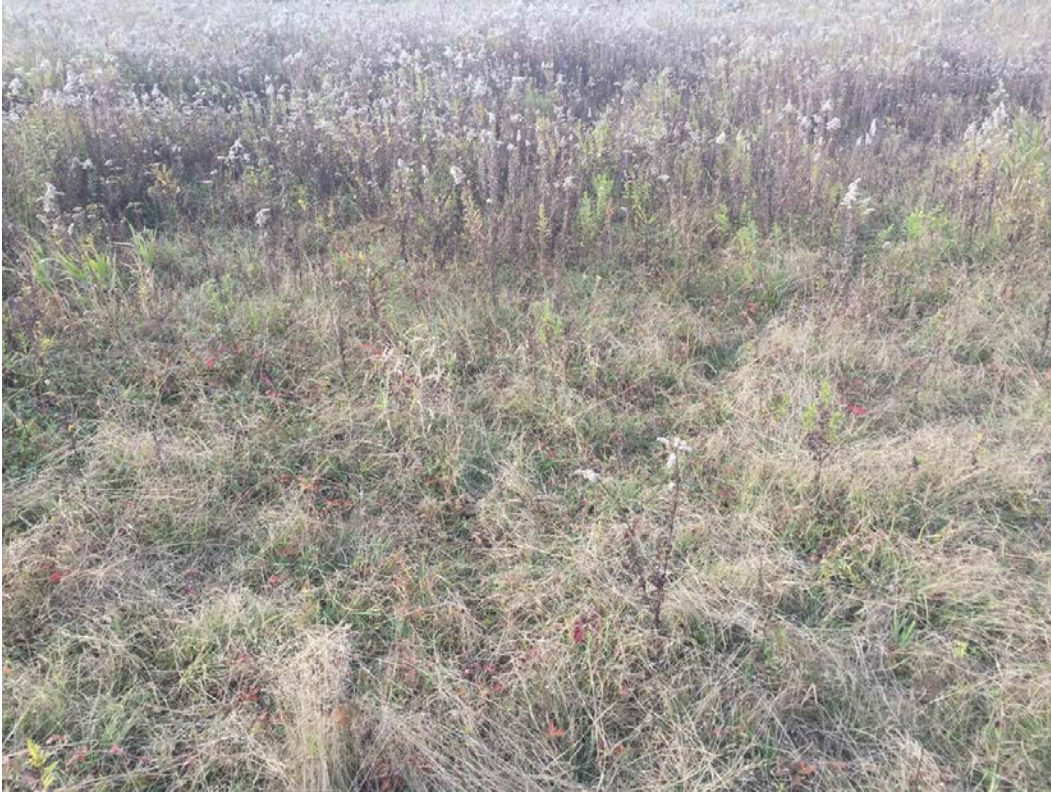
Figure 21. Vegetation for Sample #1 (looking west) (see text for description).

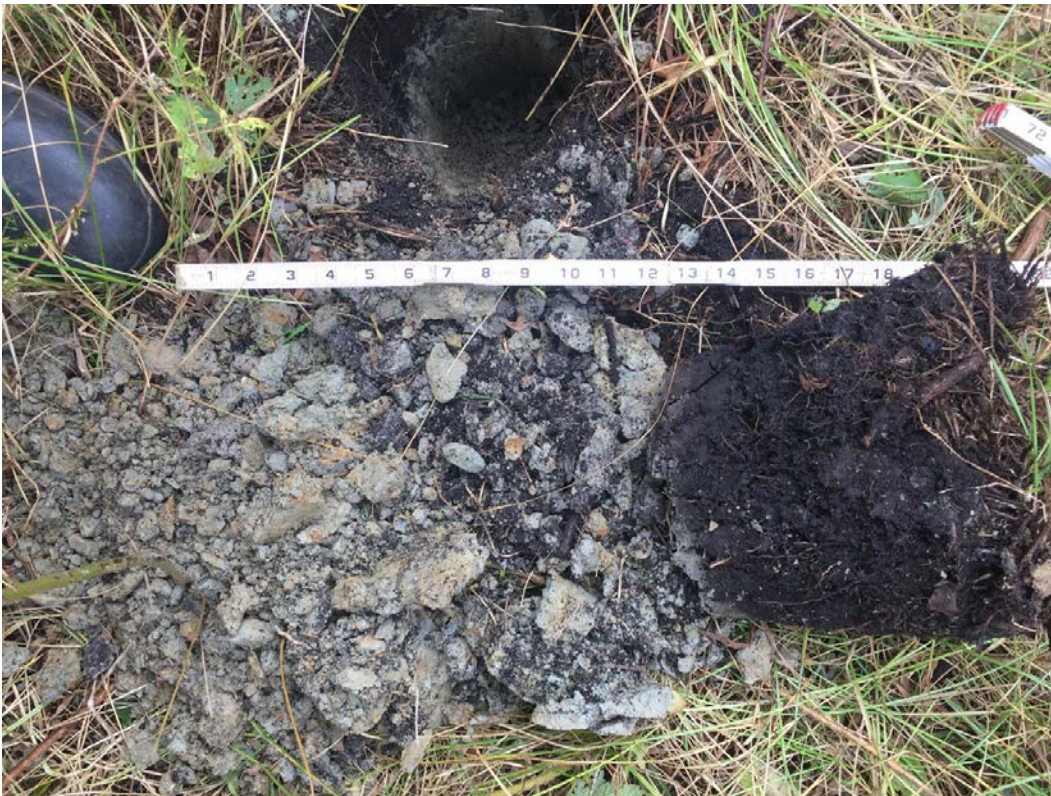
Figure 22. Marsh Site Sample #2 soil pit and profile (see text for description).

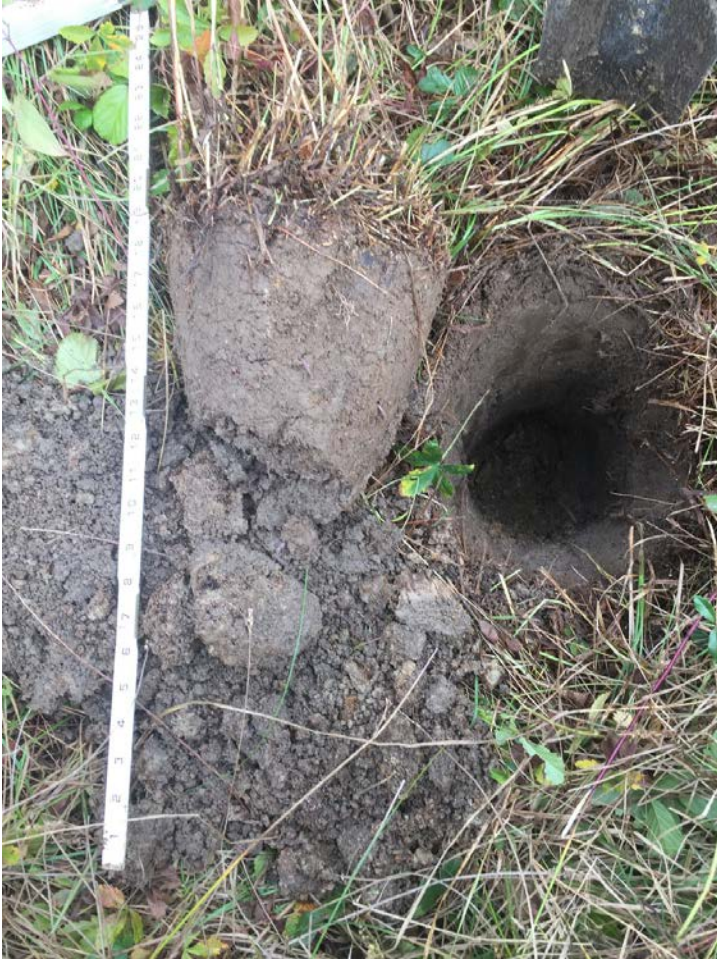
Sample Point #3 – Located at (41.9806992, -80.0470911) in a level area about 200 feet off Sharp Road. According to the Erie County Soil Survey, this point is located near the transition between Canandaigua mucky silt loam, which is listed as a strongly hydric soil in this county, and Red Hook silt loam (along Sharp Road), which is listed as a non-hydric soil (Figures 17 & 18). The soil pit suggested this is a transition area, with 5YR5/1 matrix from 0-10 inches, and mottles occupying 10% with a color of 75YR5/6. Oxidized rhizospheres were observed (and photographed, Figure 25) in the upper 9-10 inches. The soil texture was not gritty, and produced a ribbon of 1.5 inches, indicating this is a silty clay loam. From 10-18 inches the matrix color was a mixture of 10YR6/2 and 10YR4/4, with small areas (2%) of mottles of 5YR4/4 presenting redoximorphic features (Figure 24 & 25).

Figure 24. Marsh Site Sample #3 soil pit and profile, (see text for description).

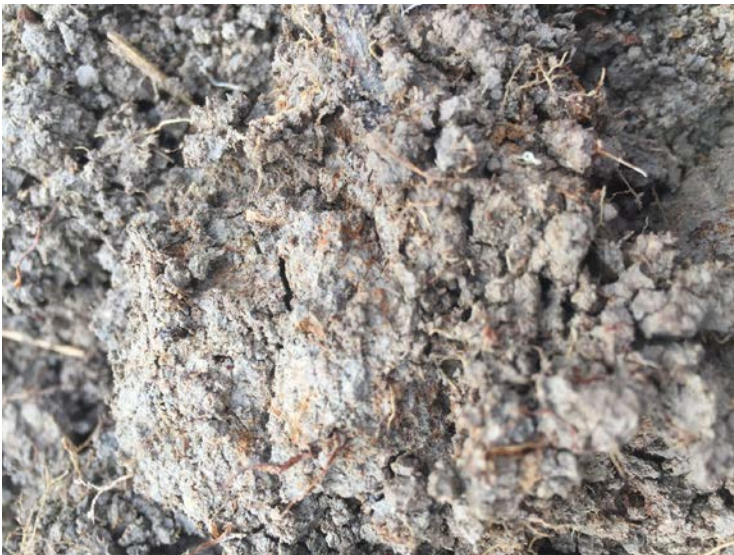
Figure 25. Marsh Site Sample #3 oxidized rhizospheres, 9-10 inches depth (see text for description).

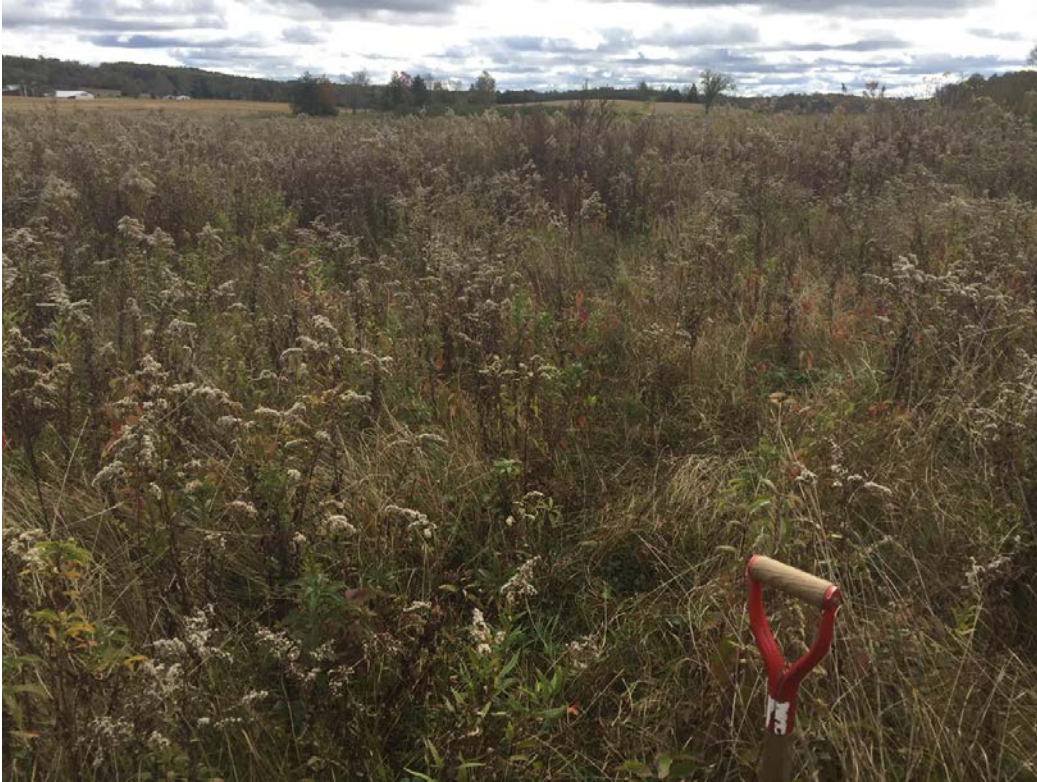
Figure 26. Marsh Site Sample #3 vegetation (looking east) (see text for description).

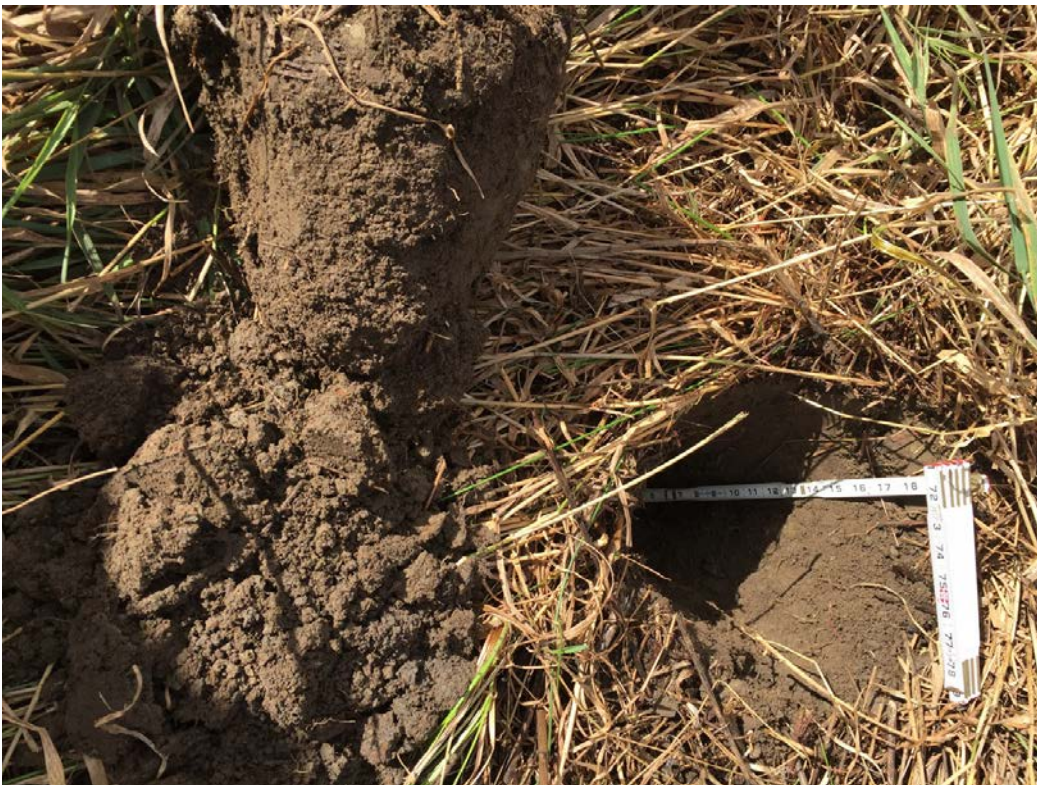
Figure 27. Marsh Site Sample #4 soil pit and profile (see text for description).

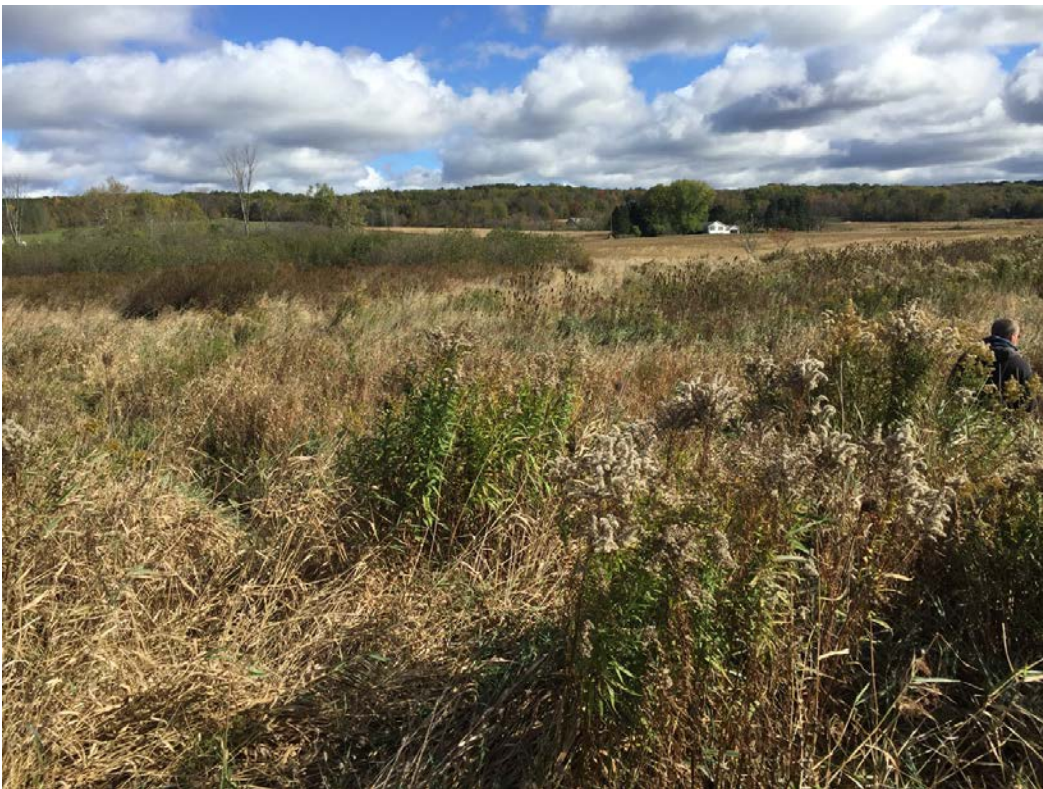
Figure. 29. View of Marsh Site looking east over Elk Creek near Sample Site #4.

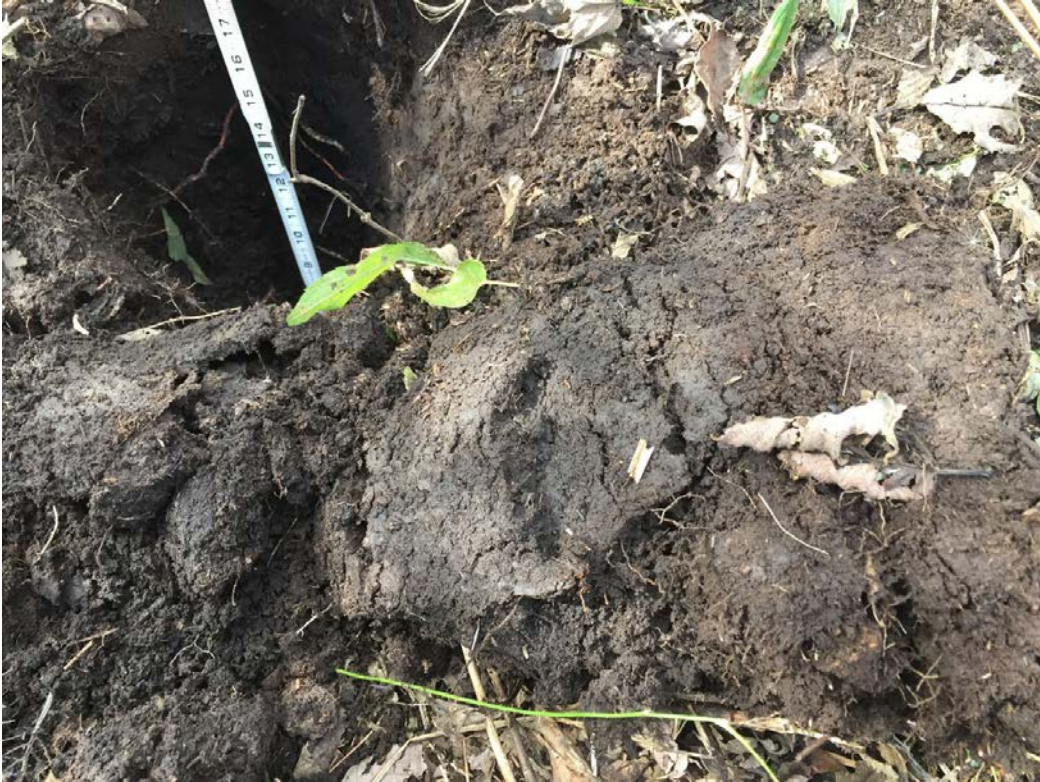
Figure 30. Marsh Site Sample #5 soil pit and profile (see text for description).

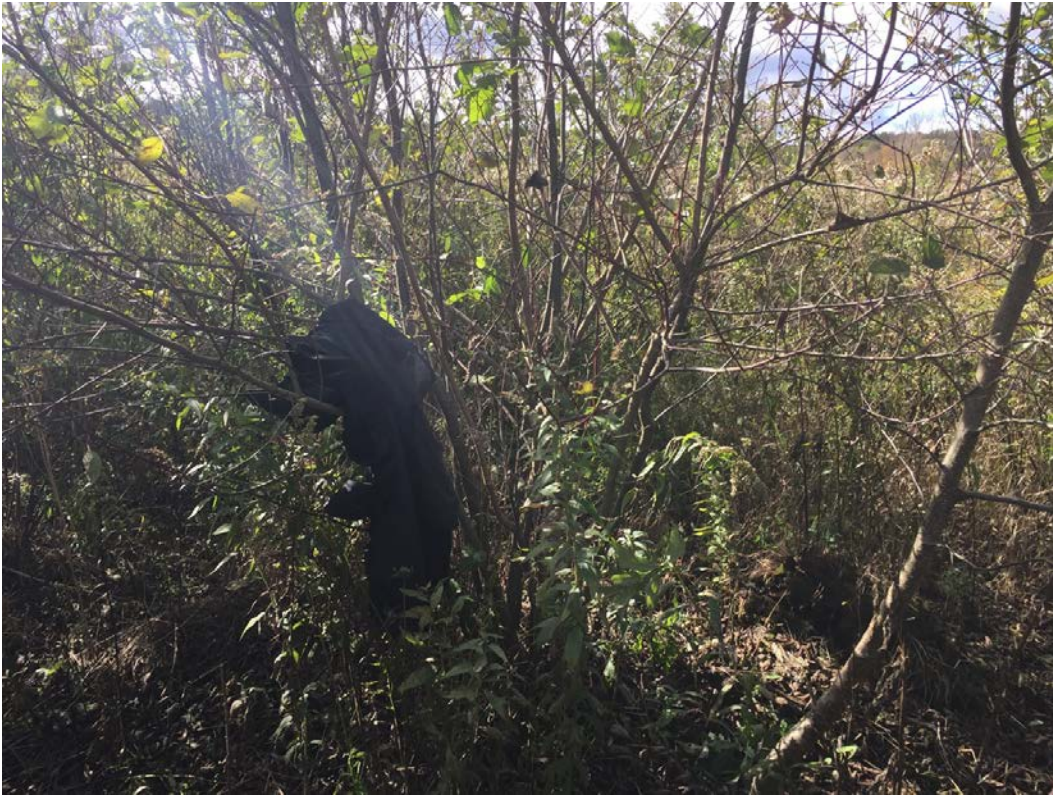
Figure 32. Marsh Site Sample #5 speckled alder shrubs typical of patch near Elk Creek.

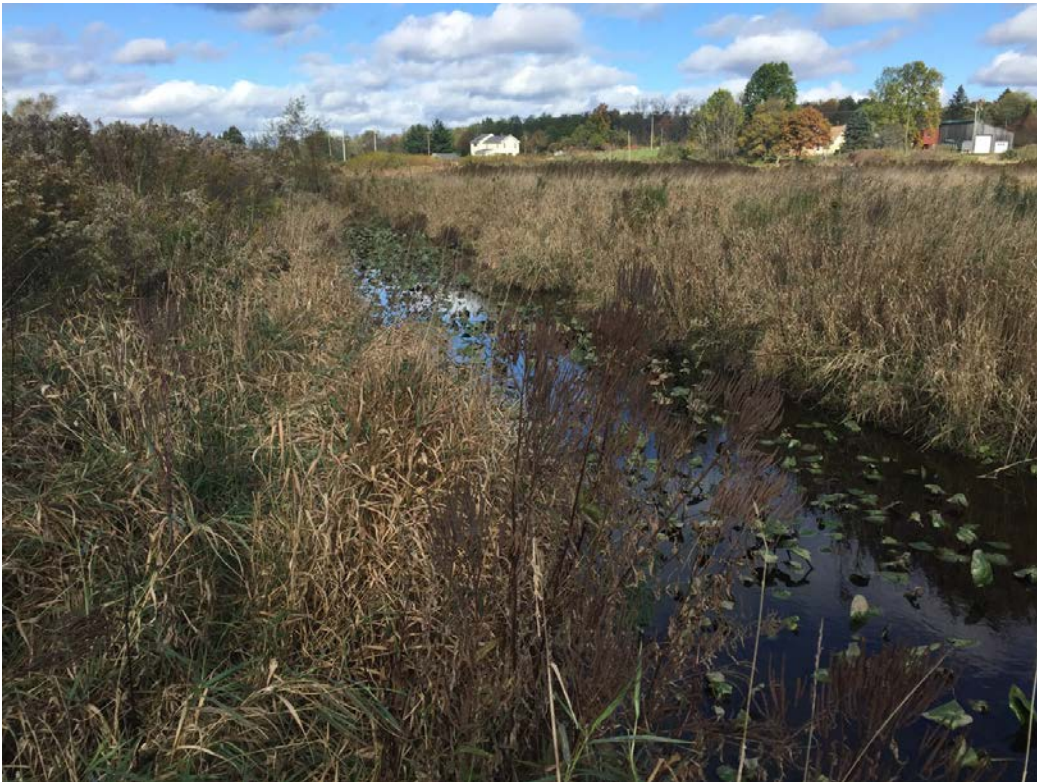
Figure 33. Elk Creek on Marsh Site near Sample #5 showing wetland and aquatic vegetation.

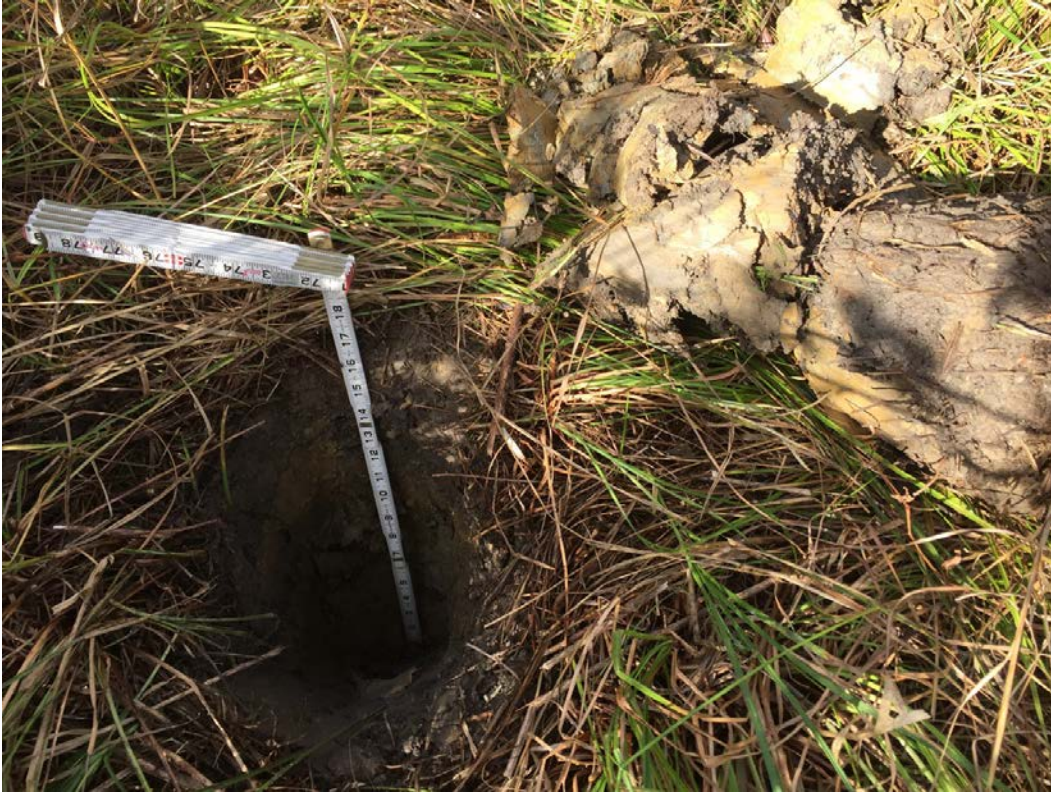
Figure 34. Marsh Site Sample #6 soil pit and profile (see text for description).

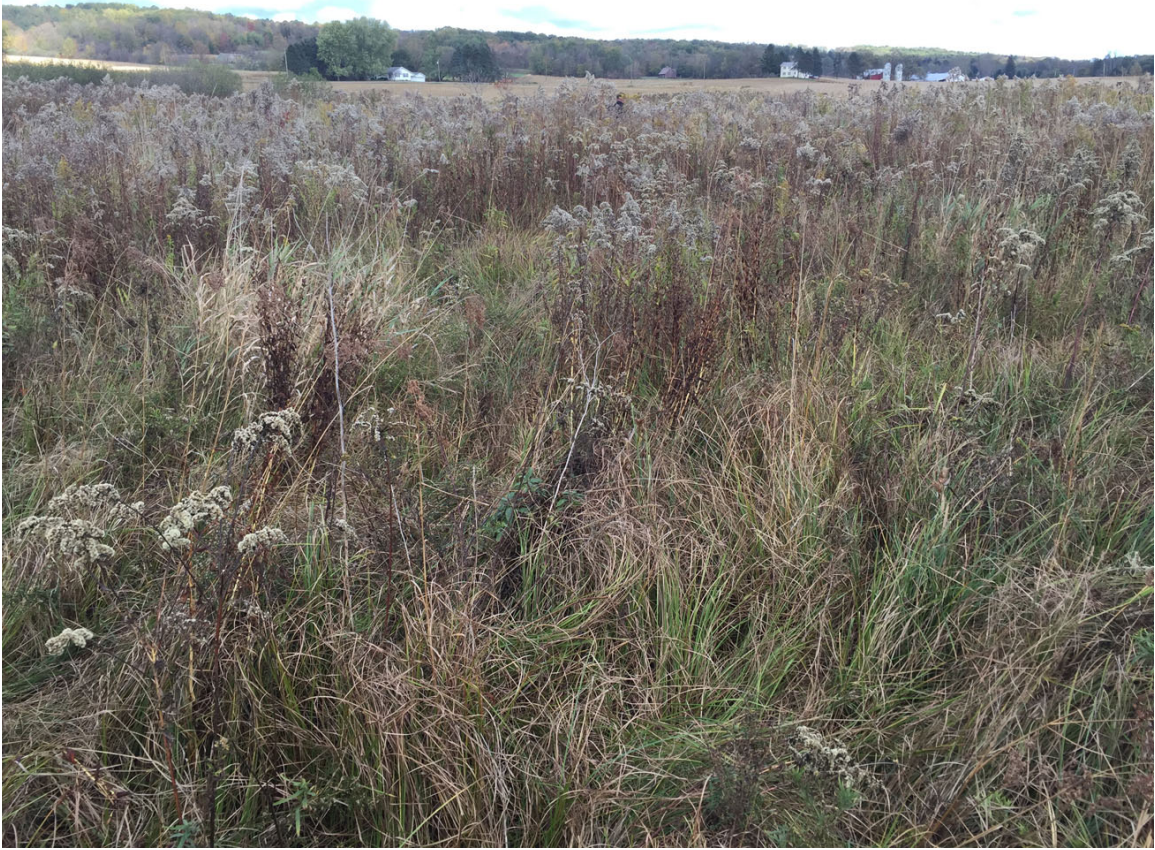
Figure 36. Marsh Site Sample Point #6 vegetation dominated by wetland plant species.

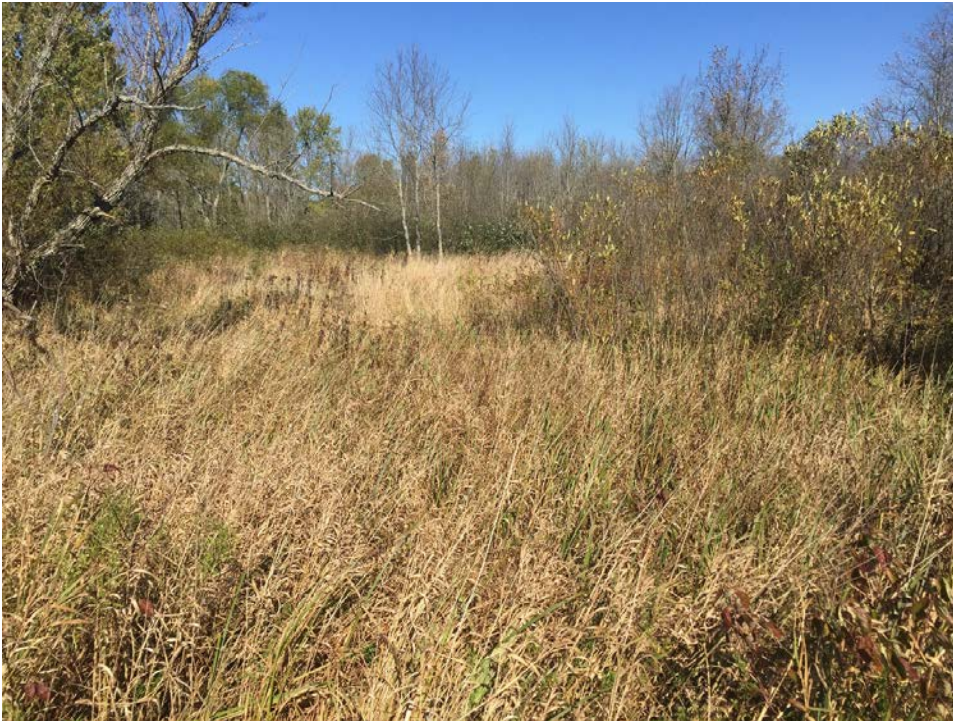
Figure 39. Sample #7 – Reference wetland State Game Lands 109 vegetation.

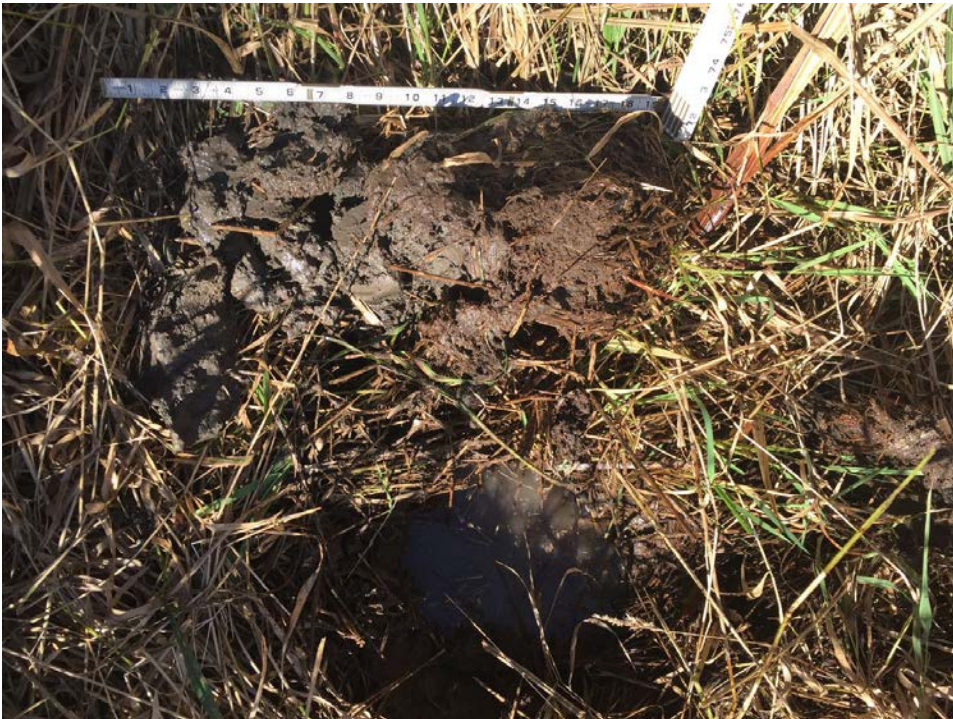
Figure 40. Sample #7 – Reference wetland State Game Lands 109 soil pit and profile.

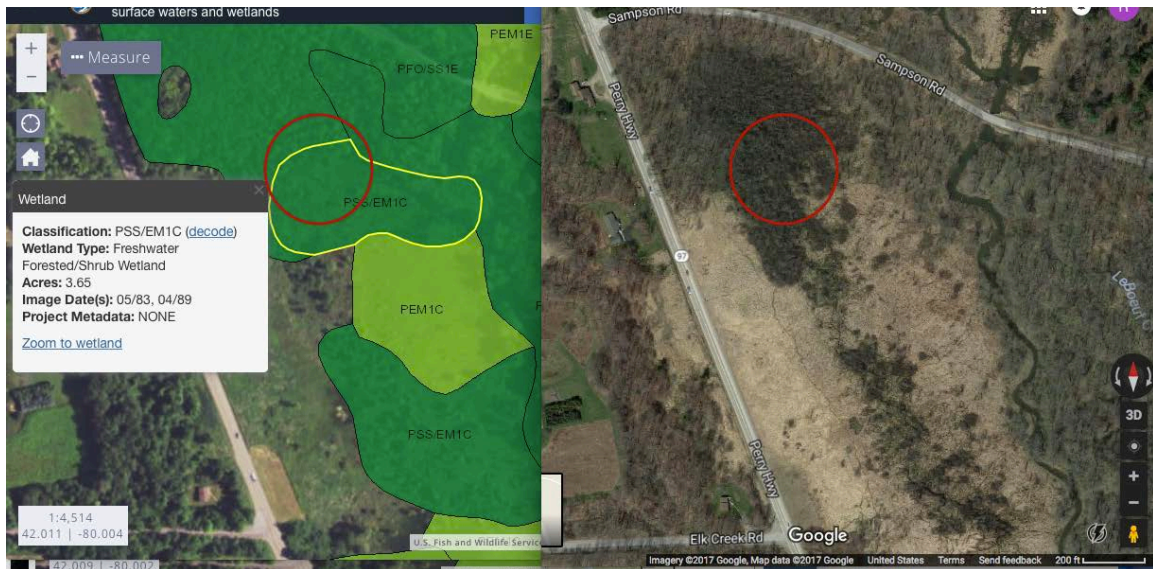
Figure 41. Sample #8 – Reference wetland State Game Lands 109 off Sampson Road, National Wetland Inventory (left) and Google Earth image (right) (see text for description).

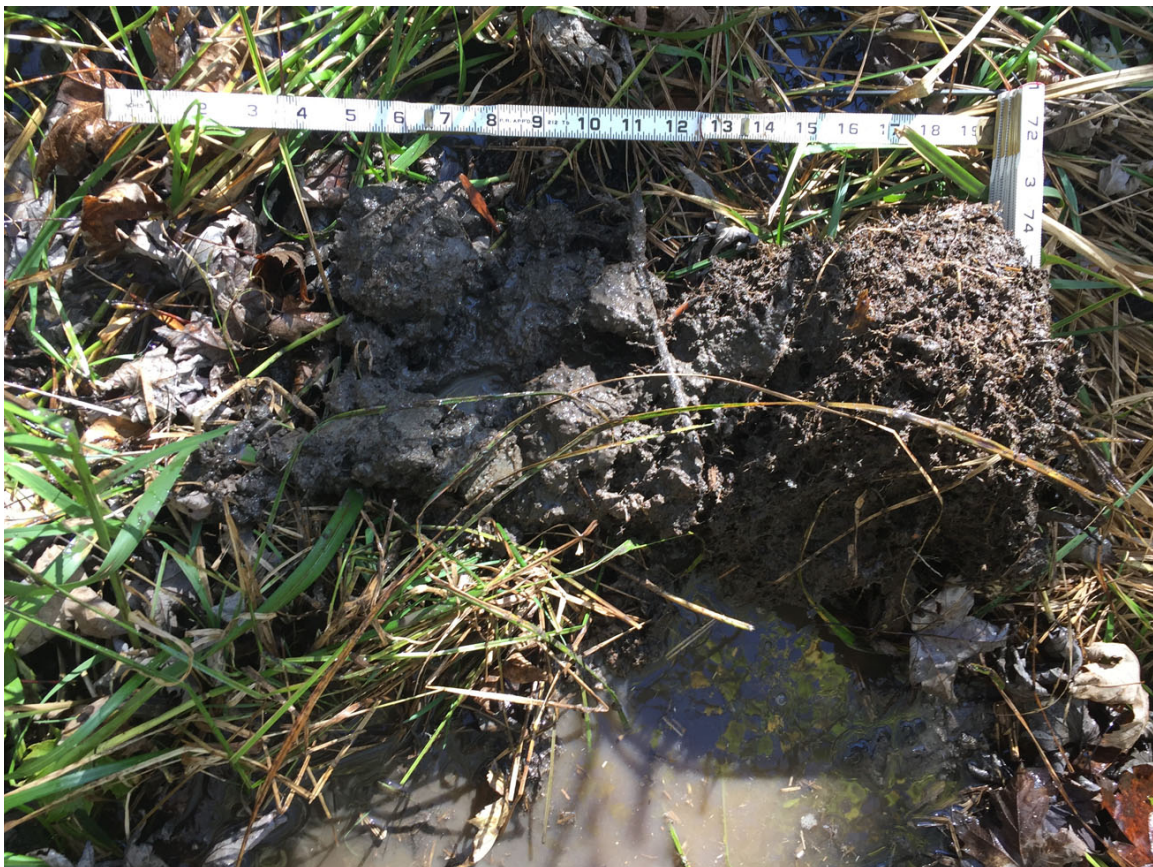
Figure 42. Sample #8 – Reference wetland State Game Lands 109 off Sampson Road soil pit and Profile (see text for description).

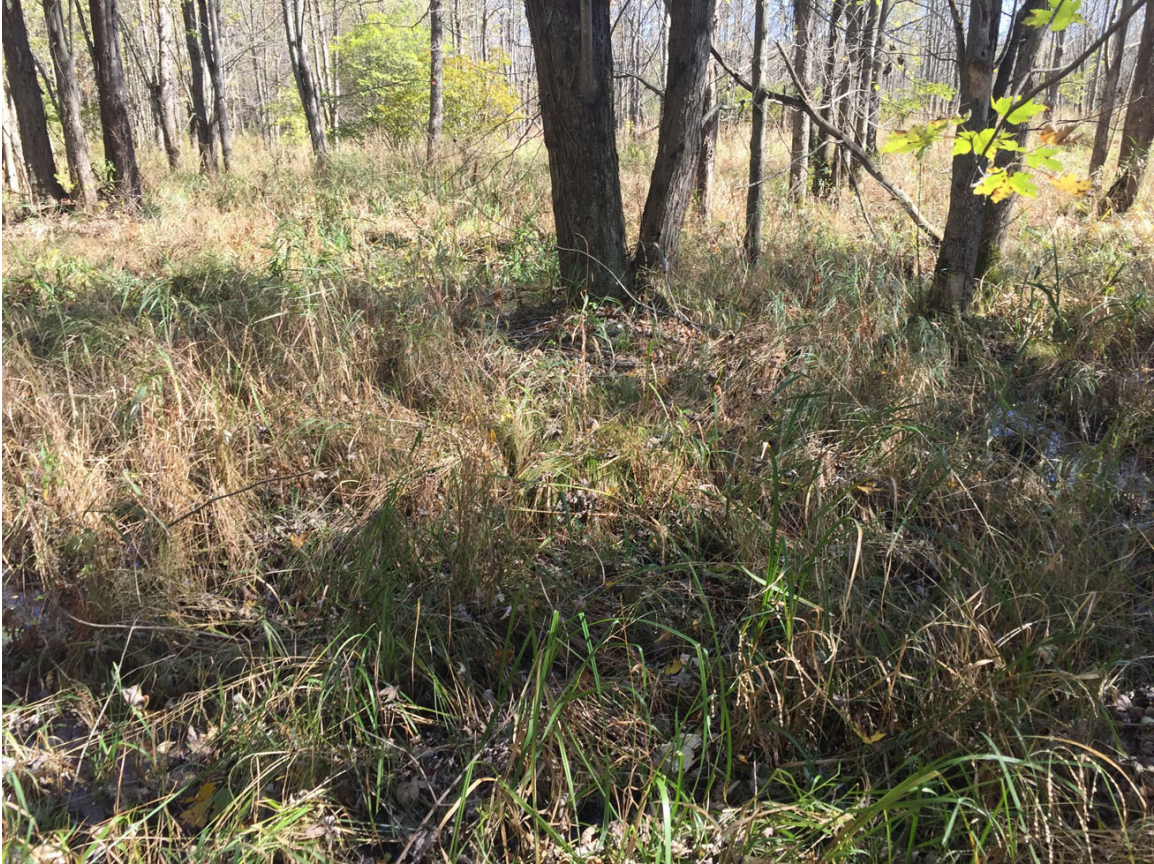
Figure 43. Sample #8 – Reference wetland State Game Lands 109 off Sampson Road vegetation (see text for description).

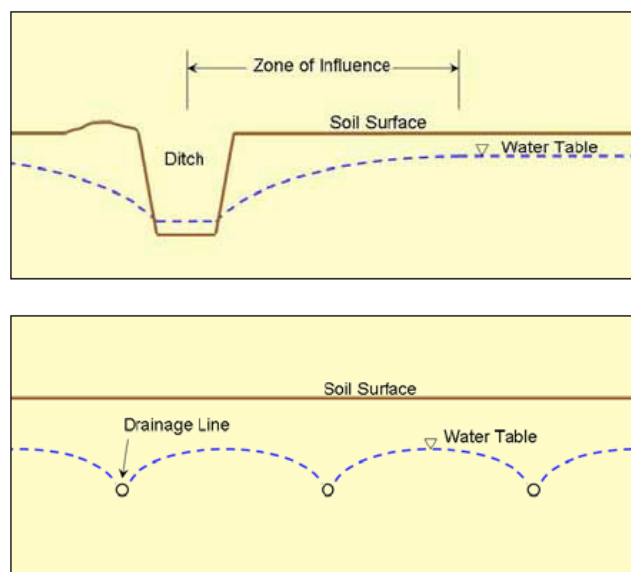
Figure 62. Effects of ditches (upper) and parallel subsurface drainage lines (lower) on the water table.

Figure 48. Illustration of impacts on wetlands hydrology by ditches and tile drains (from Corps 2012).

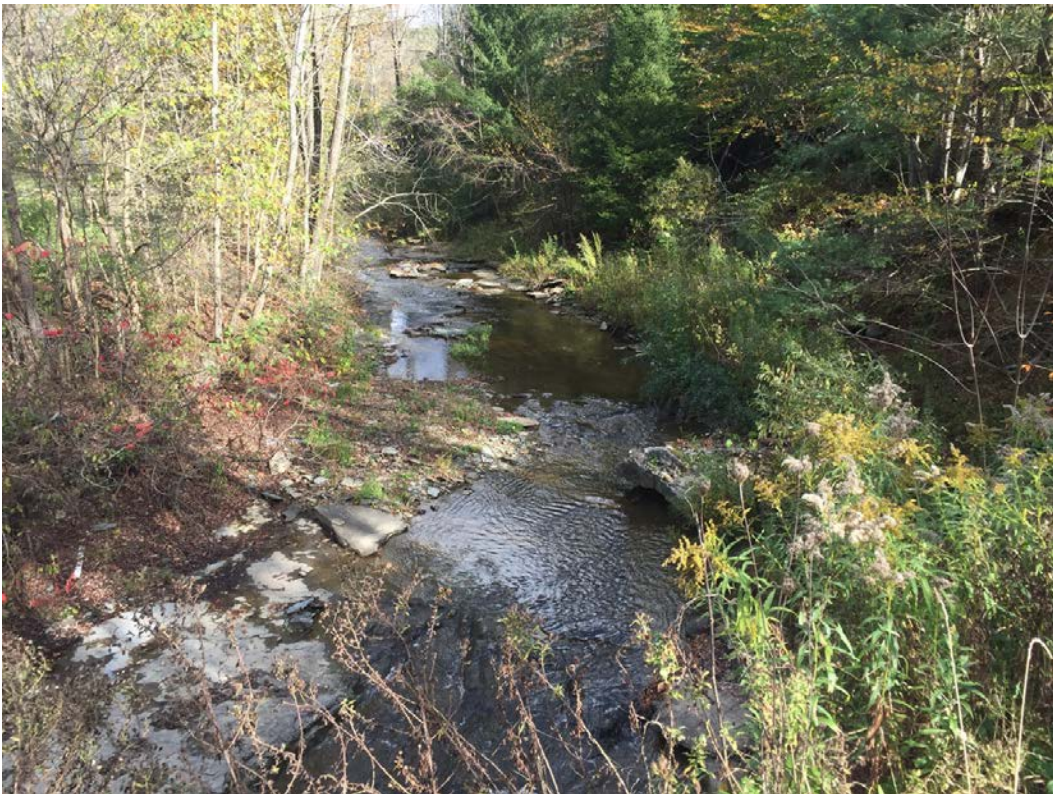
Figure 52. Hamot Road bridge looking upstream; stream bed rocky and relatively steep-sided, more incised than upstream portions of Elk Creek.
