United States v. Brace et al., 17-cv-06, W.D. Pa.
Expert Report: Ecological Functions and Connections
of Wetlands and Waters at the Marsh Site,
Waterford, Erie County, Pennsylvania

Prepared for:
U.S. Department of Justice

Prepared by:
Robert P. Brooks, Ph.D.
Brooks Consulting
61 Aloha St.
Port Matilda, PA 16870
rpbrooks2@gmail.com, 814-880-7607

18 December 2017

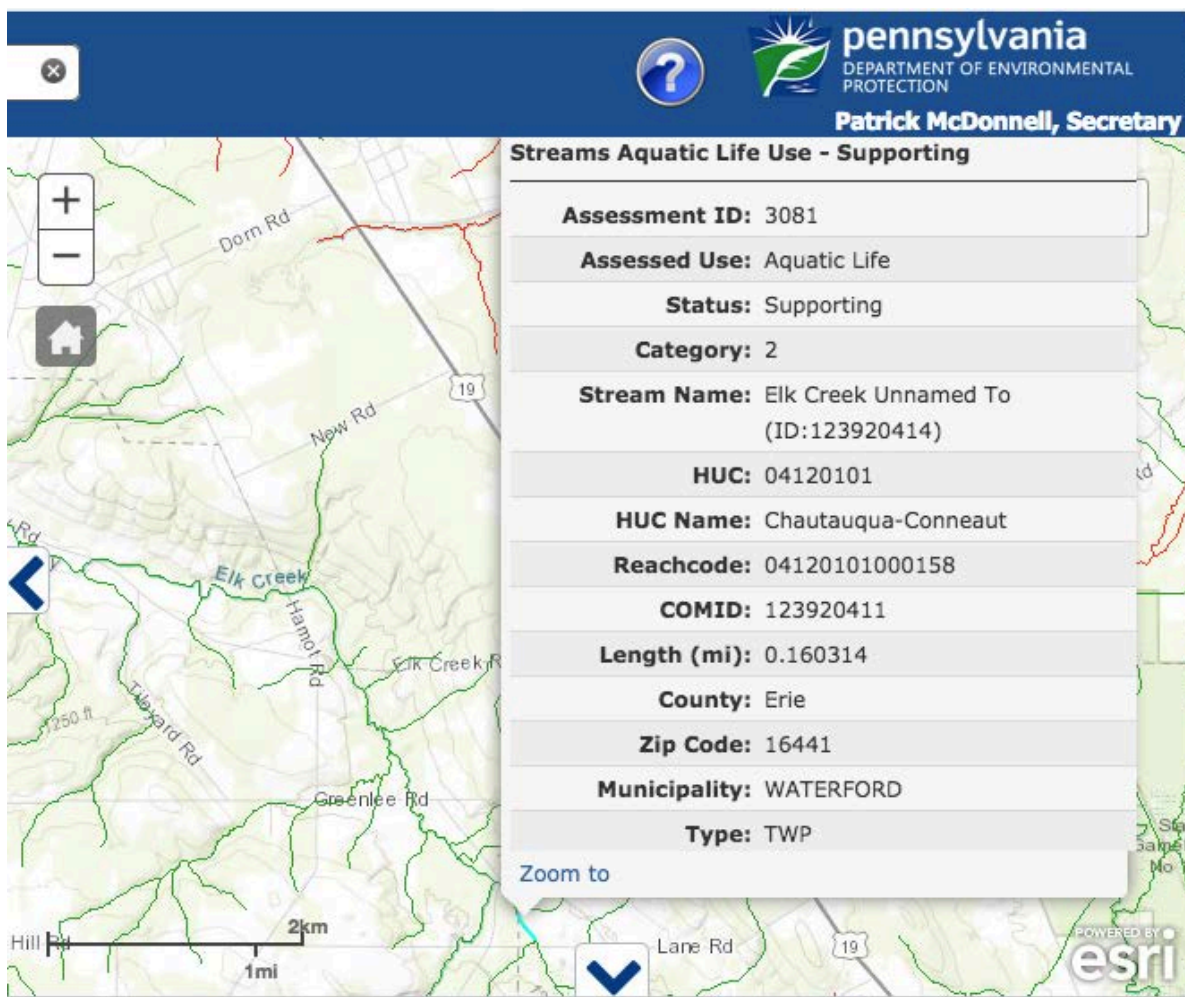
Figure 67. Elk Creek reach along the Marsh Site (see Zoom to arrow above) assessed by PADEP as Supporting Aquatic Life Use for the 2016 Triennial Integrated Water Quality Monitoring and Assessment Report (303(d) list). All streams of Elk Creek watershed appear to be in the same category.

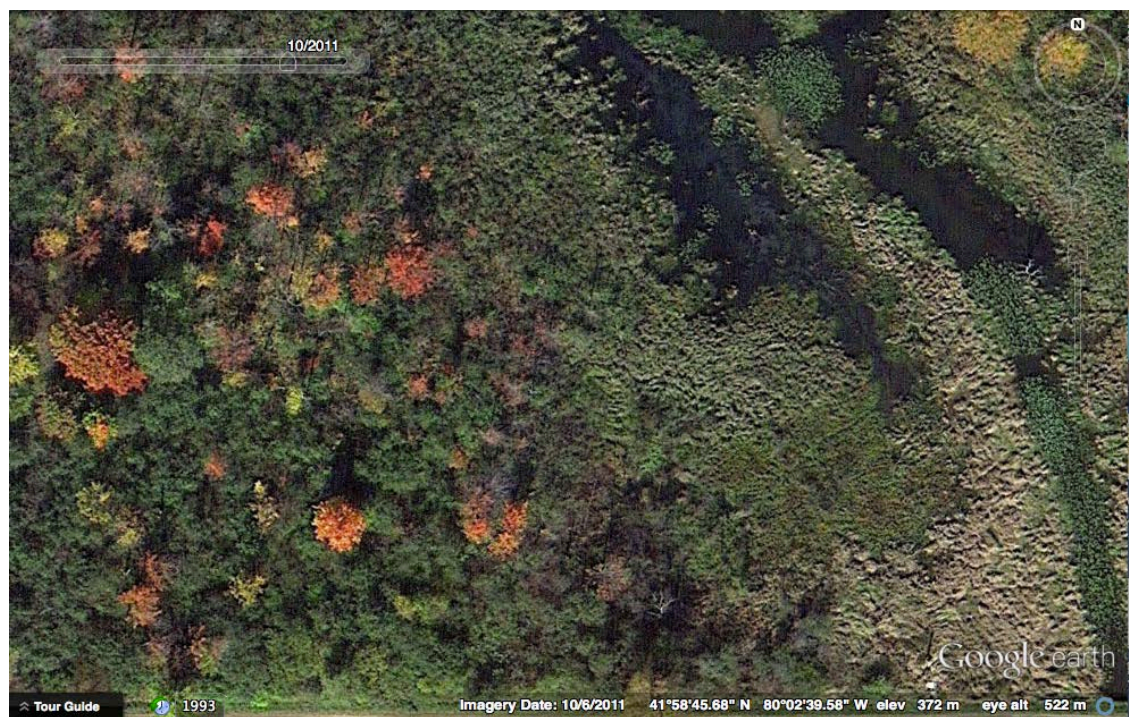
Figure 68. Conceptually, wetland and stream restoration of the Marsh Site should be designed and constructed to reach vegetation communities and hydrologic regimes comparable to the pre-disturbance condition of the site (2011 aerial photograph – close-up of southeast corner of the Marsh Site (Google Earth)).
