Report: moriarty18rabbitrun

Confidential Inspection Report
123 Beach Rd.
Nantucket, MA 02554

Inspection Table of Contents

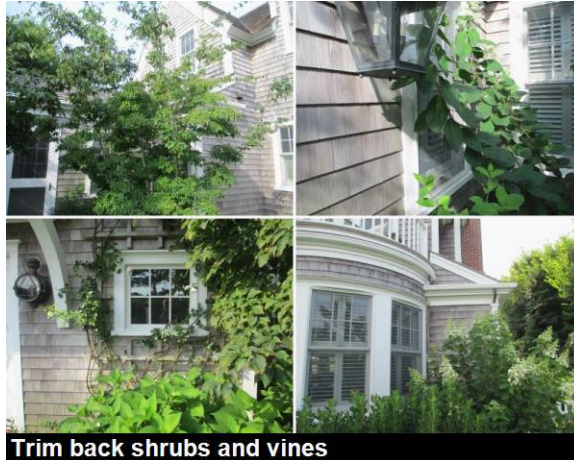
Observation: The exterior of the home or the foundation & / or chimney are partly covered with vines that obstructed access for inspection.

Observation: The shrubs along the perimeter of the foundation are overgrown and are in contact with the home.

Trim back shrubs and vines

Recommendation: I advise that you hire a contractor to remove all vines from the exterior of the building. After removal, all areas that were covered by the vines should be further investigated and repaired as determined. Seek a cost estimate **NOW** in order to determine the impact on your budget.

Recommendation: You should hire a landscaper to prune, remove or replace the shrubbery as required to provide a working clearance (24") between the shrubs and the home. Once the problem is corrected, the foundation, basement windows and lower siding & trim should be re-inspected for defects that were obstructed at the time of inspection. Be advised that major trees should be at least 20 feet from the home to prevent storm damage and siding and trim should have a minimum 6" clearance from the soil. **WARNING** - be on alert for hidden bees nests. If through your negotiations access becomes possible, components become readily accessible, repairs are done or systems are restored, you may desire to schedule a "return visit" inspection with this office, at an additional charge, prior to purchase.

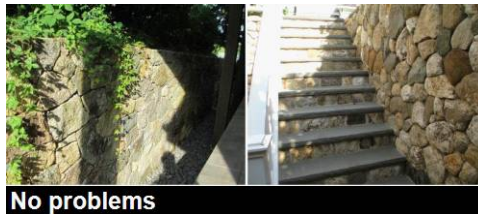
Mortared field stone wall. (Note: Mortar joints require inspection and maintenance repointing.)

No problems

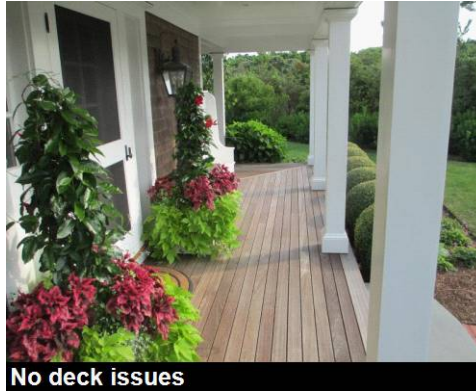
Pressure treated wood frame with mahogany floor boards.

* **FUNCTIONAL**, no evidence of deck problems was observed where readily accessible & observable at time of inspection.

Observation: Readily accessible and observable areas and deck components appeared functional or with no visible problems at time of inspection. (Note: The application of a wood preservative is advised every year to prevent sun damage. Due to current industry trends, metal joist hangers may be subjected to corrosion from the preservatives in treated lumber. All metal joist hangers should be re-inspected by the homeowner every two years. You should verify the age of the deck as all decks over 15 year of age should be considered as fully depreciated)

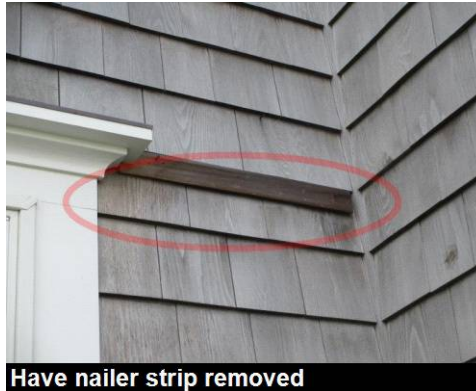
* **FUNCTIONAL**, no evidence of siding problems was observed where readily accessible & observable at time of inspection.
(Disclaimer: The type and condition of underlying siding materials is undetermined.)

Observation: I did not observe any critical problems where readily accessible and observable at time of inspection.

(Note: Siding with Southern exposure will usually age at a faster rate. Types and condition of underlying siding and sheathing are undetermined as they are not readily accessible.)

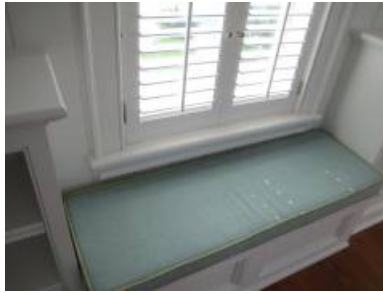
Analysis: **WARNING** - be advised that windows are not suitable for use as a backrest when sitting on a window seat. There is a risk of personal injury if the glass breaks or if a toddler falls from the window.

Recommendation: Use the window seat with caution or install approved window guards for safety.

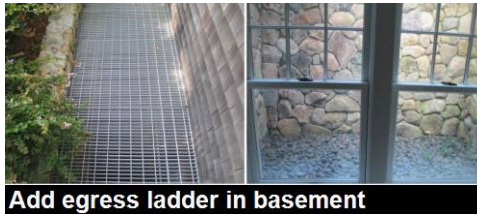
Add egress ladder in basement

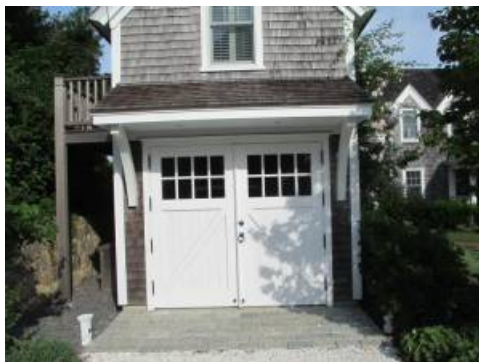
1 car attached garage with apartment above.

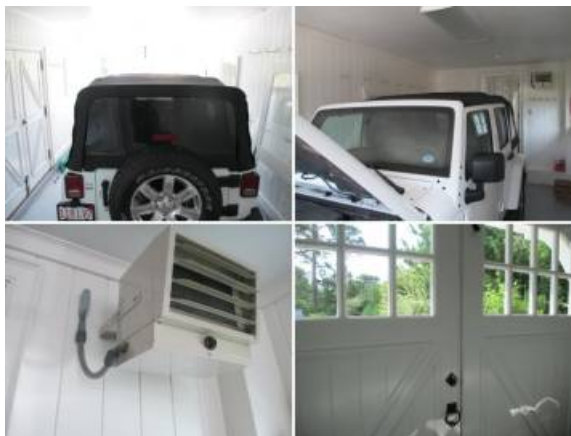
Analysis: Conditions under and around the car are undetermined. Note: There is a potential for concealed damage.

Recommendation: Further investigation is advised when the car is removed.

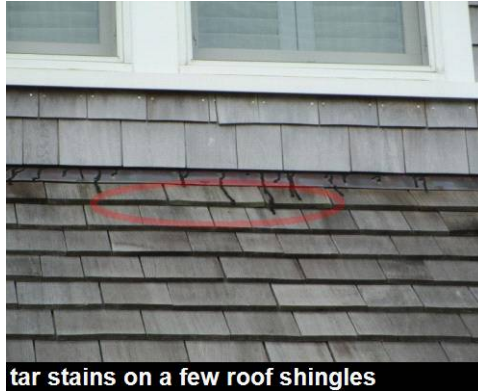
tar stains on a few roof shingles

Recommendation: You should ask the owner whether they have had any problems with the roof, and to disclose the age of the roof covering so that you can establish a budget for future age replacement.

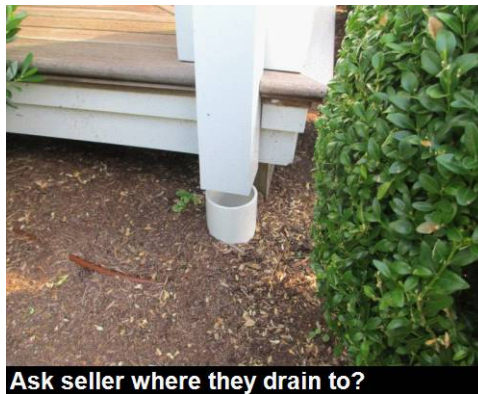
Ask seller where they drain to?

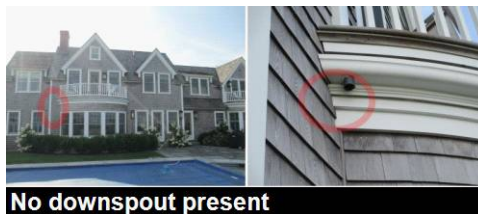
No downspout present

Recommendation: You should examine each downspout and perform corrections as needed. Make sure that all water draining from the roof is directed away from the home.

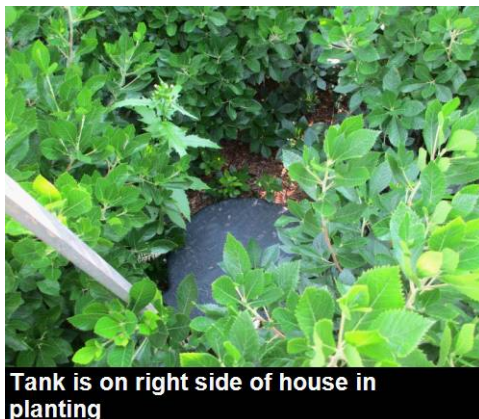
Observation: The home has an outside buried propane tank and copper piping leading into the home. (Note: You should ask if the tank is rented or owned.)

Tank is on right side of house in planting

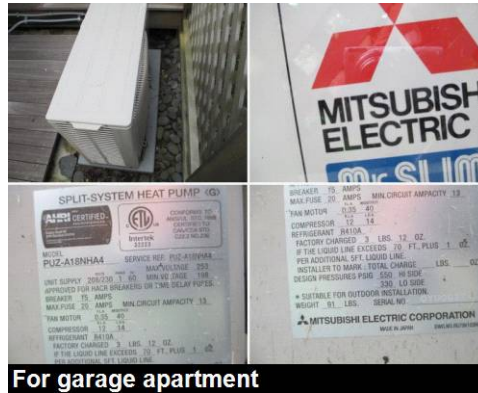
* **FUNCTIONAL.** Observation: I did not observe any evidence of problems where **readily accessible** and **observable** at time of inspection. The central air conditioning system responded to operational controls at time of inspection and cool air was distributed to those rooms serviced. The exterior compressor and the interior fan/coil unit were each operational. Be sure to discuss the age of the equipment and past maintenance record with the owner. An annual service contract is advised.

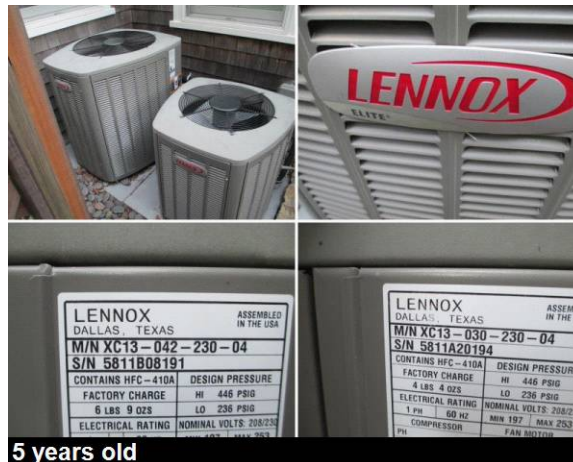
Brand: Lennox
Model: XC13-042-230-04
Serial: 5811B08191
Est. age: 2011

Brand: Lennox
Model: XC13-030-230-04
Serial: 5811A20194
Est. age: 2011

Brand: Mitsubishi
Model: PUZ-A18NHA4
Serial: OY000274C
Est. age: unknown

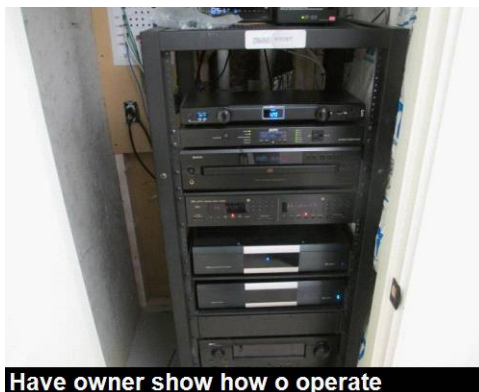
Have owner show how o operate

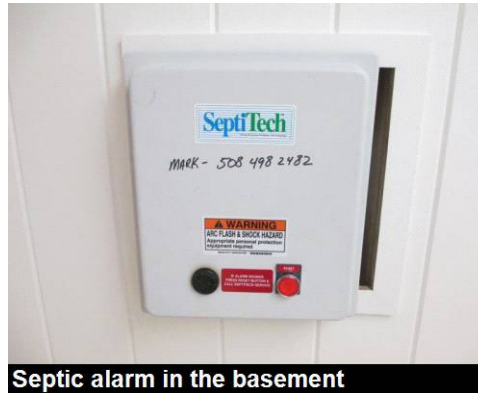
All septic systems that use a pump to move wastewater from a septic pump tank to a drain field or mound have an alarm installed in the house. The alarm goes off when wastewater is not being pumped from the septic pump tank to the drain field or mound. When the alarm goes off, you have approximately 400 gallons of capacity in your septic pump tank before wastewater starts to back up into your basement. When you hear the septic tank alarm buzzing, you should call a septic service company as soon as possible.

Septic alarm in the basement

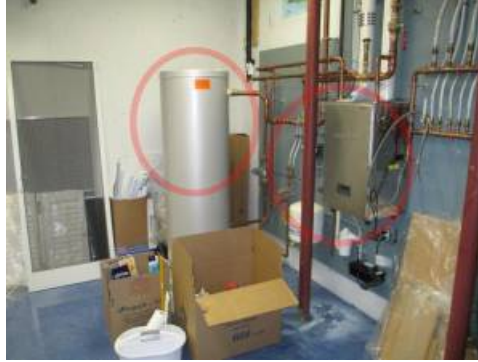
Observation: As indicated by the data plate, the water heater appears to be approximately 5 years old:

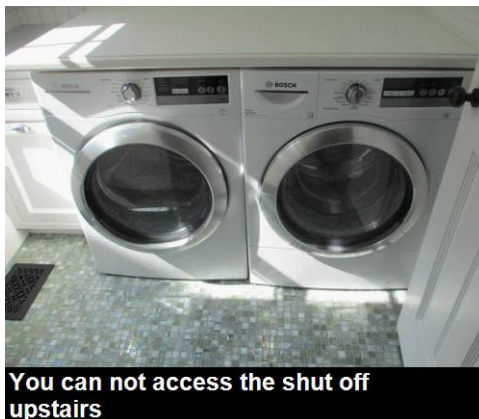
Analysis: Be advised that the rubber hoses running from the supply valves the washing machine are not designed to be under constant pressure as they can burst and cause flooding. Hoses develop rubber fatigue, blisters and cracks with age. Valves should be accessible so that they can be closed after each wash. Newer laundry installations have one modern ball type shut off valve which is more conveniently used (ex. Watts Regulator Co. No. 2 Duo-cloz).

Recommendation: While not required, you may want to hire a plumber to relocate the washing machine supply valves to simplify shutting them off and thereby preventing possible water damage. Braided stainless steel fill hoses are advised. Consult a plumber for a cost estimate as elected.

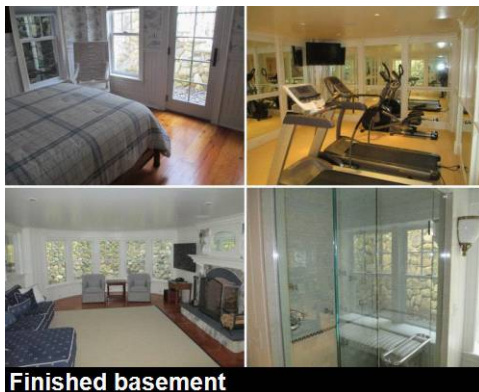
Finished basement

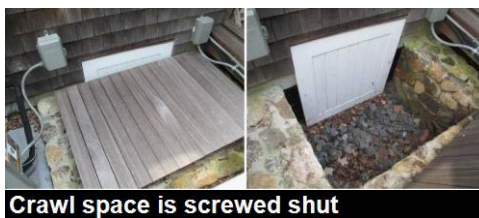
Crawl space is screwed shut

Recommendation: I advise that **safe access** be created and that the space be inspected by a professional prior to the expiration of the inspection contingency period. Check for signs of pest activity, decay, a vapor barrier on the earth, a means of cross ventilation and insulation. A crawl space is required to have a hatch measuring not less than 18" x 24". If through your negotiations access becomes possible, components become **readily accessible**, repairs are done or systems are restored, you may desire to schedule a "return visit" inspection with this office, at an additional charge. Inspection by a pest control company is advised **NOW**.

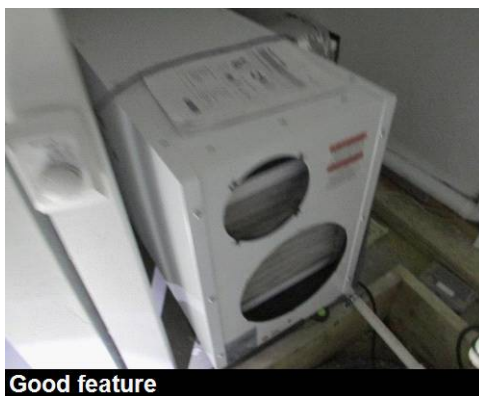
Good feature

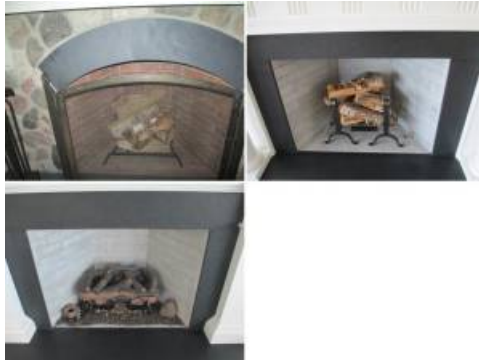
Observation: The home has a direct vent gas fireplace.
