Attachment 1
Saxon Schematic Design Report

SAXON HARBOR MARINA AND CAMPGROUND SCHEMATIC DESIGN REPORT

JANUARY 2018

Custom Soil Resource Report for **Iron County, Wisconsin**

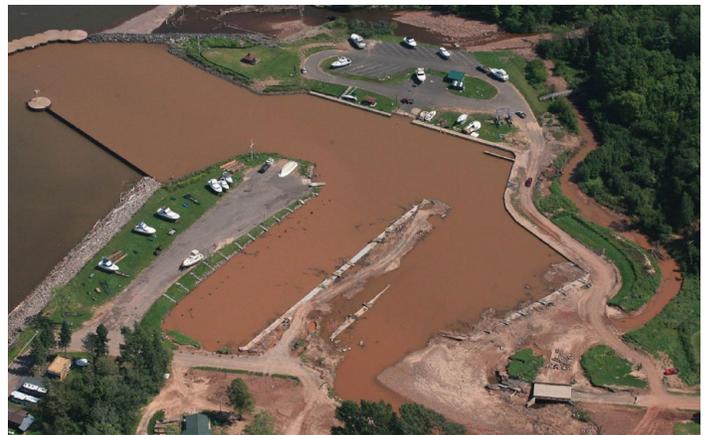
Post-flood aerial view of Saxon Harbor Park looking east.

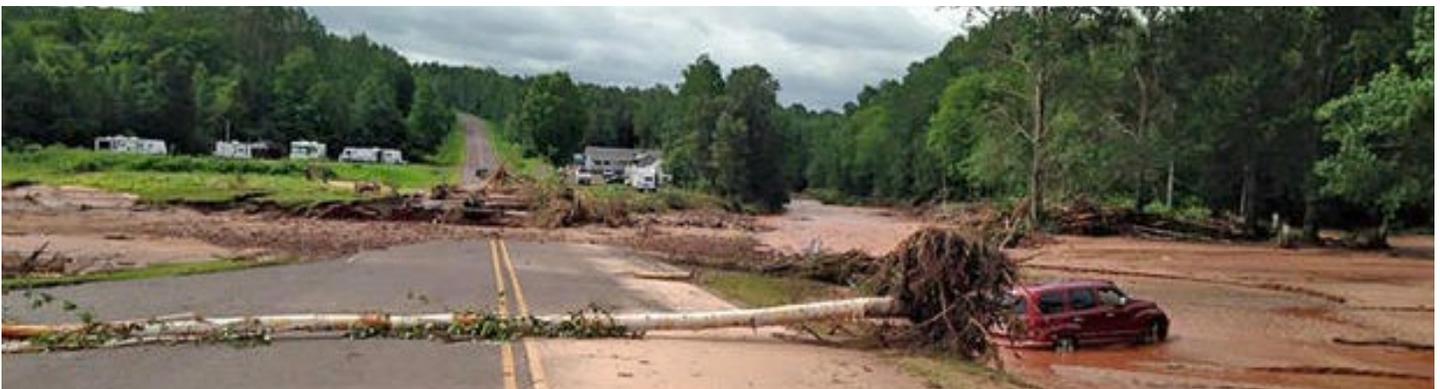
Water breached the stream banks and washed out CTH A at the bridge over Oronto Creek, as well as the campground and marina.

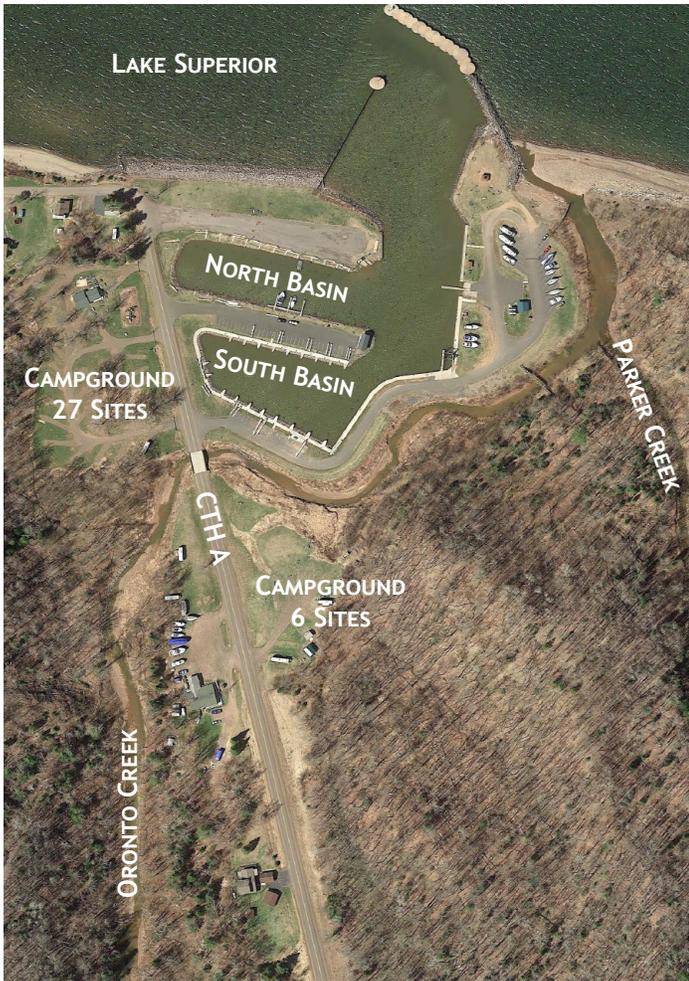
Saxon Harbor Park prior to July 2016 flood.

Slips in the South Basin and along the south side of the North Basin were floating docks accessed off a perimeter sidewalk set at a field verified elevation of 605.25 (NAVD88). These docks were destroyed by the 2016 flood, along with the central restroom building. Slips along the north side of the North Basin were not damaged, and consist of older fixed, pile supported docks individually accessed by steeply sloping wooden ramps and staircases over a stone revetment edge.

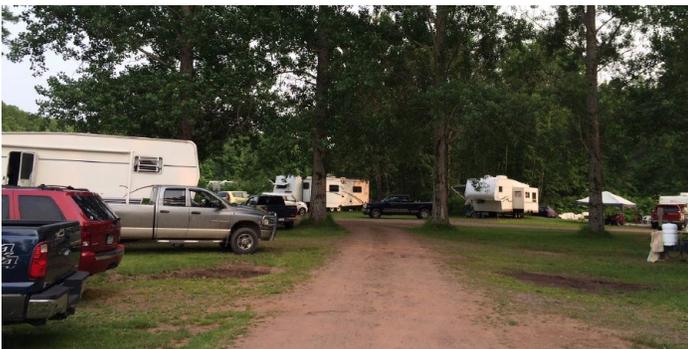
The main campground area featured 27 campsites.

The campground previously featured 33 total campsites, located on both sides of Oronto Creek. The main campground area included 27 sites of various sizes, of which 26 were severely damaged by the flood. The adjacent playground was also destroyed, and the park pavilion including restrooms required cleaning and restoration. Southeast of the CTHA bridge over Oronto Creek, a smaller campground included six sites and a restroom building in a dead-end road configuration. This area was not damaged by the flood. Five tent campsites were also located on the peninsula between the North Basin and the Lake Superior shoreline, and an additional five rustic walk-in sites were located at the confluence of Oronto and Parker Creek as accessed by a pedestrian footbridge from the east boat launch area or a trail from the smaller RV campground.

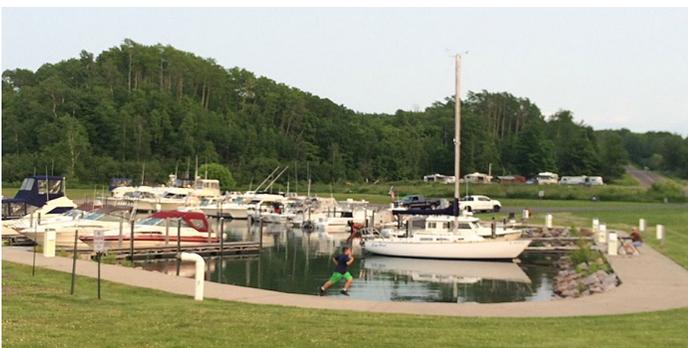
The smaller campground overlooked the harbor from across Oronto Creek.

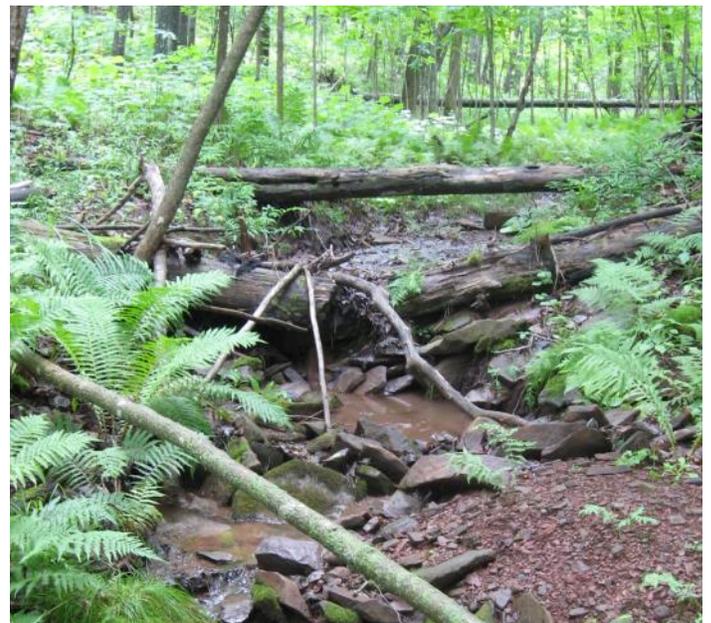
Non-navigable unnamed tributary to Oronto Creek (Photo courtesy WDNR)

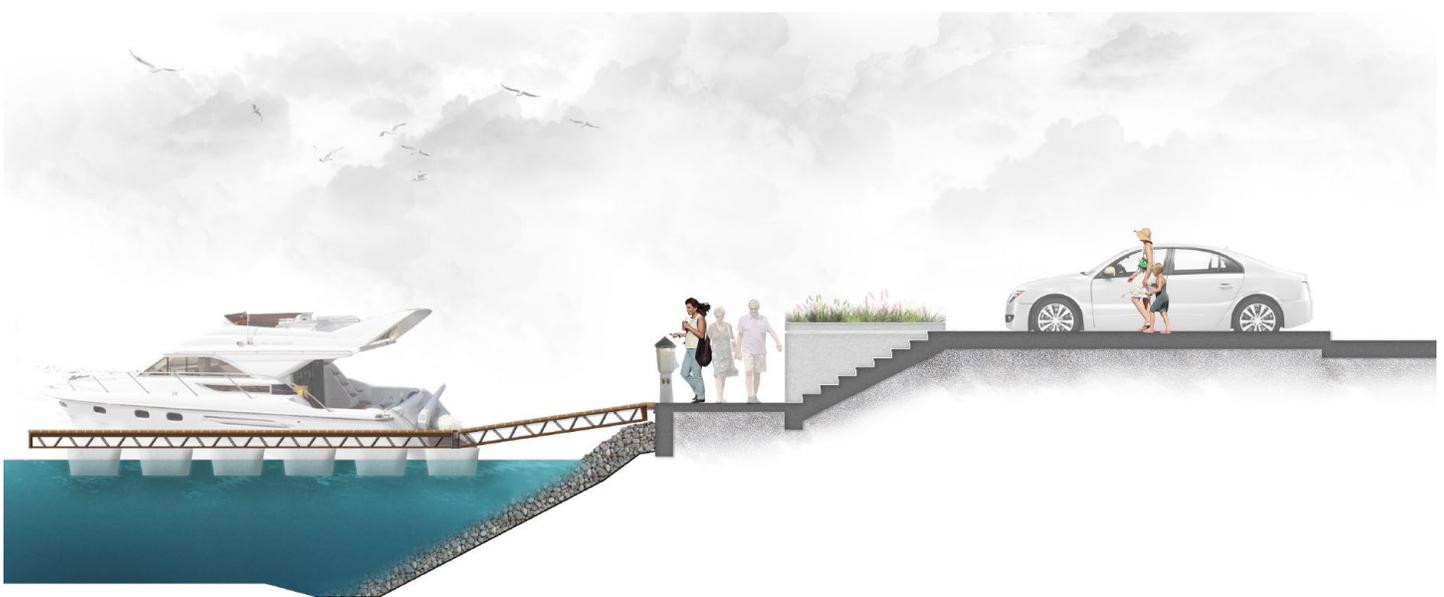
Proposed section for slips and parking along the north edge of the North Basin

For the marina, the basin is reconstructed as it existed prior to the flood, except that the slips along the north side of the North Basin have been replaced with floating slips and a perimeter walk to match the rest of the harbor. To transition grade between the walk and parking area, an approximately 4 foot high retaining wall is required at the west end of the

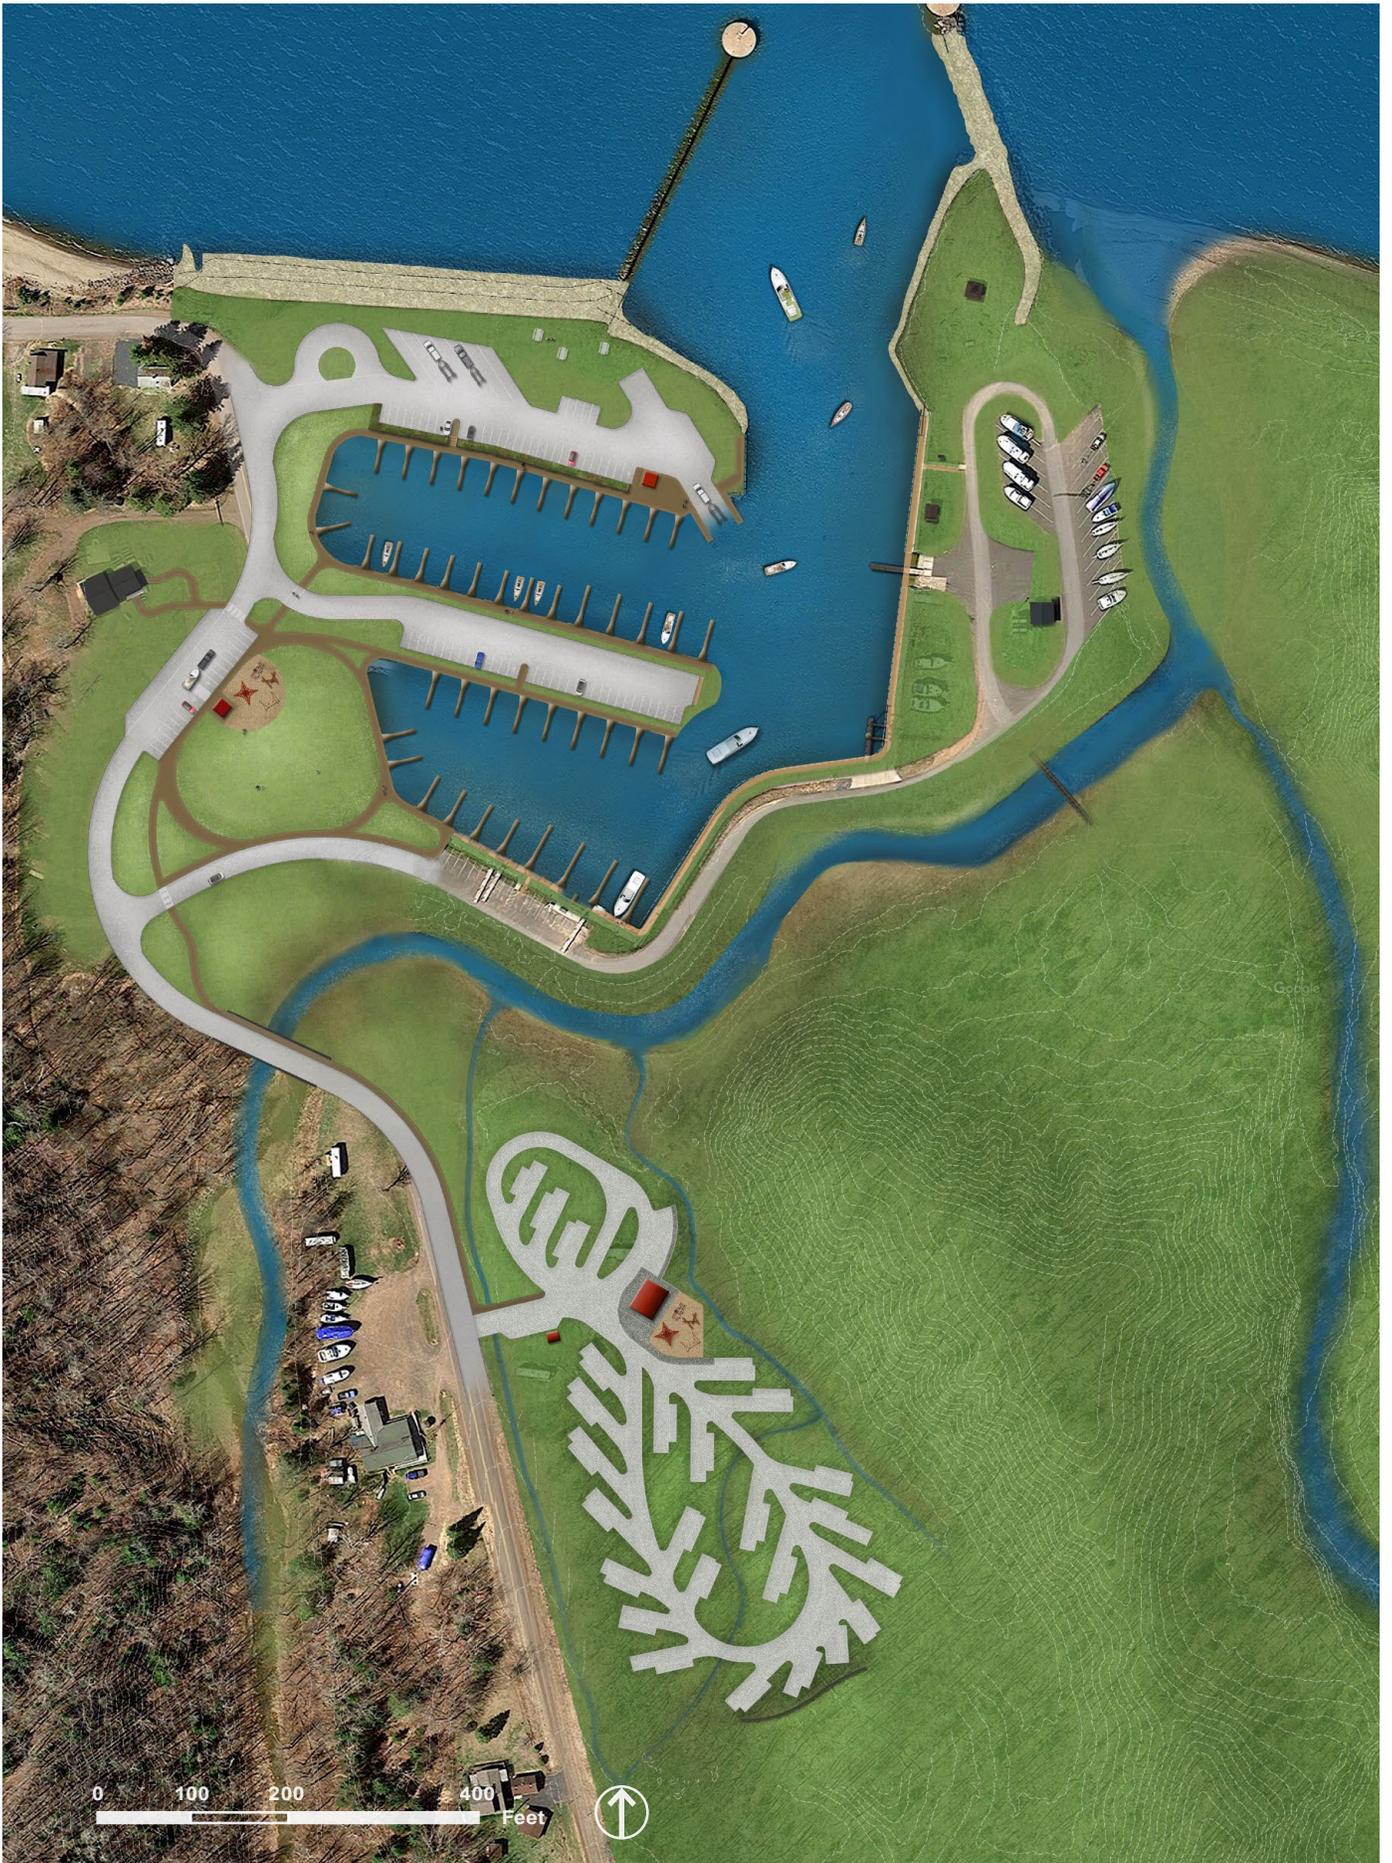
Reconstruction Alternative A.

site that slopes down to match grade at the boat launch. Tent camping is replaced at the lakefront with an expanded day use area. The north boat ramp is integrated with a kayak launch, and the parking area is reconfigured to define 7 auto-trailer stalls, a turnaround for launch retrieval, 17 stalls for seasonal slip users, and 14 day use parking stalls for the beach area.

The new curved alignment of CTH A creates a larger area between the roadway and South Basin. For this alternative, the restroom from the center peninsula is relocated to an open lawn day use area in this space. Parking is provided along the east side of CTH A adjacent to the restroom and playground, while a pull-off lane on the west side allows temporary parking and access to the existing pavilion.

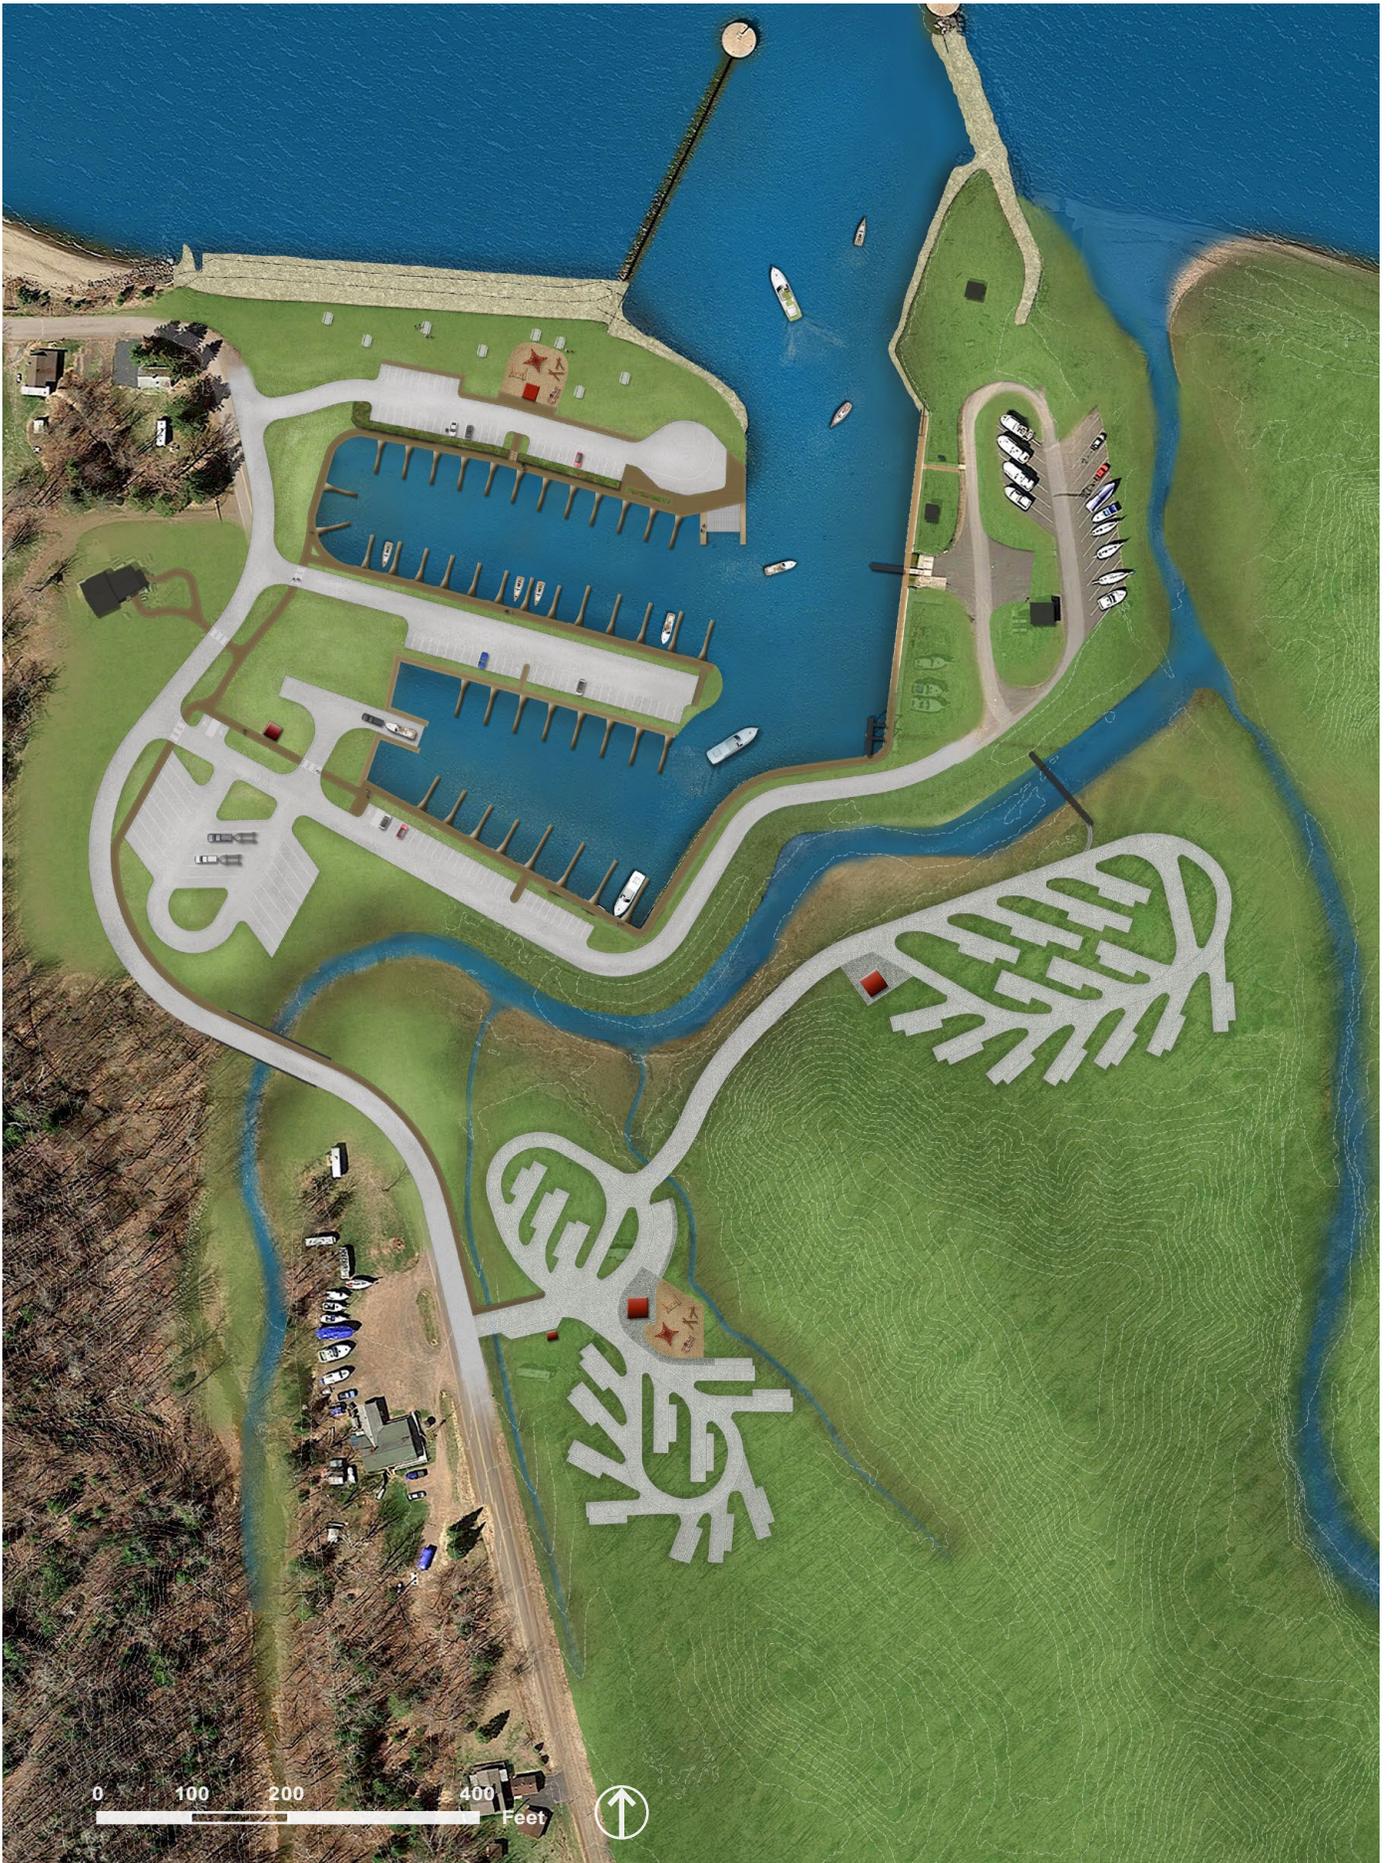
Reconstruction Alternative B.

The campground located along CTH A again replaces and expands the existing 6 site campground area with 14 campsites arranged within two internal loops. The south loop is smaller than in Alternative A and does not require the large retaining wall to meet grade. A new access road connects to a third loop at the creek confluence, which provides 16 additional campsites. Construction of this road requires more intensive stabilization and setback of the eroding bluff above. The rustic campsites which were previously located at the confluence are replaced elsewhere, potentially at the remote bluff site originally considered for the campground.

For the marina, Alternative B takes advantage of the new curved alignment of CTH A to relocate the boat launch to the west end of the South Basin. Although this replaces the two smallest finger piers, the new location resolves the challenges with wave climate that both launches currently experience, making retrievals easier in harsh wind conditions. The restroom is located adjacent to the launch, with 2 accessible auto stalls and 20 auto-trailer stalls.

Slips along the north side of the North Basin are similar to Alternative A, with a separate kayak launch at the former boat launch location. The kayak launch is configured to include a lift for universal accessibility. By removing trailer traffic from the north peninsula, the parking provides 17 stalls for seasonal slip users, 22 stalls for day use, and a drop-off turnaround at the kayak launch. The expanded lakefront day use area includes a restroom or pavilion, with playground and picnic area.

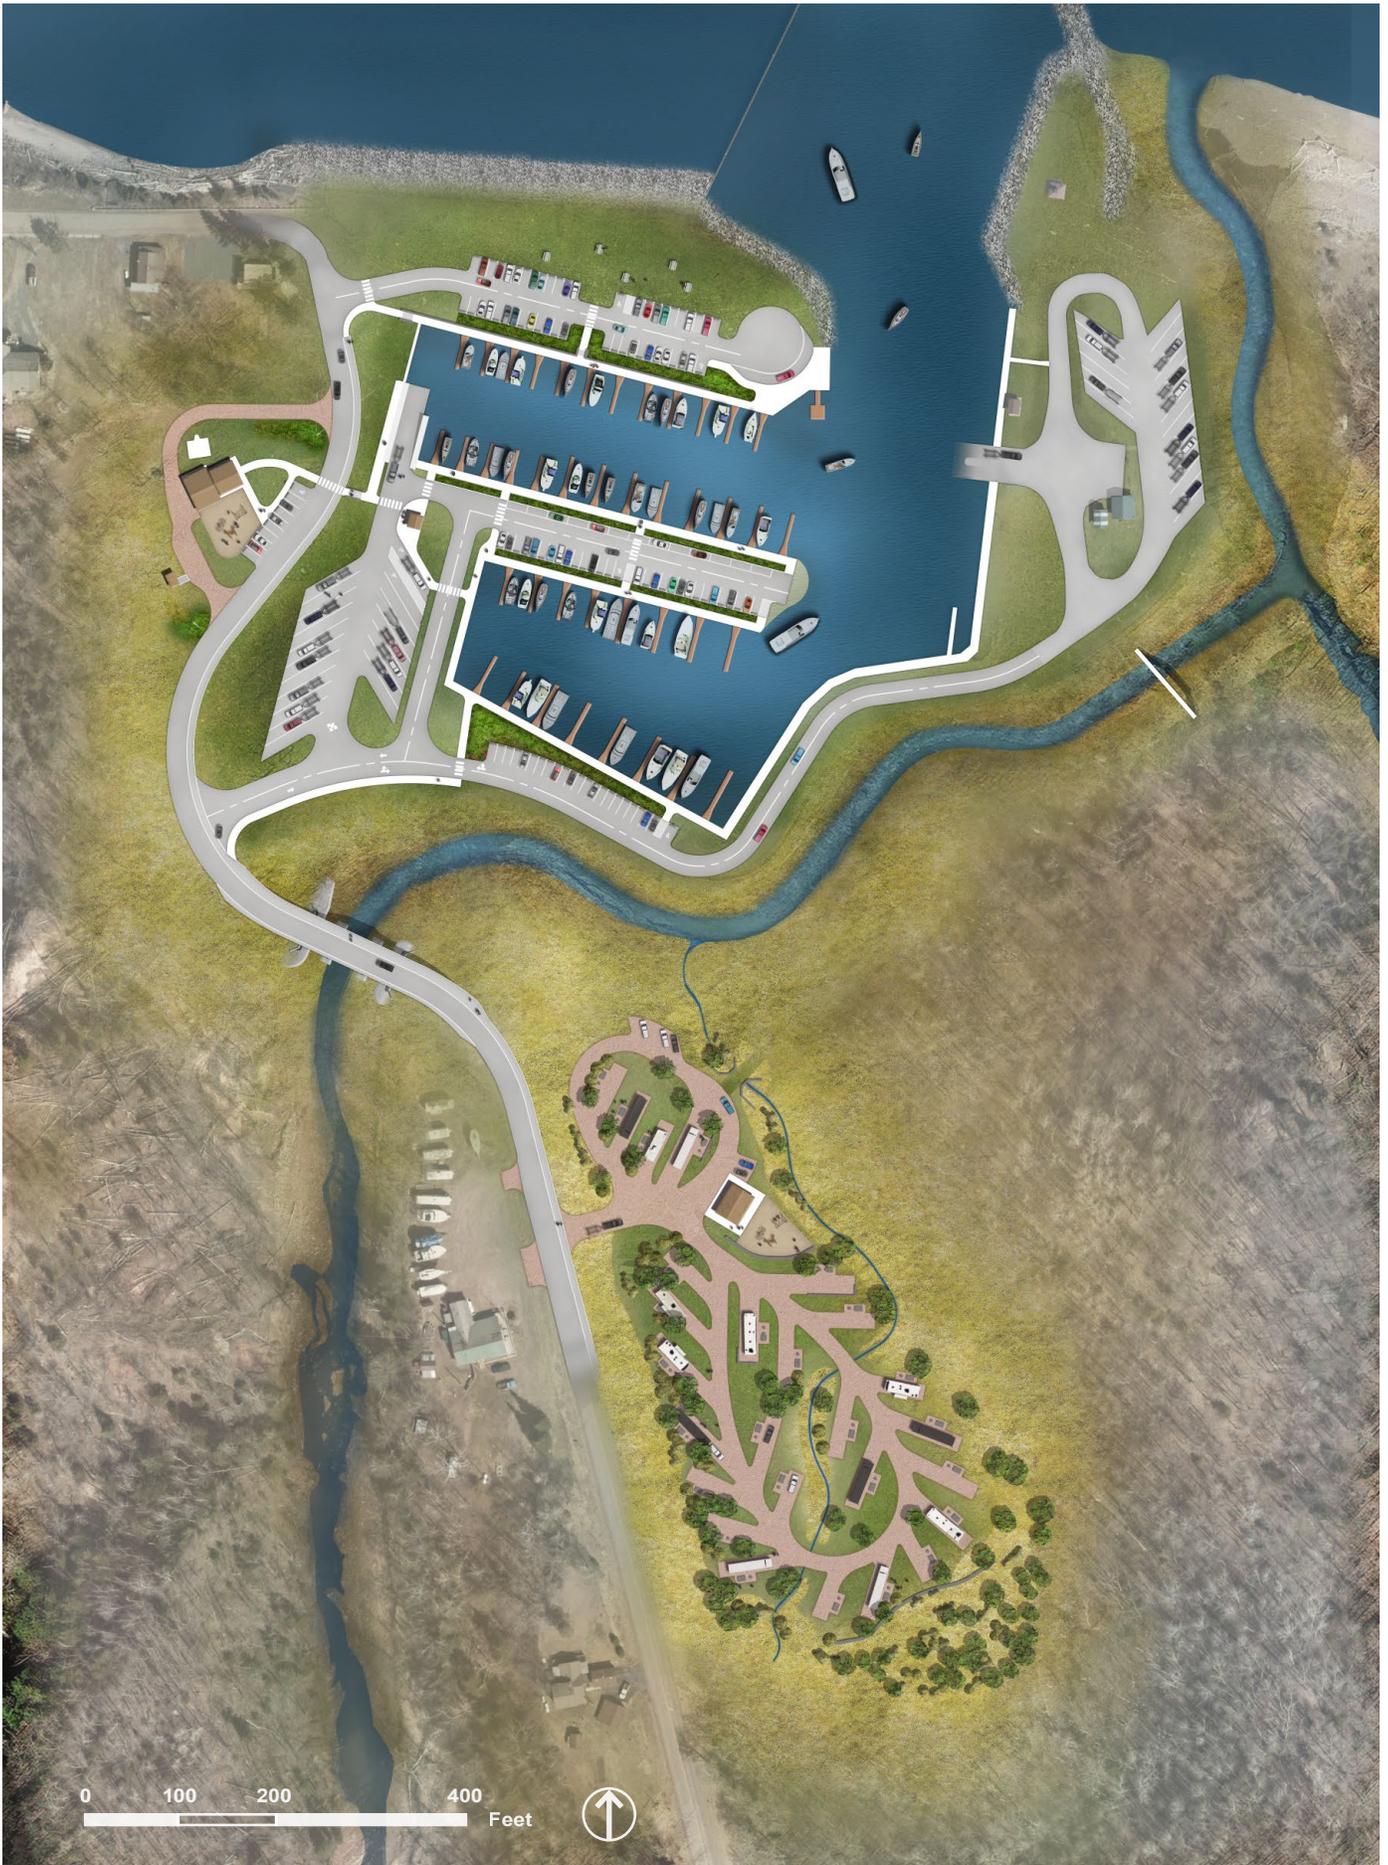
Saxon Harbor Reconstruction Consensus Plan.

Other campground modifications included refinements to the parking layout and landscaping. In Alternative A, all extra parking stalls were located immediately adjacent to the restroom building. To better accommodate the existing drainage corridor, the parking was revised to provide two stalls (including one ADA compliant) at the restroom. The five stalls serving the rustic campsites at the confluence were moved to a flatter location between the campground and Oronto Creek that is still close to the trailhead. Landscape restoration at the campground includes a dense buffer of native trees and shrubs along CTH A required by zoning ordinance. Restoration-grade trees and shrubs are also planned to begin reforestation of the steep slope at the south end of the site. Mown turf is designated for only the areas immediately surrounding the campsites, while native seed mixes provide soil stabilization and wildlife habitat for the steep slopes and intermittent stream corridors.

The final marina layout includes relocation of the boat launch to the west edge of the North Basin. The restroom building is located near the launch, along with 19 auto-trailer parking stalls (2 ADA). Other improvements are similar to Alternative B, with a kayak launch at the former boat launch location, and a day use picnic area along the lakefront with 49 total parking stalls to serve both seasonal slips and day users (3 ADA). A memorial to the flood event and the life of Assistant Fire Chief Mitch Koski will be located in the day use area along the lakefront. The playground is relocated close to the existing pavilion, with 10 parking stalls (1 ADA) along CTH A to serve the building. A new office and storage building is planned south of the playground, and the gravel drive around the back of the pavilion is widened to serve as a one-way loop for service access and campground registration.

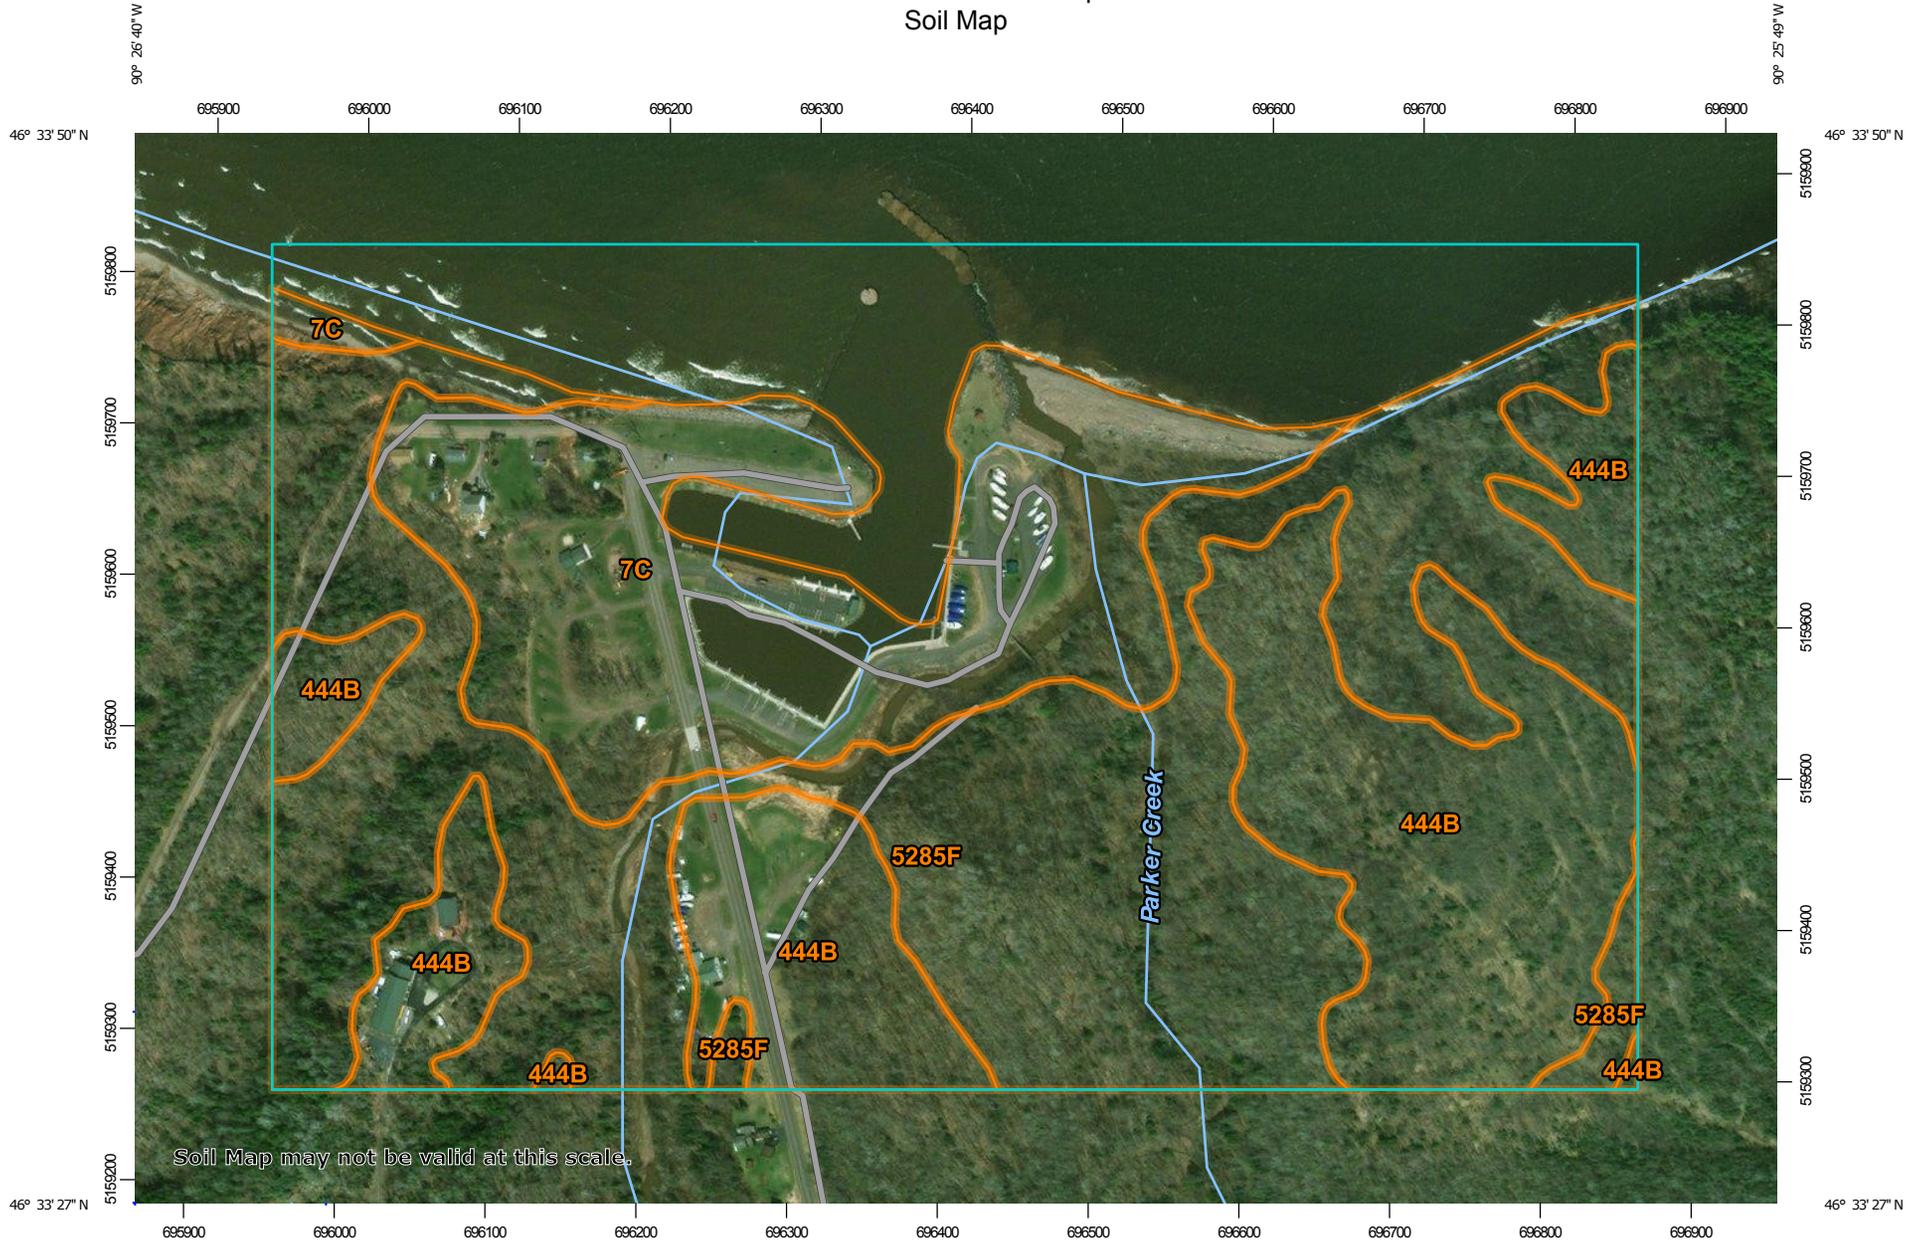
Custom Soil Resource Report Soil Map

Map Scale: 1:4,980 if printed on A landscape (11" x 8.5") sheet.
