Service Life Prediction for Buildings Exposed to Severe Weather

Karim El-Dash

Abstract

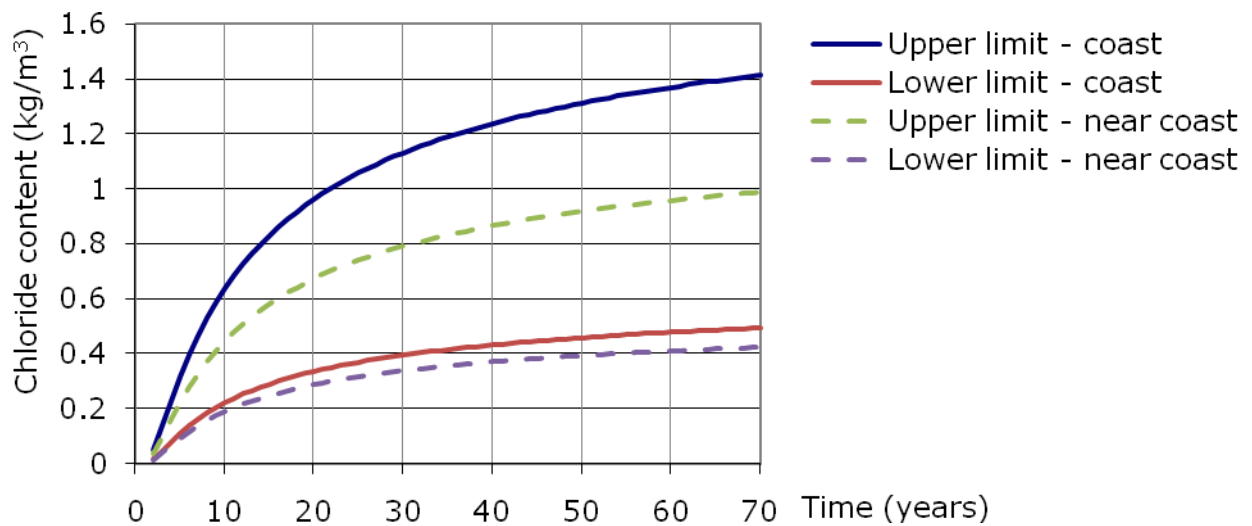
**Figure 1** Variability of internal chloride content

Figure (1) shows the upper and lower limits of the expected chloride content over a period of 70 years starting from the assumed construction date.

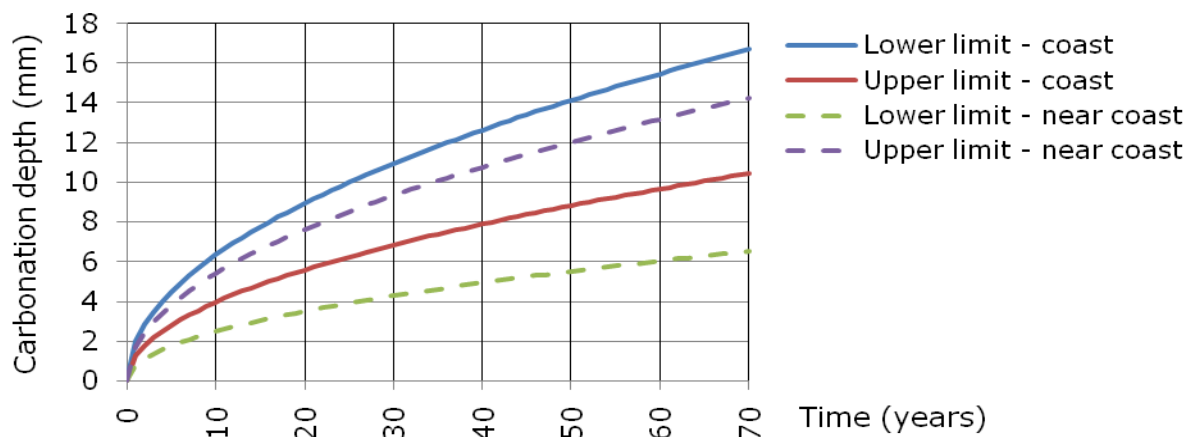
Figure 2 Effect of time on the carbonation depth

Figure (2) presents the extrapolation of the upper and lower limits of carbonation depth in concrete elements for both regions. The same trend is observed with respect to concrete resistivity where the resistance greater than 20,000 Ωcm indicates low corrosion activity (McGee et al.; 2002).
