# Property Inspection Report

**Property Address:**  
65 West 1st Street  
Inspectionville NJ 76666

**Terra Home Inspections LLC**

<b>Date:</b> 9/16/2015	<b>Time:</b> 10:00am	<b>Report ID:</b> 20150288
<b>Property:</b> 65 West 1st Street Inspectionville NJ 76666	<b>Customer:</b> Tony Inspection	<b>Real Estate Professional:</b> Sally Realtor

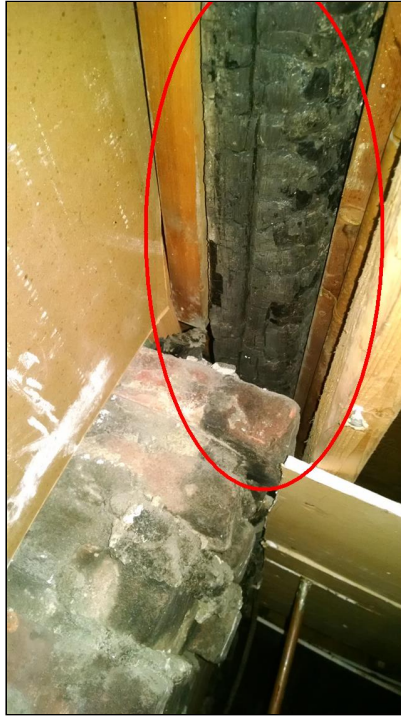
(1) There appeared to have been a fire in the basement at one time. There was numerous areas of the 1st floor wood structure (the sections that weren't covered up with drywall in the basement), basement stairs and walls and other areas of the basement that were charred/fire damaged. Also, as viewed from the inside of the 1st floor bathroom, there were sections of the right side exterior wall above the drop ceiling that were charred. Since most of the basement ceiling is covered with drywall as well as the 1st floor living space and the rest of the house, the extent of the fire damage to the structural framing members could not be determined. All this charred wood is a concern, as the fire may have compromised the structural integrity of the structural framing members and the foundation that is still in place. Recommend further evaluation of these areas by a qualified, licensed contractor.
