CONSERVATION AUTO TOUR

SITE 3: GRASSED WATERWAY

Conservation Cooperator PROJECT FACT SHEET

Jeff Gibbs/Grade Stabilization-Complete 7/28/19

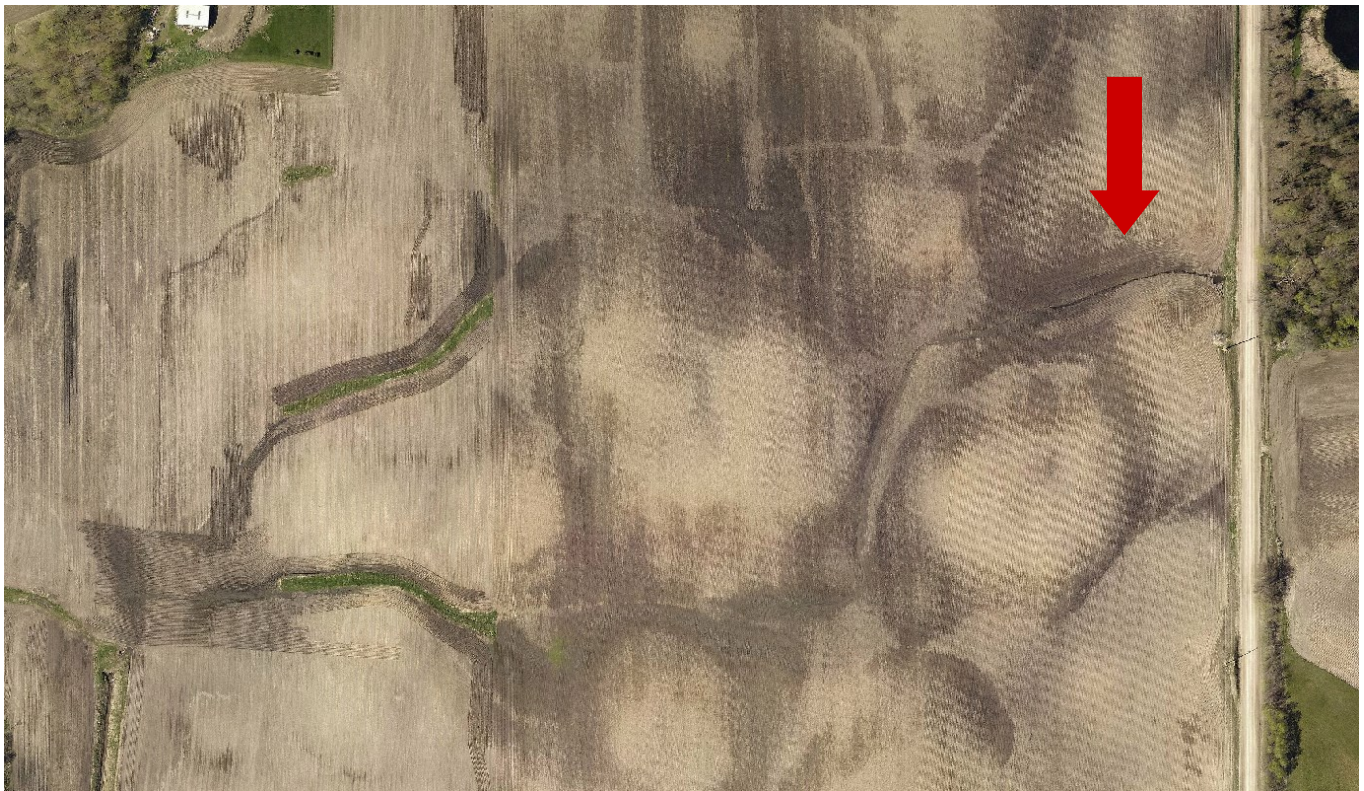
Install a grade stabilization structure along Le Sueur/Rice, the site has a large amount of water coming from Rice County that does not all go into tile. The site is washed out from the county road 450' west. A waterway will be installed downstream until the grade stabilizes.

Above: Picture of erosion before Construction Below: Approx. Site Location
