Analysis of New Centrifugal Pump Installation Exhibiting Excessive Vibration

Ken Singleton
Manager KSC Consulting
19676 Serenity Lane
Bristol VA 24202
Office/Fax 276-669-8459
ksingleton@vibrationconsulting.com

Robert R McGinnis P.E.
M M Engineering
429 Fondulac Drive
Kingsport TN 37663
Office/Fax 423-239-9713
Mmengineering@charter.net

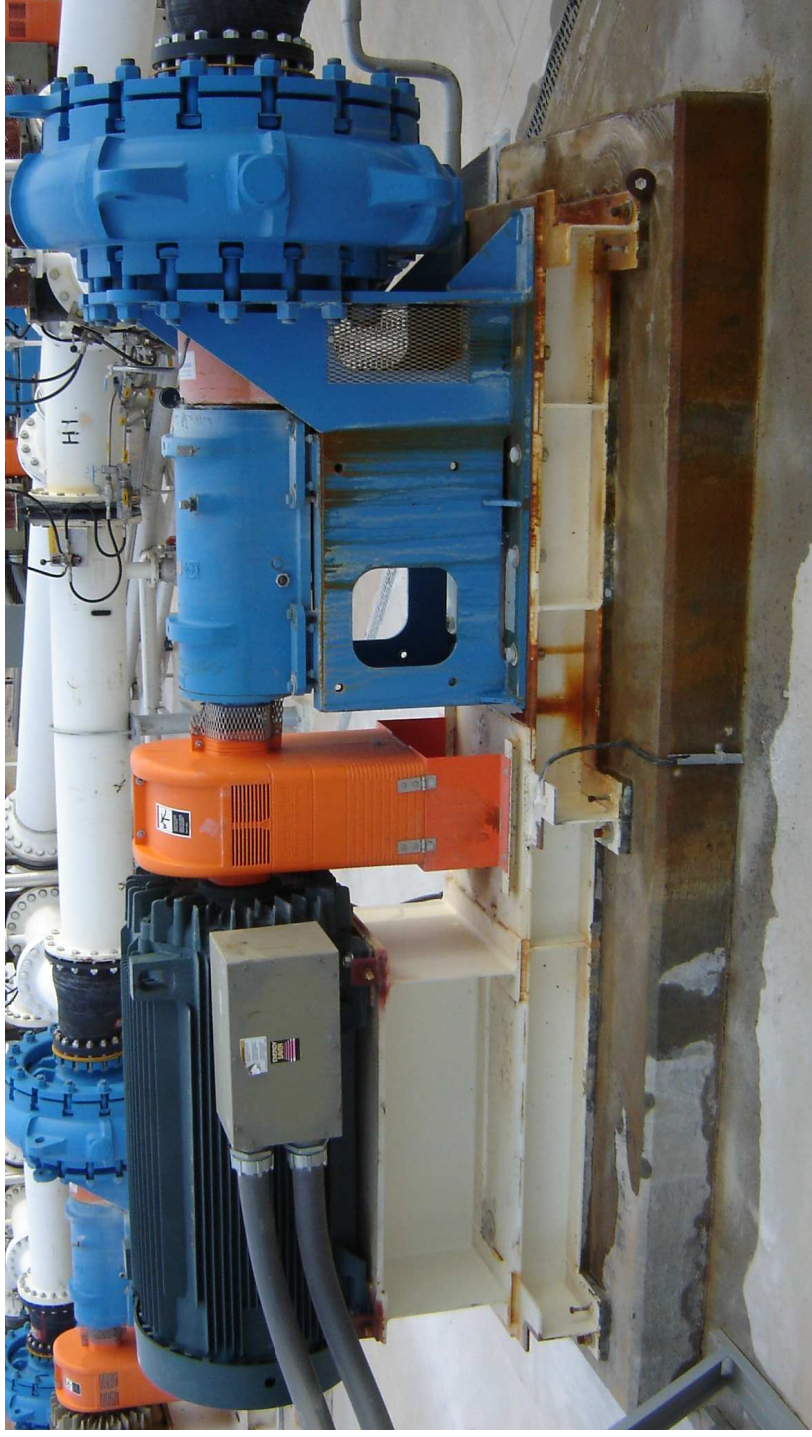
- **Motor & Pump Mounted on Fabricated Skid.**
- **Skid Bolted & Epoxy Grouted To Concrete Base.**
- **Skid filled with grout.**
- **Project received to investigate root cause of excessive vibration and make recommendations for correction.**

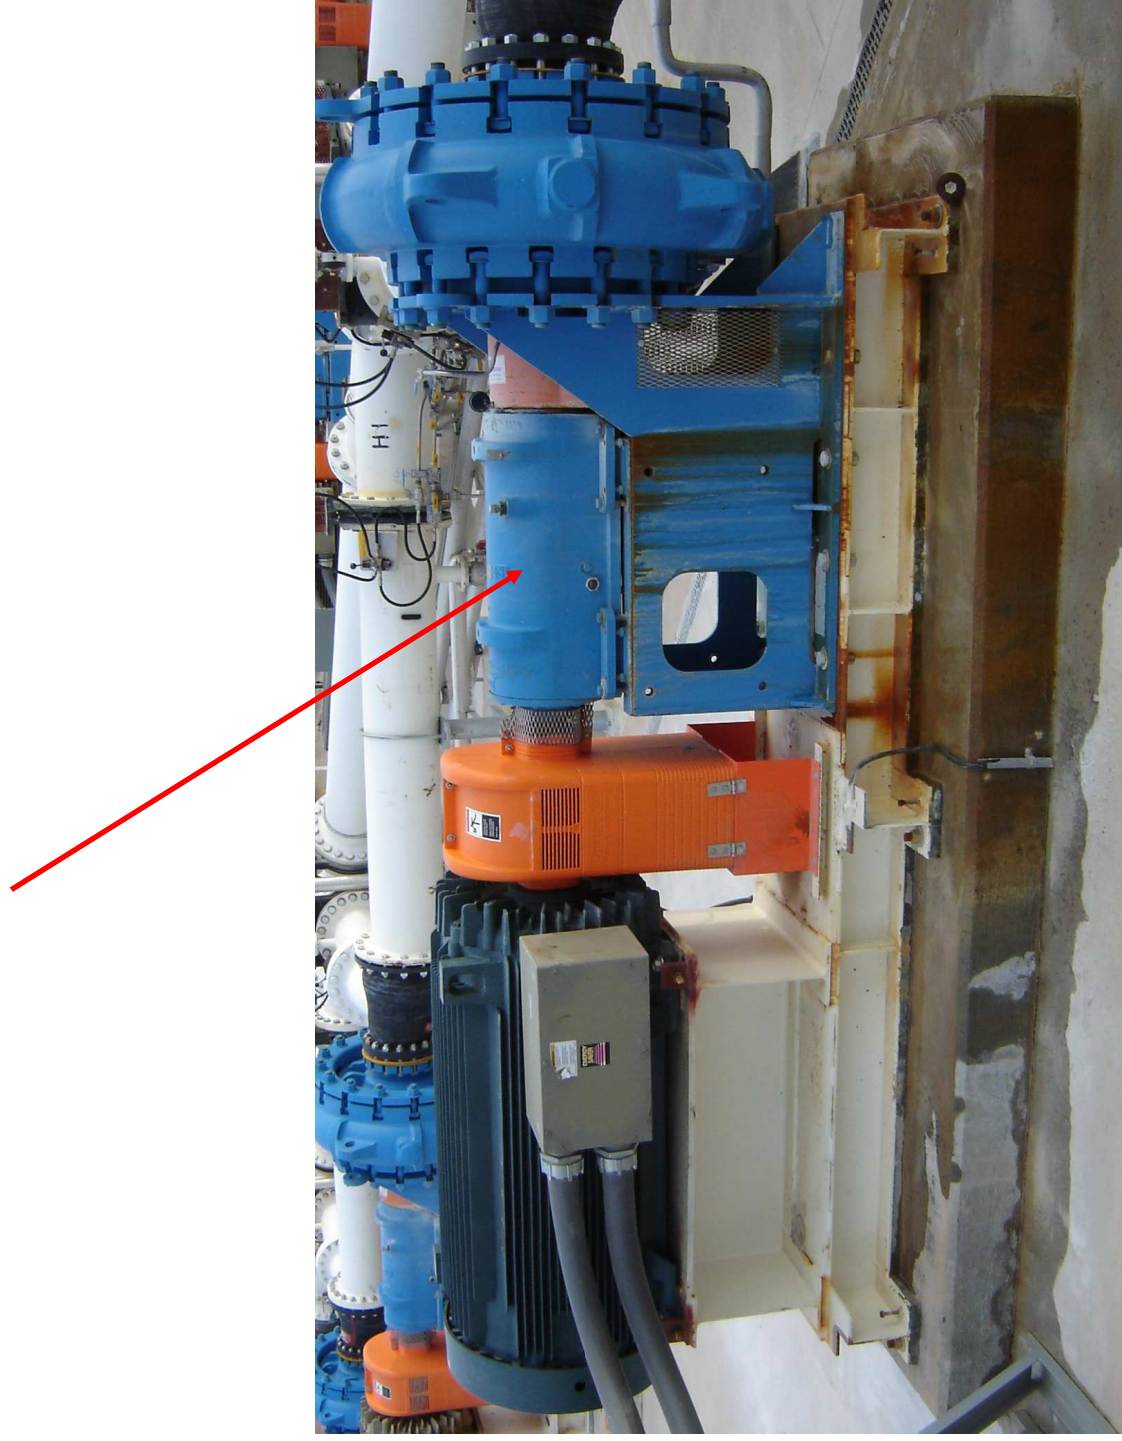
Fabricated Pump Base is bolted to the skid

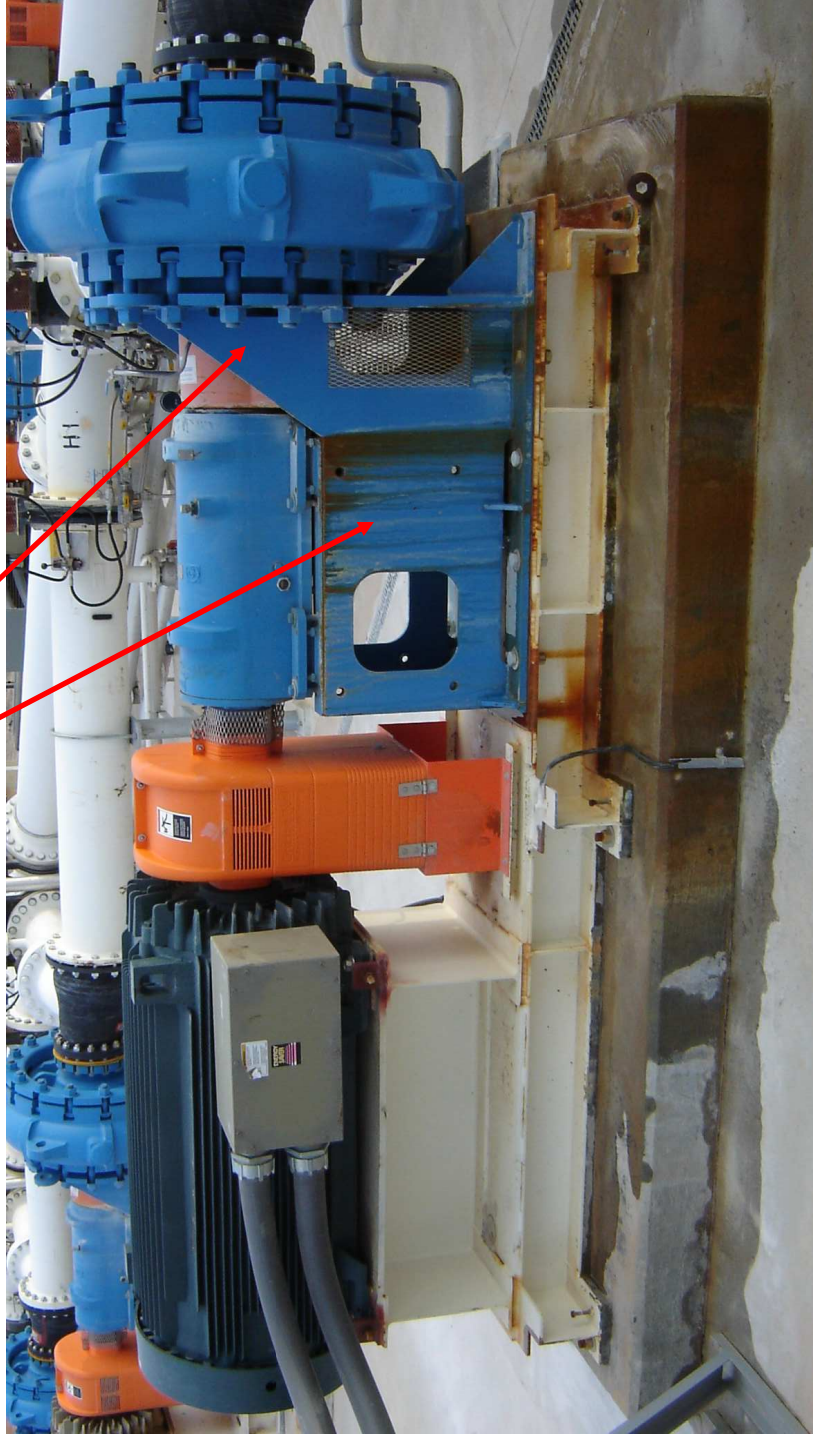
The Skid Base is fabricated of 6" Channel, with wide flange beams and 1/2" top plate.

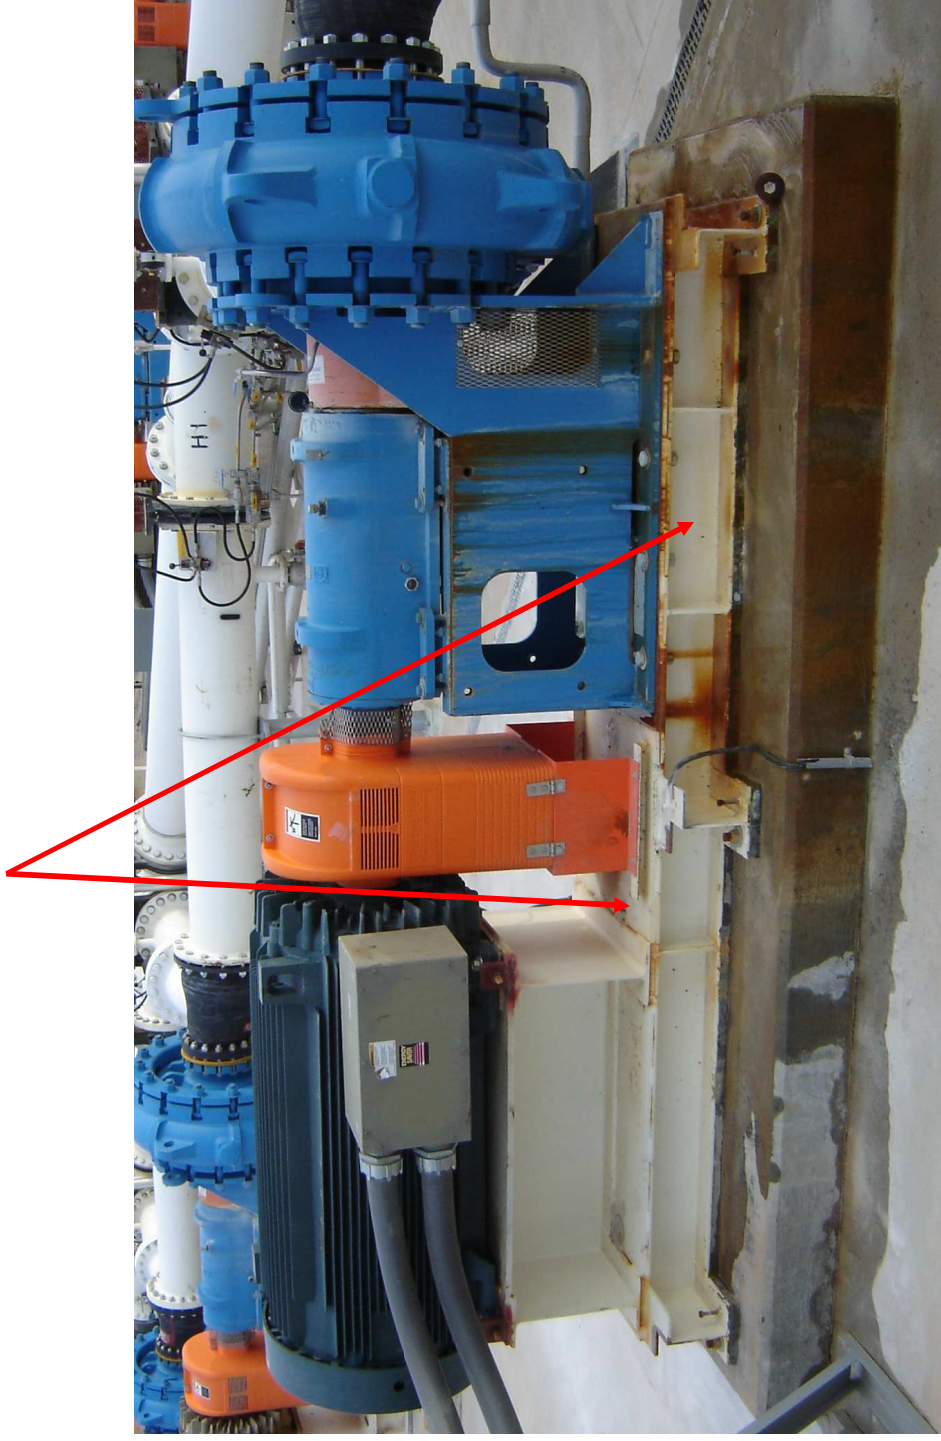
Skid Epoxy Grouted to the Concrete Base.

Six anchor bolts fastened the skid to the concrete base.

Leveling Jack Bolts beside each anchor bolt.

6. Replace anchor bolt washers with washers a minimum $\frac{1}{2}$ " thick and hole size no more than $\frac{1}{16}$ " larger than the bolts.
7. To correct the relative movement between the concrete base and concrete pad, injection of epoxy grout should be considered. If stiffening of the structural steel is successful, then grout injection may not be required.

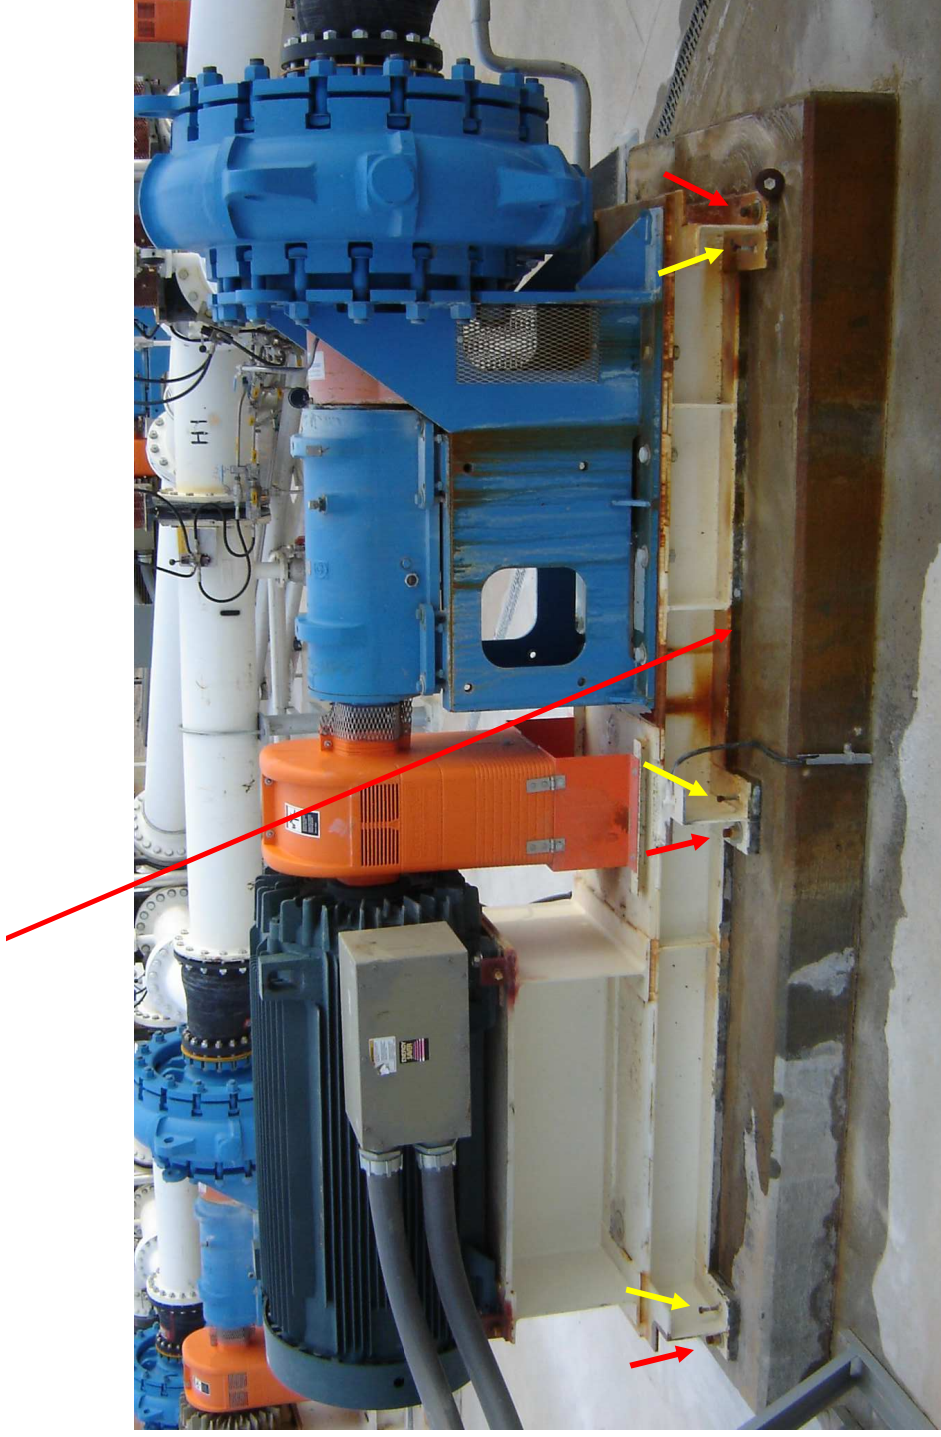
Per the drawings, the Concrete Base was 1 foot deep.

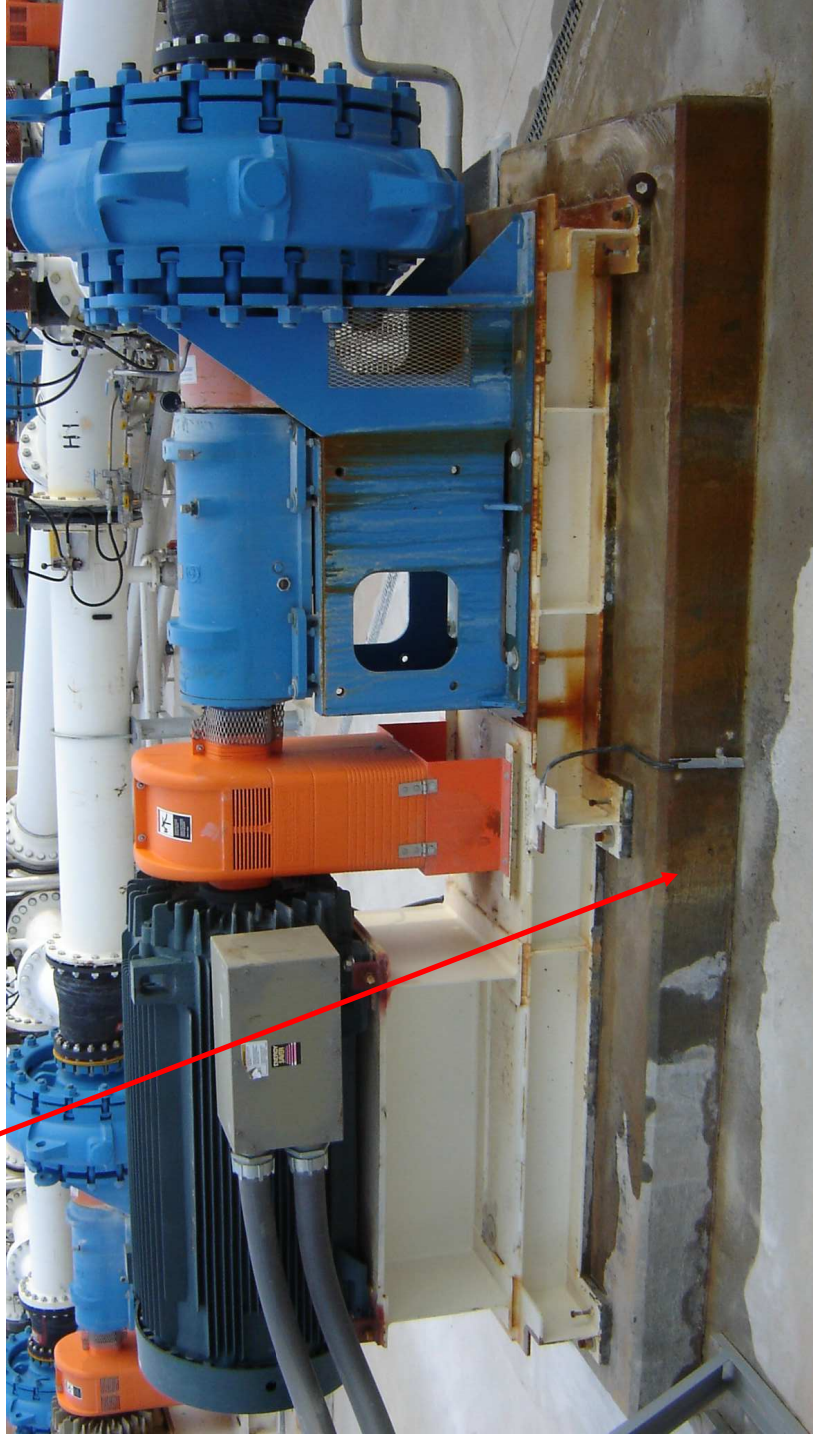
Plate Welded to Skid at the Pump End For Anchor Bolt.

3. Weld gussets to the left side of the pump skid at the pump end to increase stiffness of the skid at the anchor bolt location.
4. Remove the carbon steel shims from the motor shim stack and replace with ground stainless steel shims. Limit shim stack to five shims.

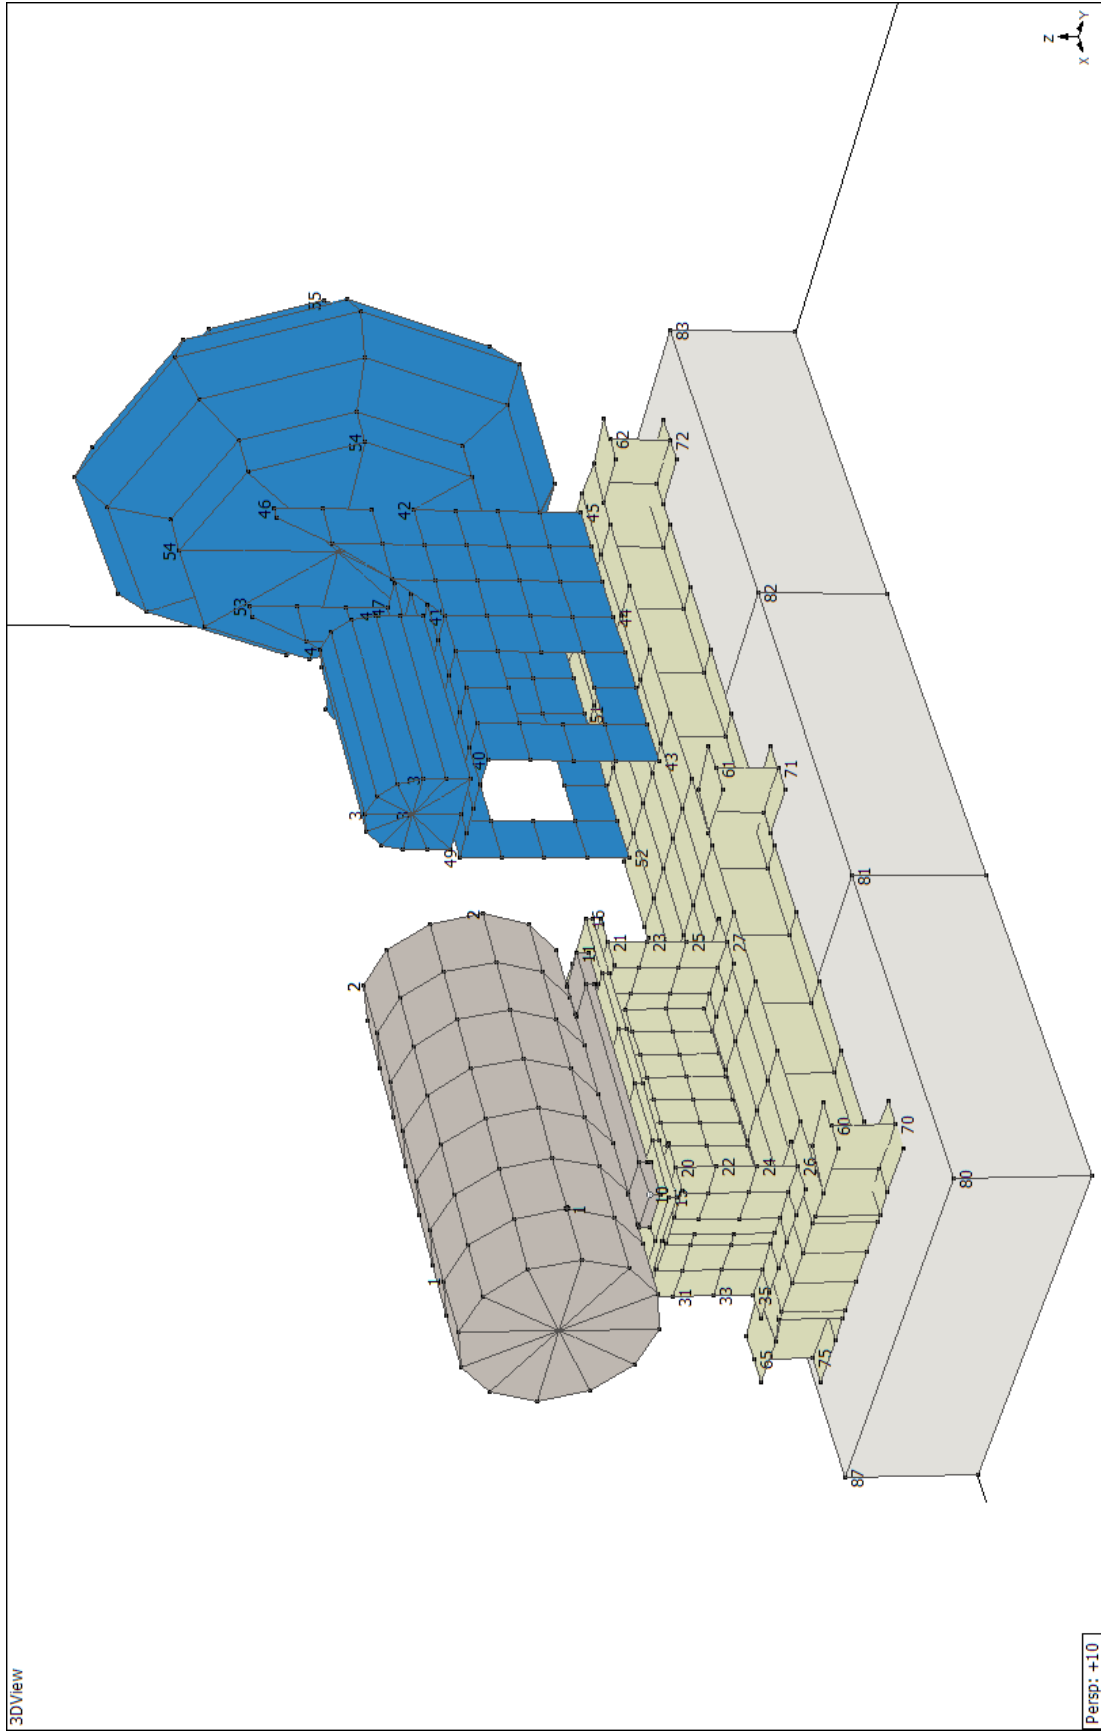
17.9 Hz ~ 1074 CPM natural frequency near pump operating speed. Mode shape was side-to-side motion of the motor with flexure in the supporting structural steel pedestal and skid frame. Very little participation of the concrete base in the mode shape.

1. Stiffen each skid and the motor pedestal (to increase horizontal natural frequency above the running speed and pump vane passing frequency).
2. Install two additional anchor bolts at the Motor Inboard Skid location to reduce flexure of the skid.
