# Property Inspection Report

**Property Address:**  
9 Big Court  
Great City New Jersey 07000

**Frank Glomb**

**Terra Home Inspections LLC**

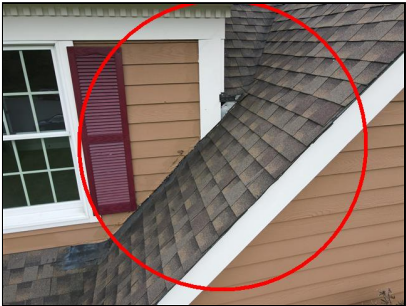
2.0 Item 1 (Picture)

(1) As observed on the exterior, there were portions of some of the exterior elements (windows, window frames, window flashings, doors, door frames, door flashings, siding/cladding, masonry, brick and/or stone veneer, trim, framing, flashings, eaves, fascias, soffits and/or gable ends) that were either missing, had open gaps/holes/unsealed joints, were not functioning as intended, were deteriorated/damaged and/or had a peeling paint condition. The main issue is the siding/cladding was cupping/curling on all four sides of the exterior. Some of the siding/cladding was pulling off the house with the nails pulling out as a result of the cupping/curling. The condition of the noted elements/areas may worsen as well as possible structural/moisture damage behind/under these elements could occur if the needed repairs are not completed. Damage to the interior finishing materials may also occur. **A further evaluation of the ENTIRE exterior of the dwelling should be completed by a qualified, licensed contractor and the necessary repairs be completed. There may be hidden moisture damage, deterioration and/or wood destroying insect damage within the structure behind/under the effected exterior elements that was not visible at the time of the inspection.**

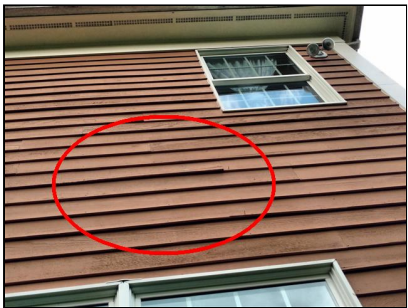
2.0 Item 13 (Picture) Cracked

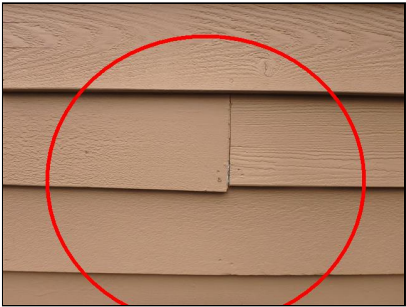
2.0 Item 15 (Picture) Sub standard repair

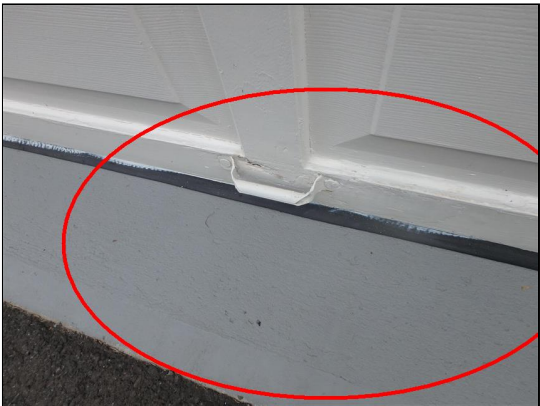
2.0 Item 29 (Picture) Soft spot

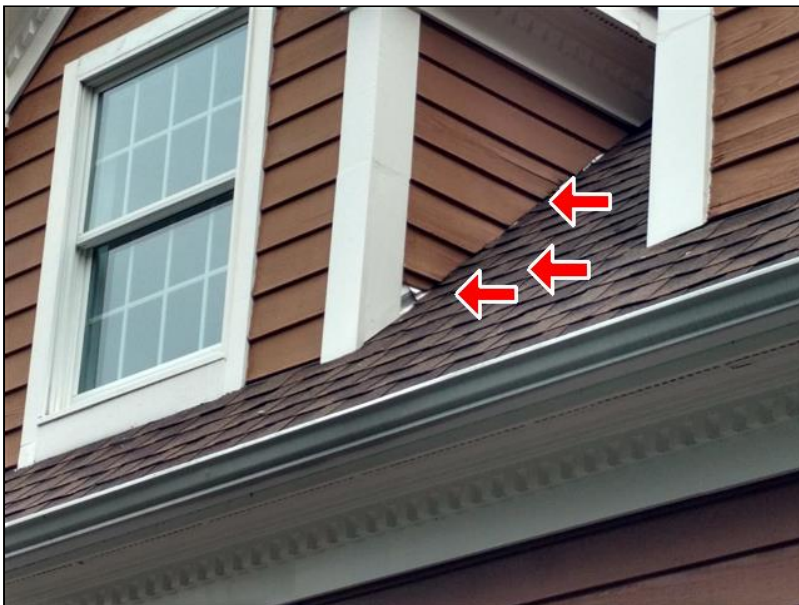
2.0 Item 34 (Picture)

(2) The bottom portion of some of the exterior wood lap siding/cladding was deteriorated slightly as a result of what appears to be excessive moisture present from the roof covering. The roof covering should not be in contact with the wood siding. There should be a 1/2"-3/4" gap between the bottom of any exterior cladding and the roof covering to prevent this type of deterioration. Further deterioration of the wood siding as well as possible moisture intrusion into the structure behind the siding could occur if the needed repairs are not completed. Recommend further evaluation by a qualified, licensed contractor and repair as necessary.

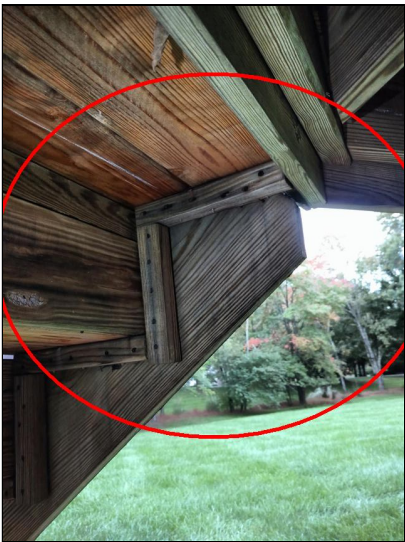
2.10 Item 1 (Picture)

(2) There were numerous issues were observed pertaining to the rear wood deck. They included:

- 1) There were no beam to joist and stair stringer to the deck structure mechanical connectors present.
- 2) There were numerous nails that were sticking up from the deck surface which is a major concern if your walking on the deck with bare feet.
- 3) The staircase was separating from the main deck structure.
- 4) The handrails were loose.

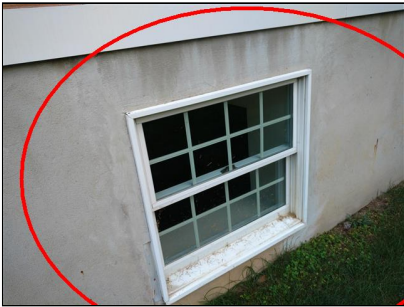
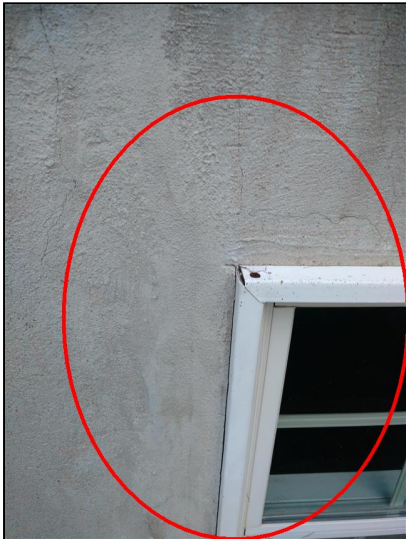
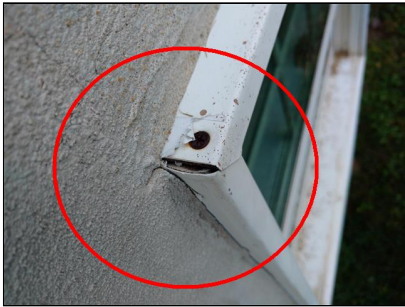
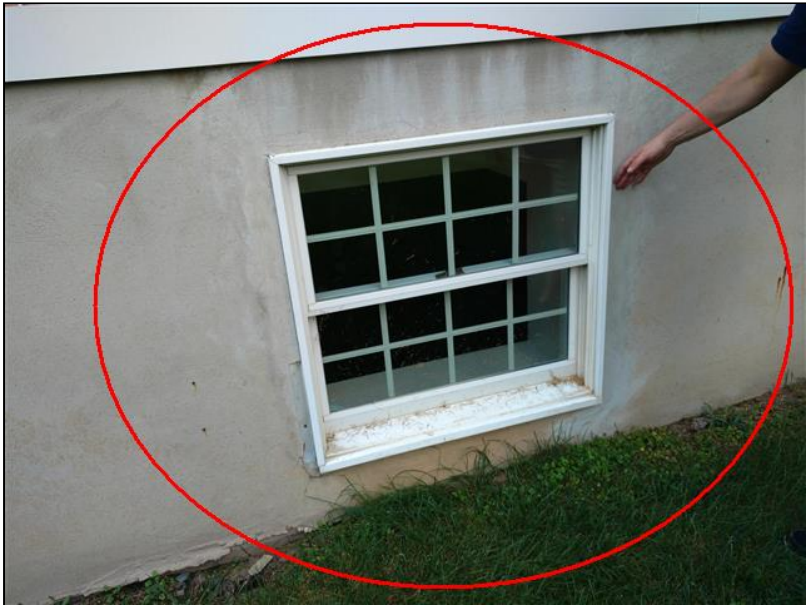
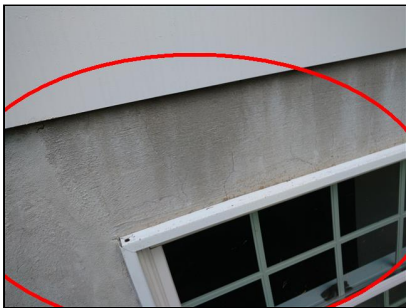
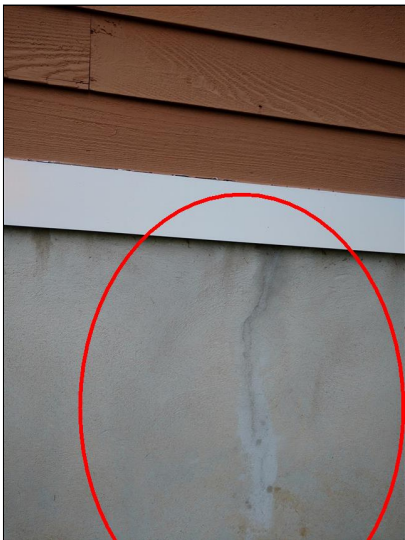
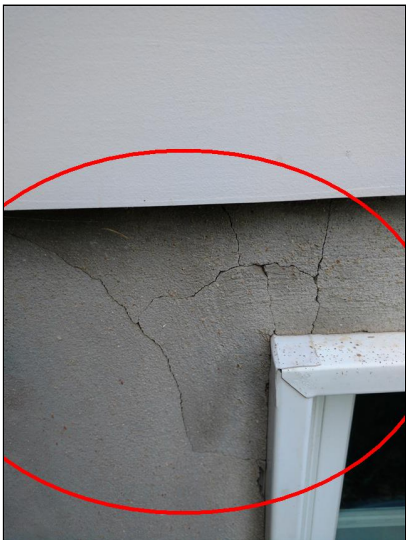
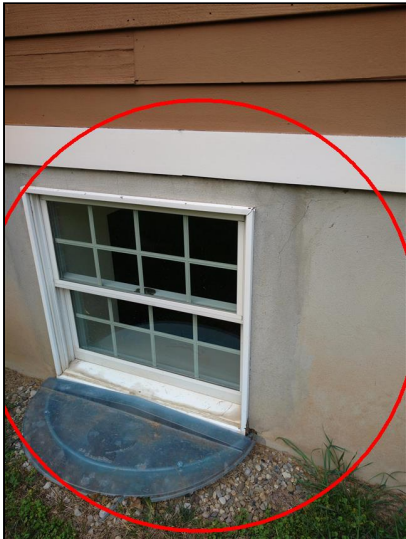
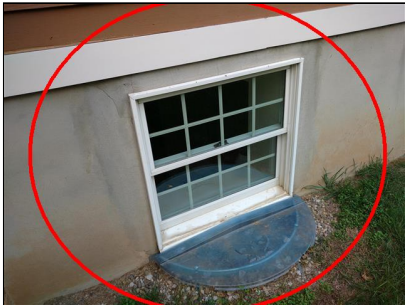
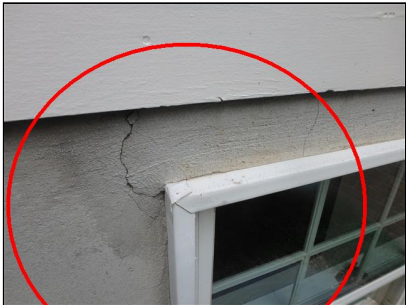
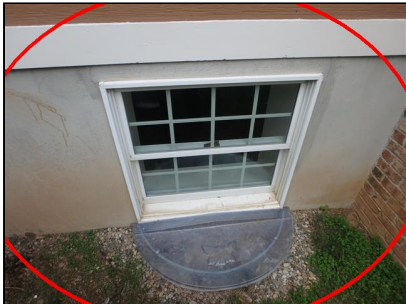
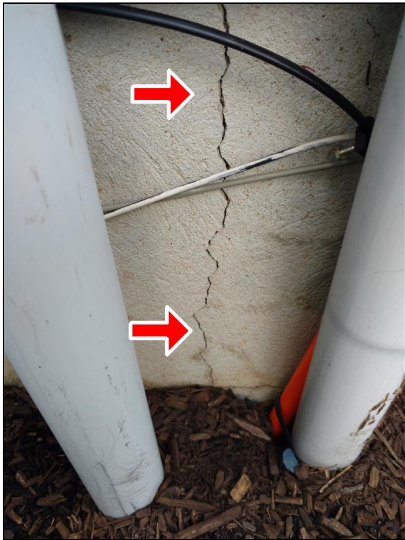
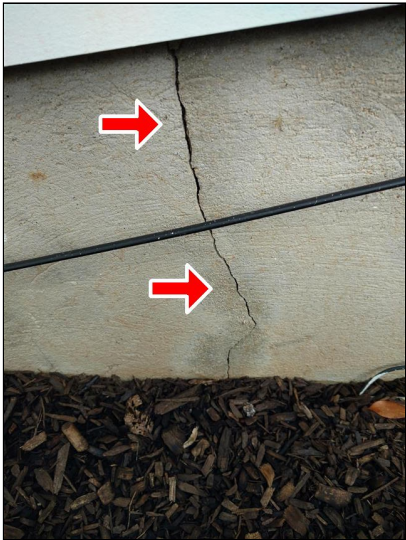
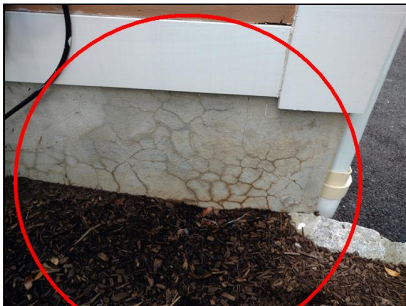
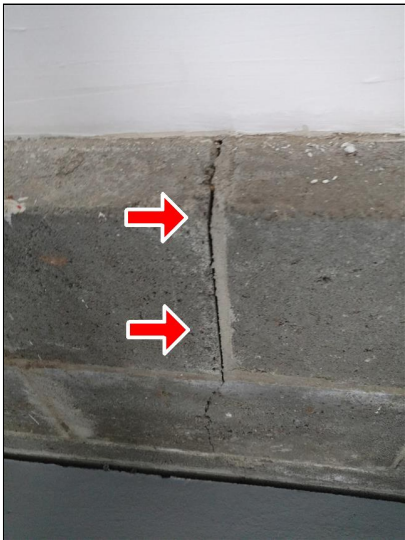
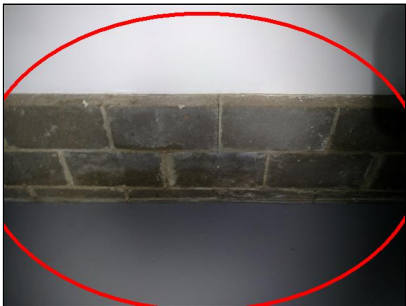
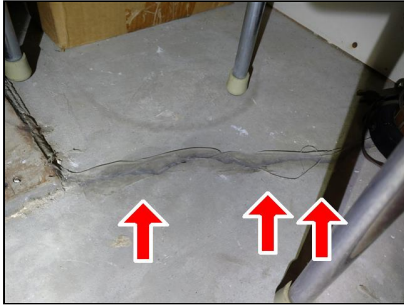
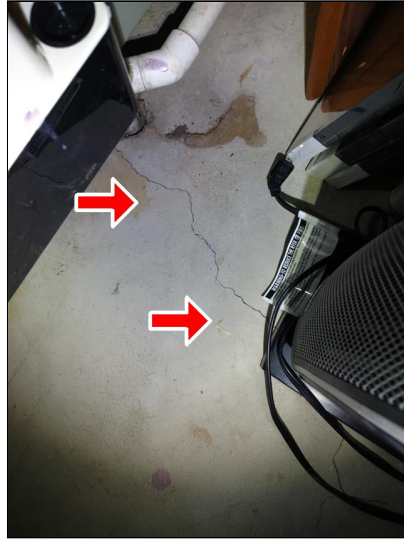
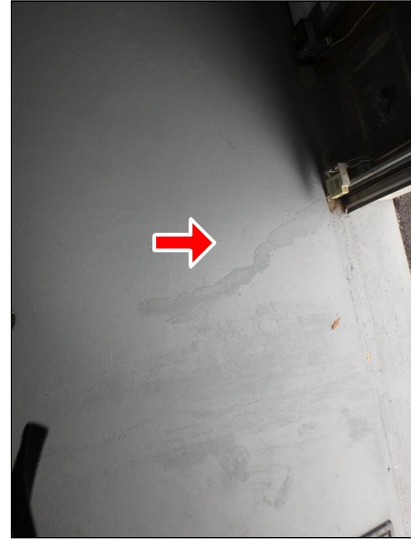
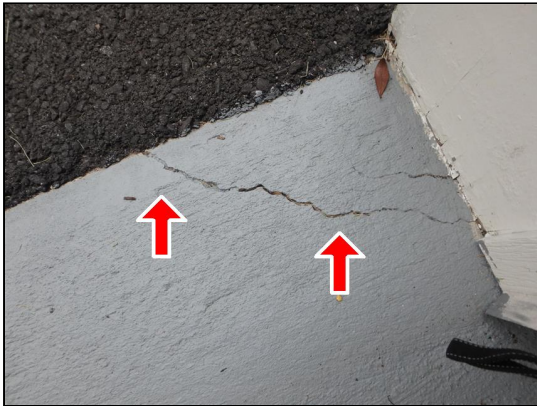
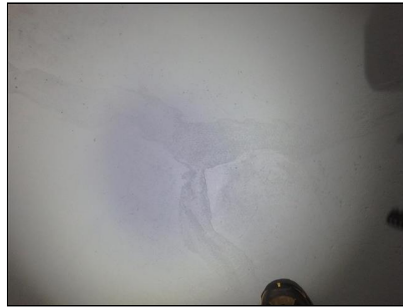
There were numerous cracks and/or deteriorated areas present on some portions of the interior and/or exterior foundation wall/floor surfaces. These conditions if not repaired may lead to possible moisture intrusion into the foundation walls and the basement along with possible deterioration of the foundation walls and the interior finishes of the house. These conditions may also worsen if the needed repairs are not completed. A further evaluation of the ENTIRE foundation (both interior and exterior) should be completed by a qualified, licensed structural contractor and the necessary repairs be completed. **These conditions may also exist behind finished basement walls/floors. They may be less severe or worse than what was visible.**

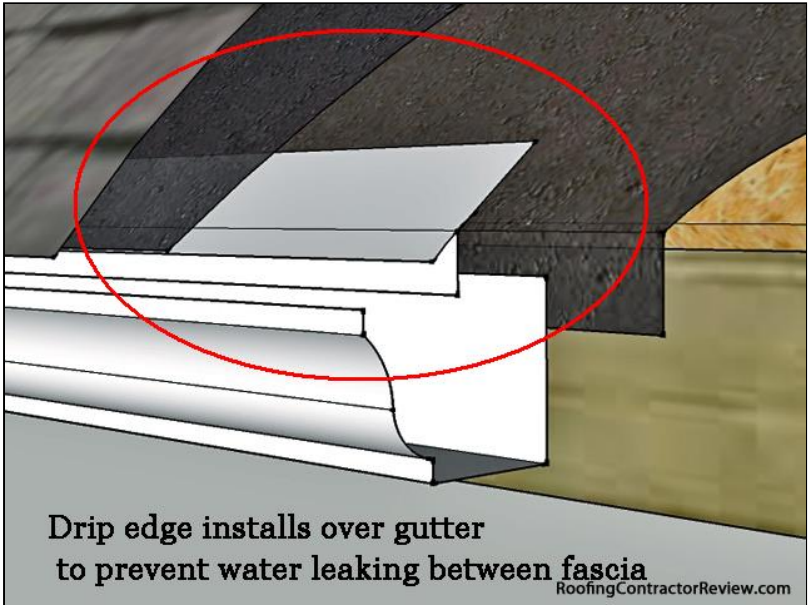
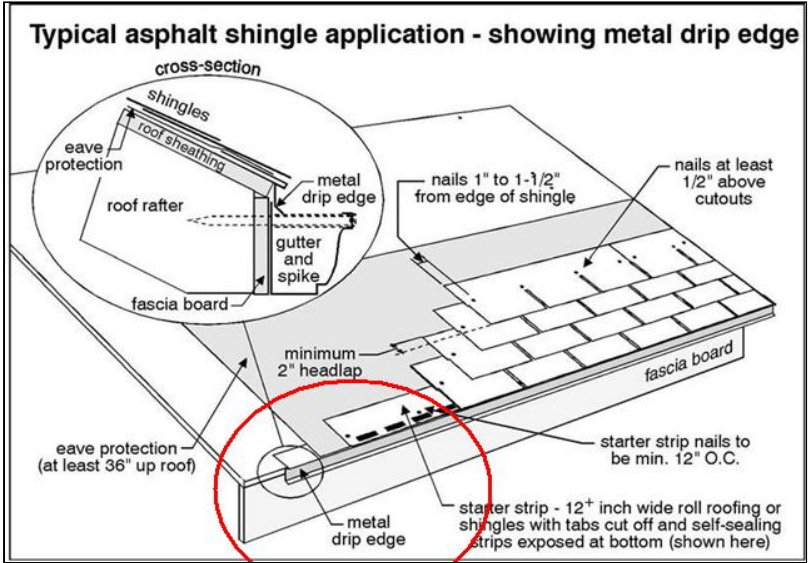
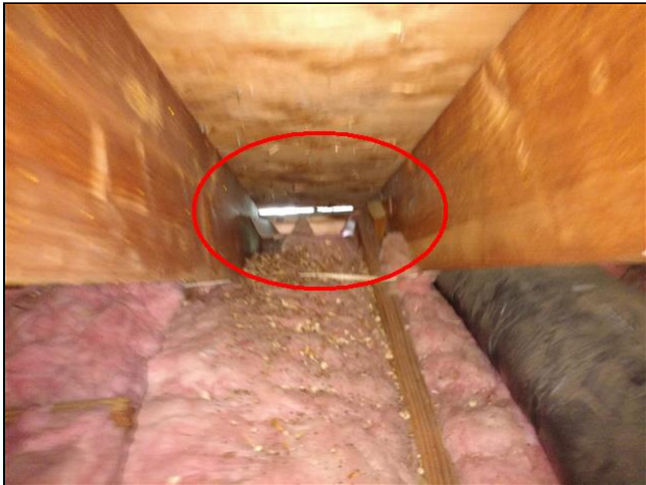
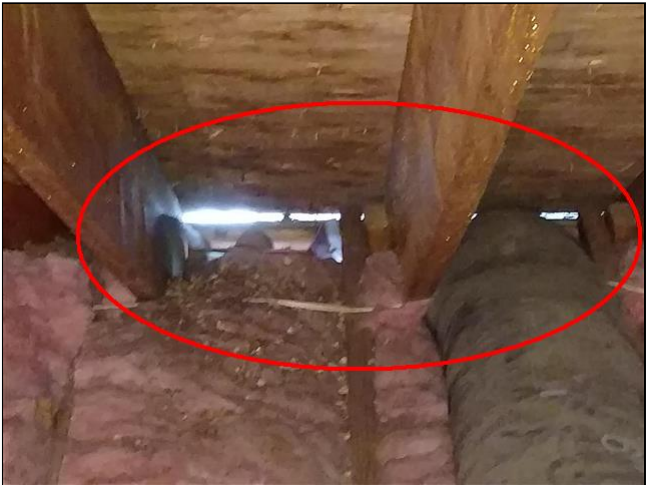
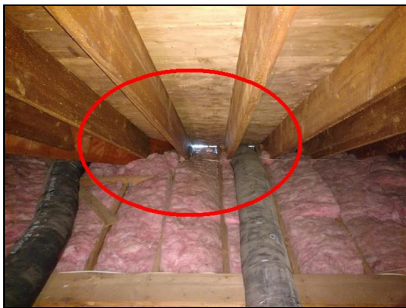
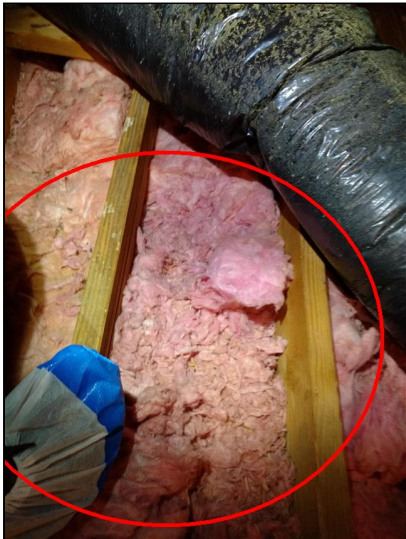
As observed in the rear of the attic space, there were sections where the roof decking meets the fascia board that daylight could be seen. You should not see any daylight at these joints as there should be drip edge flashings that go over the roof decking and then wrap down onto the fascia board. Drip edge flashings may not be present. **The concern is these gaps may allow unwanted wildlife (insects, mice, etc) to get into the attic space.** Recommend further evaluation by a qualified, licensed contractor and repair as necessary.

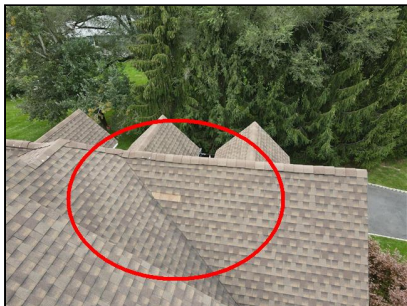
5.0 Item 1 (Picture)

Just to note, there were a few shingles that appeared to have been repaired. The seller's disclosure noted these shingles were repaired due to damage from the recent hurricane Ida storm. There was some previous moisture staining on the roof structure in the attic space under this space. The roof structure was dry at the time of the inspection. It is unknown why these shingles failed.

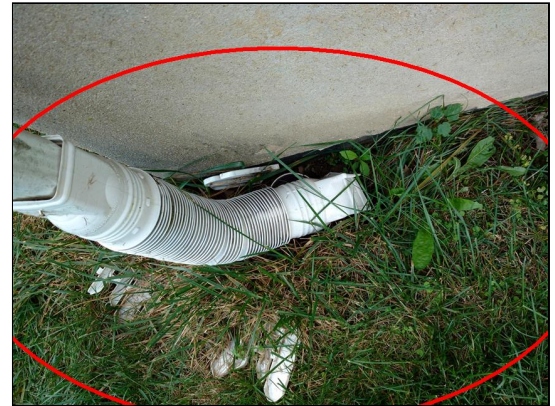
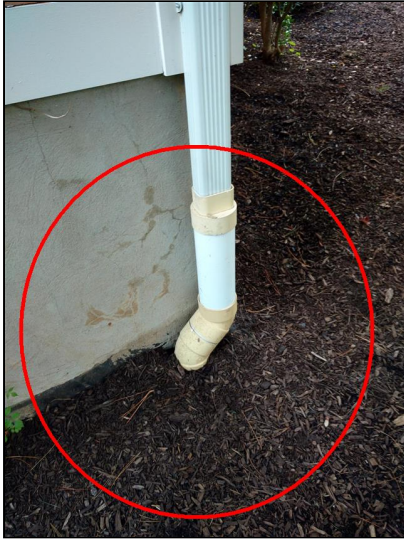
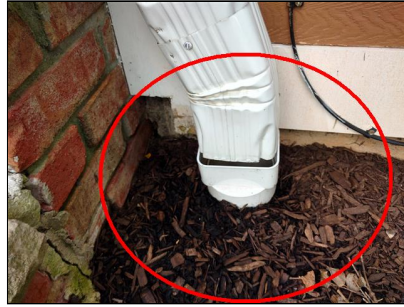
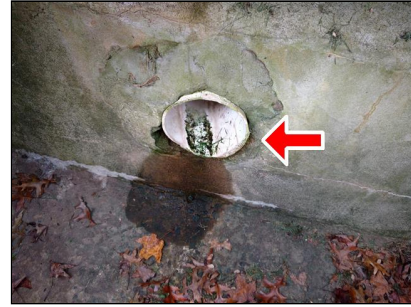
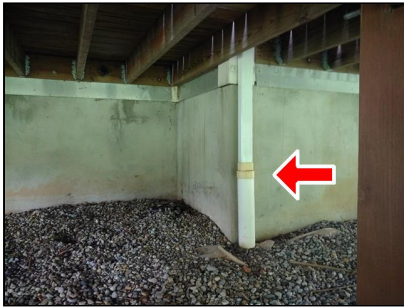
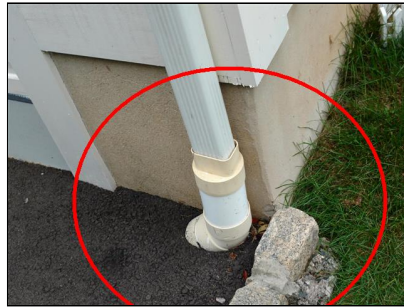
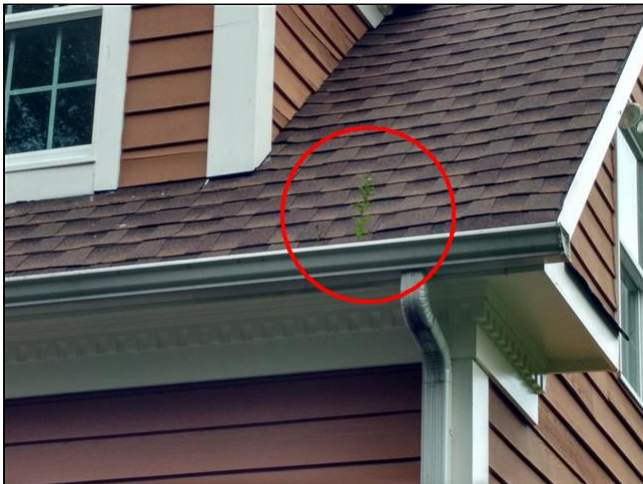
The downspouts that are not directed into underground drainage pipes should be extended at least 4-6 feet (or as far away as possible) from the foundation of the house. Ideally, they should be extended away with rigid downspout material or PVC pipe. The accordion style extenders that are sometimes present often fail, deteriorate and may collect water in the ripples where mosquitos may breed in the standing water. Extending the downspouts helps shed water away from the foundation. Water can weaken and deteriorate the foundation and can possibly migrate into the basement. Recommend extending the downspouts as necessary. Also to note, some of the downspouts are currently piped into underground drainage. While this is a great arrangement as it is supposed to carry the roof runoff water away from the house, it is unknown if the system is functional and not clogged with debris. If the underground drainage gets clogged, the water may spill out at the downspout connection and possibly migrate into the foundation/basement. It should be ascertained as to where all this underground drainage is draining to. **Also, it is recommended a further evaluation and testing of the ENTIRE underground drainage piping/system be completed by a qualified, licensed contractor to insure it is fully functional and not clogged with debris.** Any needed repairs should be completed. There was also a downspout in the left rear corner that was not connected to the underground drainage and was discharging its water right next to the foundation. This may result in moisture intrusion. In addition, the gutter above the garage needs to be cleaned out as there was vegetation growing out of it.

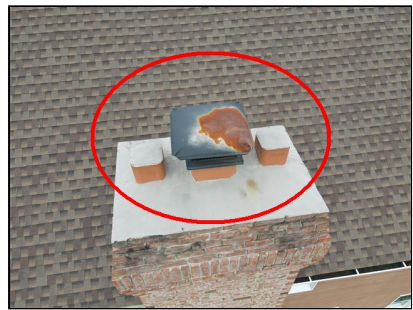
5.5 Item 1 (Picture)

solid fuel burning appliance, or following an external event likely to have caused damage. Our inspection of the fireplace(s) and/or chimney components is limited to the readily, visible components/areas. This visual inspection is not adequate to discover hidden deficiencies or damage should they exist. A NFPA 211 Standard, Level 2 inspection entails the use of specialized tools and testing procedures, such as video cameras, etc., to thoroughly evaluate/inspect the chimney(s) and/or fireplace(s) system/components. Therefore, it is highly recommended a level 2 inspection of all of the fireplaces and/or chimneys pertaining to the dwelling be performed before closing and/or any contractual deadlines. Additional information pertaining to fireplace/chimney inspections can be found in Chapter 14 of the NFPA 211 standard. <http://www.nfpa.org/codes-and-standards/document-information-pages?mode=code&code=211> Also to note, the chimney flue cap was rusted which may cause staining to the chimney crown and the side of the chimney.

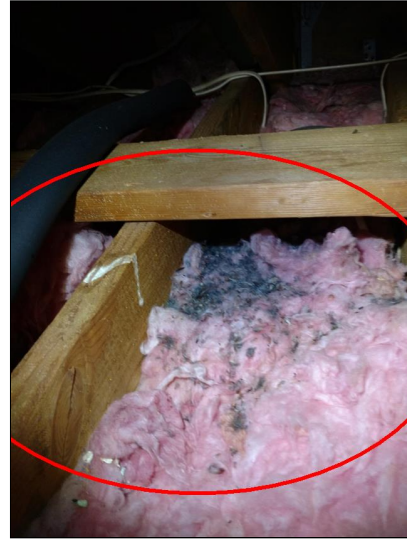
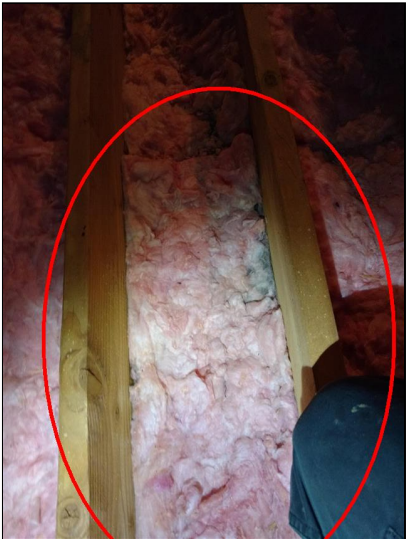
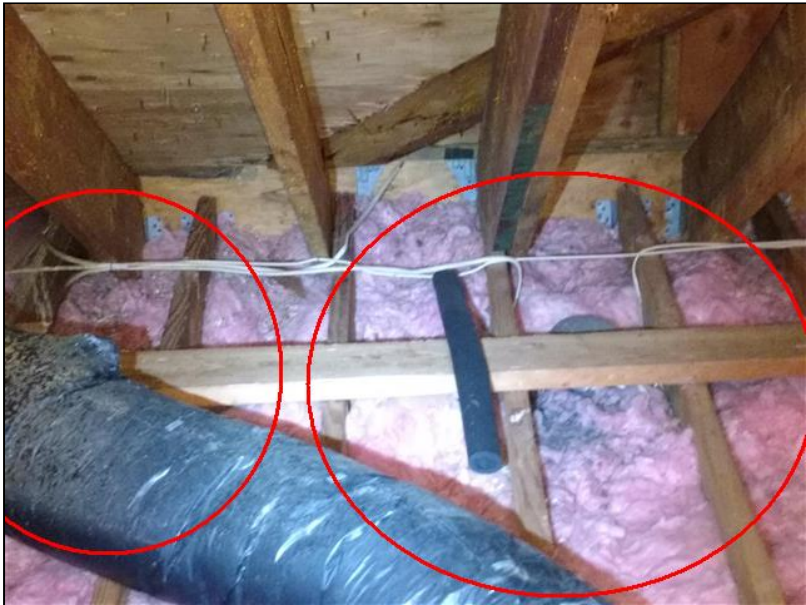
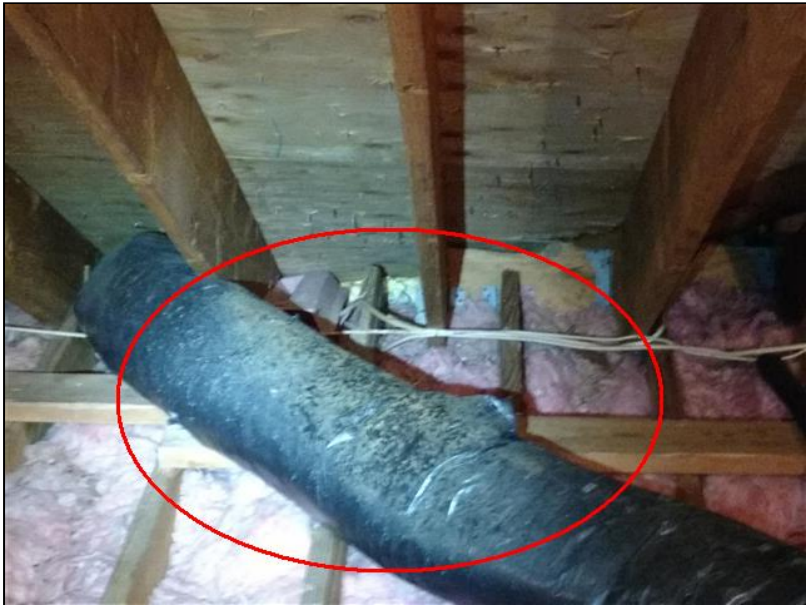
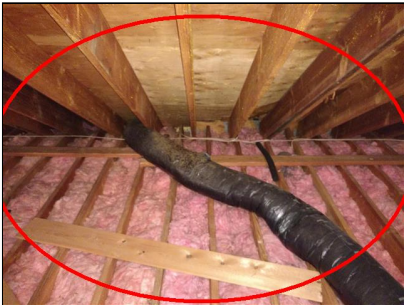
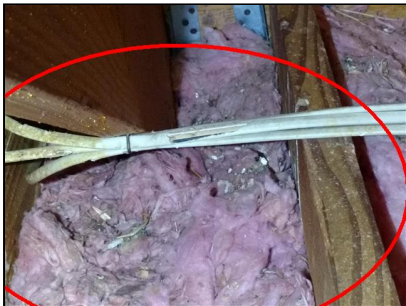
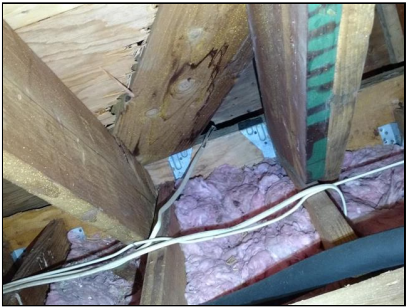
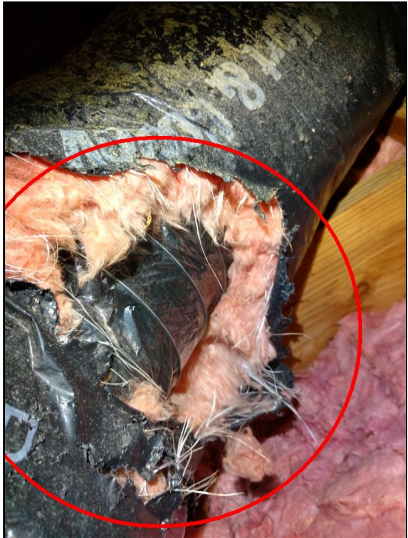
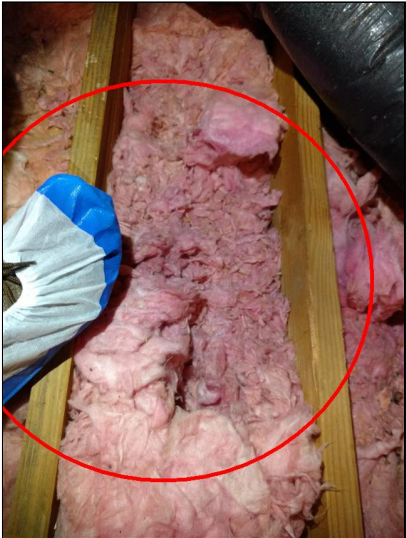
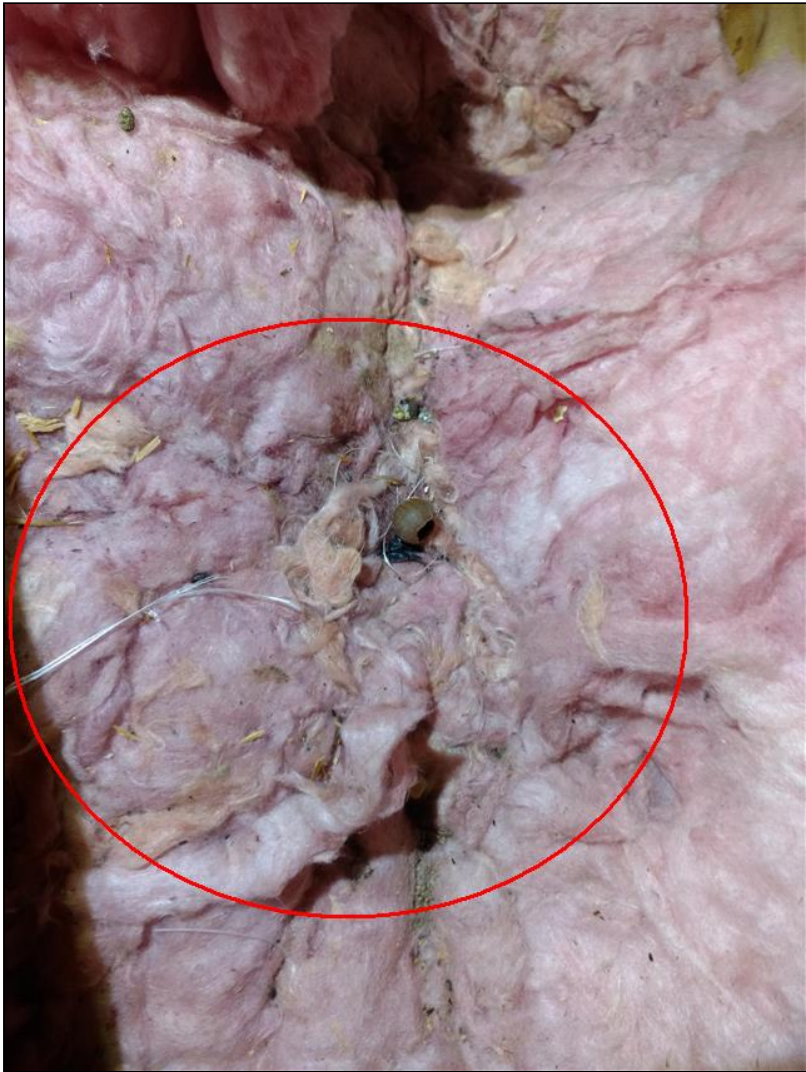
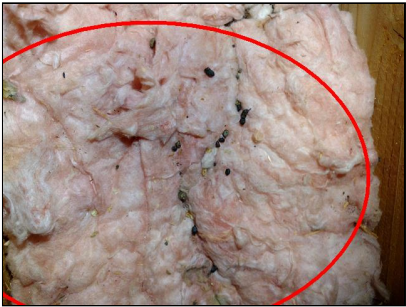
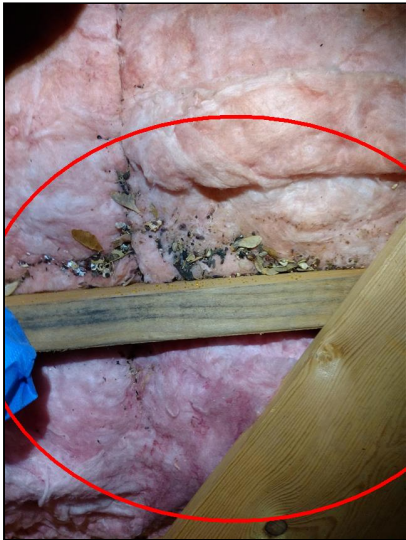
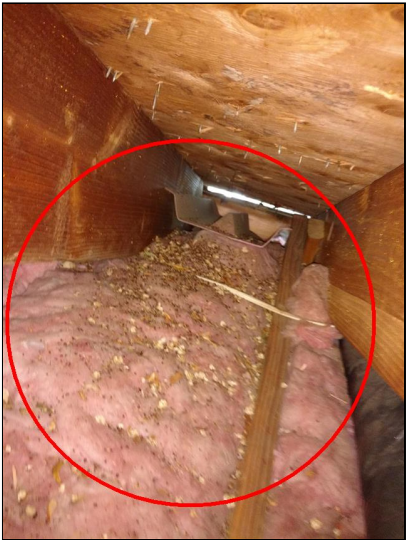
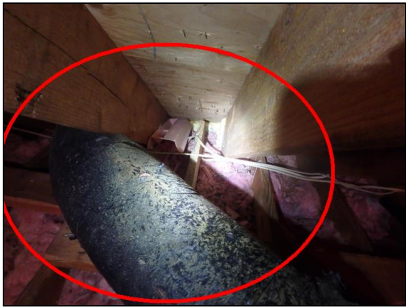
There was what appeared to be fecal matter/possible urine from mice/squirrels or similar vermin observed in numerous areas in the attic space as well as several areas of the attic insulation that was damaged. There was also a section of the HVAC ducting that was damaged along with sections of the electric wiring. This is a health concern. **A further evaluation of the ENTIRE attic space should be completed by qualified, licensed pest control professional and the necessary repairs/remediation should be completed ASAP. The wiring needs to be repaired by a qualified, licensed electrician and the insulation should be repaired by a qualified, licensed contractor. The access points into the attic space should also be repaired/sealed up.**

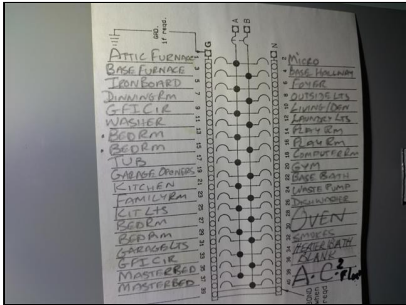
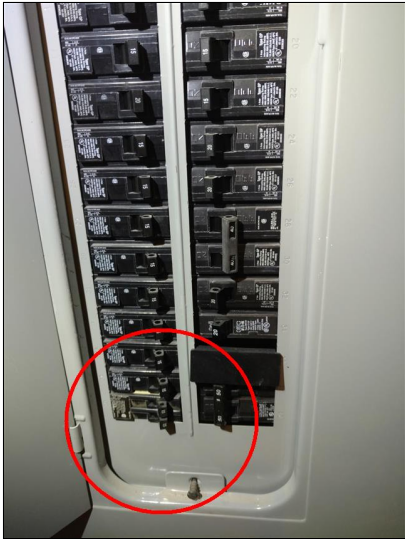
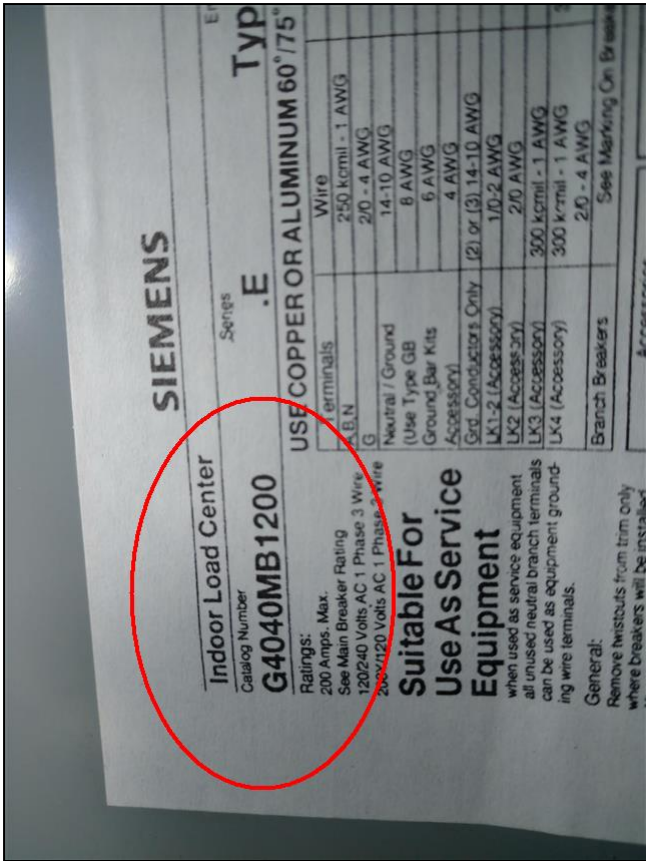
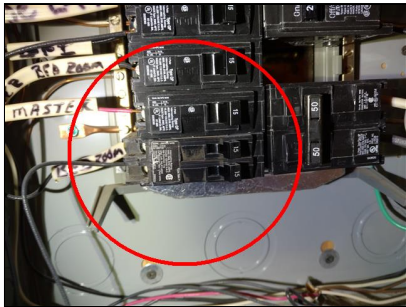
There was a tandem circuit breaker observed in the main electric service panel. Per the manufacturer's panel specifications, it is believed tandem circuit breakers are not permitted in this electric panel. This is a safety concern and potential fire hazard. Recommend a further evaluation of this panel by a qualified, licensed electrician to insure tandem circuit breakers are safe for use in this panel and make any necessary repairs.

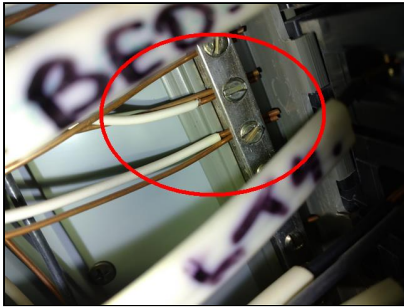
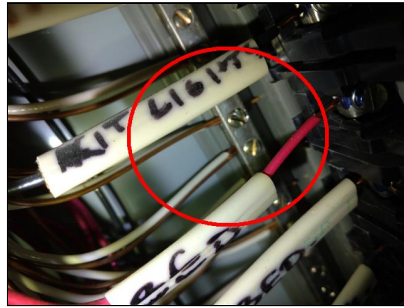
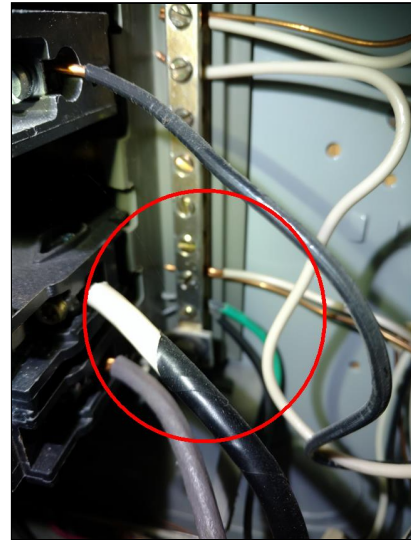
(1) There were grounded (neutrals) and grounding wires that were doubled up under the same terminals (lugs) on the neutral bus bar in the main electric service panel. The connection of grounded and grounding wires in this situation creates a significant problem. One of the objectives of a correct arrangement of bonding jumpers, neutrals and grounding wires is to allow for circuit isolation if the electrical system needs to be worked on. Also most panels are only designed for one grounded wire per lug. The wires could come loose and heat up if they are double lugged. This requirement has been generally been enforced in the past by a close review of the manufacturer markings and by NEC 110.3 (b). Clause 12.3.10 of UL 67 (panelboards) states, "Each neutral conductor shall terminate within the panel board in an individual terminal that is not also used for another conductor". Recommend having a qualified, licensed electrician make all the corrections necessary to ensure the safe and proper operation of the service panel.

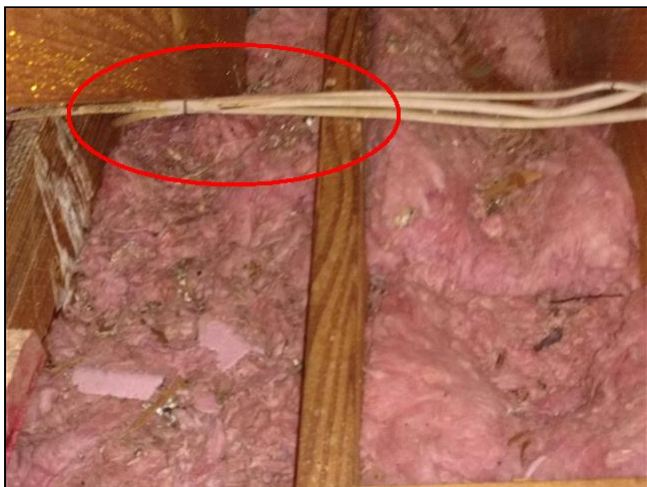
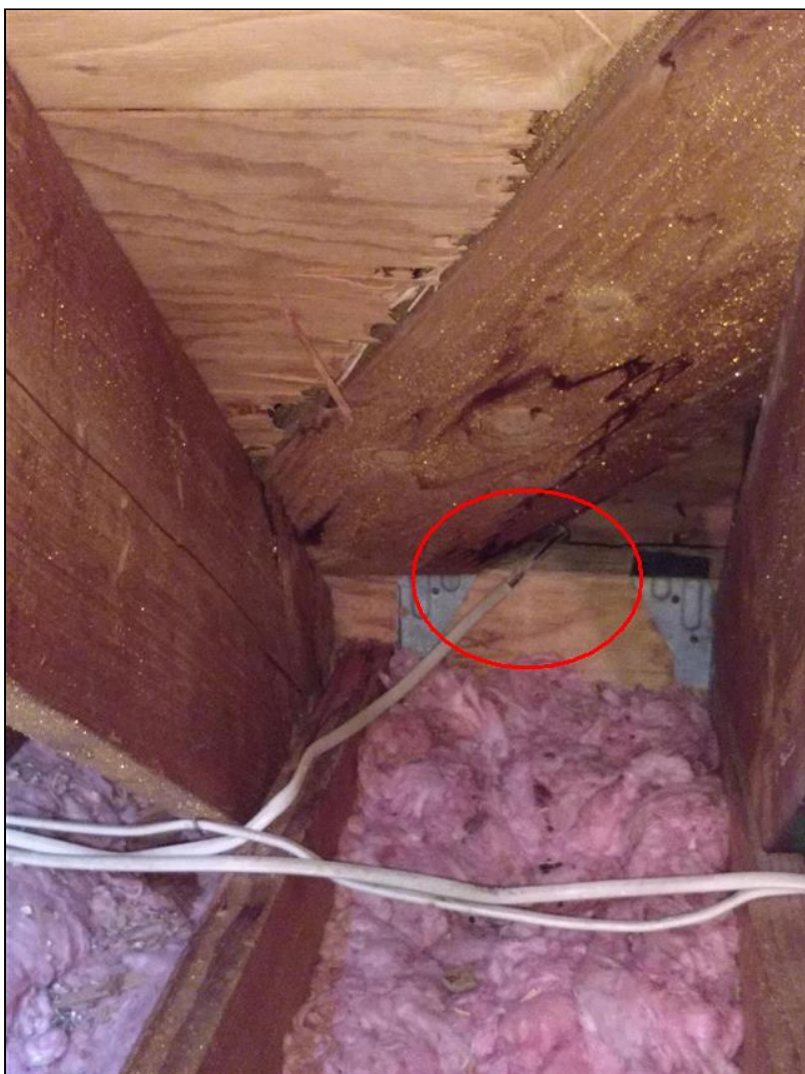
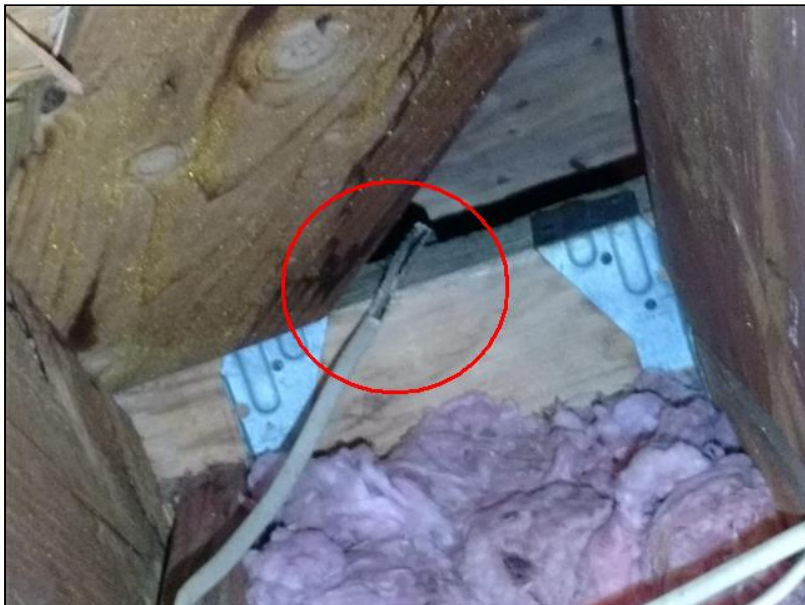
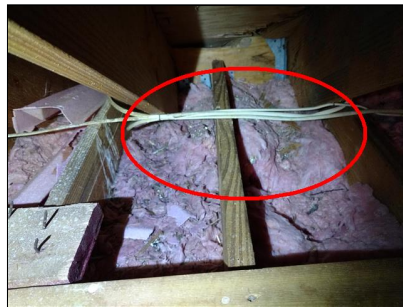
(2) As observed in the front portion of the attic space, there was at least two visible sections of the electric circuit branch wiring that were chewed/damaged from what was assumed to be a squirrel/mice, etc. There was other damage to the attic space. This is a MAJOR safety concern and a fire hazard. There may be other damaged wiring that was not visible. **The necessary repairs should be completed ASAP and ALL of the circuit branch wiring in the attic space should be further evaluated by a qualified, licensed electrician.**

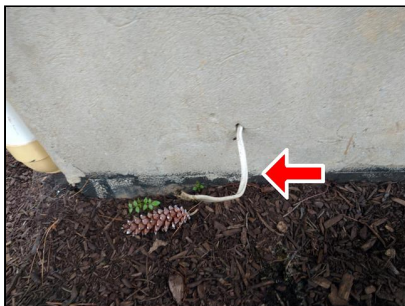
7.7 Item 9 (Picture)

(4) There was a wire sticking out of the front foundation wall. The wire was not live at the time of the inspection. This is a safety issue and a potential fire hazard. Recommend further evaluation by a qualified, licensed electrician and repair as necessary.

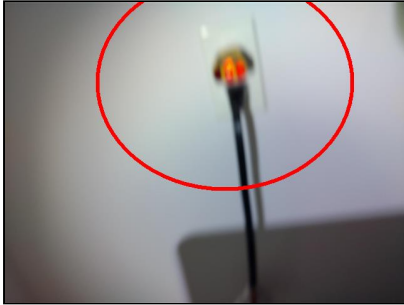
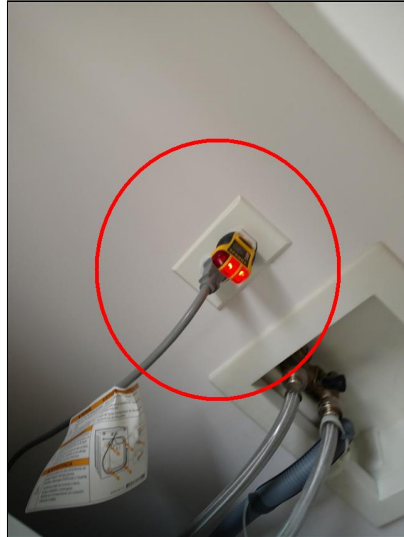
(1) The electric receptacle located behind the laundry area was not GFCI protected. Receptacles located on the exterior, in garages, kitchen sink area, bathrooms and laundry areas should be GFCI protected. A ground fault circuit interrupter (GFCI) is a device (outlet or circuit breaker) that shuts off an electric power circuit when it detects that current is flowing along an unintended path, such as through water or a person. It is used to reduce the risk of electric shock. They can also prevent fires, like when a live wire touches a metal conduit. For safety purposes, would recommend upgrading this receptacle.. This should be done by a qualified, licensed electrician.

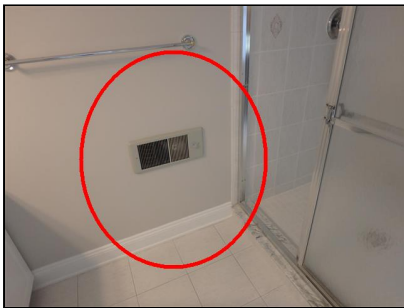
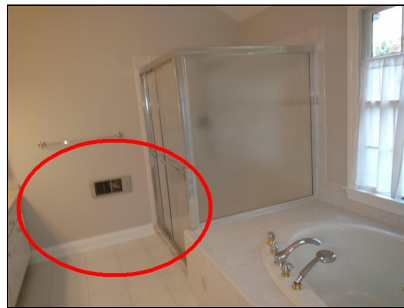
(2) There was a wall mounted electric heater present in the master bathroom. This is a safety issue as this heater is very close to an open water source and it is not appear to be GFCI protected. For safety, GFCI protection is required in all areas within a close proximity of a water source. A ground fault circuit interrupter (GFCI) is a device (outlet or circuit breaker) that shuts off an electric power circuit when it detects that current is flowing along an unintended path, such as through water or a person. It is used to reduce the risk of electric shock. They can also prevent fires, like when a live wire touches a metal conduit. For safety purposes, I would recommend a further evaluation of this heater for GFCI protection to be done by a qualified, licensed electrician.

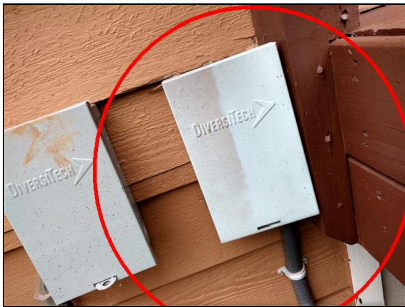
7.8 Item 6 (Picture)

(3) One of the A/C disconnect switches front cover would not close all the way. It was hitting the deck. Recommend further evaluation by a qualified, licensed electrician and repair as necessary.

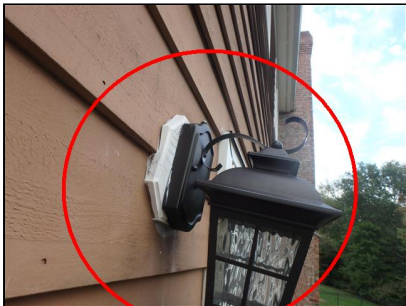
7.8 Item 7 (Picture)

(4) As observed on the exterior, some of the light fixtures were loose. Also, these light fixtures should be caulked/ sealed on the top and sides of them to prevent water from getting into the wiring and the electric box they are connected to. A further evaluation of all of the exterior light fixtures should be completed by a qualified, licensed electrician and the necessary repairs should be completed.

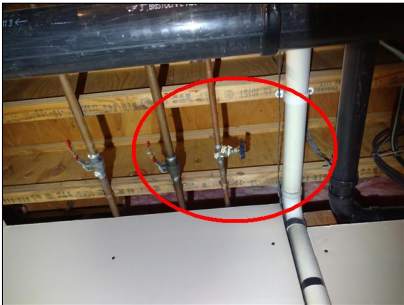
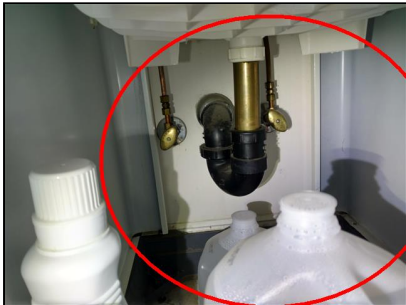
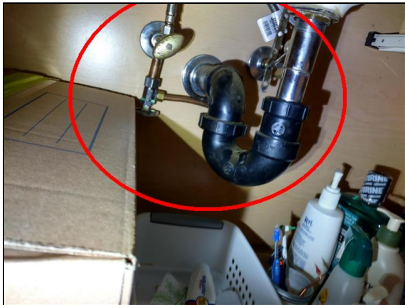
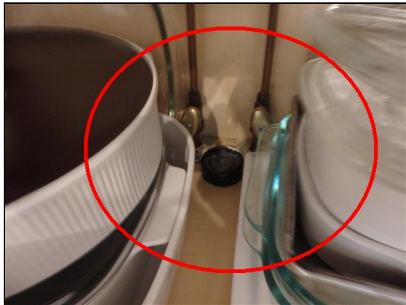
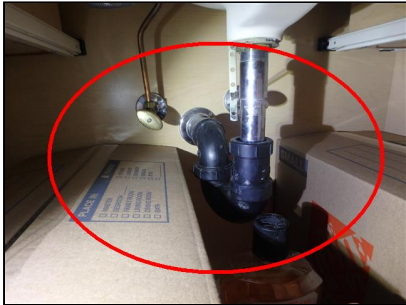
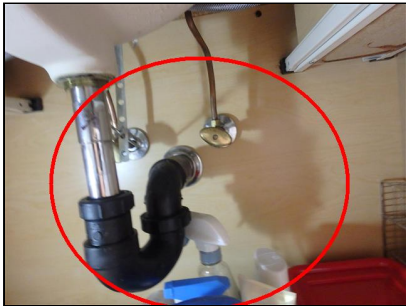
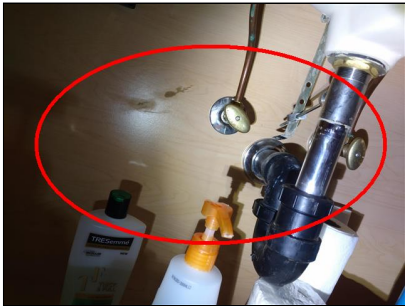
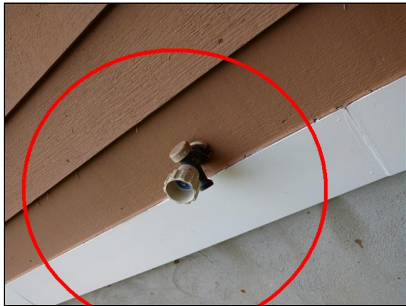
Testing of the water shut off valves located throughout the dwelling (especially the ones located in basements, crawlspaces, under sinks, behind toilets, etc.) and on the exterior for functionality is beyond the scope of the home inspection. Sometimes if the valves are turned/tested even just slightly, they may start to leak due to mineral buildup on the packings/seals. Also, due to age, corrosion and/or mineral buildup that may be on them, they may or may not function properly in the future in the event of an emergency or a need to service part of the plumbing system.

**Therefore, a further evaluation of ALL of the water shut off valves in the dwelling (basement, under sinks, behind toilets, etc.) and any on the exterior should be completed by a qualified, licensed plumber and any necessary repairs/valve replacements should be completed.**

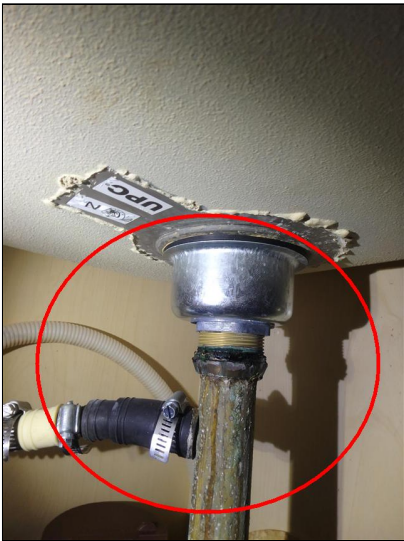
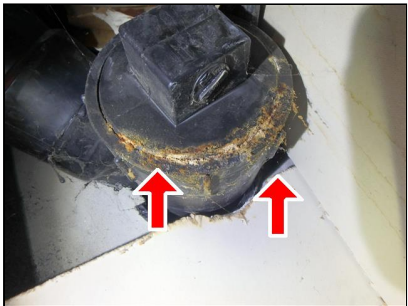
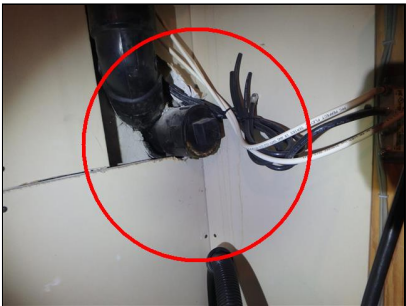
(1) As observed in the dwelling, there were numerous sections of the DWV (drain, waste, vent) piping that were ABS. While the interior visible portions appeared to be in a serviceable condition, the underground portions may be compromised. The main concern is the portions that run from the house to the sewer main. To insure the main DWV system is 100% functional, it is recommended the DWV piping be scoped by a qualified, licensed plumber/professional to ascertain the integrity of such piping.

(2) The kitchen sink drain was leaking. If this leak is not repaired, moisture damage to the surrounding area and/or a mold condition could occur. Also to note, in the basement next to the electric panel, one of the clean out plugs on the ABS DWV piping may be leaking. There was staining on the outside of the pipe. Recommend further evaluation by a qualified, licensed plumber and repair as necessary.

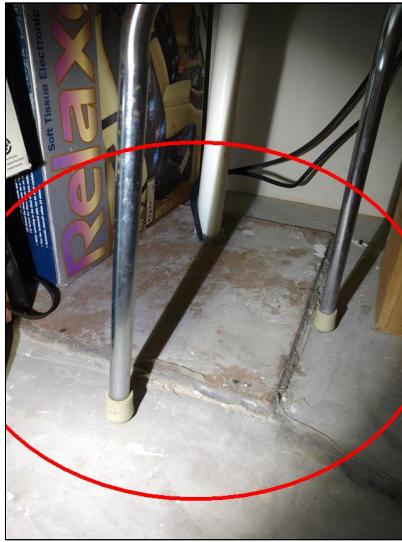
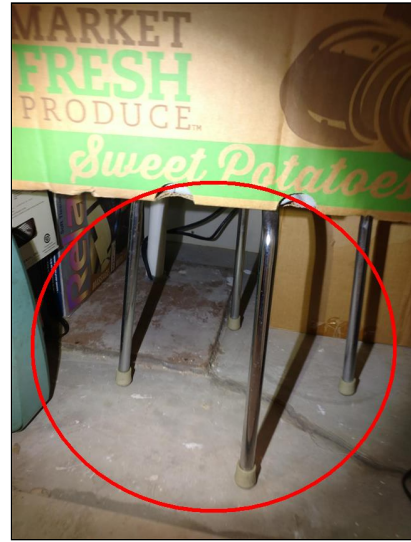
The top covers on the sump pump pits were sealed and could not be removed to check the operation of the sump pumps. Therefore, the inspection of the sump pumps, discharge piping and the sump pump pits was limited. The sump pumps could not be manually tested for proper functionality and may not be functional. The sump pumps should be further evaluated/tested by a qualified, licensed plumber to make sure it is functioning as intended to avoid possible flooding of the basement. Any needed repairs should be completed.
