# Property Inspection Report

**Property Address:**  
9 Big Court  
Great City New Jersey 07000

**Frank Glomb**

**Terra Home Inspections LLC**

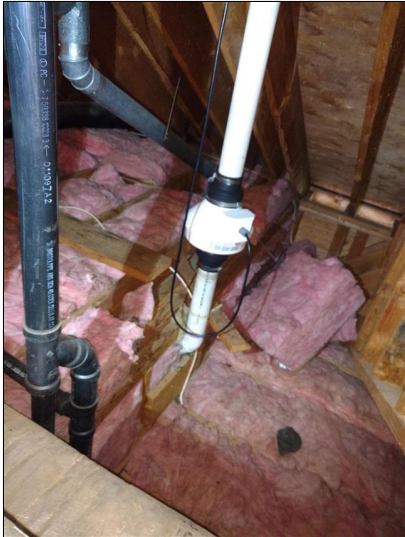
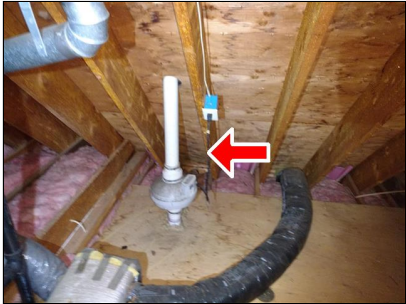
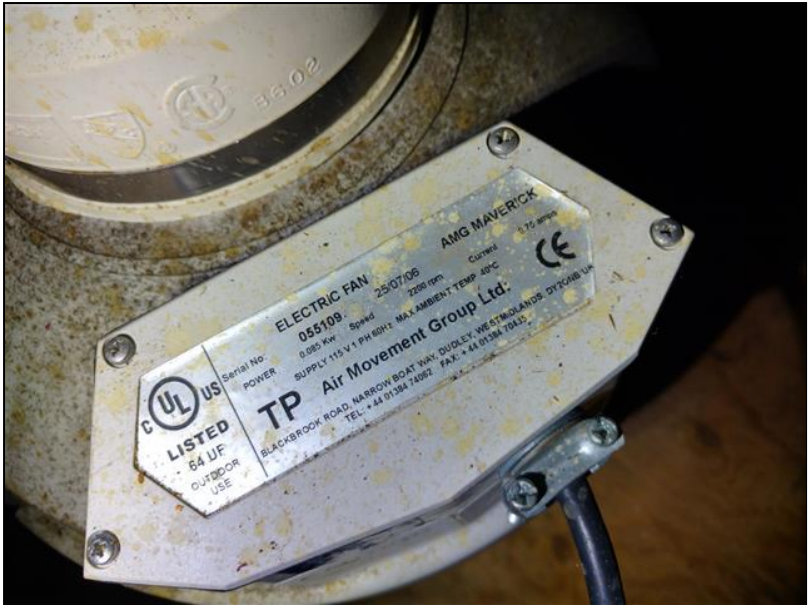
There were two active radon mitigation systems present. The suction fans were located in the attic and the basement was finished. The suction pipes/points in the basement could not be viewed. The radon systems did not have a warning device. A warning device must be installed to alert you if an active system stops working properly. Examples of system failure warning devices are: a liquid gauge, a sound alarm, a light indicator, etc. The warning device must be placed where it can be seen or heard easily. This is a concern as not having potentially non-functioning radon mitigation systems is a health hazard for the occupants. **A further evaluation of the ENTIRE radon mitigation systems should be completed by a state licensed radon mitigation contractor and the necessary repairs should be completed to insure the safety of the occupants.**

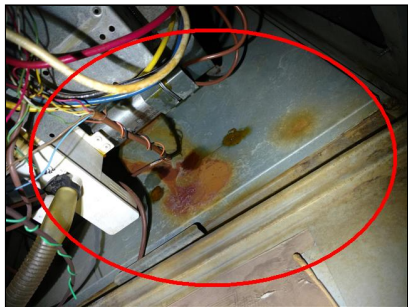
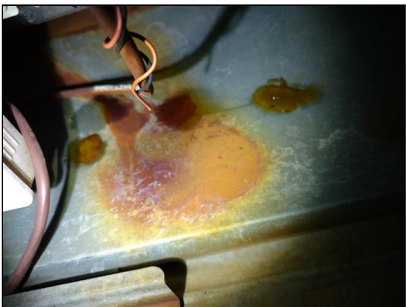
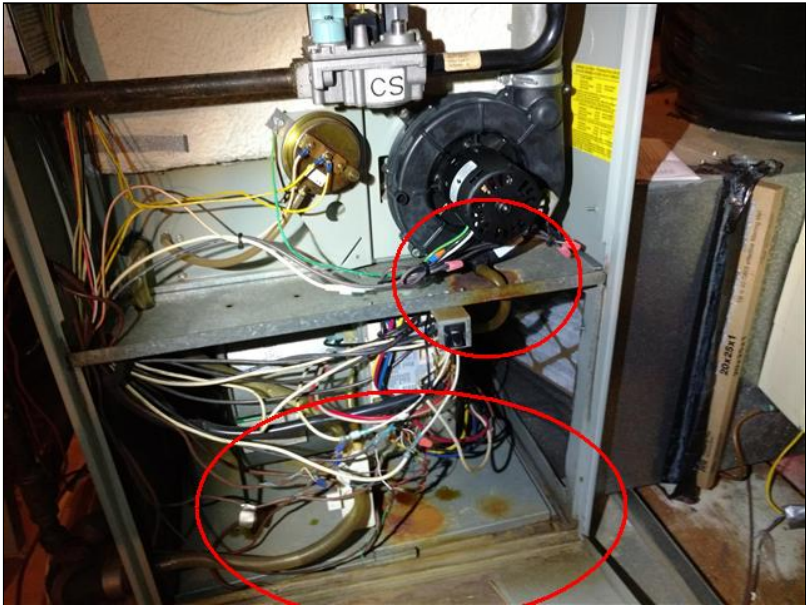
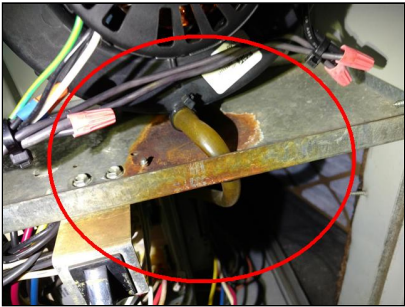
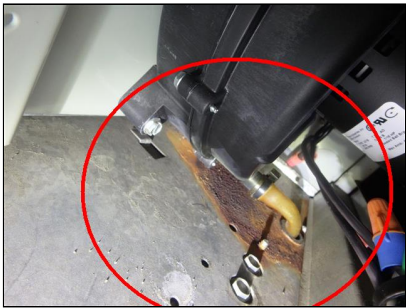
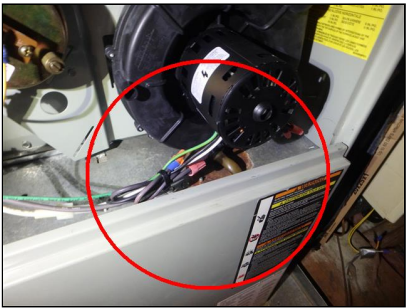
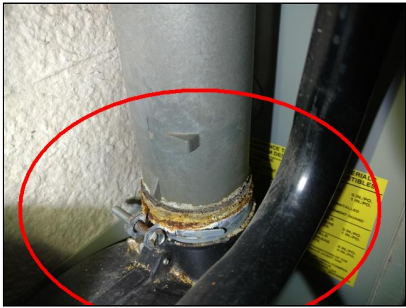
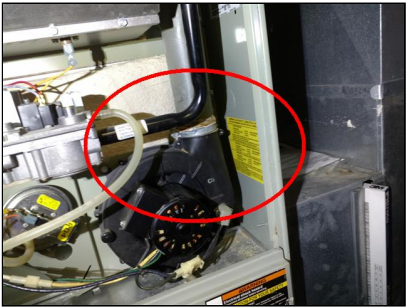
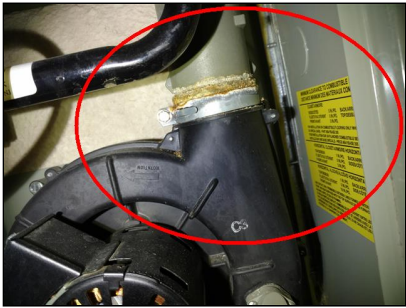
(3) As observed in attic furnace, these was water stains in the top compartment under the draft inducer blower unit. The attic unit had a large amount of rust in the bottom compartment as well. The draft inducer or surrounding components may be leaking. This condition may cause moisture damage to the furnace as well as affect the performance of the furnace. There was also some corrosion on the draft inducer in the basement furnace. **A further evaluation of BOTH of the furnaces should be completed by a qualified, licensed HVAC professional and any necessary repairs be completed. As noted elsewhere, these units were original and around 25 years old.**

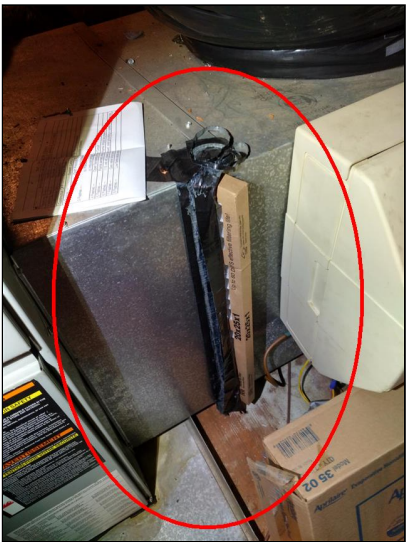
10.5 Item 2 (Picture)

The installed disposable type filters for the HVAC units were not the proper size for the return air ducting they are installed in. The filter should be inside the ducting and the opening in the ducting for the filter should be covered. This is a potential health concern as it may effect the indoor air quality as well as possibly changing the pressure balance of the system. It could also cause the water heater to possibly backdraft. Recommend further evaluation by a qualified, licensed HVAC professional and repair as necessary.

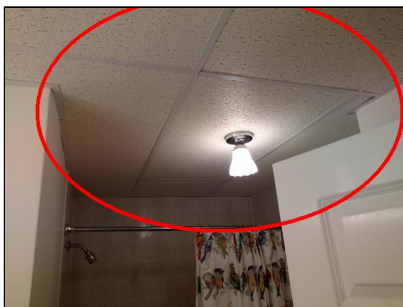
12.1 Item 2 (Picture)

There was a drop ceiling present in the basement bathroom which covered the entire ceiling. This is an issue as the metal framing could possibly rust due to the moisture while taking a shower and also moisture could possibly get trapped in the space above the drop ceiling and the floor subfloor above. Mold could possibly form on the ceiling tiles as well as the space above the drop ceiling. There was an exhaust fan in the bathroom but it was in the toilet closet and not in the central shower area.. Recommend further evaluation by a qualified, licensed contractor and repair as necessary. Also to note, there was a crack ceiling tile in the basement.

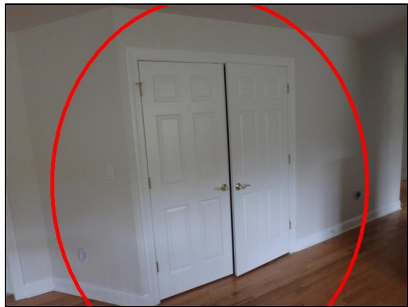
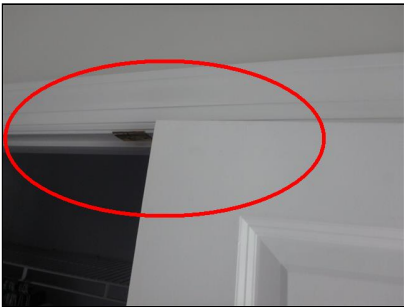
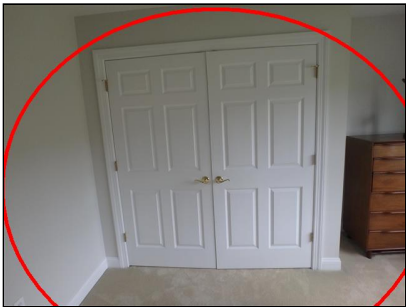
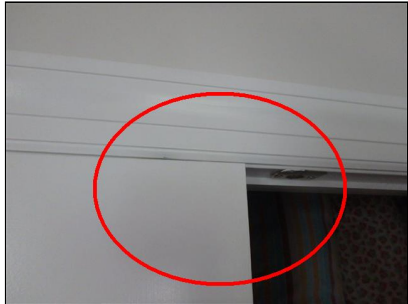
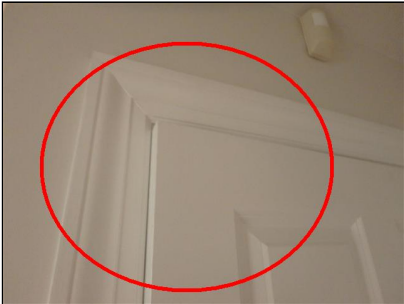
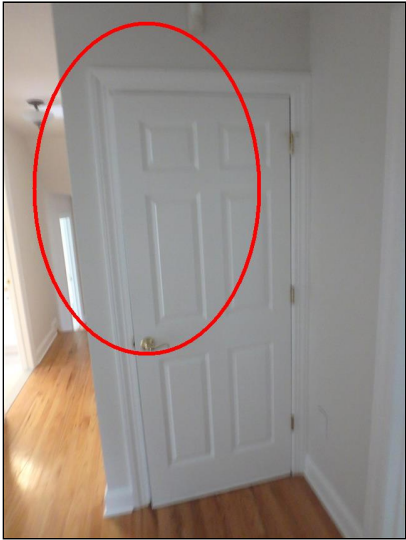
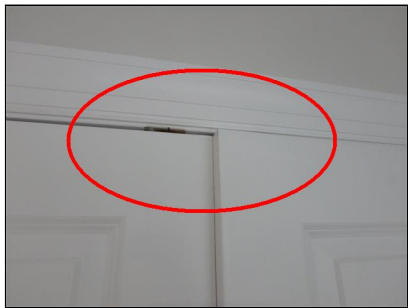
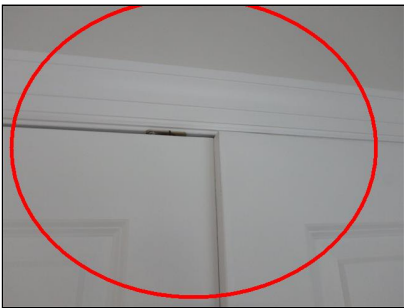
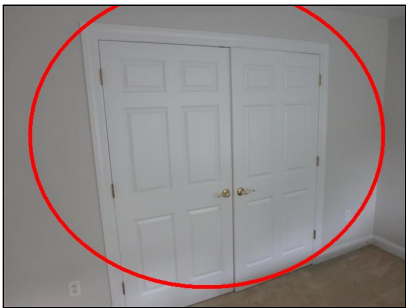
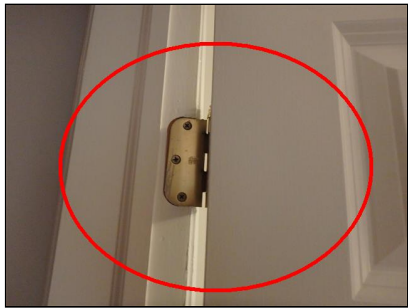
As observed on the 2nd floor, there were numerous doors that would either not close all the way and latch, were damaged/deteriorated, were rubbing on their door frames, were not functioning as intended and/or had missing and/or damaged hardware. These conditions may worsen as well as possible future damage to the doors/door frames if the

necessary repairs are not completed. A further evaluation should be completed by a qualified, licensed contractor and the necessary repairs be completed.

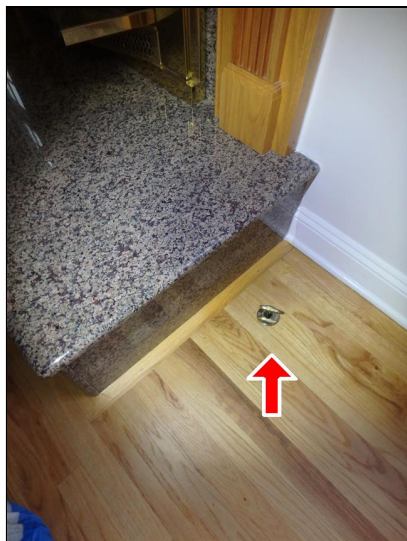
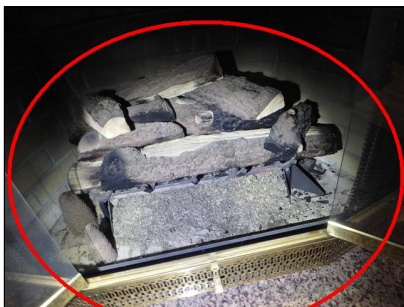
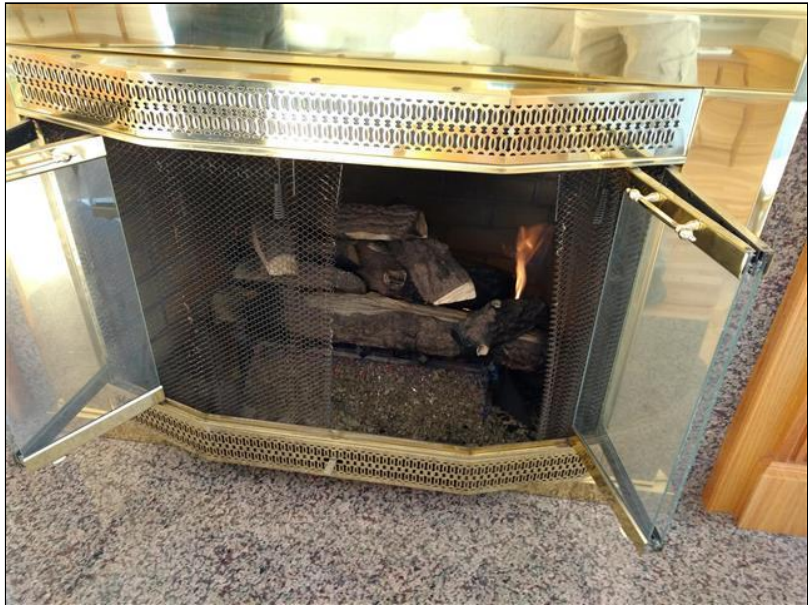
(2) The natural gas fueled fireplace in the rear family room would not light under normal controls. Therefore, it could not be tested for proper functionality and was only visually inspected. For safety reasons, the inspector does not light any pilot lights on these components. The pilot light may be out for a reason. Every effort on the inspectors part to alleviate this situation was done as the following paragraph was included with the pre-inspection agreement that was sent to the client before the inspection **"All natural gas fueled fireplaces/log sets (if present) must be ready to be operated under their normal operating controls. Meaning the gas supply to the fireplace/log set is turned on, the pilot light is lit (if it has one), and the fireplace/light is ready to be tested using whatever means it has to turn it on and off (remote control, on/off push button/dial on unit, wall mounted on/off switch, etc.). Please have your agent advise the LISTING AGENT of these requirements to insure a complete inspection of this component"**. In order to verify proper operation, I would recommend having the homeowners or a qualified, licensed fireplace professional operate the fireplace for you and make any necessary repairs prior to closing or any other contractual deadlines.

10/18/2021 UPDATE The homeowners operated the gas fueled fireplace on 10/15/2021 when the radon test was retrieved. The fireplace is functioning as intended.

12.8 Item 3 (Picture) Fireplace functioning

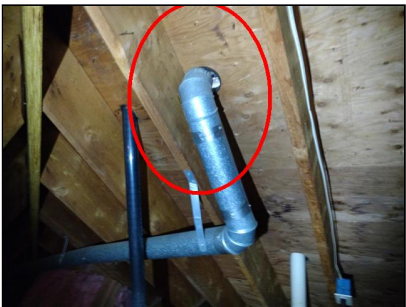
13.1 Item 2 (Picture)

As observed in the attic space, one of the bathroom exhaust fan vents was not secured to the roof mount. This venting should be terminated outdoors and may cause moisture damage/a mold condition to the surrounding structure if the needed repairs are not completed. Recommend further evaluation by a qualified, licensed contractor and repair as necessary.

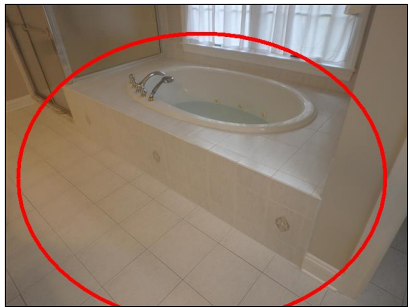
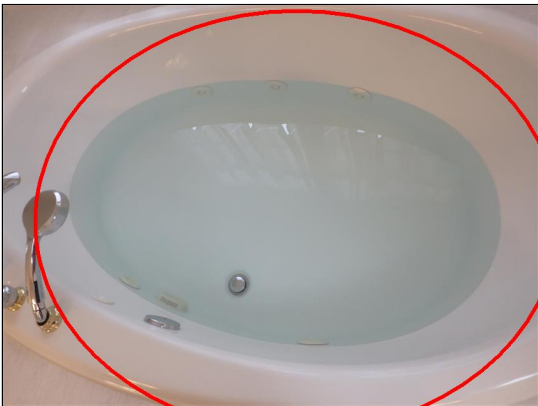
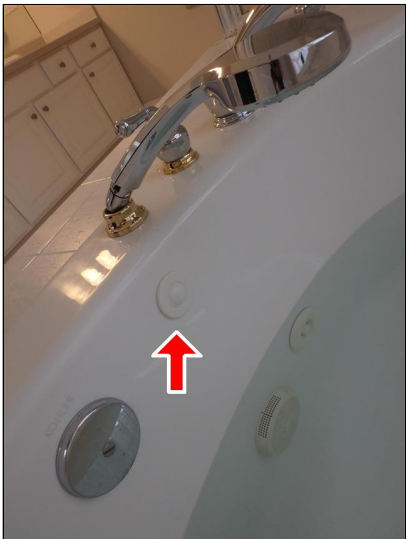
13.3 Tub(s)  
Comments: Repair/Replace  
In the master bathroom, there did not appear to be any access in the side of the whirlpool tub structure to service the motor/pump if need be. This is a safety issue as well as the fact that you would have to remove some surrounding tiles to access the motor/pump which is under the whirlpool tub. Also, the whirlpool tub was not functioning. The jets didn't turn on. Recommend further evaluation by a qualified, licensed contractor and repair as necessary.

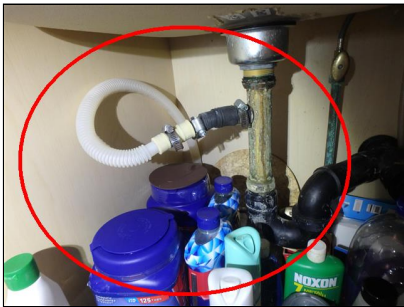
14.5 Item 1 (Picture)

The drain line on the dishwasher is not high looped under the countertop. The dishwasher drain line under the kitchen sink should be looped up as high as possible in the cabinet and up under the countertop. This prevents dirty/contaminated water from the sink from back flowing into the dishwasher. Recommend further evaluation by a qualified, licensed plumber and repair as necessary.

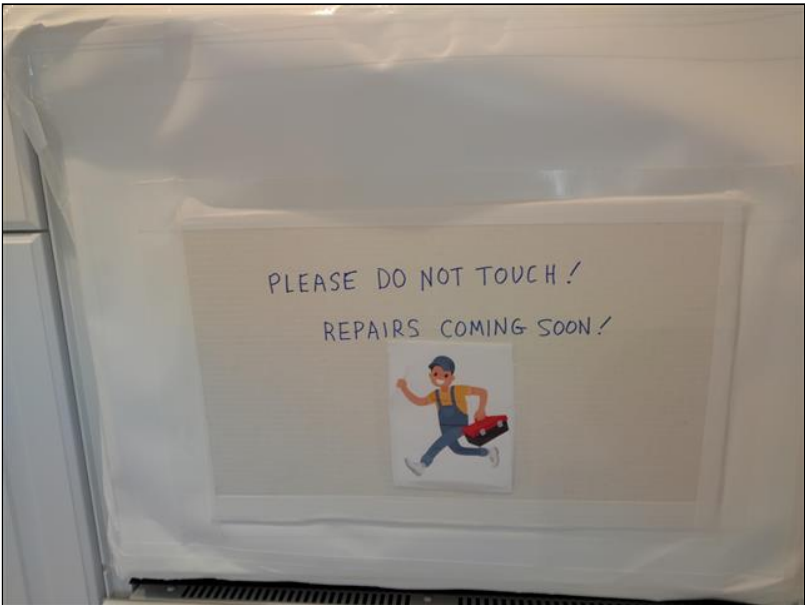
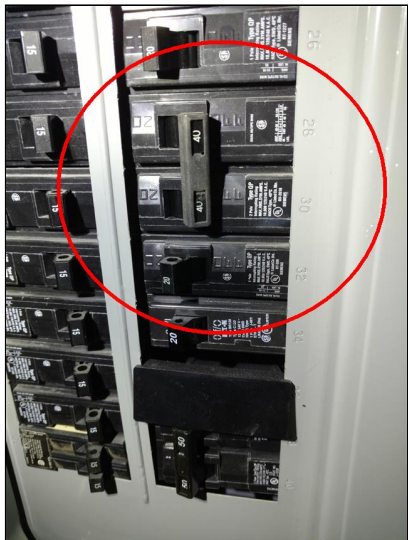
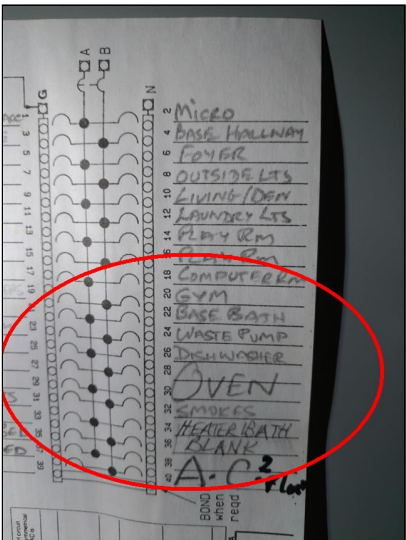
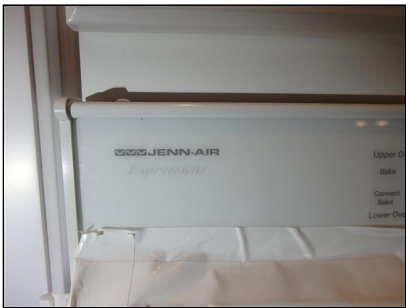
The wall oven was not functioning and was being repaired. Recommend further evaluation by a qualified, licensed appliance professional and repair/replace as necessary.

14.9 Item 3 (Picture) Circuit breaker off

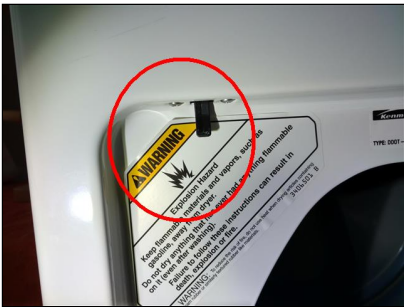
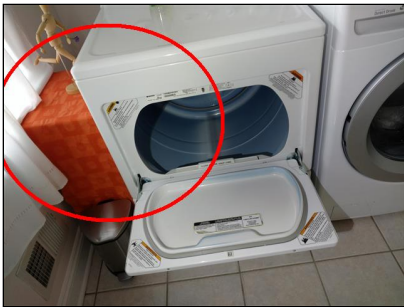
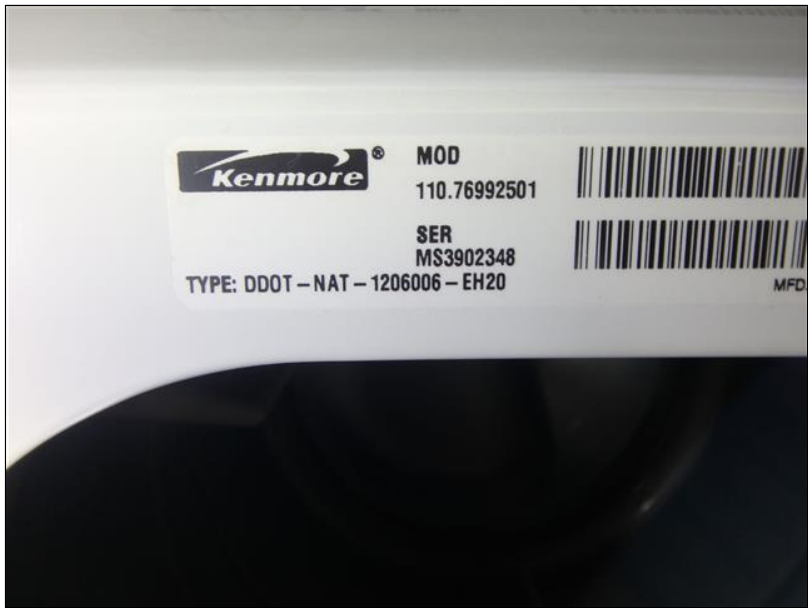
The safety switch that turns the dryer off when the front door is opened was not functioning which is a MAJOR safety concern. Recommend further evaluation by a qualified, licensed appliance professional and repair as necessary.

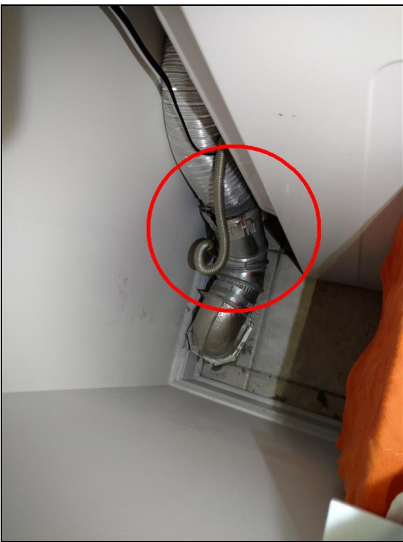
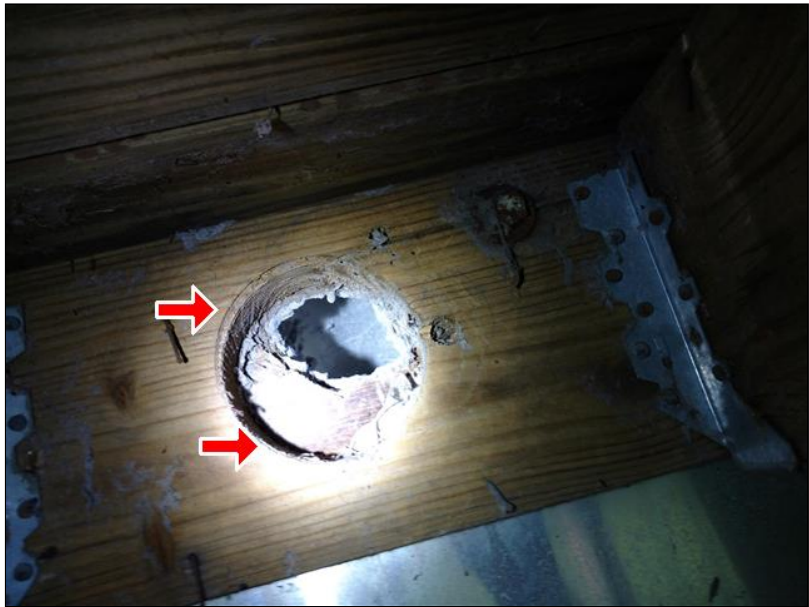
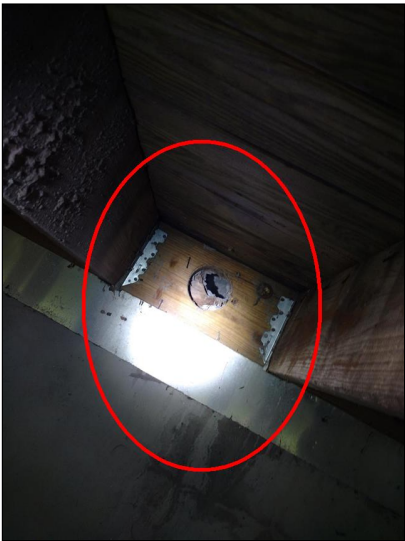
The exterior vent assembly for the clothes dryer was missing. This condition could allow unwanted wildlife to enter the vent ducting which could affect the performance of the clothes dryer and possibly restrict the venting which may start a lint fire in the vent ducting or dryer. The dryer duct was also semi-blocked by the deck ledger board. The dryer ducting was also disconnected behind the dryer. The ENTIRE dryer ducting should be repaired ASAP by a qualified, licensed contractor.

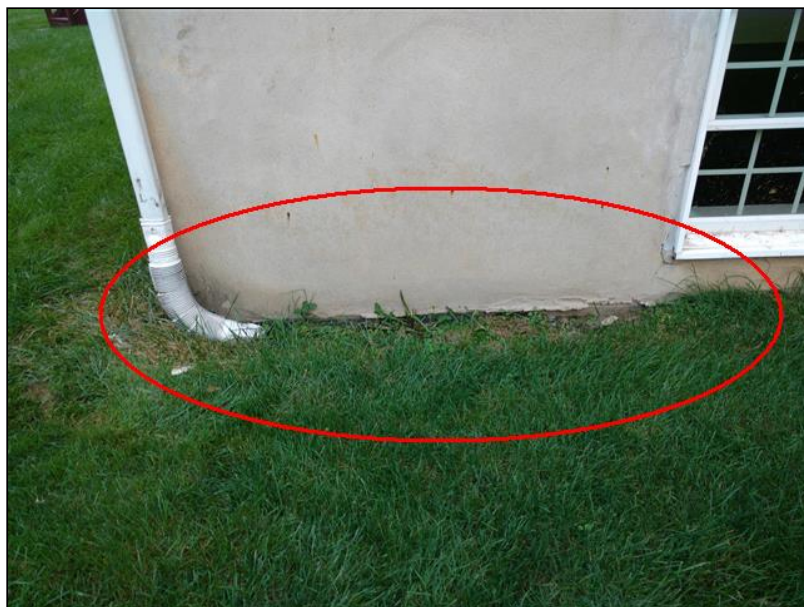
The grading (slope of ground surface) next to the left side foundation was pitched towards the foundation. The grading whenever possible should be pitched away from the foundation to prevent moisture intrusion from entering the foundation walls and basement. The ground was being undermined by the downspout that was dumping water

next to the foundation. Recommend further evaluation of all of the exterior grading by a qualified, licensed contractor and repair as necessary.

1.2 Item 1 (Picture) Ground getting undermined

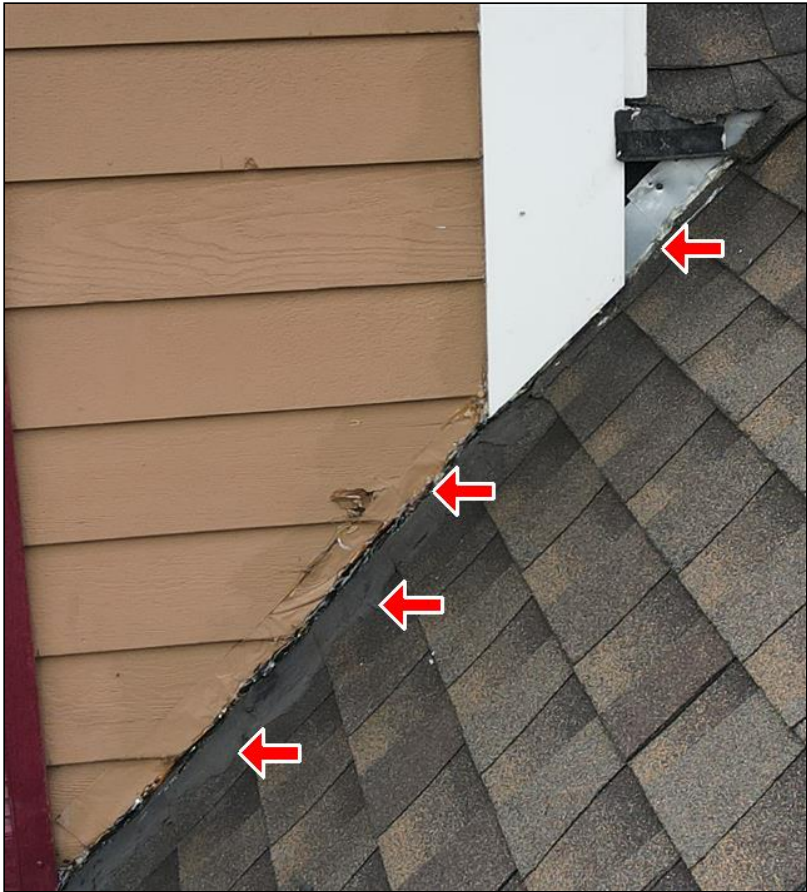
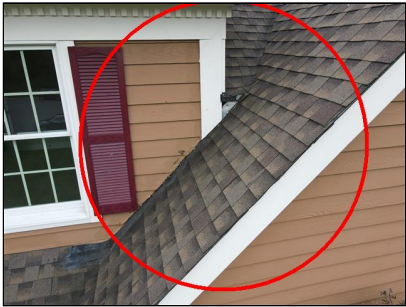
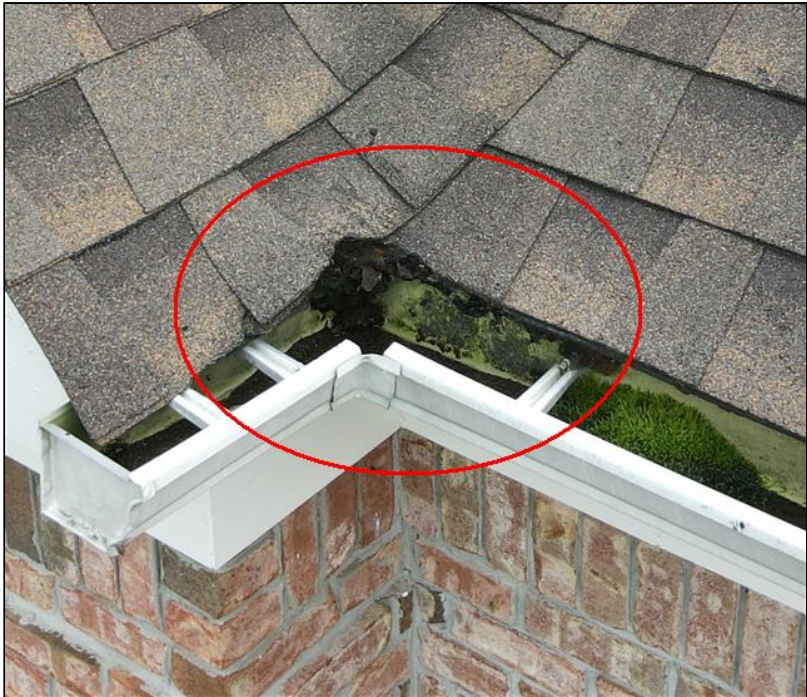
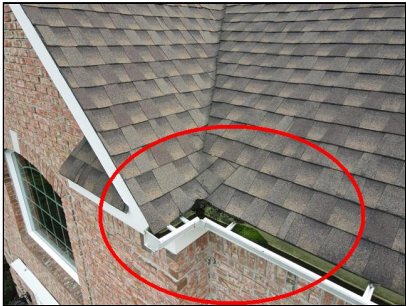
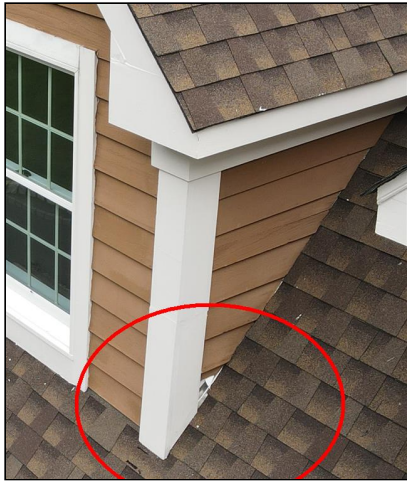
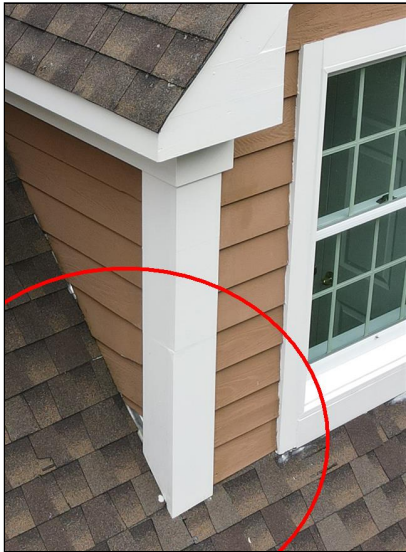
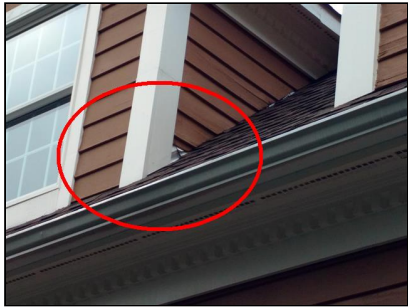
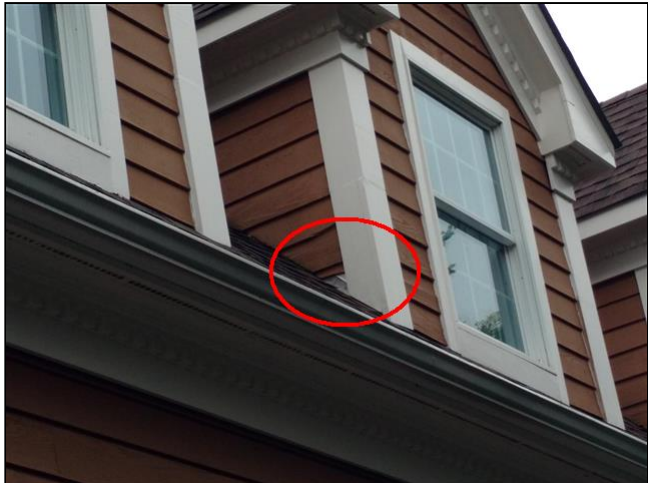
(1) As observed on the exterior, there were portions of some of the exterior elements (windows, window frames, window flashings, doors, door frames, door flashings, siding/cladding, masonry, brick and/or stone veneer, trim, framing, flashings, eaves, fascias, soffits and/or gable ends) that were either missing, had open gaps/holes/unsealed joints, were not functioning as intended, were deteriorated/damaged and/or had a peeling paint condition. The main issue is the siding/cladding was cupping/curling on all four sides of the exterior. Some of the siding/cladding was pulling off the house with the nails pulling out as a result of the cupping/curling. The condition of the noted elements/areas may worsen as well as possible structural/moisture damage behind/under these elements could occur if the needed repairs are not completed. Damage to the interior finishing materials may also occur. **A further evaluation of the ENTIRE exterior of the dwelling should be completed by a qualified, licensed contractor and the necessary repairs be completed. There may be hidden moisture damage, deterioration and/or wood destroying insect damage within the structure behind/under the effected exterior elements that was not visible at the time of the inspection.**

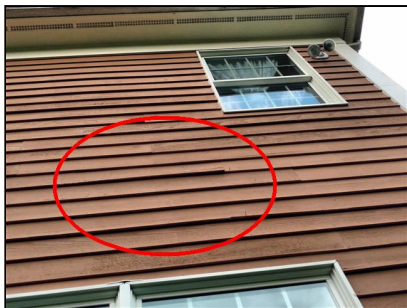
2.0 Item 13 (Picture) Cracked

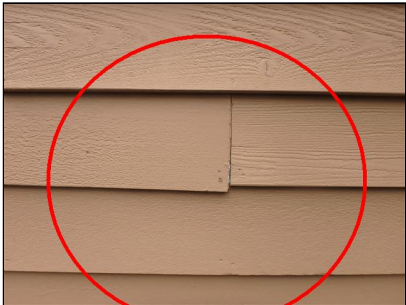
2.0 Item 15 (Picture) Sub standard repair

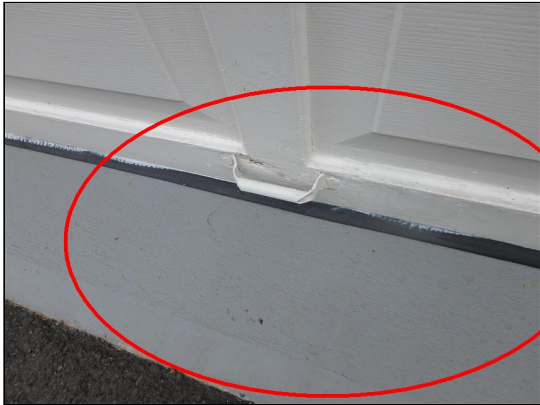
2.0 Item 29 (Picture) Soft spot

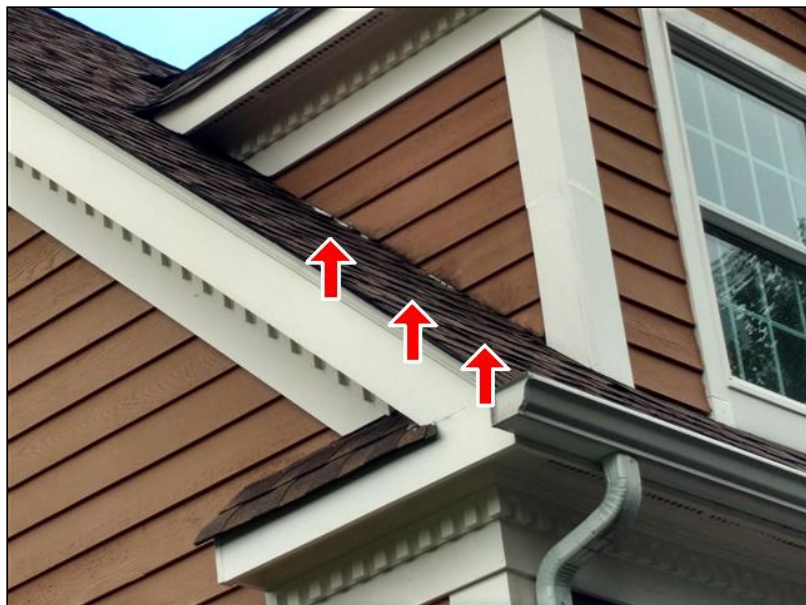
2.0 Item 34 (Picture)

(2) The bottom portion of some of the exterior wood lap siding/cladding was deteriorated slightly as a result of what appears to be excessive moisture present from the roof covering. The roof covering should not be in contact with the wood siding. There should be a 1/2"-3/4" gap between the bottom of any exterior cladding and the roof covering to prevent this type of deterioration. Further deterioration of the wood siding as well as possible moisture intrusion into the structure behind the siding could occur if the needed repairs are not completed. Recommend further evaluation by a qualified, licensed contractor and repair as necessary.

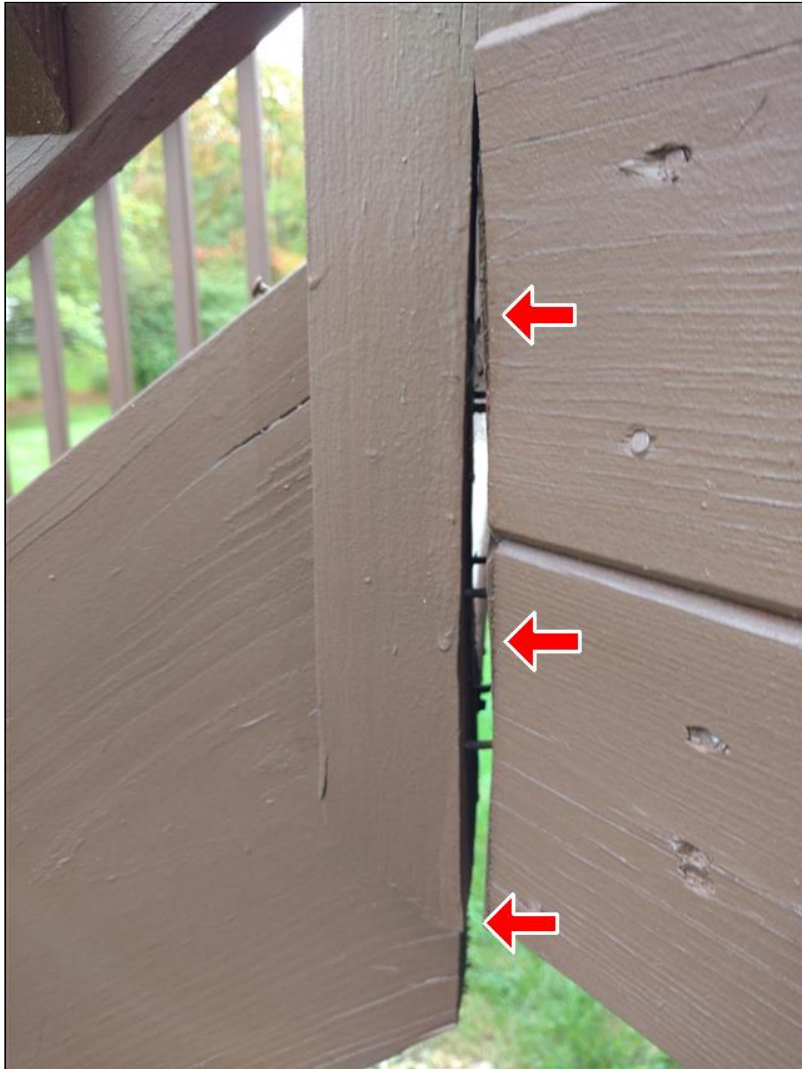
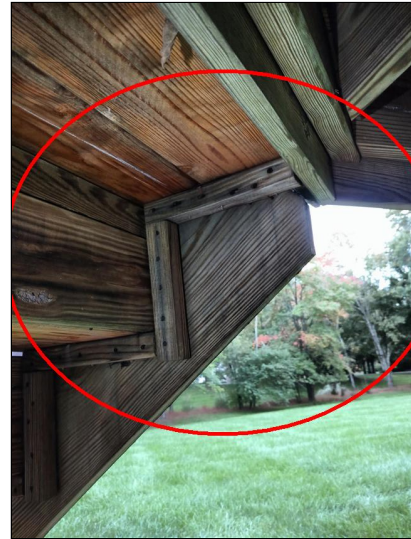
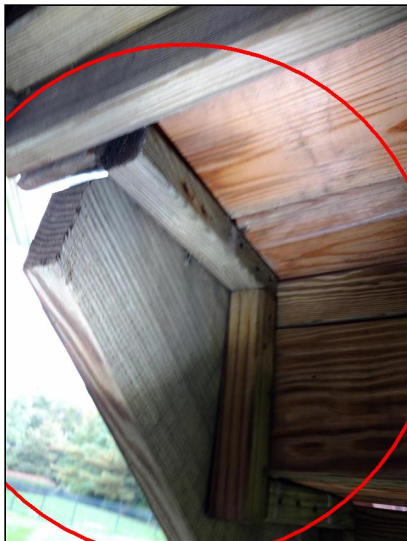
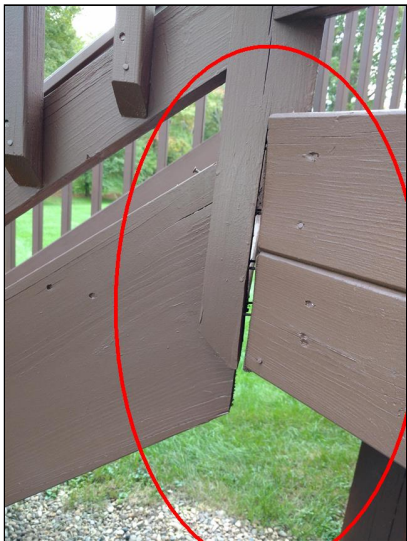
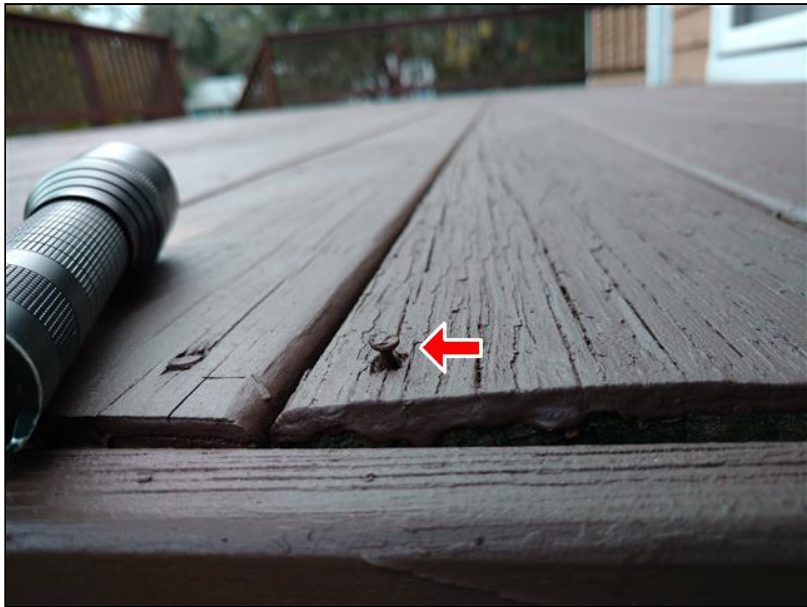
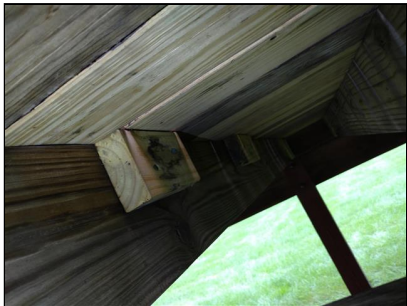
(2) There were numerous issues were observed pertaining to the rear wood deck. They included:

- 1) There were no beam to joist and stair stringer to the deck structure mechanical connectors present.
- 2) There were numerous nails that were sticking up from the deck surface which is a major concern if your walking on the deck with bare feet.
- 3) The staircase was separating from the main deck structure.
- 4) The handrails were loose.

These are safety concerns. These conditions may also worsen if the needed repairs are not completed. A further evaluation of the ENTIRE deck should be completed by a qualified, licensed deck contractor and the necessary repairs be completed.

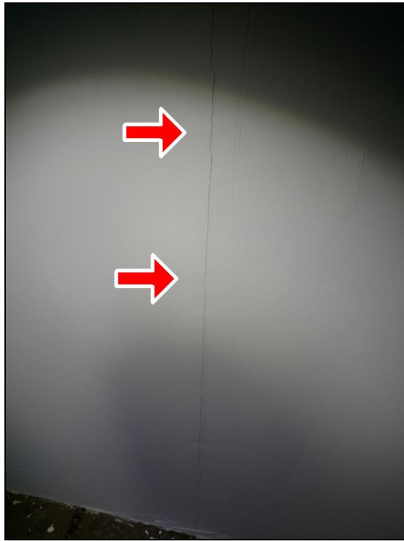
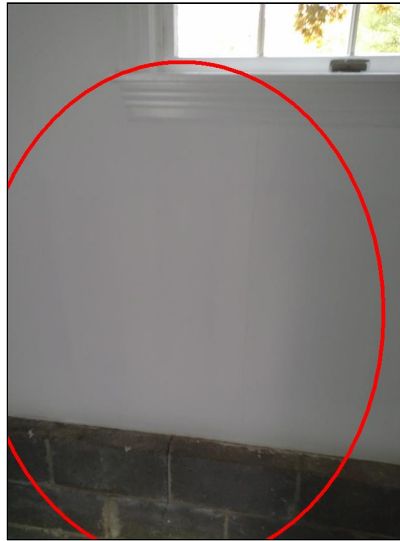
- (1) Please see notes under Item #4.0 (1)
- (2) A few sections of the garage wall drywall were cracked. These conditions may worsen. Recommend further evaluation by a qualified, licensed contractor and repair as necessary..

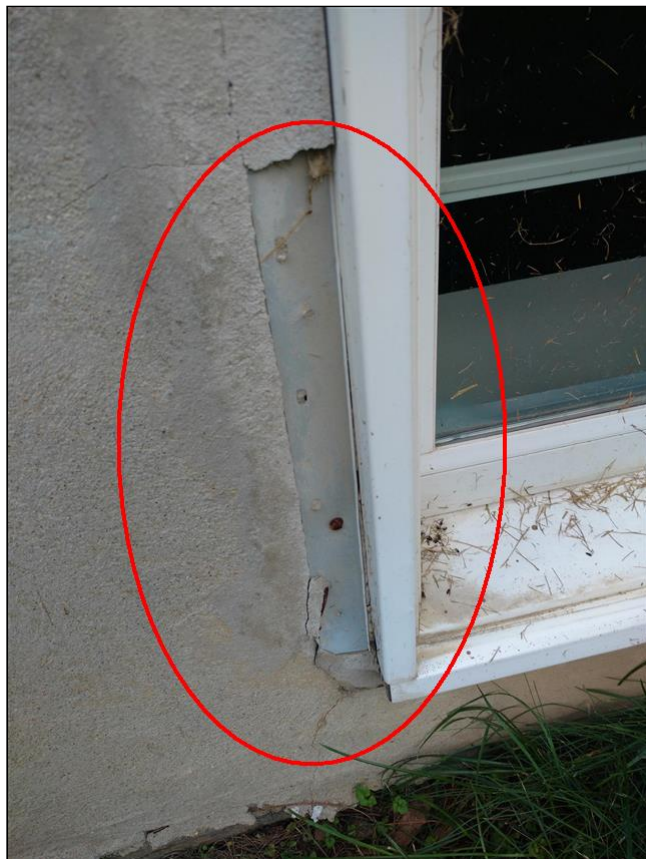
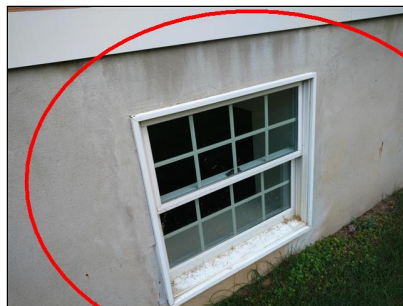
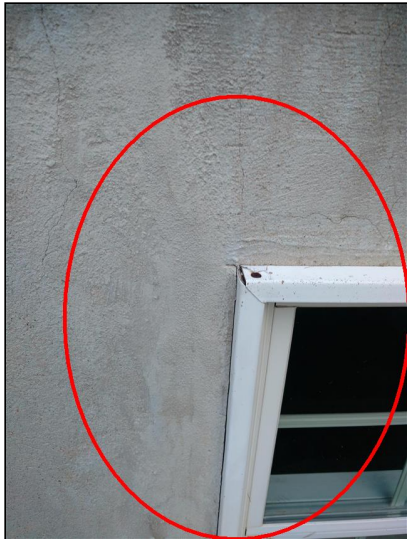
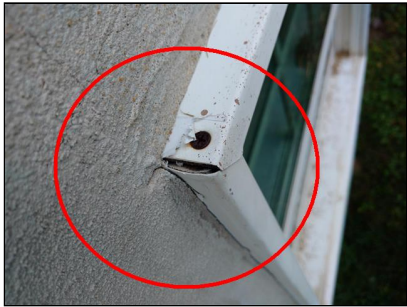
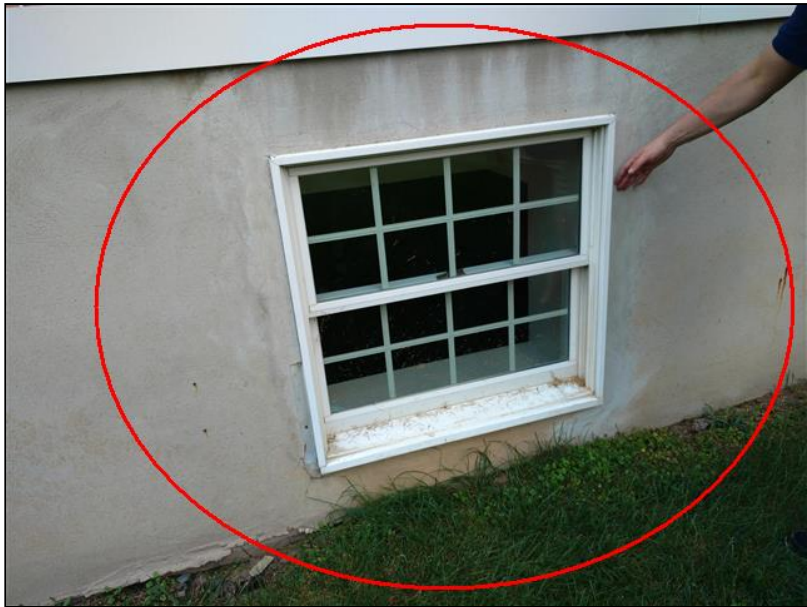
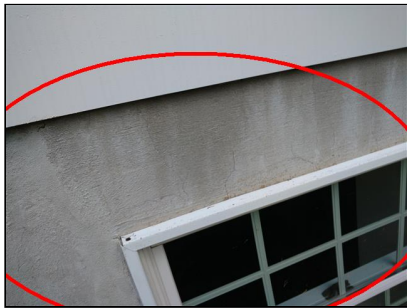
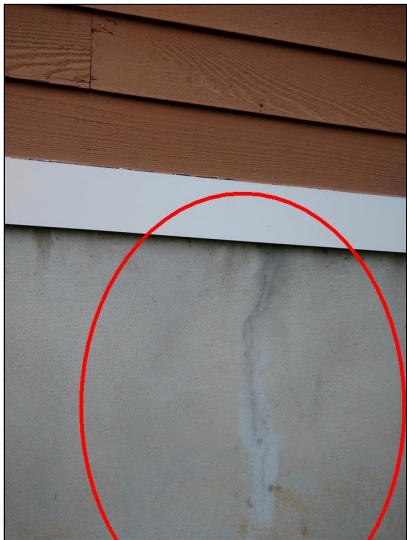
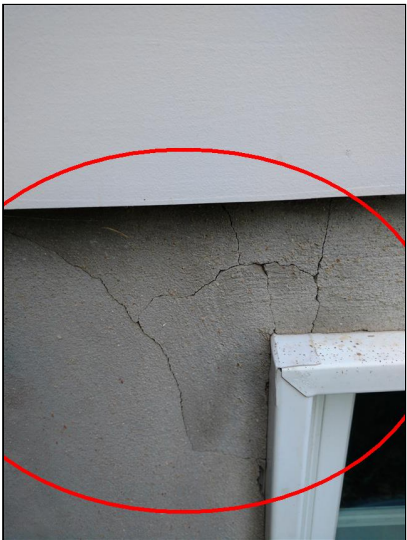
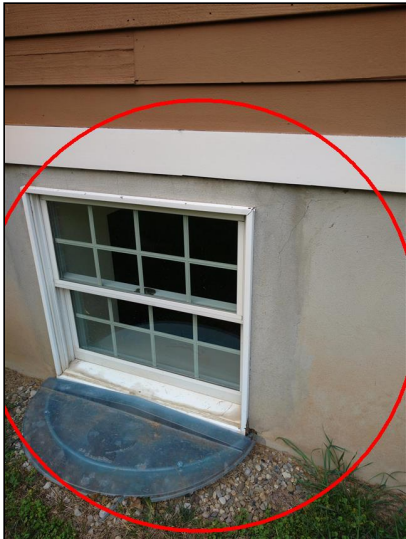
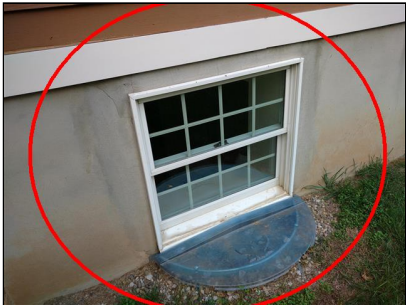
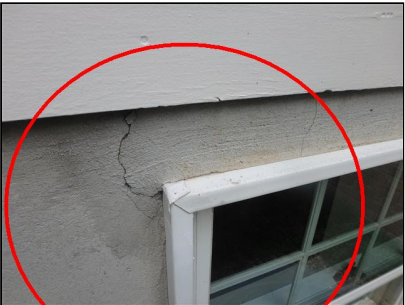
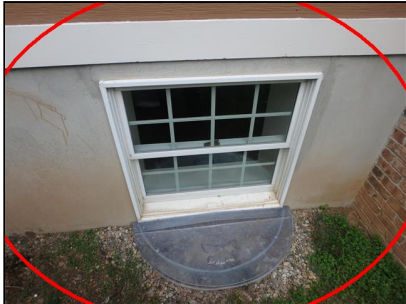
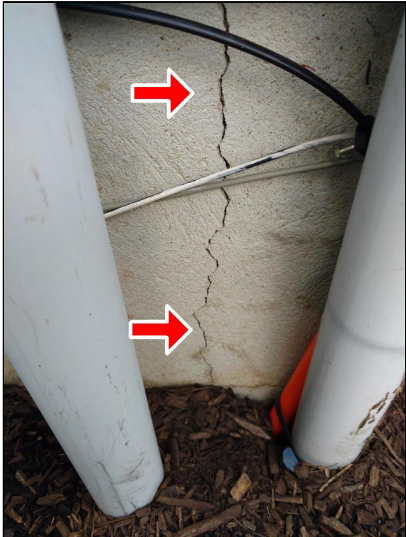
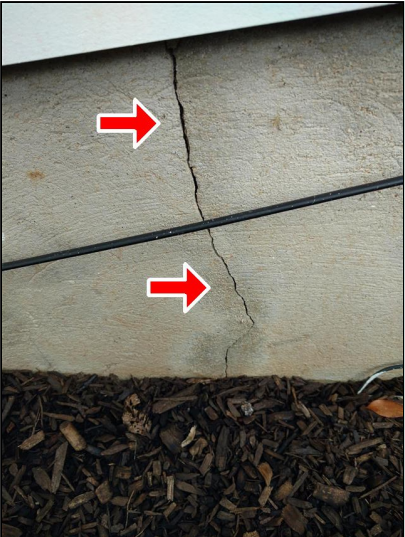
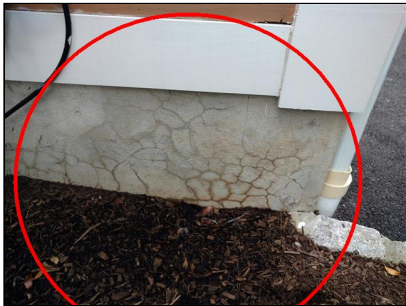
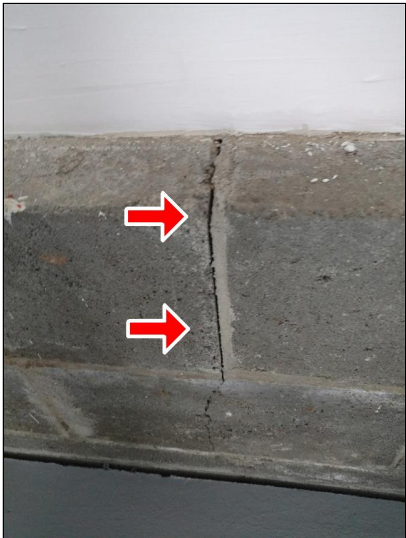
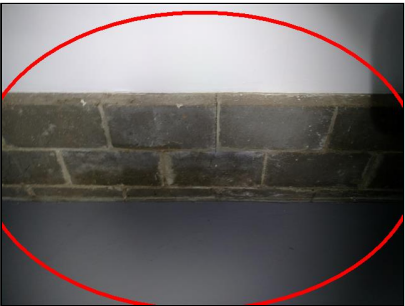
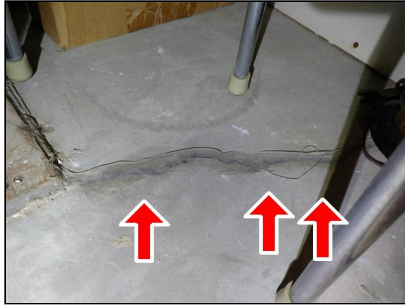
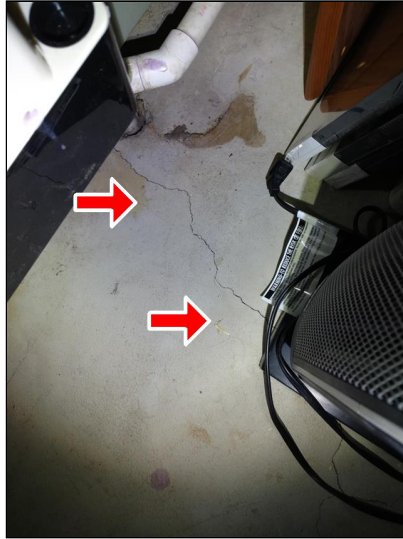
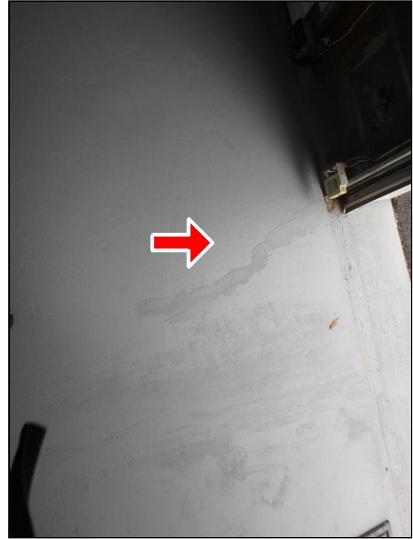
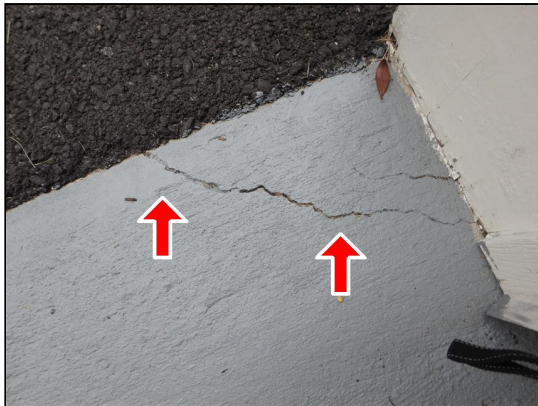
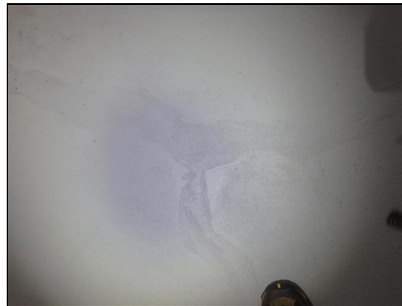
There were numerous cracks and/or deteriorated areas present on some portions of the interior and/or exterior foundation wall/floor surfaces. These conditions if not repaired may lead to possible moisture intrusion into the foundation walls and the basement along with possible deterioration of the foundation walls and the interior finishes of the house. These conditions may also worsen if the needed repairs are not completed. A further evaluation of the ENTIRE foundation (both interior and exterior) should be completed by a qualified, licensed structural contractor and the necessary repairs be completed. **These conditions may also exist behind finished basement walls/floors. They may be less severe or worse than what was visible.**
