# Property Inspection Report

**Property Address:**  
9 Big Court  
Great City New Jersey 07000

**Frank Glomb**

**Terra Home Inspections LLC**

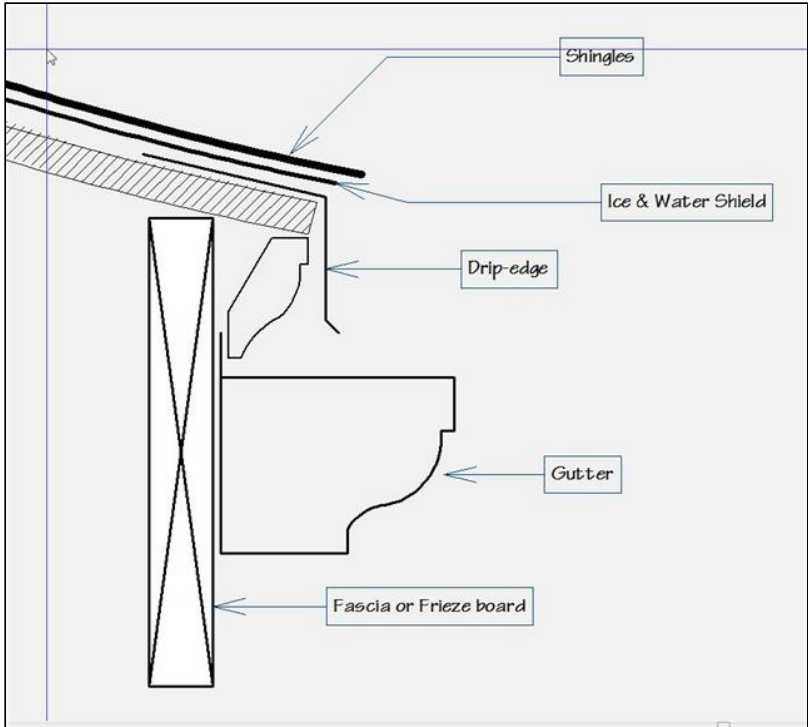
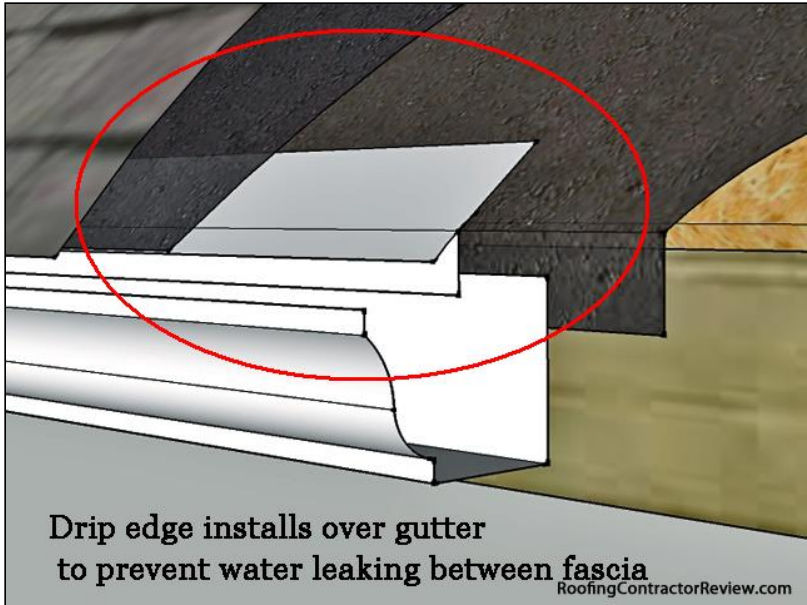
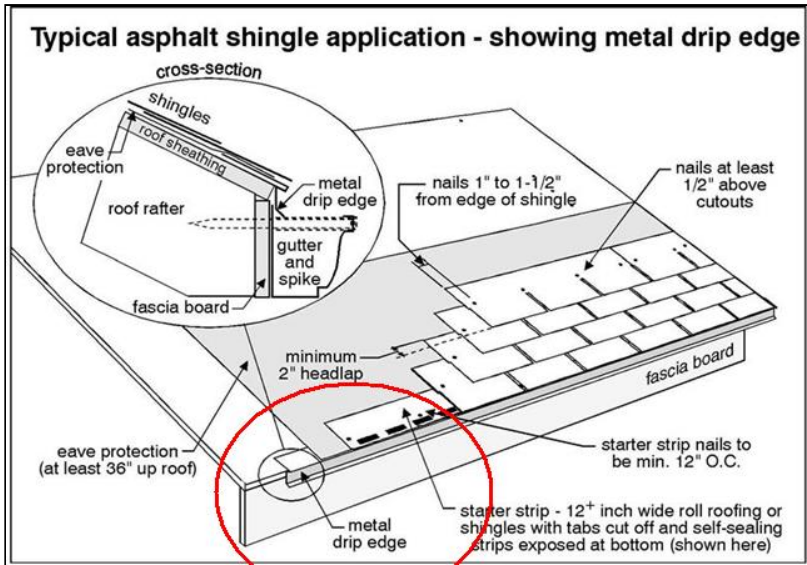
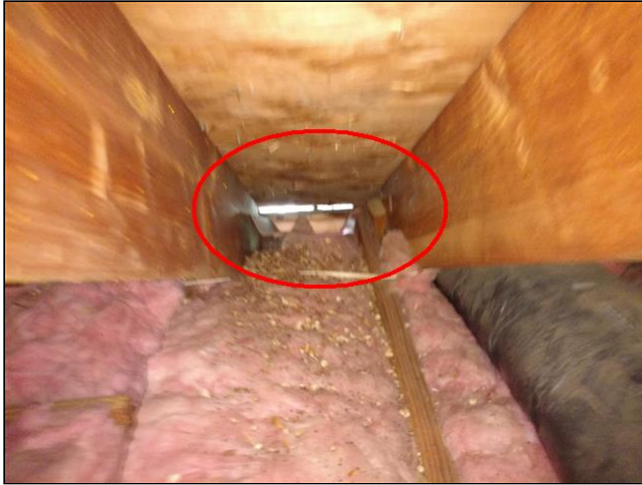
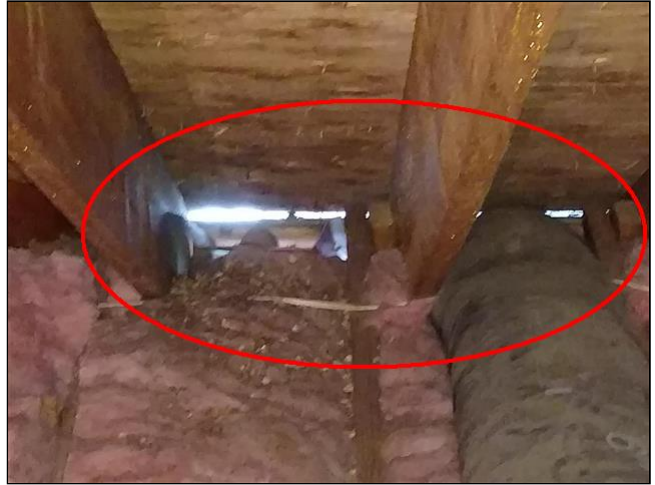
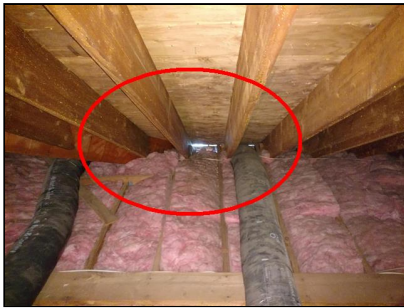
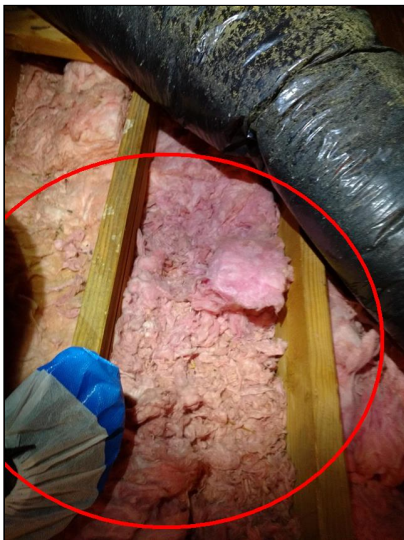
As observed in the rear of the attic space, there were sections where the roof decking meets the fascia board that daylight could be seen. You should not see any daylight at these joints as there should be drip edge flashings that go over the roof decking and then wrap down onto the fascia board. Drip edge flashings may not be present. **The concern is these gaps may allow unwanted wildlife (insects, mice, etc) to get into the attic space.** Recommend further evaluation by a qualified, licensed contractor and repair as necessary.

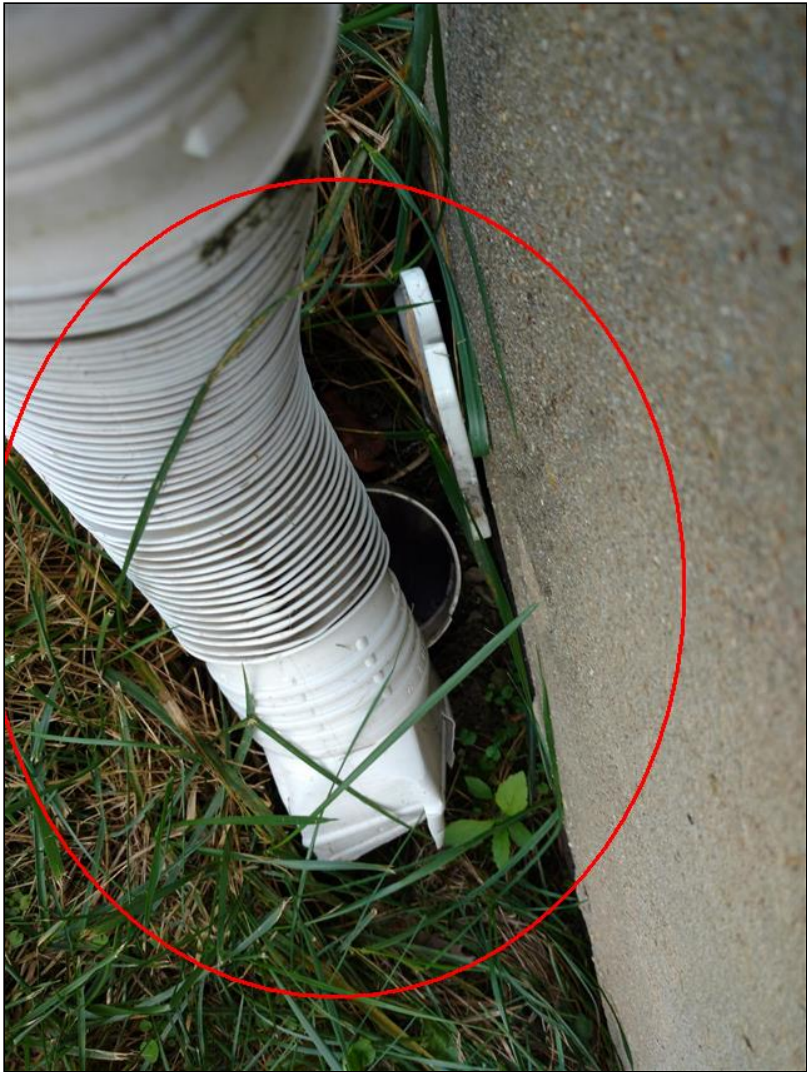
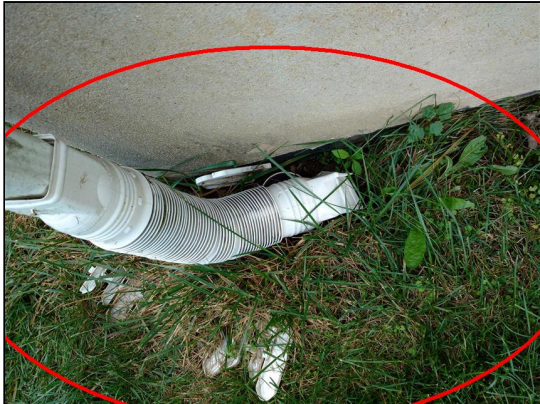
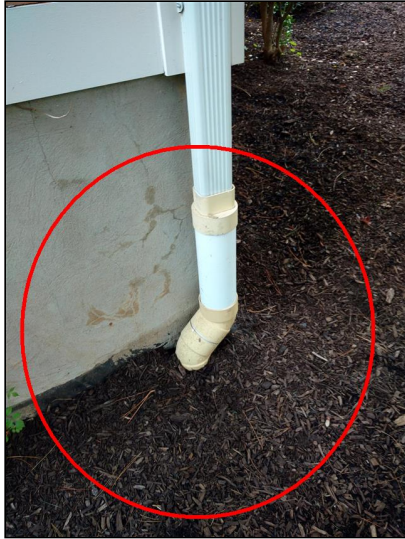
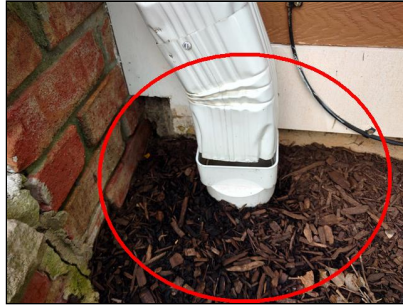
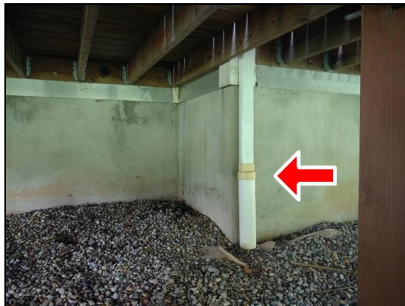
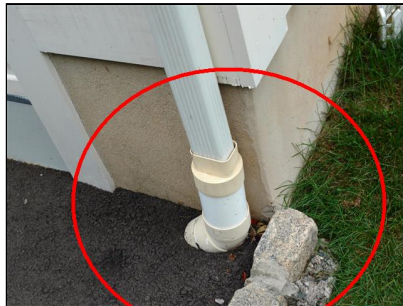
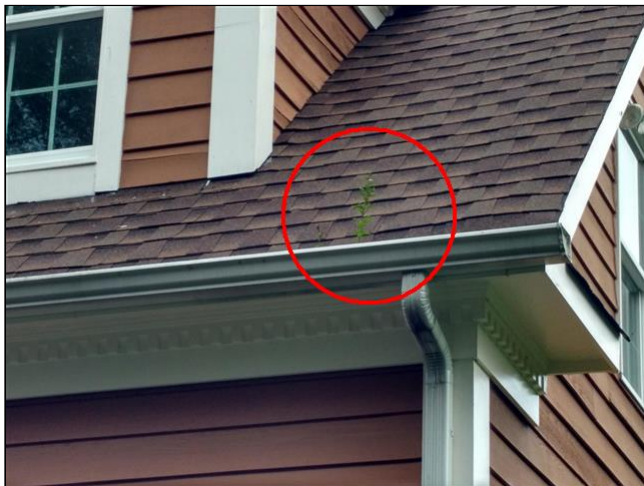
The downspouts that are not directed into underground drainage pipes should be extended at least 4-6 feet (or as far away as possible) from the foundation of the house. Ideally, they should be extended away with rigid downspout material or PVC pipe. The accordion style extenders that are sometimes present often fail, deteriorate and may collect water in the ripples where mosquitos may breed in the standing water. Extending the downspouts helps shed water away from the foundation. Water can weaken and deteriorate the foundation and can possibly migrate

into the basement. Recommend extending the downspouts as necessary. Also to note, some of the downspouts are currently piped into underground drainage. While this is a great arrangement as it is supposed to carry the roof runoff water away from the house, it is unknown if the system is functional and not clogged with debris. If the underground drainage gets clogged, the water may spill out at the downspout connection and possibly migrate into the foundation/basement. It should be ascertained as to where all this underground drainage is draining to. **Also, it is recommended a further evaluation and testing of the ENTIRE underground drainage piping/system be completed by a qualified, licensed contractor to insure it is fully functional and not clogged with debris.** Any needed repairs should be completed. There was also a downspout in the left rear corner that was not connected to the underground drainage and was discharging its water right next to the foundation. This may result in moisture intrusion. In addition, the gutter above the garage needs to be cleaned out as there was vegetation growing out of it.

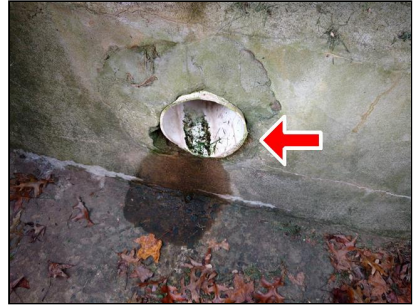
5.2 Item 5 (Picture) Pipe in street manhole

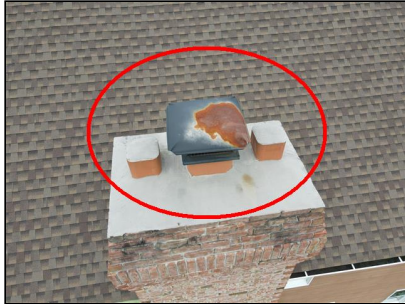
5.5 Item 1 (Picture)

visual inspection is not adequate to discover hidden deficiencies or damage should they exist. A NFPA 211 Standard, Level 2 inspection entails the use of specialized tools and testing procedures, such as video cameras, etc., to thoroughly evaluate/inspect the chimney(s) and/or fireplace(s) system/components. Therefore, it is highly recommended a level 2 inspection of all of the fireplaces and/or chimneys pertaining to the dwelling be performed before closing and/or any contractual deadlines. Additional information pertaining to fireplace/chimney inspections can be found in Chapter 14 of the NFPA 211 standard. <http://www.nfpa.org/codes-and-standards/document-information-pages?mode=code&code=211> Also to note, the chimney flue cap was rusted which may cause staining to the chimney crown and the side of the chimney.

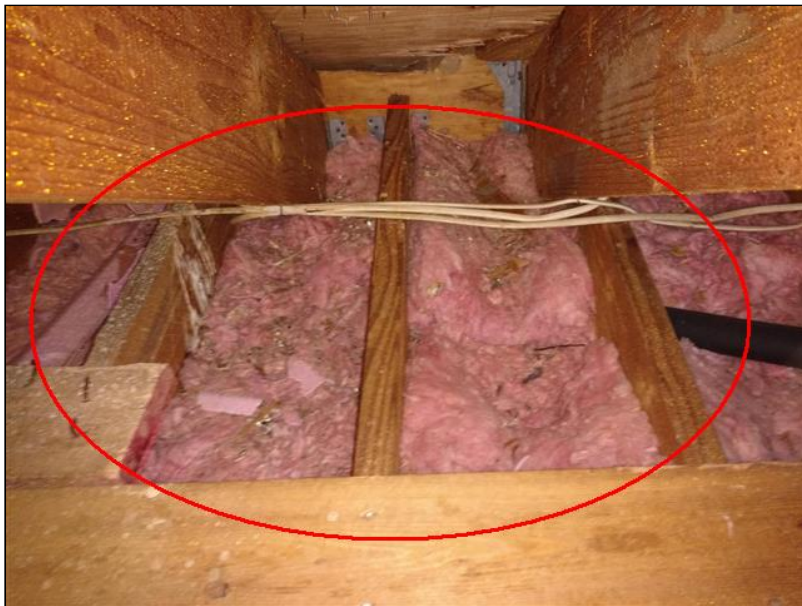
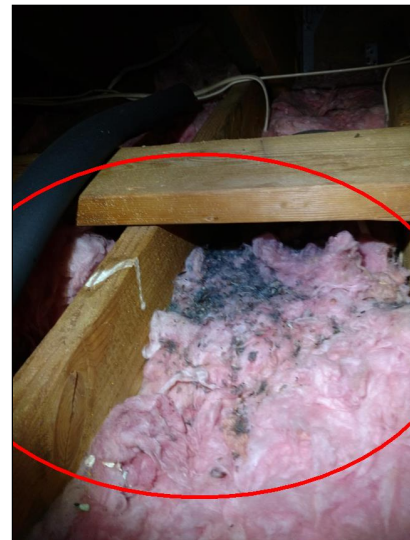
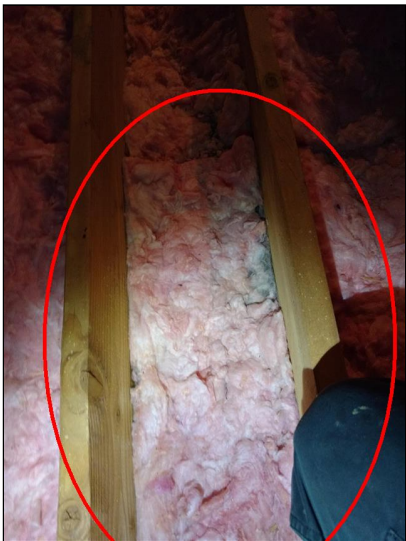
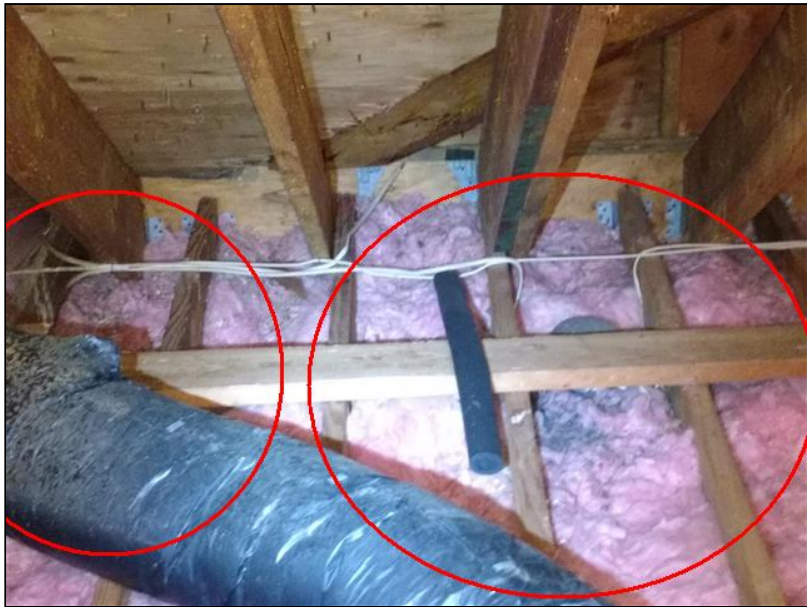
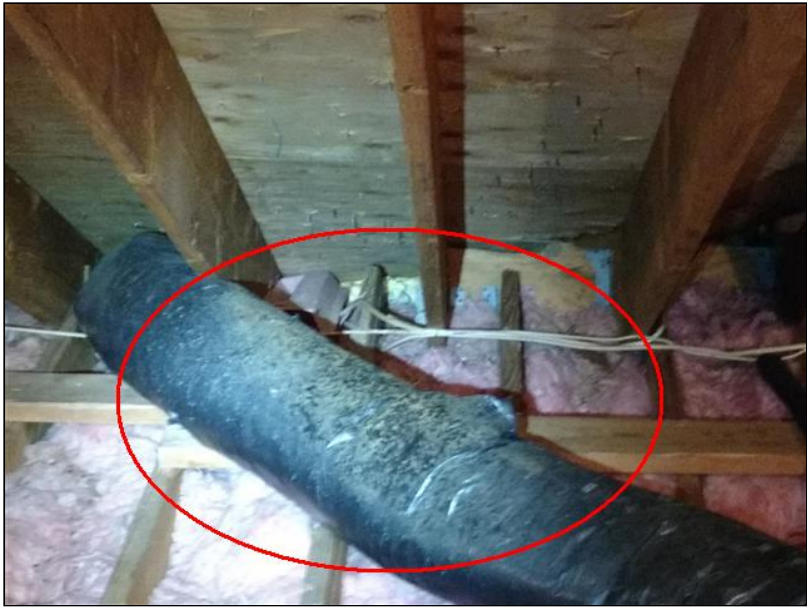
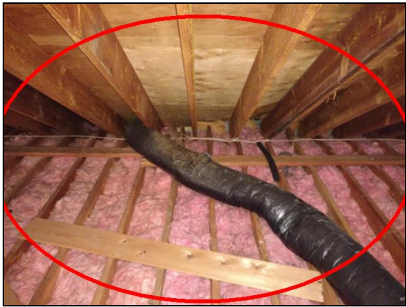
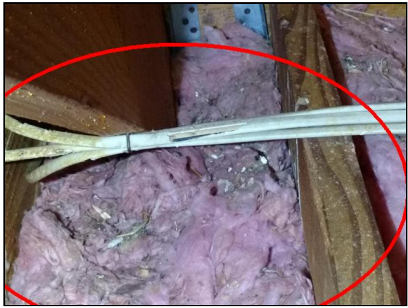
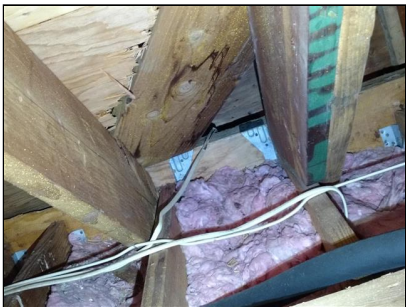
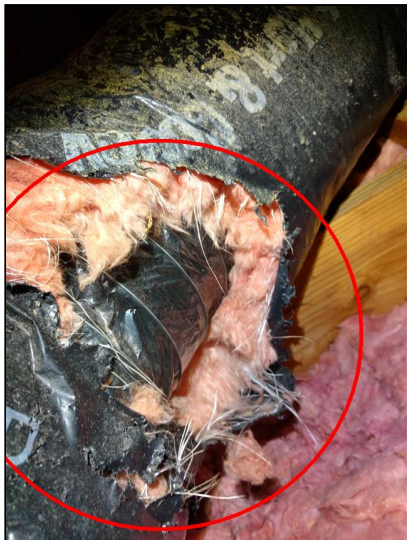
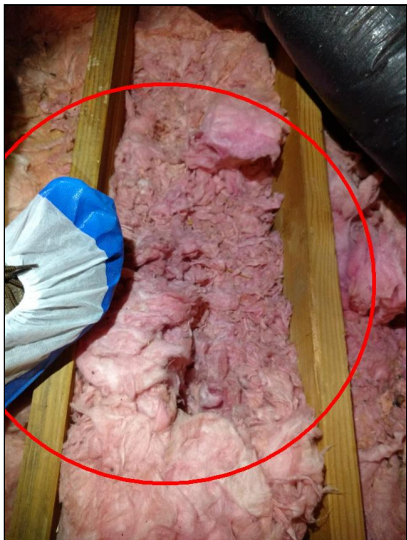
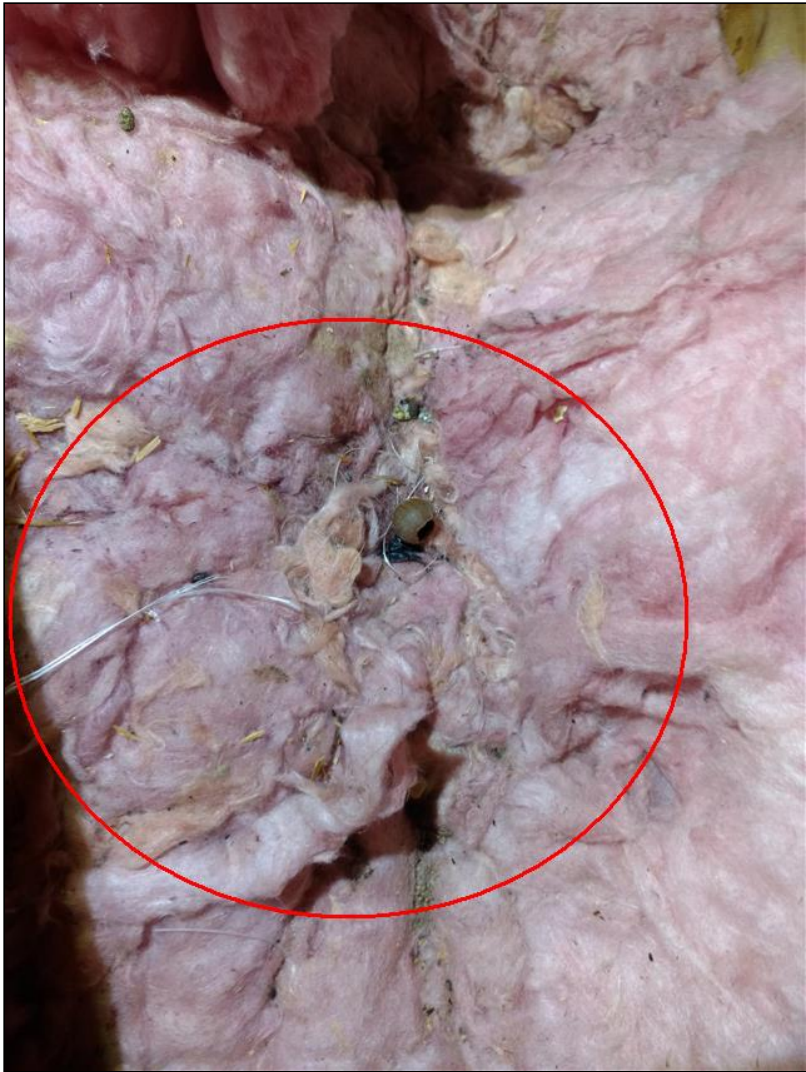
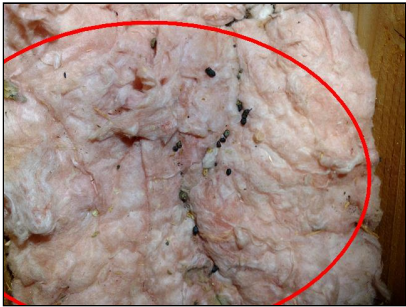
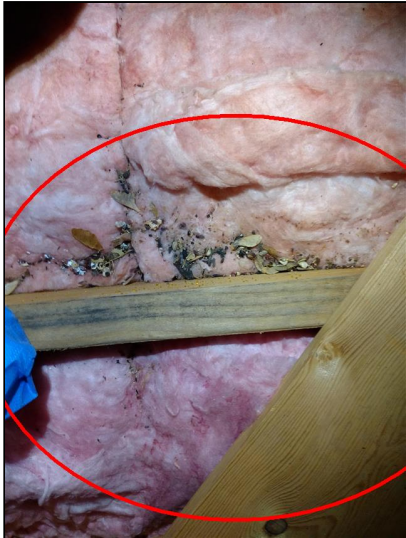
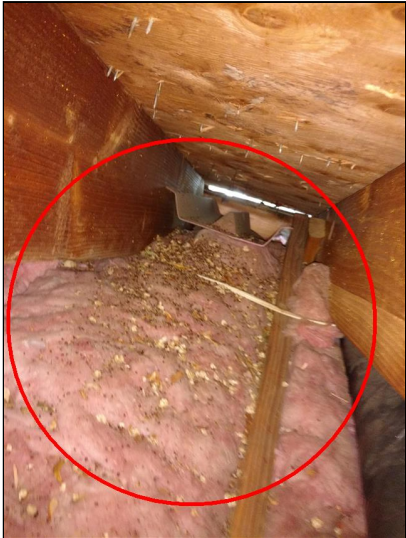
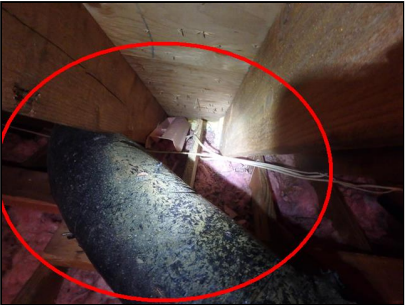
There was what appeared to be fecal matter/possible urine from mice/squirrels or similar vermin observed in numerous areas in the attic space as well as several areas of the attic insulation that was damaged. There was also a section of the HVAC ducting that was damaged along with sections of the electric wiring. This is a health concern. **A further evaluation of the ENTIRE attic space should be completed by qualified, licensed pest control professional and the necessary repairs/remediation should be completed ASAP. The wiring needs to be repaired by a qualified, licensed electrician and the insulation should be repaired by a qualified, licensed contractor. The access points into the attic space should also be repaired/sealed up.**

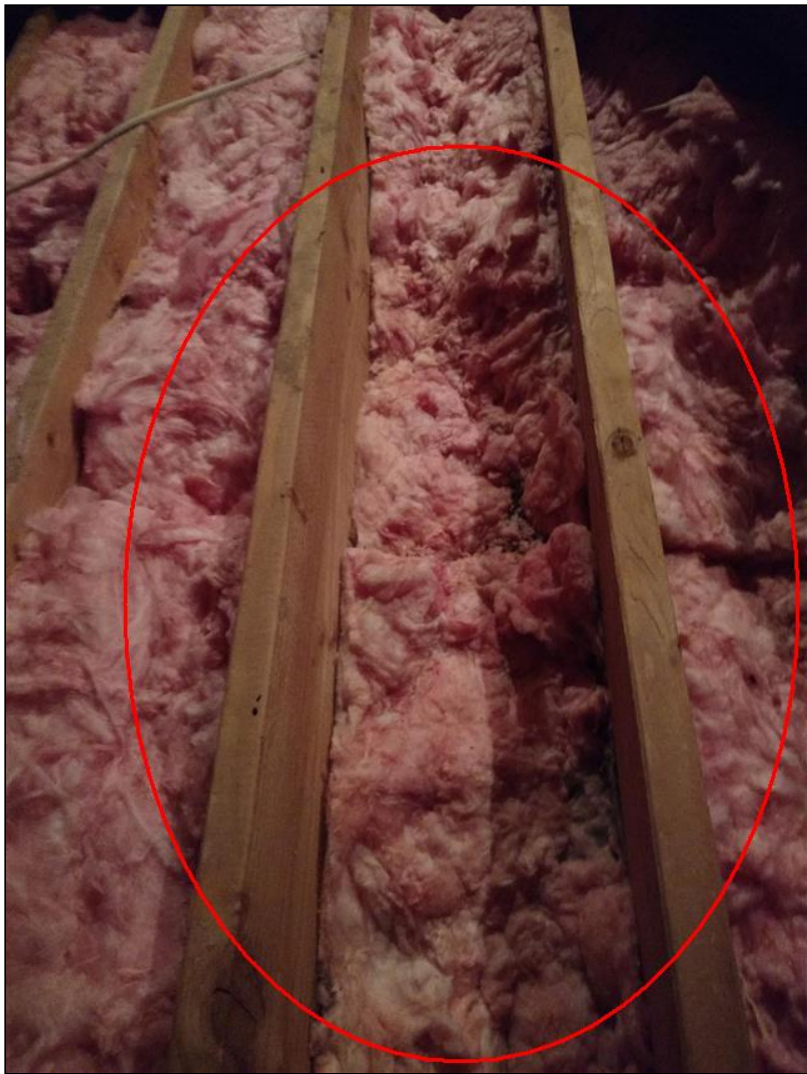
6.0 Item 3 (Picture) Damaged insulation

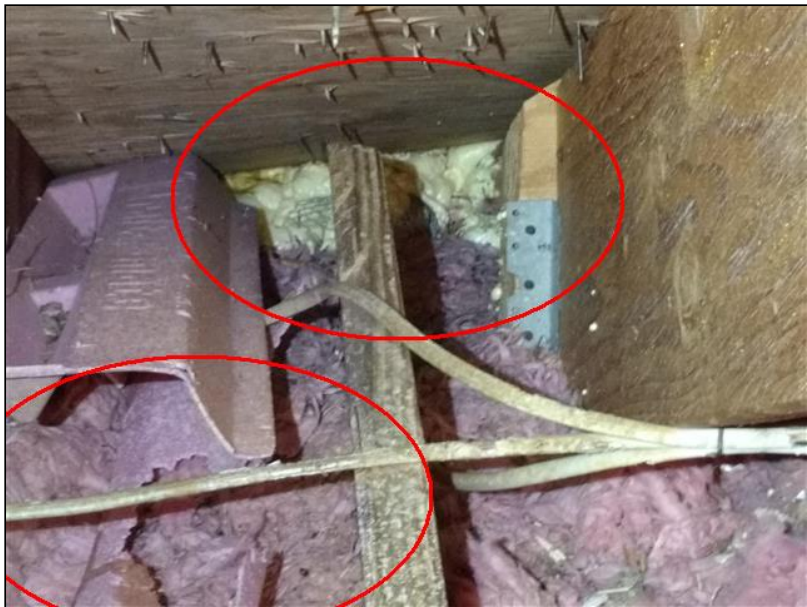
6.0 Item 9 (Picture) Baffles damaged

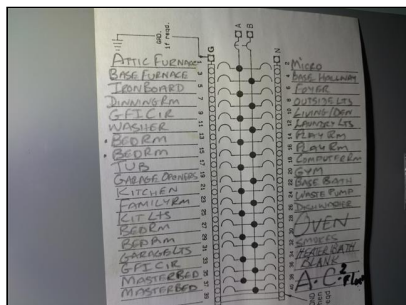
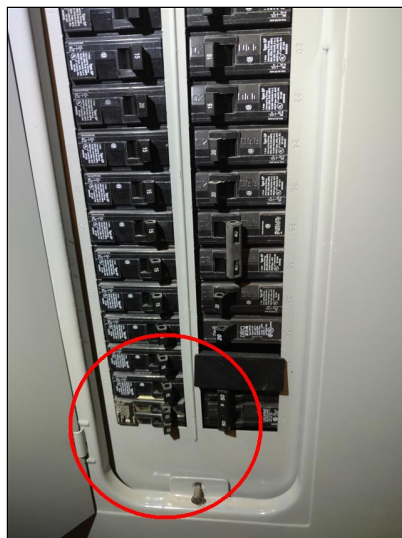
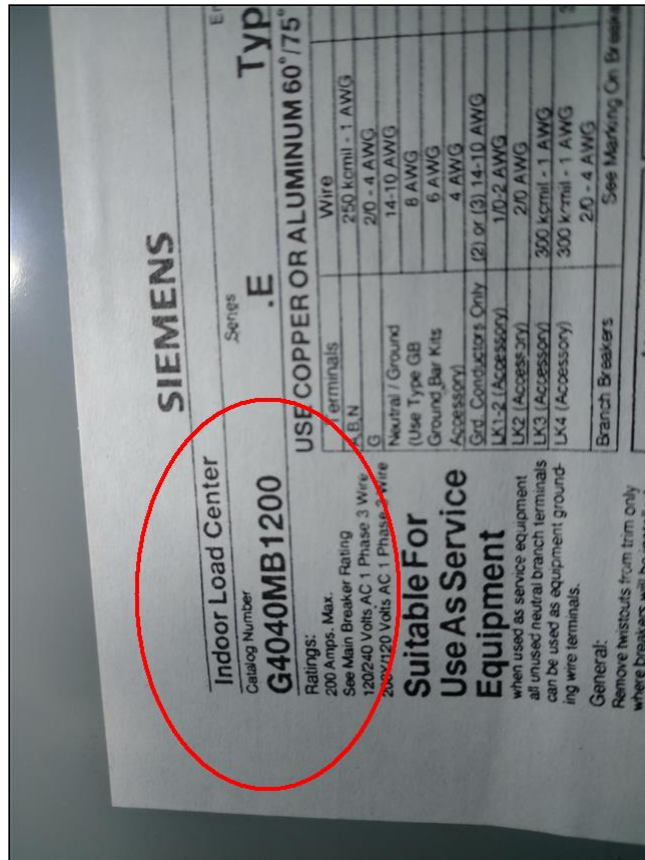
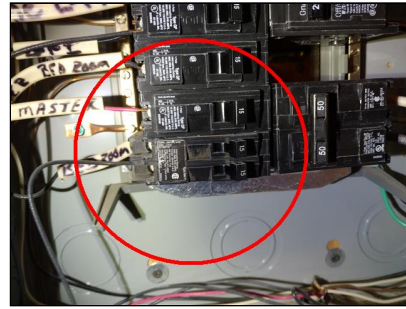
There was a tandem circuit breaker observed in the main electric service panel. Per the manufacturer's panel specifications, it is believed tandem circuit breakers are not permitted in this electric panel. This is a safety concern and potential fire hazard. Recommend a further evaluation of this panel by a qualified, licensed electrician to insure tandem circuit breakers are safe for use in this panel and make any necessary repairs.

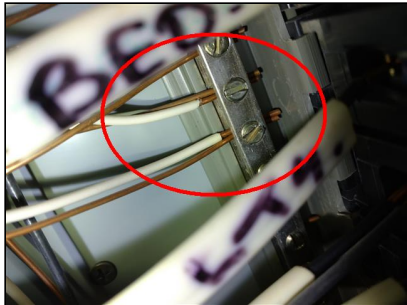
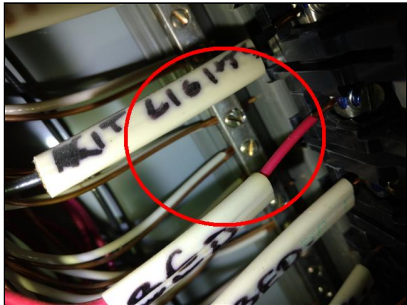
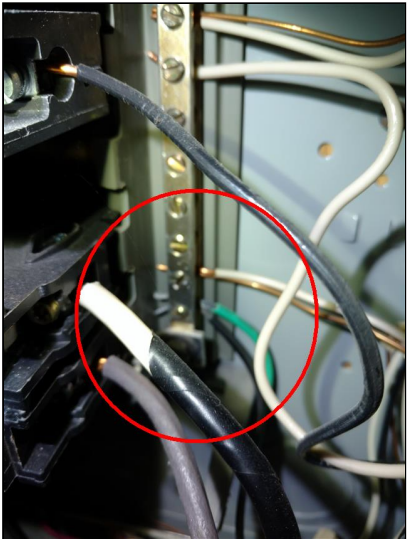
(1) There were grounded (neutrals) and grounding wires that were doubled up under the same terminals (lugs) on the neutral bus bar in the main electric service panel. The connection of grounded and grounding wires in this situation creates a significant problem. One of the objectives of a correct arrangement of bonding jumpers, neutrals and grounding wires is to allow for circuit isolation if the electrical system needs to be worked on. Also most panels are only designed for one grounded wire per lug. The wires could come loose and heat up if they are double lugged. This requirement has been generally been enforced in the past by a close review of the manufacturer markings and by NEC 110.3 (b). Clause 12.3.10 of UL 67 (panelboards) states, "Each neutral conductor shall terminate within the panel board in an individual terminal that is not also used for another conductor". Recommend having a qualified, licensed electrician make all the corrections necessary to ensure the safe and proper operation of the service panel.

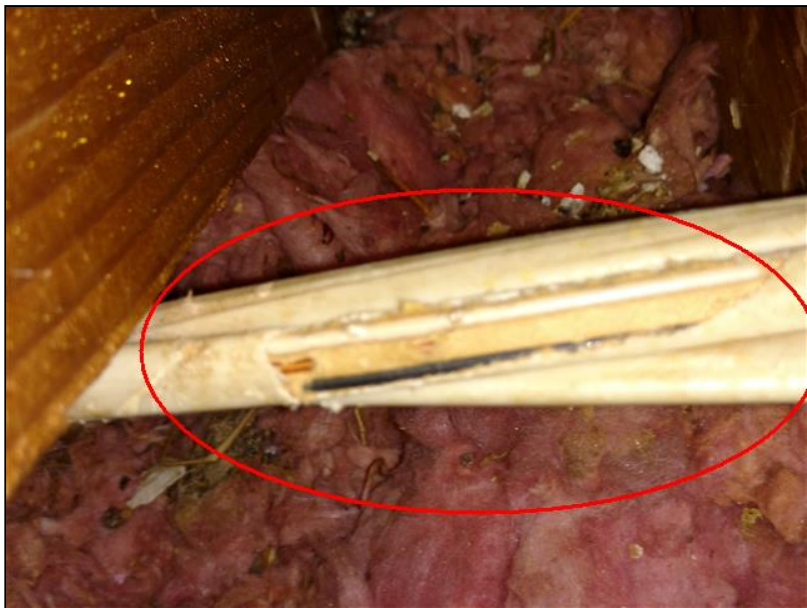
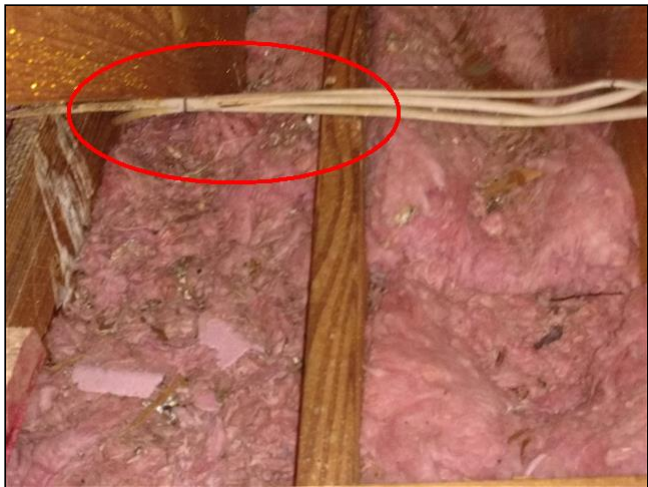
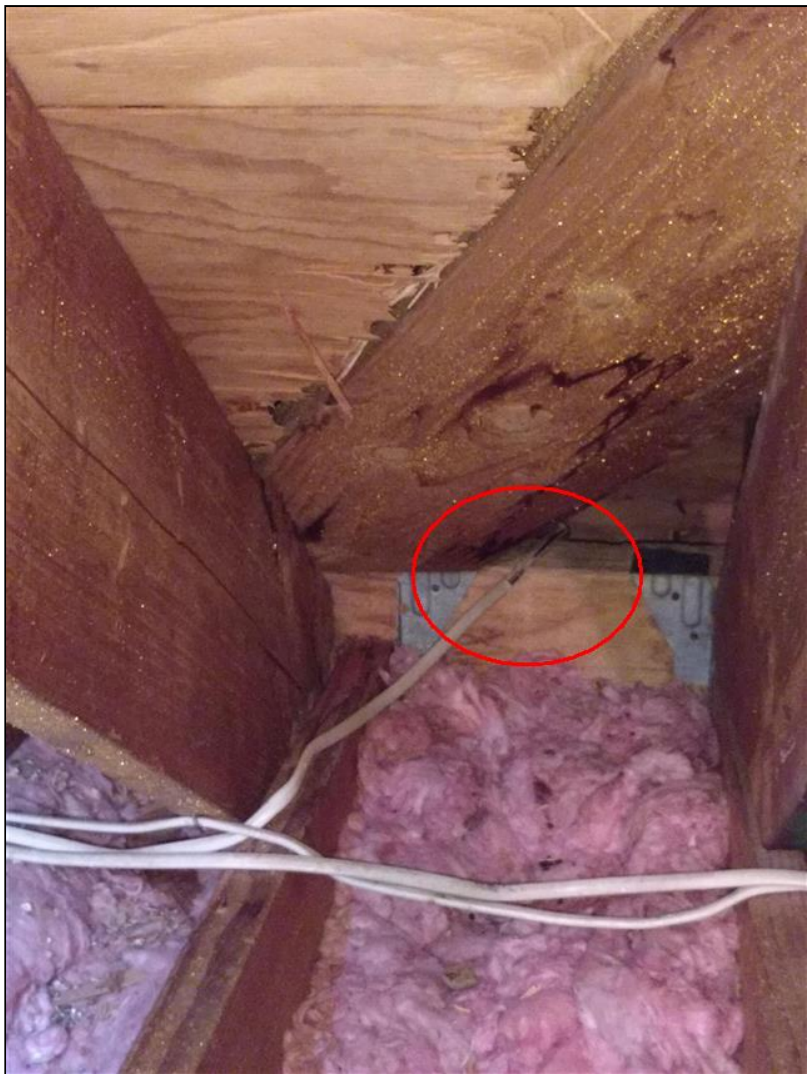
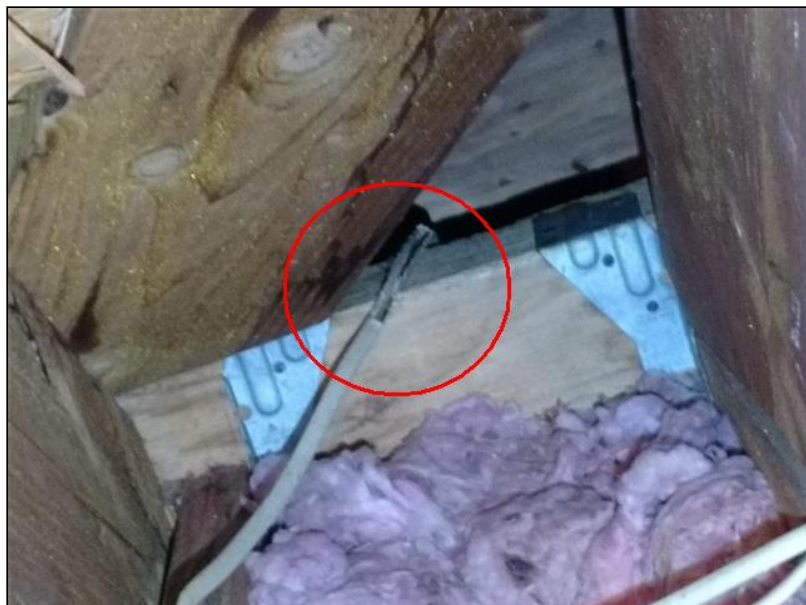
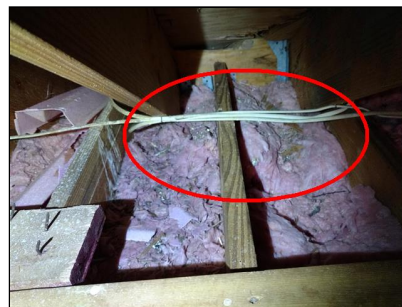
(2) As observed in the front portion of the attic space, there was at least two visible sections of the electric circuit branch wiring that were chewed/damaged from what was assumed to be a squirrel/mice, etc. There was other damage to the attic space. This is a MAJOR safety concern and a fire hazard. There may be other damaged wiring that was not visible. **The necessary repairs should be completed ASAP and ALL of the circuit branch wiring in the attic space should be further evaluated by a qualified, licensed electrician.**

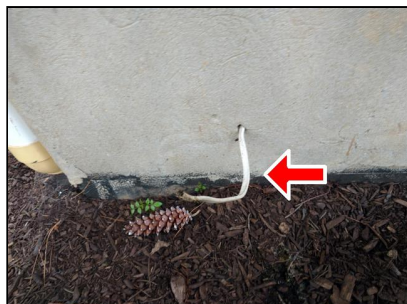
7.7 Item 9 (Picture)

(4) There was a wire sticking out of the front foundation wall. The wire was not live at the time of the inspection. This is a safety issue and a potential fire hazard. Recommend further evaluation by a qualified, licensed electrician and repair as necessary.

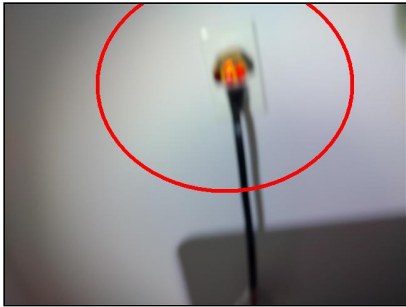
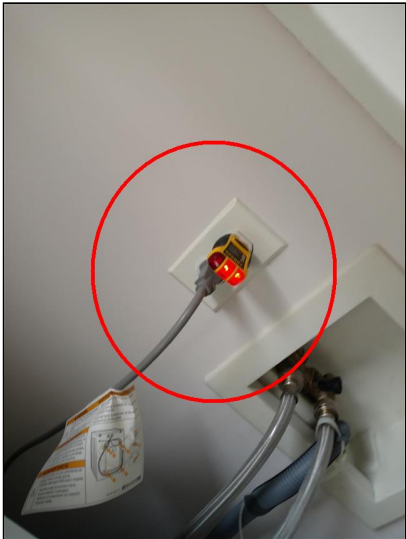
(1) The electric receptacle located behind the laundry area was not GFCI protected. Receptacles located on the exterior, in garages, kitchen sink area, bathrooms and laundry areas should be GFCI protected. A ground fault circuit interrupter (GFCI) is a device (outlet or circuit breaker) that shuts off an electric power circuit when it detects that current is flowing along an unintended path, such as through water or a person. It is used to reduce the risk of electric shock. They can also prevent fires, like when a live wire touches a metal conduit. For safety purposes, would recommend upgrading this receptacle.. This should be done by a qualified, licensed electrician.

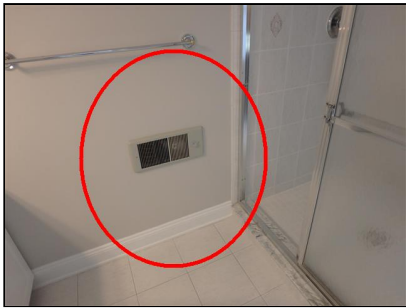
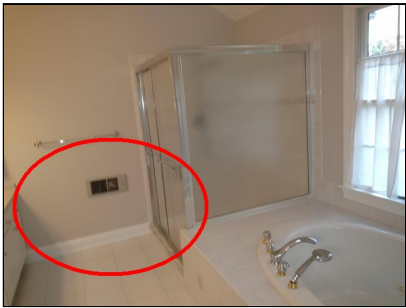
(2) There was a wall mounted electric heater present in the master bathroom. This is a safety issue as this heater is very close to an open water source and it is not appear to be GFCI protected. For safety, GFCI protection is required in all areas within a close proximity of a water source. A ground fault circuit interrupter (GFCI) is a device (outlet or circuit breaker) that shuts off an electric power circuit when it detects that current is flowing along an unintended path, such as through water or a person. It is used to reduce the risk of electric shock. They can also prevent fires, like when a live wire touches a metal conduit. For safety purposes, I would recommend a further evaluation of this heater for GFCI protection to be done by a qualified, licensed electrician.

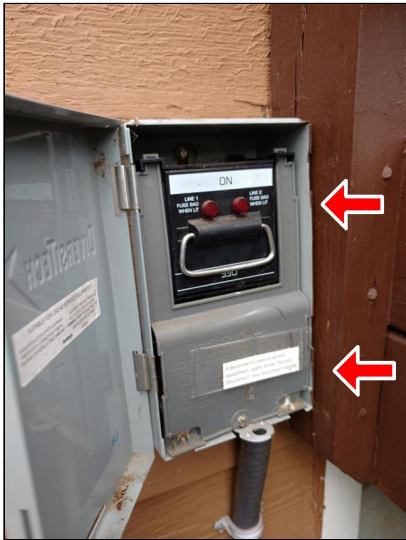
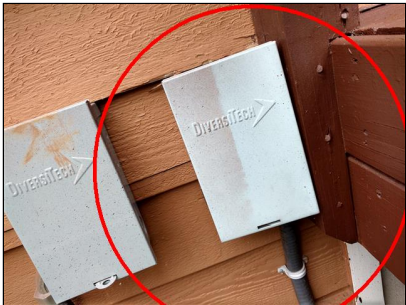
(3) One of the A/C disconnect switches front cover would not close all the way. It was hitting the deck. Recommend further evaluation by a qualified, licensed electrician and repair as necessary.

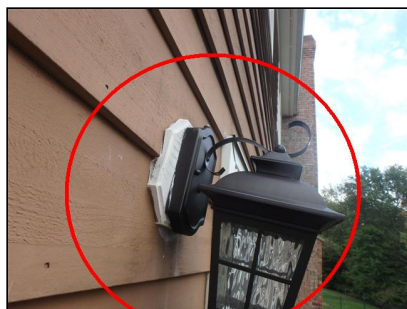
7.8 Item 7 (Picture)

(4) As observed on the exterior, some of the light fixtures were loose. Also, these light fixtures should be caulked/sealed on the top and sides of them to prevent water from getting into the wiring and the electric box they are connected to. A further evaluation of all of the exterior light fixtures should be completed by a qualified, licensed electrician and the necessary repairs should be completed.

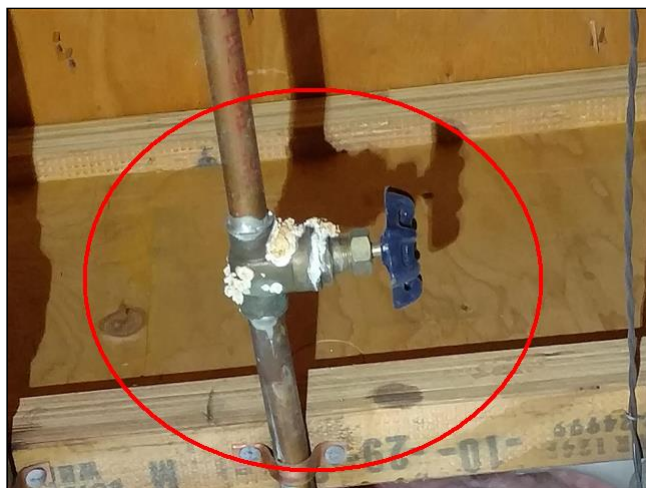
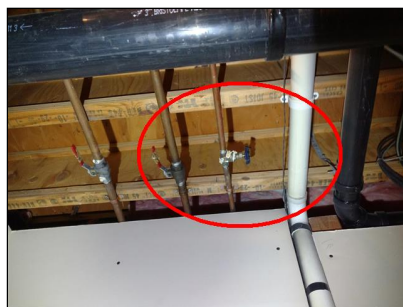
Testing of the water shut off valves located throughout the dwelling (especially the ones located in basements, crawlspaces, under sinks, behind toilets, etc.) and on the exterior for functionality is beyond the scope of the home inspection. Sometimes if the valves are turned/tested even just slightly, they may start to leak due to mineral buildup on the packings/seals. Also, due to age, corrosion and/or mineral buildup that may be on them, they may or may not function properly in the future in the event of an emergency or a need to service part of the plumbing system.

**Therefore, a further evaluation of ALL of the water shut off valves in the dwelling (basement, under sinks, behind toilets, etc.) and any on the exterior should be completed by a qualified, licensed plumber and any necessary repairs/valve replacements should be completed.**

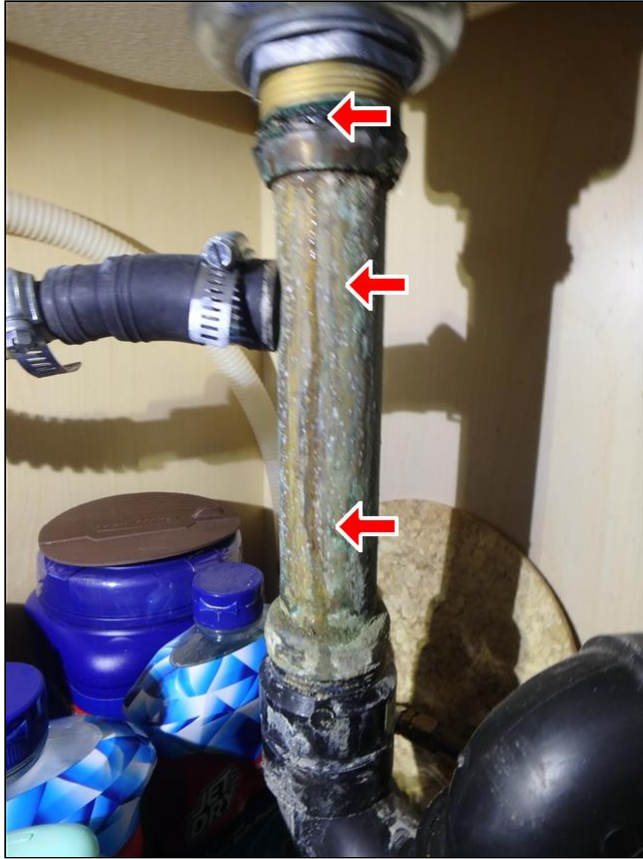
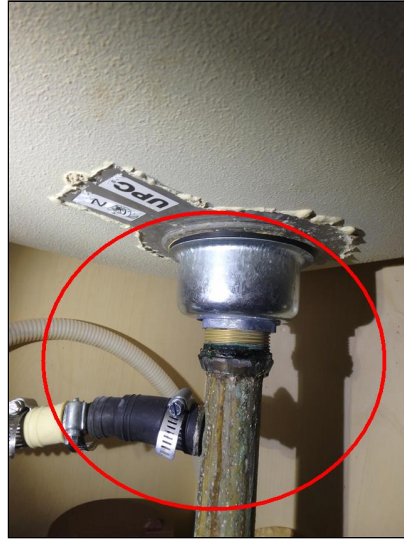
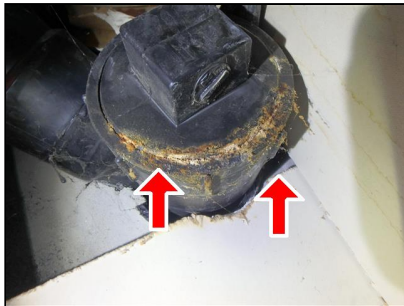
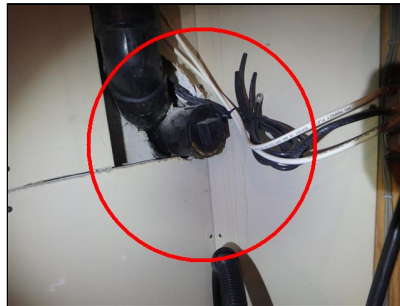
(1) As observed in the dwelling, there were numerous sections of the DWV (drain, waste, vent) piping that were ABS. While the interior visible portions appeared to be in a serviceable condition, the underground portions may be compromised. The main concern is the portions that run from the house to the sewer main. To insure the main DWV system is 100% functional, it is recommended the DWV piping be scoped by a qualified, licensed plumber/professional to ascertain the integrity of such piping.

(2) The kitchen sink drain was leaking. If this leak is not repaired, moisture damage to the surrounding area and/or a mold condition could occur. Also to note, in the basement next to the electric panel, one of the clean out plugs on the ABS DWV piping may be leaking. There was staining on the outside of the pipe. Recommend further evaluation by a qualified, licensed plumber and repair as necessary.

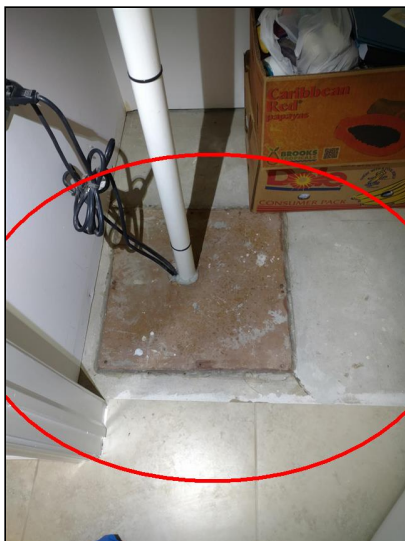
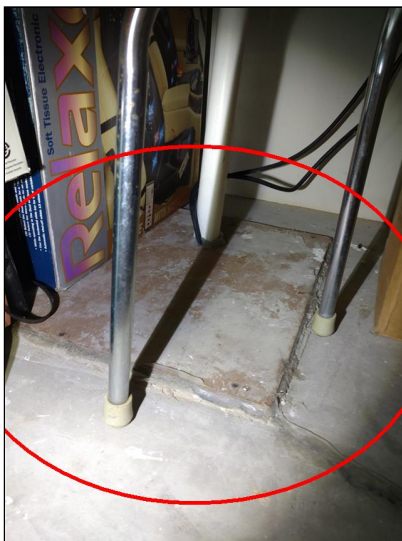
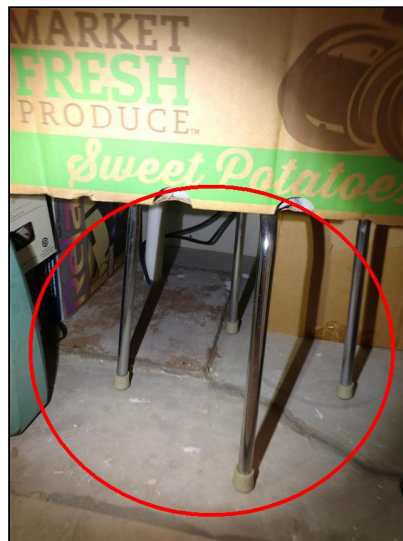
The top covers on the sump pump pits were sealed and could not be removed to check the operation of the sump pumps. Therefore, the inspection of the sump pumps, discharge piping and the sump pump pits was limited. The sump pumps could not be manually tested for proper functionality and may not be functional. The sump pumps should be further evaluated/tested by a qualified, licensed plumber to make sure it is functioning as intended to avoid possible flooding of the basement. Any needed repairs should be completed.

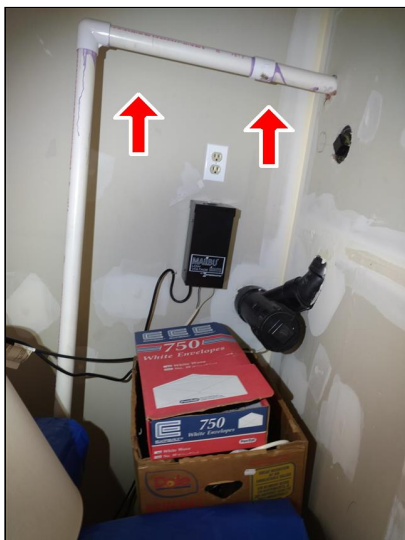
8.5 Item 1 (Picture)

(2) The left front sump pump drainage pipe was going out the left side foundation wall. But, on the exterior there was no drainage pipe visible. It is unknown where this sump pump is draining to which is a concern. It may back up or affect the function of the sump pump if it is not draining to the exterior in a proper fashion. Also, the discharge water could possibly migrate back into the foundation/basement. Recommend further evaluation by a qualified, licensed plumber and repair as necessary.

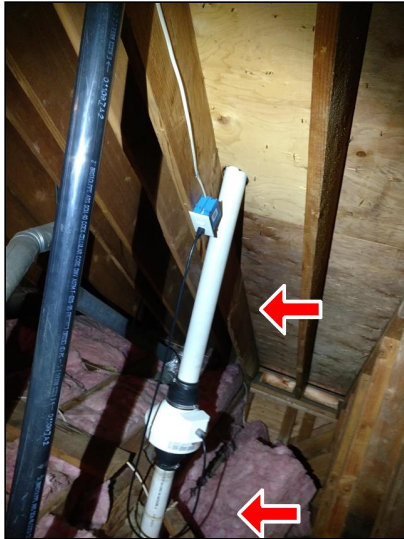
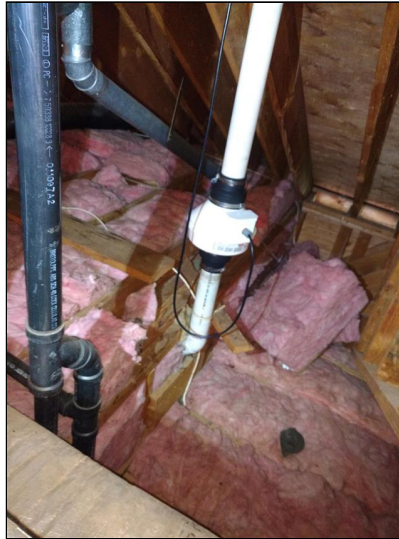
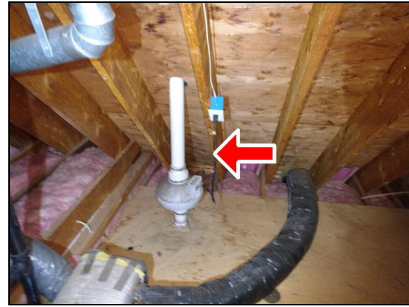
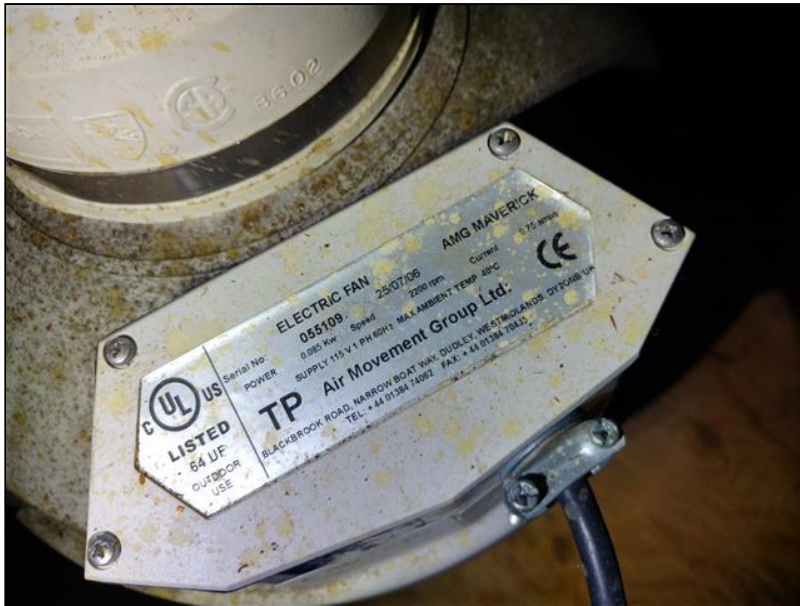
There were two active radon mitigation systems present. The suction fans were located in the attic and the basement was finished. The suction pipes/points in the basement could not be viewed. The radon systems did not have a warning device. A warning device must be installed to alert you if an active system stops working properly. Examples of system failure warning devices are: a liquid gauge, a sound alarm, a light indicator, etc. The warning

device must be placed where it can be seen or heard easily. This is a concern as not having potentially non-functioning radon mitigation systems is a health hazard for the occupants. **A further evaluation of the ENTIRE radon mitigation systems should be completed by a state licensed radon mitigation contractor and the necessary repairs should be completed to insure the safety of the occupants.**

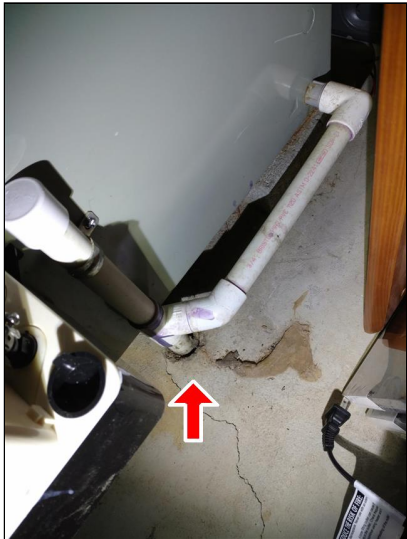
10.0 Item 2 (Picture)

(2) The condensate drain pipe for the basement furnace was draining the condensate (water) it produces into the basement concrete slab. This is not an ideal arrangement as this condensate may cause the earth under the basement concrete floor to undermine which may cause damage to the basement floor. This arrangement may also cause a high humidity level in the basement space. Some townships will allow this arrangement and some will not. Ideally, the condensate should be draining into the condensate pump that the A/C is draining into. Recommend further evaluation by a qualified, licensed HVAC professional and repair as necessary.
