# Property Inspection Report

**Property Address:**  
9 Big Court  
Great City New Jersey 07000

**Frank Glomb**

**Terra Home Inspections LLC**

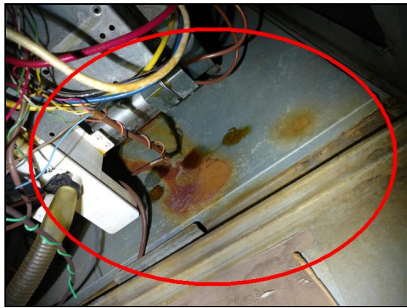
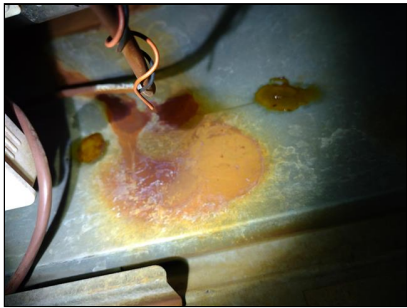
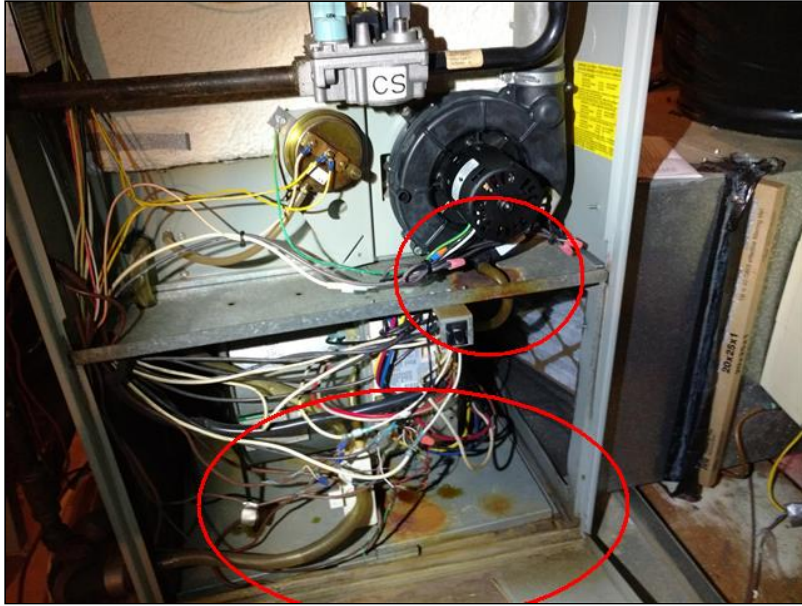
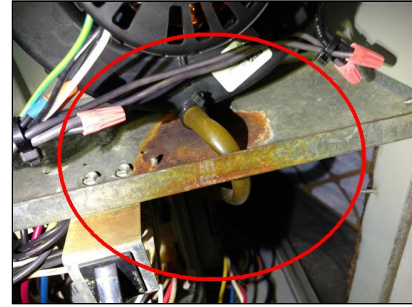
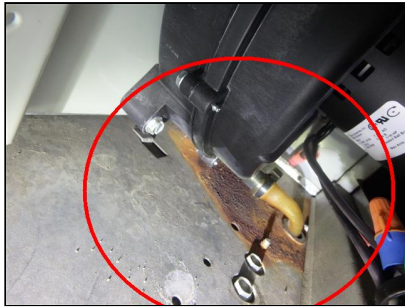
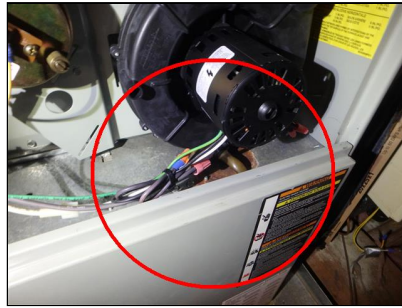
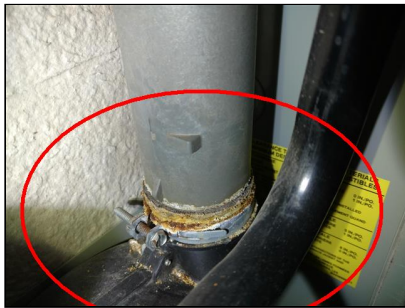
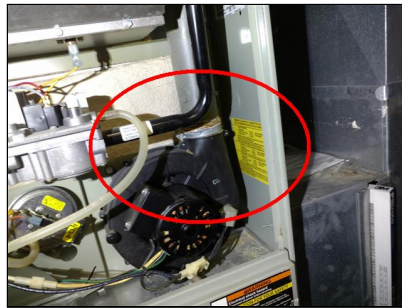
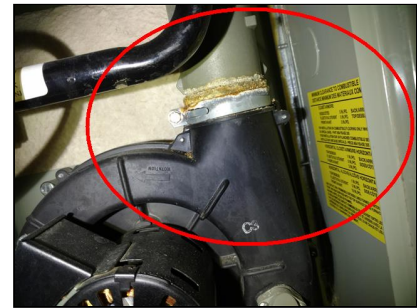
(3) As observed in attic furnace, these was water stains in the top compartment under the draft inducer blower unit. The attic unit had a large amount of rust in the bottom compartment as well. The draft inducer or surrounding components may be leaking. This condition may cause moisture damage to the furnace as well as affect the performance of the furnace. There was also some corrosion on the draft inducer in the basement furnace. **A further evaluation of BOTH of the furnaces should be completed by a qualified, licensed HVAC professional and any necessary repairs be completed. As noted elsewhere, these units were original and around 25 years old.**

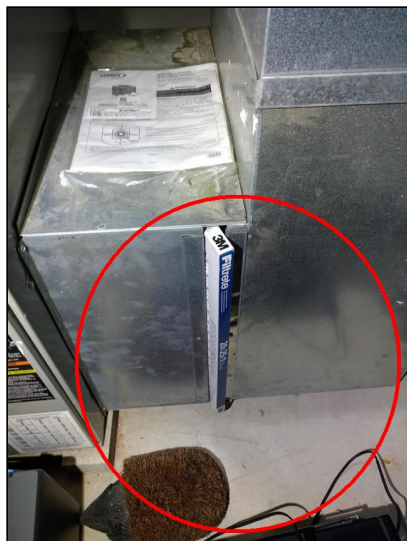
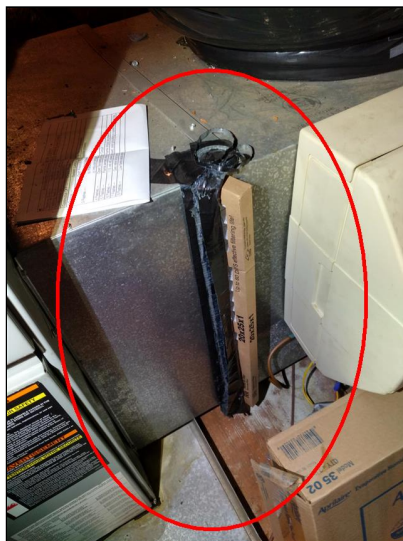
The installed disposable type filters for the HVAC units were not the proper size for the return air ducting they are installed in. The filter should be inside the ducting and the opening in the ducting for the filter should be covered. This is a potential health concern as it may effect the indoor air quality as well as possibly changing the pressure balance of the system. It could also cause the water heater to possibly backdraft. Recommend further evaluation by a qualified, licensed HVAC professional and repair as necessary.

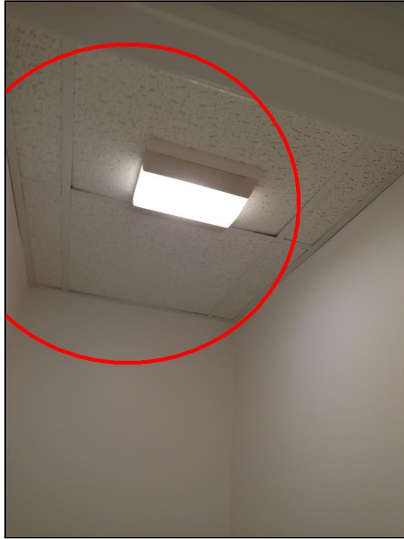
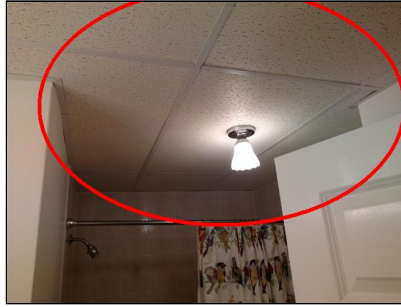
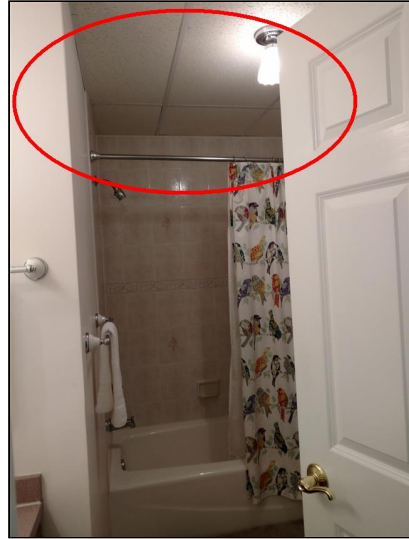
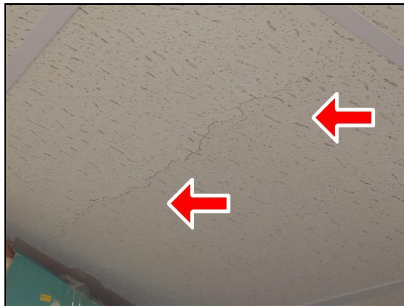
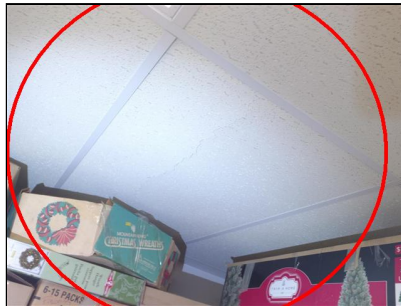
There was a drop ceiling present in the basement bathroom which covered the entire ceiling. This is an issue as the metal framing could possibly rust due to the moisture while taking a shower and also moisture could possibly get trapped in the space above the drop ceiling and the floor subfloor above. Mold could possibly form on the ceiling tiles as well as the space above the drop ceiling. There was an exhaust fan in the bathroom but it was in the toilet closet and not in the central shower area.. Recommend further evaluation by a qualified, licensed contractor and repair as necessary. Also to note, there was a crack ceiling tile in the basement.

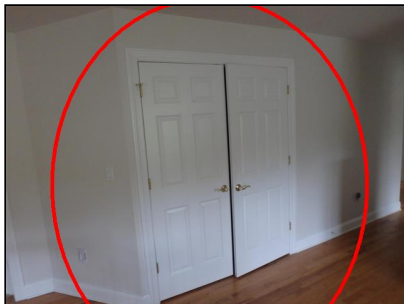
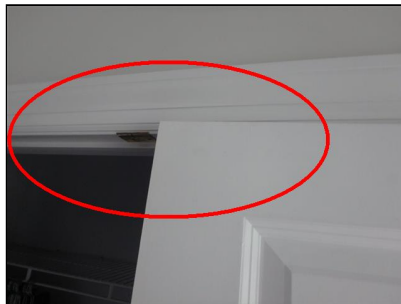
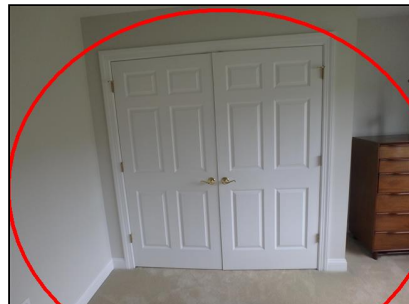
As observed on the 2nd floor, there were numerous doors that would either not close all the way and latch, were damaged/deteriorated, were rubbing on their door frames, were not functioning as intended and/or had missing and/or damaged hardware. These conditions may worsen as well as possible future damage to the doors/door frames if the necessary repairs are not completed. A further evaluation should be completed by a qualified, licensed contractor and the necessary repairs be completed.

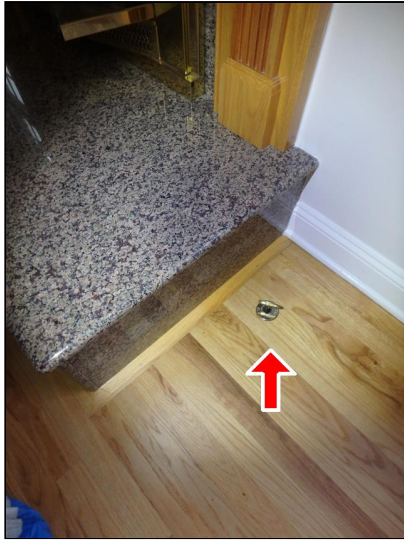
12.8 Item 1 (Picture)

(1) The NFPA (National Fire Protection Agency- [www.NFPA.org](http://www.nfpa.org)) highly recommends an annual inspection of all fireplaces and chimneys. They also recommend that an inspection take place upon the transfer of a property, the replacement of a solid fuel burning appliance, or following an external event likely to have caused damage. Our inspection of the fireplace(s) and/or chimney components is limited to the readily, visible components/areas. This visual inspection is not adequate to discover hidden deficiencies or damage should they exist. A NFPA 211 Standard, Level 2 inspection entails the use of specialized tools and testing procedures, such as video cameras, etc., to thoroughly evaluate/inspect the chimney(s) and/or fireplace(s) system/components. Therefore, it is highly recommended a level 2 inspection of all of the fireplaces and/or chimneys pertaining to the dwelling be performed before closing and/or any contractual deadlines. Additional information pertaining to fireplace/chimney inspections can be found in Chapter 14 of the NFPA 211 standard. <http://www.nfpa.org/codes-and-standards/document-information-pages?mode=code&code=211>

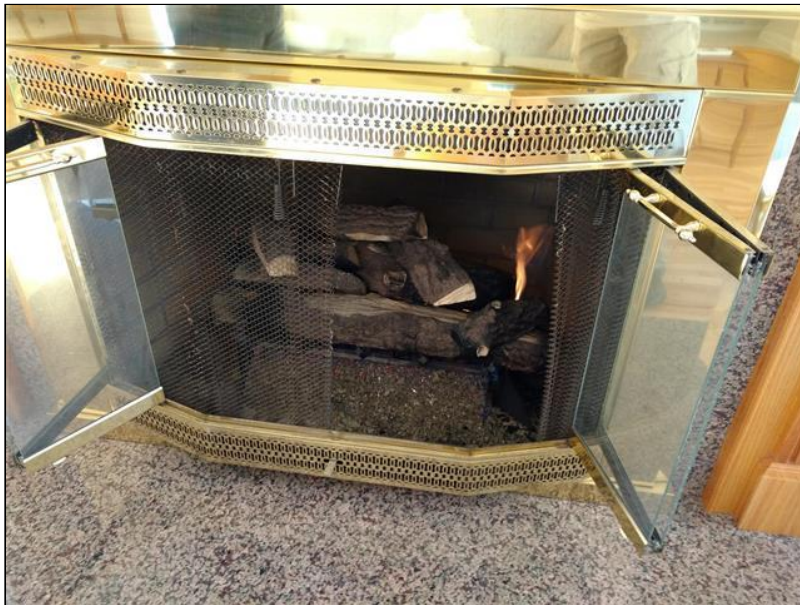
10/18/2021 UPDATE The homeowners operated the gas fueled fireplace on 10/15/2021 when the radon test was retrieved. The fireplace is functioning as intended.

12.8 Item 3 (Picture) Fireplace functioning

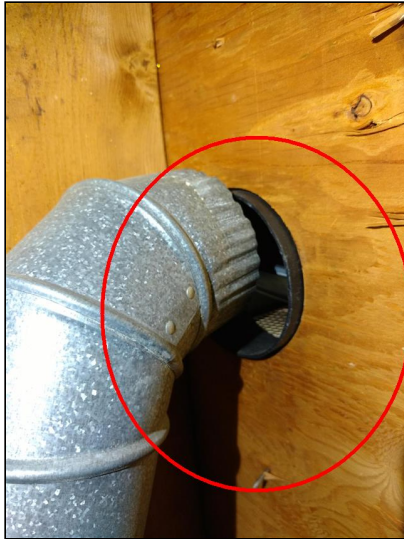
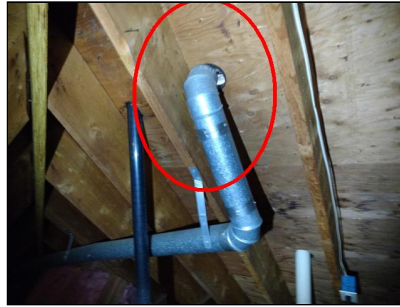
As observed in the attic space, one of the bathroom exhaust fan vents was not secured to the roof mount. This venting should be terminated outdoors and may cause moisture damage/a mold condition to the surrounding structure if the needed repairs are not completed. Recommend further evaluation by a qualified, licensed contractor and repair as necessary.

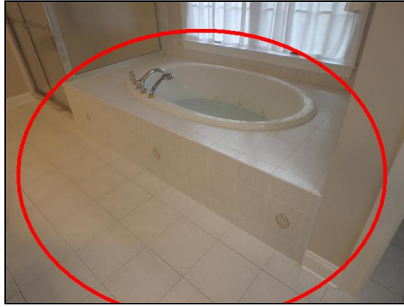
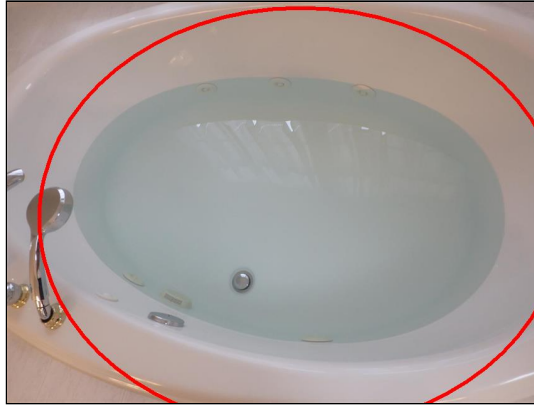
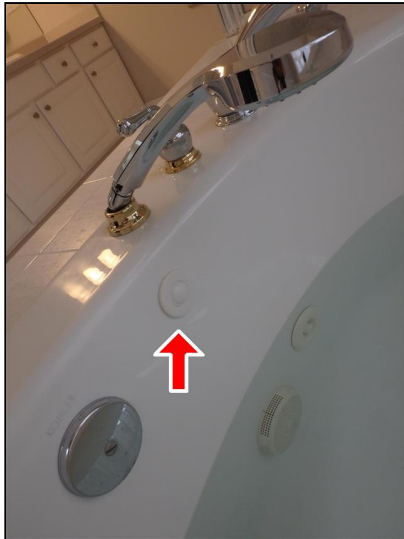
In the master bathroom, there did not appear to be any access in the side of the whirlpool tub structure to service the motor/pump if need be. This is a safety issue as well as the fact that you would have to remove some surrounding tiles to access the motor/pump which is under the whirlpool tub. Also, the whirlpool tub was not functioning. The jets didn't turn on. Recommend further evaluation by a qualified, licensed contractor and repair as necessary.

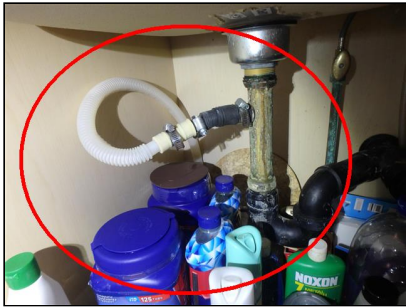
14.5 Item 1 (Picture)

The drain line on the dishwasher is not high looped under the countertop. The dishwasher drain line under the kitchen sink should be looped up as high as possible in the cabinet and up under the countertop. This prevents dirty/contaminated water from the sink from back flowing into the dishwasher. Recommend further evaluation by a qualified, licensed plumber and repair as necessary.

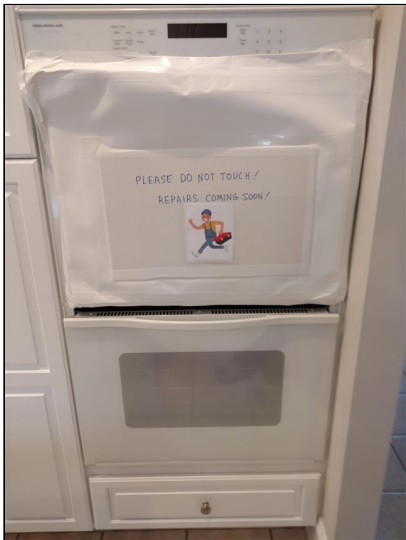
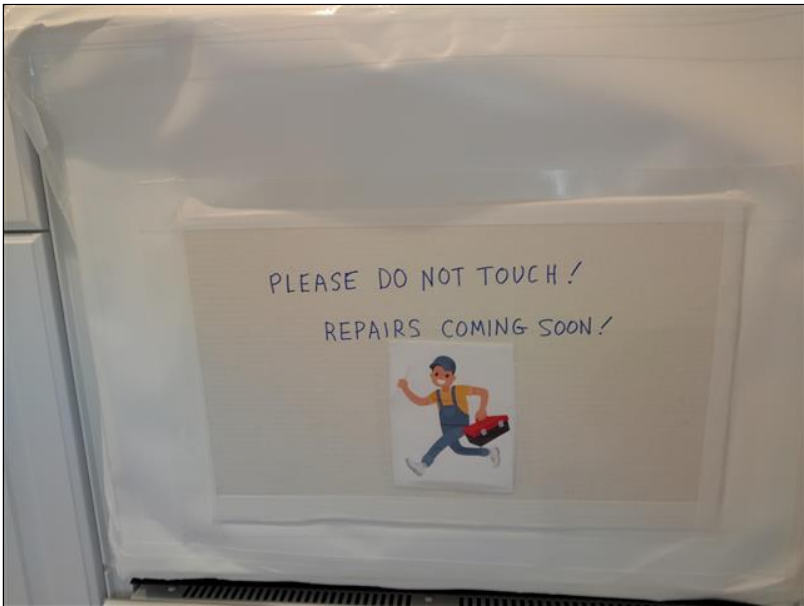
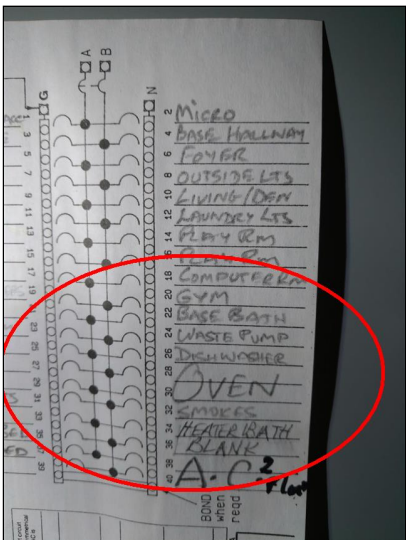
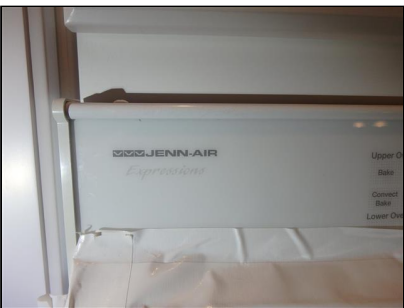
The wall oven was not functioning and was being repaired. Recommend further evaluation by a qualified, licensed appliance professional and repair/replace as necessary.

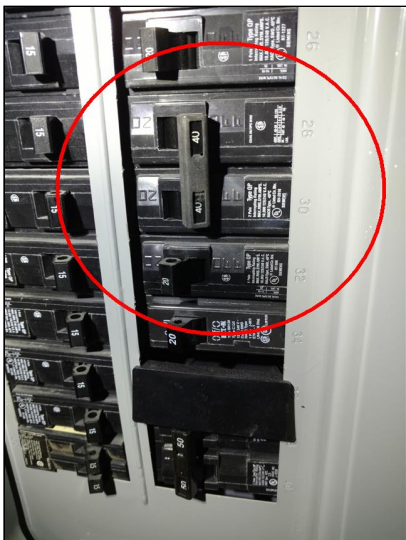
14.9 Item 3 (Picture) Circuit breaker off

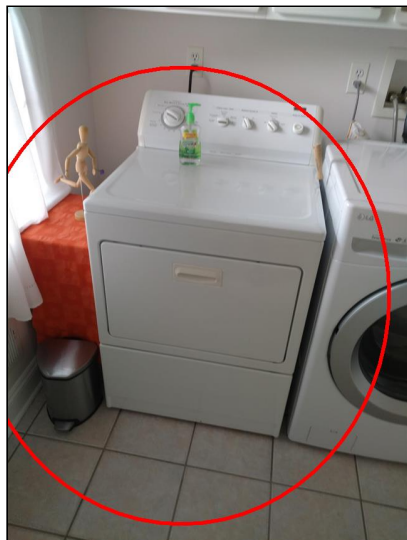
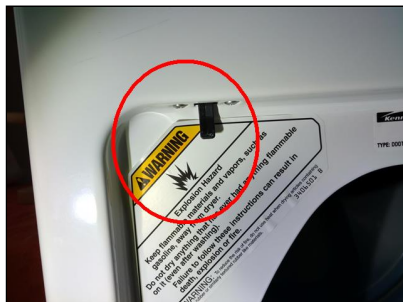
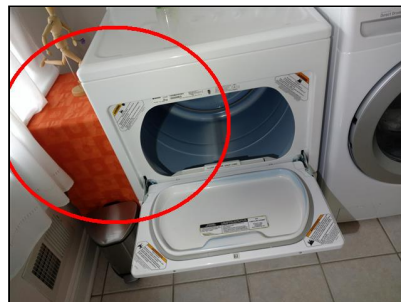
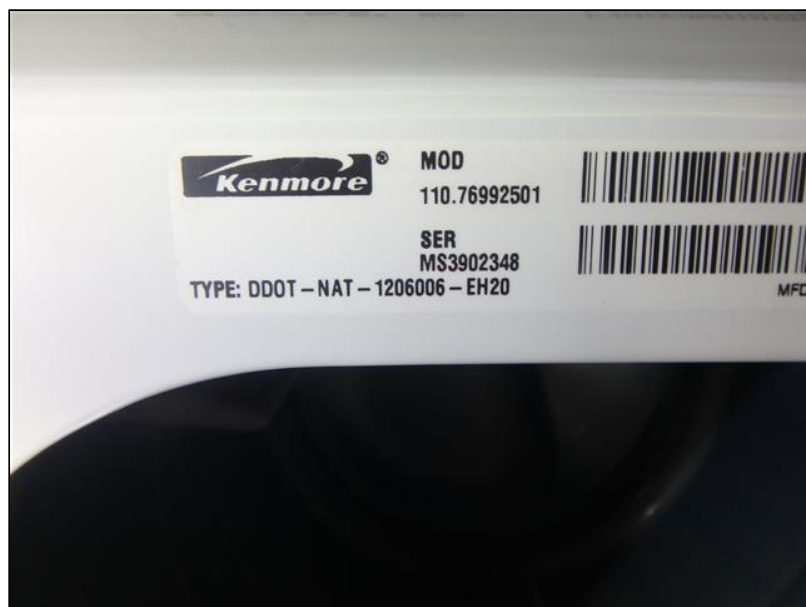
The safety switch that turns the dryer off when the front door is opened was not functioning which is a MAJOR safety concern. Recommend further evaluation by a qualified, licensed appliance professional and repair as necessary.

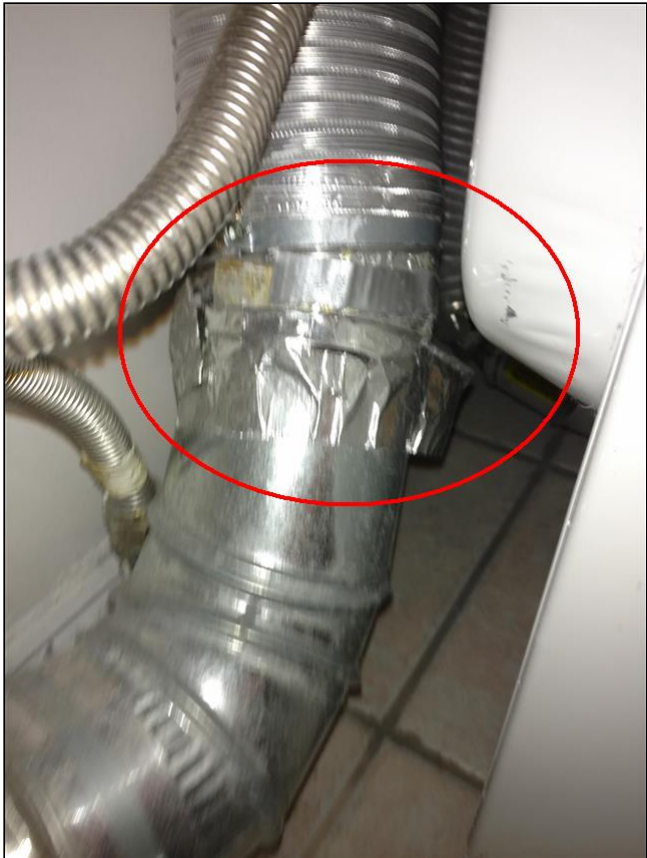
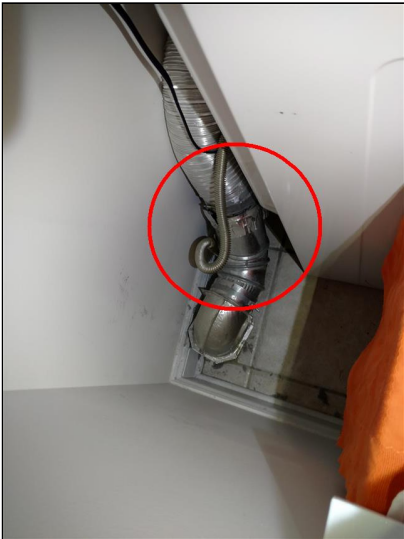
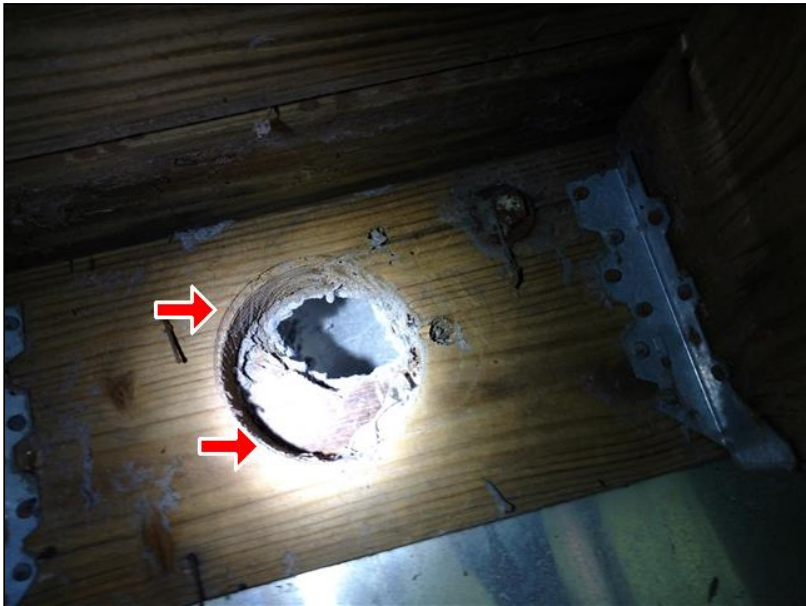
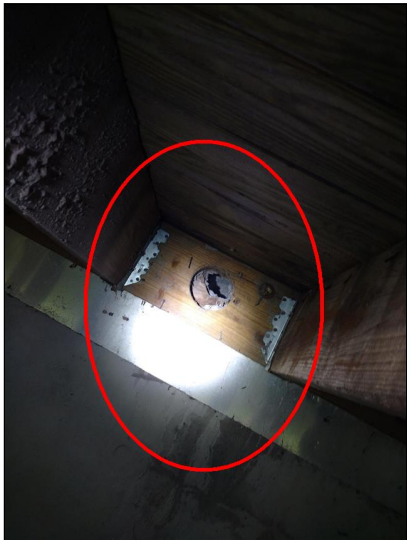
The exterior vent assembly for the clothes dryer was missing. This condition could allow unwanted wildlife to enter the vent ducting which could affect the performance of the clothes dryer and possibly restrict the venting which may start a lint fire in the vent ducting or dryer. The dryer duct was also semi-blocked by the deck ledger board. The dryer ducting was also disconnected behind the dryer. The ENTIRE dryer ducting should be repaired ASAP by a qualified, licensed contractor.
