Home Inspection Report

**Delk
Home
Inspections**

Sample Inspection Report, Gloucester, Va.

Report Number: 4534 Temperature: 50's Conditions: dry

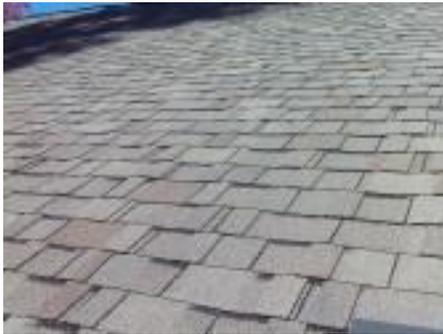
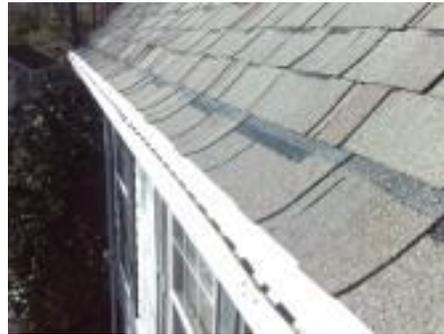
The roof, gutters, downspouts and gutter guard are in good condition overall. No deficiencies were observed. No leakage was observed.

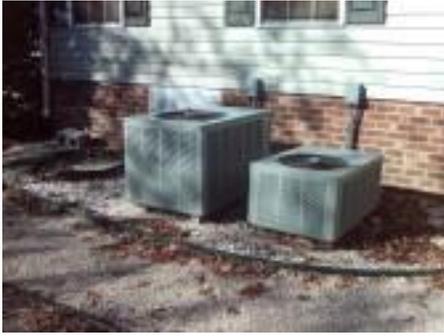
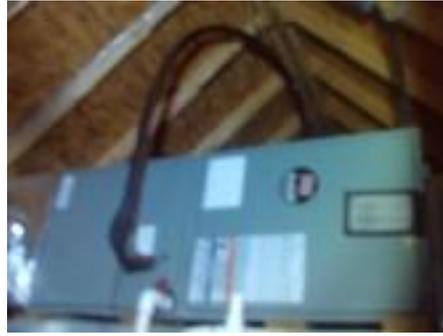
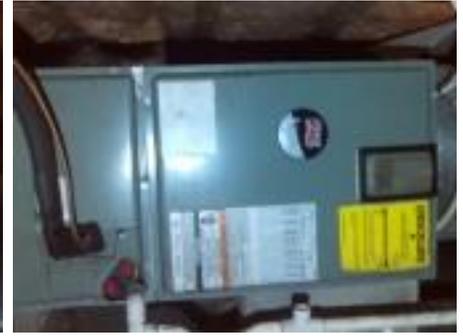
Both systems were tested and performed properly. The units appear to have been properly serviced since new. No deficiencies were found. Yearly cleaning/servicing is recommended by the manufacturer.

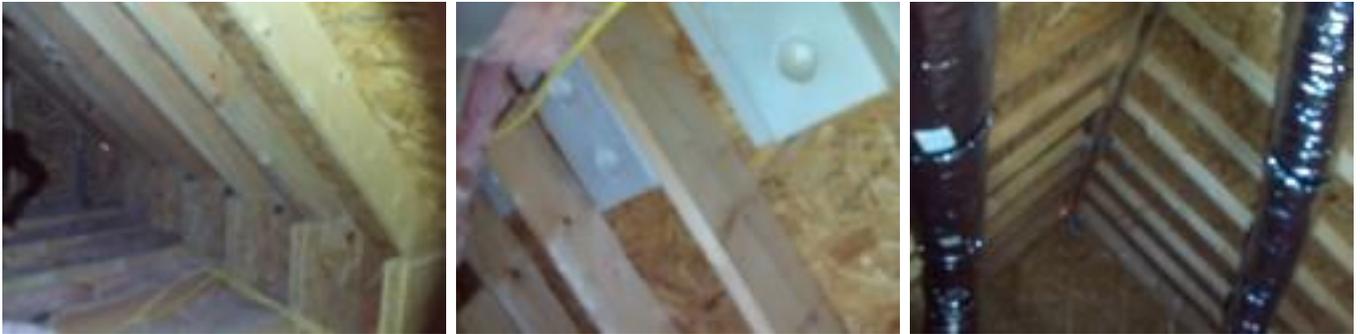
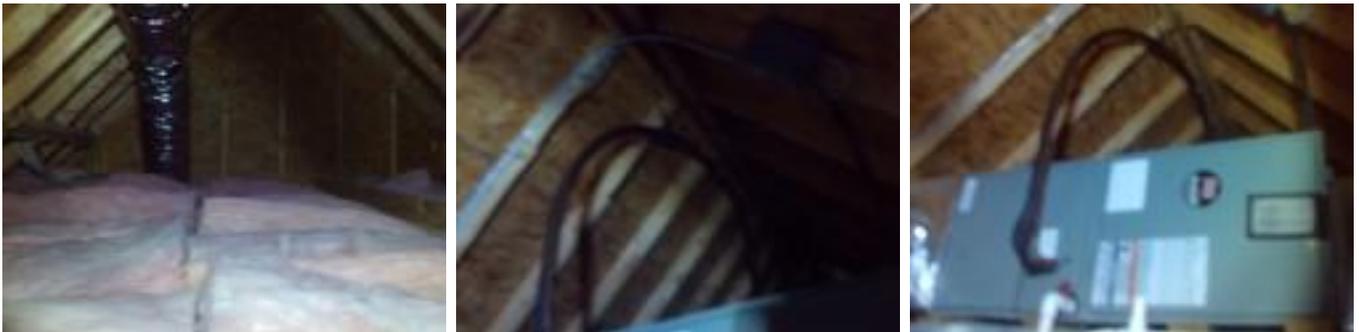
All attic spaces are properly ventilated and insulated. Access is not difficult for the 2nd floor air handler. No leakage or structural issues were observed.
